USDA Forest Service
Shasta-Trinity National Forest

Yolla Bolly Complex Trail Treatment Monitoring Report 2008

Executive Summary - Soil Quality Standards and Soil Productivity

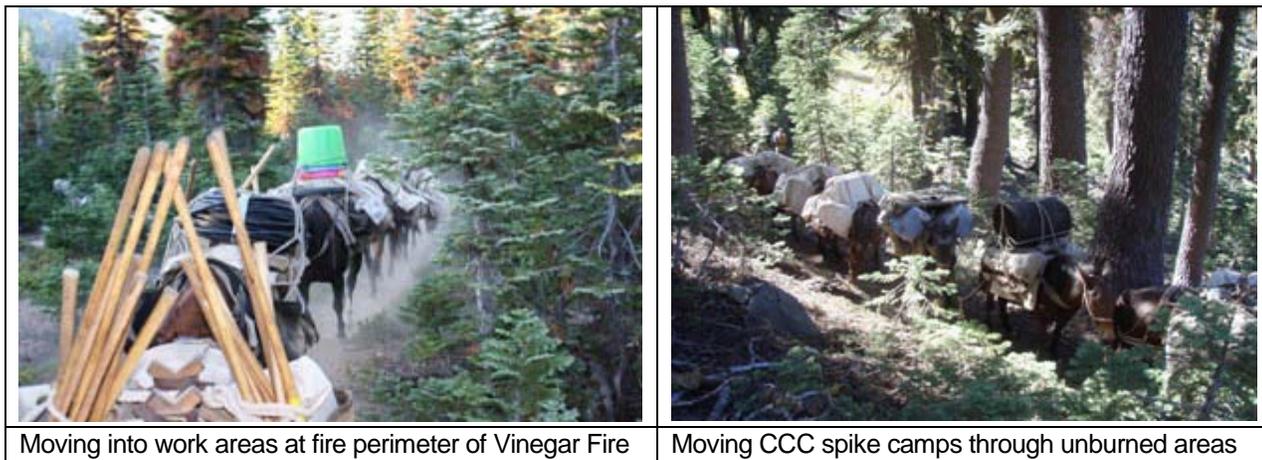
Moving into work areas at fire perimeter of Vinegar Fire

Moving CCC spike camps through unburned areas

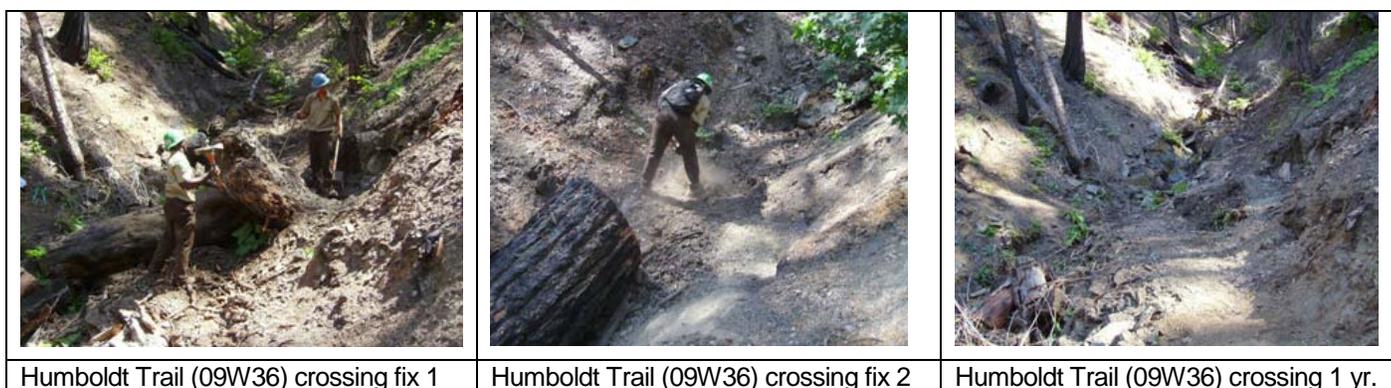
Figure 2: Trail Crossing Repair on Humboldt Trail in Timber and After One Year

Results: On the average for areas that were timbered with low to moderate soil burn severity trail crossing treatments were highly effective (Grouse Fire see Table 1 below). In areas with timber/brush cover (Vinegar Fire) that was burned moderate to hot, trail crossing treatments were highly effective vs. trail burnout treatments were moderately effective due to settling (see Figures 2 and 3 below). With areas that had dominate brush (Yellow and Vinegar Fire S-facing steep slopes) and high soil burn severity, treatments (crossing armoring, waterbars, burnout repairs) were moderately effective due to increased overland flows.

Recommendations: Use large rocks and place small rocks and gravel to reduce undermining of trail stream crossings. For stump burnouts, pack dirt and rocks into burnout and leave excess soil on top for settling. For areas that were very steep (greater than 60% slopes) and on exposed burned slopes, concentrate treatments on stream crossings and water-baring to stop trail flow capture (see Figure 3 below).

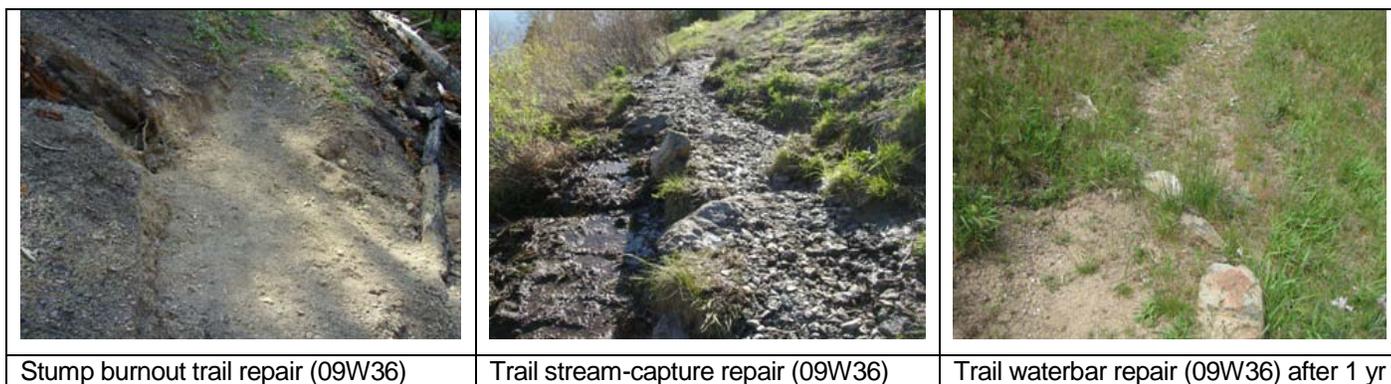
Figure 3: Trail Repairs on Humboldt Trail in Brush/Timber and After One Year

High burn severity areas in brush had erosional pavement between bushes where all fine soil was washed away leaving rock fragments as cover. Erosion recovery in these areas expected to recovery in the next 5 years.
