**Snodgrass Mountain Geologic Hazards
and Assessment of Potential Effects of
Ski Area Development on Slope Stability**

TECHNICAL REPORT

October 12, 2006

**by
United States Forest Service
Grand Mesa, Uncompahgre and Gunnison (GMUG)
and San Juan National Forests**

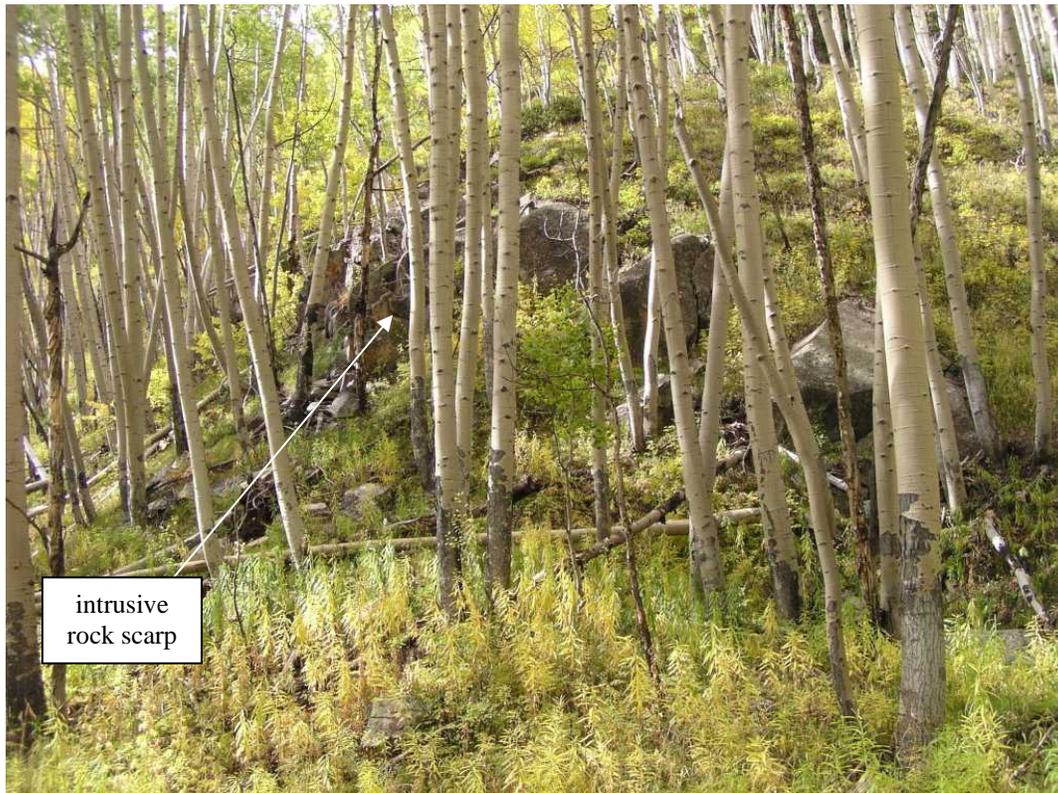
The Upper West Slide is bowl-shaped and it appears that a massive landslide originated at this location and deposited much of the soil and rock that forms the Lower West Slide. It is called the “Landslide Evacuated Area” by Irish (1996) and RCE (1995) mapped a continuous scarp along the sides and rim of this slope, supporting this interpretation. The bowl is characterized by steep scarps, some with sparse vegetation and slump blocks. These slide features developed after the major slide event suggested above. Baum (1996), based in part on the USGS geologic mapping (Gaskill, 1991), mapped the top of the West Slide at the top of ridge, which includes the more obvious of these more recent features. Towards the upper part of the slide, intrusive igneous rock is visible in the scarps, as seen in the following photograph (el. 10,250’). Upslope

from the larger scarps at the head of the slide are small scarps and evidence of rapid soil creep indicating that retrogressive failure up the slope is occurring.

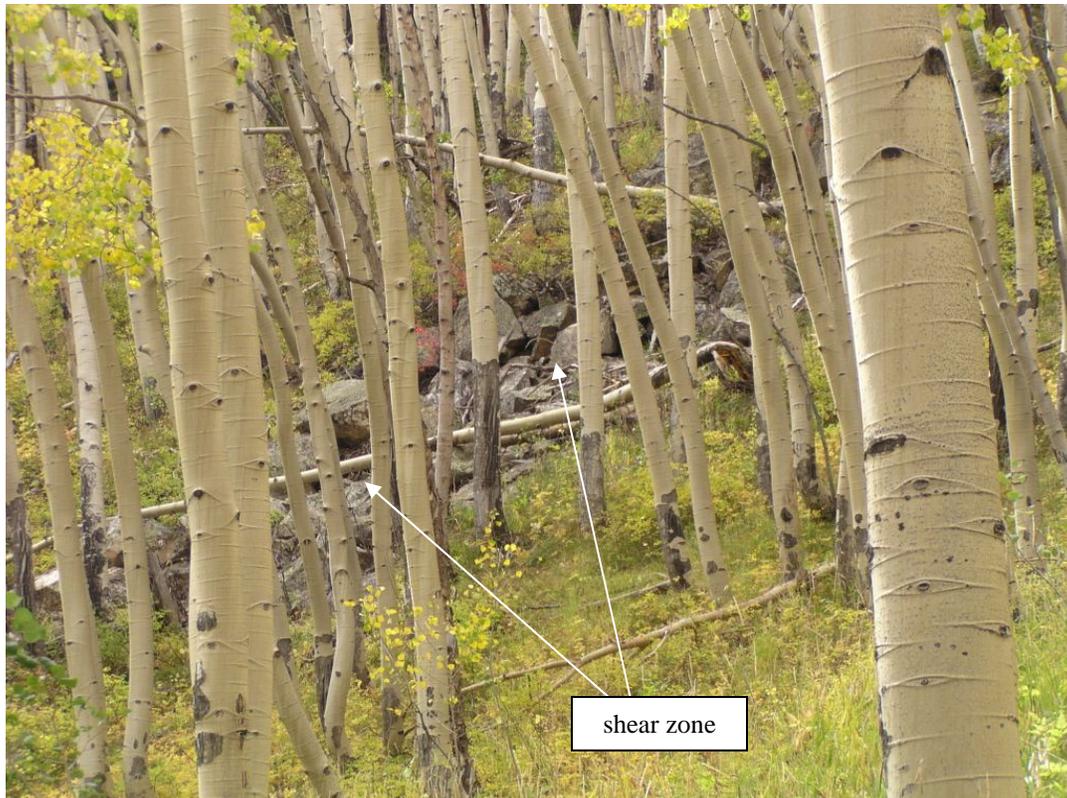
There were two areas of recent shear zones observed in the Upper West Slide. These shear zones, based on the small amount of leaves and litter between the fractured rocks, may have occurred within the past several years. Just to the east of the rock scarp shown in the above photograph (el. 10,200’), there is a fresh 25-foot-wide shear zone that extended about 100 feet uphill. This shear zone is shown in the following photograph.

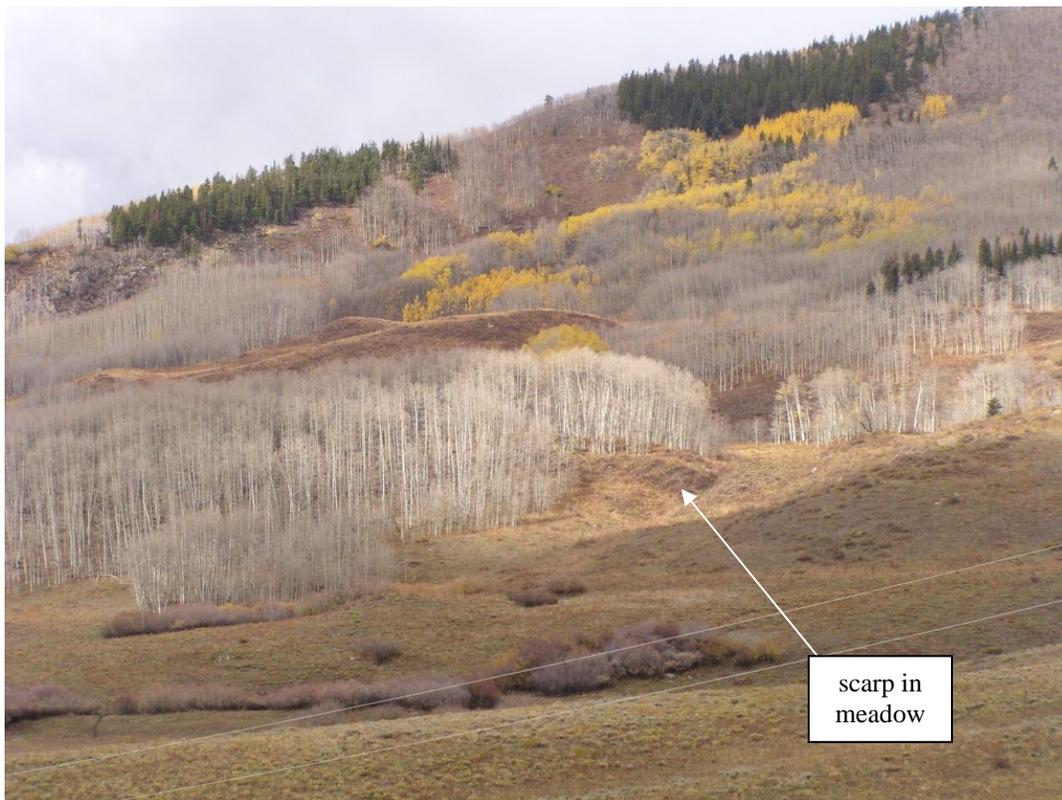
The Slump Block and West Slide Complex are separated by the Lower Earthflow and an Unnamed Drainage. To the northeast, the Slump Block adjoins and is partially covered by the earthflow portion of the Lower East Slide, making movement of the Slump Block older. The source area is probably from the northwest where large, clearly-defined scarps are still evident in the lower part of the Middle Slide Complex and the Lower West Slide. The surface is hummocky with numerous old scarps and leaning and curved aspen. On aerial photographs, the tree canopy appears irregular and mottled. To the north of the forested portion of the Slump Block, there is an undrained depression formed by a smaller slump. Surface runoff has eroded a small steep gully in the slope below the depression, exposing bare soil. This slope is part of a scarp that starts in the meadow and extends into the aspen, as seen in the middle of the following photograph.

Both on and below this scarp there are numerous leaning trees. Near the northern edge of the Slump Block and adjacent to the Lower East Slide (el. 9,650') there is a ranching fence that is clearly bowed in the downhill direction. Some of the posts have been nearly pulled to the ground by tension on the wire. Based on the displacement of the fence, undrained depressions, and the leaning trees, this slump on the larger Slump Block is considered active (less than 100 years old).

It is not likely that the Slump Block will move en mass, but based on the easily identifiable slump scarps, hummocky topography, disrupted drainage, leaning trees and mottled tree canopy, most of the slopes of the Slump Block should be considered only marginally stable and future localized failures are likely, and more likely with disturbance.

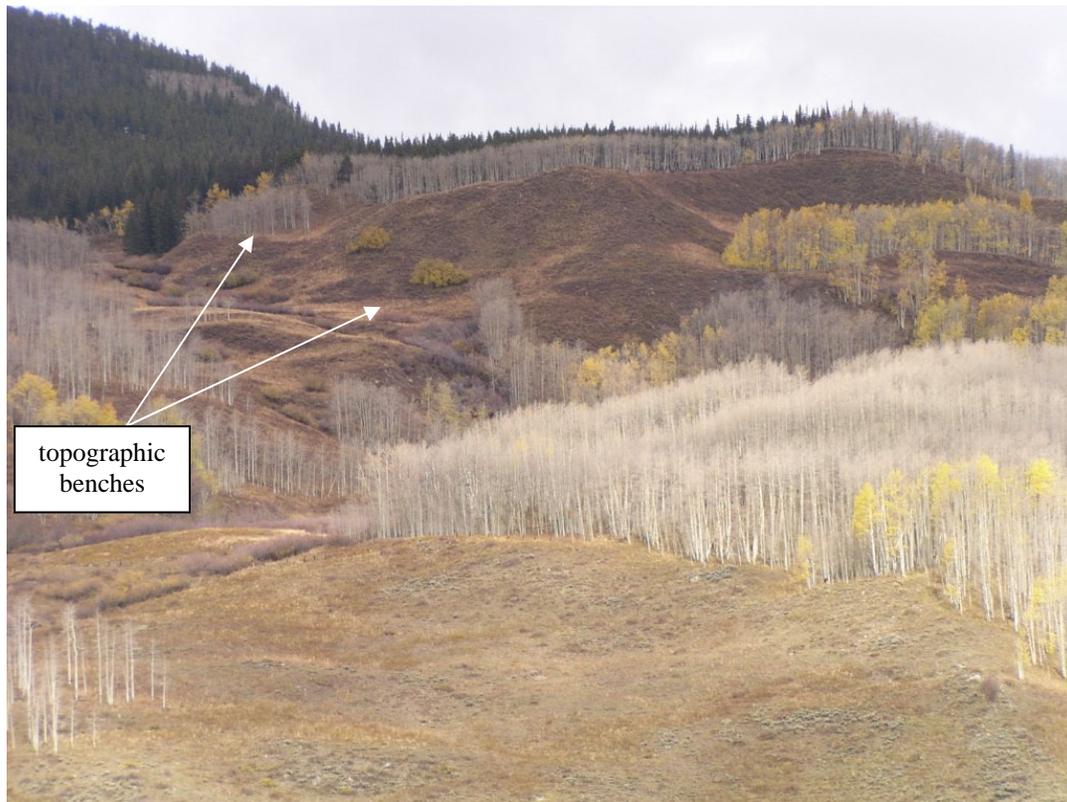
RCE (1995) and Irish (1996) included the Middle Slide Complex as part of the East Slide and Baum (1996) as part of the West Slide. Primarily for convenience in preparing the risk assessment, but also because of some differences in the nature of the landslides from the other areas, the Middle Slide Complex is treated as a separate unit. It consists of numerous scarps and associated slump blocks that, in some cases, transition into earthflow deposits. A series of retrogressive scarps and slump blocks characterized by topographic benches extend up the slope along the northeast side of the Unnamed Drainage, as seen in the following photograph.

Wetlands with poor surface drainage and at least one undrained depression are in this area. Movement of these landslides has been towards the southeast. This series of scarps and slump blocks is roughly parallel to the Unnamed Drainage and the Lower Earthflow. Steep scarps in shale are not stable over the long term and it is probable that this series of slides, through renewed movement, will become an earthflow complex similar to the East Slide Complex.

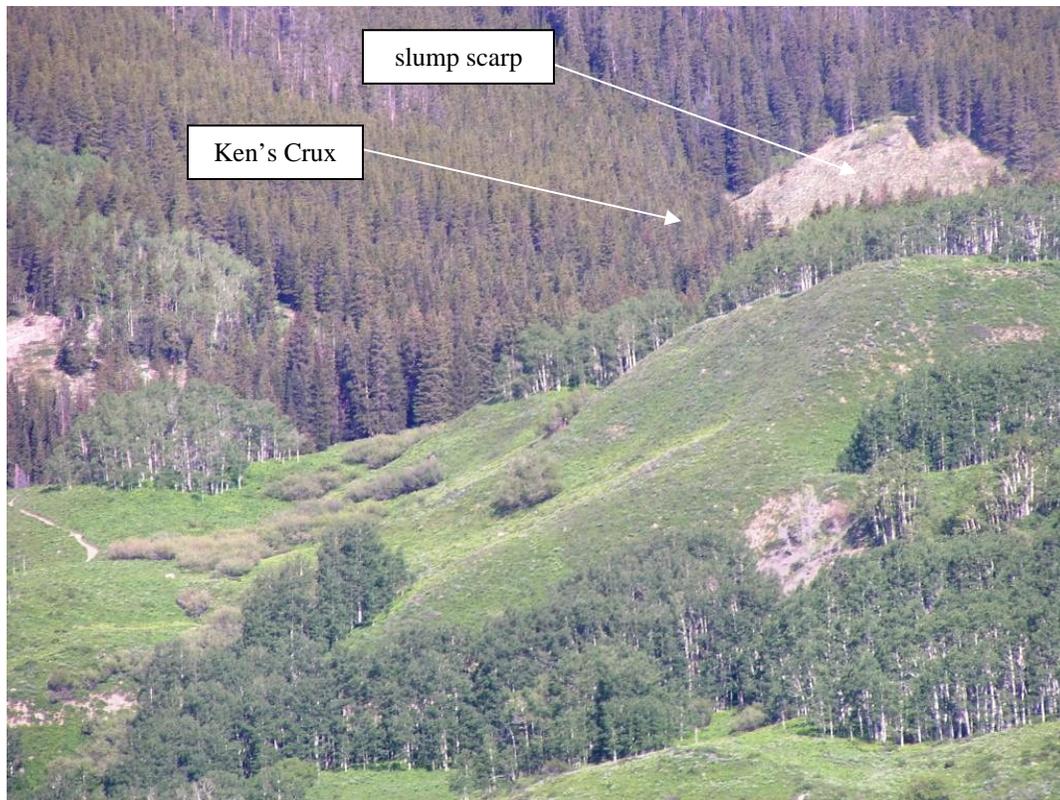
Several slumps at the head of the Middle Slide Complex have moved to the south towards the Unnamed Drainage. The scarps with the least vegetation are the lowest in elevation and

probably the most recent. Several of these scarps and the associated slides, including one with the prominent bare spot (shown in the following photograph), have removed material from the East Slide Complex.

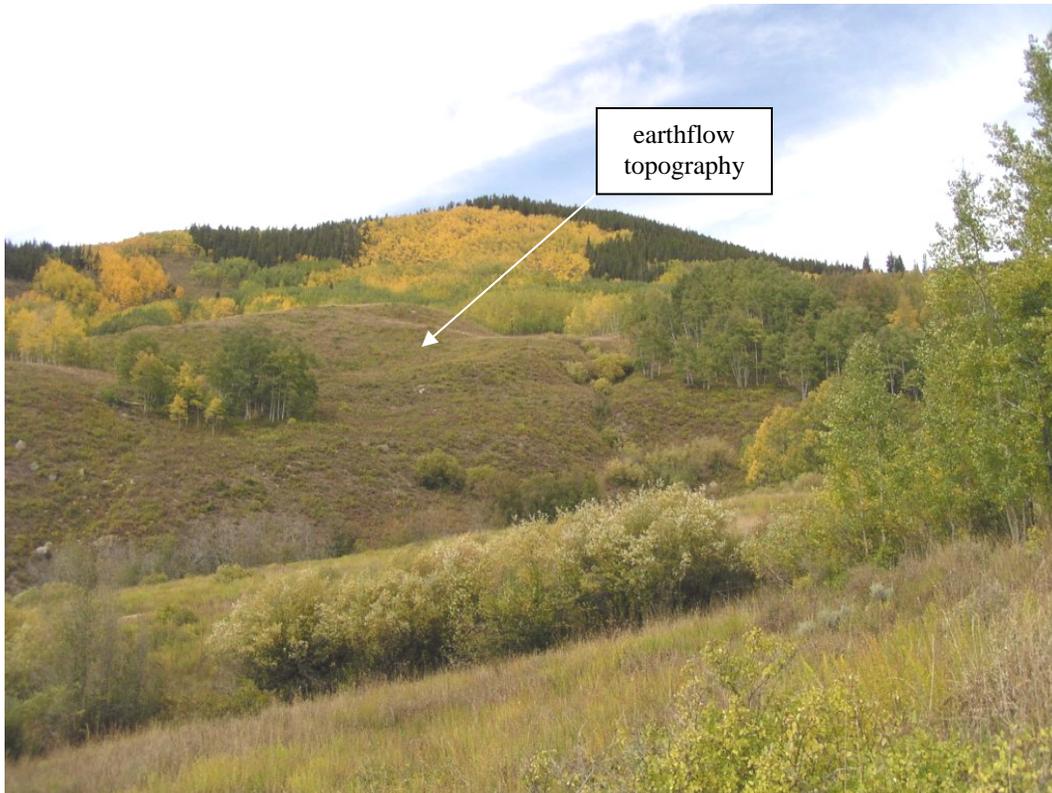
The ground slope on the Lower Earthflow varies but is generally under 20% down to the south and southeast. Evidence that this unit is an earthflow includes a plant community indicative of a high water table, low gradient hummocky surface, lobate form, roughly parallel drainages on each side, and the lack of mature aspen and conifers on its surface. Some of these features can be observed in the following photograph, taken looking northwest at the middle portion of the Lower Earthflow.

No recent cracks were observed on the surface along two traverses of the slide, which supports but does not prove that the earthflow is not currently moving. Other than the two traverses, this unit was not viewed in great detail on the ground. The lower end of this unit appears to have pushed the stream in the valley bottom against the opposite side. On aerial photos the stream does not appear to have eroded the toe of the slide and the channel gradient upstream from the slide is flatter than downstream. It is not clear whether this large lobe is part of the earthflow that extends upslope between the Slump Block and the Middle Slide Complex or is part of the West Slide Complex. However, in either case, the fresh appearance of the lobe on aerial and ground photos is evidence of massive movement within probably the past few hundred years.

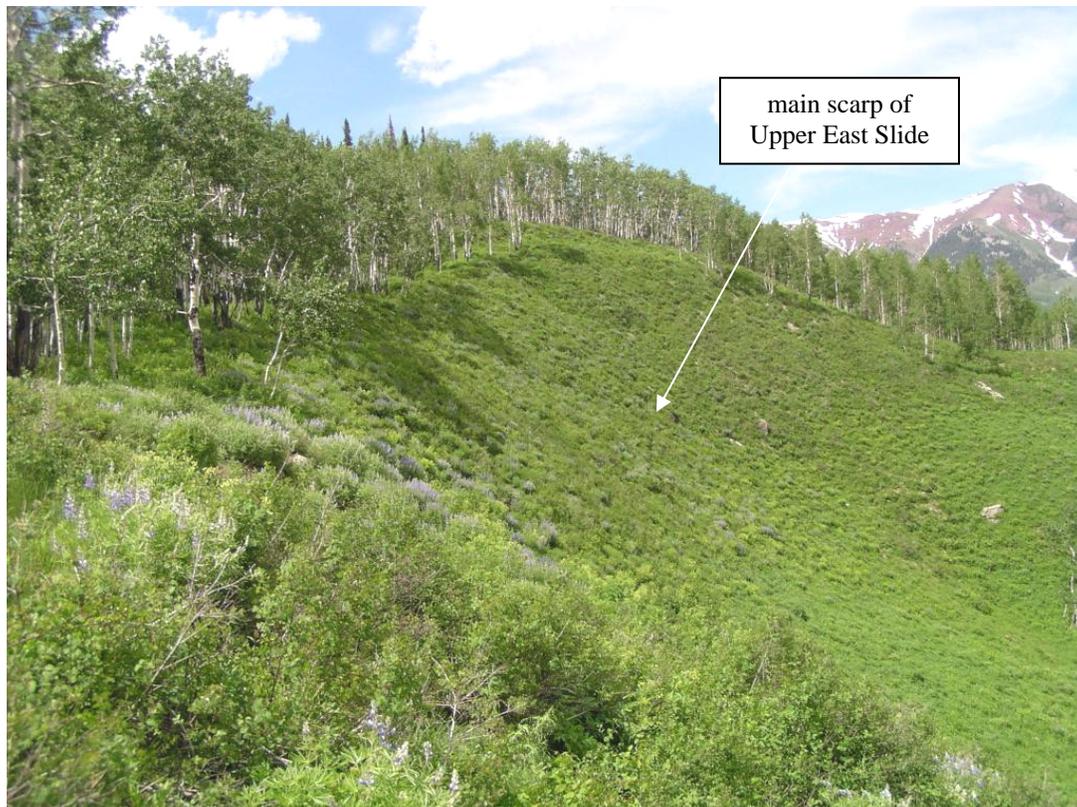
depressions. It is important to note that within the Upper East Slide (el. 9,960'), McCalpin and Burke observed fresh transverse soil cracks in a topographical trough that was probably formed recently by a rotational slump.

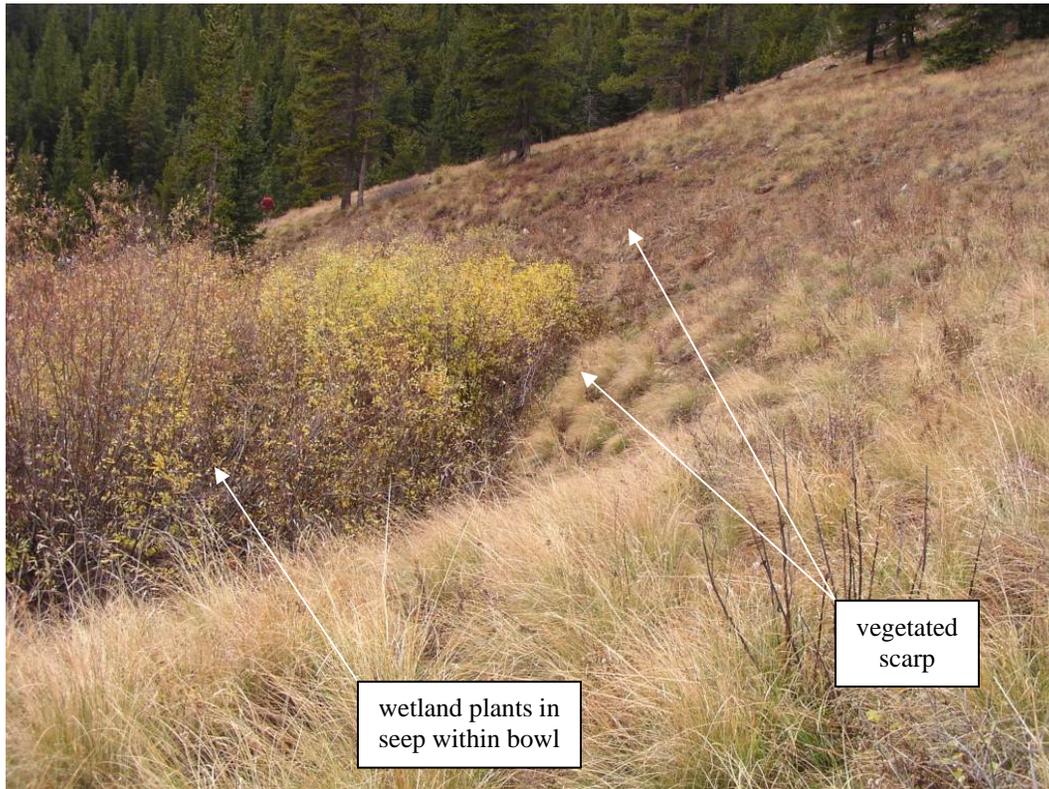
only shallow movement of the near surface soils over shale. The meadows are hummocky with numerous visible scarps, indicating previous slumping, some of which are probably less than 100 years old. One such vegetated scarp is shown in the following photograph. Note the wetland plants in the bowl of the scarp, suggesting groundwater seepage in this area. Although the Unnamed Drainage was dry throughout the Chicken Bone unit, there is evidence of some springs in the area, such as this one.

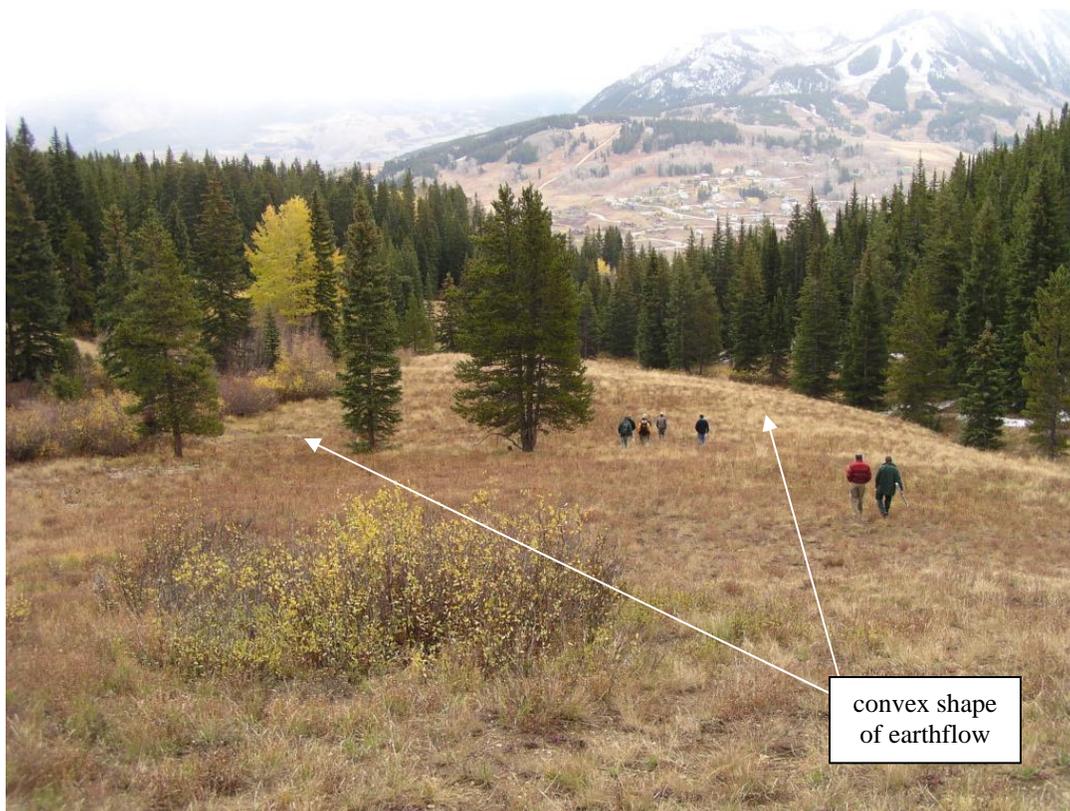
The slumps are on relatively low gradient slopes (generally under 20%) with numerous wetlands and seeps suggesting that the underlying bedrock and main sliding surface is shale. Along the west edge of Chicken Bone there are earthflow deposits from slope failures on the lower slope of the East Facet (GHU #7). It appears that most of the Chicken Bone area, as well as some of the upper slopes of the East Face (GHU #12), were formed by deposition from an older massive landslide originating on the East Facet to the northwest. Also, between the Unnamed Drainage and a parallel spring-fed stream to the northeast that originates in the wetlands below the scarp shown in the above photograph, there is a gentle low ridge that has the morphology of an earthflow. This convex-shaped surface bounded by parallel drainages is shown in the following photograph.

Some leaning trees were observed on this probable old earthflow, but no cracks in the ground were seen. Recent, slow movement is likely but major movement may have occurred over 100 years ago and it appears relatively stable. Although scarps and earthflow morphology is present in this unit, they were likely formed during past, wetter conditions.

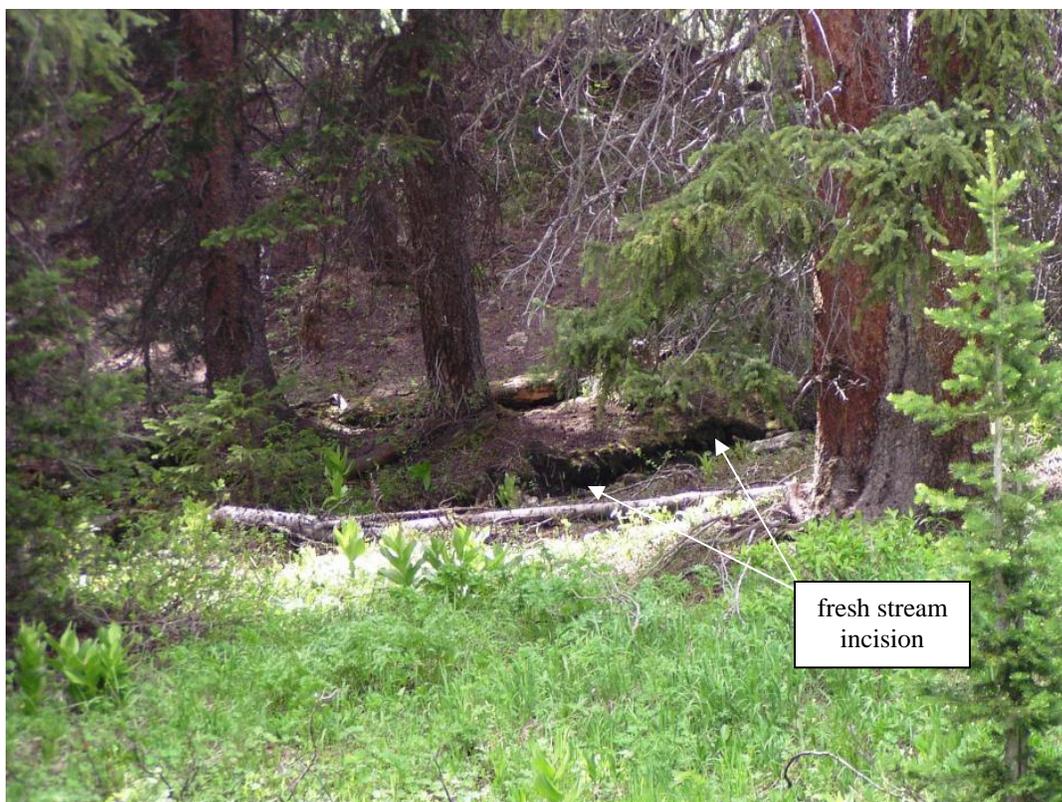
The eastern part of the Chicken Bone unit is thickly forested with mature conifers except for an arcuate open area north of the narrow ravine (Ken's Crux) in the Middle Slide Complex (GHU #3). This open area is clearly seen as an arcuate feature on the detailed topographic map of Snodgrass Mountain (Map 1) near the southeast edge of the unit at an elevation of 10,190 feet. The open area has topography consistent with being an eroded main scarp. It appears that this cleared area is the southeast half of a landslide that has been partially obscured by subsequent slope failures in the more open meadows to the northwest. Aerial photographs show subtle arcuate traces suggestive of slide movement upslope from this probable slide. Also, leaning and bent trees are in this area and the detailed topographic map shows arcuate and hummocky topography. A small stream with low but steep eroded banks and angular changes in direction is located just downslope of this open area. This freshly incised stream is shown in the following photograph. The recently eroded appearance of the stream channel and the leaning trees suggest slope movement within the last 100 years or less.

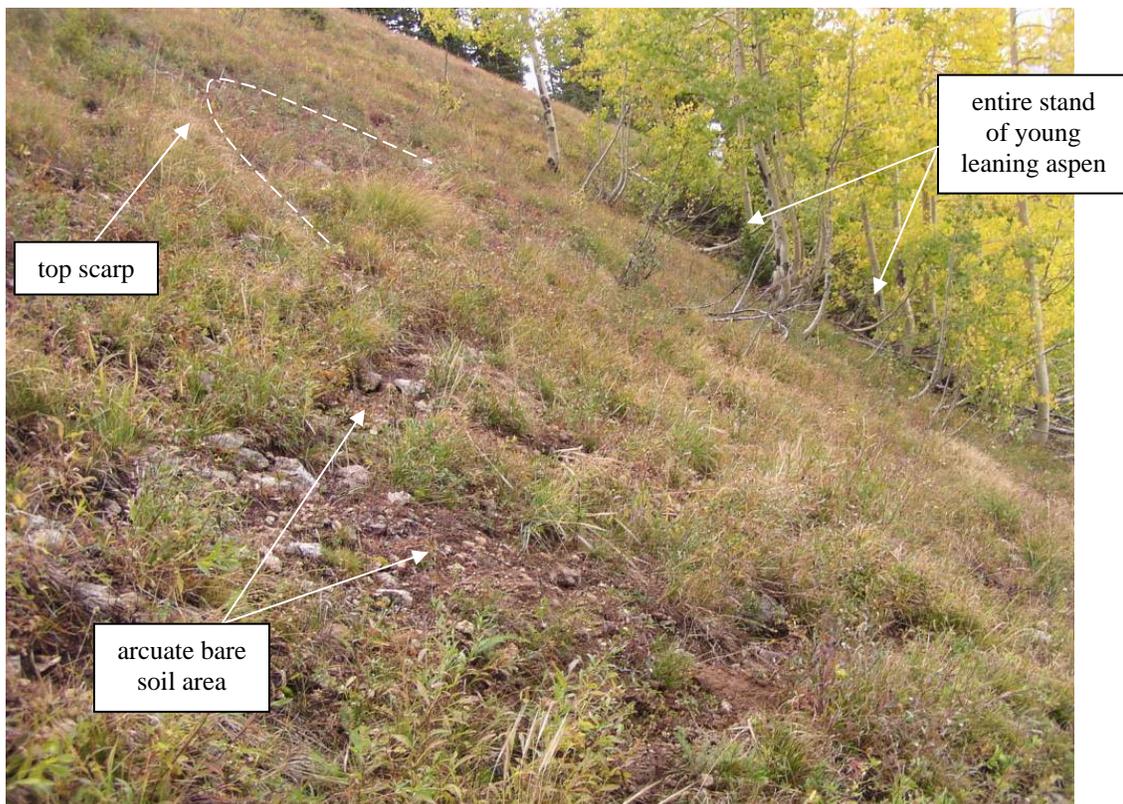
Several small aspen stands on the northeast portion of the area are on clearly identifiable small slumps and the small size of the leaning aspen indicates slope movement within the last 25 to 50 years. Also, within an area of sparse conifers a top scarp was clearly identifiable, as shown in the following photograph, near the middle of the East Facet at an elevation of 10,575 feet. The leaning and bent trees on the slide mass suggest ground movement within the past 100 years.

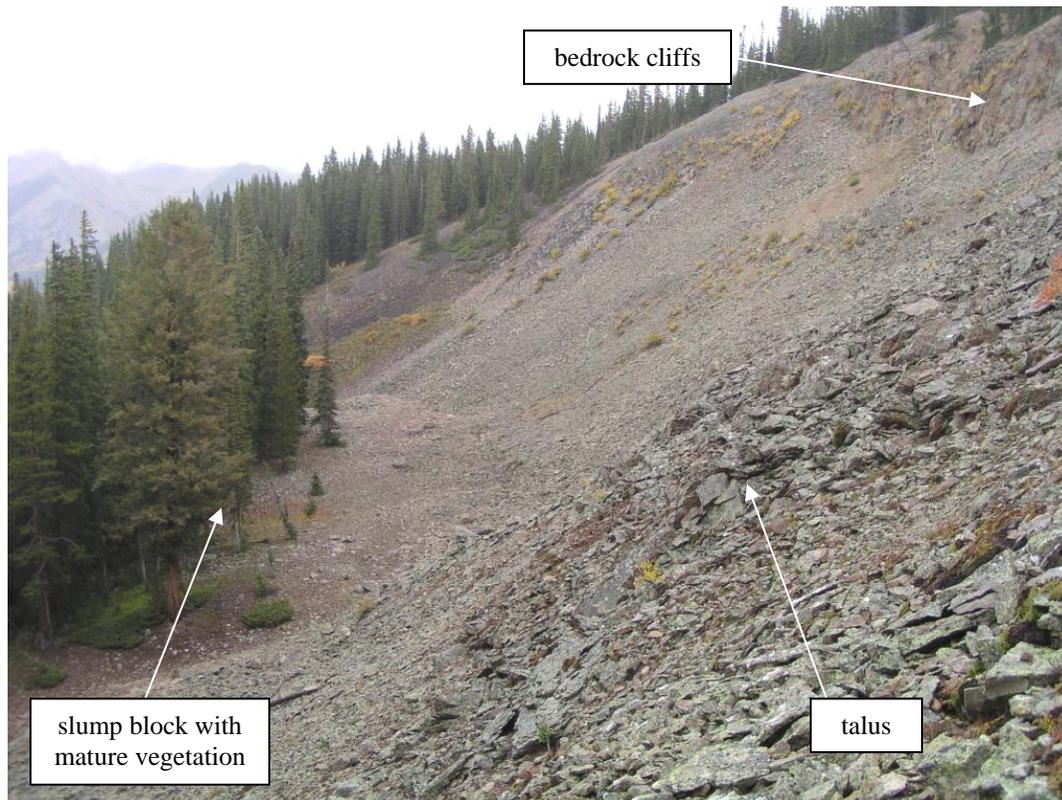
On the West Face – North unit, the upper two-third's of the area contains soils that are thin and granular, developed in-place from weathering of the underlying fractured igneous intrusive rock of the laccolith. Where exposed, the igneous rock is fractured and jointed. At mid-elevation in this unit, there is a band of terrain that exceeds grades of 40% and, is often much steeper, including near vertical bedrock cliffs. These areas are old block slumps in igneous intrusive rocks, indicated by bare talus deposits below bedrock cliffs. These rock slumps have likely developed along the contact of the igneous rock with the underlying Mancos Shale and are due to weakening of shale underlying fractured igneous intrusive bedrock. These areas also have rockfall potential. The following photograph, taken of the largest area of exposed bedrock cliffs and talus, shows the nature and steepness of this landform, located in the northern portion of the

West Face – North unit (el. 10,400). This area, and a smaller similar outcrop, show up clearly on the orthophotos, topographic map, and is easily viewed from Washington Gulch Road.

The mature conifers on the slump block in the above photograph indicate that major movement is probably older than 100 years. However, curved traces are visible on the orthophoto just upslope from the main scarp, suggesting that retrogressive failure up the slope is developing.

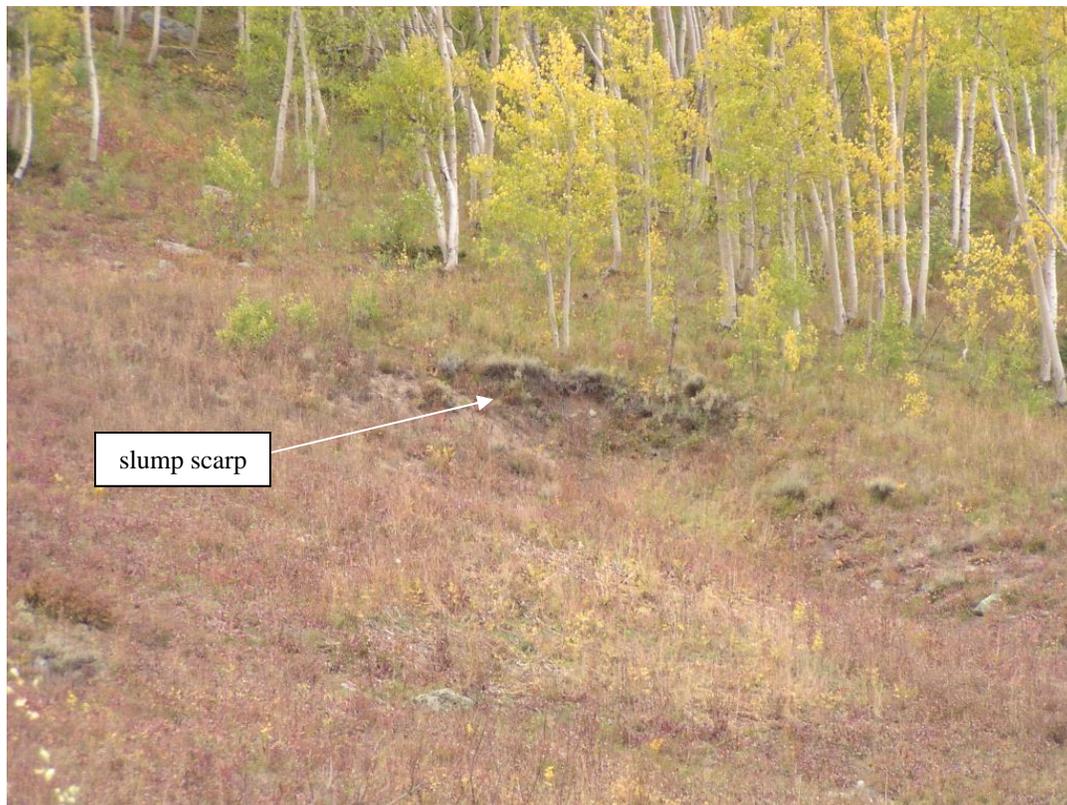
years old. One such small slump is shown in the following photograph. Notice the bare soil in the scarp, the disrupted vegetative pattern of the groundcover, and the many young aspen trees in the background that are leaning in various directions.

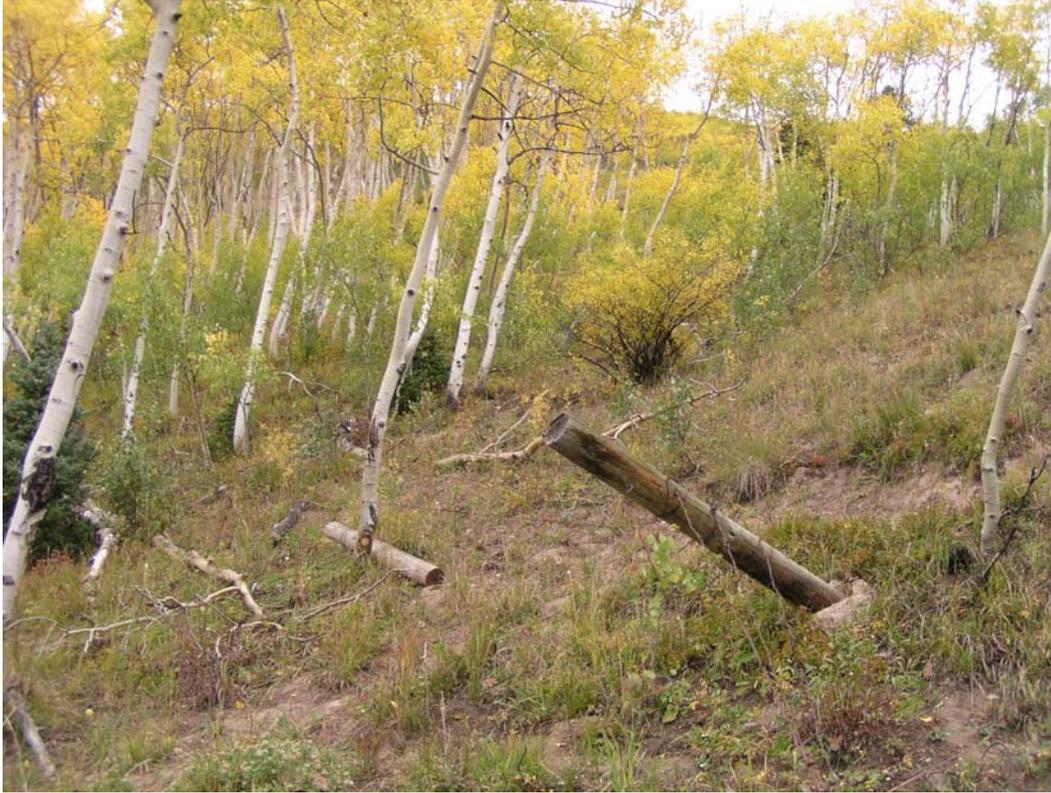
On the lower slope, near the southern edge of the West Face - South unit, there is a translational slide with a circular (in plan view) main scarp that transitions into an earthflow. Except for clumps of grasses and a small stand of young aspen, there is very little vegetation on the exposed failure surface. This arcuate area is clearly seen in the photograph on page 32, to the right of the right arrow. The main scarp at the top of the evacuated area is only a few feet high and exposes fractured igneous intrusive rock. The earthflow deposition zone is currently or very recently moving, as evidenced by large exposures of bare mineral soil, the leaning and bent young aspen trees, cracks in the ground, and displacement of a barbed wire fence (see following photograph). The mottled appearance of the aspen canopy and arcuate traces on aerial and orthophotos, suggest that upslope and laterally to the south of this area, accelerated creep is occurring and slumps are starting to develop. The following photograph, taken of this earthflow, shows the exposed soil, leaning trees, and fence posts that are being dragged and pulled to the ground.

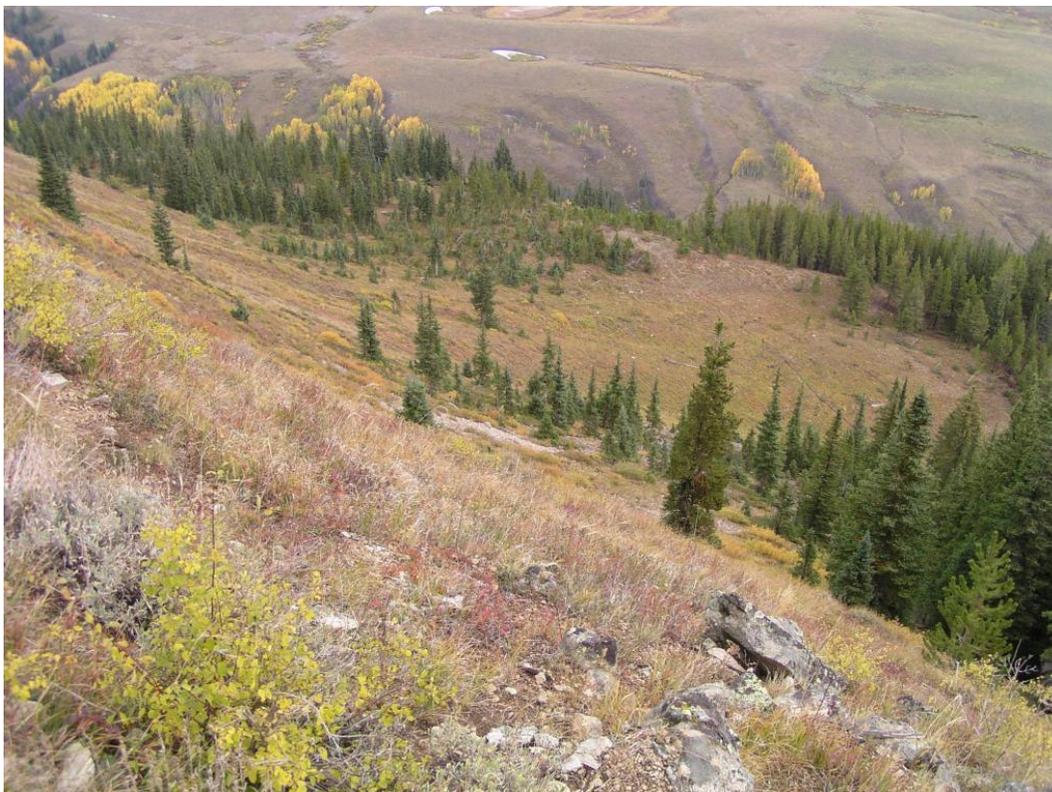
The upper slope of the North Face (GHU #11) is formed from fractured igneous rock with little or no residual soil cover. This steep, rocky, open slope is shown in the following photograph.

Numerous debris and rock slides have occurred on the steep upper slopes, starting in the weathered and jointed igneous rock. These slide zones can be seen on Map 2 as narrow rocky (unvegetated), parallel chutes that run, perpendicular to the contours, from near the summit of Snodgrass down to Gothic Road and below. These rock slides, as well as snow avalanches, have removed or prevented tree cover from becoming established due to regular events.

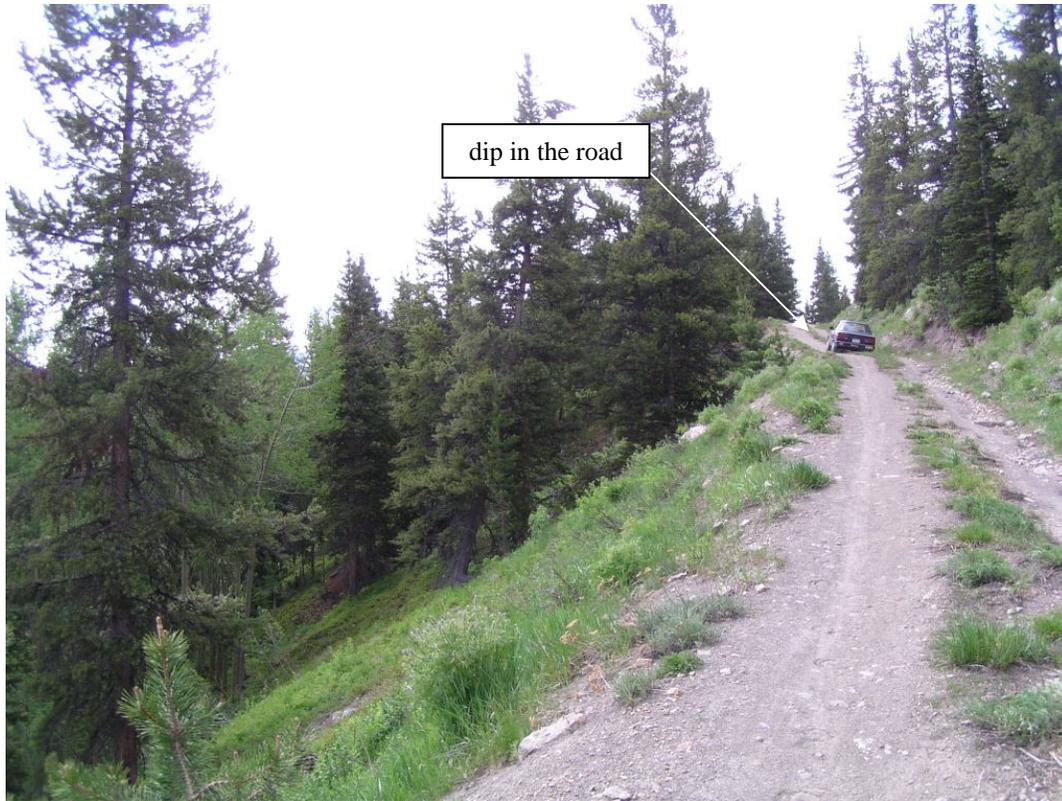
Below the area geologically and topographically similar to the Chicken Bone, the slopes are steeper (30-60%), and the study of aerial photos as well as field checking revealed a number of landslides that appear to have been active within the past 100 years. There are a number of slides that the access road traverses in the depositional area below the East Facet (GHU #7). The following photograph was taken of the lateral scarp of one such slide. Note the change in aspect of the ground surface, the dip in the road where the car is located, and the leaning and bent trees. The head of the scarp is upslope of the road and an arcuate scarp and slump block are obvious features in that area. More slumps were observed along the road uphill of this site.

The supporting evidence for the interpretation of these areas as slump blocks includes the sparsely vegetated soil, disruption of trees, shape of the ground surface, and review of the detailed topographic map. Aerial photograph interpretation supports these a being landslides, and the leaning and bent trees visible on the ground, support a likely age of under 100 years since last movement. Additionally, just south of where the access road reaches the ridge between the Chicken Bone (GHU #6) and the East Slide Complex (GHU#5), there is a sag pond at the head of a slide, which extends to below the lower road (el. 10,250'). The middle portion of this slide has numerous leaning and bent aspen suggesting movement within the last 25 to 50 years. A several hundred foot long portion of the lower road appears to have been displaced by movement of a landslide (el. 10,000'). The amount of displacement is minor, but probably occurred within the past 100 years.

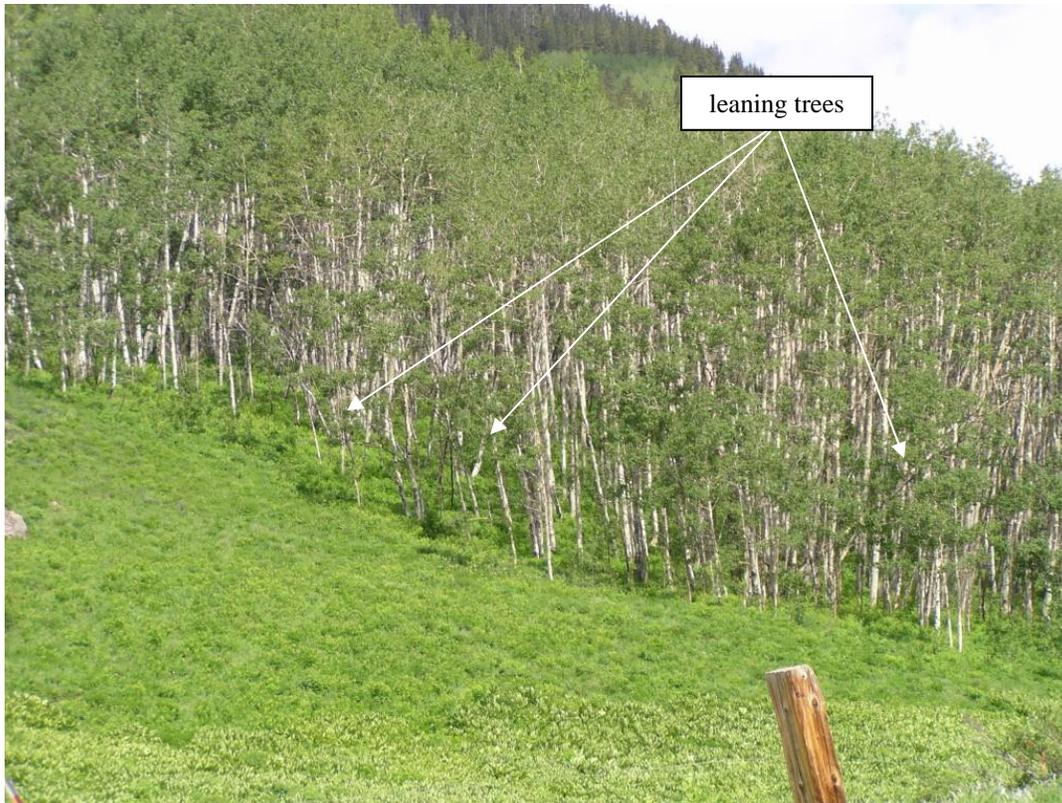
There is a slide or series of slides that extends from the top of the East Face, just north of the main scarp of the East Slide Complex (GHU #5), across the road, and down to the flatter slopes at the bottom of the East Face. The following photograph was taken of the stand of aspen being moved by the slide. Note the extensive area of leaning and bent trees that extend up the slope, suggesting movement within the last 25 to 50 years. Some trees are leaning uphill, some downhill, and others are bent mid-trunk.
