EXISTING CONDITIONS REPORT

Beal Mountain Mine

*Beaverhead-Deerlodge National Forest
Silver Bow County, Montana*

Maxim Technologies, Inc.
851 Bridger Drive
P.O. Box 1413
Bozeman, Montana 59715

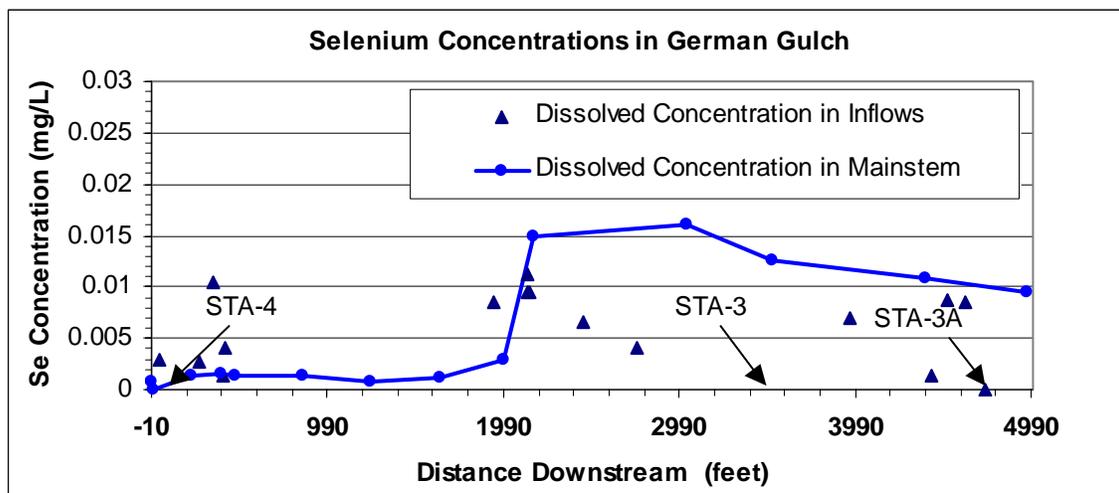
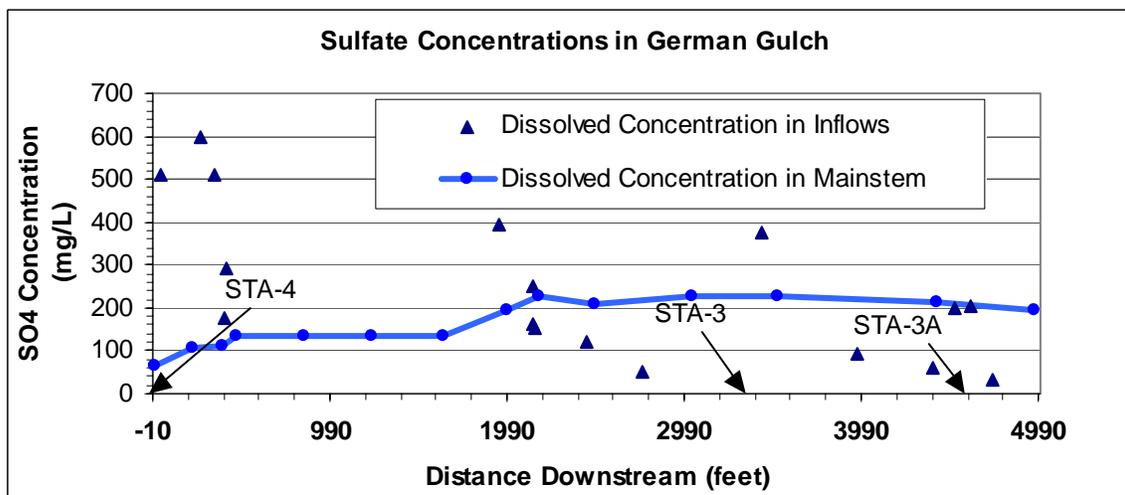
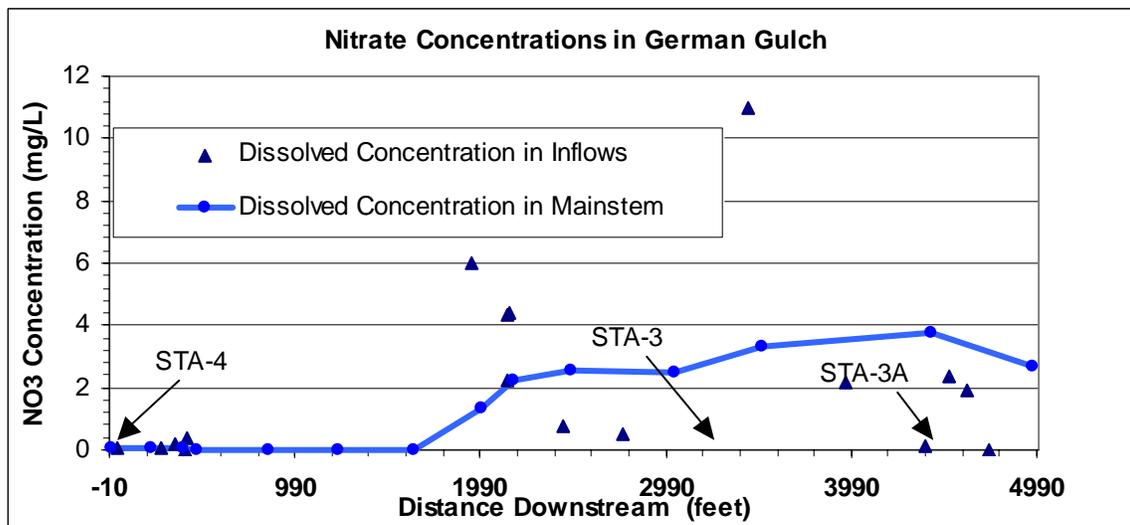
Figure 15. Selenium, Sulfate and Nitrate Concentrations in German Gulch (milligrams per liter; after Gurrieri, 2003)

The synoptic study identified potential sources of selenium to German Gulch, including the waste-rock dump, waste material used as road fill, and the leach pad dike where waste rock was used in dike construction (Gurrieri, 2003). The chemical signature of selenium, sulfate, and nitrogen are a clear indicator of contamination from waste rock. Altered and in-place bedrock is not a likely source based on historical water quality data. The study also concluded that ground water discharging to German Gulch from the faults that cross the valley in the vicinity of the main Beal pit are probably not a source of selenium because the pit water has low to negligible selenium concentrations (Gurrieri, 2003). The report speculates that shallow subsurface flow between the waste rock dump and the section of German Gulch containing road fill may be an important selenium transport pathway.

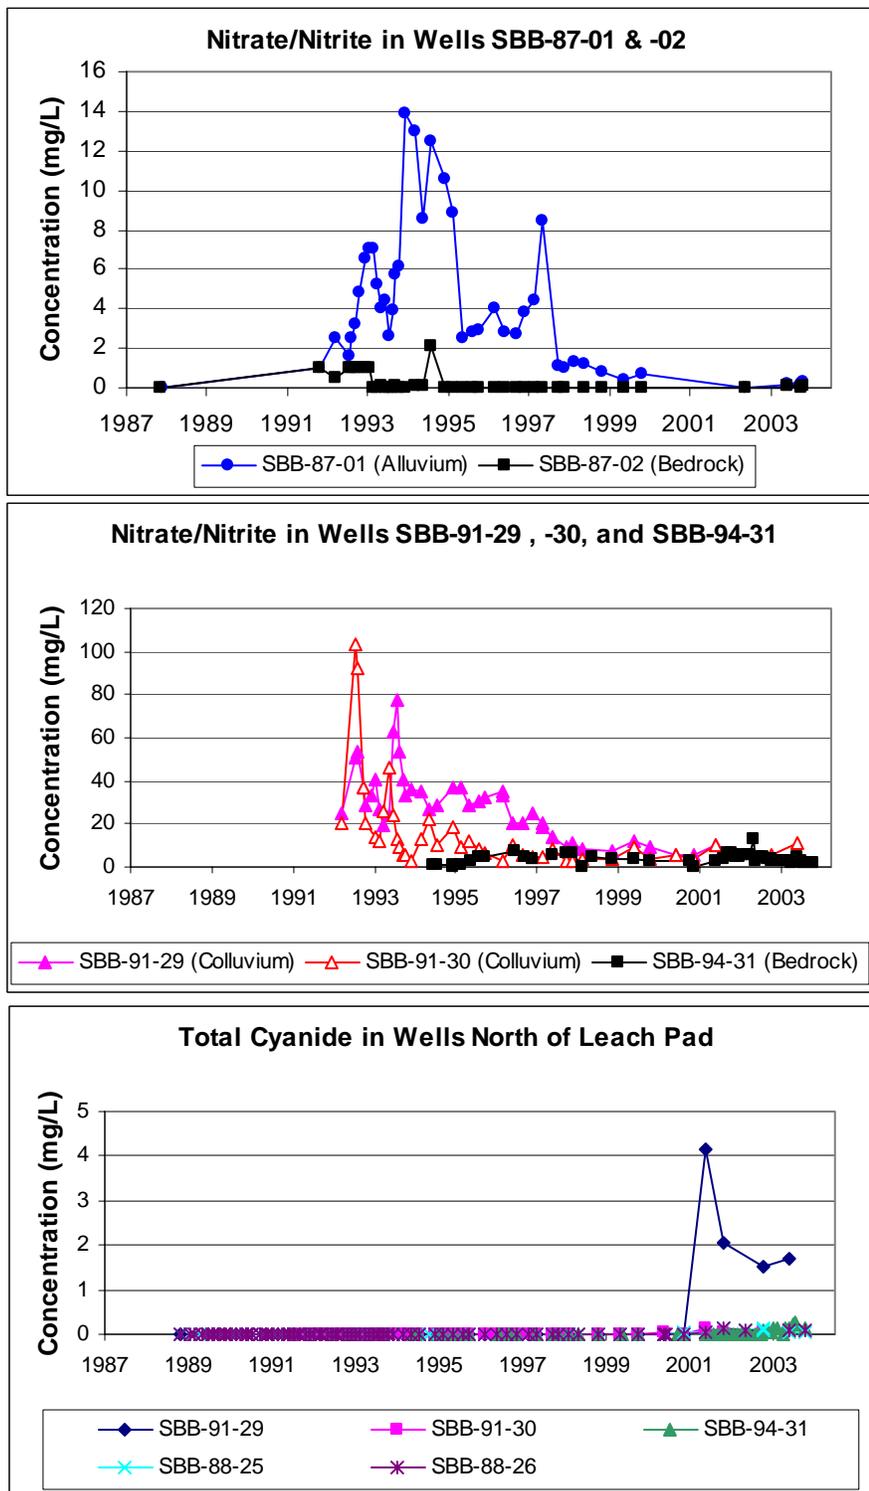
Figure 21. Nitrate and Cyanide Trends in Select Monitoring Wells (milligrams per liter)

Figure 21 shows that cyanide was generally not detected in monitoring wells north of the leach pad before land application discharge (LAD) operations began in 2001. Since that time, with the active land application of treated leach pad solution on-going until November 2003, cyanide concentrations in most monitoring wells north of the leach pad have increased.

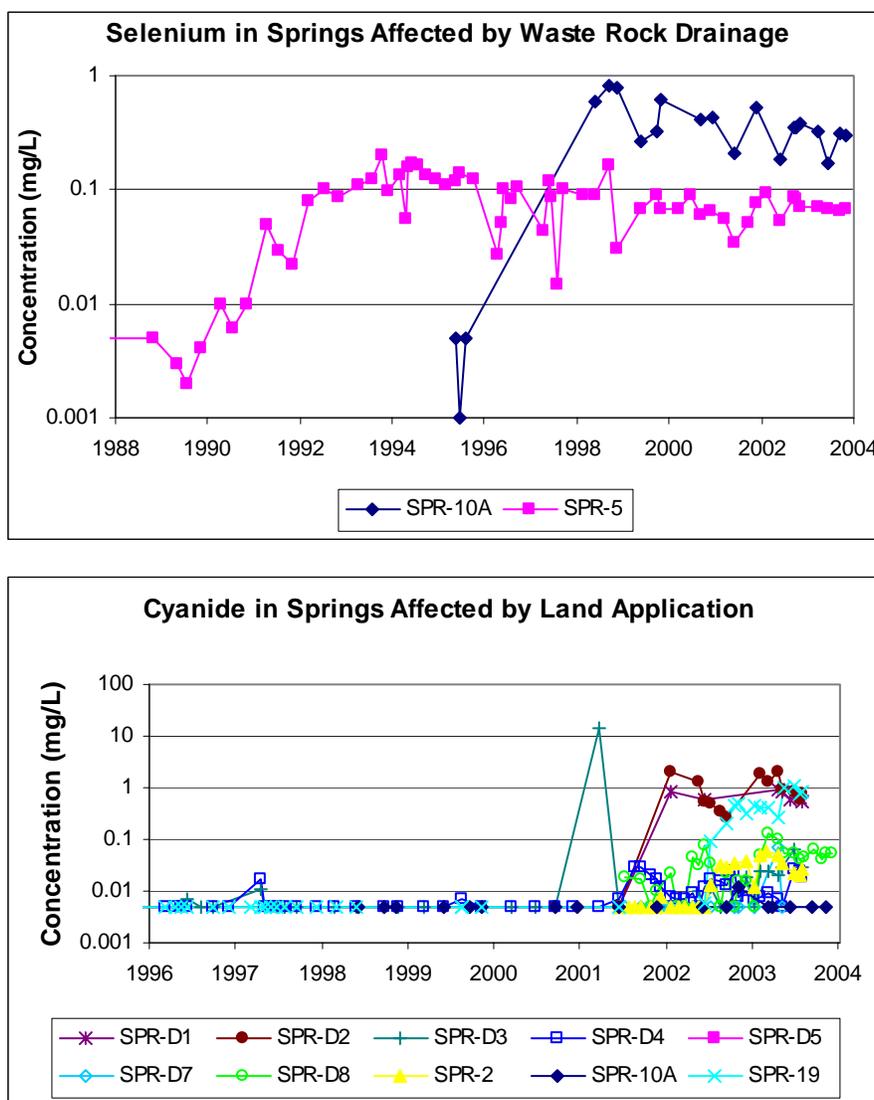
Figure 22. Springs Affected by Waste Rock Drainage and LAD Application (milligrams per liter)

Impacts to water quality have been noted in several springs. For example, springs SPR-5 and SPR-10A have been impacted by water in contact with the waste rock dump (**Figure 22**). Concentrations of selenium, sulfate, nitrate, and total dissolved solids are elevated in these springs. Springs located within and downhill of the land application area have also shown impacts from mine operations, with appreciable increases being measured in cyanide and selenium concentrations since land application began in 2001 (**Figure 22**).

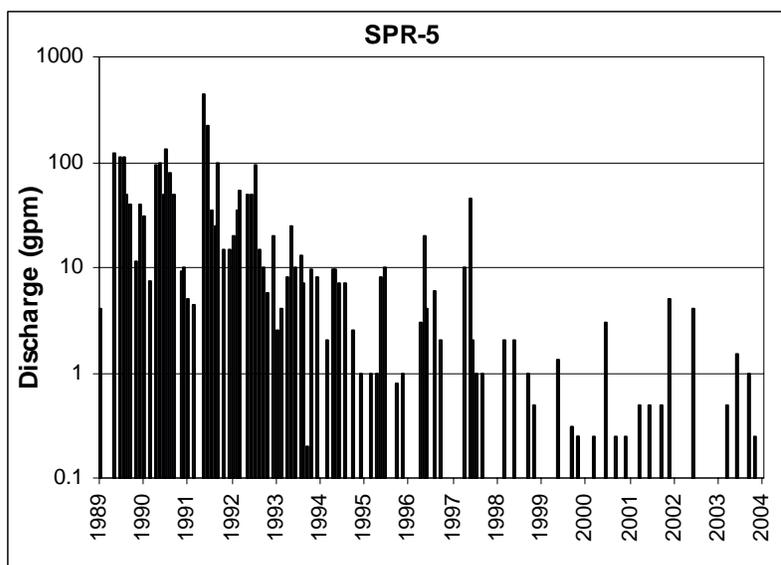
Figure 23. Discharge at Spring SPR-5 (gallons per minute)

Spring SPR-5 occurs at the waste rock dump toe where it joins with water piped from SPR-10A and water collected in the toe drain. This water is collected in a pipe and is pumped to the process water pond near the plant site. Flow measured at SPR-5 has ranged from no flow to 450 gpm (**Figure 23**).

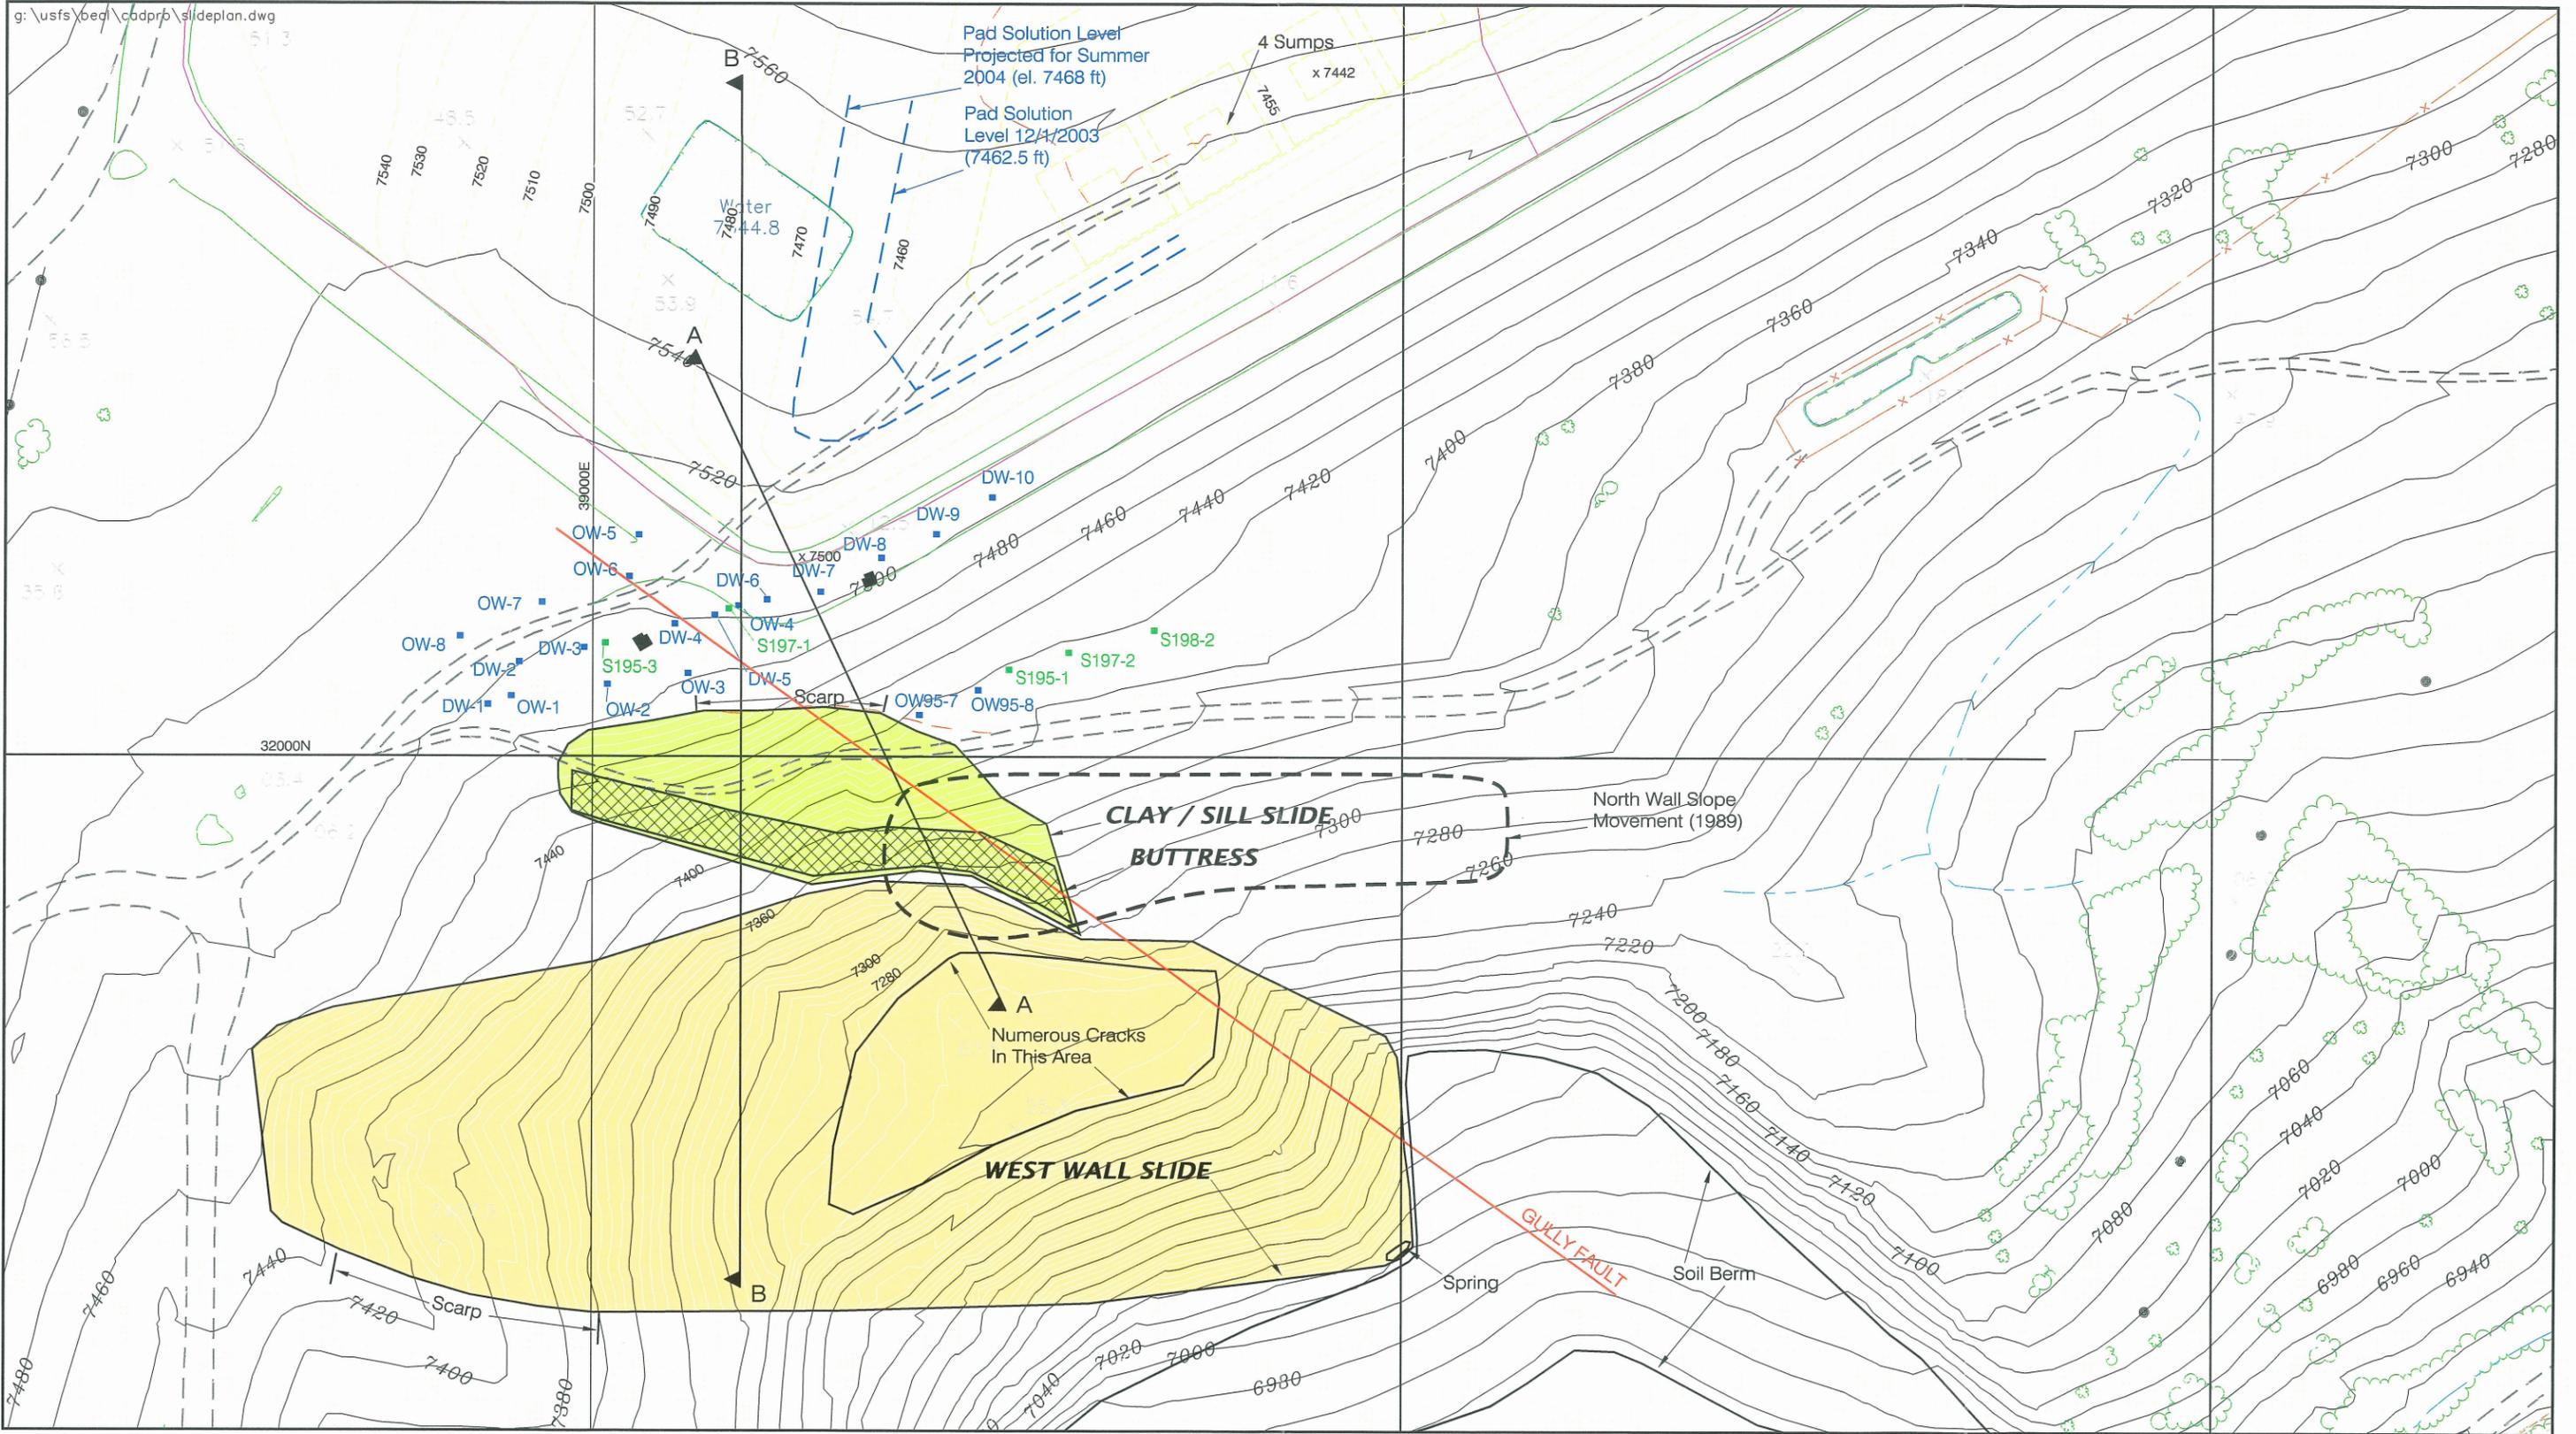
Main Beal Pit Slides
 Beal Mountain Mine
 Silver Bow County, Montana
FIGURE 25

unsupported and allowed it to move to the south and east toward the pit. During the period of active mining, movement of this slide propagated slump-like features and cracks or fractures upward into the unconsolidated fill of the southern corner of the heap leach pad. These features lead to geotechnical stability studies of the leach pad dike in the southern corner of the pad.

Slope stability analyses indicate that the crest of the leach pad dike has a relatively low factor of safety under worst-case conditions (1.02) and regression of the clay/sill slide uphill into the leach pad dike could occur. If the slide should regress further uphill, cracking on the dike face may be observed. However, large-scale movement of the slide (i.e. on the order of 10 or more feet per year) is not anticipated, and this amount of movement has not been characteristic of slide movement at any time in the past. Regression of the clay/sill slide into the leach pad dike is not likely based on existing data. The portion of the leach pad's interior presently containing solution (i.e. within the volume defined by the 7465 to 7467 foot contours and the pad's base liner) has a relatively high factor of safety under worst-case conditions (1.40) with respect to stability. Regression of the clay/sill slide into this area is not likely. A monitoring plan has been implemented to detect deleterious movements, and a contingency plan has been developed for the leach pad facility to assure the geotechnical integrity of the leach pad.

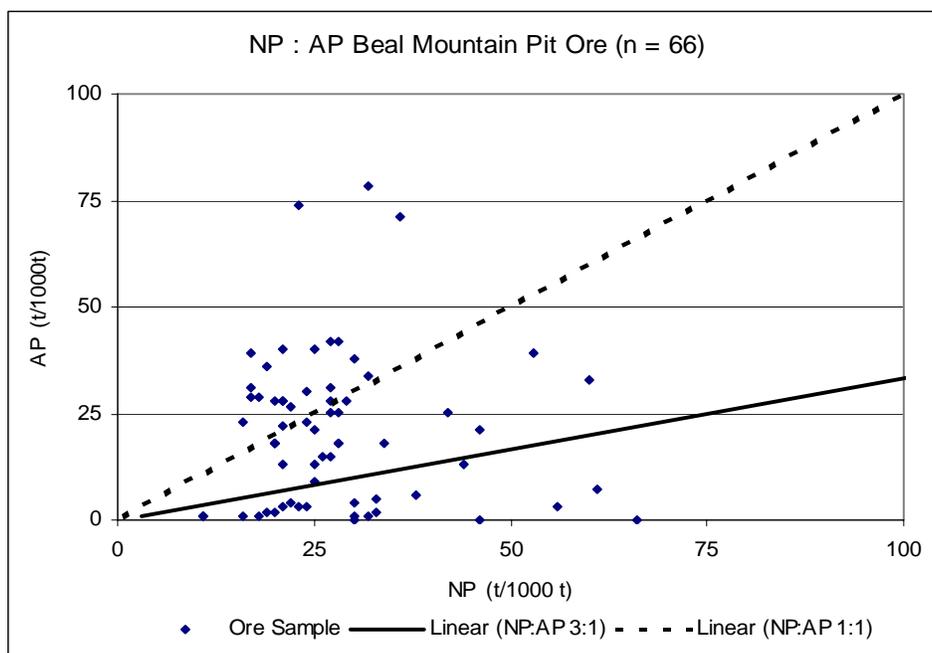
Figure 28. Beal Mountain Pit ore static test results (tons/1 000 tons)

The potential for acid generation from non-mined ore remaining in the Beal Mountain pit was evaluated based on static test results for 66 samples of ore as reported by Gallagher (1994 and 1995) and Schafer and Associates (1994) (**Figure 28**). It is unclear whether these samples were representative of the range of ore lithology and sulfide content observed in the highwall, or were collected from the active mining level at the time of sampling. Thirty-five percent of the samples had NP:AP ratios less than 1 while 30 % were between 1 and 3. The remaining 35 % of main Beal Mountain ore samples had NP:AP ratios greater than 3. These results indicate that a significant percentage of ore exposed in the Beal Mountain pit floor and highwall areas presents a risk of acid generation with associated trace element release.

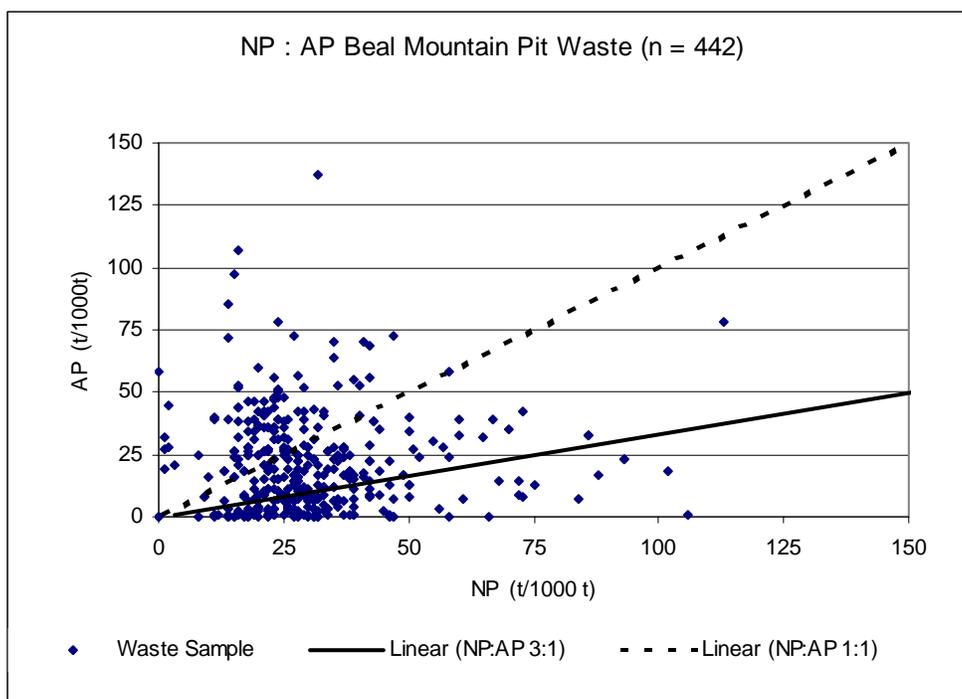
Figure 29. Beal Mountain Pit waste rock static test results (tons/1000 tons)

Of the 442 samples of Beal Mountain pit waste rock for which data are available (**Figure 29**), 30% had NP:AP ratio less than 1 while 33 % were between 1 and 3. The remaining 37 % of main Beal Mountain waste rock samples had NP:AP ratios greater than 3. These data show that a portion of waste rock exposed in the Beal Mountain pit floor and highwall areas, placed as fill, or located in the waste rock dump will present a risk of acid generation.

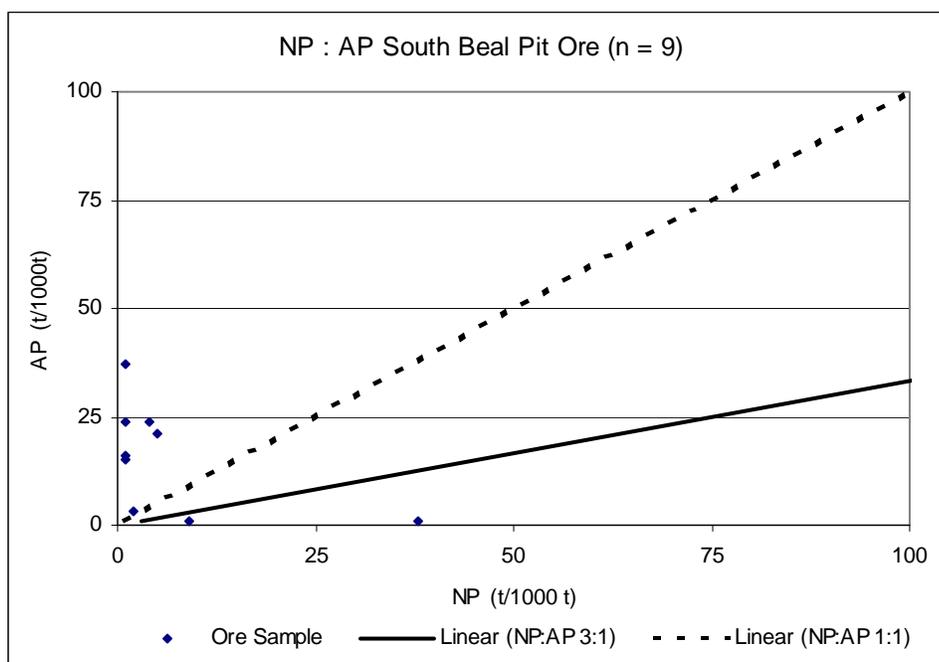
Figure 30. South Beal Pit ore static test results (tons/1000 tons)

Evaluation of potential acid generation from non-mined ore remaining in the South Beal pit floor and highwalls is based on static test data from nine South Beal ore samples (**Figure 30**) (Gallagher, 1994). Seventy-eight percent of these samples had NP:AP ratio less than 1:1 indicating a high potential for acid generation from residual ore remaining in the pit. No kinetic test data are available for predicting acid generation from South Beal ore. Likewise, no tests for metal mobility were conducted on South Beal ore.

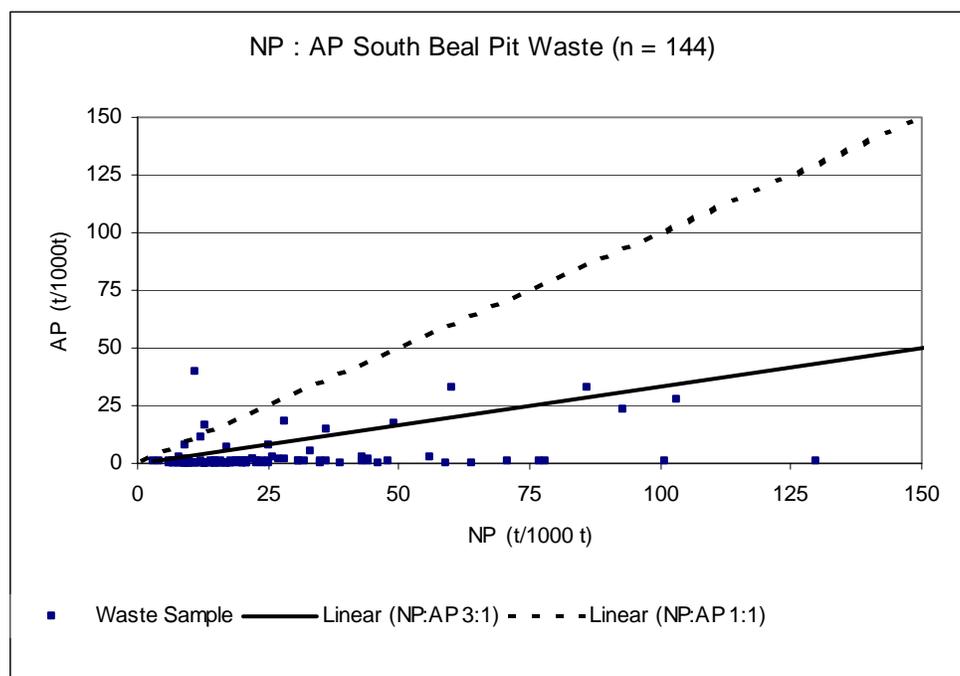
Figure 31. South Beal Pit waste rock static test results (tons/1000 tons)

Data for evaluating the acid generation potential from waste remaining in the South Beal pit floor and highwalls include NP:AP ratios for 144 samples of waste rock mined from South Beal (**Figure 31**) (Gallagher, 1994; Pegasus Gold, 1998; and Schafer and Associates, 1994). Eight percent of the samples had NP:AP ratio less than 1 or between 1 and 3. The remaining 92 % of the samples had NP:AP ratio greater than three indicating that the pit floor / highwalls (excluding residual ore) and waste removed from this pit have little potential to generate acidity.

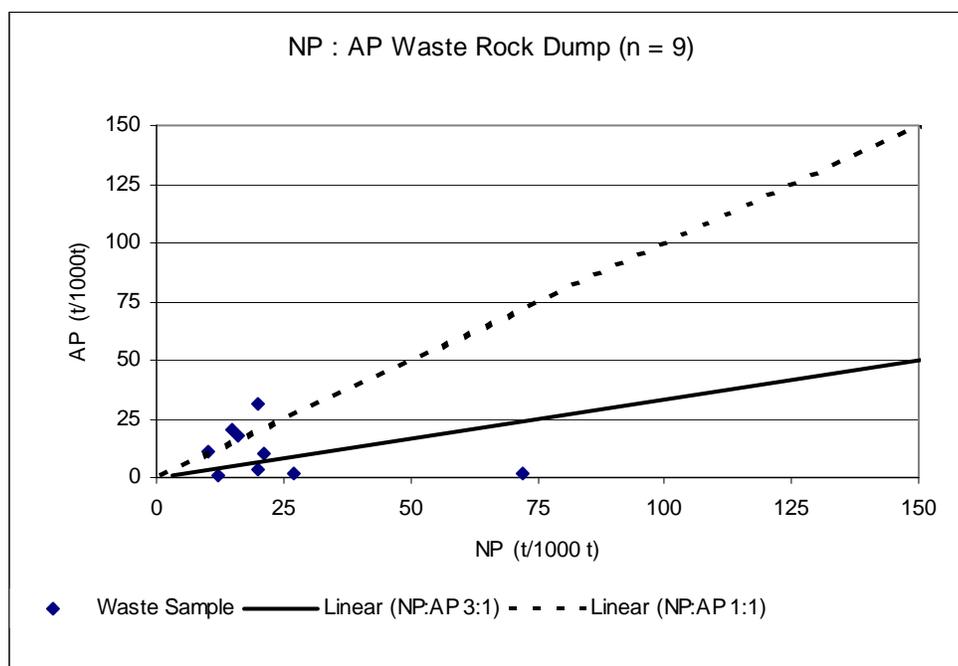
Figure 34. Waste rock dump static test results (tons/1 000 tons)

During the 1993/1994 Geochemical Assessment Program (Gallagher, 1994) two reverse circulation boreholes were drilled into the waste rock dump and nine samples representative of run-of-mine waste rock were collected and subjected to static testing (**Figure 34**). Of these 9 samples, 44 % had NP:AP ratio greater than 3 and 44 % had NP:AP ratio less than 1. The remaining 11 % had uncertain acid generating potential. These data suggest that predictions based on waste rock origin only slightly over-predict risk of acid generation of the run-of-mine waste rock and that the waste rock dump does represent a source of potential acid generation. It is also likely that trace elements released by sulfide oxidation or locally acidic conditions may become mobile in seepage from this facility.

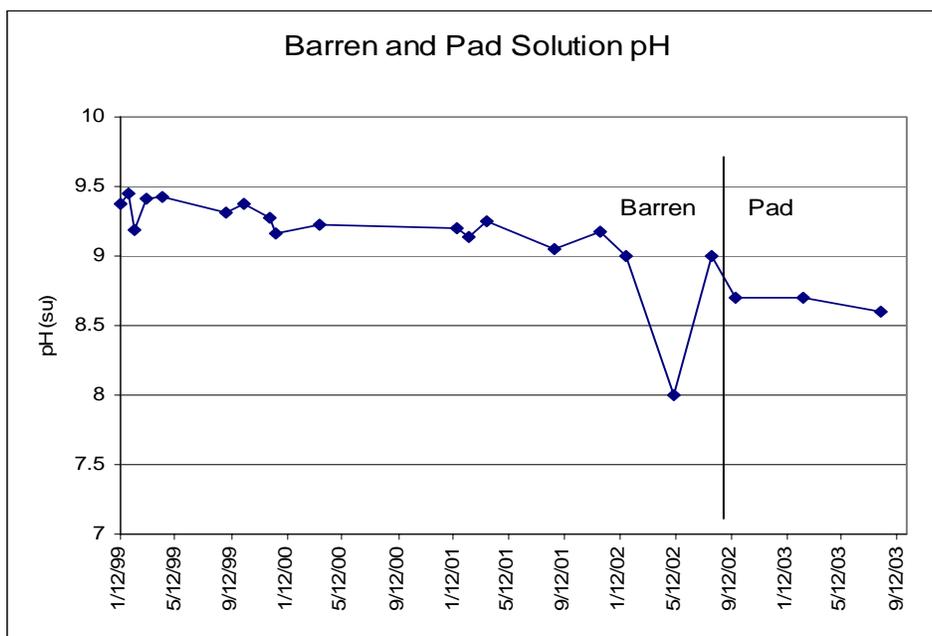
Figure 37. Beal Mountain Barren and Pad solution pH (standard units)

Barren/pad solution data indicate that acidic conditions are not currently present in the heap leach facility (**Figure 37**). Between January 1999 and August 2002 barren solution pH decreased slightly from approximately 9.5 to 9.0 su, with one outlying pH measurement of 8.0 su. Pad solution pH decreased slightly from 8.7 to 8.6 following discontinuation of leach operations.

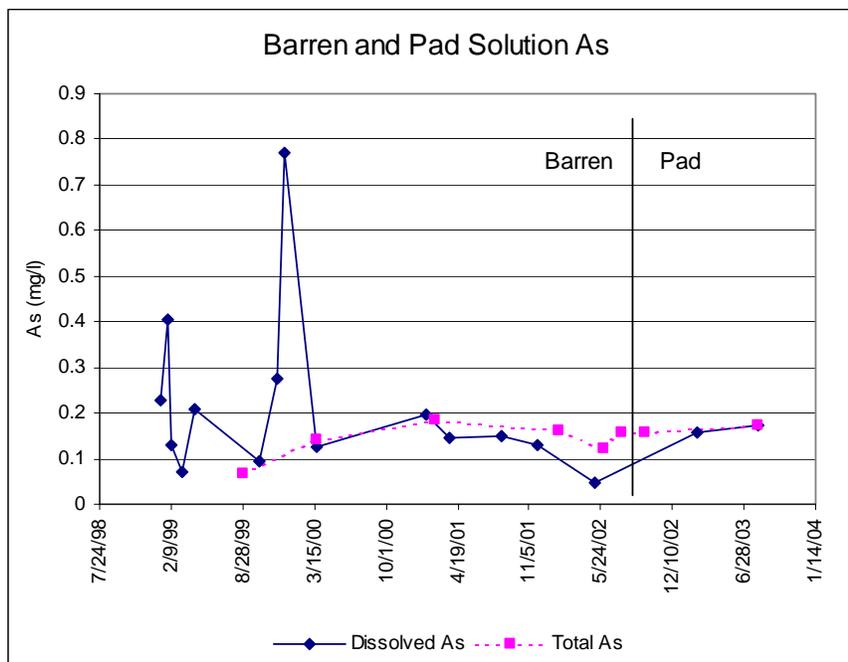
Figure 40. Beal Mountain Barren and Pad Solution Arsenic Concentration (milligrams/liter)

Dissolved arsenic concentrations were relatively steady, fluctuating between 0.05 and 0.2 mg/L between 1999 and 2003 with a peak of 0.77 mg/L in December 1999 (**Figure 40**). Total arsenic concentrations increased from approximately 0.06 mg/L in August 1999 to a maximum of 0.18 mg/L in February 2001. Afterwards, dissolved arsenic concentrations declined to 0.16 mg/L where they remained steady following cessation of leach operations.

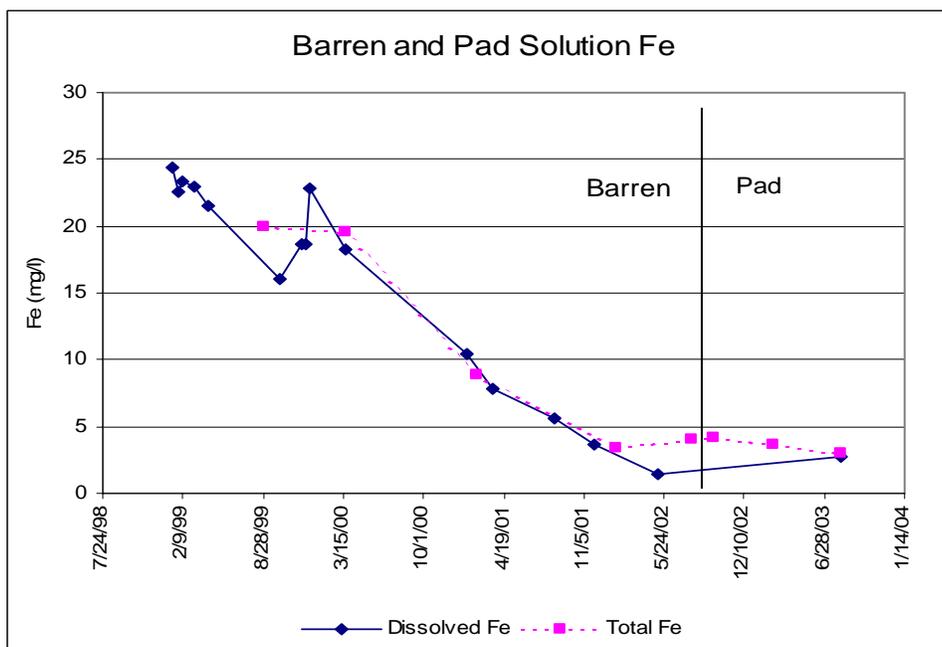
Figure 41. Beal Mountain Barren and Pad Solution Iron Concentration (milligrams/liter)

Dissolved and total iron concentrations were similar and decreased steadily over the monitored period (Figure 41). Maximum concentrations of approximately 25 mg/L were recorded in early 1999 and decreased to approximately 3 mg/L by 2002. Total iron remained between 3.5 and 4.5 mg/L following cessation of leach operations.

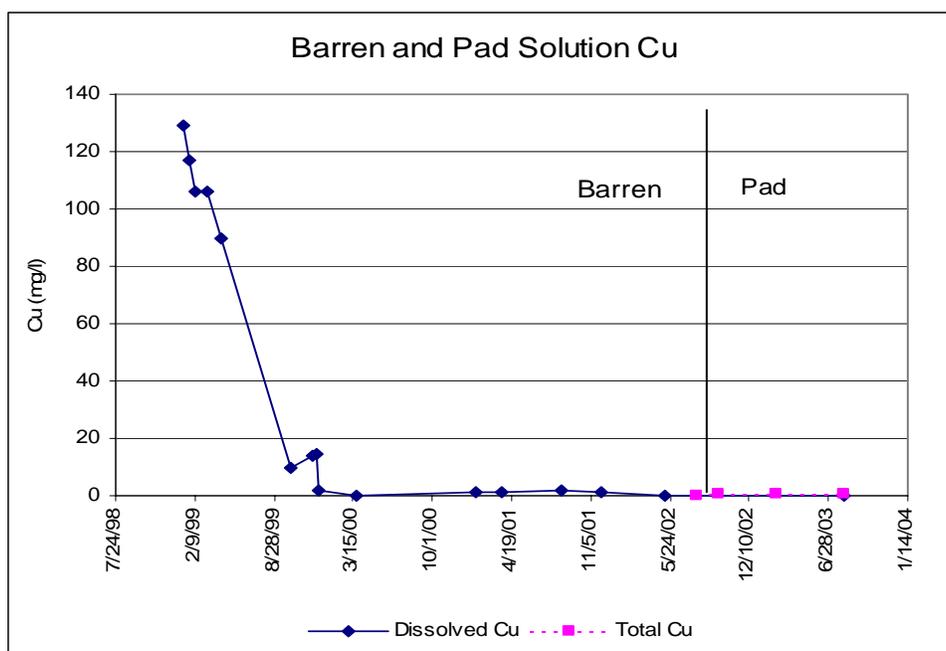
Figure 42. Beal Mountain Barren and Pad Solution Copper Concentration (milligrams/liter)

Dissolved copper concentrations followed the same trend as iron, decreasing from initial concentrations of greater than 300 mg/L (1997 and 1998, B. Parker, personal communication, 2/9/04) to less than 1 mg/L after January 2000 (**Figure 42**). Total copper concentrations available for four dates between August 2002 and August 2003 indicate that copper remained below 0.45 mg/L, although an increase from 0.13 mg/L to 0.42 mg/L occurred following discontinuation of leach operations.
