USDA Forest Service
Shasta-Trinity National Forest

August 2010

Chalk-Goose Fires Road & Hillside Monitoring Report 2009

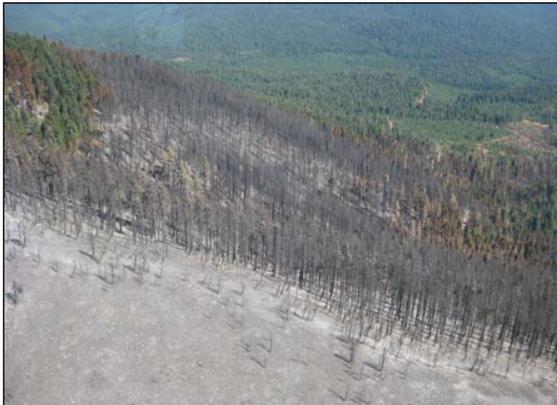
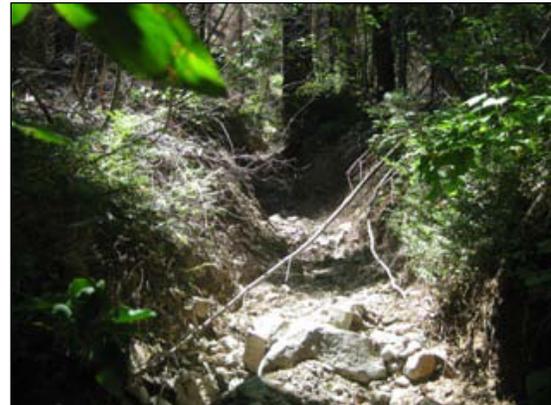
Figure 1: Chalk Mt. Hillside Ck. Burned Watershed and Erosion after One Winter Season

This report documents road and hillside monitoring part for the Shasta-Trinity Burned Area Emergency Response (BAER) implementation effort for the fires of 2009. Road treatments were very effective in handling increased flows even when culverts plugged from excessive sediments. Natural recovery was selected for hillslope recovery in areas that suffered moderate to high soil burn severity. Overall effectiveness after 1 year was adequate recovery in moderate burned severity timbered sites and fair to poor for high burned severity sites. Hillside Creek suffered extensive rilling and gully erosion due to steep slopes, lack of cover, and concentrated thunder-cell activity in this area (see pics below).

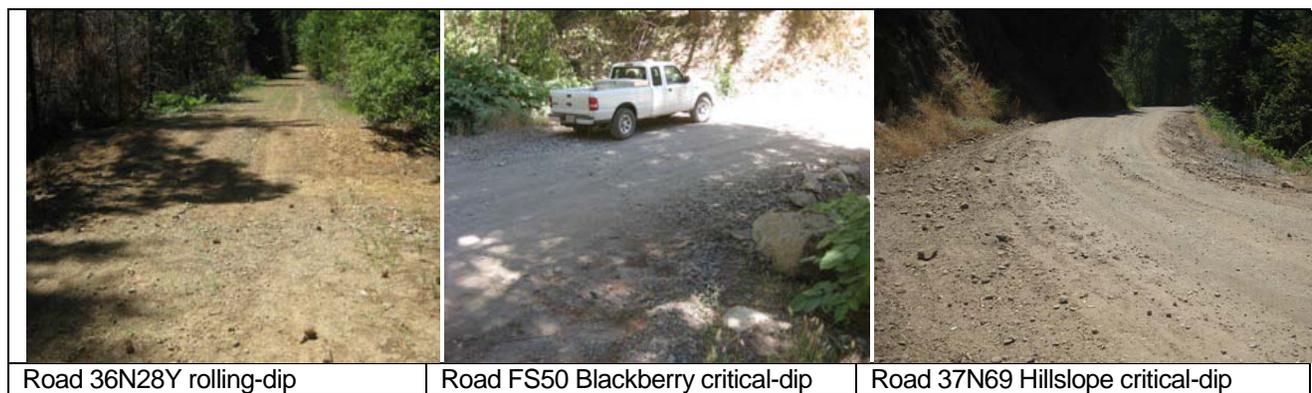
Figure 3: Road Repairs on Chalk-Goose Fire Area after One Winter Season

For roads it was determined no treatment was necessary due to rolling dips functioning well and flood water passing critical-dips with no significant road damage (see Figure 3 below).

Chalk-Goose Road Repair Effectiveness							
Resource	Terrain	Burn Severity	Soil Cover %	Cover Type	Recovery	Effectiveness	Remarks
Road 36N28Y	steep volcanics	mod-high	30-50	mixed conifer	good	good	some crossing damage
37N69, FS50	steep volcanics	mod-low	50-70	mixed conifer	very good	excellent	no damage

Recommendations: For areas that were very steep (greater than 60% slopes) and on exposed burned slopes, concentrate treatments on stream crossings to stop road tread flow capture.

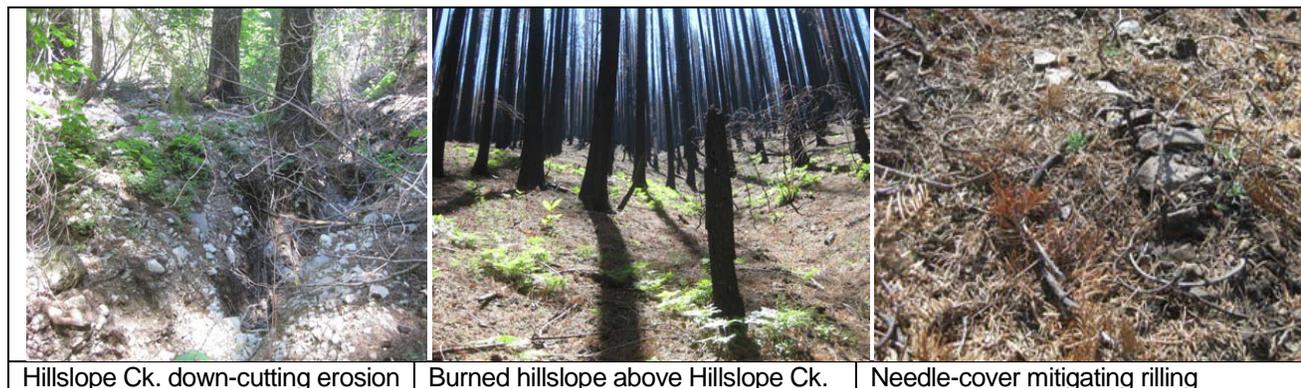
Figure 4: Chalk Hillside Creek Watershed Erosion and Cover after One Winter Season

Results: On the average for areas that were timbered with moderate soil burn severity hillslopes were intact and cover was adequate (see needle cover pic below). In areas that burned hot, hillslopes were compromised due to steep gravelly sandy loam volcanic soils that received intensive thunder-cell rainfall (see Figure 4 below). Analysis of severe hillslope erosion showed slopes over 50% with severe burning and cover less than 30% developed deep riling that led to debris flows in shallow very gravelly sandy loam soils (low clay and soil strength, see pics below). On slopes from 35 to 50% slopes rills were 4 to 6 inches deep every 20 feet and slopes over 50% rills were every 10 feet. Calculated WEPP erosion rates were 44 t/a for the first year and 31 t/a for the second year. With observed erosion these rates seemed reasonable. Recovery in these areas expected to recovery in the next 5 years.
