Monitoring Results of Past Dam Projects
T. Anderson, 8/31/06

The Mill Lake Dam Slip-Lining Project (reference Mill Lake Dam Project, Environmental Assessment, May 2005) was successful and met the terms and conditions for dam safety and erosion control based on the following:

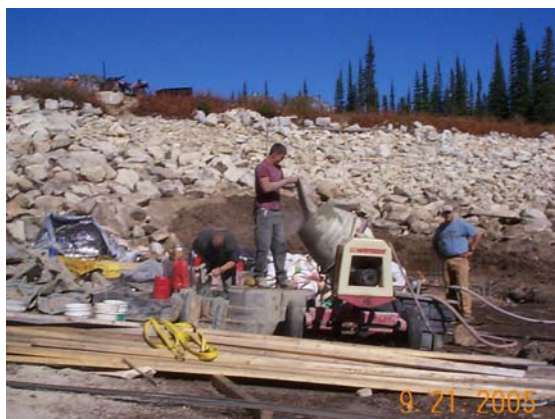
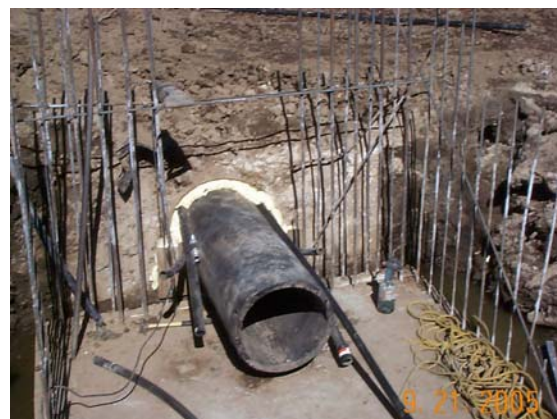
1. There was no seepage around the outlet pipe in the spring of 2006 following the 2005 slip-lining project. The primary evidence for a successful slip-lining project is the elimination of excessive seepage that was occurring around the outlet pipe.

5. The upstream area within the existing reservoir area was dewatered prior to the grouting operations and placement of concrete for the trashrack structure. Dewatering of the reservoir and construction site essentially offered an effective erosion control measure. There was no evidence of sediment transport into the stream channel below the dam.
