<b>UNIT LOG</b>		<b>1. Incident Name</b> Canyon Lake Dam Reconstruction	<b>2. Date Visited</b> 7-30-2004	<b>3. Visited:</b> Canyon Lake Dam and Wyant Lake
<b>4. Project Area</b> Canyon Lake Dam		<b>5. (Name and Position)</b> Rob Brassfield, NZ fisheries bio.		
<b>7. Parties Involved</b>				
<b>Name</b>		<b>Position</b>		
no others				
<b>8. Activity Log</b>				
<b>Activity Reviewed</b>				
Placement of small boulders on Dam		I observed the MCC crew placing small boulders on the upstream side of the dam face. Their work was above the water line and there were no effects to water quality.		
Notch in concrete above conduit		I observed the area where the dam had been notched, above the conduit. I also observed the wet meadow area downstream of the notch to see if there had been much erosion, as was predicted may occur if high water were concentrated through this new "spillway" in the dam. Historically, the spillway was on the north side of the dam and that route was scoured to rock. There was very little sign of recent scouring in the wet meadow downstream of the dam.

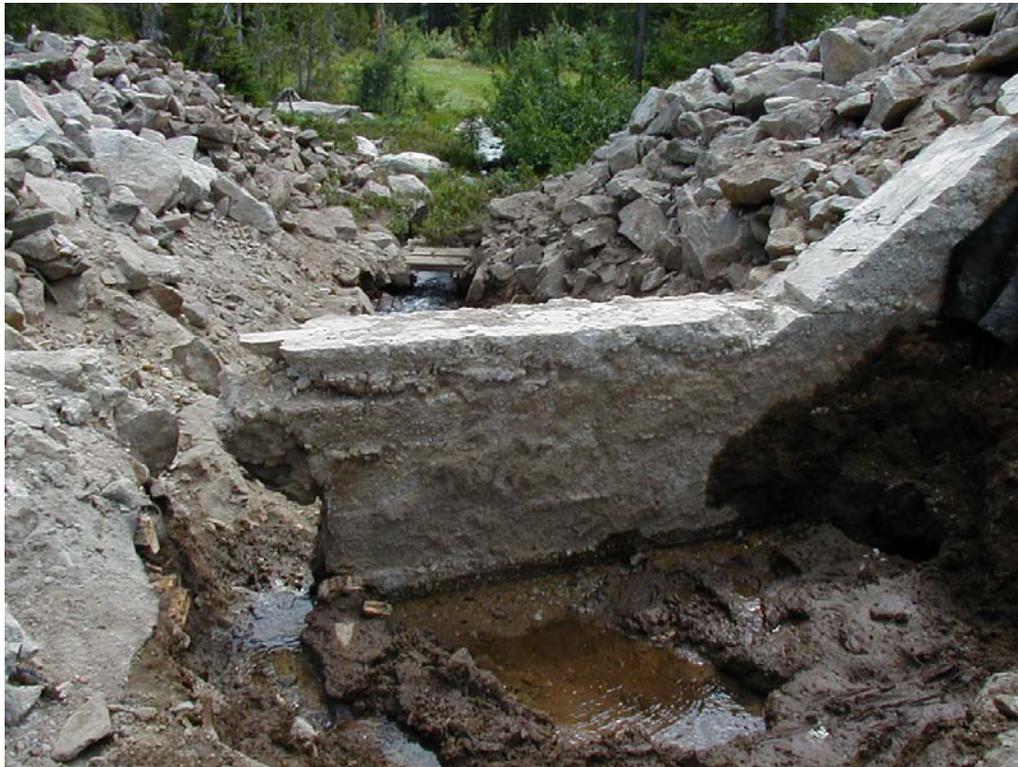
This is the outlet of Canyon Lake. Most of the water was flowing through the conduit and smaller amounts were running through the notch. The picture following this one is of the meadow in the background.

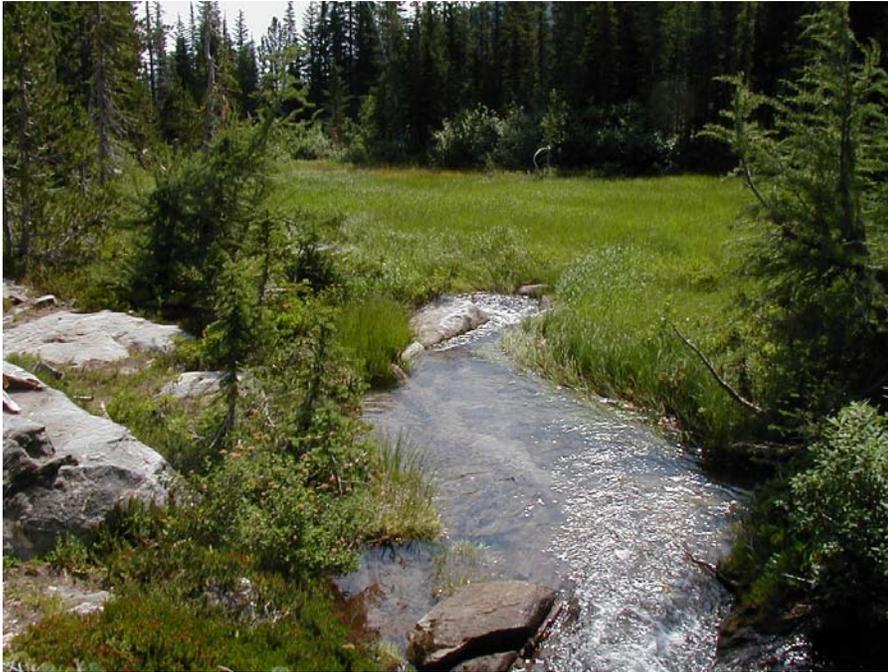
There was concern that parts of this meadow would erode substantially as the spillway was moved during construction to a point immediately upstream of the meadow. The historical spillway is to the north (left in the picture). There was no readily observable impact to the meadow or downstream fish habitat.

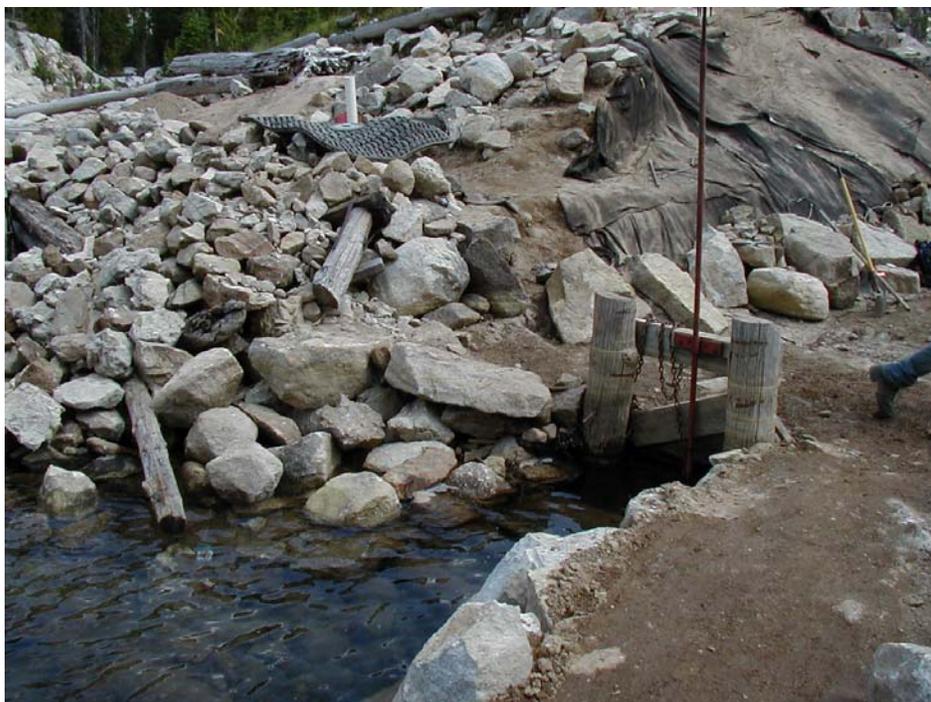
Cutting of Notch in concrete above conduit		I noticed a gas can sitting in the construction area near the notch. It was approximately 40 feet from the reservoir. It was set so it could not be easily knocked-over, and it was probably safe, but it was not secured as directed in the mitigation measures. I asked that it be stored in a containment area away from surface water. Aaron (Hydrometrics) moved it almost immediately to a safe location.  There was no sign of recent scouring in the wet meadow downstream of the dam (Photo).  Although there was some fine sediment that entered the stream, as evidenced by the sides of the steep cuts made to uncover the conduit, the amount appeared to have no impact on the depth of pools or other indices of fish habitat.

The photo below shows the inlet of the conduit, some of the fine material in the dam structure, and the gas can (red, left and above center in photo) that was moved to reduce the risk of inadvertent spillage toward surface water.
