2003 Tin Cup Dam Repair Project - Fisheries Monitoring Report

On July 1, 2004, I visited Tin Cup Dam to check compliance with the terms and assumptions that were made in the fisheries Biological Assessment and Evaluation (BA/BE, dated September 2, 2003).

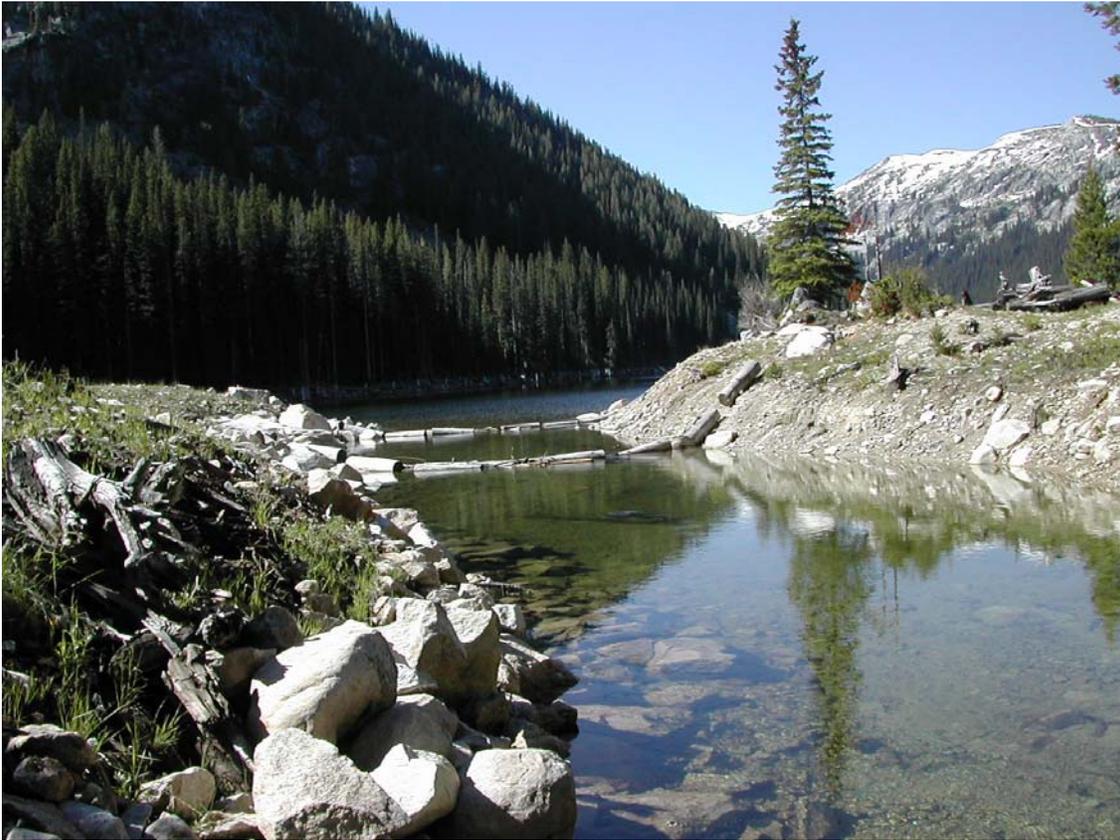
I walked the spillway (Photos #1 and #2) and the lower gradient section of Tin Cup Creek downstream of the dam and looked for signs of unusual sedimentation. I did not find any unusual sediment deposits or indications that adverse sediment increases had occurred as a result of the repairs. Sediment levels looked similar to those that were monitored in 2000-01.

Photo #1. The spillway, looking out towards Tin Cup Lake.

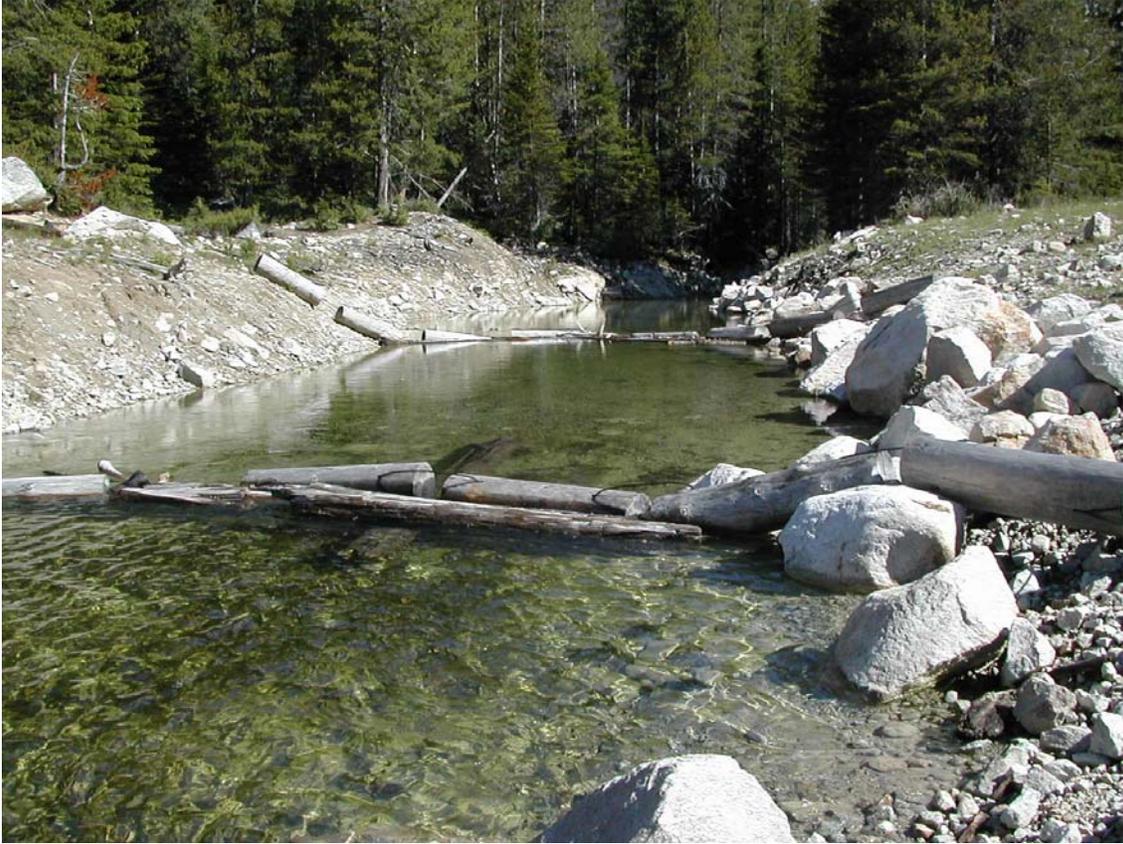
Photo #2. The spillway looking downstream.

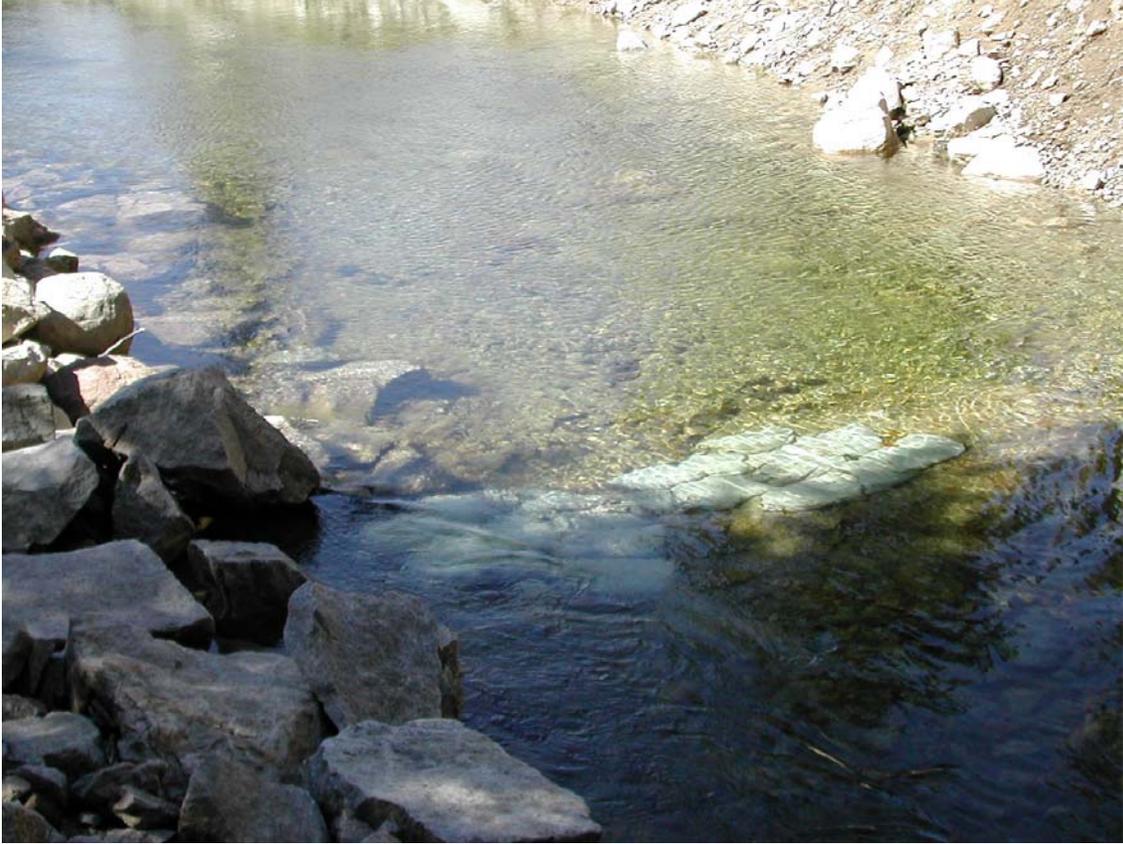
There are about 20 sandbags on the bottom of the spillway near the area where the spillway narrows and increases in gradient (Photo #3). There is also a large pile of sandbags stacked near this area, on the south bank of the spillway.

Photo #2. Sandbags in the bottom of the spillway.

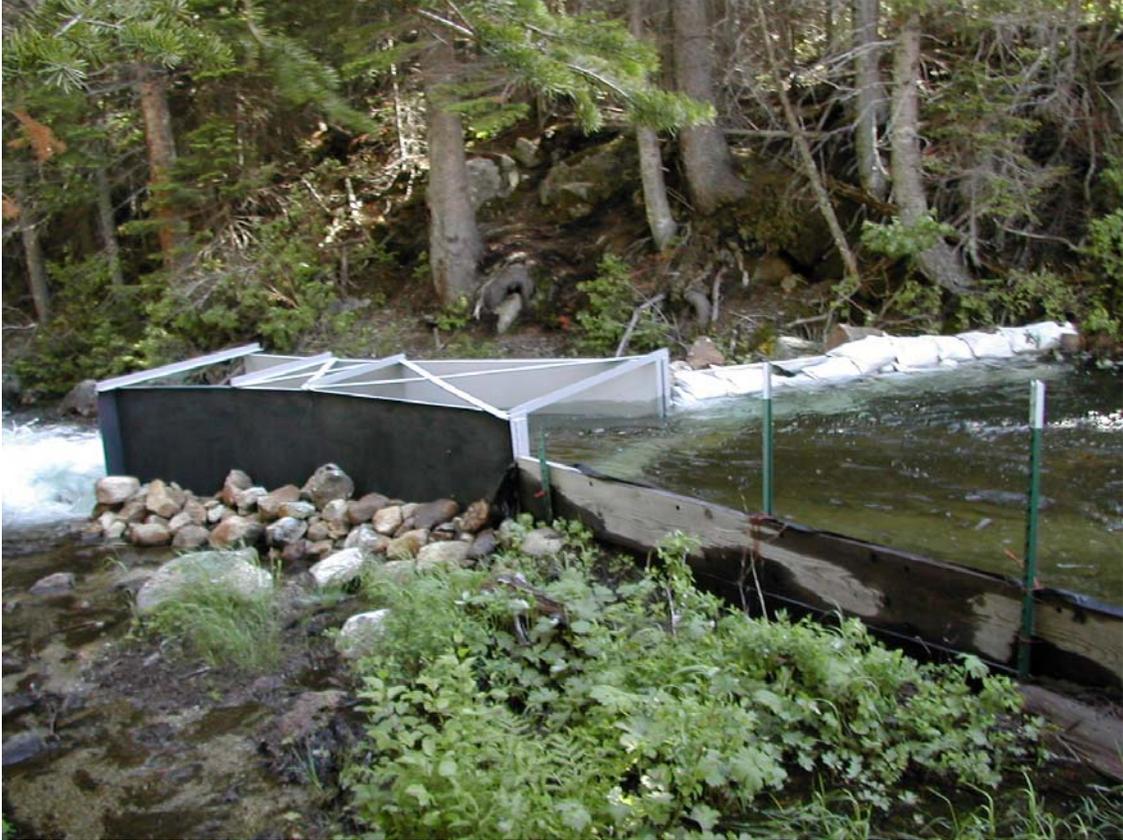
The biggest change that I noticed since my last visit to the dam in October, 2001 is the presence of a parshell flume in Tin Cup Creek about 20 feet downstream of the outlet pipe in the dam (Photos #4 and #5).

Photo #4. The flume below Tin Cup Dam. The boards making up the wingwalls are leaking some flow.

This flume was not present in 2001, and I do not know if the flume was installed as part of the 2003 repair project, or if it was already present prior to 2003. If the flume was installed as part of the 2003 repair project, then the BA/BE was incorrect in stating that all of the work at the dam would occur in areas outside of live water because the installation of the flume had to have occurred at a time when live water was flowing down Tin Cup Creek. In any case, the installation of the flume does not appear to have increased sediment levels in Tin Cup Creek. If anything, it has resulted in a channel structure that has flushed more sediment from the low gradient section of Tin Cup Creek directly below the outlet pipe. Instead of a channel primarily composed of lower gradient riffle and a couple of shallow pools, there is now a large pool above the flume, a high gradient riffle/cascade at the outlet of the flume, and a larger pool below that. Upstream fish passage is not a concern at the flume because the flume is located very near to the impassable outlet pipe of the dam. Fish can easily pass downstream through the flume. In any event, the short, low gradient section of Tin Cup Creek that is being impacted by the flume is not permanently inhabited by fish. Fish that are washed out of the outlet pipe may hold in this area during the summer months, but do not survive the winter due to very low water levels and freezing.

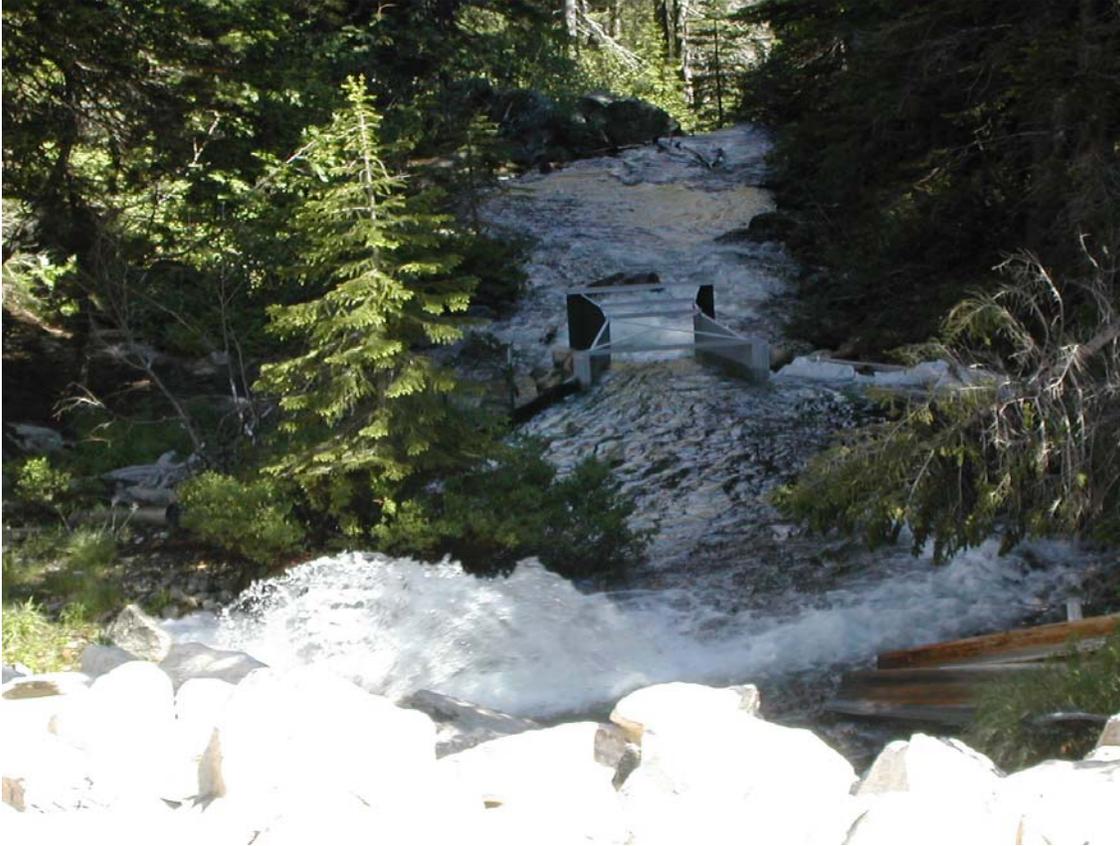
Photo #5. From the dam crest, looking downstream at the boulder deflecting water and the flume.

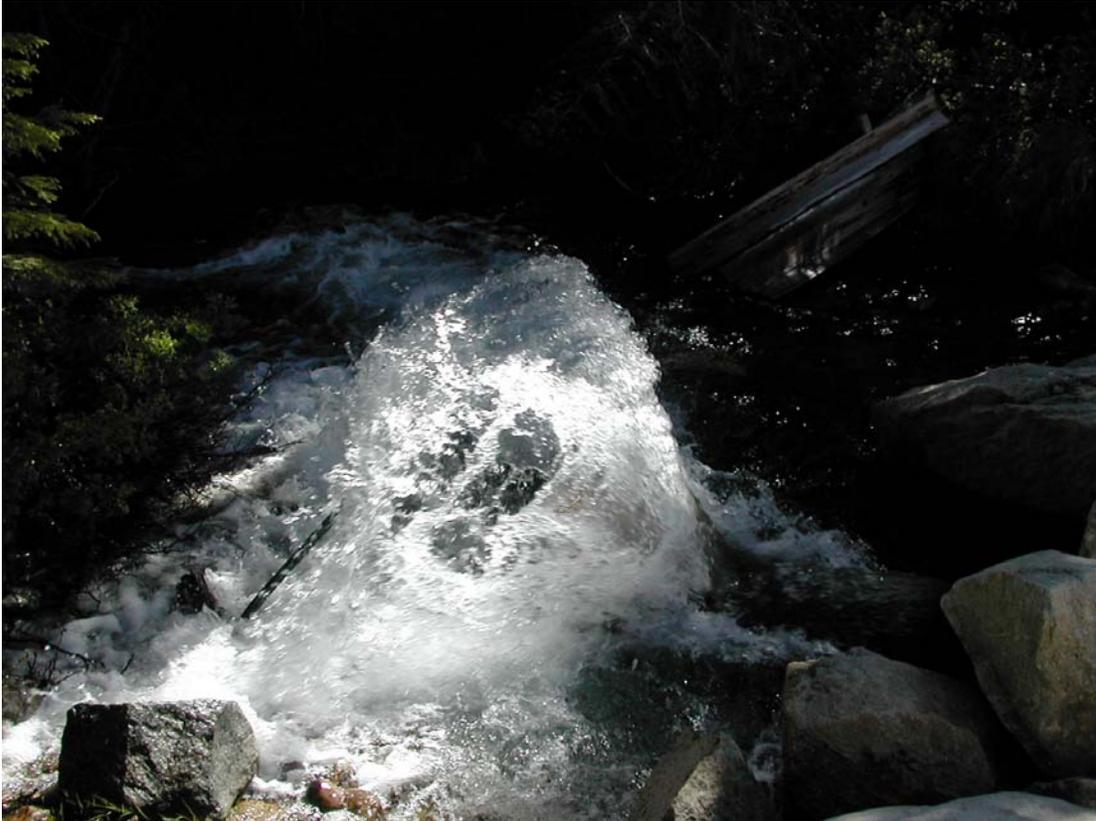
There is a large boulder (one of the boulders used for rip-rap) in Tin Cup Creek about three feet directly downstream of the outlet pipe (Photo #6).

Photo #6. Boulder deflecting the full force of the water coming out of the Tin Cup Dam outlet pipe.

This boulder deflects the full force of the water coming through the outlet pipe, shoots the water several feet into the air in a “fountain effect”, and then steers the thalweg of the stream towards the opening in the flume. I don’t know if the placement of this boulder was accidental or intentional, but I recommend that the boulder be left alone because it is currently doing several good things. It is dissipating the considerable power of the water shooting through the outlet pipe, it is protecting a small island from erosion, and it is helping to steer the thalweg into the opening of the flume. If the boulder were to be removed, the island would almost certainly be blown away, and the full force of the water coming out of the outlet pipe would not enter the opening of the flume cleanly. It would hit the wooden boards that funnel water into the flume and cause additional leakage through the boards (which are already leaking a small amount).

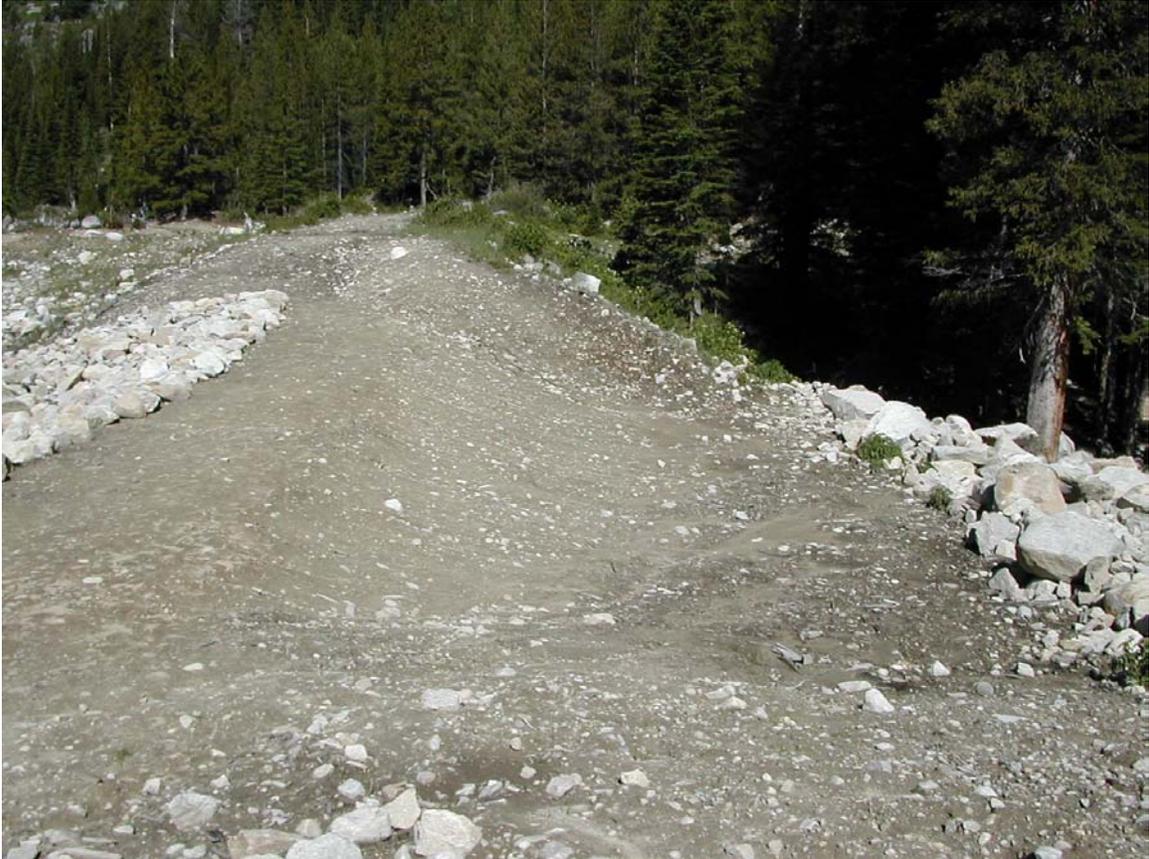
The breach in the dam was filled in 2003, but the crest of the dam at the site of the breach is currently unvegetated and has rilled and eroded during recent rains (Photos #7 and #8).

Photo #7. The filled-in portion of the dam breach. Rilling is visible on the downstream (right) slope.

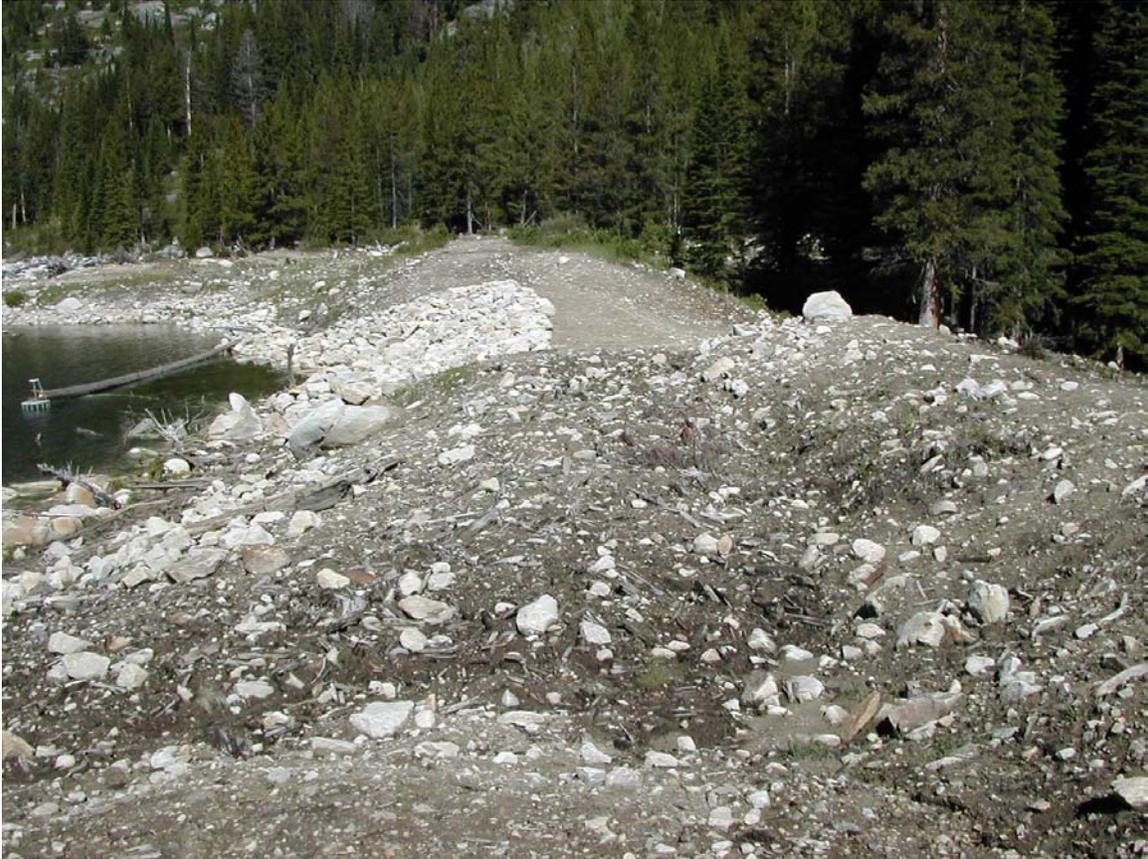
Photo #8. A wider-angle view of the dam crest and filled-in breach, looking north.

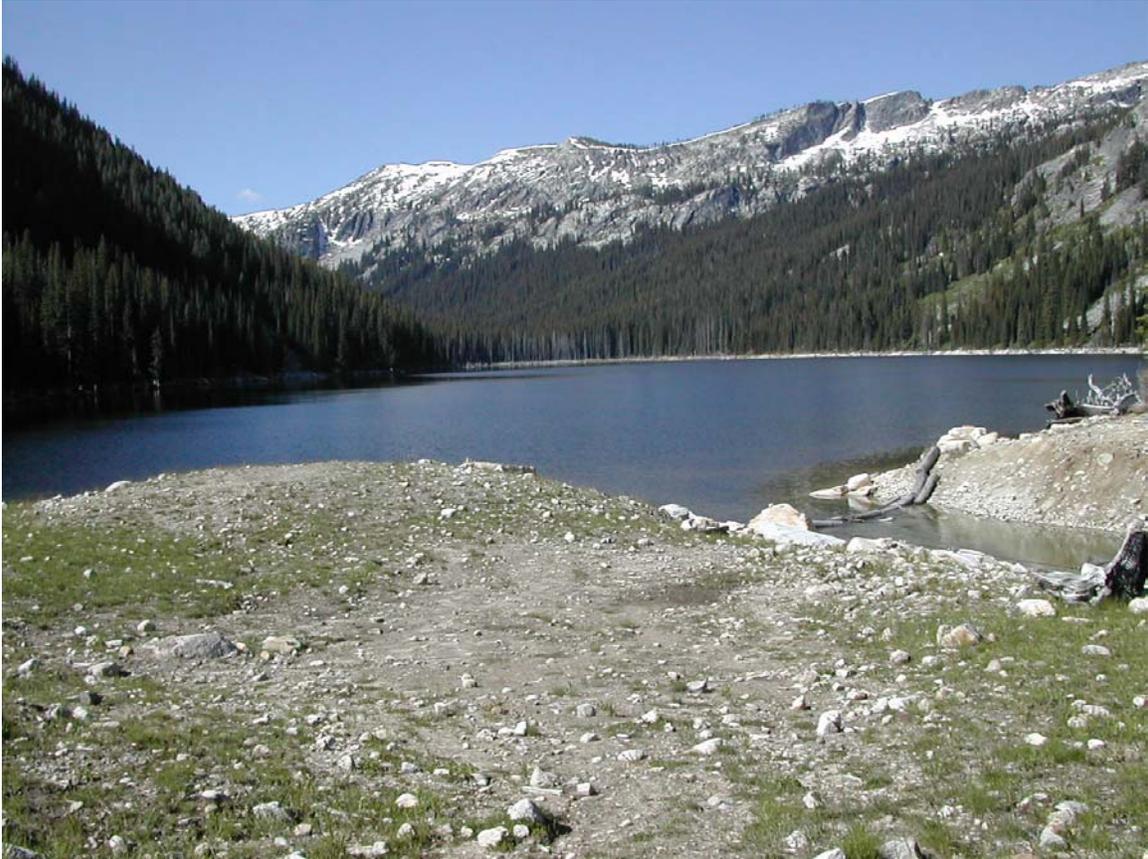
The mudflat area between the dam crest and spillway does not appear to have been disturbed much by the 2003 repairs. Vegetation is returning to the mudflat, mostly grasses, forbs, and very small shrubs (Photo #10).

Photo #10. The mudflat area between the dam and spillway.

I pulled about a dozen small knapweed plants on the mudflat. It was more knapweed than I saw anywhere along the trail. There were also a few tall buttercup plants. Vegetation is making a good recovery along the outer ring of the lake, particularly in the wetter areas.

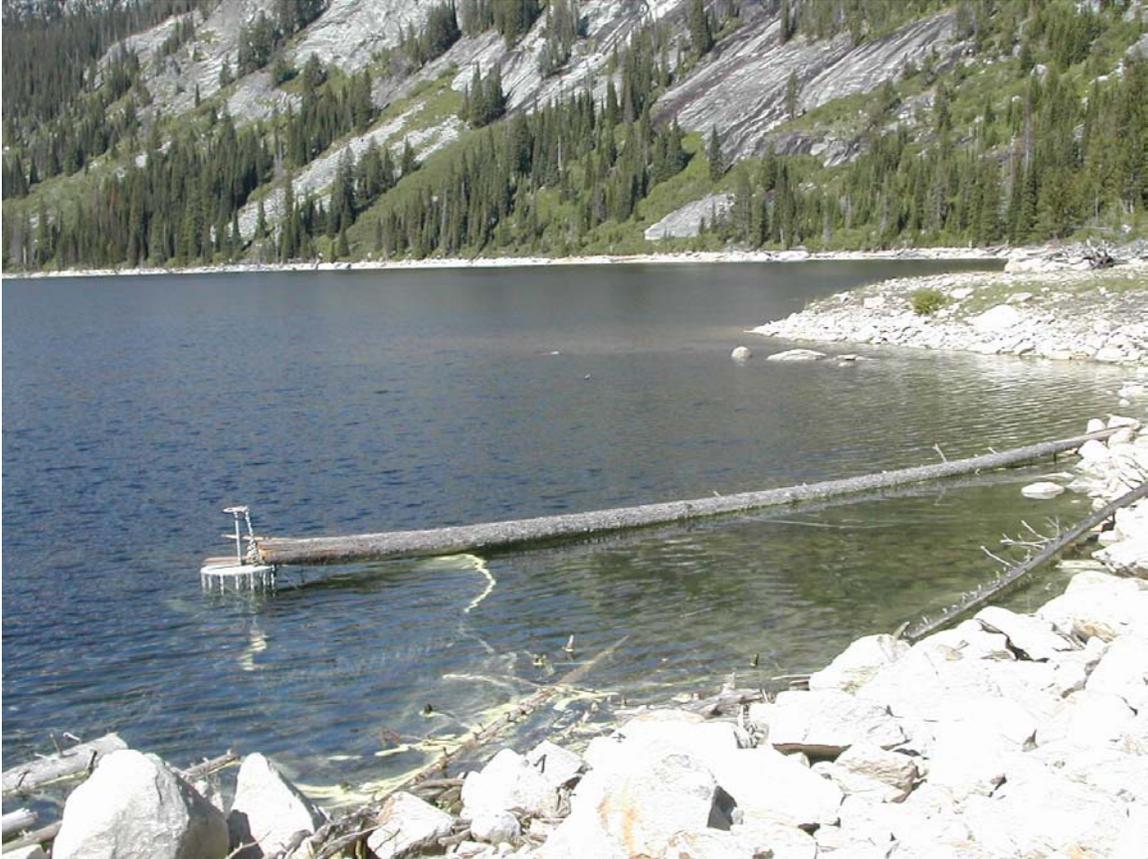
The butt of a snapped-off spruce log is currently resting on the cage of the headgate structure, with its top end resting on the rip-rap of the dam face (Photo #11). The log does not appear to be attached to the cage by any man-made means.

Photo #11. Spruce log caught on the headgate cage.
