UNITED STATES DEPARTMENT OF AGRICULTURE
FOREST SERVICE

**Ferguson Rock Slide
Geology Report**

June 20, 2006

Alan J. Gallegos and Jerry DeGraff

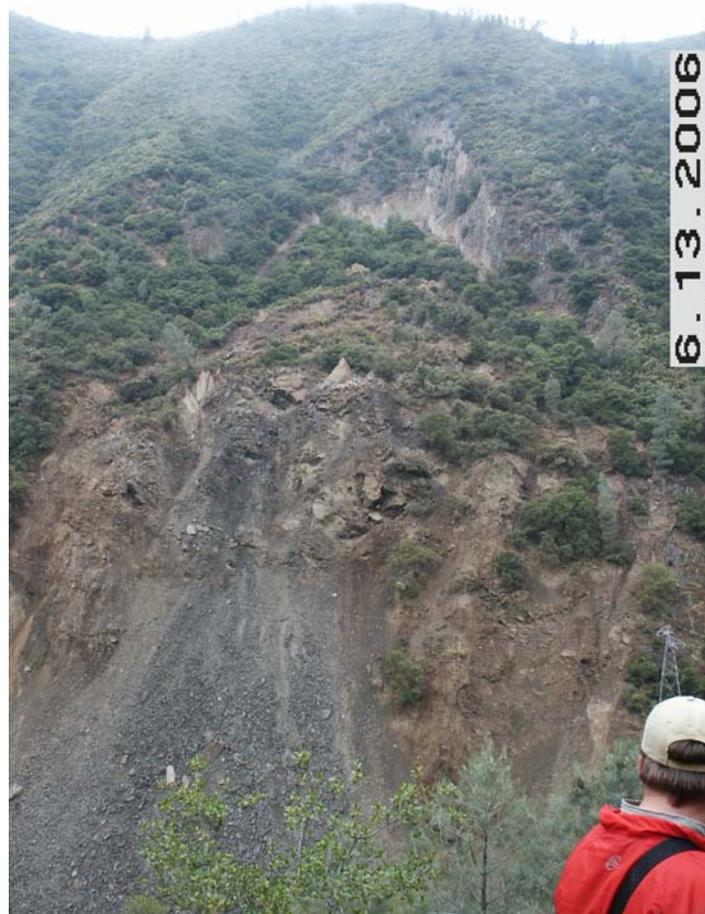
The landslide consists of a reactivated deep-seated rock block slide that toes out on a steep canyon slope, approximately 150-200 feet above the Merced River (Fig. 1). A smaller lobe of the slide is located on the west side of slide, where the head scarp, main block and several tension cracks were reviewed during the field review. The main scarp of the rock block slide was observed on the west side of the slide during the field review, where displacement along the head scarp was measured between 4 and 6 feet. This displacement is only a small proportion of the total scarp height. Most of the scarp was exposed in an earlier pre-historic movement. The surface of the slide is severely broken up with scarps and tension cracks throughout the slide mass. Field observations suggest movement of the slide is translational in nature. It is estimated, based on aerial photography and topographic maps that the maximum displacement of the slide at the head scarp is 30 feet. At the time of the field review the landslide did not appear to be moving, but we could not exclude the possibility that the slide was slowly creeping. The slip surface of the rock block slide is visible in the steep canyon face above the rock fall deposit. The slip surface is obvious on the east side of the slide where it is located above outcropping bedrock. The slip surface continues to the west, where it is buried by the landslide deposit and then it is visible again where it surfaces and undulates under the western lobe of the landslide. There is also the possibility that there could be multiple slip surfaces above the lower failure plane (Fig. 2). Another interpretation of a lower landslide slip surface was given by Ed Harp of the USGS. This lower slip surface could be where the lower dashed line is located on Figure 2. The location of the lower failure plane is significant in the determination of the volume of the rock slide. The depth and the volume of the rock slide will be determined by the location of the failure plane.

Figure 1 – View of rock block slide and landslide deposit below toe of rock slide. Toe of landslide is 200 feet above the Merced River.

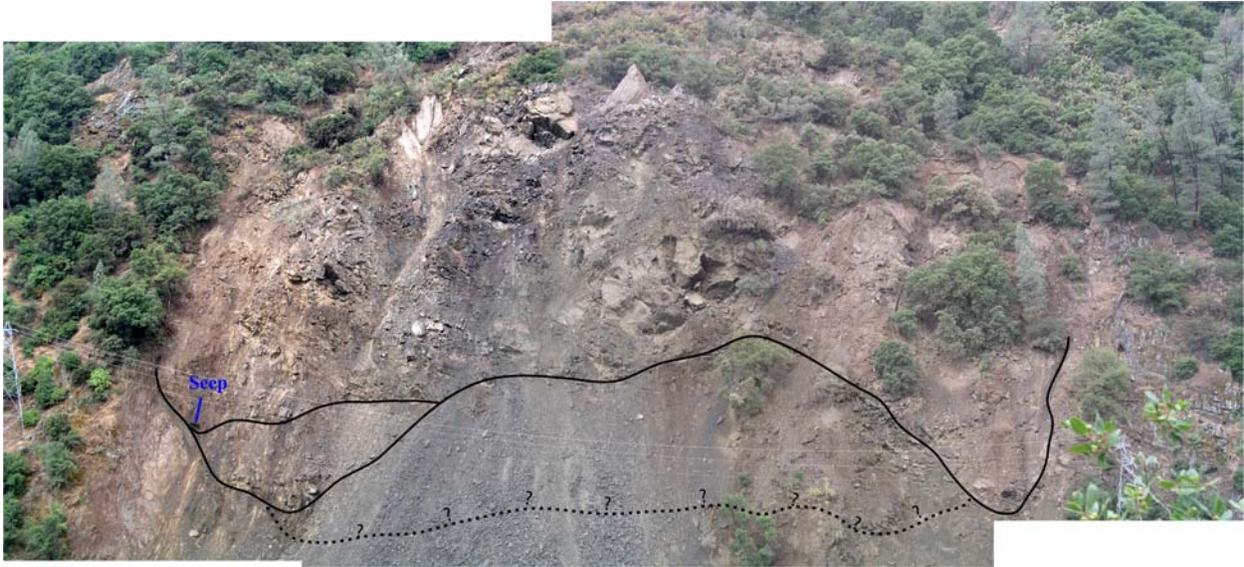
Figure 2 – Photo of rock slide toe taken from slope above the Incline Road showing interpretation of failure planes (solid lines). Lower line with ?...?...? is a possible lower failure plane covered with landslide deposit.

Very little ground water was observed on the rock slide mass. A small seepage area was observed along the east margin of the slide above the rock slide failure plane (Fig. 2). This wet area does not appear to have very much water flowing and is more of a seep than anything else. Vegetation on the slide mass is drying out and turning brown as a result of the root systems being disrupted and shallow soil water draining through fractured rock.

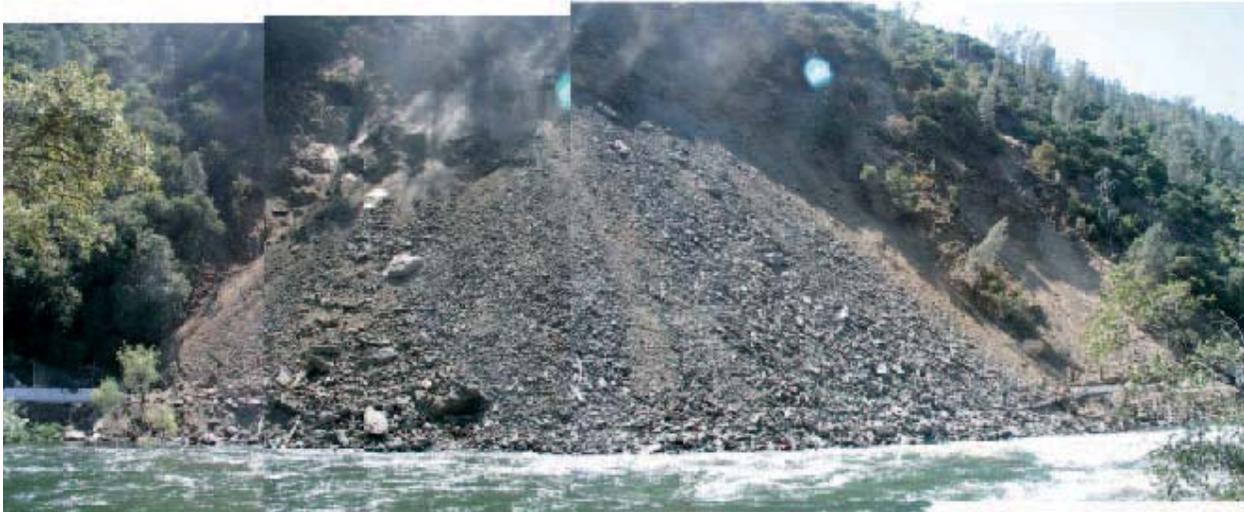
A rock fall/rock slide area is located below the rock block slide and has formed a deposit with a 38° slope. This material has deposited into the Merced River and has reduced the width of the Merced River by approximately 30 feet (Fig. 3)). This landslide deposit consists of somewhat

elongated, highly fractured blocks that range from small car size boulders to 6-inch diameter rocks. The flow of the Merced River has not moved a significant amount of the rock fall/rock slide material downstream.

Figure 3 – View of landslide deposit below toe of landslide. Landslide material has encroached approximately 30 feet into Merced River.

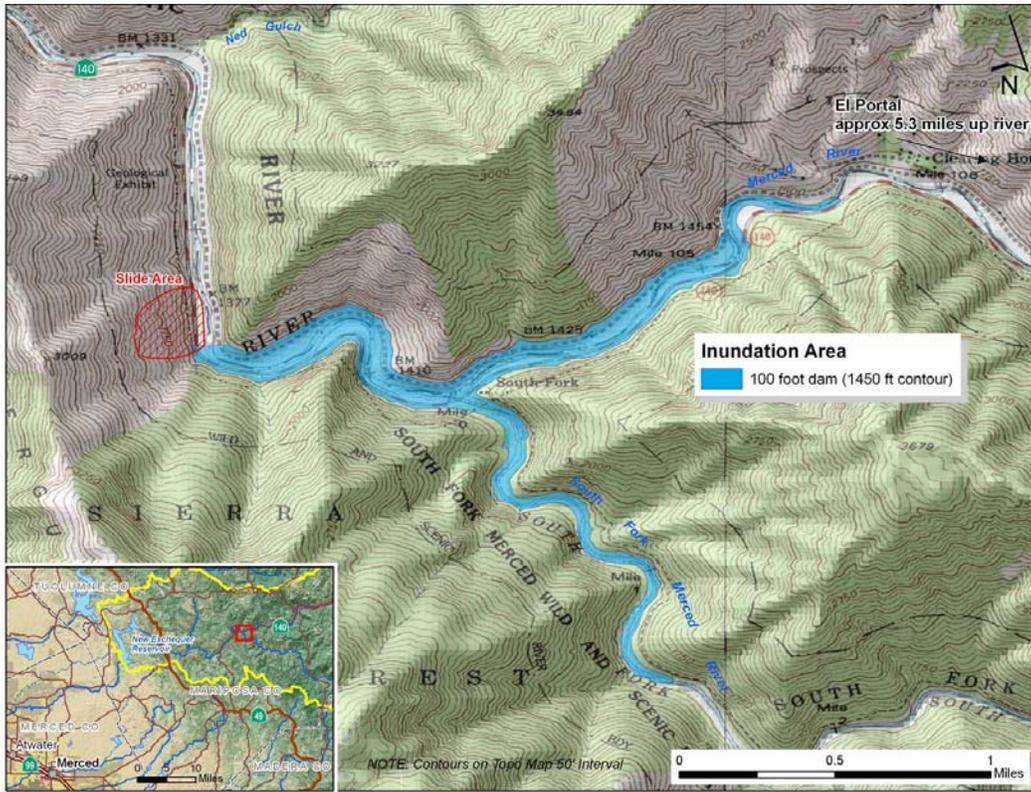
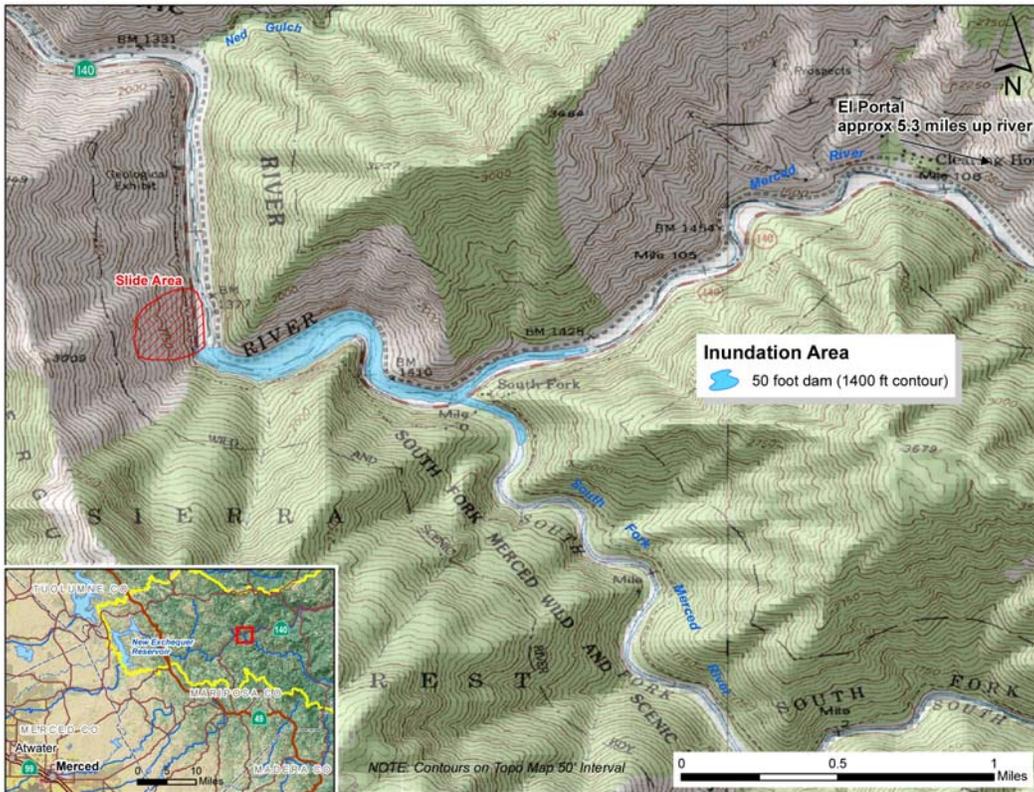
The immediate effect of either landslide dam scenario is the impoundment of water flow up the Merced River (Fig. 4). This would include both the main stem of the Merced and the South Fork which enters about 0.5 mile upstream from the Ferguson Rockslide. The impounded waters would transform part of the Merced River into a temporary lake. The upstream limit and downstream of the impounded waters within the canyon are important to analyze the safety of evacuation routes and identify people and structures at risk from flooding water.

Figure 4. 100-ft (upper map) and 50-ft (lower map) landslide dam inundation areas.

The 100-foot landslide dam would impound the most water creating the greatest impact upstream. While it is not possible to be exact, it would appear that some low-lying buildings around Savage's Trading Post at the junction of the main stem of the Merced River and the South Fork could be partially flooded. Also, California Highway 140 and Incline Road would be under water for most of their length until a point just downstream from the Clearinghouse Mine. Under the 50-foot landslide dam scenario, the principal difference is the strong possibility that no structures at Savage's Trading Post would be impacted and both California Highway 140 and Incline Road would be above water upstream from the junction of the Merced and South Fork. Under no current scenarios is inundation forecast to affect Cedar Lodge or any other residential or commercial structures farther upstream from the Ferguson Rockslide area. An earlier emergency map exercise by the Mariposa County Sheriff's Office found that such an extensive impoundment would require a landslide dam at least 350 feet high. Such a large landslide dam currently is inconsistent with the highest landslide deposit volume estimates.

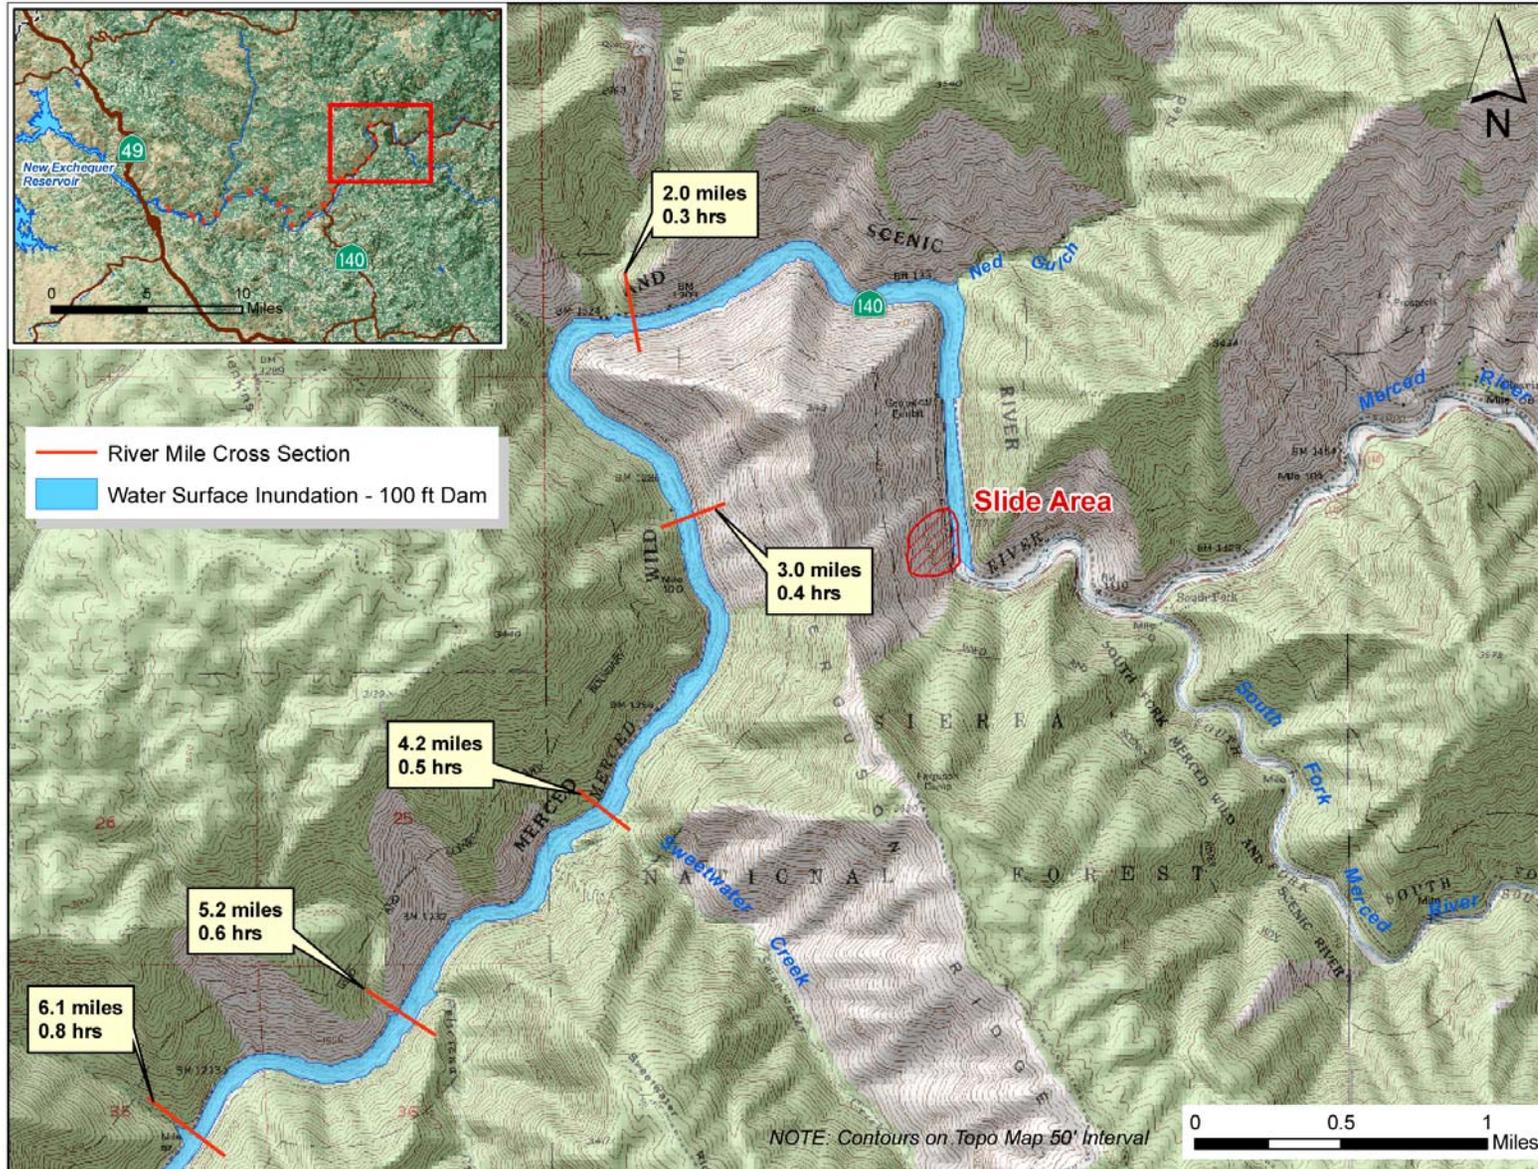
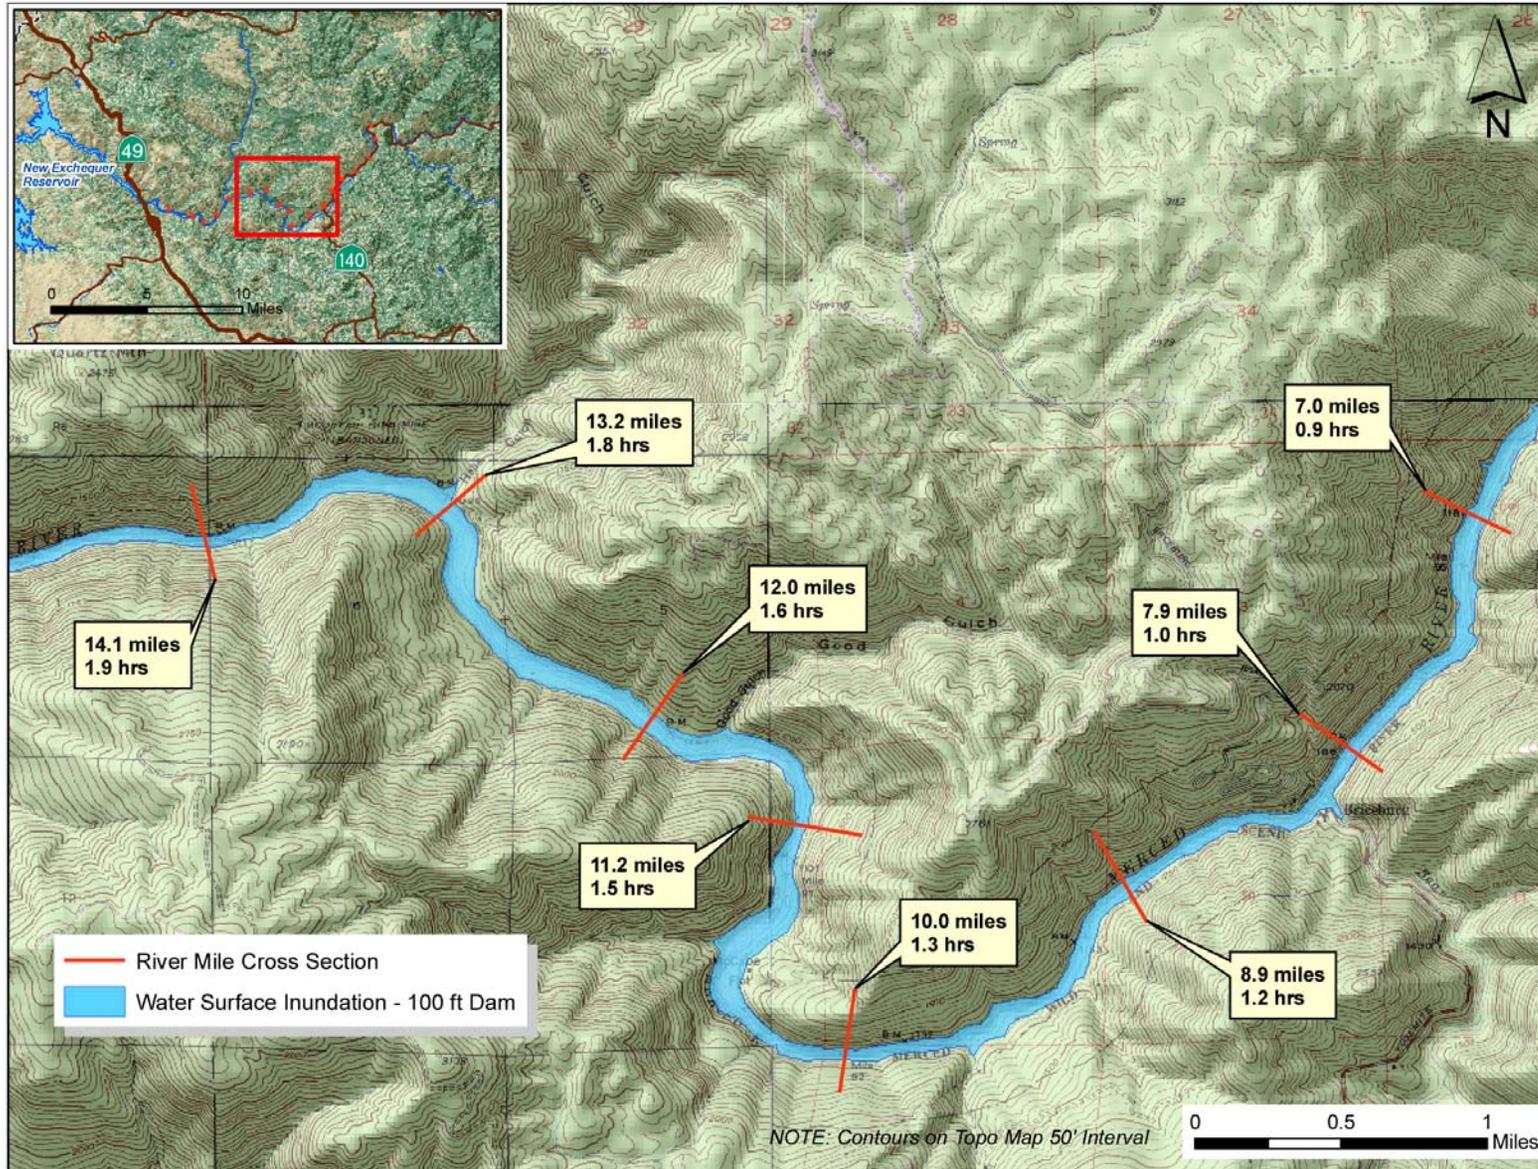
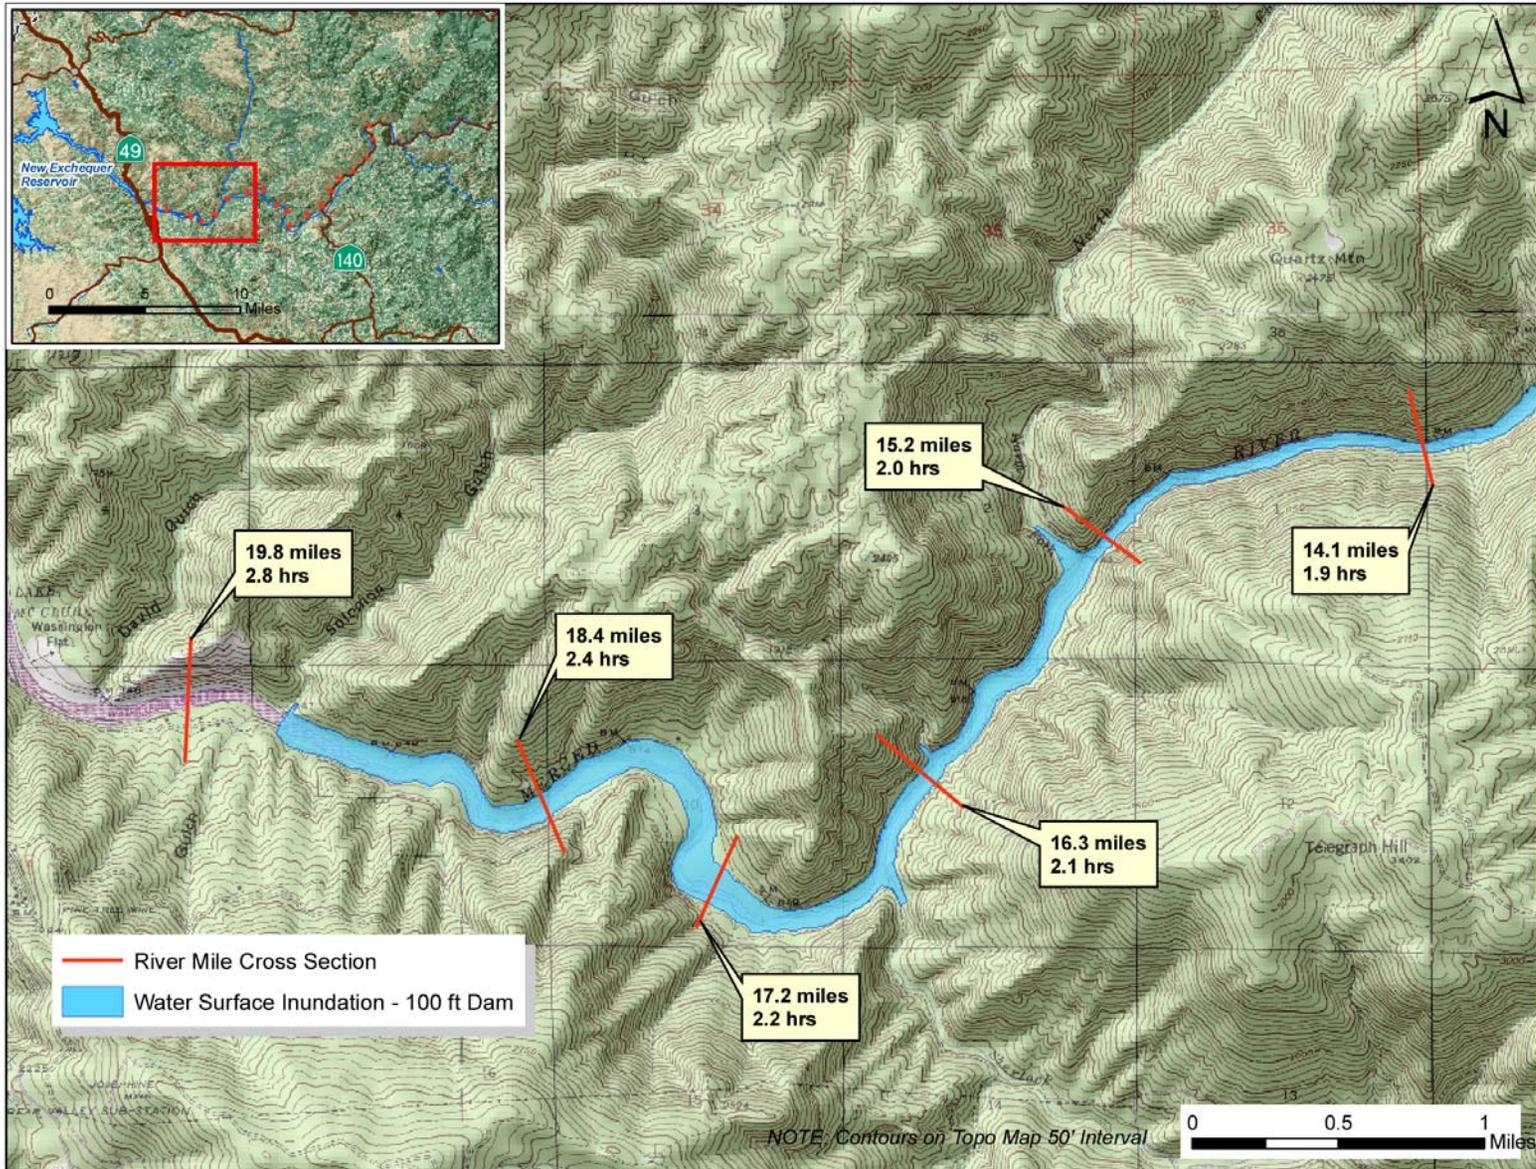
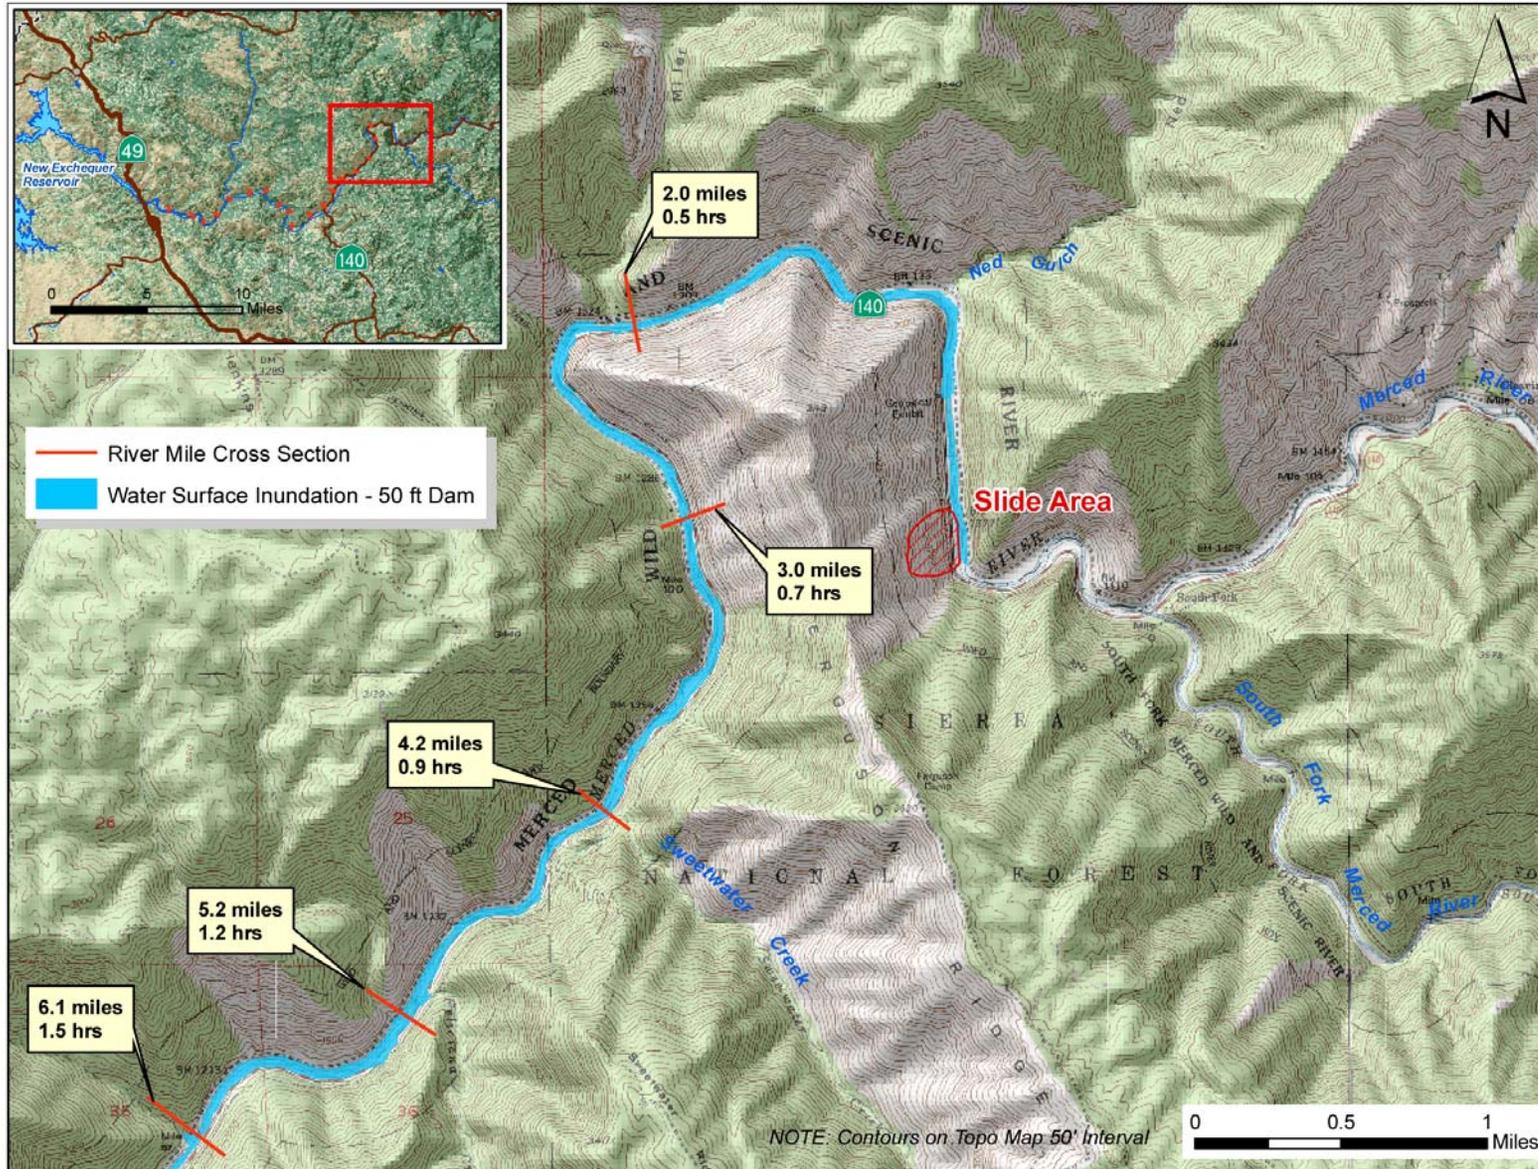
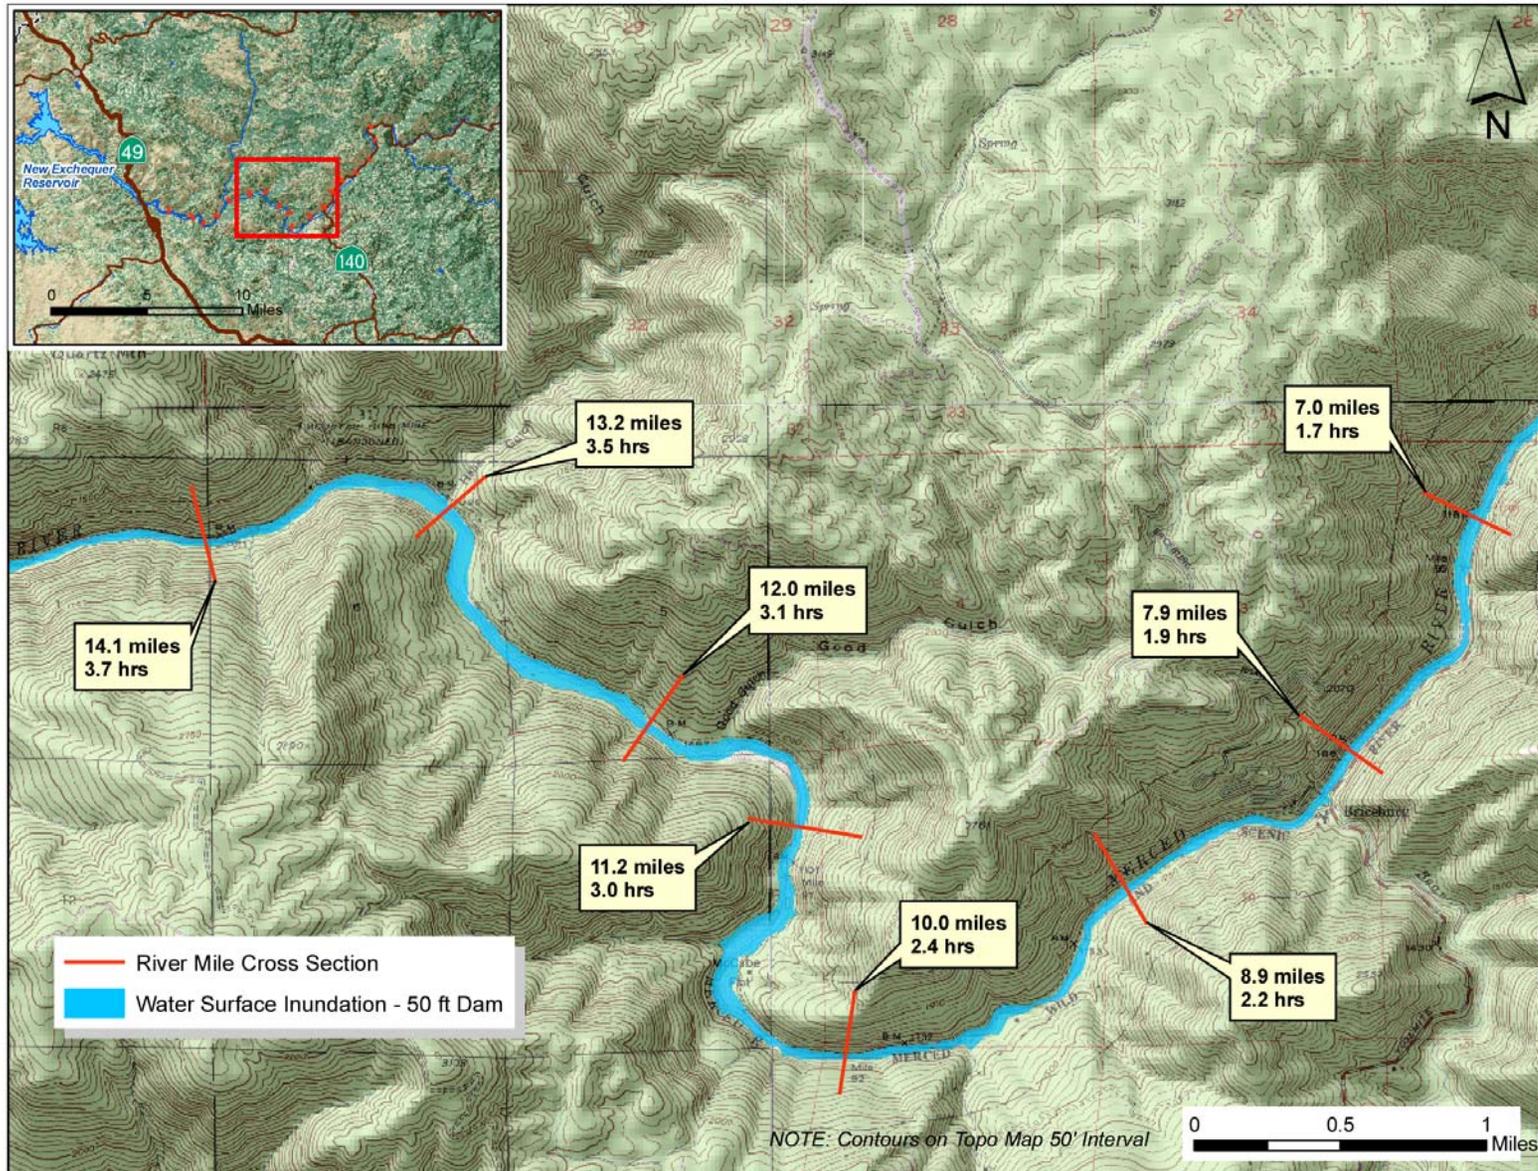
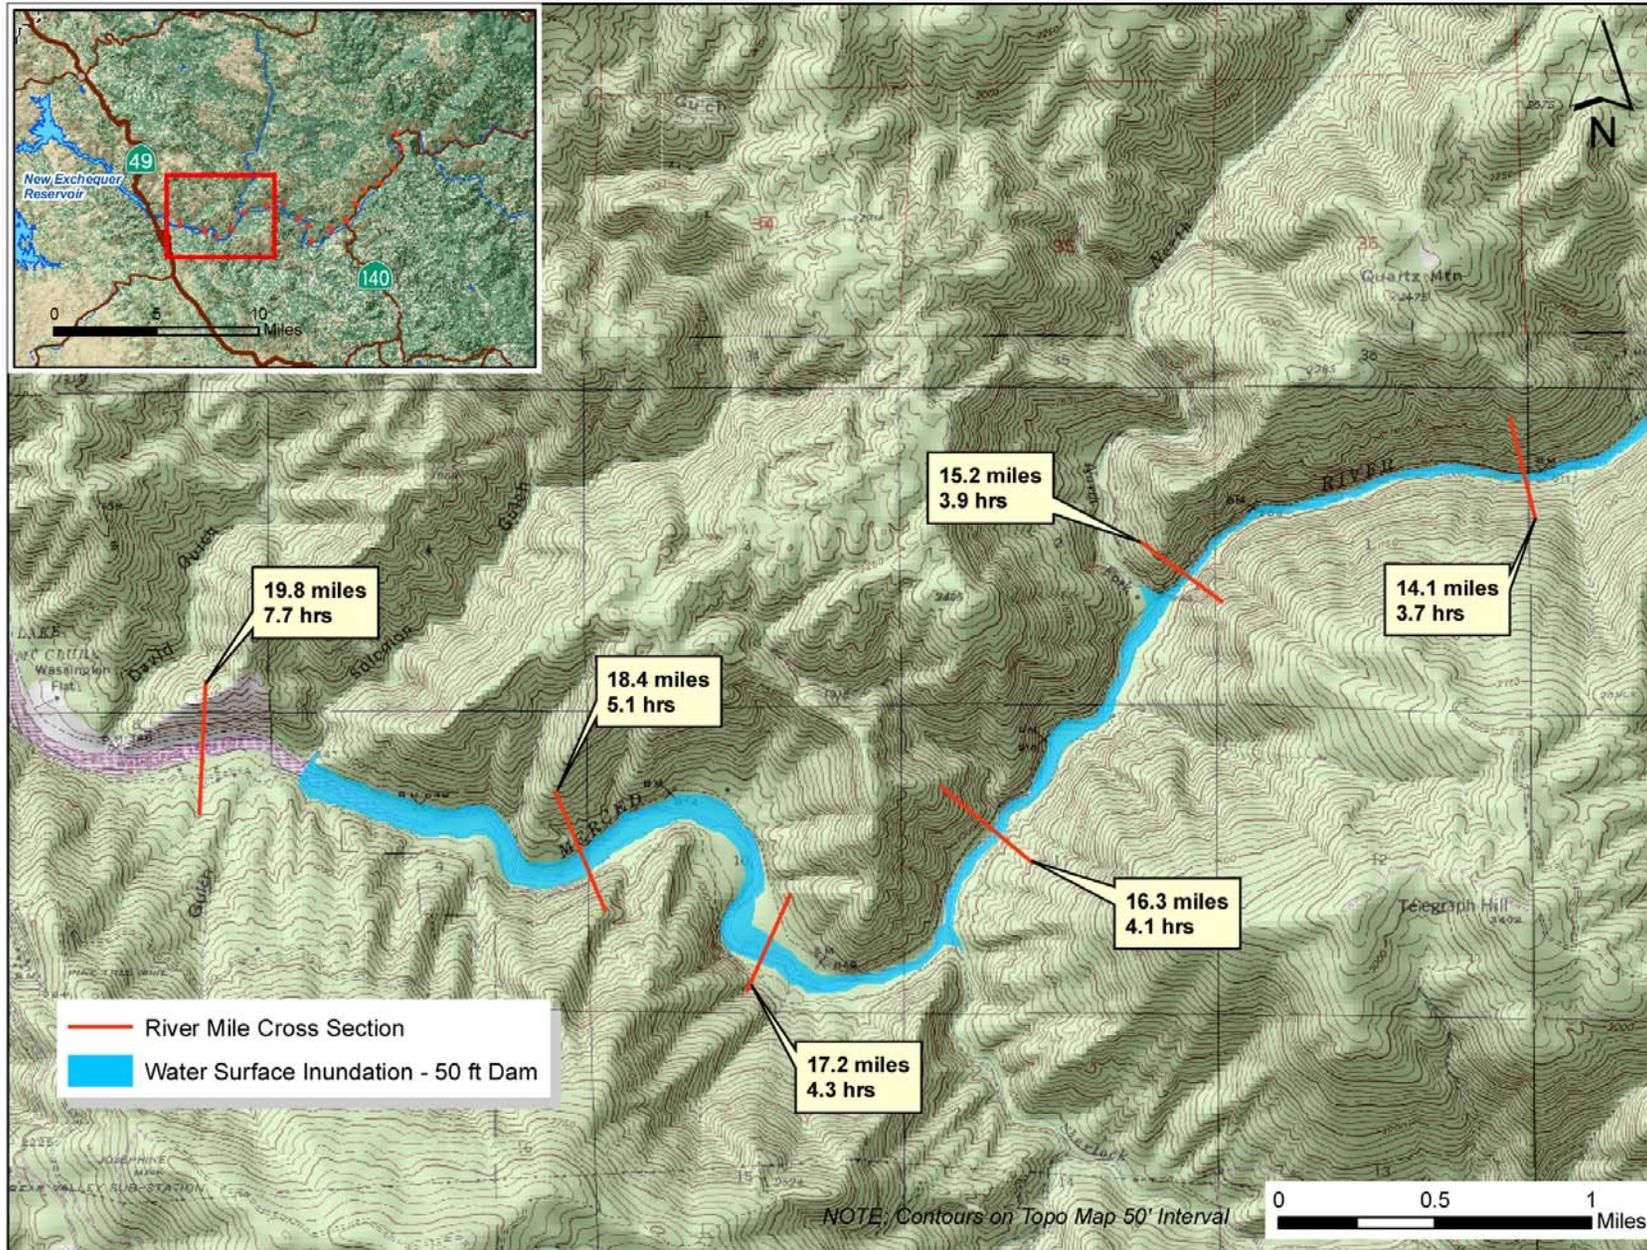
Appendix A – Flood Inundation Maps Downstream of Potential Rock Slide Dam

Appendix A contains the six maps showing the area underwater from the flood flows from breaching of the 100-foot and 50-foot landslide dam scenarios. It is important to remember that the river channel prior to any breaching the landslide dam would be virtually dry. If seepage does occur before overtopping, it would support a very low discharge. Consequently, the water surface inundation displayed on the maps would be the maximum occurring starting with the

Obviously, the release of nearly 3,800 acre-feet of water impounded by the 100-foot landslide dam affects a greater area adjacent to the channel than the 540 acre-feet associated with the 50-foot landslide dam. The water also moves faster for the larger release associated with the 100-foot landslide dam. It arrives upstream of McClure Lake (16.3 miles down stream from the landslide dam location) in 2.1 hours. This compares to 4.1 hours for the release of water impounded by the 50-foot landslide dam.
