**Pine Creek/Sulphurbeds Allotment:  
Grassy Creek Spring  
Mary O'Brien  
Grand Canyon Trust  
2008-2010**

**2009 Update**  
Wayne Hoskisson  
Grand Canyon Trust

**2010 Update**  
Wayne Hoskisson/Mindy Wheeler

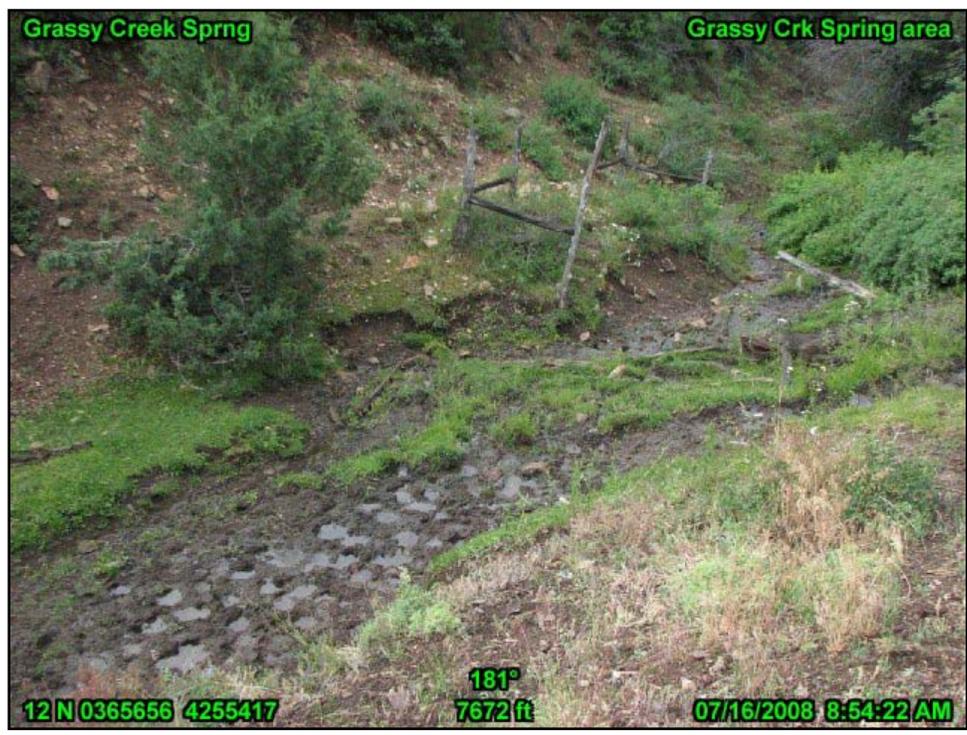
**(2008)** Grassy Creek Spring lies midway up Grassy Creek at the southern end of Pine Creek/Sulphurbeds Allotment in the Wildcat Pasture. An old spring development has broken down, and cattle are directly trampling the creek and spring area (Fig. 1) and the wetlands below the spring (Fig. 2). Capacity on the heavily-grazed adjacent uplands is questionable, given the cover of cattle-avoided lupine and cheatgrass (Fig. 3).

Fig. 1 (7/16/08) Pine Creek/Sulphurbeds: Trampled creek banks and wetlands; spring development in disrepair.

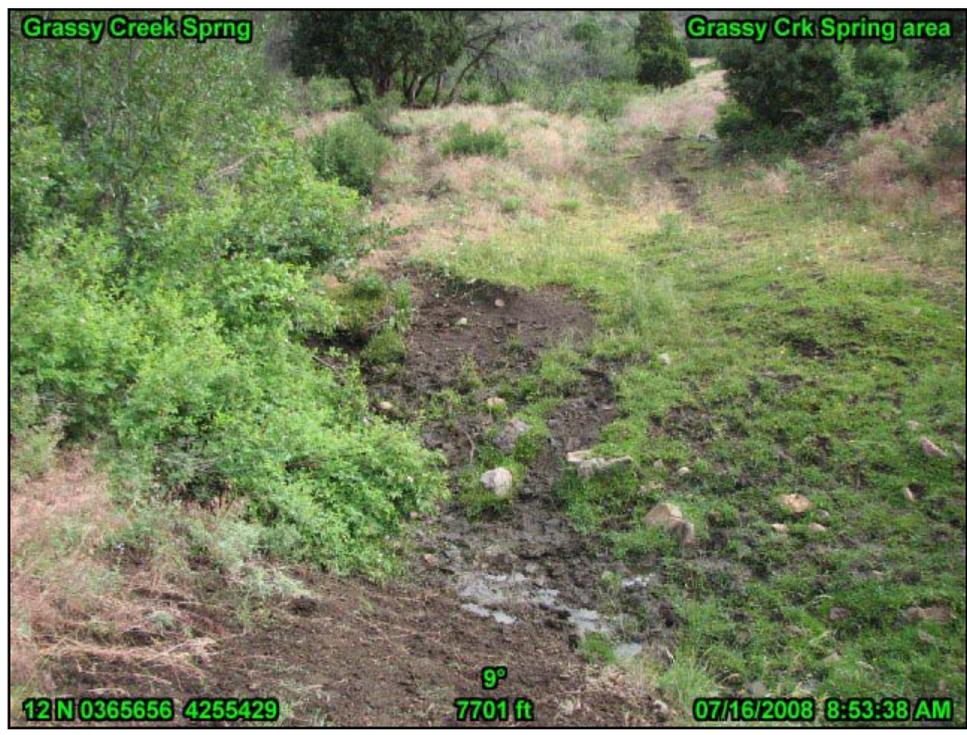
Fig. 2. (7/16/08) Pine Crk/Sulphurbeds: Trampled spring area and wetlands.

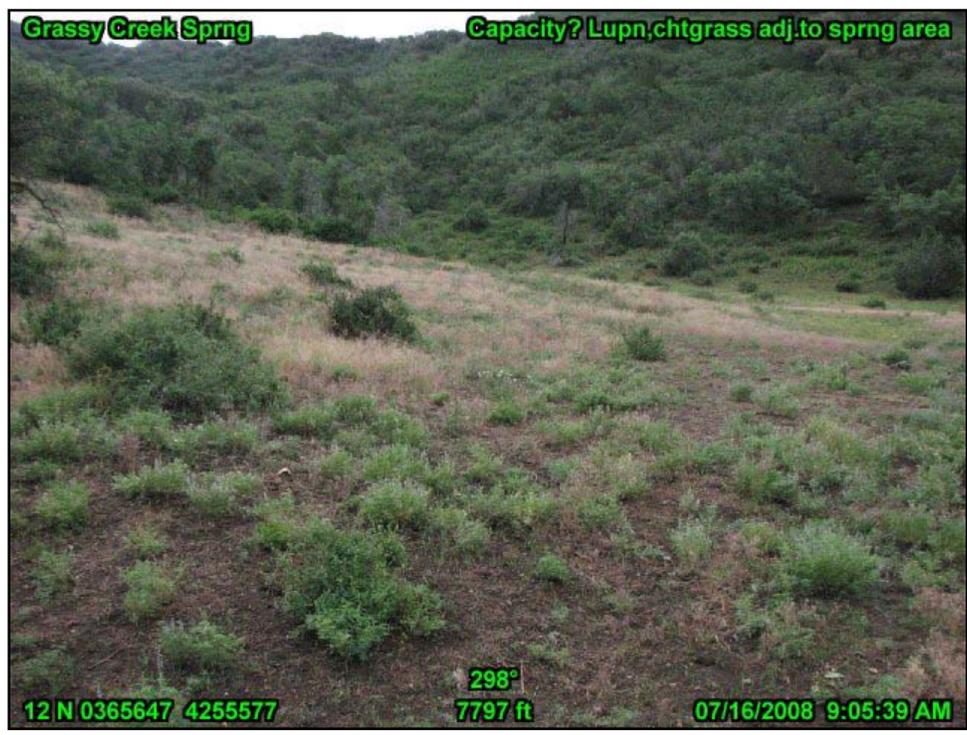
Fig. 3. (7/16/08) Pine Crk/Sulphurbeds: Slope adjacent to spring area. Lupine and cheatgrass are dominants.

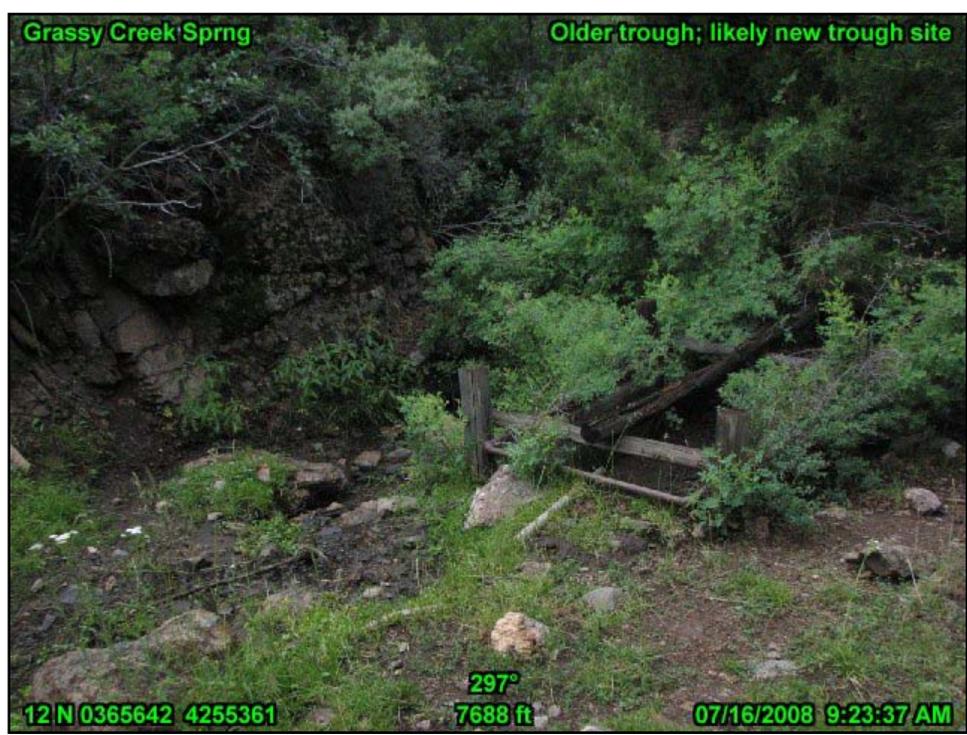
Fig. 4. (7/16/08) Pine Crk/Sulphurbeds: Potential water trough with entrance from road

If this area were to be considered productive enough for cattle, a trough might be built near the older spring development, with an entrance from the road (Fig. 4). The cliff wall immediately behind would armor one side of the trough. Protection of the spring and its wetlands as well as the creek from trampling would remain a problem.

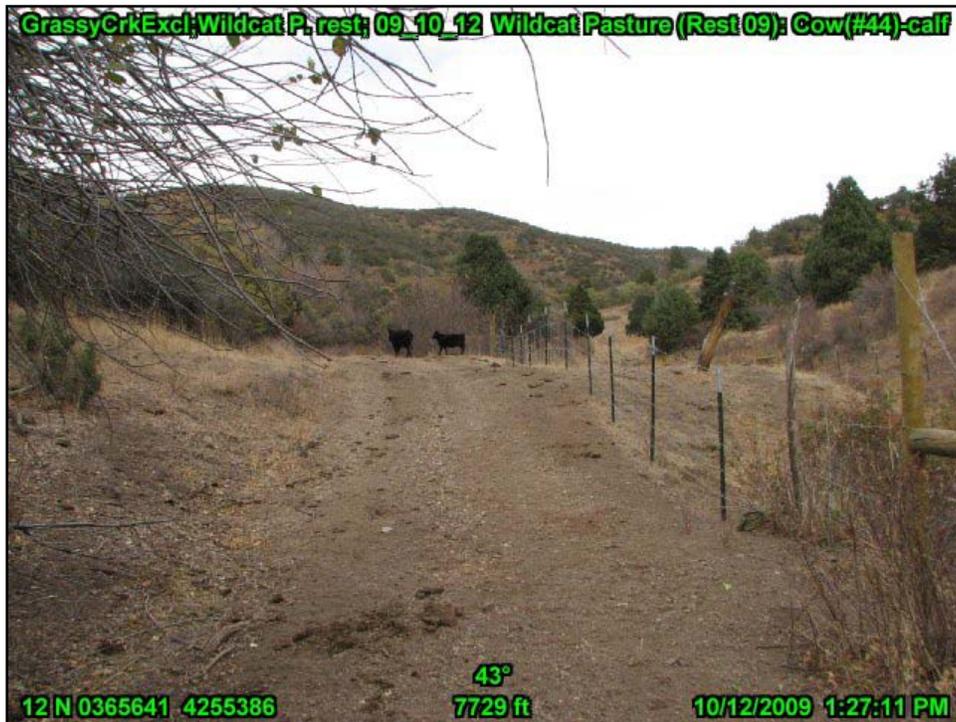
On Oct. 12, 2009, we saw cattle on the road adjacent to the spring (Fig. 5). When we followed the cattle, they headed north from the spring. The Pine Creek/Sulphurbeds Annual Operating Instructions indicate the Wildcat Pasture was to be rested for two years beginning in 2009.

Fig. 5 (10/12/09) Cattle in Wildcat Pasture near Grassy Crk Spring

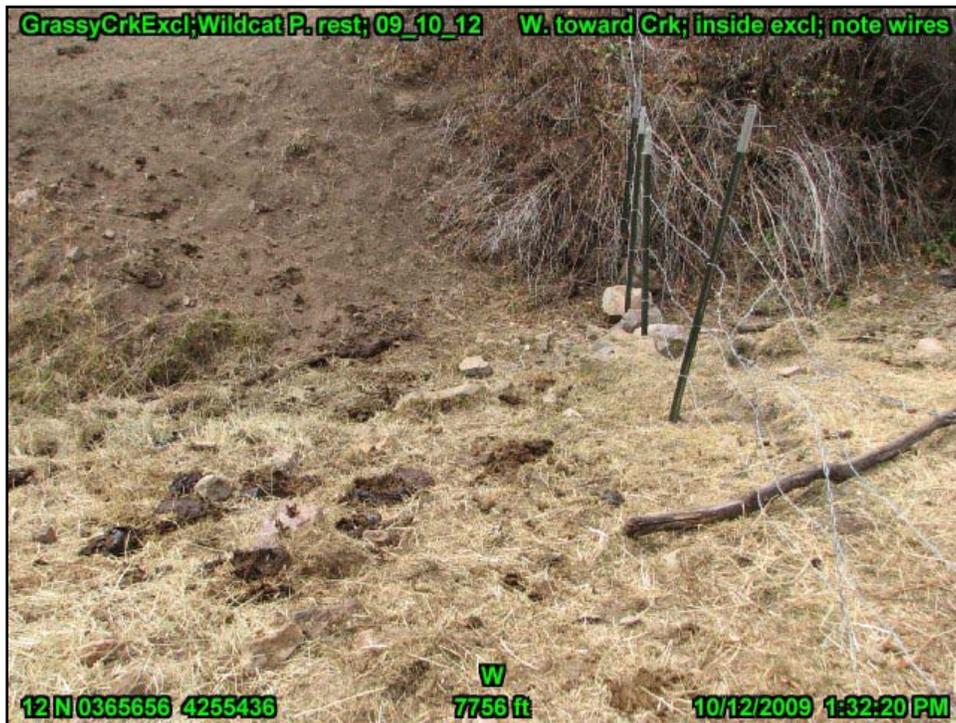
**(2009)** A barbed-wire and T-post enclosure was constructed around Grassy Creek Spring but the enclosure is non-functional and could not have been expected to withstand livestock pressure as constructed given the creek incision. The fence is down on the upstream and road sides (Figs. 6-8), cattle have grazed in the enclosure (Figs. 6, 7, 10 and 11), and the spring and brook are trampled (Figs. 7, 10, and 11). The head box is not protected because the enclosure is non-functional (Fig. 11).

Fig. 6 (10/12/09) Exclosure fence at upstream end is down and cattle have been in the exclosure. One pole is already beginning to tip over.

In the Pine Creek Water Developments Report in the April 2009 *Tushar Grazing Allotments Collaboration: Final Report*, the Beaver Ranger District had stated, "Avoid using barb-wire or net-wire since this type fence will not stand up to the increased pressure from livestock." (By: Douglas Sorensen, Rangeland Management Specialist November 7, 2008) Following this instruction would be advisable for this spring."

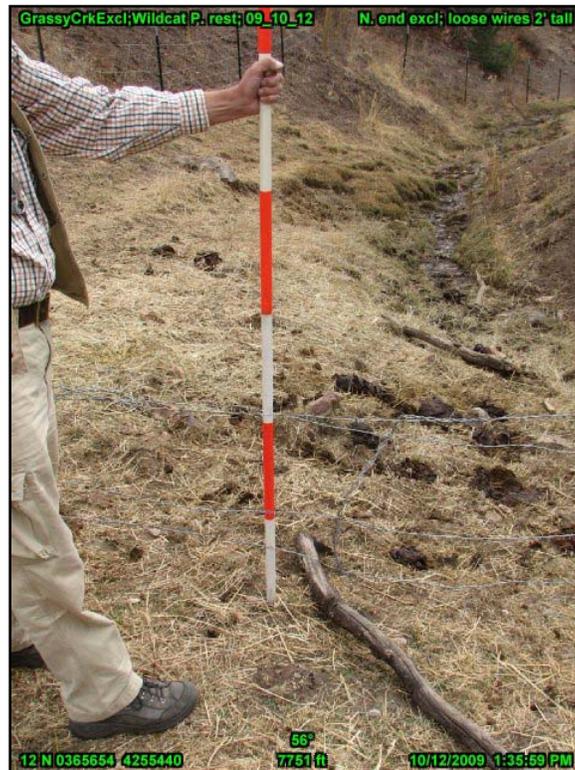
Fig. 7 (10/12/09). The fence next to the road is only 2 ft tall and loose. Note cattle have been in the enclosure. The brook is trampled

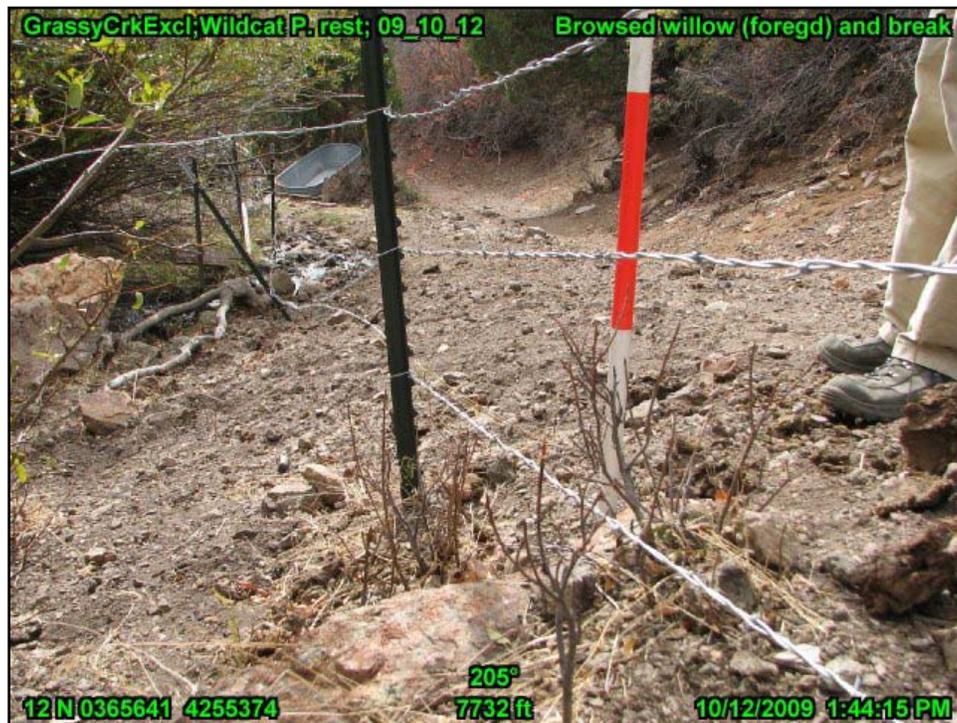
Fig. 8 (10/12/09) The fence is broken. The T-post beyond the one in the center is falling over. Note bare ground and browsed willow.

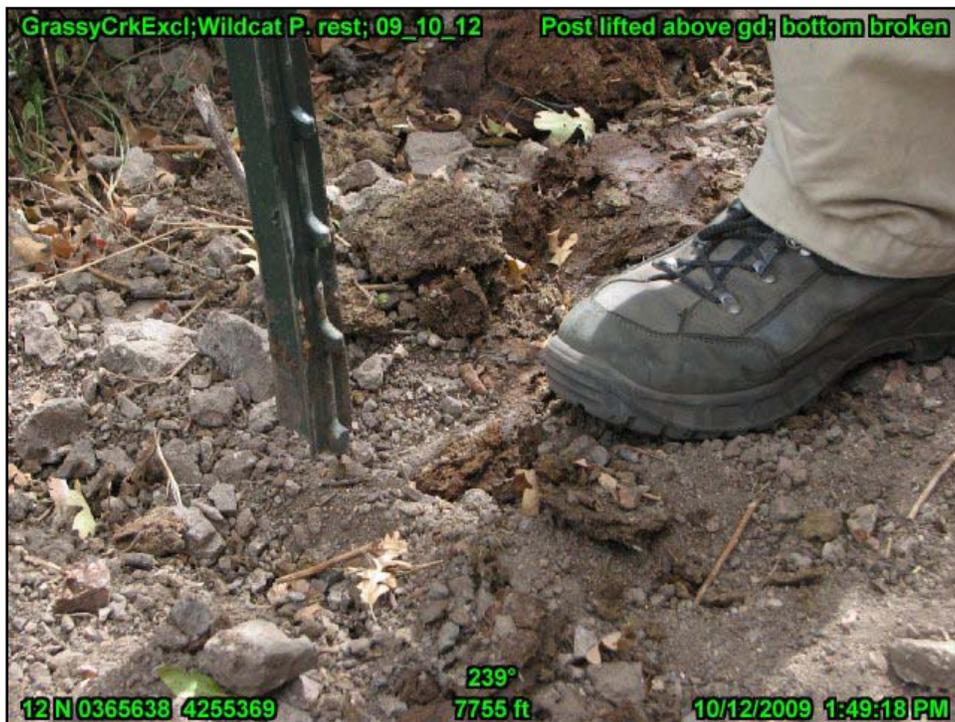
Fig. 9 (10/12/09) This T-post near the road is broken near the ground. The base cannot be seen.

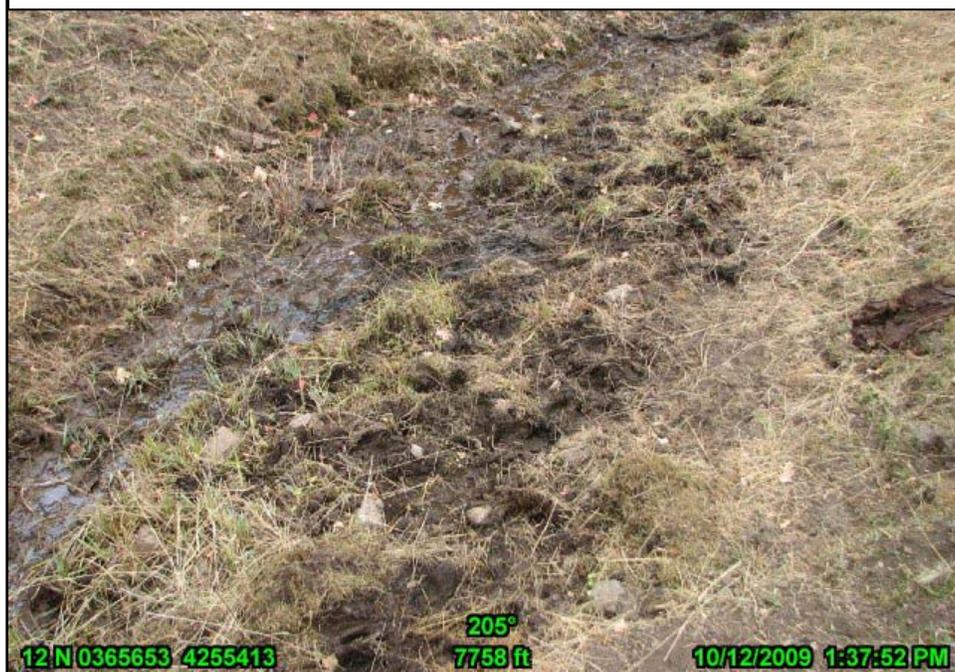
Fig. 10 (10/12/09) In the enclosure Grassy Creek is trampled. Note cow patties and bare ground.

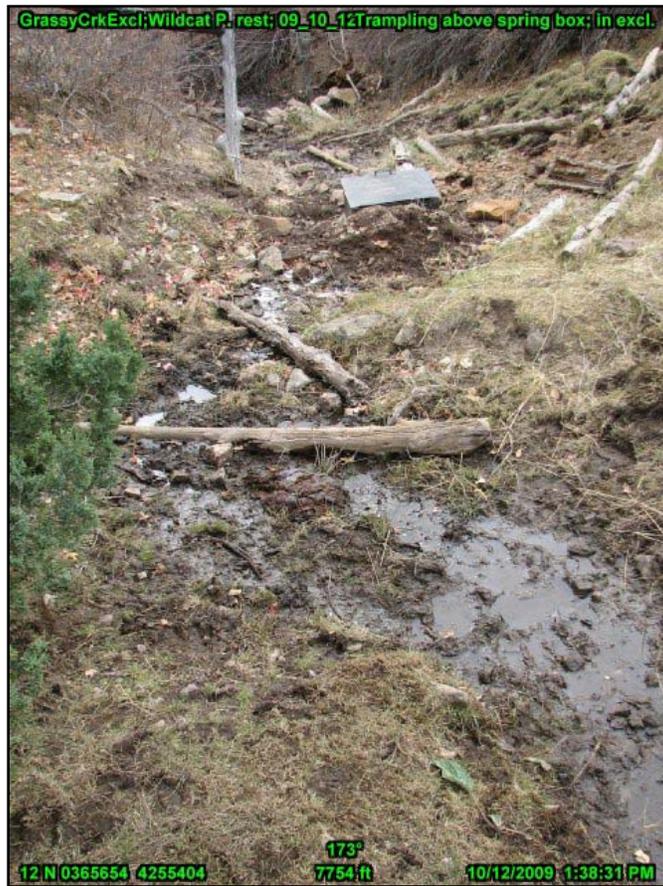
Fig. 11 (10/12/09) The spring box is not protected because the enclosure is non-functional.

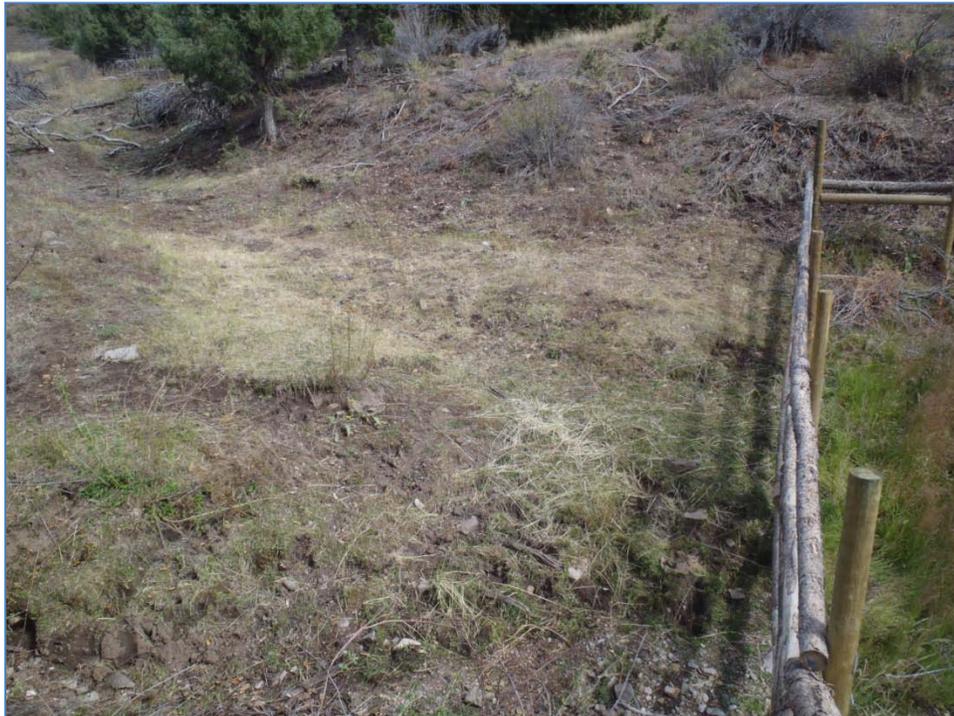
**2010** The Grassy Creek Spring is within the Wildcat Pasture, which was to be rested in 2010. There was noticeable sign of trespass cattle in the area of the Grassy Creek Spring (Figures 12, 13 and 16). Although the enclosure for Grassy Creek Spring itself had been properly rebuilt and was successfully keeping cows out of the water source (Figs 12 and 13), the pasture around Grassy Creek was in poor shape. Bare ground, cheatgrass and houndstongue (*Cynoglossum officinale*) were dominant in the area just above the spring. In order for this area to become dominated by native perennial grasses to secure the soil as well as to reduce the level of houndstongue spread, the area likely needs a combination of fencing, noxious weed control and seeding with natives.

Fig 12 (10/9/2010) Grazed/ trampled area adjacent to fenced Grassy Spring. GPS coordinates 366072E 4256514N (UTM NAD 27)

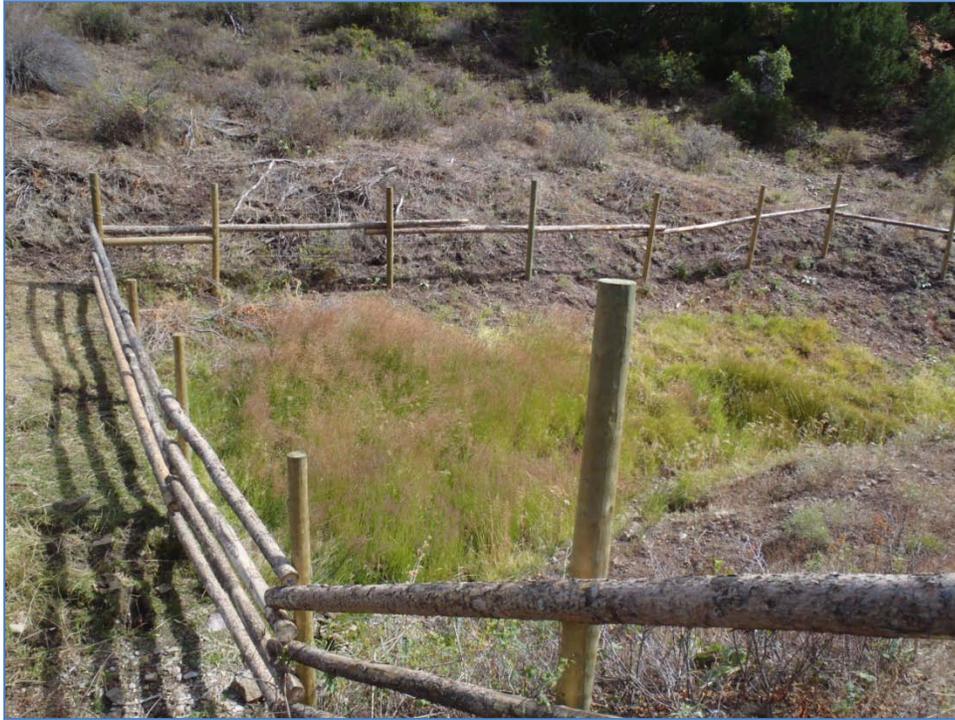
Fig 13 (10/9/2010) Abundant and tall exotic creeping bentgrass (*Agrostis stolonifera*) inside fenced Grassy Spring.  
GPS coordinate 12N 366072E 4256514N (UTM NAD 27)

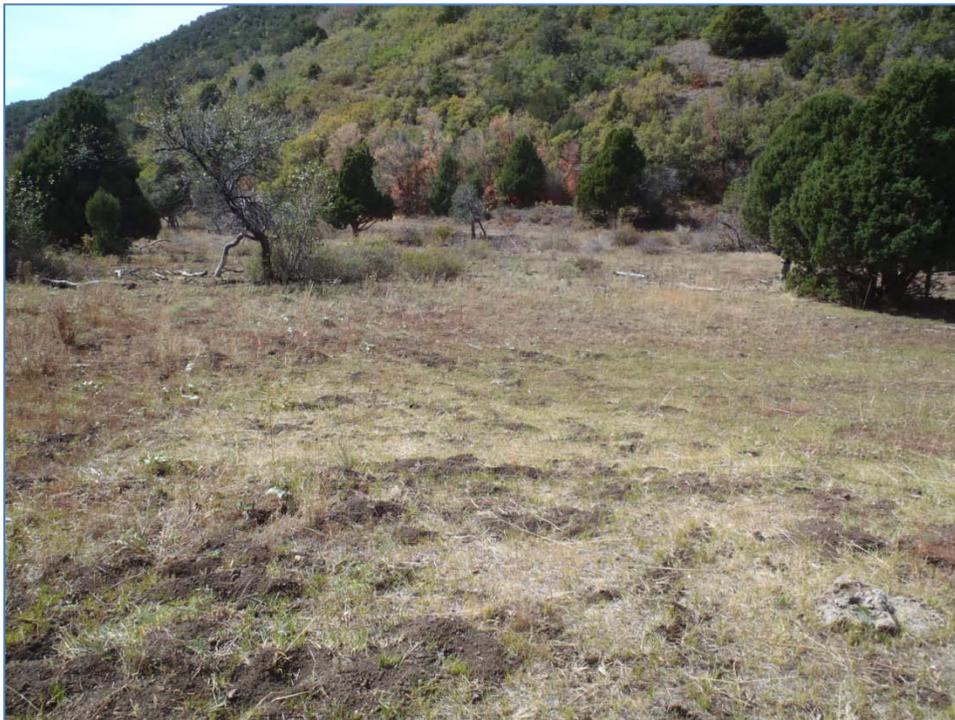
Fig 14 (10/9/2010) Bare and weedy ground just above Grassy Spring during a rest year for Wildcat Pasture.  
GPS coordinate 12N 366062E 4256614N (UTM NAD 27)

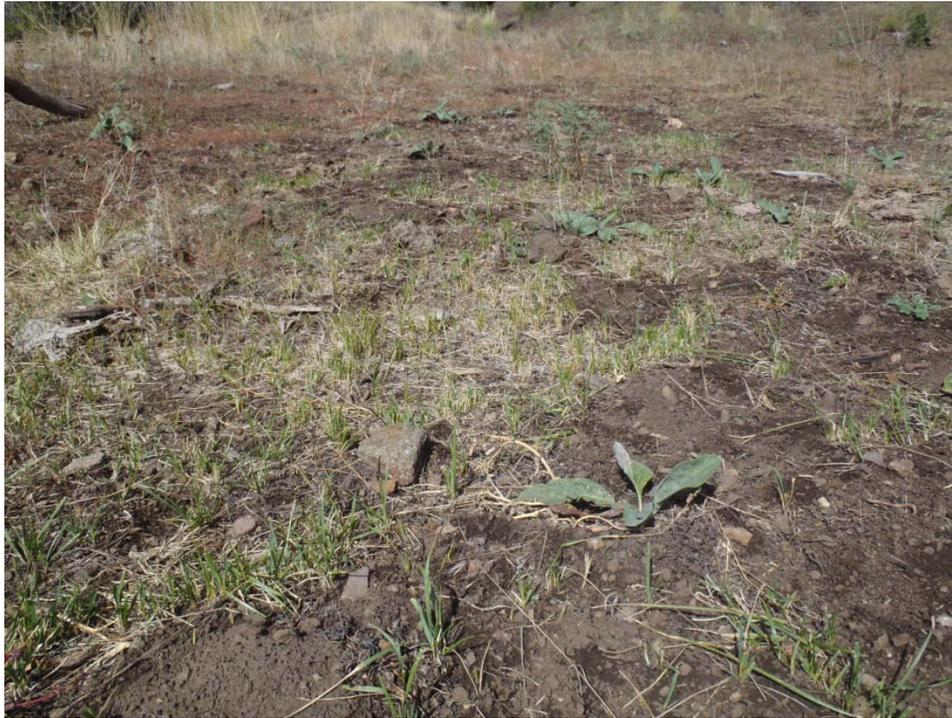
Fig 15 (10/9/2010) Bare and weedy ground just above Grassy Spring. Note strong presence of houndstongue 366021E 4256865N (UTM NAD 27)

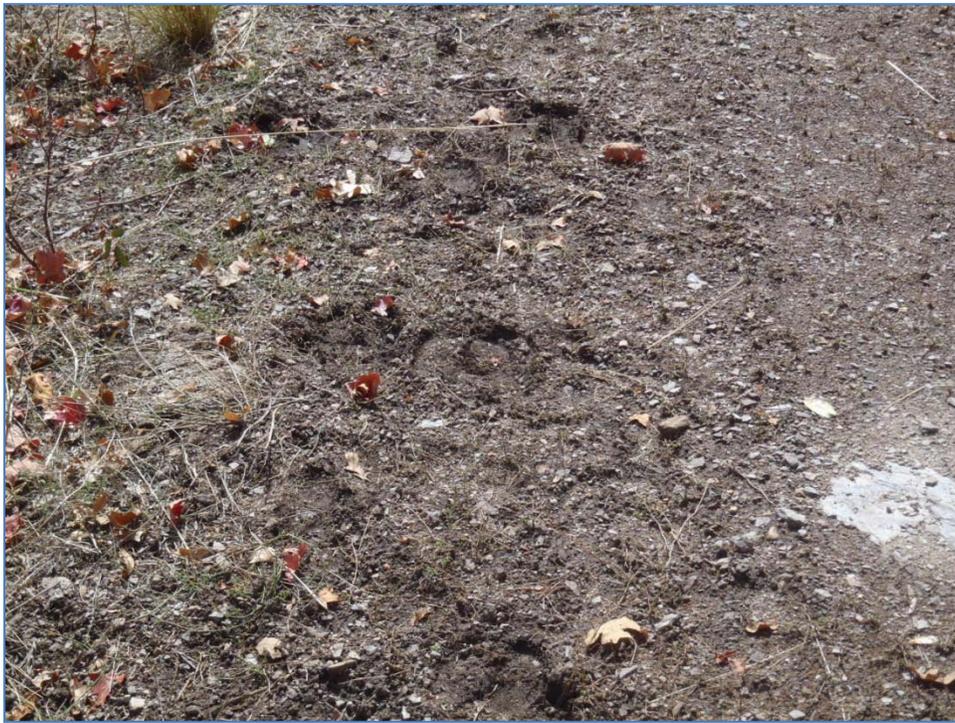
Fig 16 (10/9/2010) Cattle prints close to Grassy Spring 366003E 4256683N (in a rest year for Wildcat Pasture)

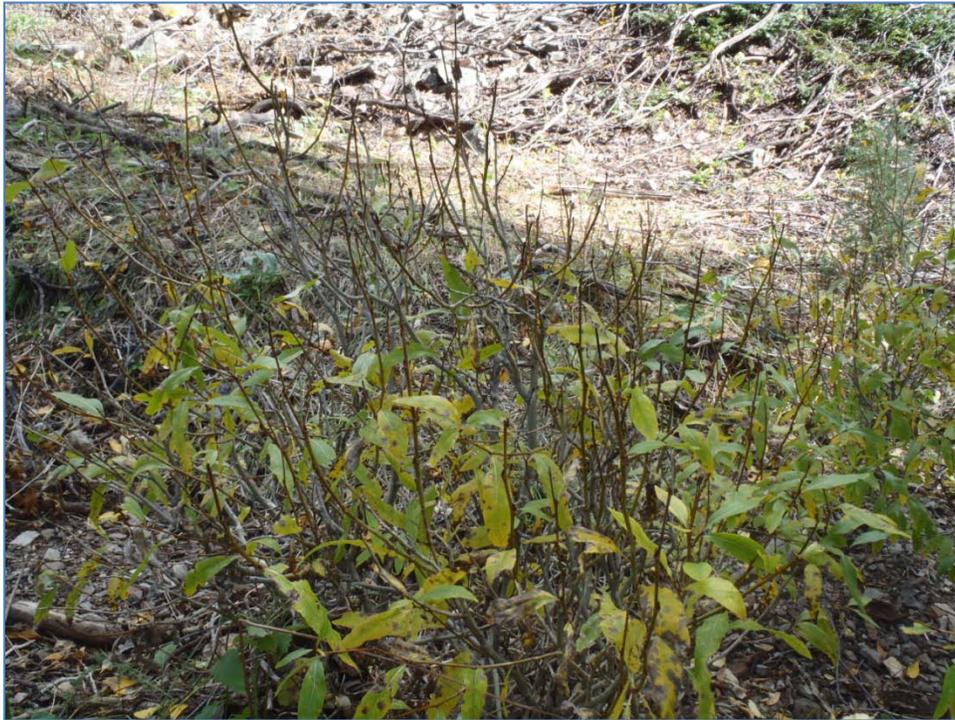
Fig 17 (10/9/2010) Heavily browsed cottonwood in Grassy Creek area  
365944E 4256450N
