Holloway Lake Dam Monitoring
July 1, 2010

Bill Goslin

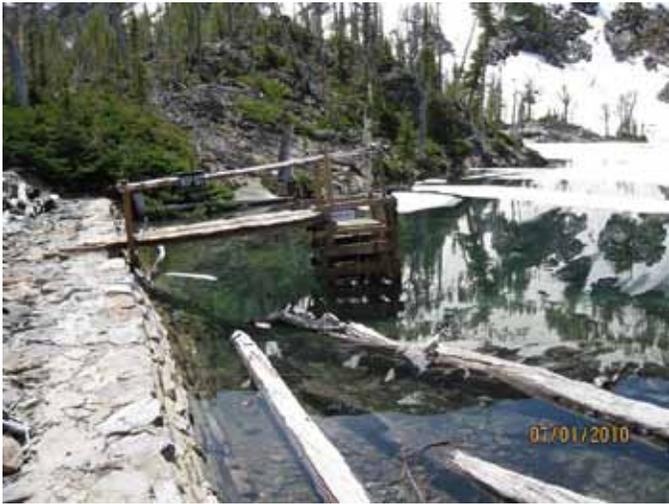
This information was collected on a brief visit to the dam during inspection of the trail clearing contract. This is a photo of the main dam. The reservoir was at full pool. There was no observed seepage in the dam. The headgate was closed. It has been several years since the last maintenance work at the dam. Everything looked OK.

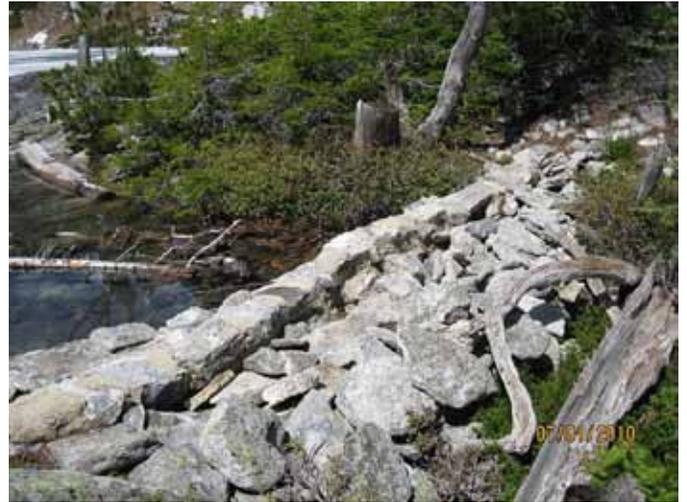
This photo is of an auxiliary dam a short distance to the north. No seepage here. The area appeared free from litter, construction materials or tool caches. Driftwood is usually not a problem at Holloway. The water level was normal so the spill way was not checked because of time constraints.
