Appendix A: Photographic Log

United States Forest Service

Blue Ledge Mine near Jacksonville, OR

Job No. 25696770

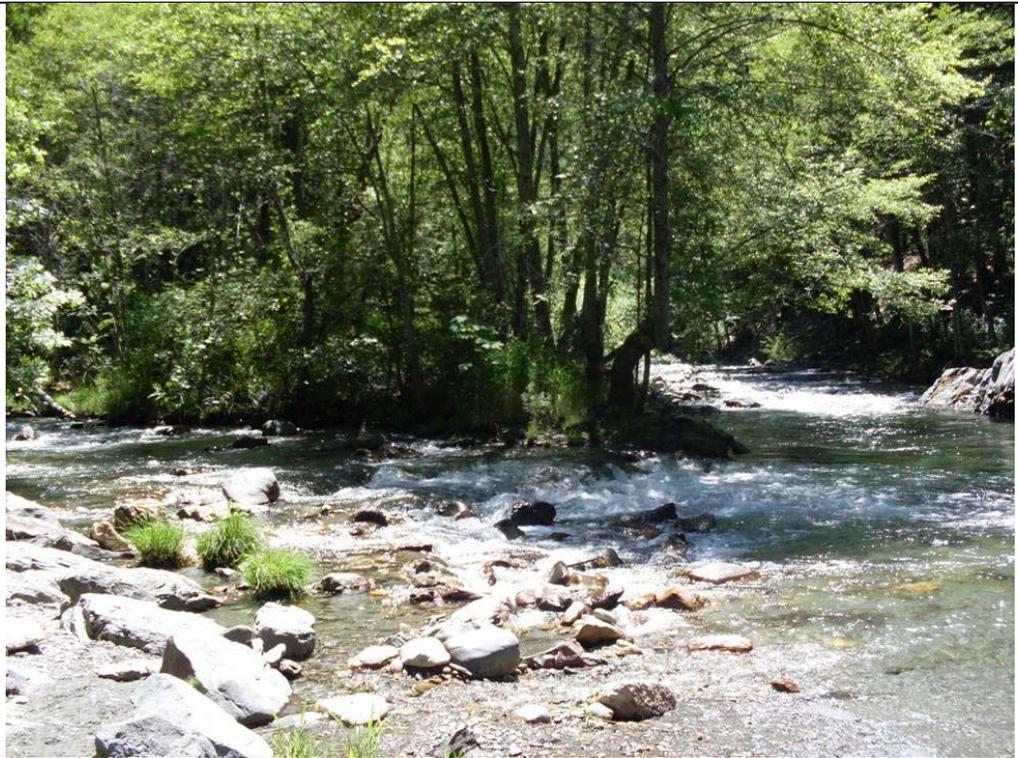
**Photo
No. 1**

Confluence of the Applegate River (right) and Elliott Creek. Stream flow measurements taken above and below confluence.

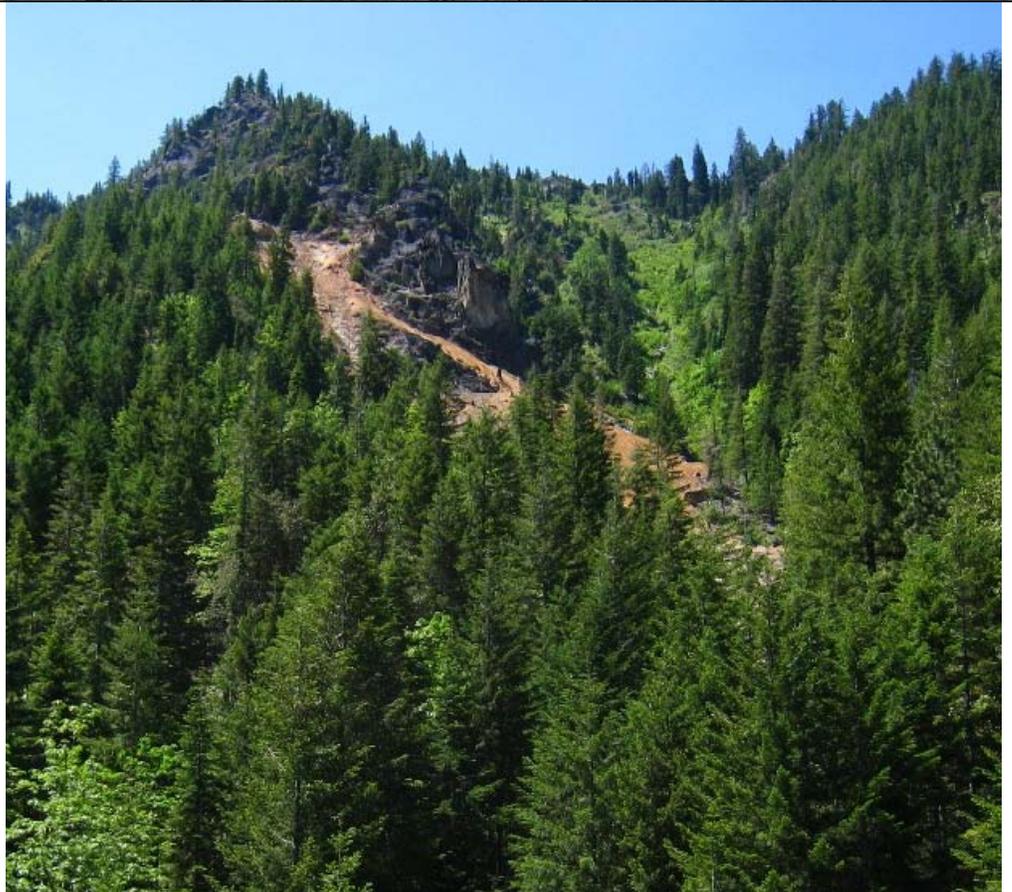
**Photo
No. 2**

View of Blue Ledge Mine from the old Eileen town site. WRP-1 (main pile).

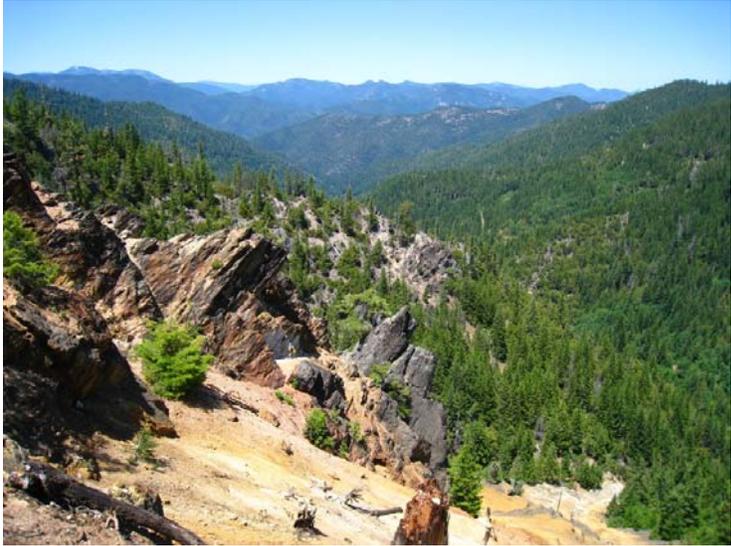
<p>Photo No. 3</p>	<p>June 2008</p>

<p>Description:</p> <p>View from the top of Blue Ledge Mine. Waste rock is visible in the foreground; adits 4A and 4b are present on the opposite hillside (not visible in this photo).</p>
<p>Photo No. 4</p>	<p>June 2008</p>

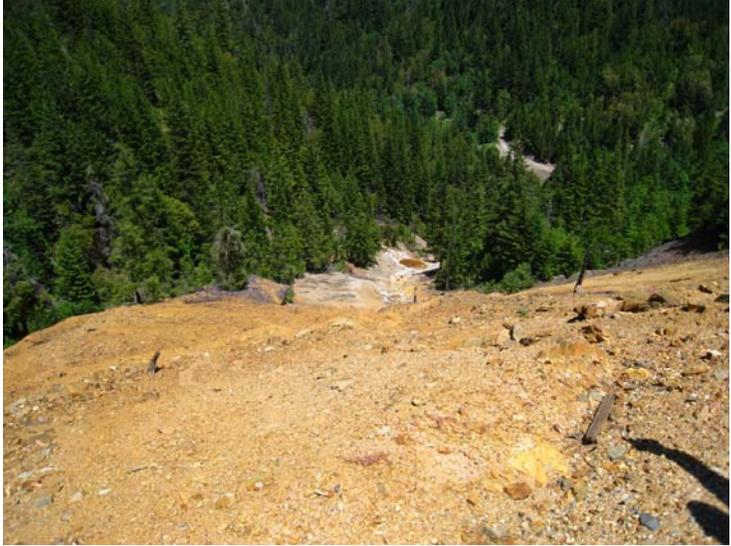
<p>Description:</p> <p>Mid slopes of WRP-1 downhill from access road. Log dam and EPA regrading at bottom.</p>
<p>Photo No. 5</p>	<p>August 2008</p>

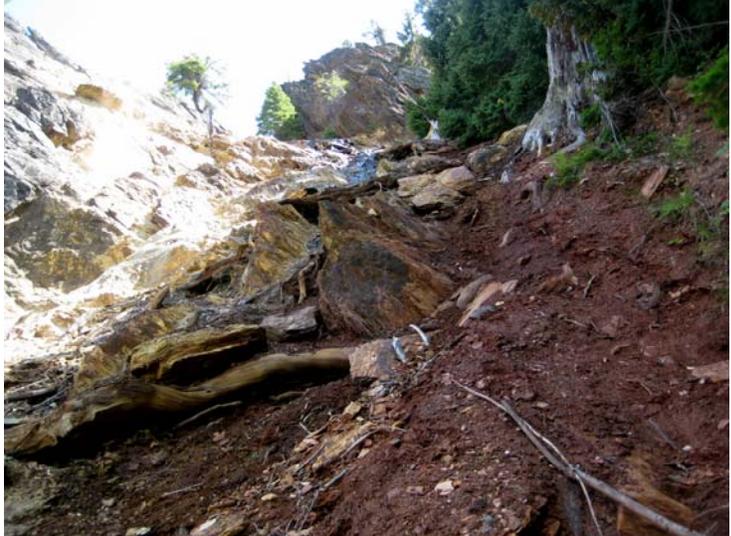
<p>Description:</p> <p>Steep waste rock in chute west of WRP-1.</p>

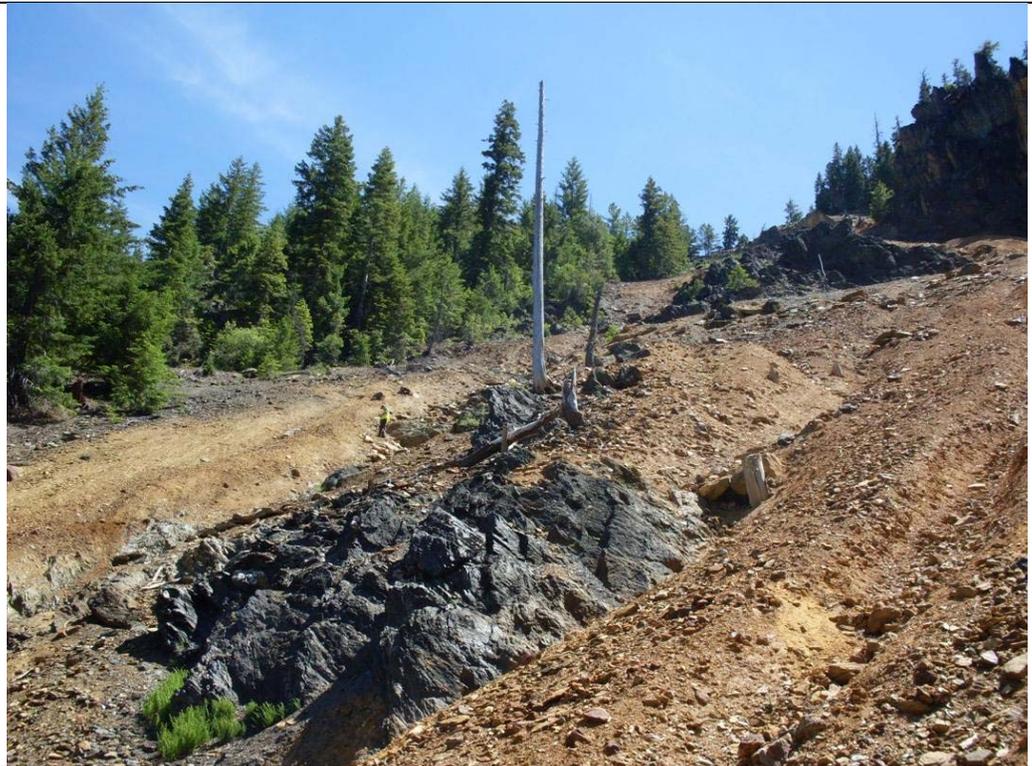
**Photo
No. 6**

Mid slopes of WRP-1 (main pile) and rock outcrop. The large outcrop at top right borders the access road.

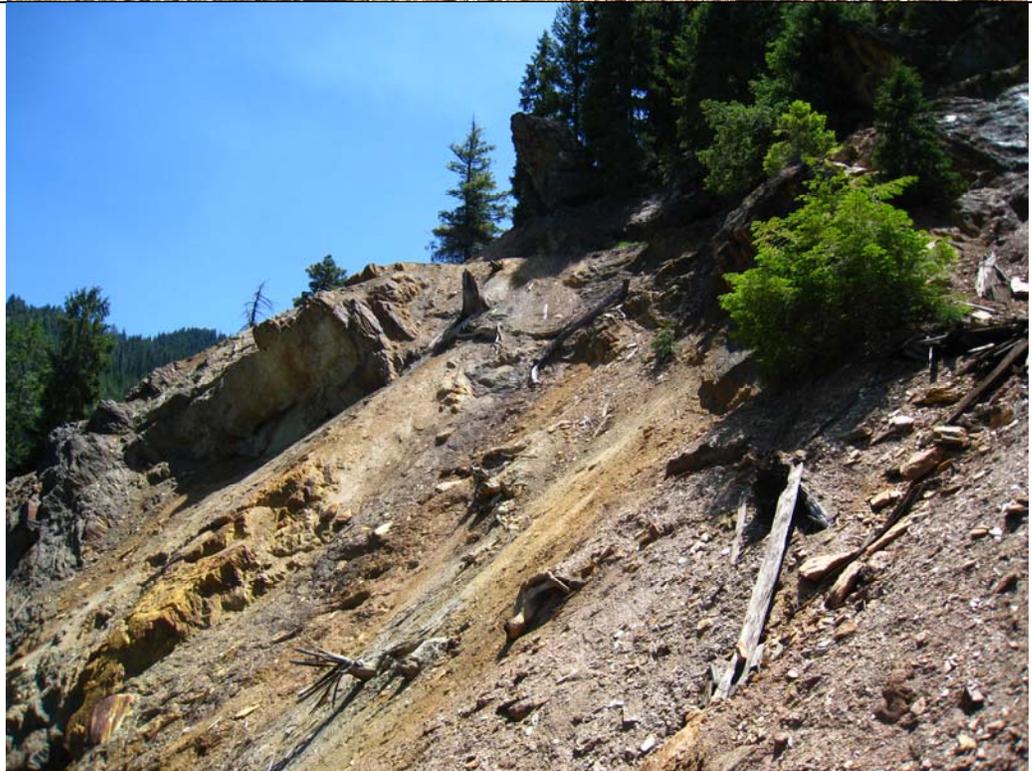
**Photo
No. 7**

Steep upper slopes of WRP-1, viewed from the access road.

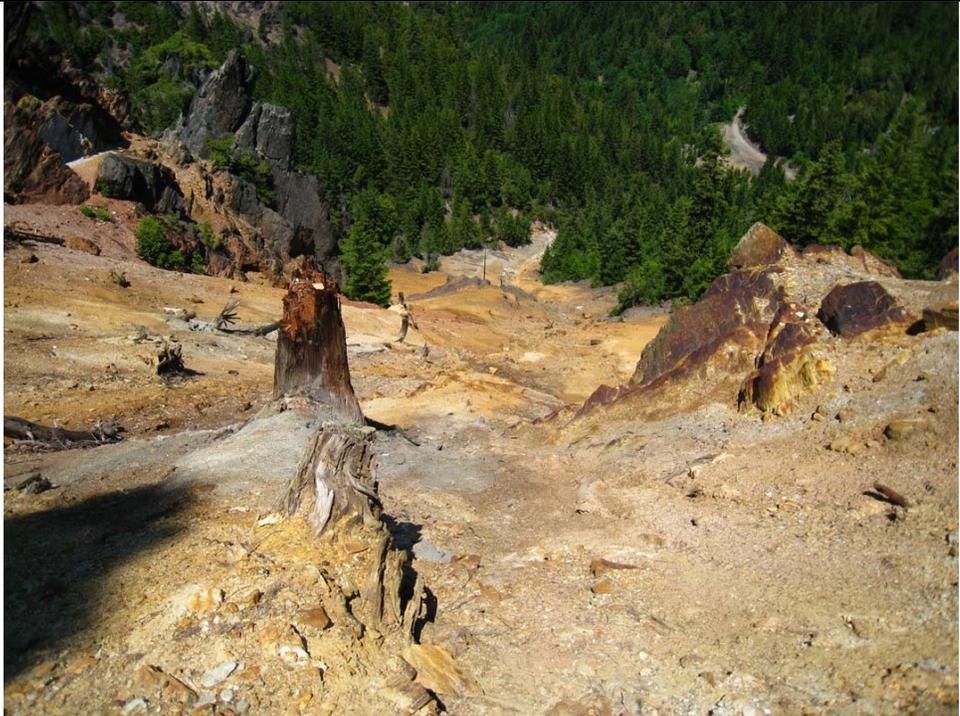
**Photo
No. 8**

Steep upper slopes of WRP-1 viewed from the top near adits. Old town site visible in top right corner.

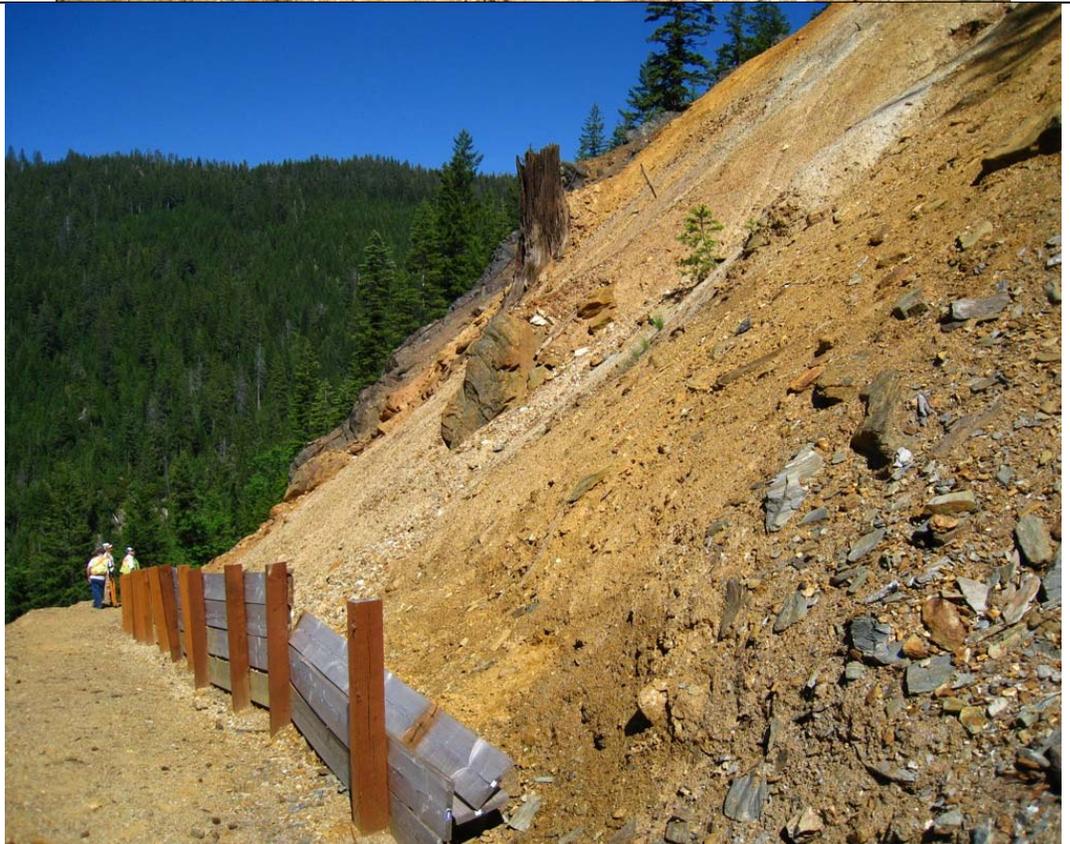
**Photo
No. 9**

Access road on WRP-1.

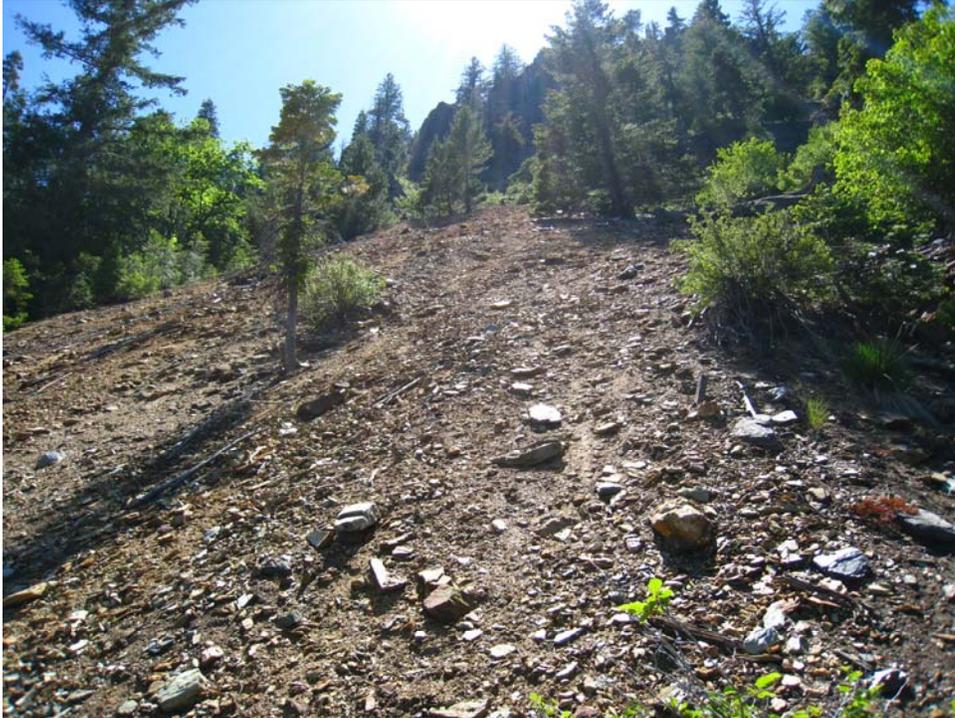
<p>Photo No. 10</p>	<p>June 2008</p>

<p>Description:</p> <p>WRP-2 from bottom. Second largest waste rock pile.</p>		
<p>Photo No. 11</p>	<p>June 2008</p>

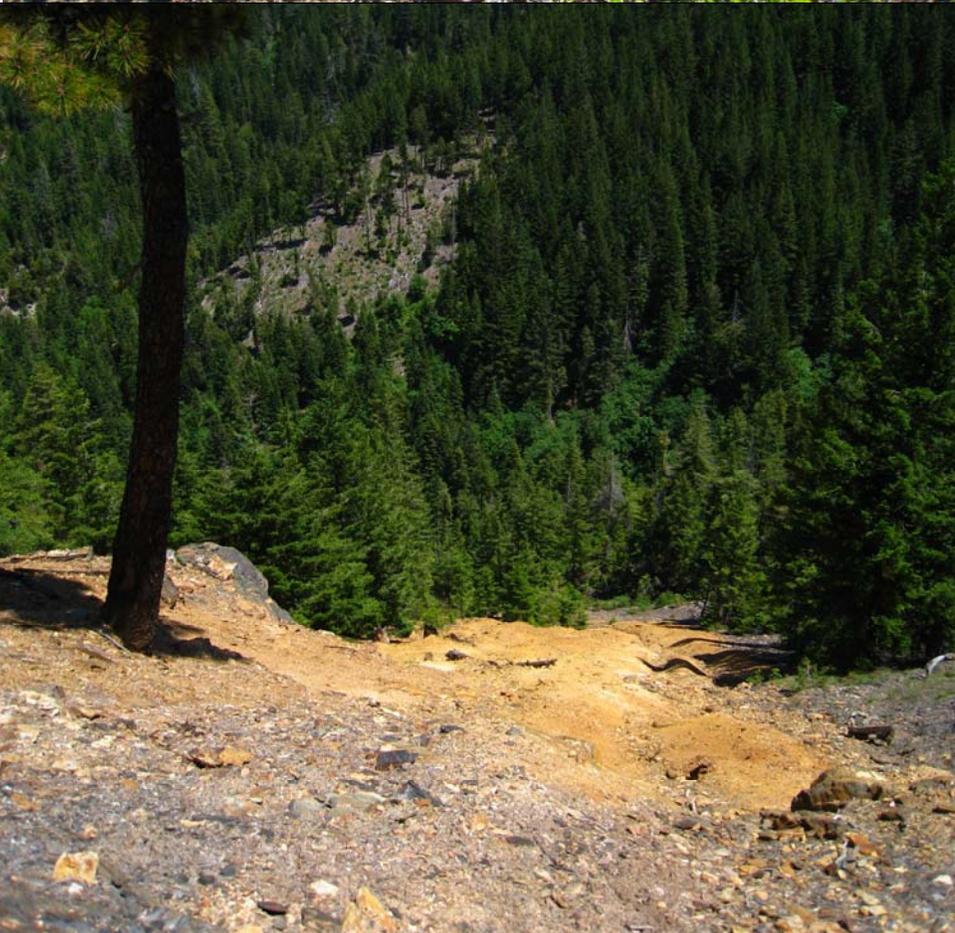
<p>Description:</p> <p>WRP-2 from top. Similar elevation to top of main waste rock, further east.</p>

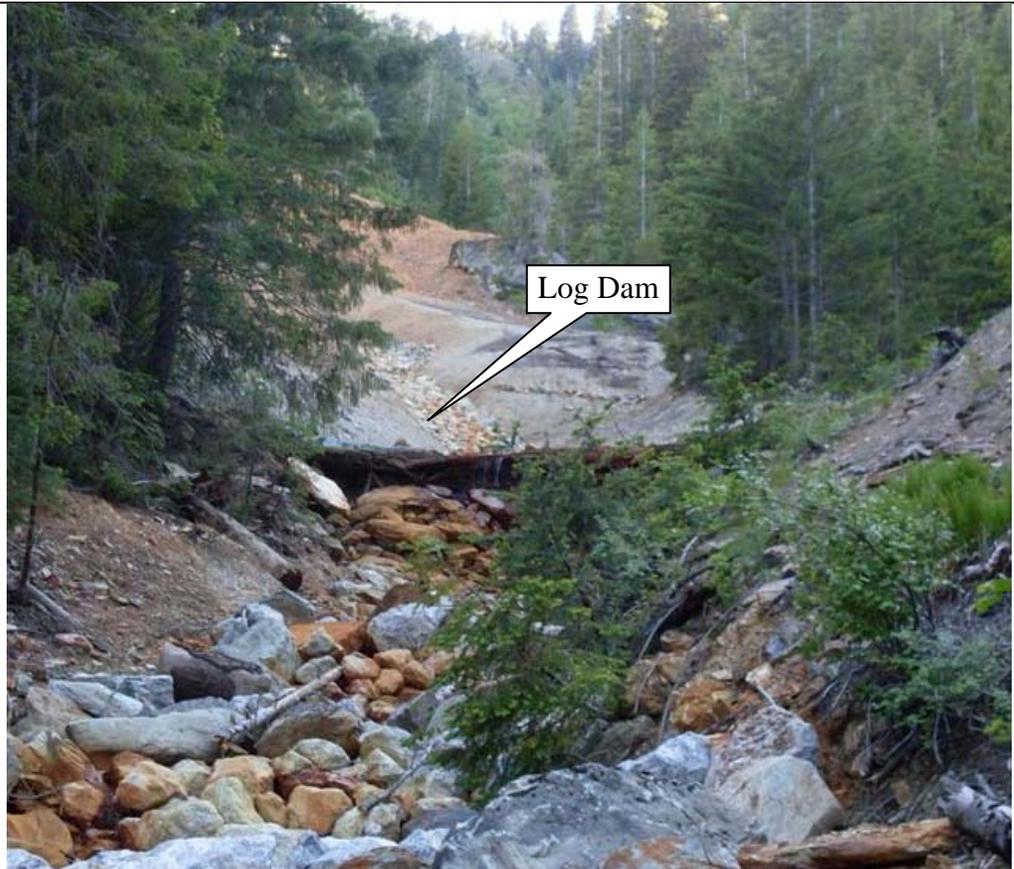
**Photo
No. 12** August
2008

Log dam and
limestone boulders.
Near bottom of
WRP-1.

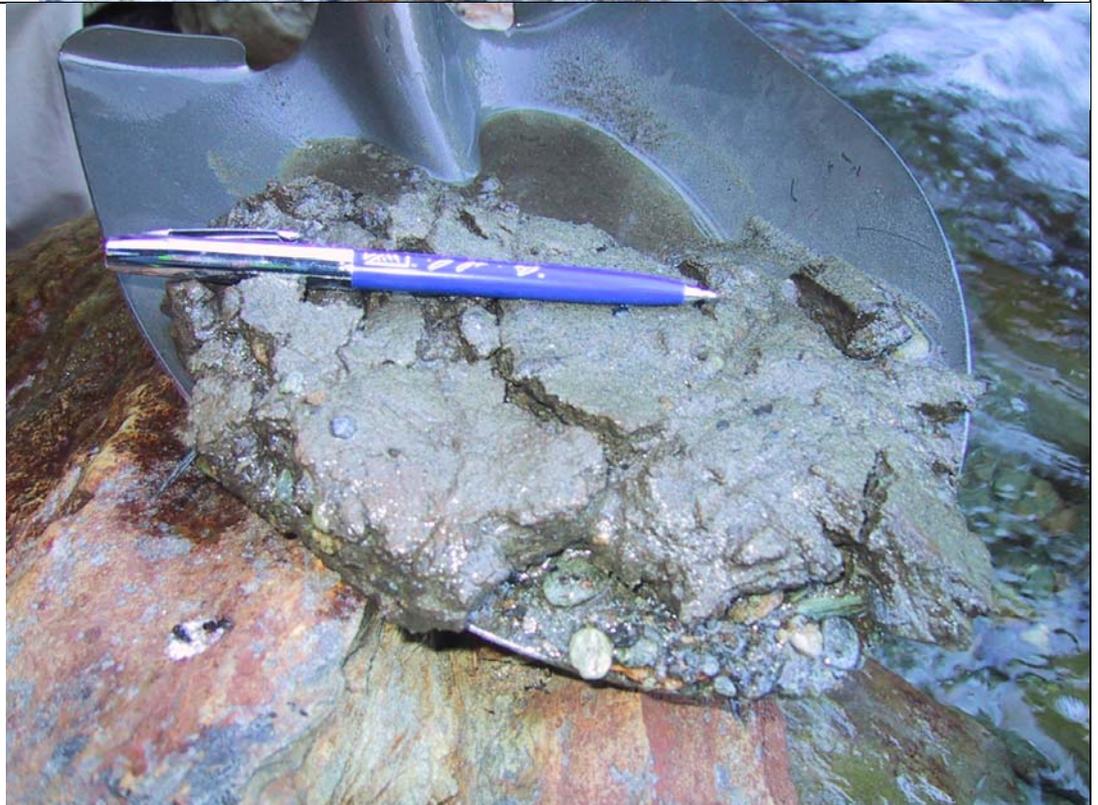
**Photo
No. 13** June
2008

Anoxic sediment
from Joe Creek.

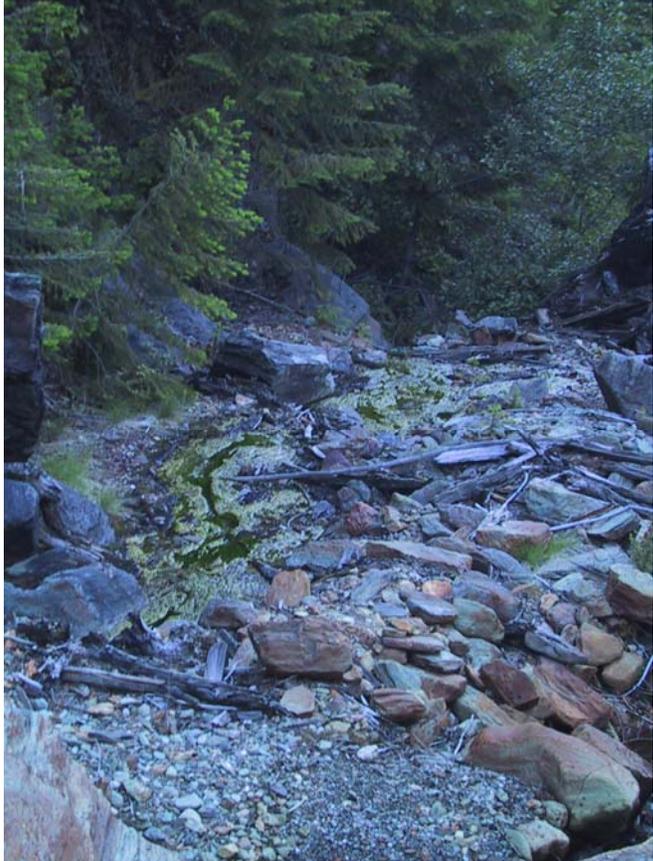
<p>Photo No. 14</p>	<p>June 2008</p>

<p>Description:</p> <p>Stream conditions in Joe Creek.</p>				
<p>Photo No. 15</p>	<p>June 2008</p>

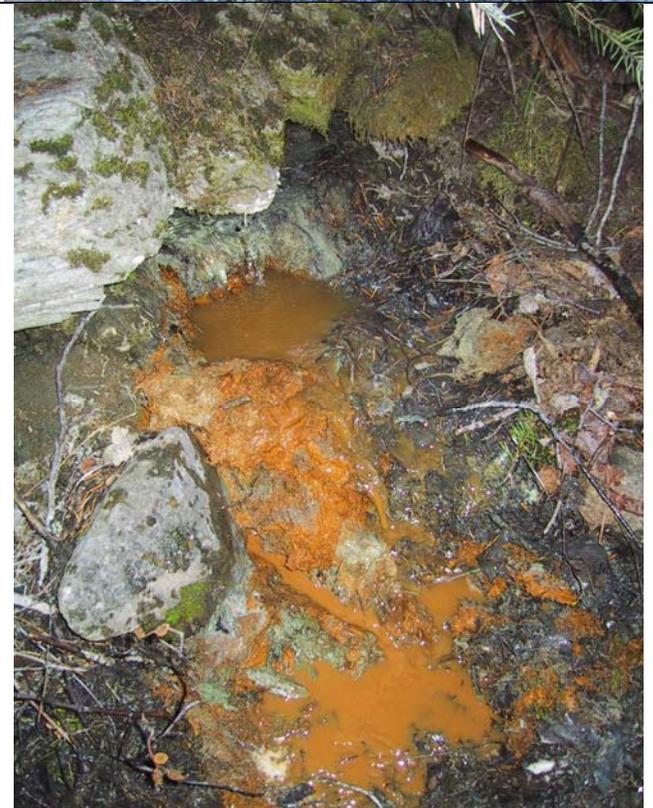
<p>Description:</p> <p>Discolored groundwater from seep near Joe Creek.</p>

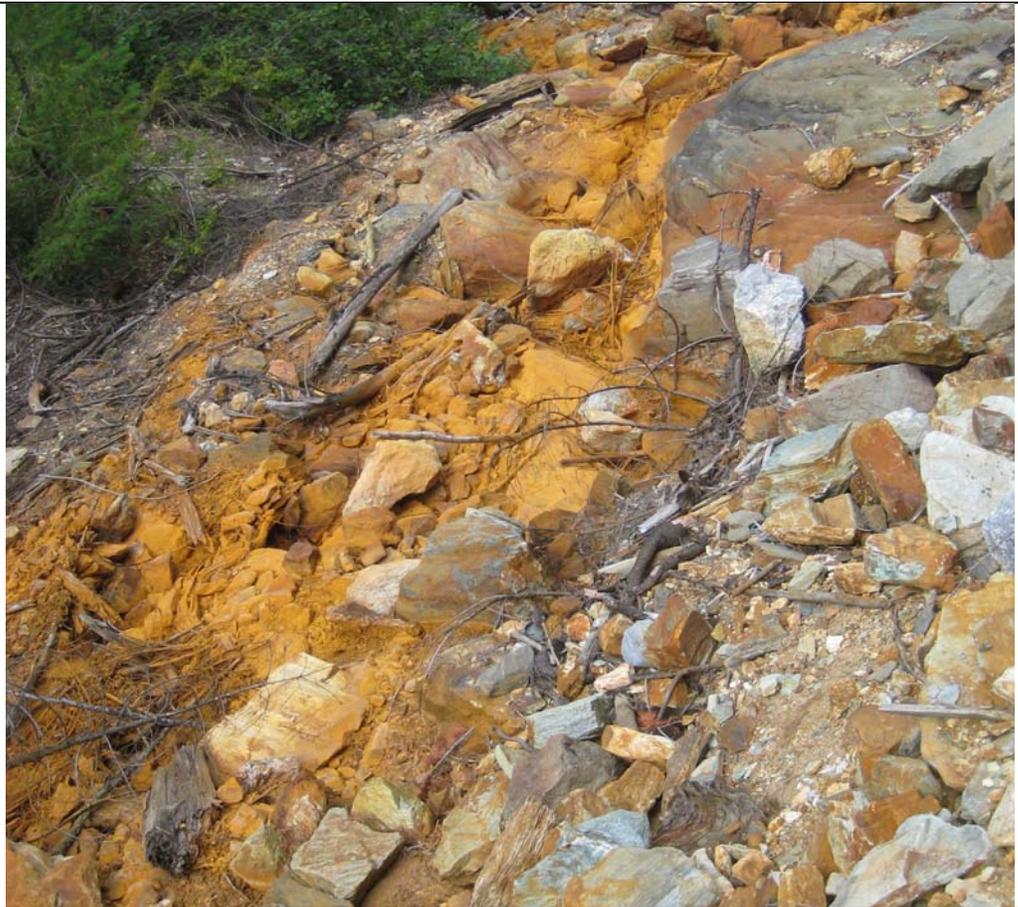
**Photo
No. 16**

Stained rock in
drainage below log
dam.

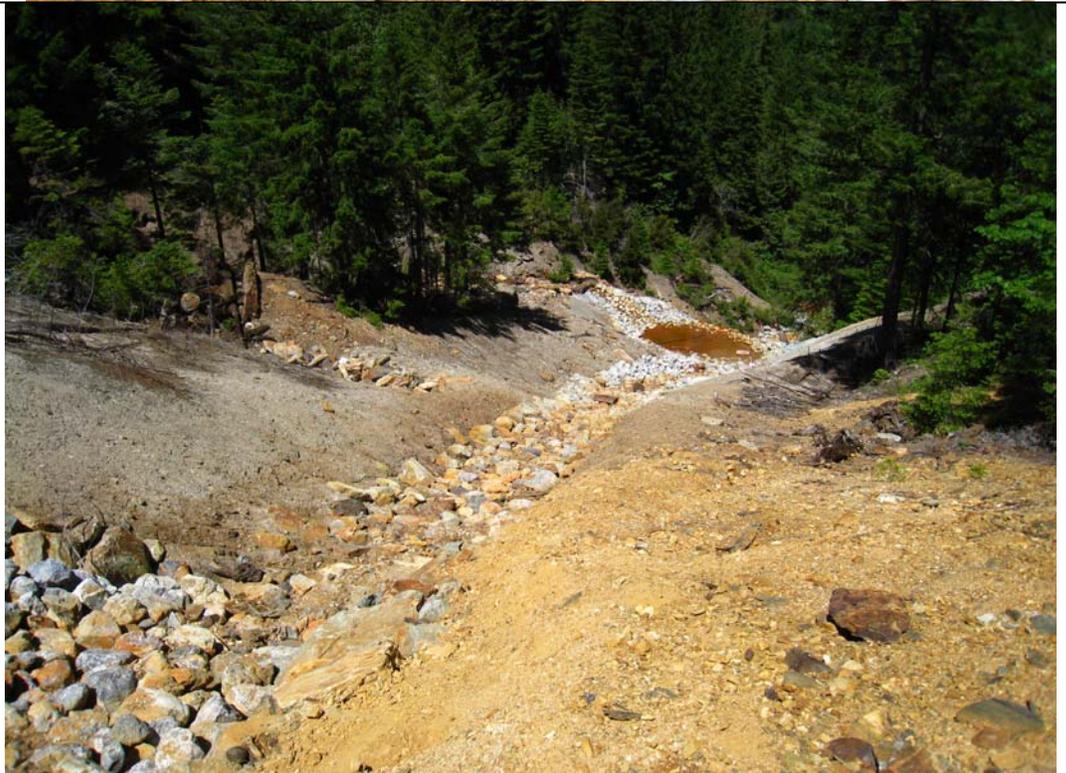
**Photo
No. 17**

EPA lined channel,
regrading, and
sedimentation
basin.

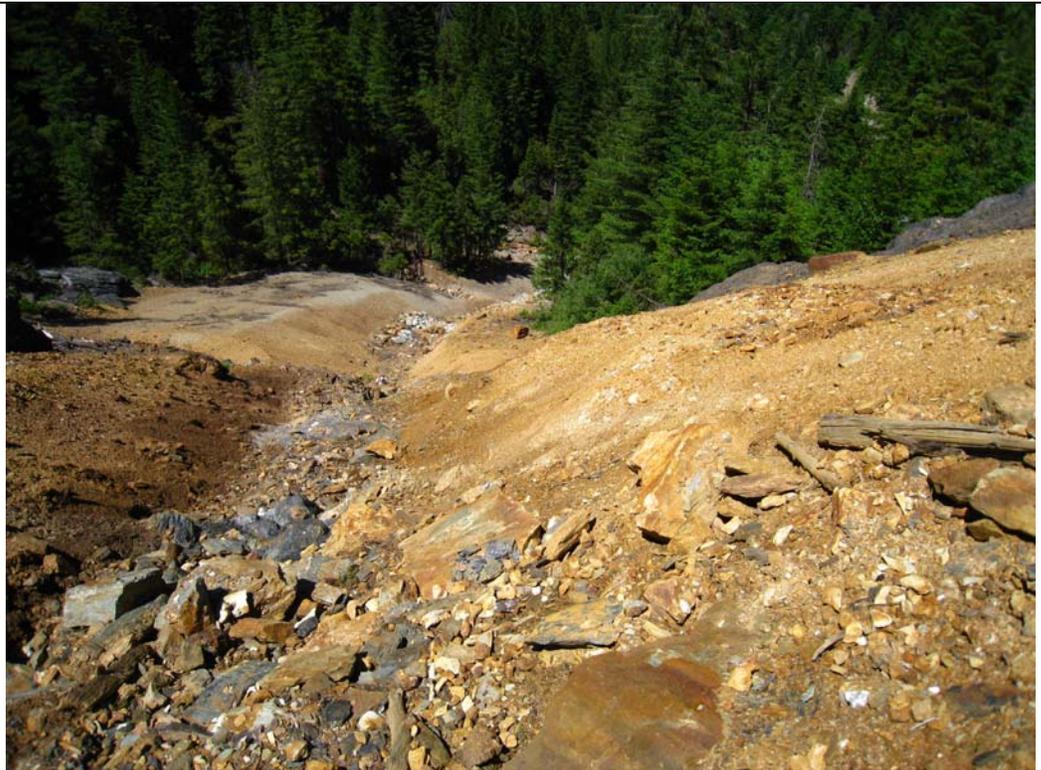
**Photo
No. 18**

EPA lined channel,
regrading, and
sedimentation
basin.

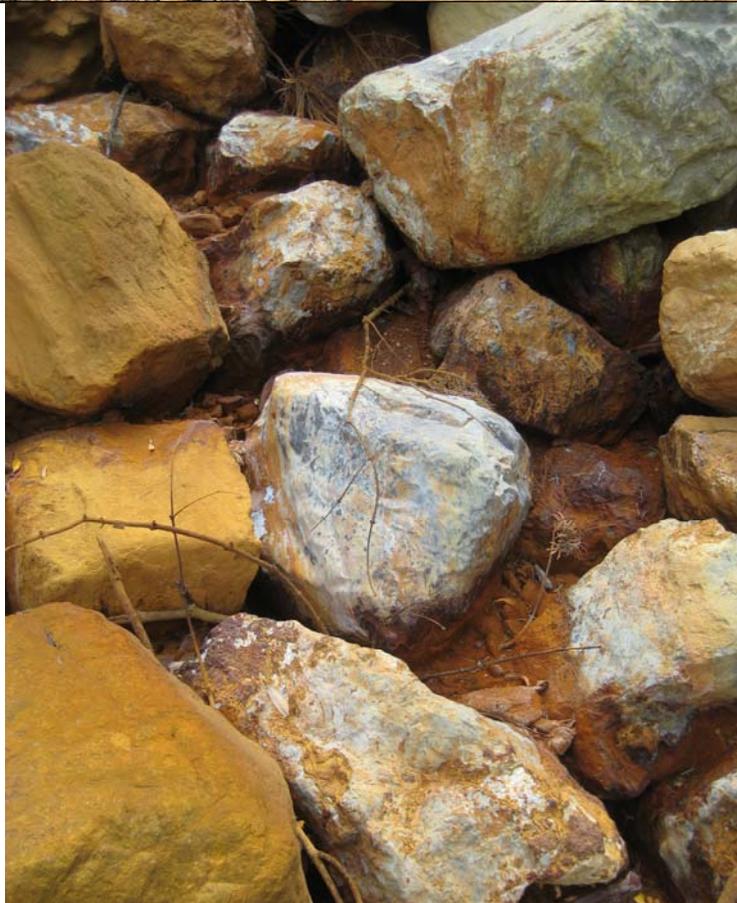
**Photo
No. 19**

Marble rock
blinded by mineral
deposits.

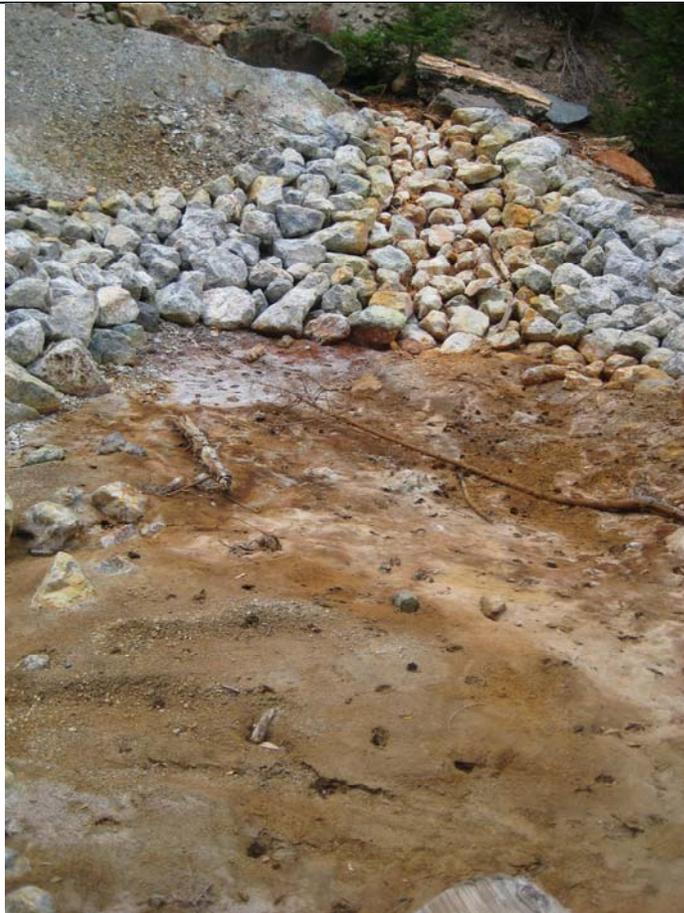
**Photo
No. 20**

Sedimentation
basin filled with
sediment.

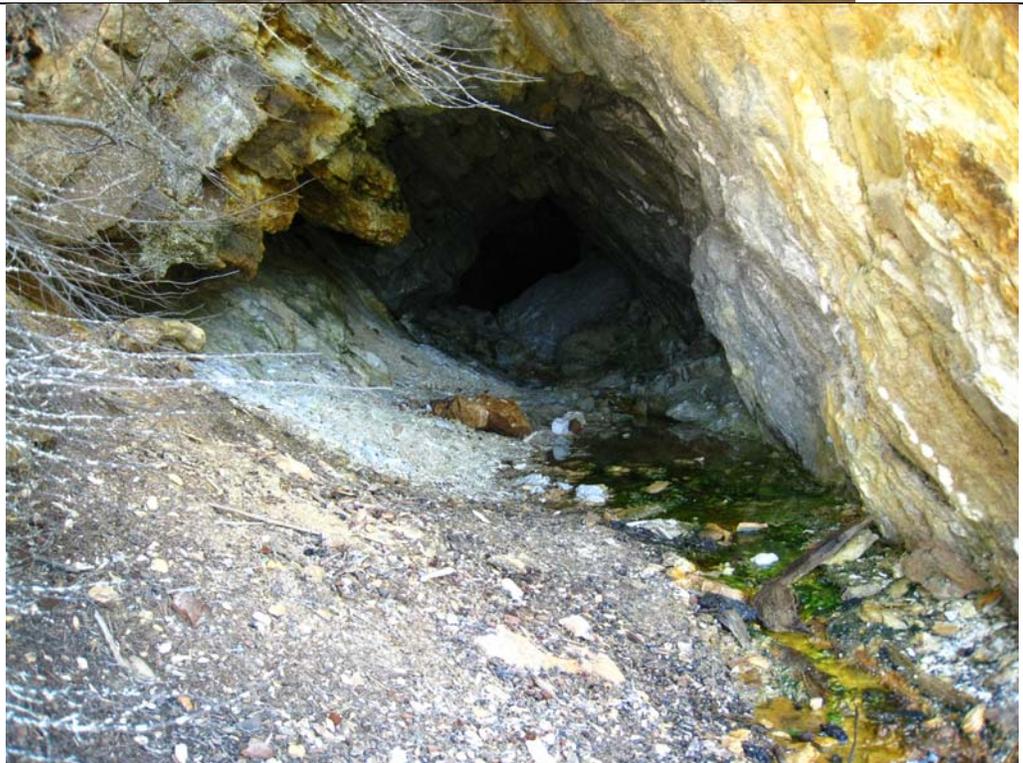
**Photo
No. 21**

Adit 1B, along path
that leads to waste
rock access road.
Water flows out to
WRP-1 west chute
and down hillside.

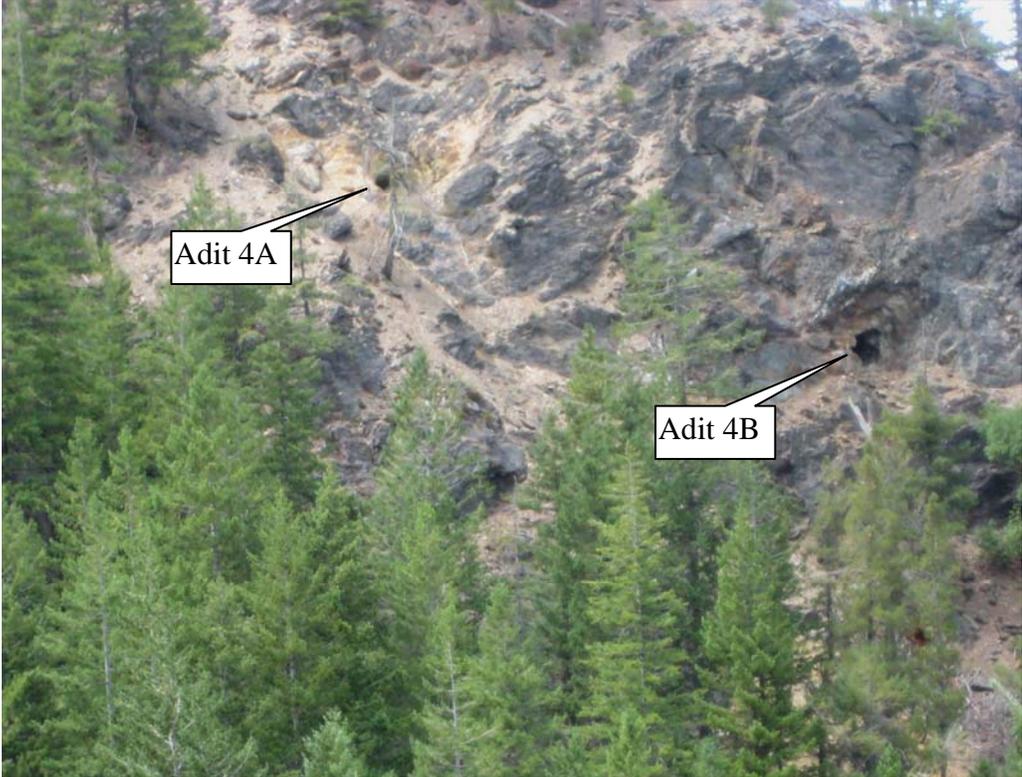
<p>Photo No. 22</p>	<p>August 2008</p>

<p>Description:</p> <p>Adits 4a (productive) and 4b (exploratory).</p>		
<p>Photo No. 23</p>	<p>June 2008</p>

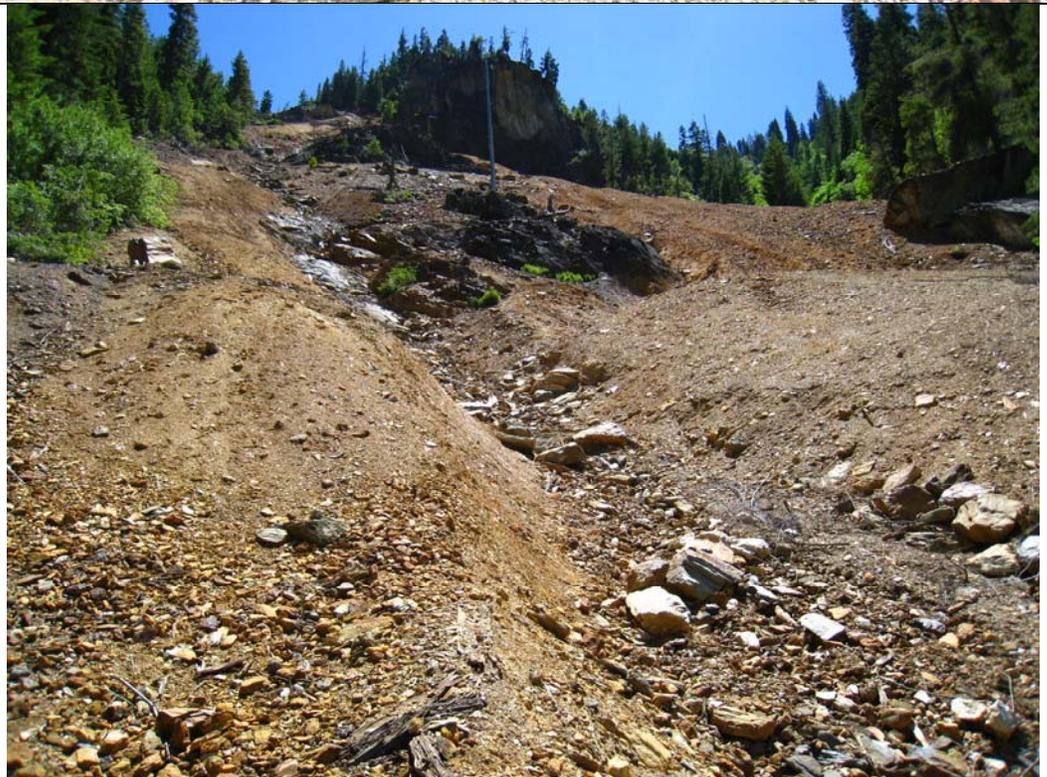
**Photo
No. 27**

WRP-1 eroded to
underlying bed
rock.

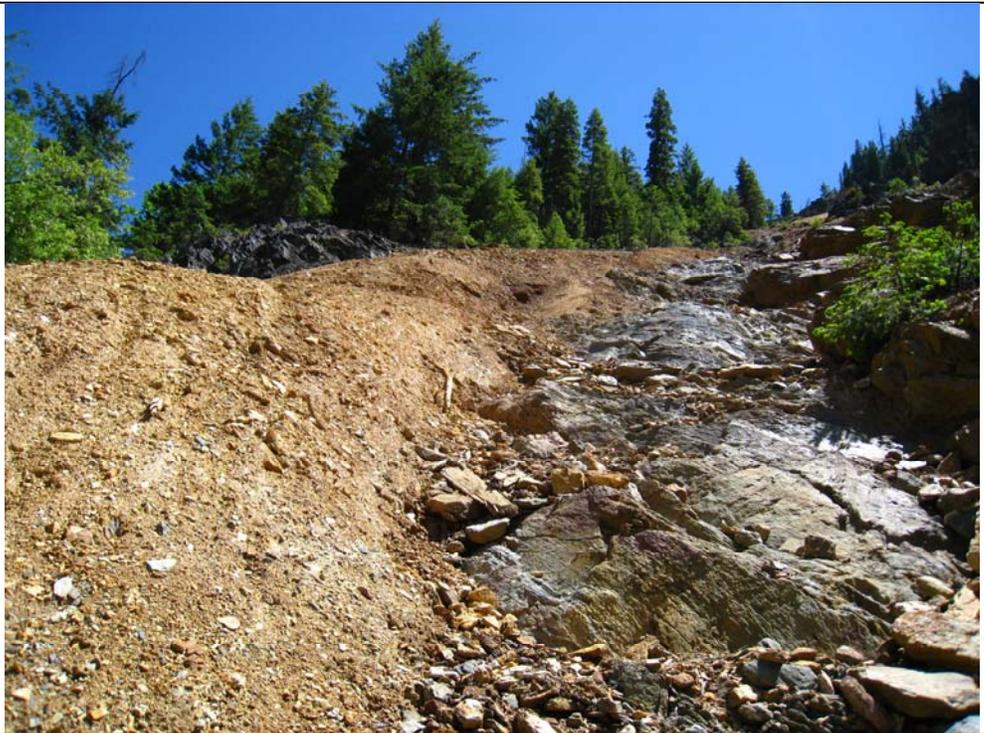
**Photo
No. 28**

WRP-1 eroded to
underlying bed
rock.

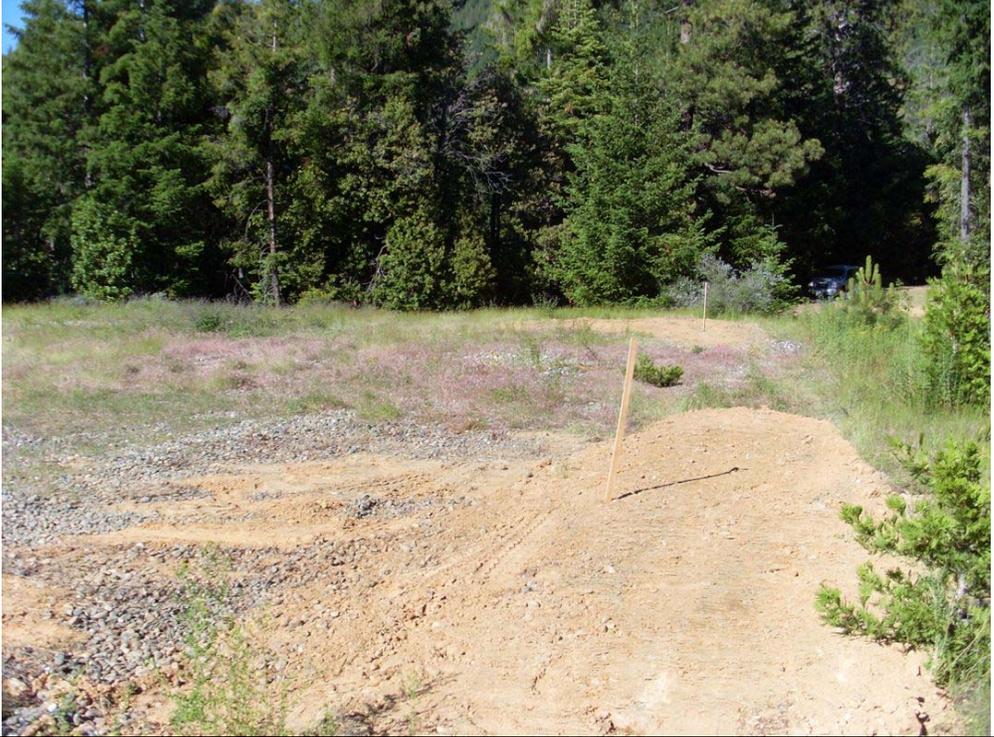
Photo No. 30	July 2008

Description: Excavations at north repository site.		
Photo No. 31	July 2008
