**South Beaver Allotment
SOUTH CREEK #1 (SC1)
Riparian Browse Assessment
(1) June 1, 2008
(2) October 17, 2010
(3) September 8, 2011**

<p>South Creek #1 (SC1) Approximately one mile from end of road</p>	<p>June 1, 2008 Landrigan/Hoskisson October 17, 2010 Hoskisson/Wheeler September 8, 2011 Hoskisson/Ratcliffe/Young</p>
<p>Fishlake NF/Beaver RD</p>	<p>Allotment: South Beaver Pasture: Big Twist</p>
<p>Stake: 12 S E 0369646 N4225978</p>	<p>Elevation: 7667'</p>

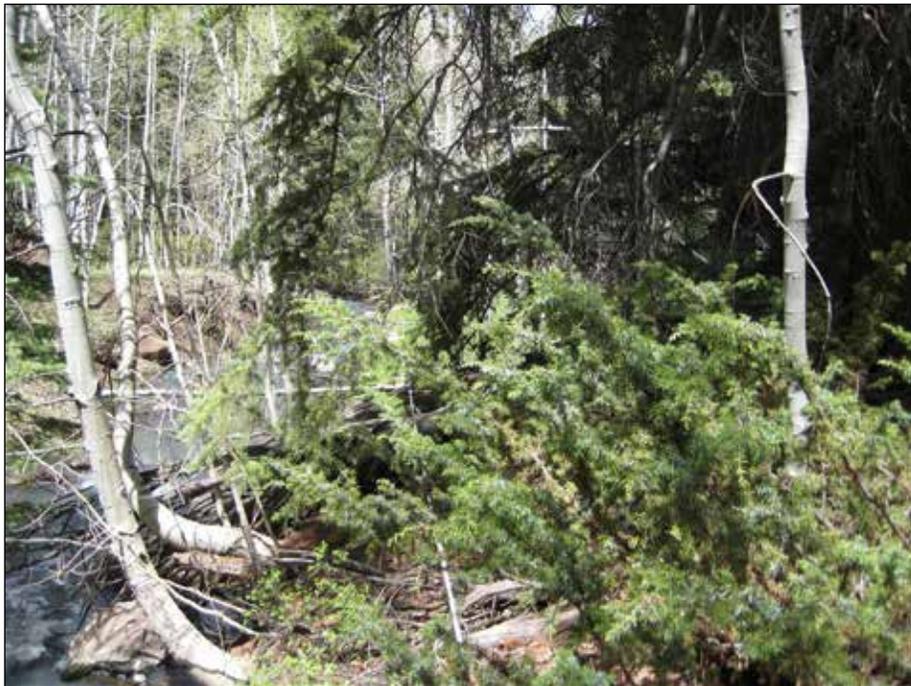
(6/1/2008): We found few aspen ramets below 3' tall. The leaders of aspen between three feet and six feet the leaders were mostly dead or browsed. Many or all of those we categorized as dead were likely browsed. The leaders were dead for the last one to three inches. We saw only one instance of insect damage and that was a gall at the end of a browsed leader. Most of the aspen taller than 6' (as shown in photographs) were one to two inches DBH. The appearance is that something permitted a pulse of generation some time in the last five to 12 years. **Question: Did management change during 1998-2001 take place that would have allowed for this pulse in regeneration?** There is a huge gap in the size of aspens in the area of the transect. The only very young ramets grew only under the protection of the spruce and juniper (as photographed). **What grazing management changes have taken place since 2003?**

Fig. 1 (2008). A few aspen under 3' tall are growing in the protection of juniper and spruce trees. (UTM 12 S 369653 4225980)

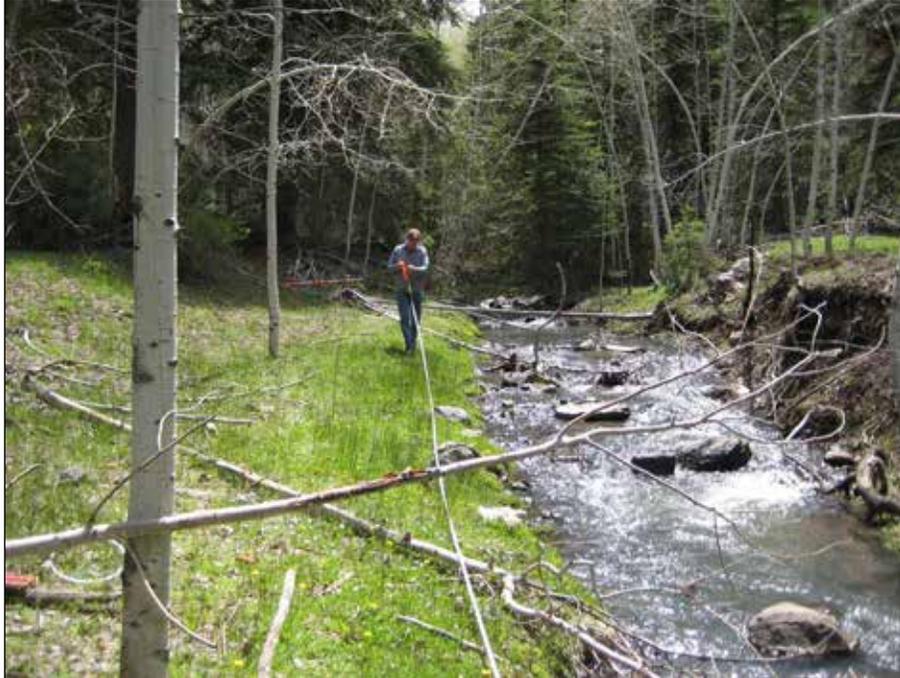
Fig. 2 (2008). Small meadow along the stream shows wire grass dominance in wet zone. Many large sapling size aspen can be seen. No smaller aspen can be seen in the meadow. To the right the cut bank can be seen. (UTM 12 S 369653 4225980)

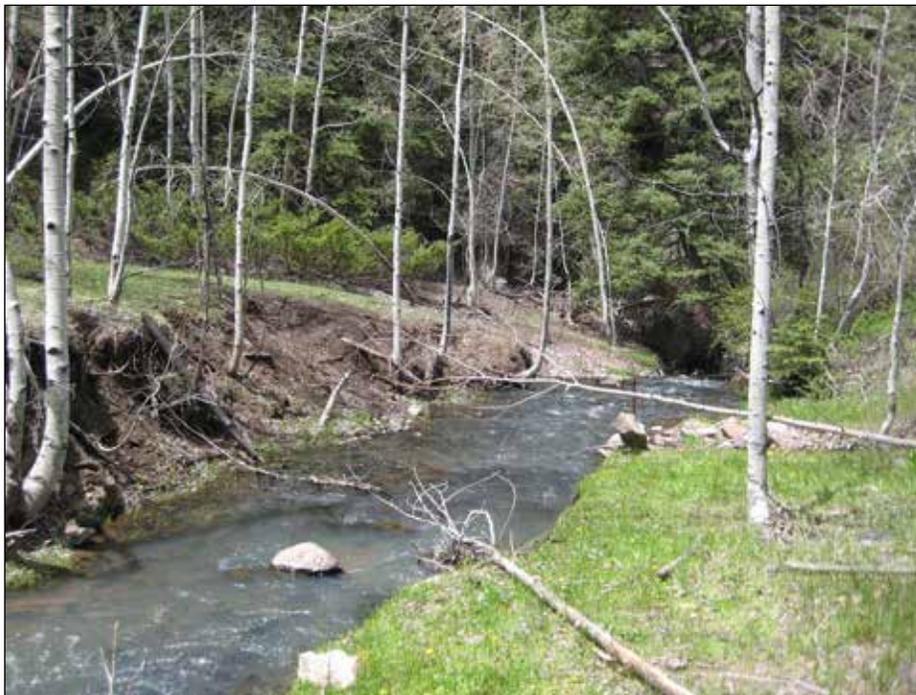
Fig. 3 (2008) Trampling of the stream bank can be seen on the left in this picture. Again sapling aspen can be seen with no very young aspen visible. The stream has a slightly milky appearance. (UTM 12 S 369664 4225980)

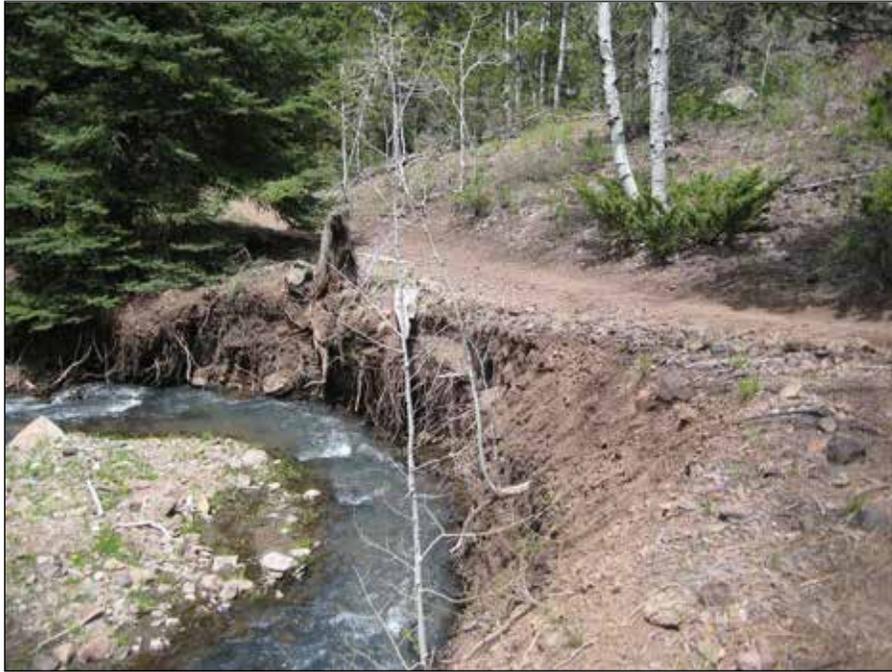
Fig. 4 (2008). View downstream from the transect. The stream is cutting towards the ORV route (068). The horizontal distance between the motorized route and the stream is only a few inches.

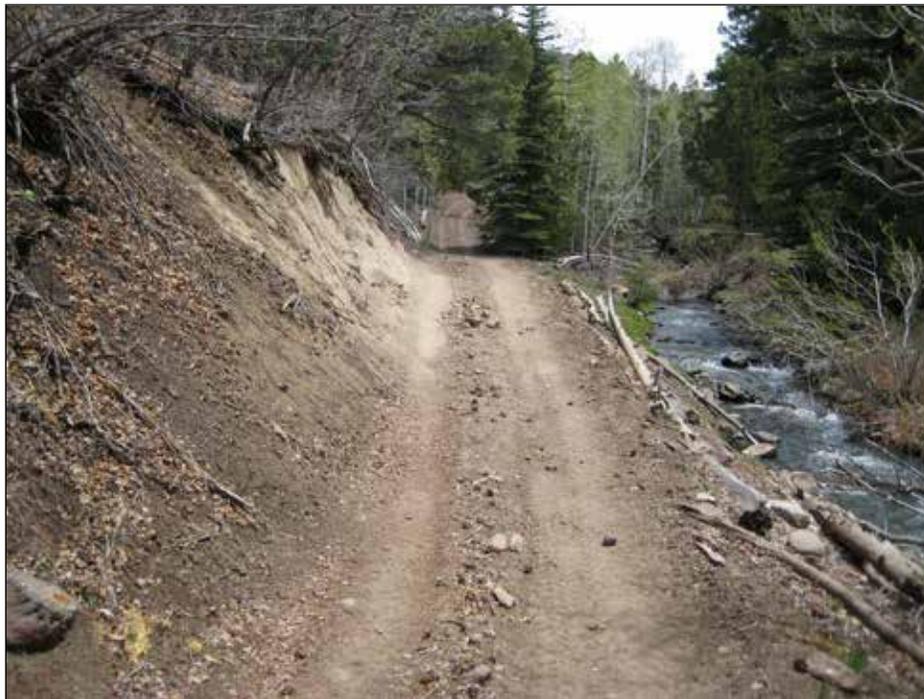
Fig. 5 (2008). The ORV route (068) and stream approach closely at another point below South Creek transect #1. (UTM 12 S 368770 4226261)

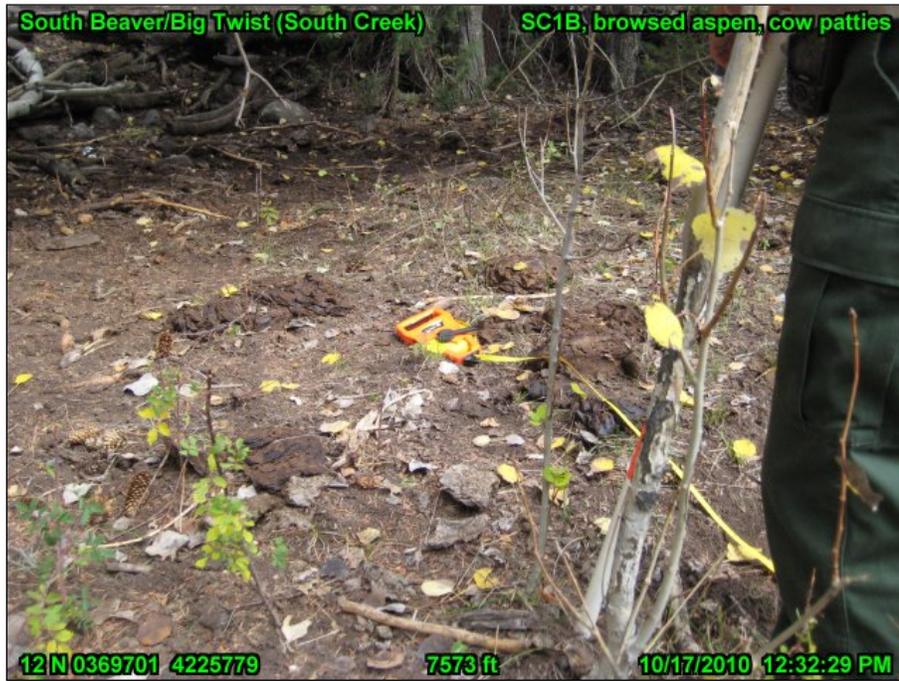
Fig 6 (10/17/2010) Browsed aspen and cow patties along South Creek #1.

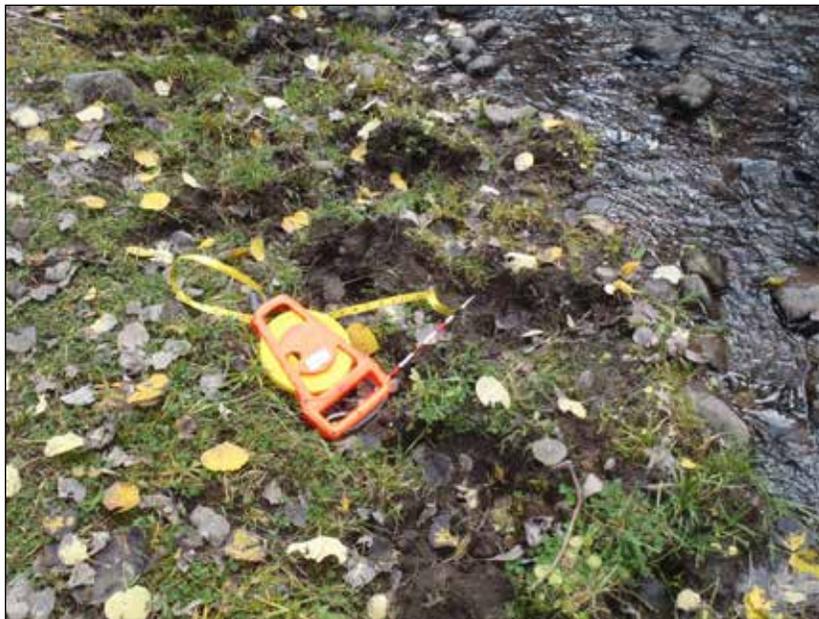
(10/17/2010): Although this pasture was to be rested in 2010, there were significant signs of recent cattle in the area (Figs 7 and 8). Stream banks in the area of the transect were clearly recently trampled, and herbaceous growth grazed. Leaders on aspen ramets were browsed 55% and 64% of these leaders were either browsed or dead. Furthermore, 79% of the aspen subleaders were browsed. The height distribution of aspen in this area continues to be bifurcate with little representation of trees between 2.1 and 6 feet tall. The combination of the continued use of this area by cattle and ORVs continues to reduce the health and functionality of this riparian area as was pointed out by Petty's Riparian Level II Inventory in 2002. This is also apparent in other areas along South Creek. Figs 8 and 9 show another closely grazed meadow as well as a trampled and hummocked area closer to the stream.

Fig 7 (10/17/2010) Multiple hoof prints on bank along South Creek #1 during a “rest” year.

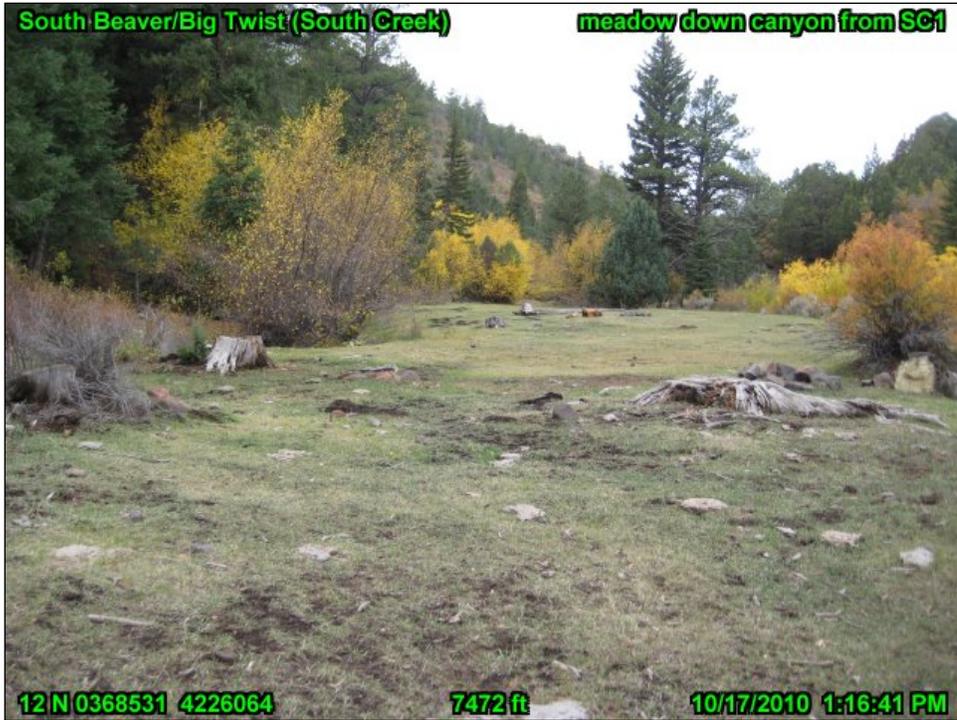
Fig 8 (10/17/2010) Grazed meadow downstream from South Creek #1

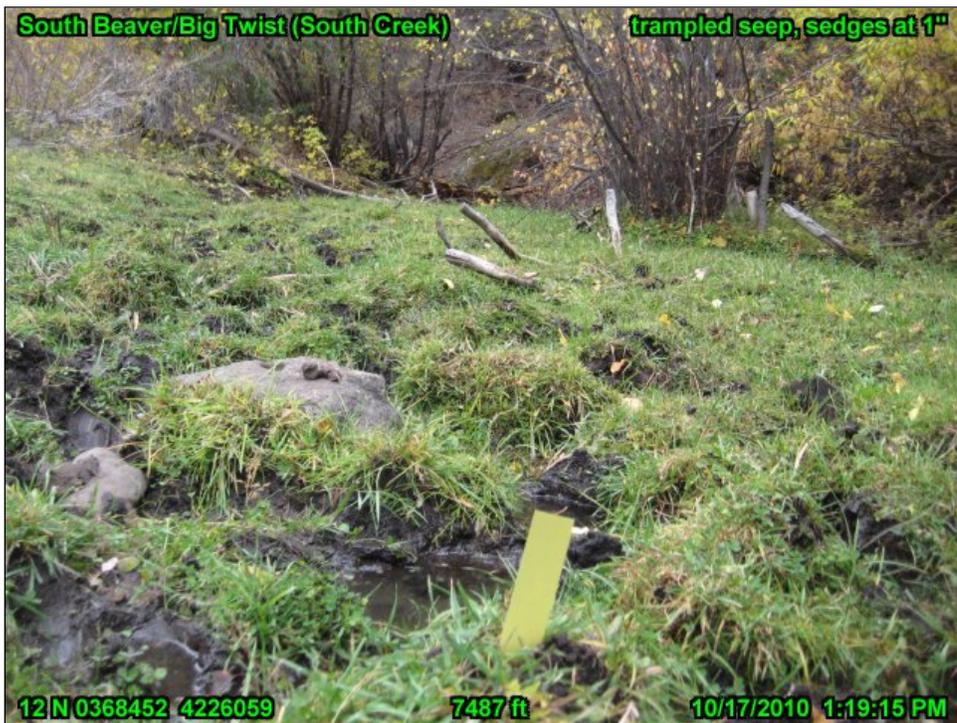
Fig 9 (10/17/2010) Trampled and hummocked area at edge of meadow in Fig 8. Note sedges are < 4".

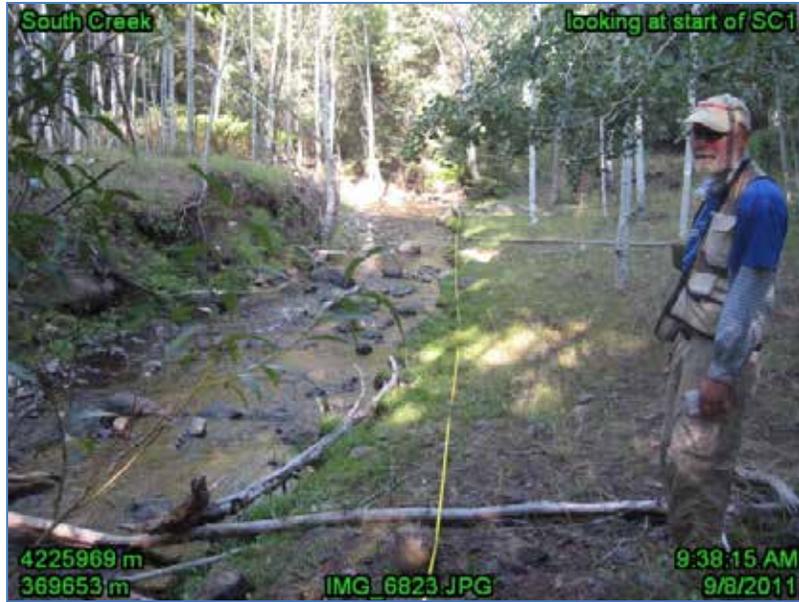
Fig 10 (9/8/2011) South Creek 1 main transect

The streambank within South Creek #1 has excessive bare ground (Figs. 10 and 12) and the meadow below South Creek still appeared to be heavily used (Fig 13) and the ORV route next to the stream continues to erode and generate sediment into the stream.

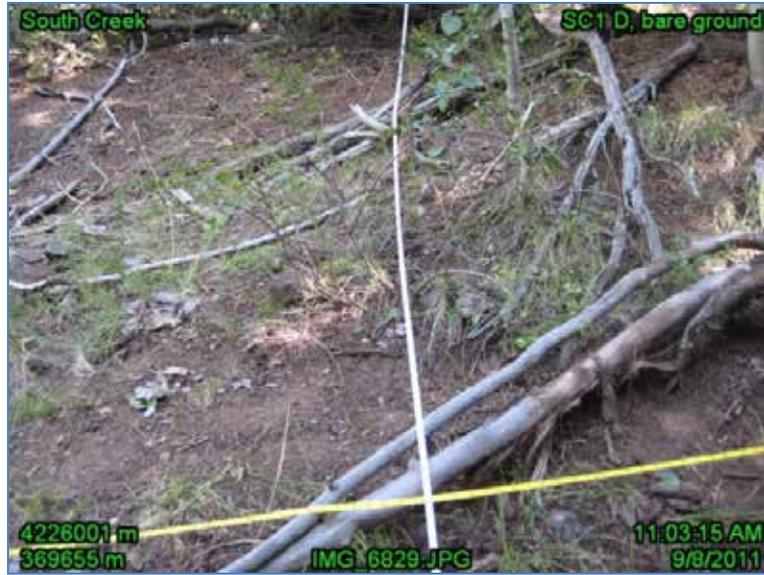
Fig 12 (9/8/2011) Excessive bare ground along transect D

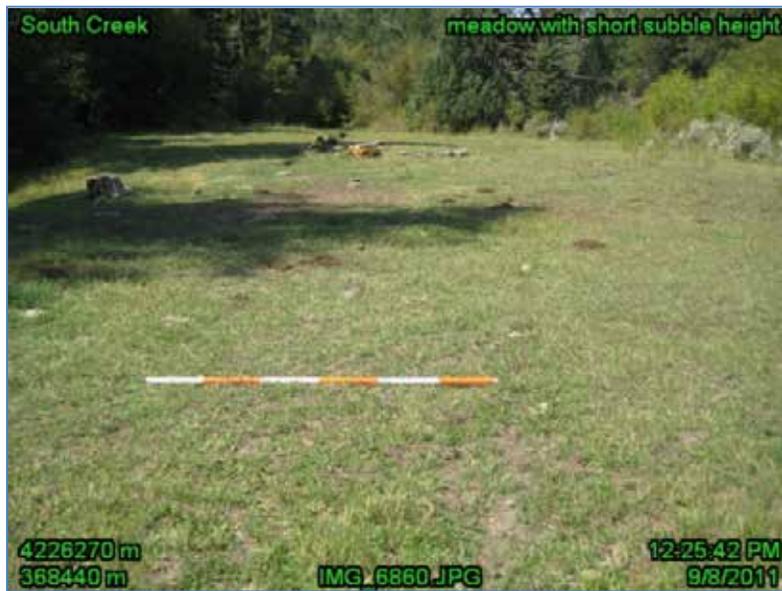
Fig 13 (9/8/2011) Meadow below South Creek 1 with very short stubble height

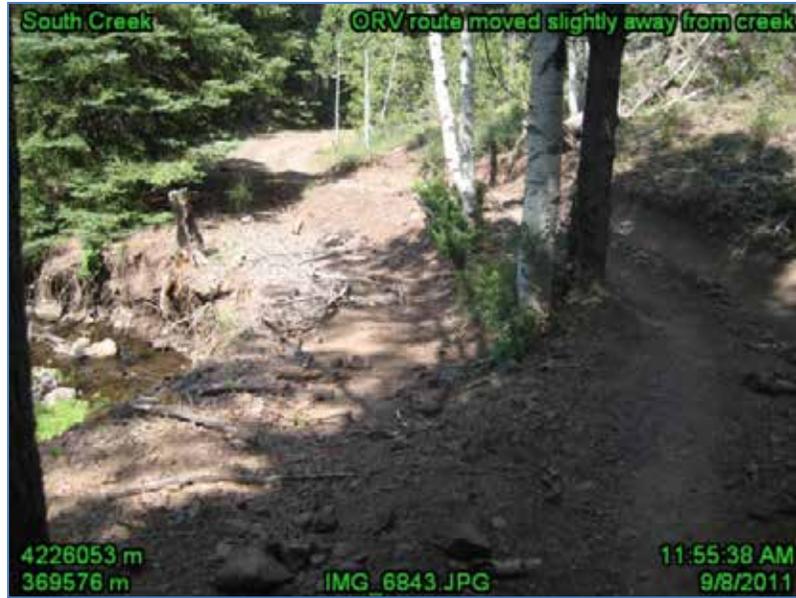
Fig 15 (9/8/2011) ORV route taken slightly away from creek (likely due to erosion and ORV's not being able to use old route???)
