# Limited Asbestos Survey Report

Sun Chief Mill Site - Office  
Southeast Corner of Arizona Highway 77 & US 70  
Globe, AZ

CSC Project # 5002357

Inspection Dates: January 26-27, 2010

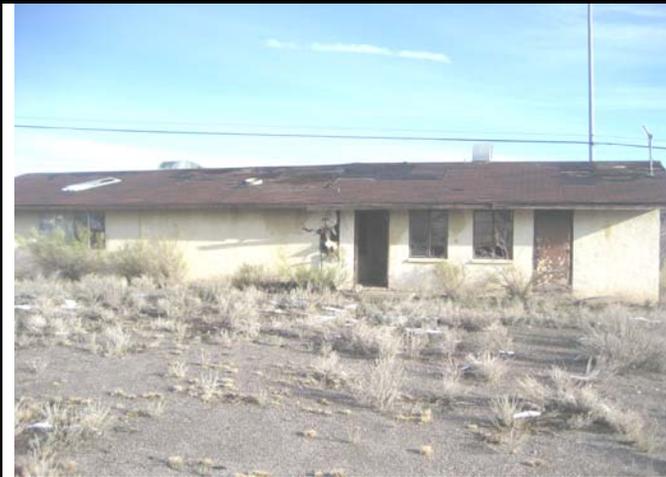
Photo 1: Office – subject property south elevation

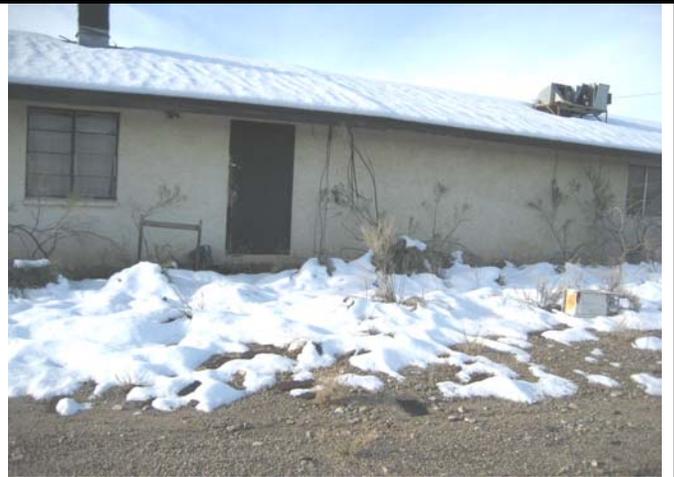
Photo 2: Office – subject property north elevation

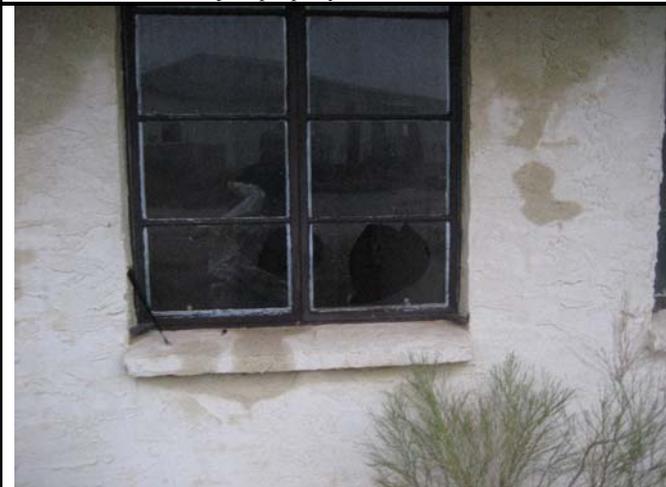
Photo 3: Example of window putty – negative for asbestos content

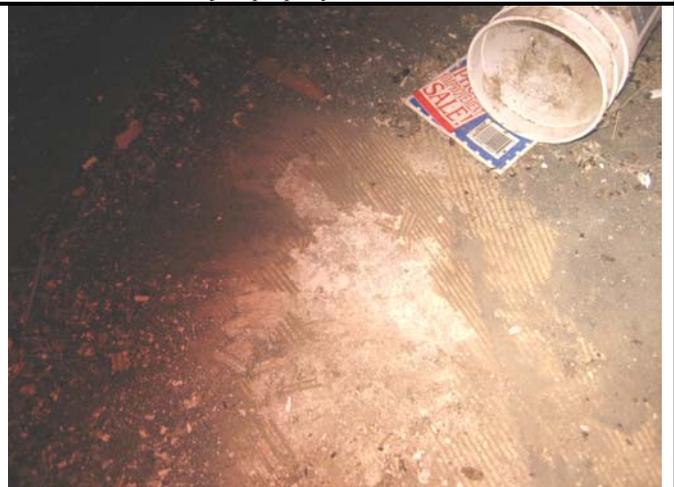
Photo 4: Example of beige carpet mastic – negative for ACM

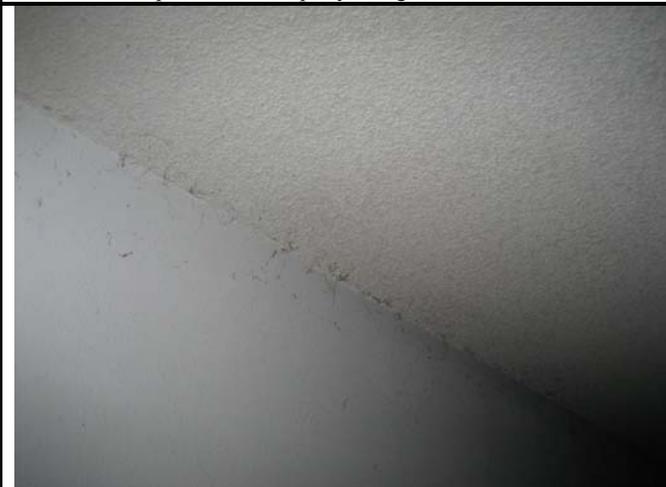
Photo 5: Example of white drywall/joint compound and spray applied acoustic ceiling material – negative for ACM

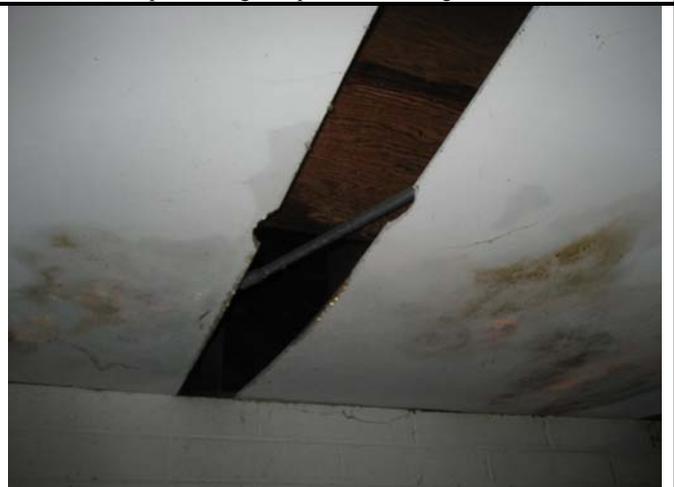
2. White transite-like ceiling panels in the powder room and restroom contained 25-30% chrysotile asbestos. The material is considered category II non-friable ACM.
3. Category of asbestos may change due to the means employed by the contractor to remove ACM.

Photo 6: Example of transite-like ceiling panels – positive for ACM

1. If suspect asbestos containing materials other than those tested are encountered, they must be assumed to contain asbestos or tested and proven otherwise.
2. Removal of category II non-friable ACM throughout the subject property should only be performed by certified asbestos abatement workers.
  - a. Removal by hand means shall be considered class 2 work.
  - b. Removal by mechanical means shall render the asbestos RACM.
  - c. Workers performing said work should comply with all state, local and federal regulations.
3. CSC should be contracted to write specifications prior to abatement and renovation activities at the subject property.
4. The contractor should be responsible for verifying locations and quantities of ACM.
5. A complete copy of this survey must be kept on site during asbestos abatement activities.
