Blackwood Creek Channel Restoration

Projects Designed to Address
Cumulative Land Use Impacts
in a Dynamic Environment

Craig Oehrli, Hydrologist – USDA Forest Service
Lake Tahoe Basin Management Unit – Project Leader - Ecosystems

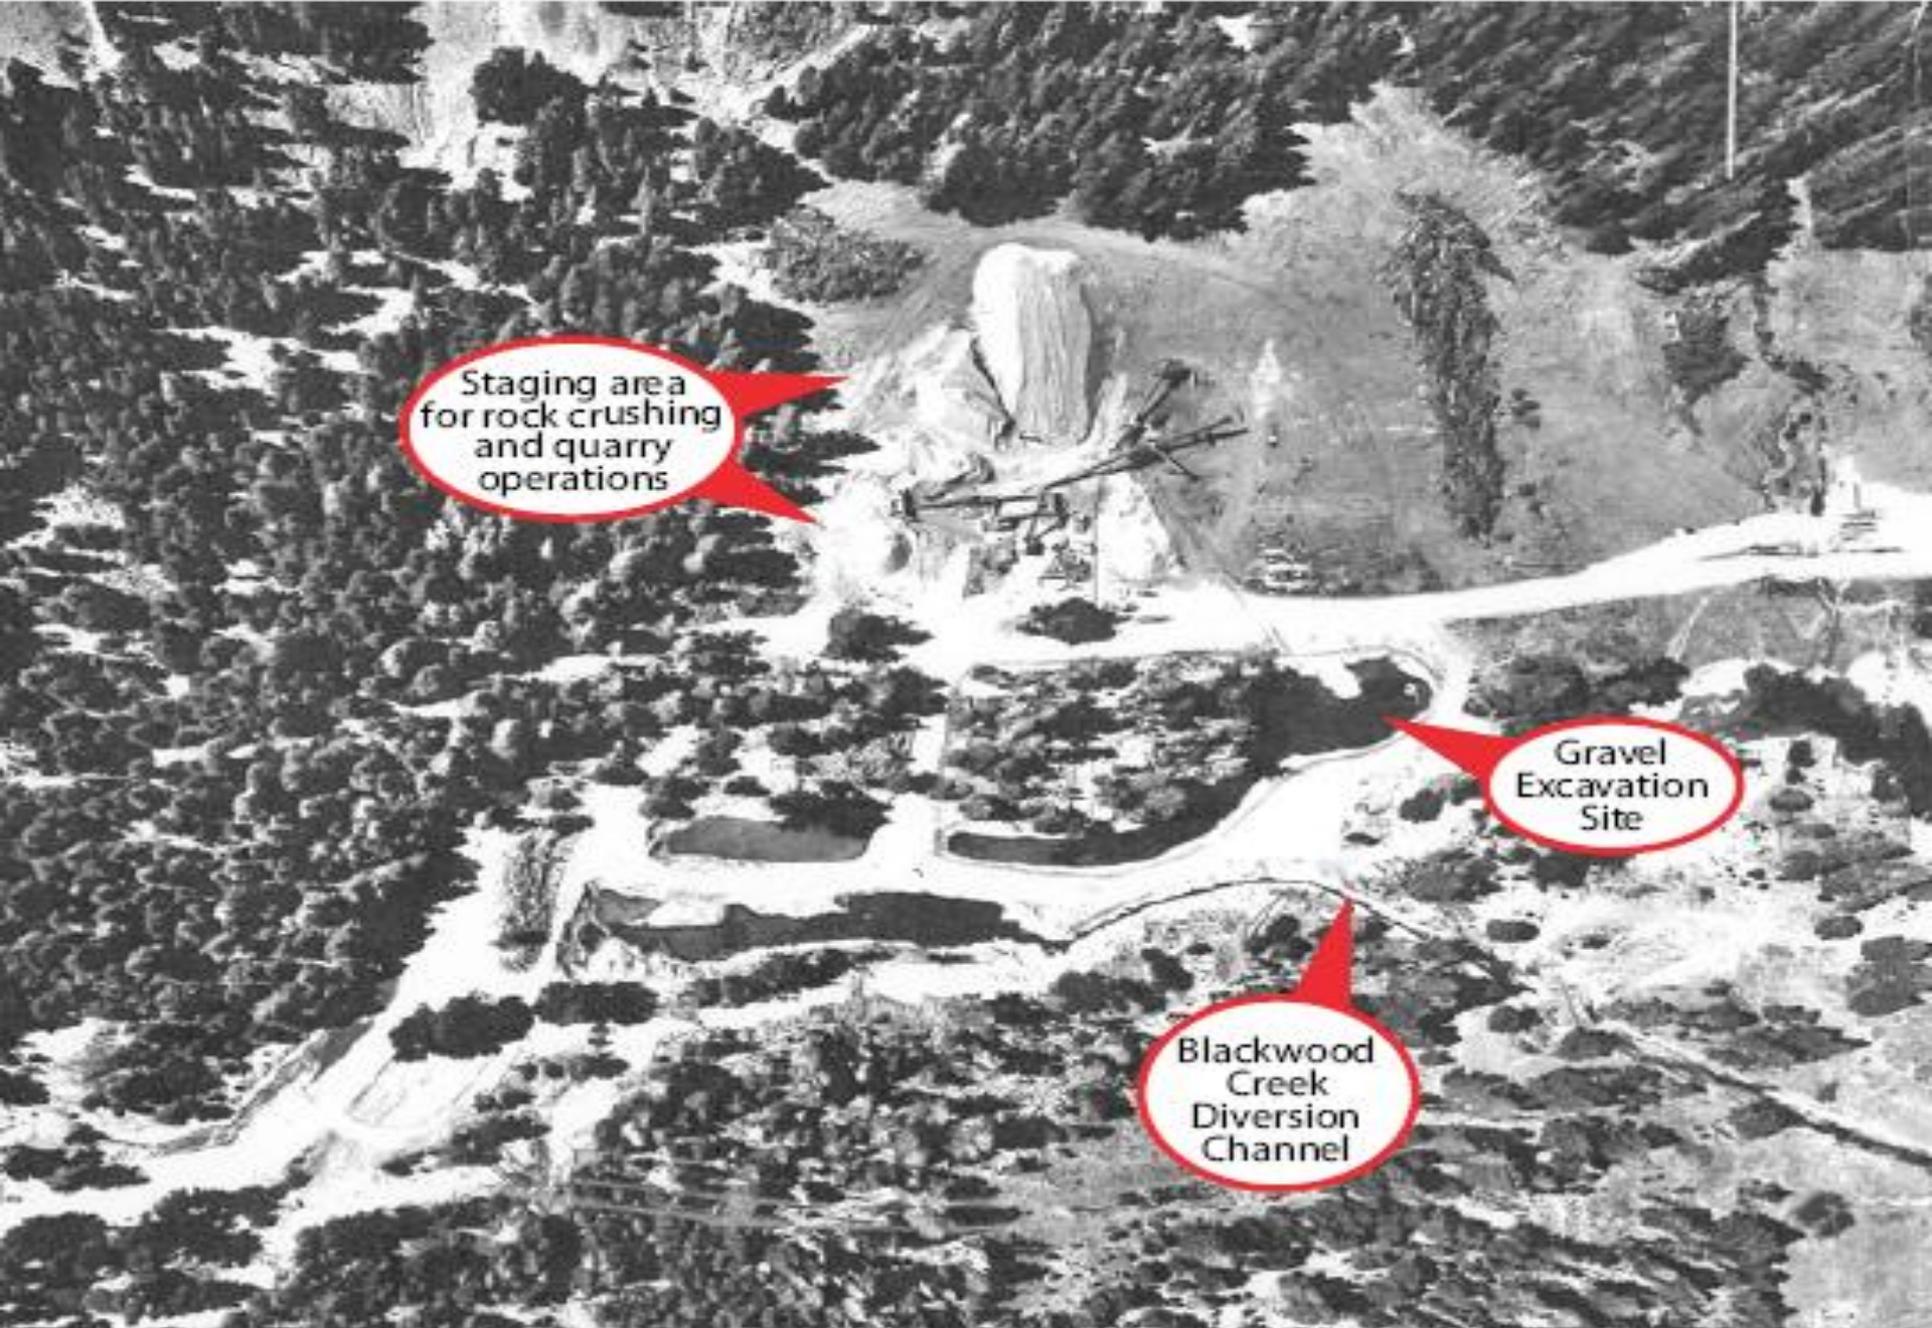
Staging area
for rock crushing
and quarry
operations

Gravel
Excavation
Site

Blackwood
Creek
Diversion
Channel

1964 – picture from TMDL Draft report - LWQCB,2007

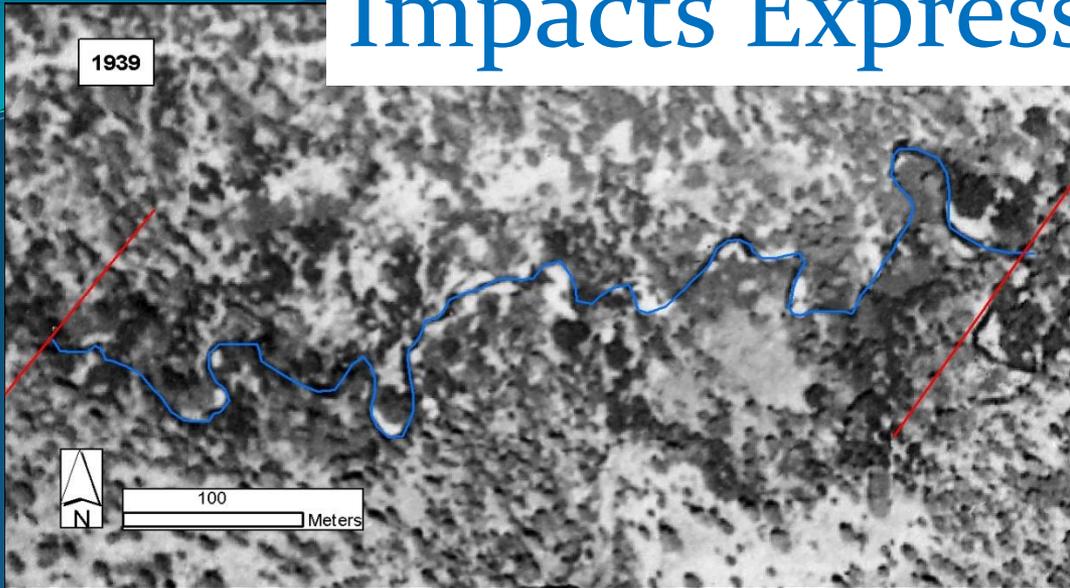
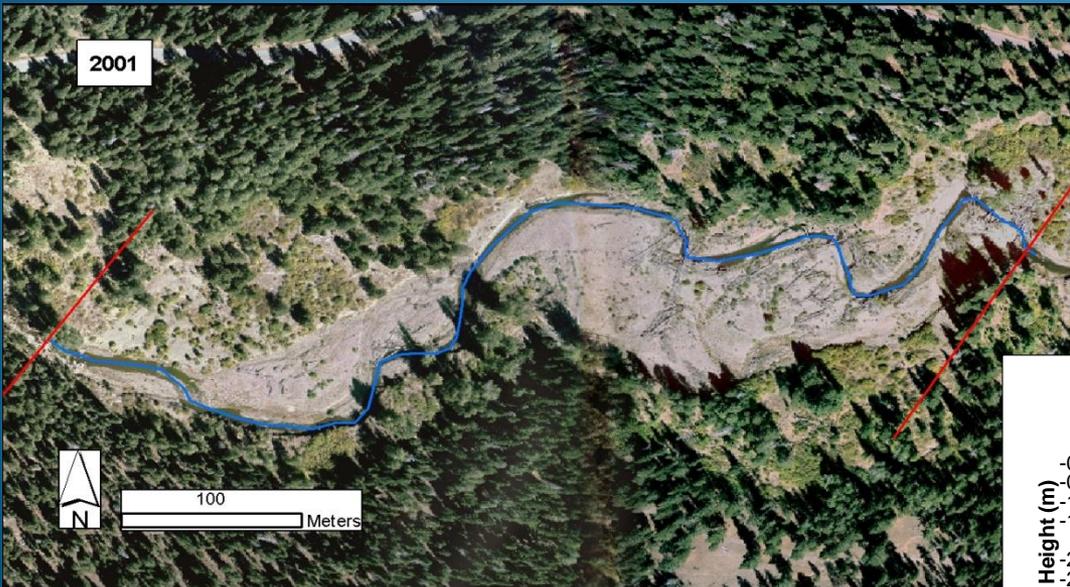
2008-09 Project Area
Channel & Floodplain
condition change in response
to mining and direct
floodplain logging...

70% channel curvature reduction

6+ feet of vertical erosion

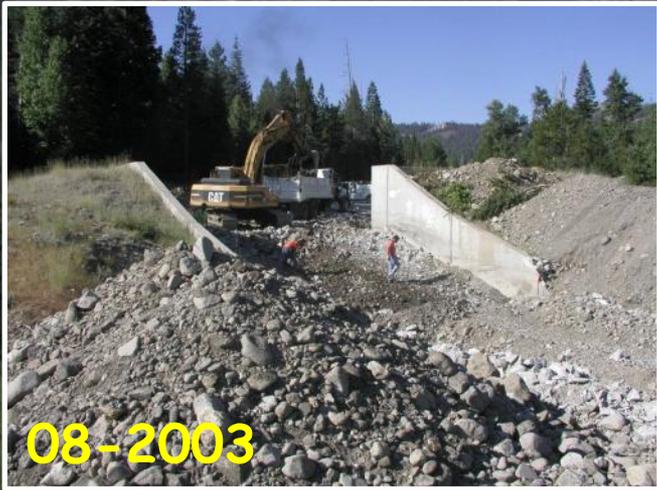
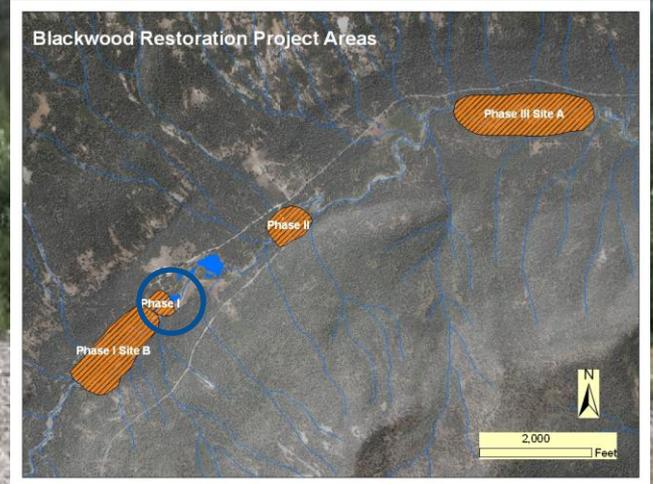
Likely fish migration impairment (LWQCB, 2007)

Phase I - 760K -LTRA

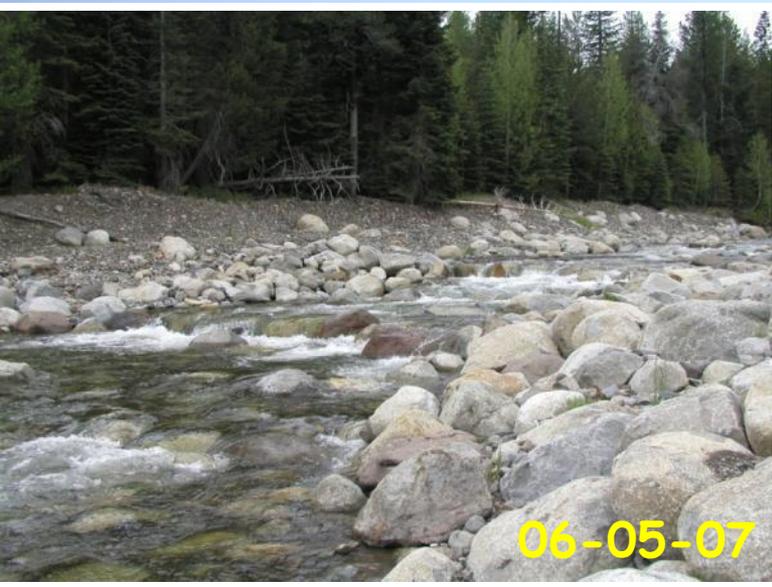
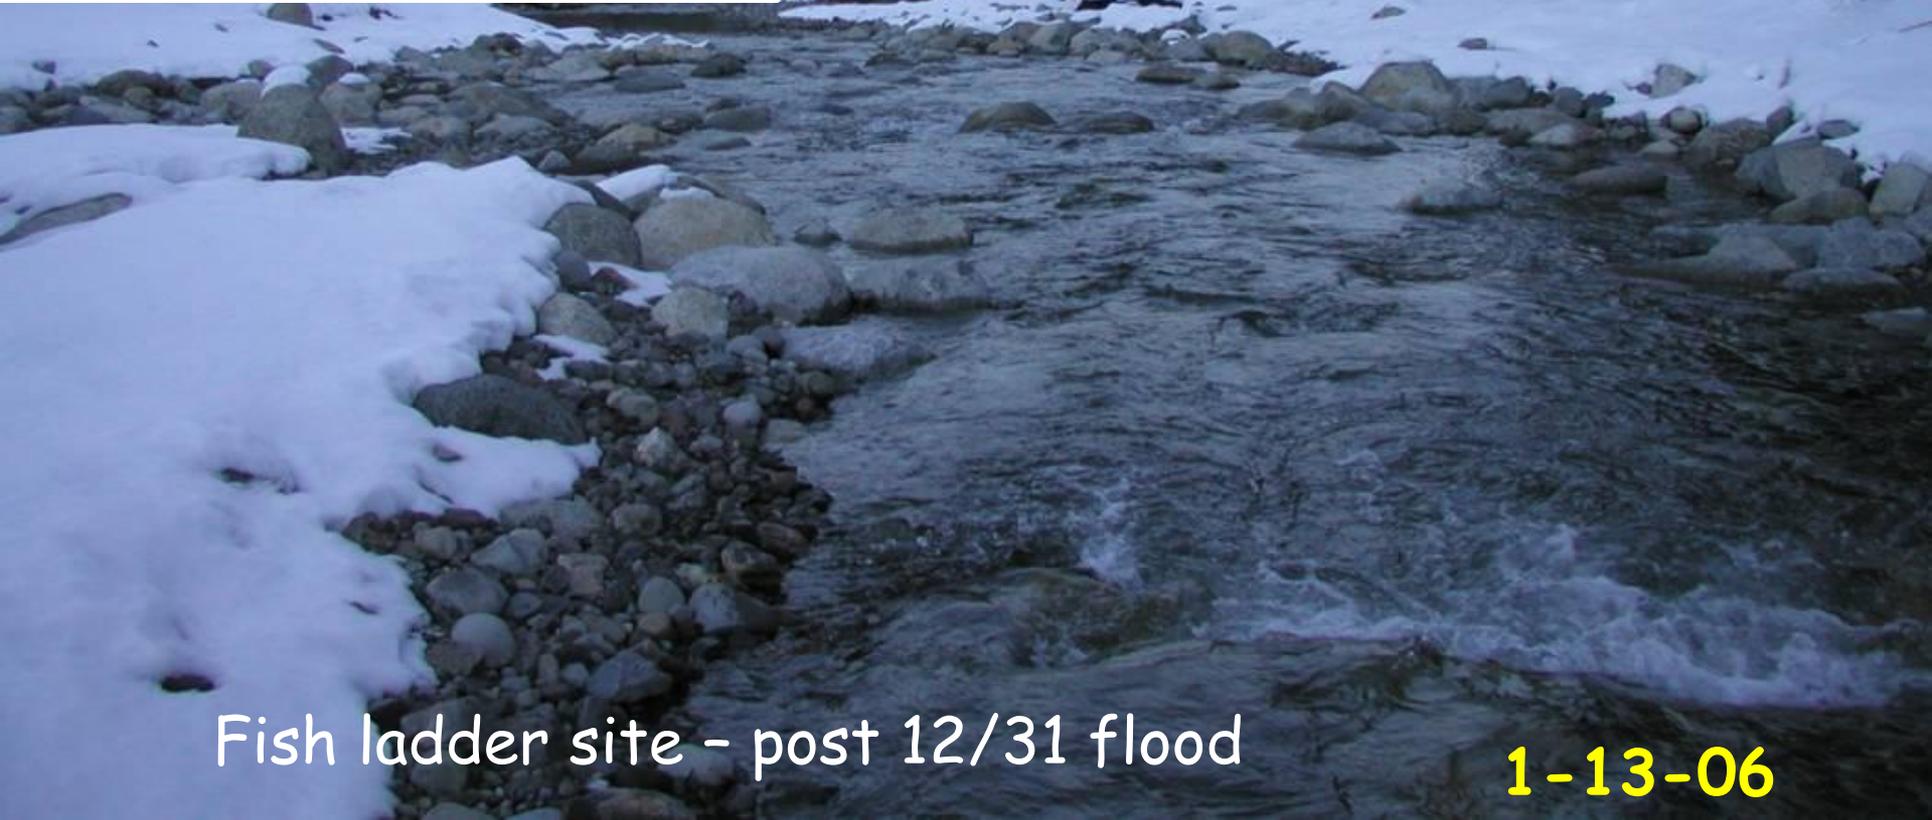
Fish ladder site - post 12/31 flood

1-13-06

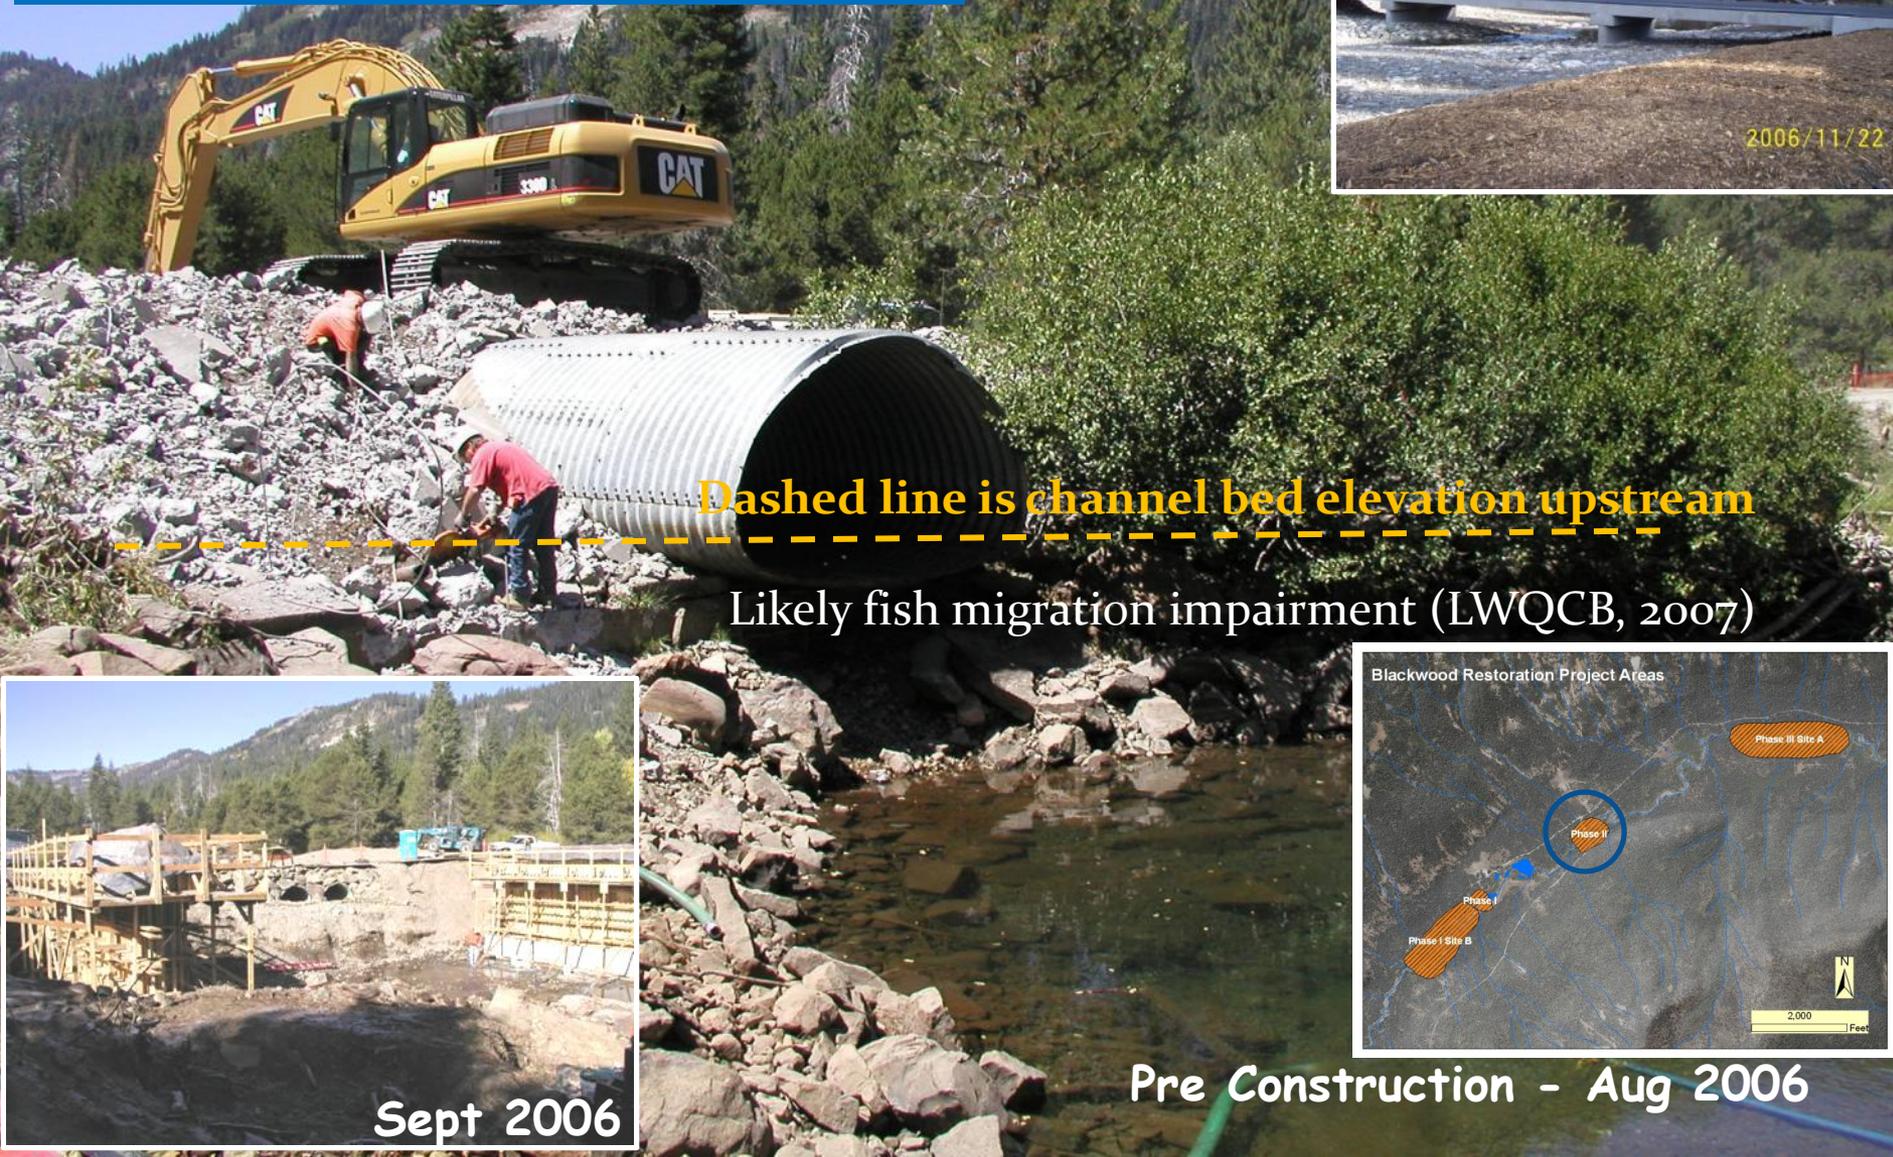
Dashed line is channel bed elevation upstream

Likely fish migration impairment (LWQCB, 2007)

Phase II - 4,200K SNPLMA

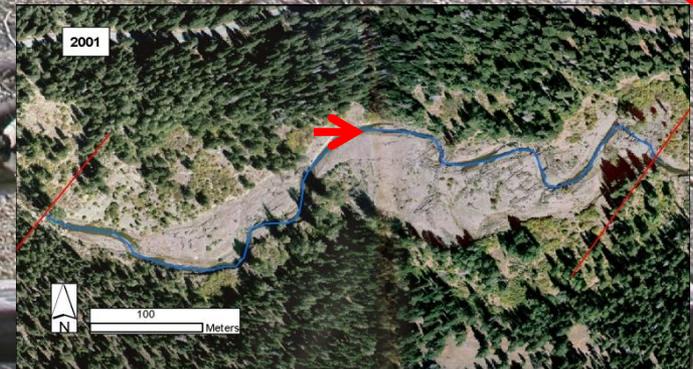
**BEDLOAD SEDIMENT
FORM AND FUNCTION
(WQO VIOLATION)**

Post 12/31/05 flood. Photo taken 7/2006

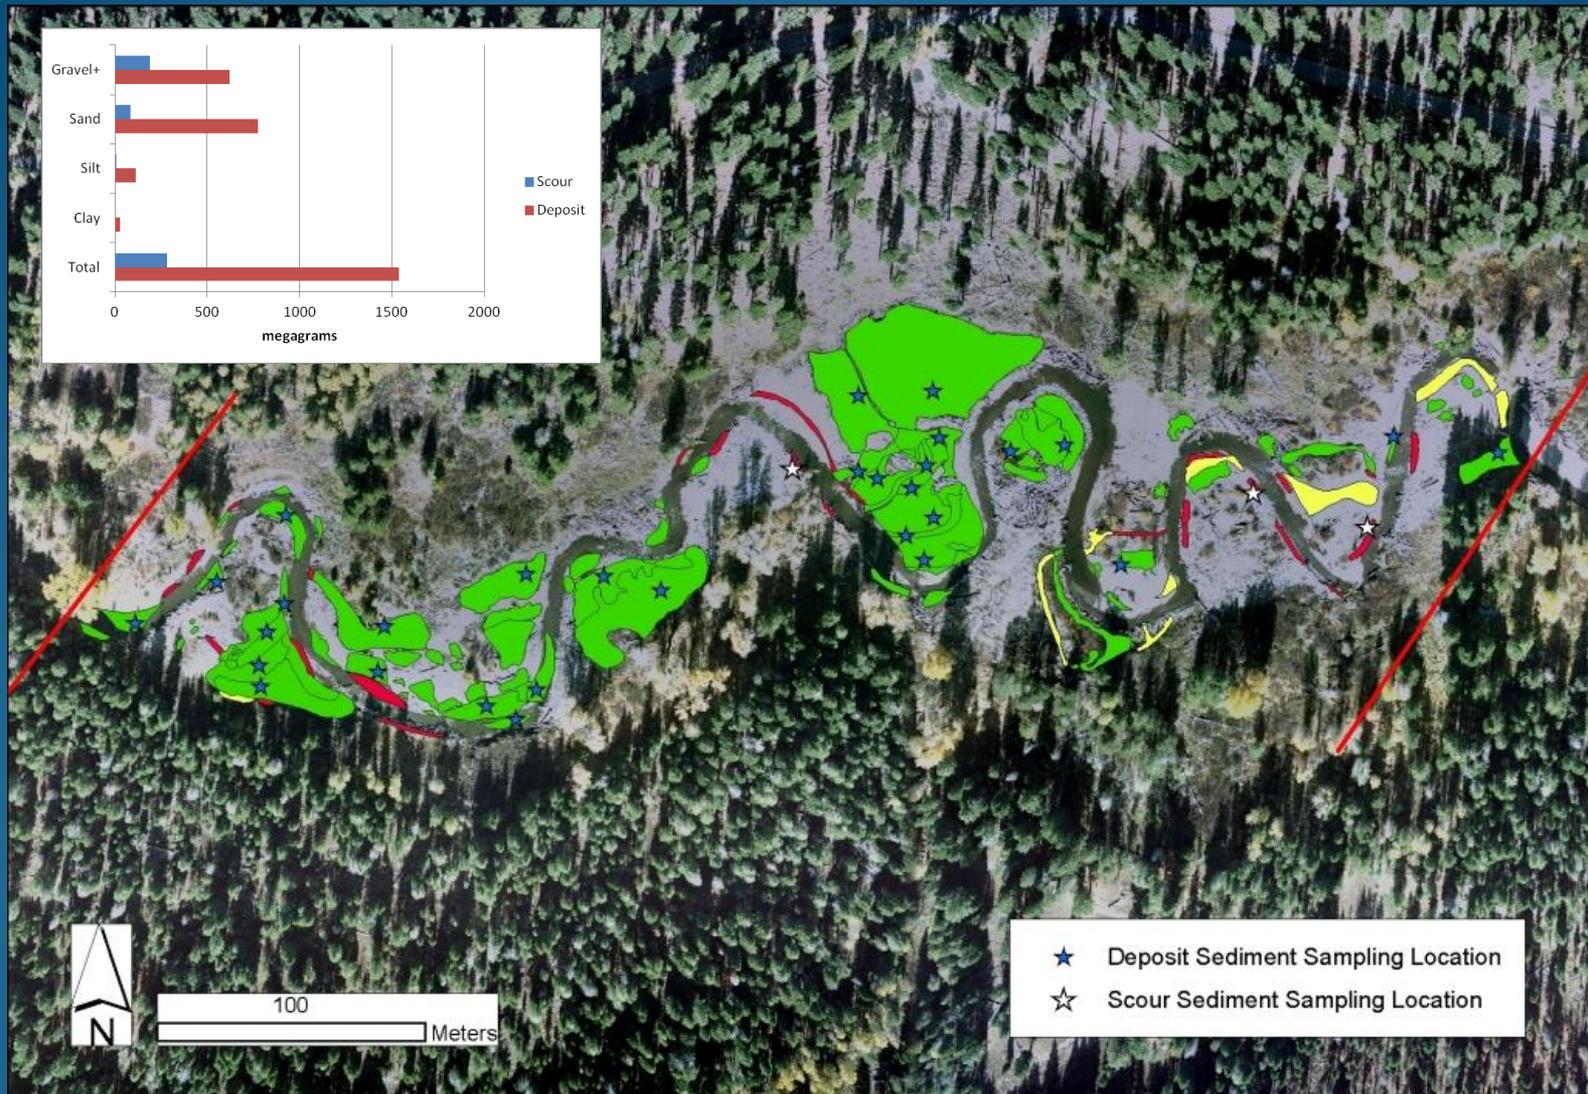
Project Effectiveness Analysis - 2010 deposit / scour

All Monitoring indicators at this time indicate positive restoration response...
2011 channel curvature = 2.1
