# FOREST-WIDE COLLABORATIVE TRAILS ASSESSMENT

CHATTAHOOCHEE-OCONEE  
NATIONAL FOREST

CHATTOOGA RIVER RANGER DISTRICT

JANUARY- MAY, 2012  
CONTRACT #: AG-435H-S-12-0001

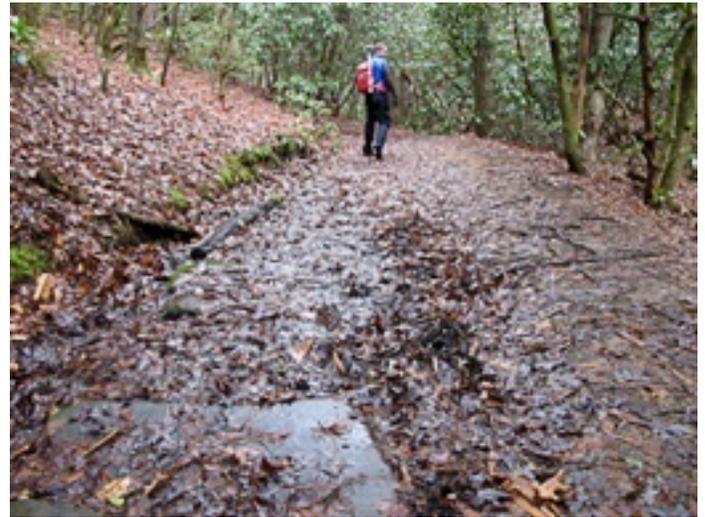
*Top Left and Right: A number of simple bridges are present on the trail, most in need of inspection/repair*

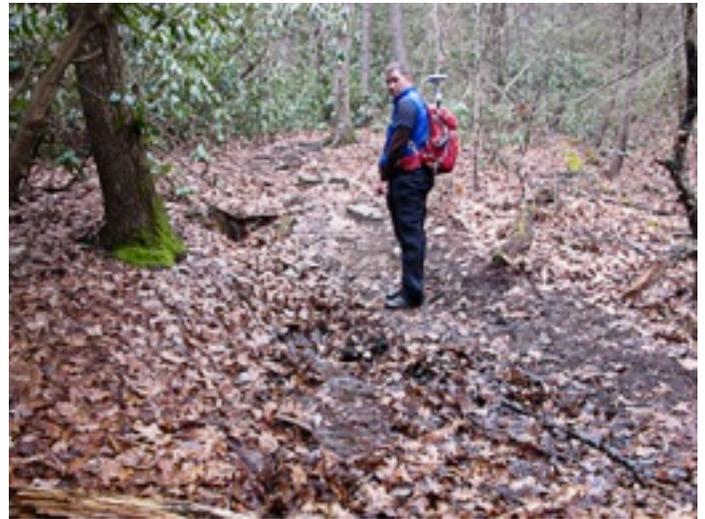
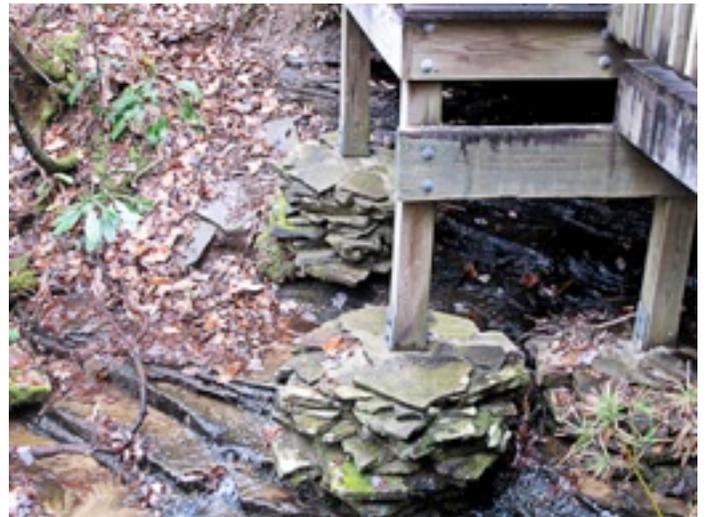
*Top Left and Right: Lack of water management has numerous saturated and eroding areas. Guide wires are broken and loose in numerous locations.*

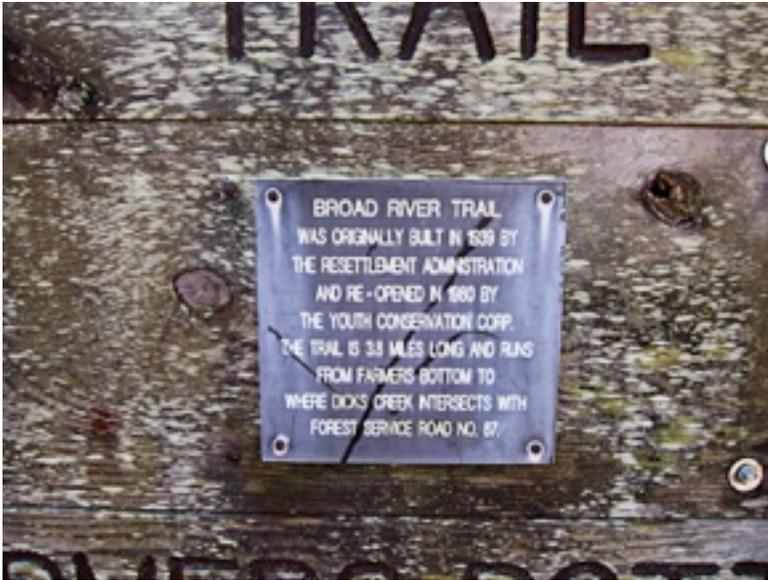
*Above Right: The Broad River Trails conditions vary as you proceed down the trail. Some portions are failing where they cross steep landform grades and have insufficient construction.*

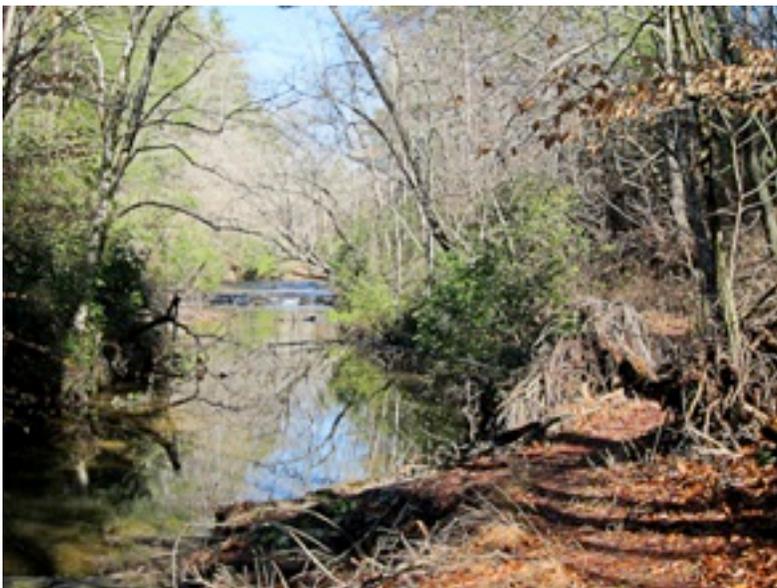
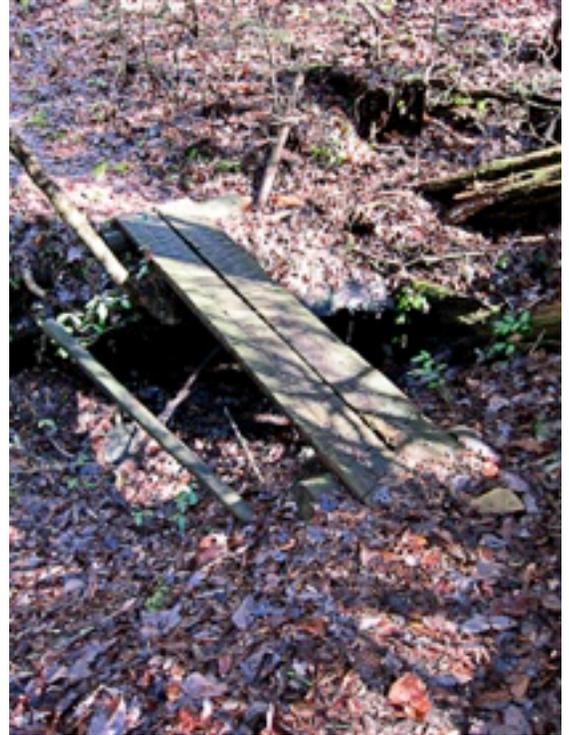
*Above, Right, and Below Right: Several bridges on the broad river trail are in need of inspection and repair.*

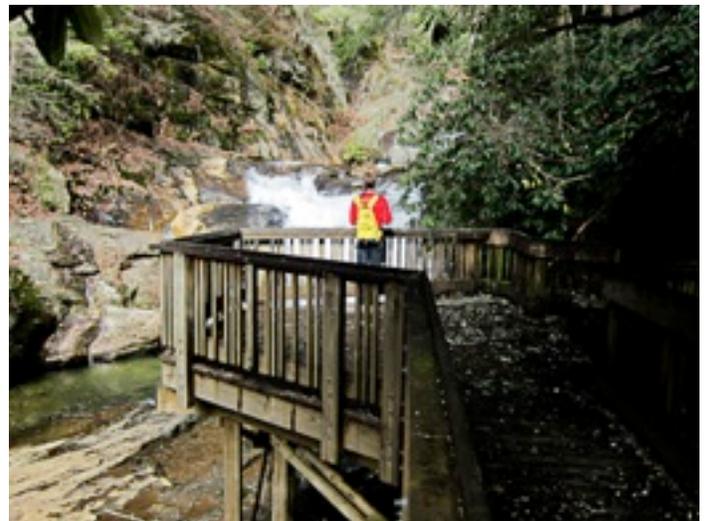
*Right and Below: Observation deck at falls overlook. The lower viewing structure is threatened by the ailing hemlock trees that flank the creek bottom.*

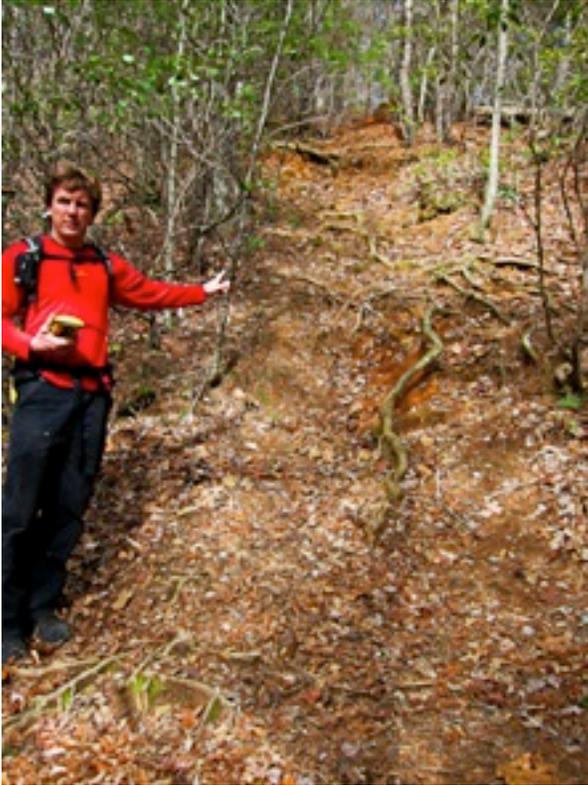
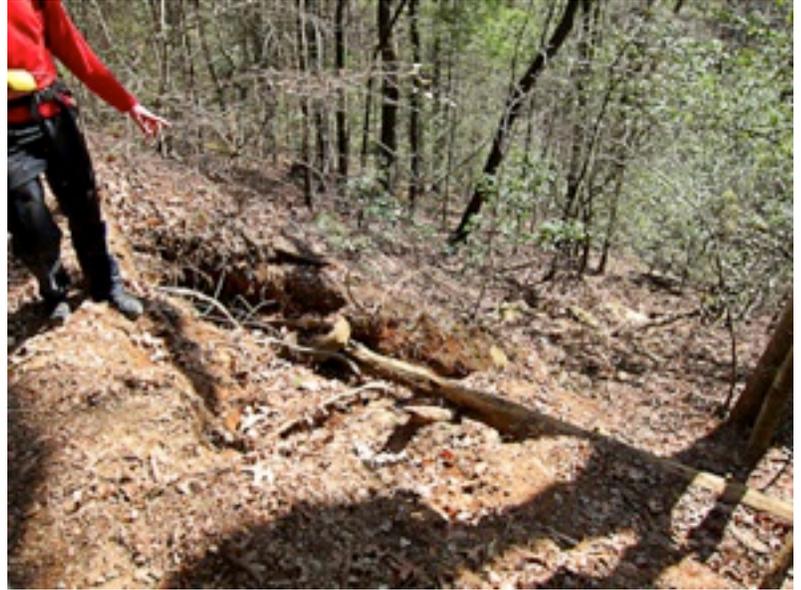
*Above Left and Right: Culverts from the road (348 Richard Russell Scenic Hwy) above the trail complicate water management and are causing natural resource damage and erosion.*

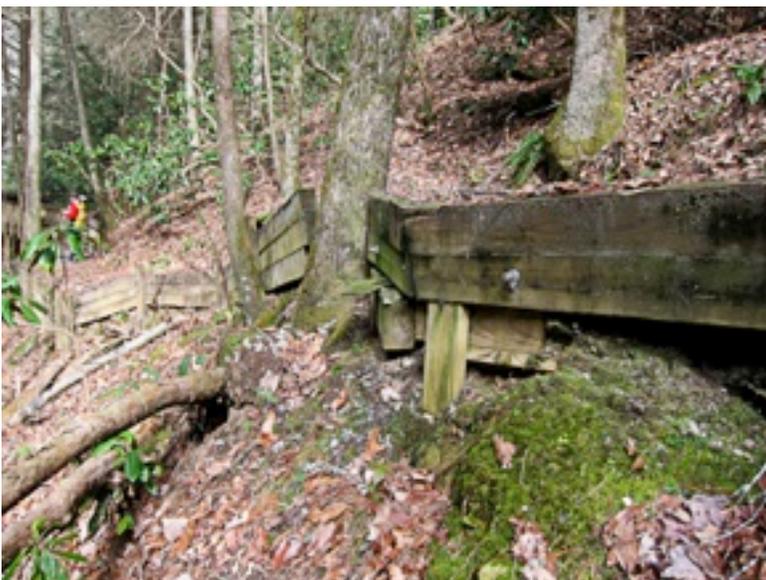
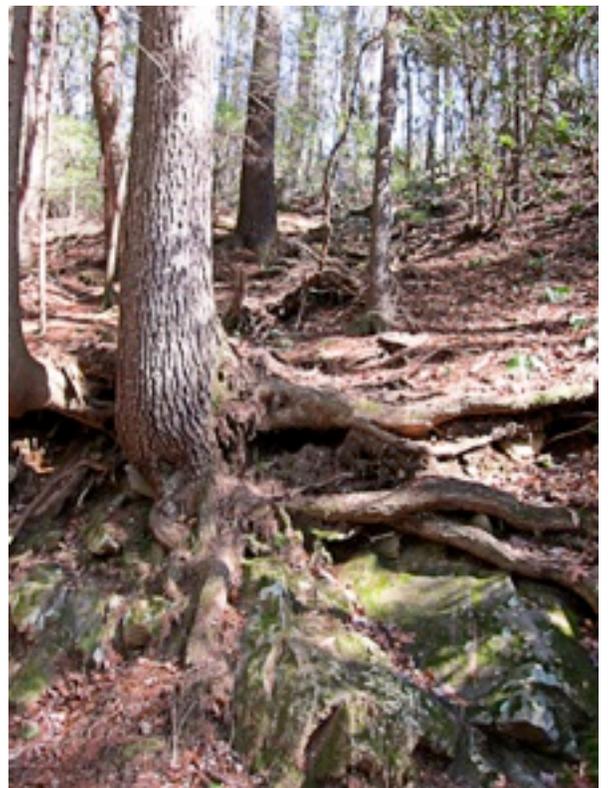
*Below Left and Right: A section of trail is held in place by a wooden structure that is starting to fail, and will need replacement soon. Multiple user shortcuts at switchbacks are a natural resource concern.*

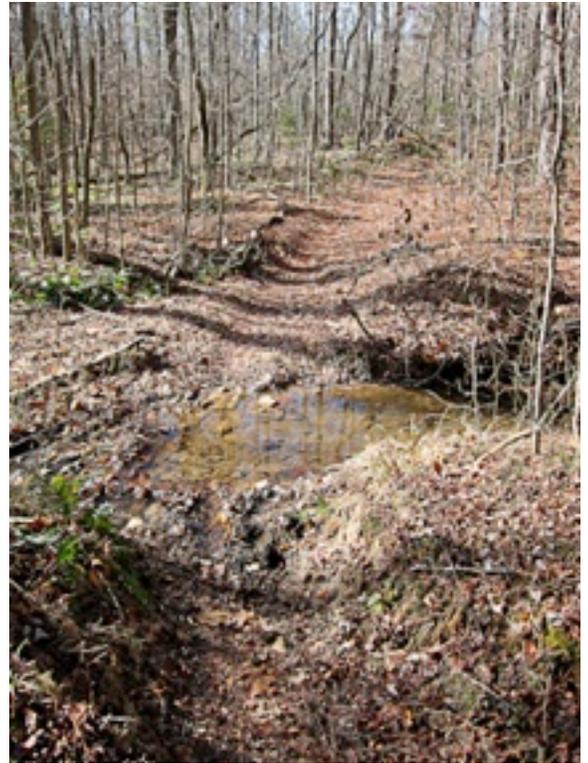
*Left, Above and Below: Trail conditions on  
Ladyslipper are complicated by illegal motorized  
use.*

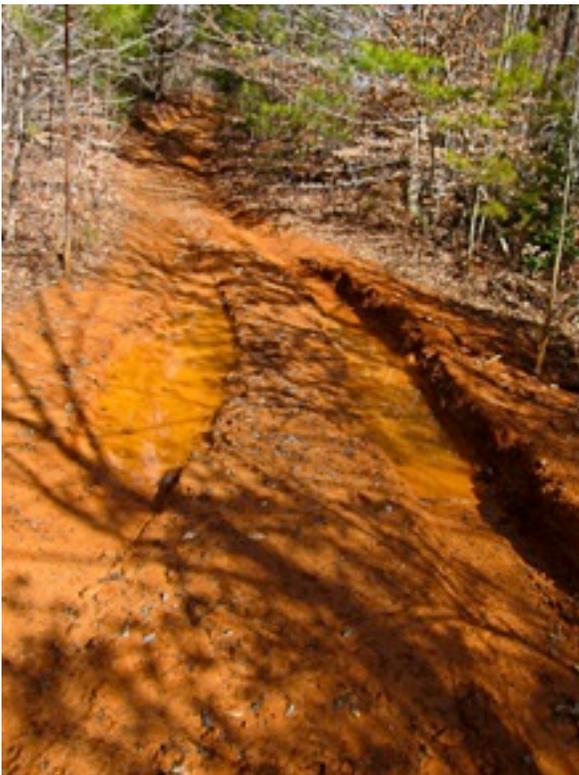
*Right, Above and Below: Steep grades and  
minimal water management have led to degrade  
trail conditions and impacts to adjacent natural  
resources.*

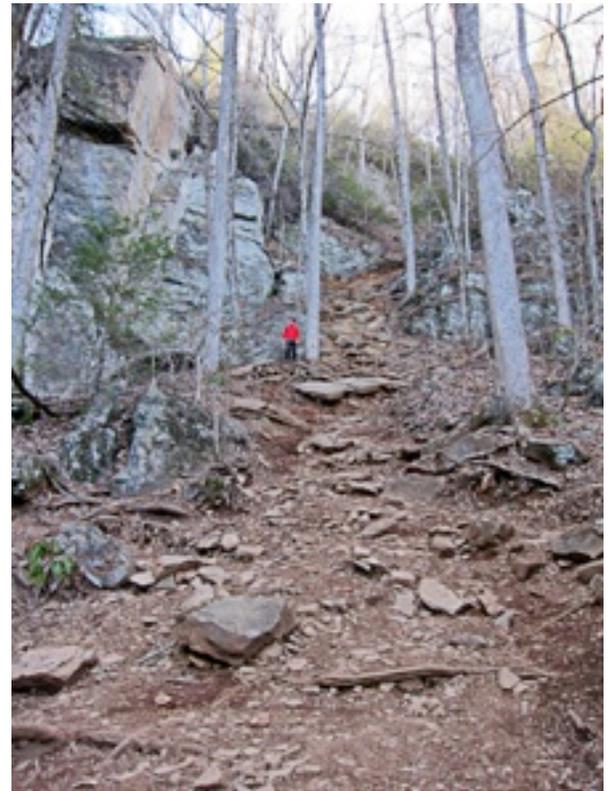
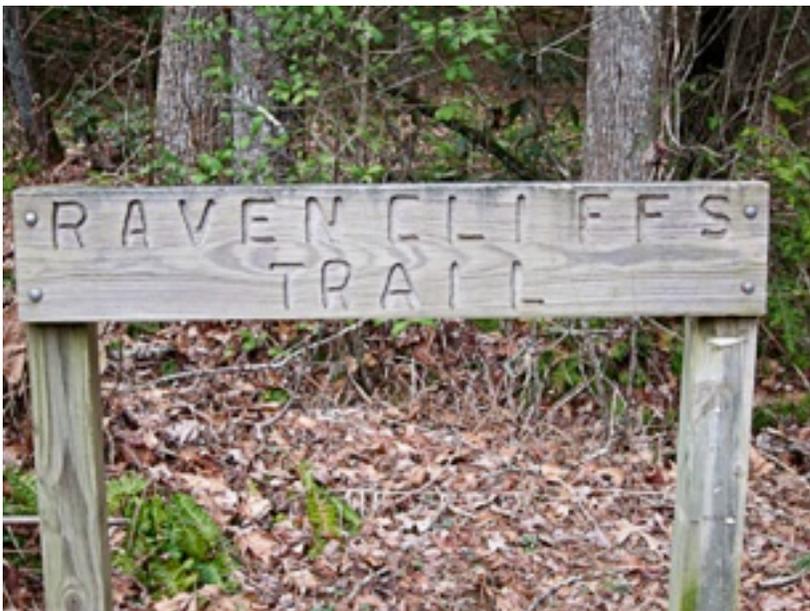
*Right: The fall-line ascent to view the falls is eroded to a width of more than 10 feet.*

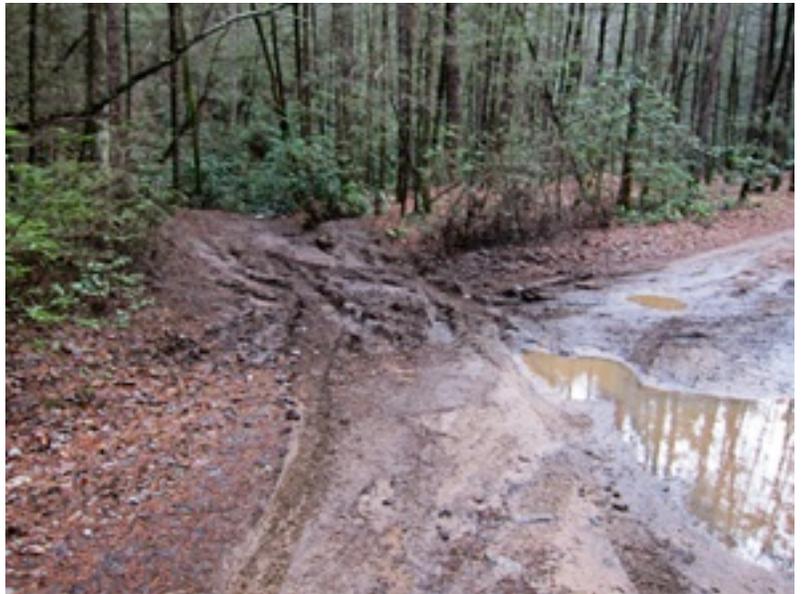
*Above: Lower section of trail has a number of muddy areas and some areas show signs of considerable off-highway vehicle use*

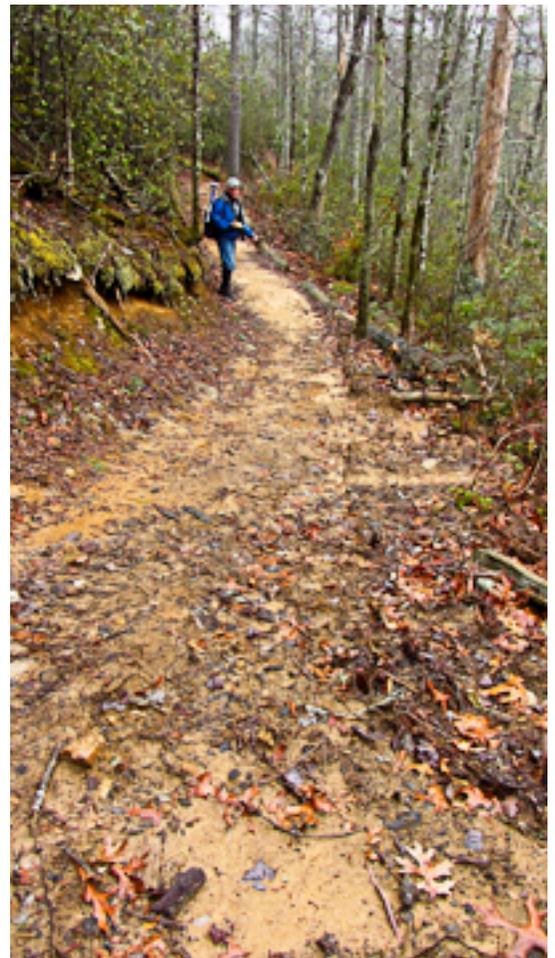
*Above and Right: Lack of rolling contour and water management leading to erosion/deposition*

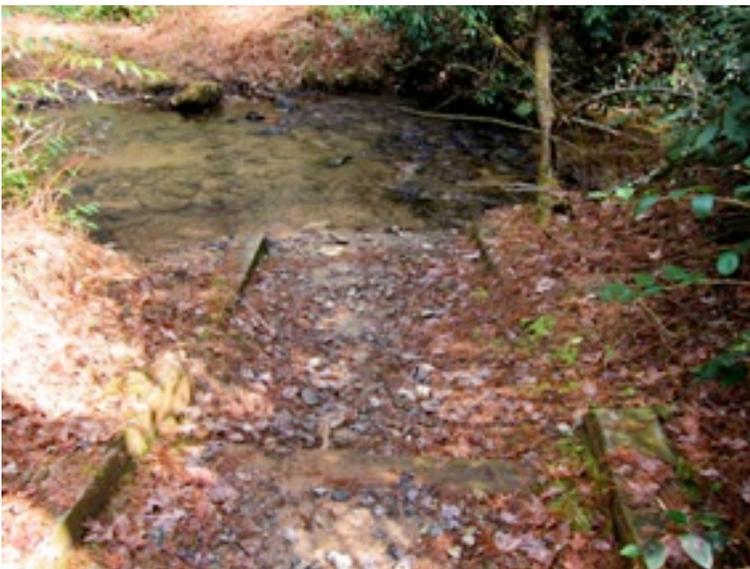
*Above Left: Stringers packed with ballast to control sedimentation. Should have cross pieces to better retain rock in structure. Structure should be crowned to avoid becoming a gutter for sediment washing down the trail*

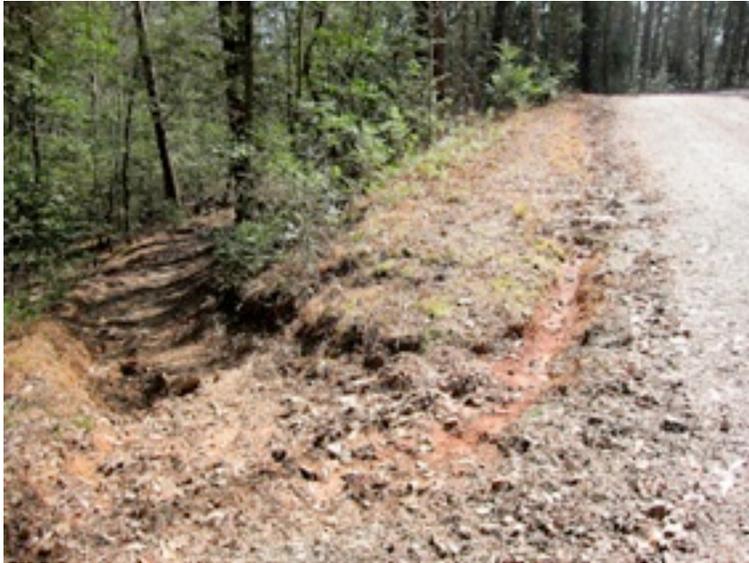
*Above and Below: Trail sections that are far too steep for equestrian use in these soil conditions become incised as tread material is loosened and lack of water management allows stormwater to entrain the sediment and carry it downslope, in some cases (below far right) directly to the river.*

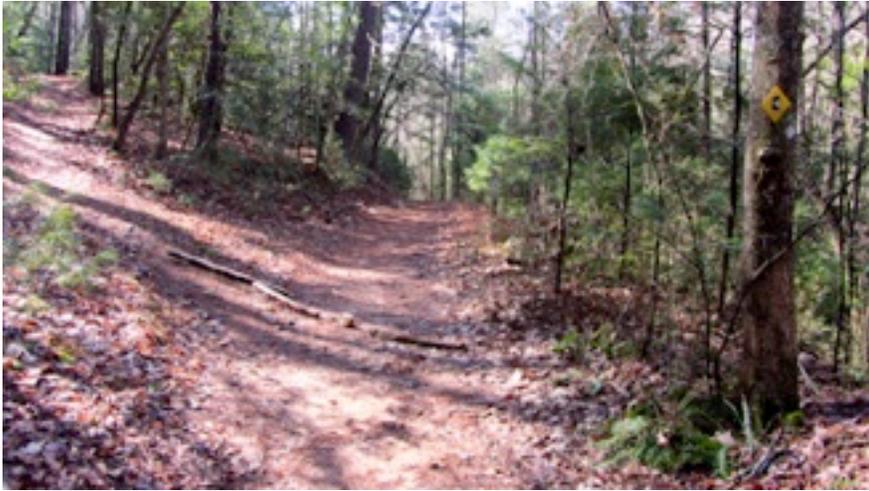
*Above Left: Open corridors become travel corridors. A branch pointing to the system route is not sufficient to minimize use on non-system routes.*

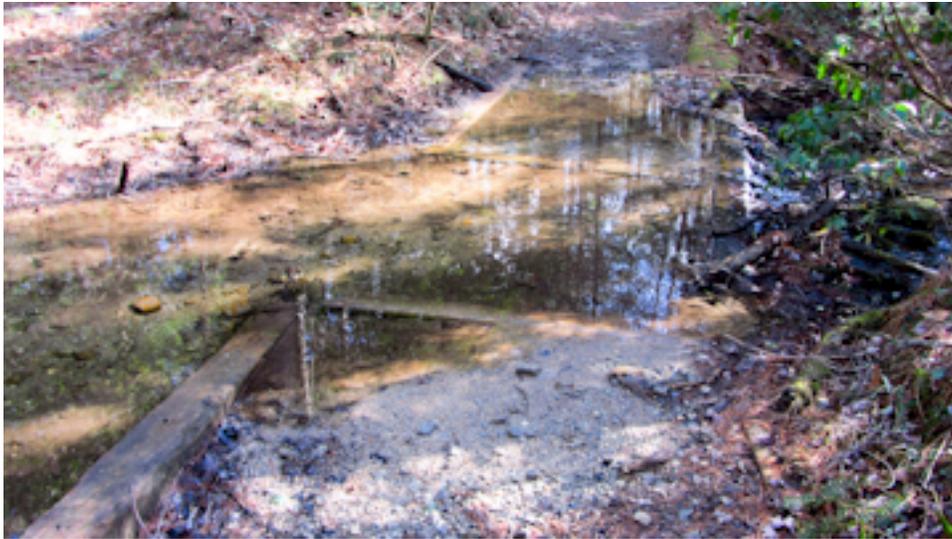
*Left: Attempt to harden water crossing. Stringers within stream channel cause flow alterations undermining fill and structure effectiveness*

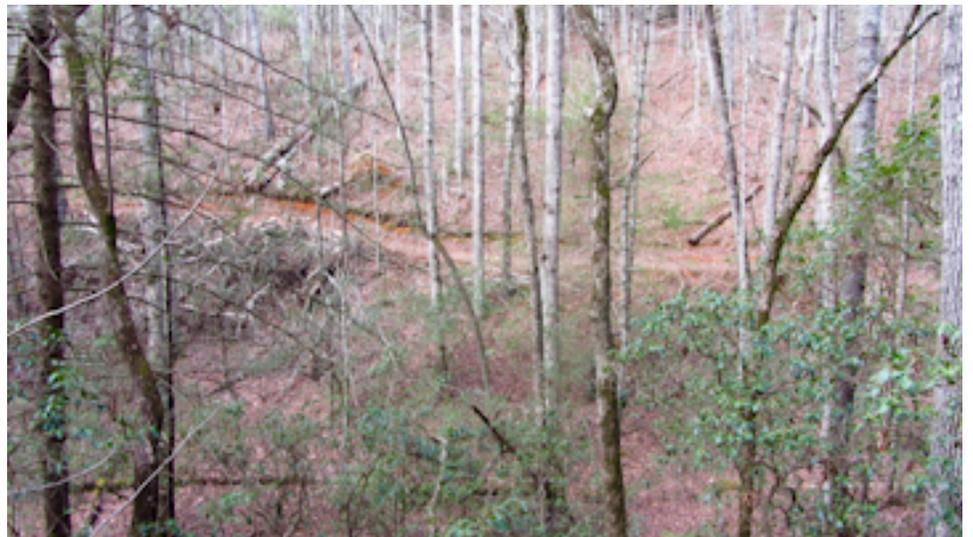
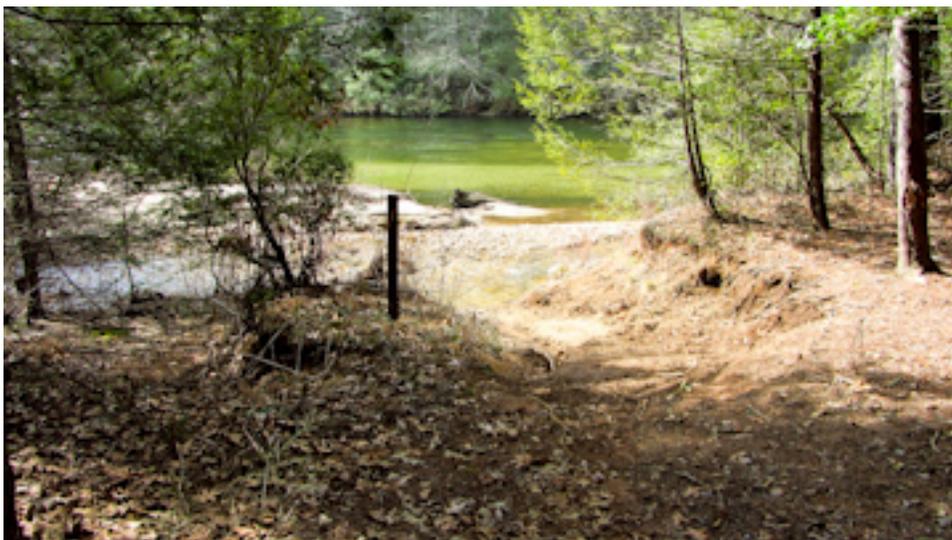
*Left: River access without sufficient water management. Incised condition demonstrates the amount of sediment that has migrated below the normal high water line*
