September 12, 2012

Ref.: 2010-084

Technical Memorandum
August 2012 Site Inspection Report
Blue Ledge Mine
Rogue River-Siskiyou National Forest

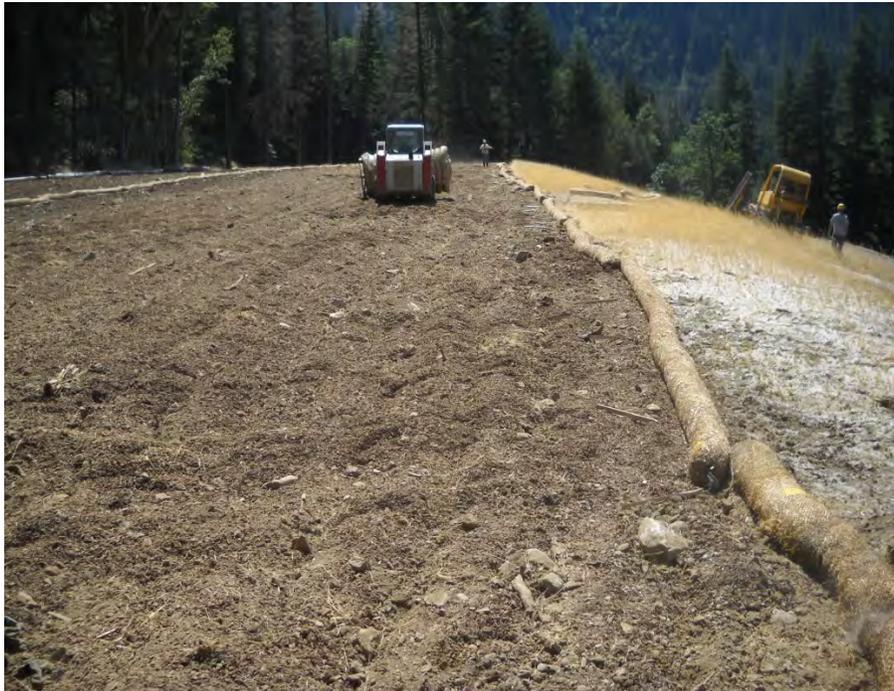
A large percentage of shrubs on the repository have died. All of the plants on the top deck and approximately 60 percent of the plantings on the side slope of the repository have died. Soil conditions under the bark mulch were drier than previously observed, but the soil was still moist. As noted in the June 2012 inspection report, saturated conditions on the top layer of soil are likely causing the high mortality rates of plants on the repository.

Photograph 1: Top of Repository looking south after scarified, with extra wattles.
Blue Ledge Mine, Rogue River-Siskiyou National Forest, CA
Photographed by: Brian Wetzsteon (ERRG) Date: August 23, 2012

- Mr. Steinfeld recommended mixing the top deck soil 25 percent bark mulch to 75 percent soil mixture. A reasonable approach was discussed as:
 - Spread the existing bark mulch over the entire area

- Use the rest of the stockpiled bark mulch to meet the 1/3 ratio
 - Rip the soil to loosen the soil
 - Scarify the mulch and soil 8 to 10 inches deep
 - Hydroseed the entire top of the repository

- Add a line of straw wattles to the top edge of the repository to encourage sheet flow down the slope
- Add two more rows of straw wattles to the repository face.

Because the reclamation shrubs on the repository top deck were dead, ERRG and the Forest Service decided to replace the plants on the top deck with grass seed as discussed during the July 17, 2012 site meeting. The existing bark mulch was spread out to cover the entire top deck approximately 2 inches thick. A small dozer scarified the top 8 to 10 inches of soil and bark to loosen the surface and allow blending of the bark mulch into the soil. ERRG added straw wattles across the center of the scarified area, at the repository shoulder, two extra rows of wattles on the slope, and one extra row of wattles along the downslope side of the repository access road. The previously stabilized rills in the bark-mulched areas below the access road were raked with bark to minimize preferential flow paths. The scarified top deck will be hydroseeded with Flexterra, grass seed, and fertilizer during September 2012. The surface of the slope will be covered with a light hydroseed application of Flexterra, grass seed, and fertilizer as recommended by the Forest Service botanist to enhance previously established grasses.

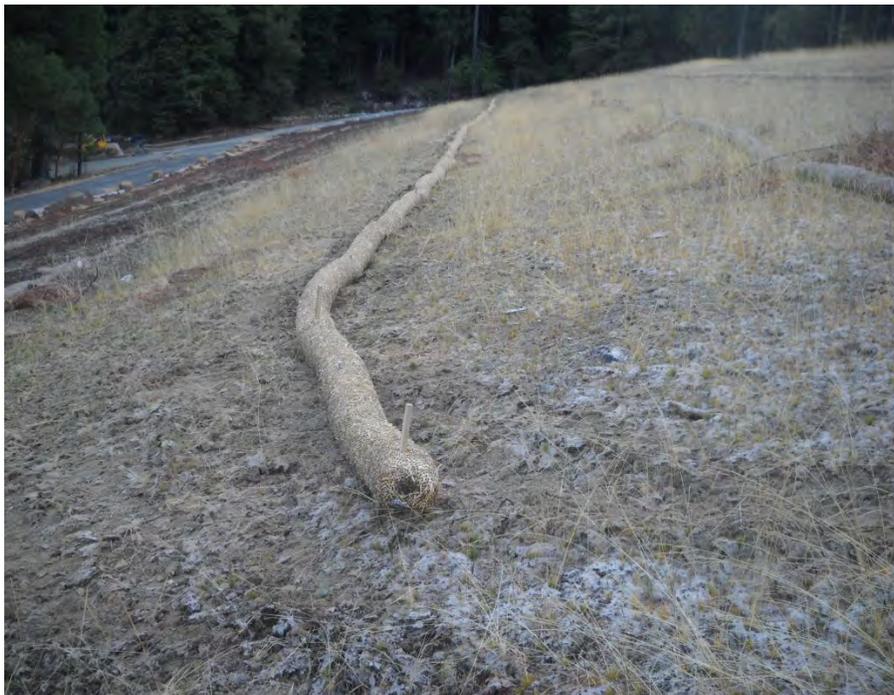
Photograph 2: Repository slope with extra wattles. Note grass growth.
Blue Ledge Mine, Rogue River-Siskiyou National Forest, CA
Photographed by: Brian Wetzsteon (ERRG) Date: August 24, 2012

- Hand rake the previously stabilized rills in the bark mulch below the access road to prevent further rilling.
- Forest Service botanist Mr. Wayne Rolle subsequently recommended a light application of hydroseed on the repository slopes to enhance grass coverage.

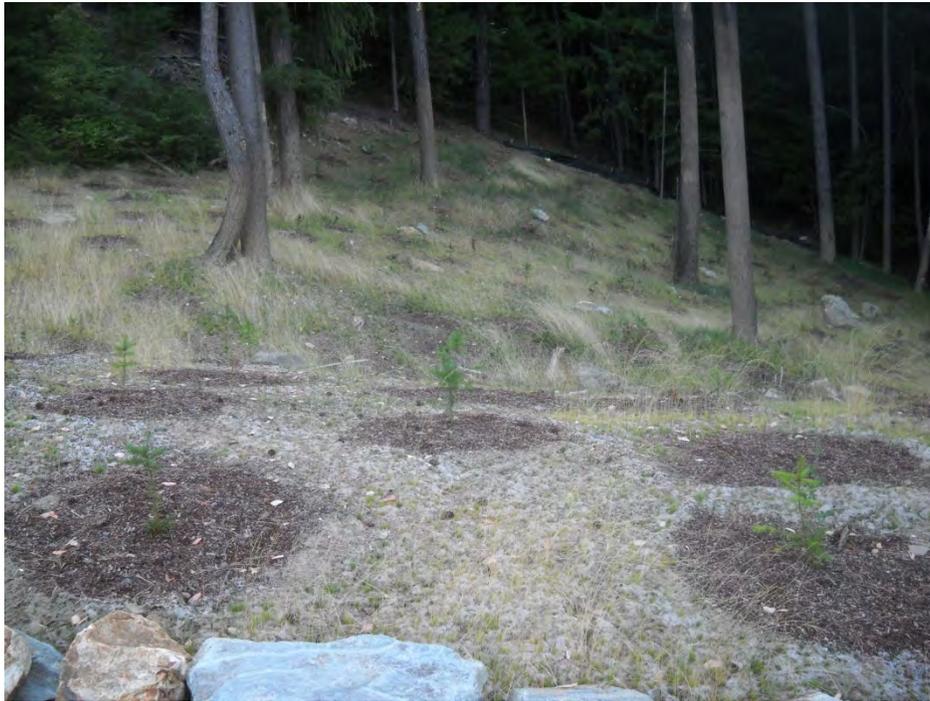
Photograph 3: Repository stockpile looking south. Good plant and grass growth.

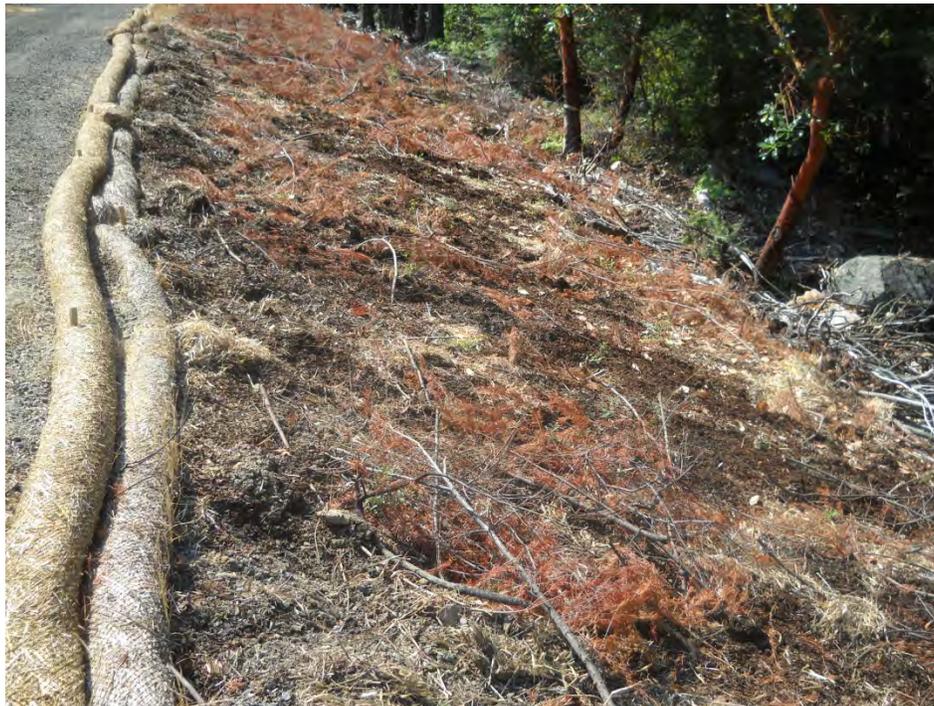
Photograph 4: Repository slope below access road. Raked rills and new straw wattle.

- Add another row of straw wattles to the toe of the access road so that stormwater coming off the repository slope won't overtop the wattles during peak events.

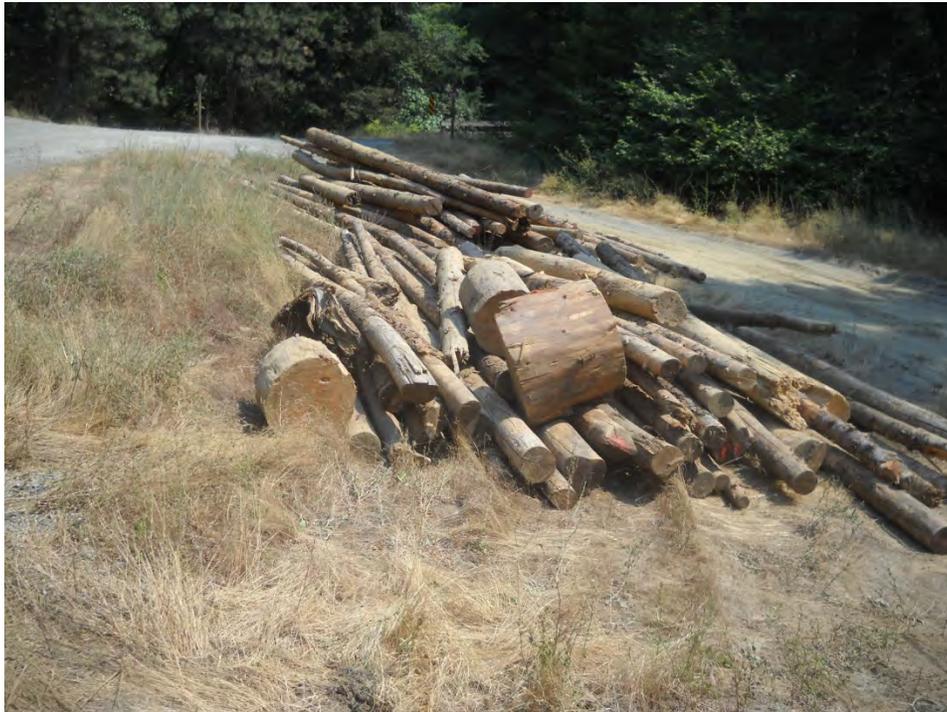
Photograph 5: Excess logs placed at public access for firewood.

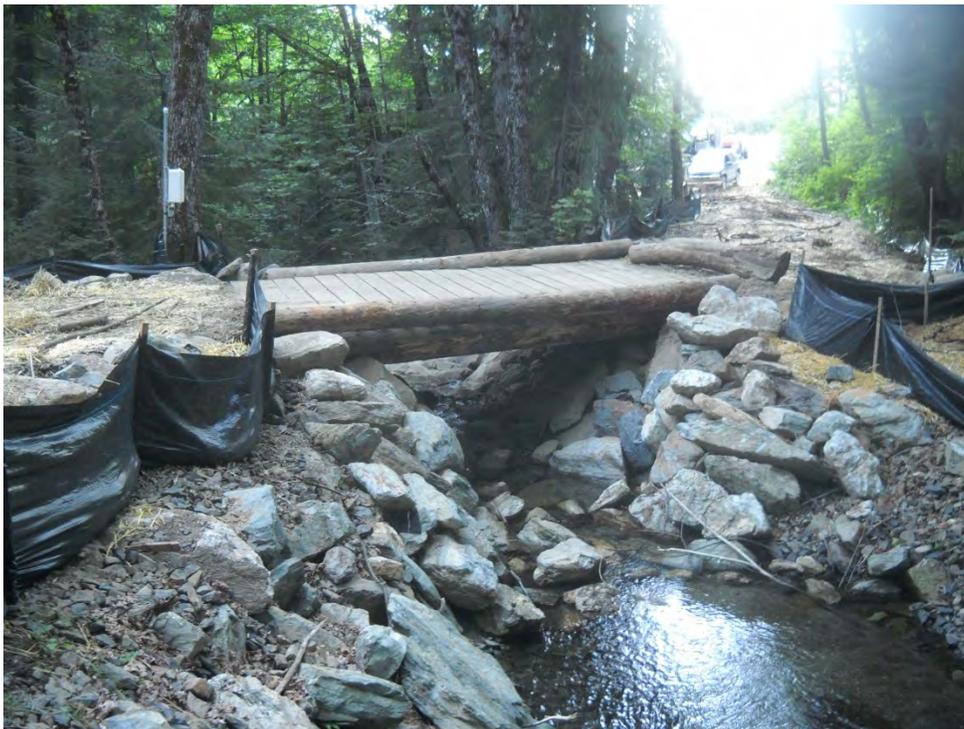
Photograph 6: Typical temporary bridge on Haul Road 1 across Joe Creek.

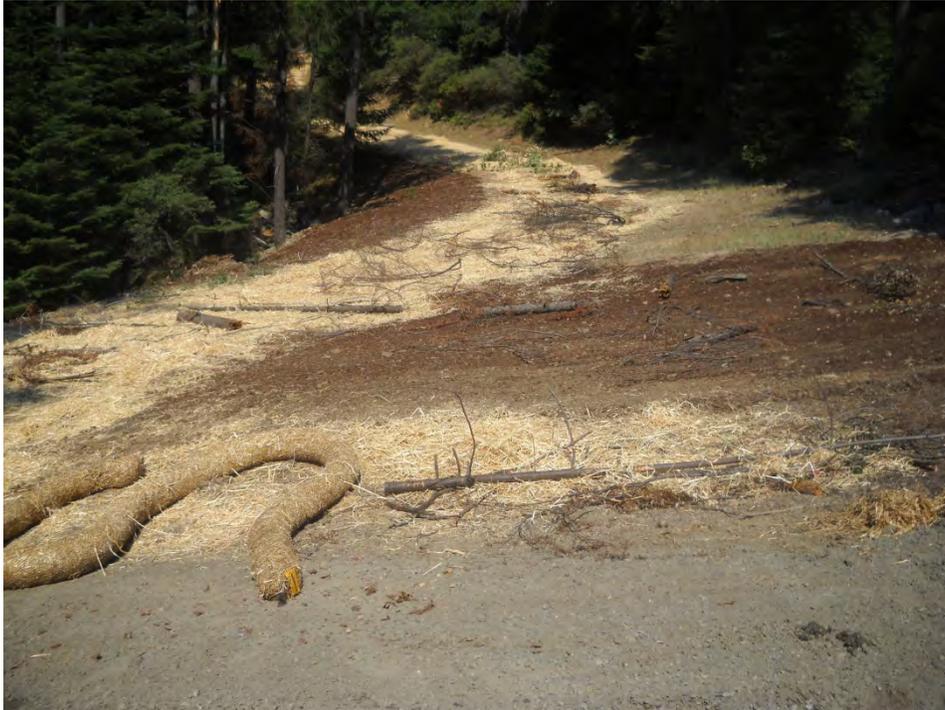
Photograph 7: Closed North Stockpile Access Road.
Blue Ledge Mine, Rogue River-Siskiyou National Forest, CA
Photographed by: Brian Wetzsteon (ERRG)

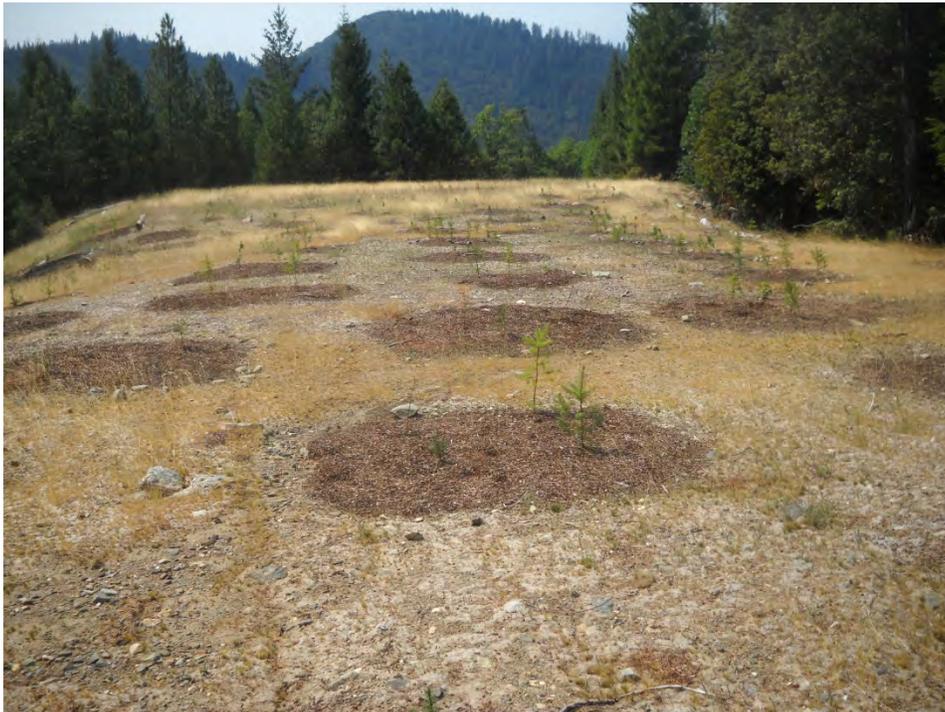
Photograph 8: North Storage Area looking west.
Blue Ledge Mine, Rogue River-Siskiyou National Forest, CA
Photographed by: Brian Wetzsteon (ERRG)

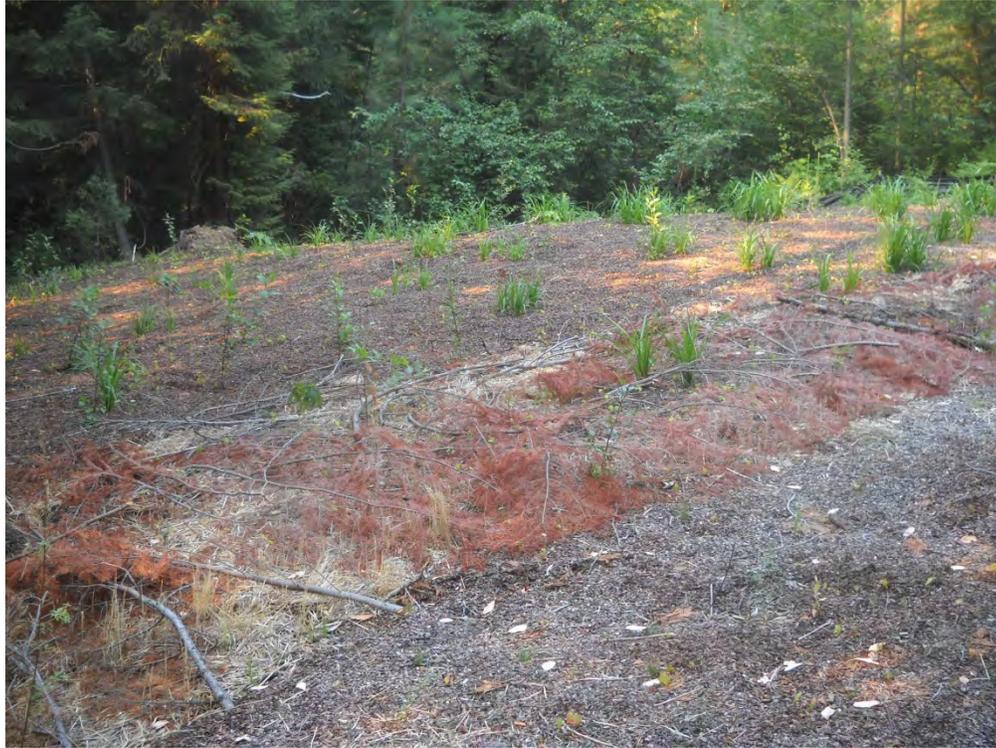
Photograph 9: South Stockpile Area looking east.
Blue Ledge Mine, Rogue River-Siskiyou National Forest, CA
Photographed by: Brian Wetzsteon (ERRG)

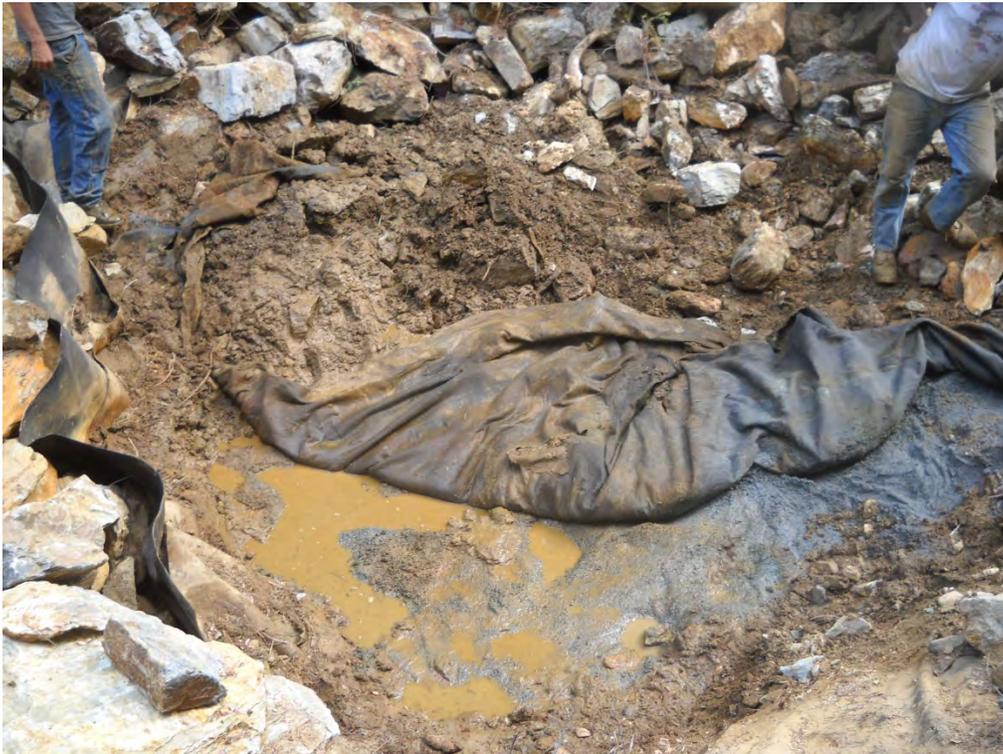
After sediment removal from the basins was completed, the rocks that provide scour protection over the geotextile that covers the agricultural limestone were removed to allow the geotextile to be peeled back to expose the limestone to evaluate the amount of fouling. The amount of fouling was determined by the staining and coating of the limestone. The scaling and coating with metal precipitates may reduce the permeability and the reactivity of the limestone. In most cases the limestone in basins 1A through 1F had developed an outer crust that likely reduces the permeability, and the limestone beneath the crust looked like it was not impacted at all. The limestone was stirred to break up the crust and blend it into the underlying limestone. Additional limestone was added to restore permeability and reactivity. The geotextile was replaced over the limestone and large flat rocks were placed as scour protection. The limestone in basins 2A, 2B, and 3 did not appear impacted by staining or precipitates and no crust was observed. These drainages do not have the low pH water that basins 1A through 1F are exposed to.

Photograph 10: Typical sediment removal and limestone inspection at Basin 1C.
Blue Ledge Mine, Rogue River-Siskiyou National Forest, CA
Photographed by: Brian Wetzsteon (ERRG)

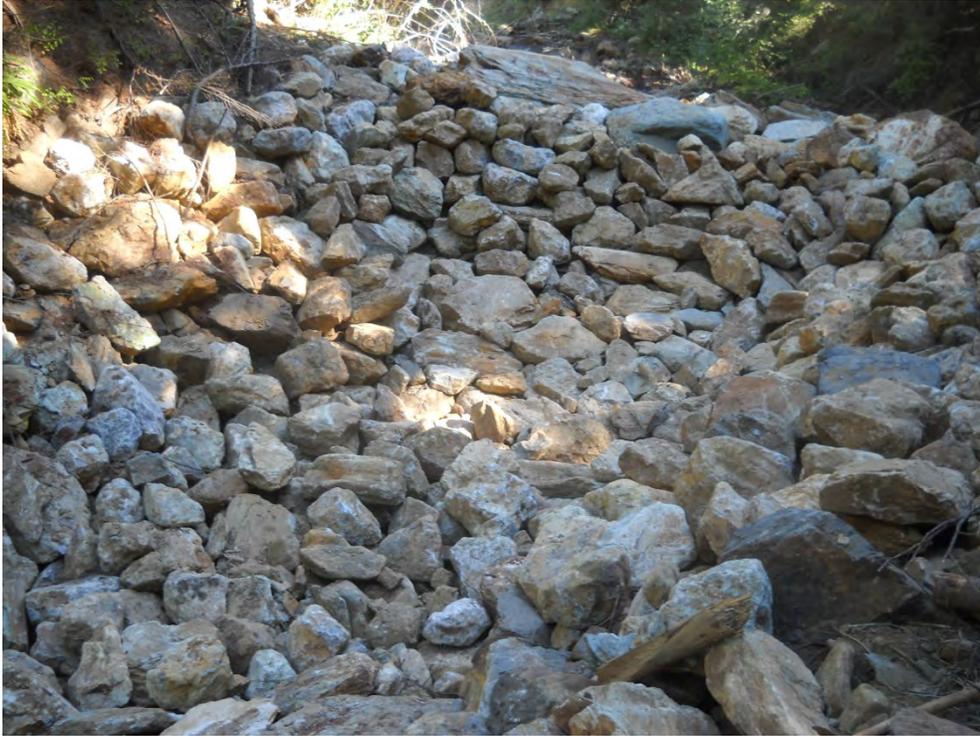
Photograph 11: Sediment/pH Treatment Basin 1A after maintenance.

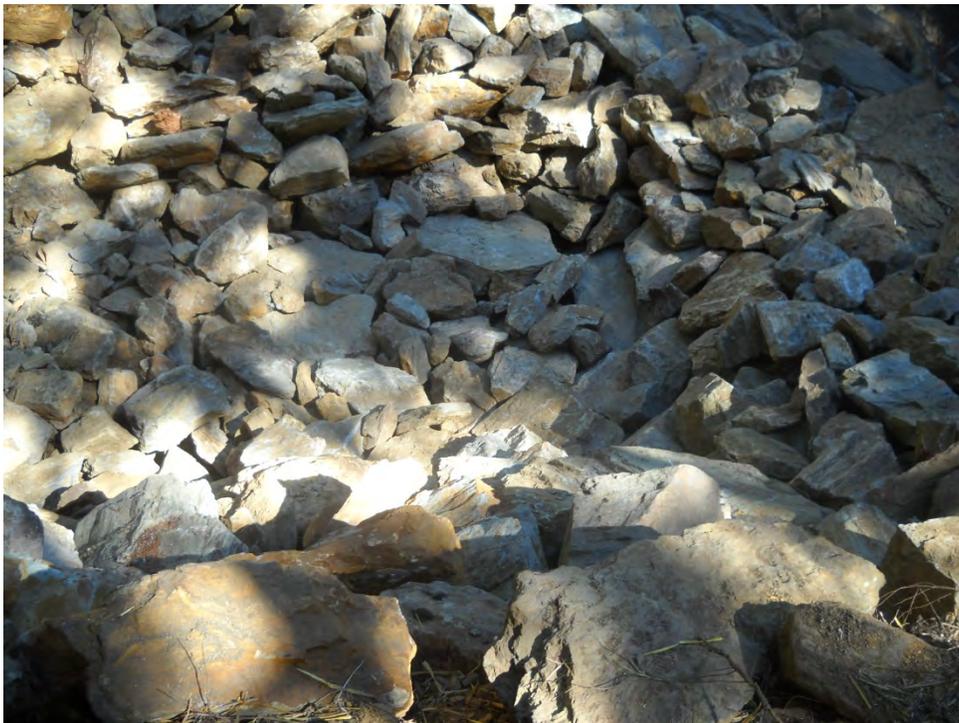
Photograph 12: Sediment/pH Treatment Basin 1B after maintenance.

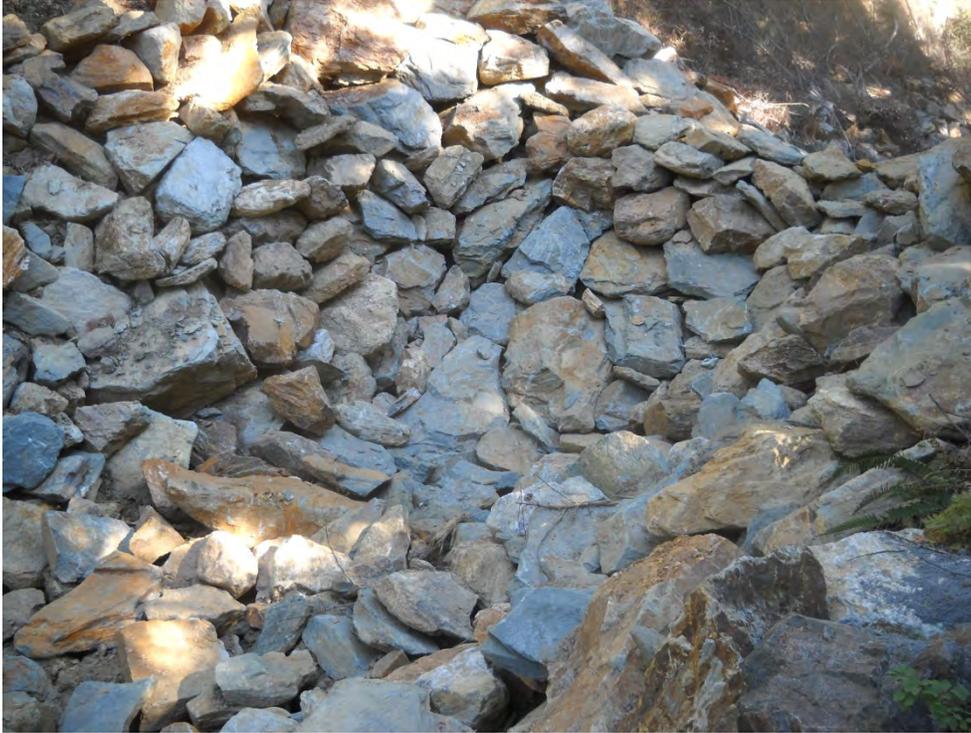
Photograph 13: Sediment/pH Treatment Basin 1C after maintenance.

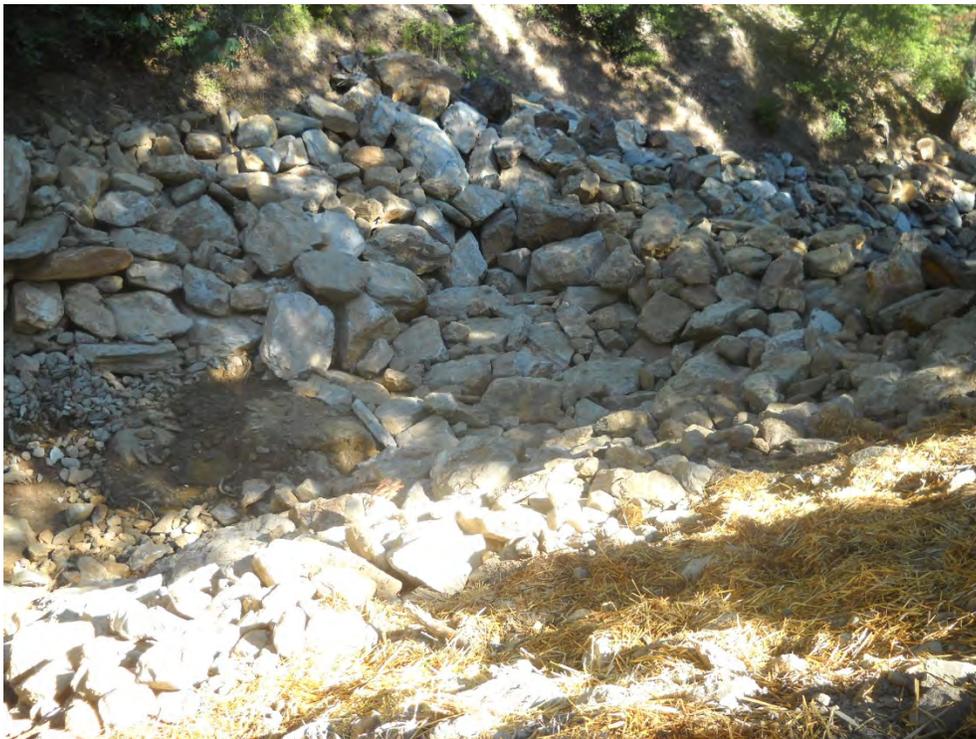
Photograph 14: Sediment/pH Treatment Basin 1D after maintenance.

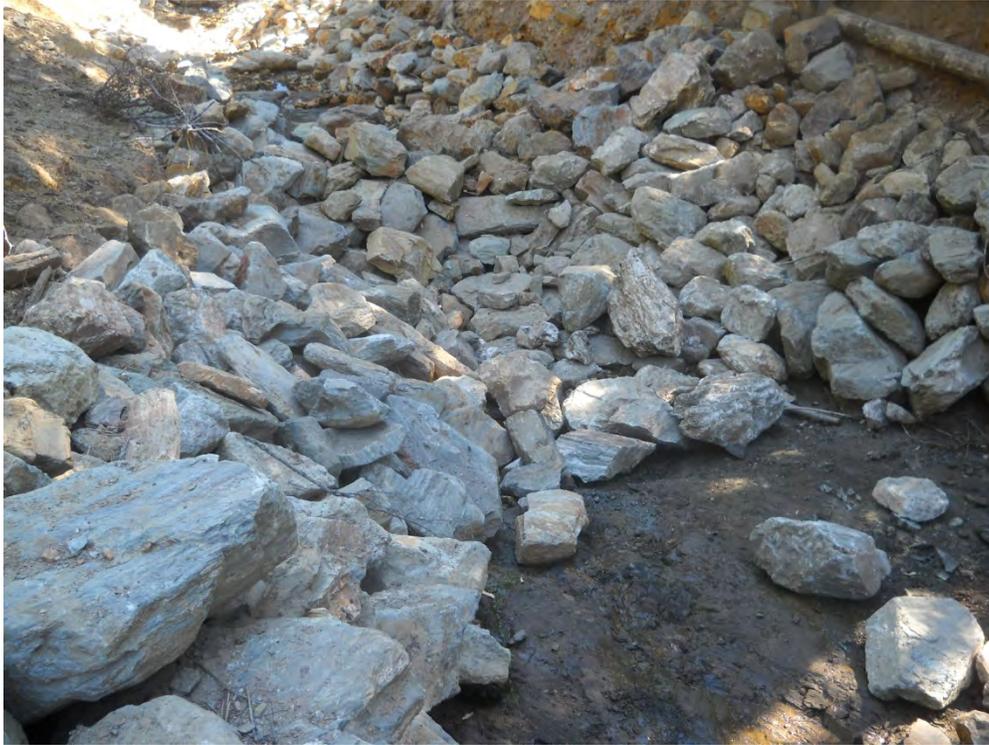
Photograph 15: Sediment/pH Treatment Basin 1E after maintenance.

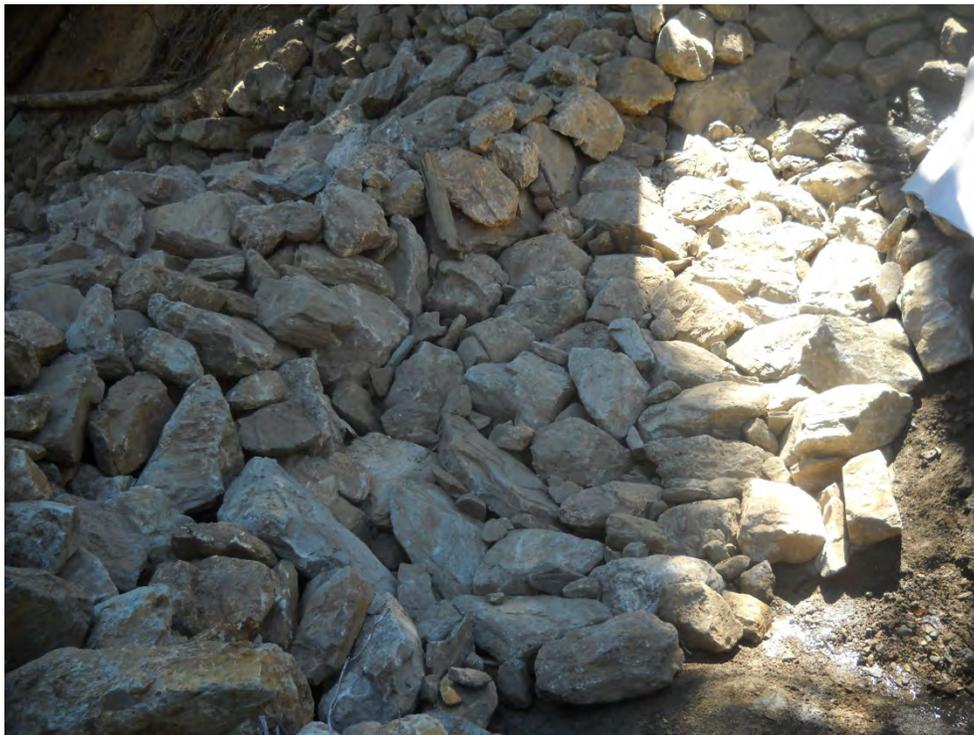
Photograph 16: Sediment/pH Treatment Basin 1F after maintenance.

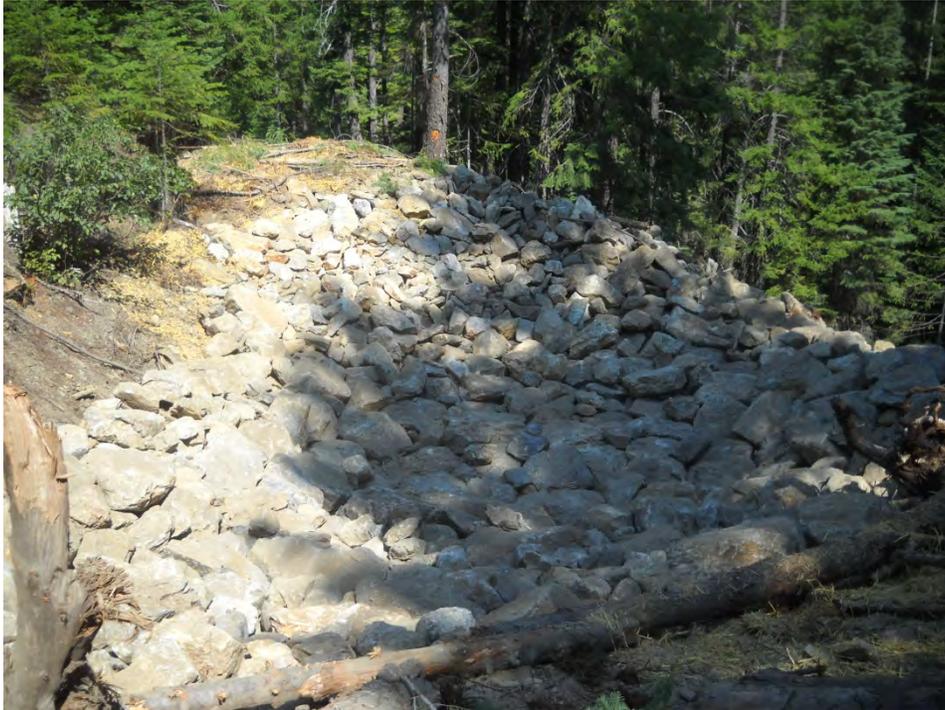
Photograph 17: Sediment/pH Treatment Basin 2A after maintenance. Sediment buried under soil and slash in upper left of photo.

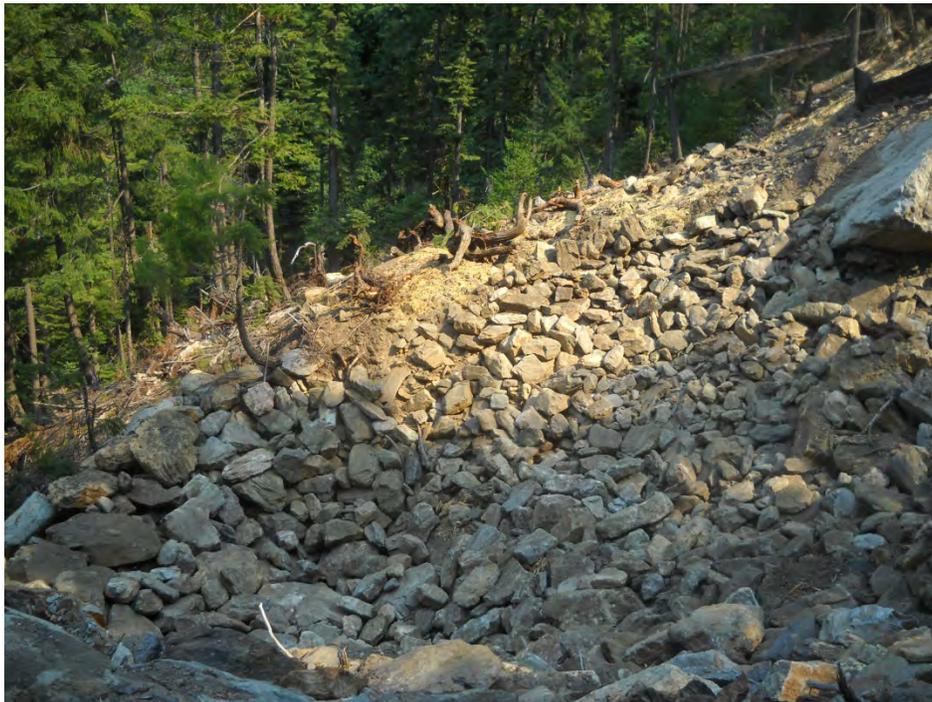
Photograph 18: Sediment/pH Treatment Basin 2B after maintenance. Sediment buried under soil and slash on slope adjacent to basin.

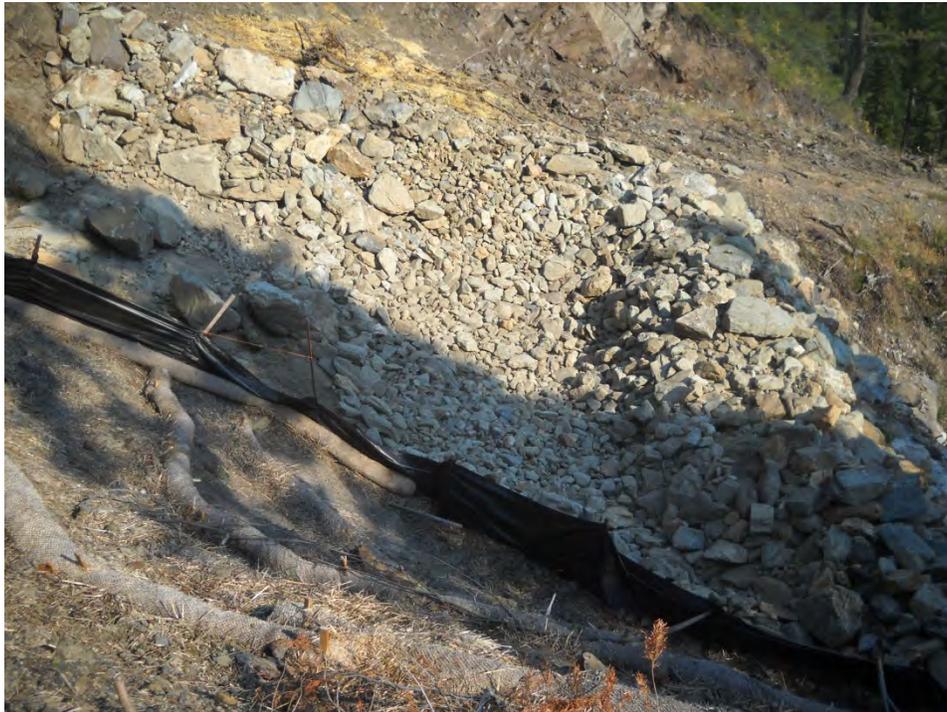
Photograph 19: Sediment/pH Treatment Basin 3 after maintenance. Sediment buried under soil and slash in upper left of photo.

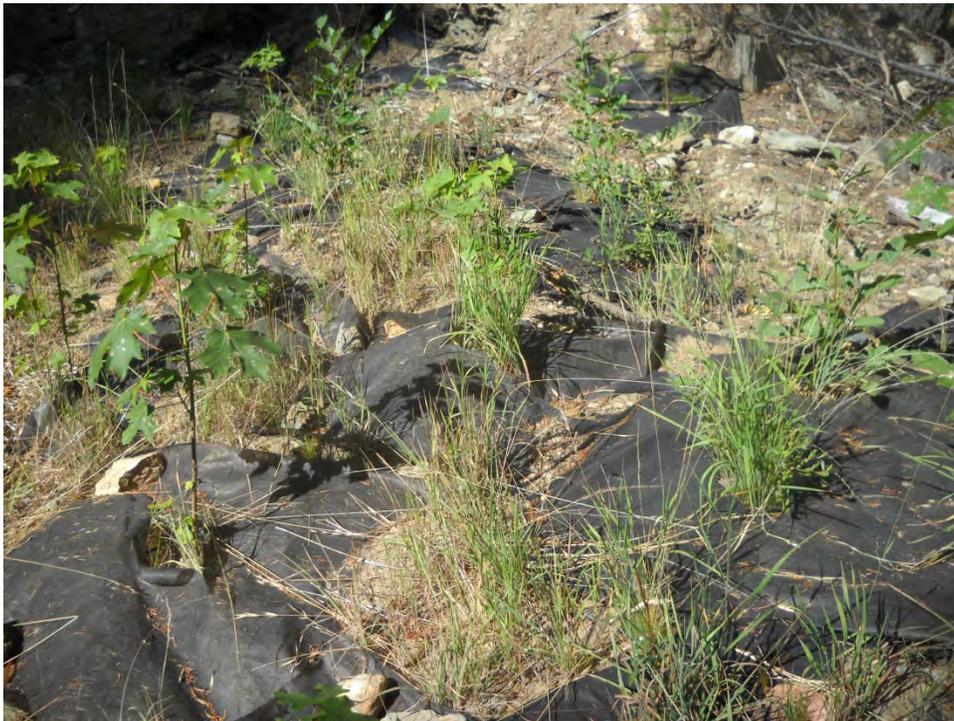
Photograph 20: WRP-1 reclamation area plants and grass.

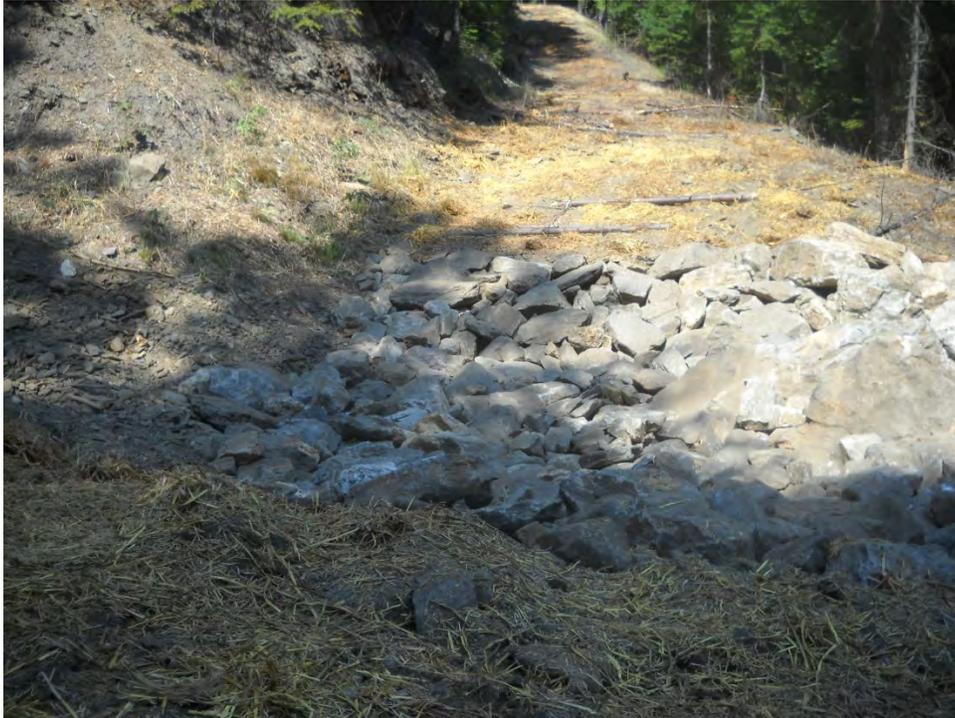
Photograph 21: WRP-2 reclamation area in left of photo, and drainage crossing for Haul Road 1 above basin 2A.

- Install new water bars above the erosion rills to reduce the amount of water entering the existing water bars and rills in the future.
- Repair the Haul Road 1 crossing in the drainage above sediment basin 2A, where erosion had occurred. The crossing and drainage channel in sediment basin 2A was rebuilt using existing soil and rock to form a rolling drainage crossing, covered by geotextile, then riprap rock.

Comments: The drainage crossing on Haul Road 1 above basin 2A and the channel into 2A is repaired with geotextile and rip rap.

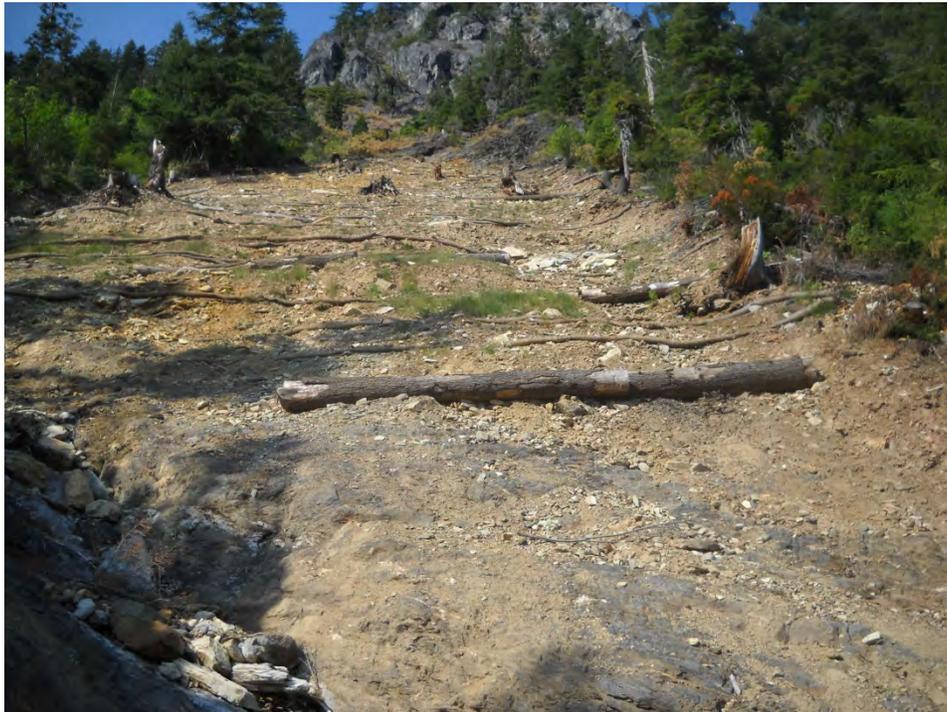
Photograph 22: WRP-3.

- Based on the site inspection reports and the July 2012 plant mortality estimate, WRP-3 was characterized as having significant mortality of plants. The estimates of mortality were overstated. The Forest Service was satisfied with the uniform distribution of the trees and shrubs with White Pine and Maple exhibiting the best survival. Most of the Douglas Fir had died. The speculation is that the cold, dry November and early December weather killed most of the Douglas Fir before they were protected by the snow. There was also good grass growth on the area. There will likely be no additional planting required assuming that most of the plants currently living don't die over the summer. The soil was still moist due to precipitation that has been occurring about every week thus far. A white pine was dug up to see if the roots had entered the native soil. The roots did penetrate the native soil below the tree planting hole. This was a very good sign that the white pine will continue to survive.

Comments: Loose straw wattles were restaked and log wattles with gaps were plugged with rock and soil.

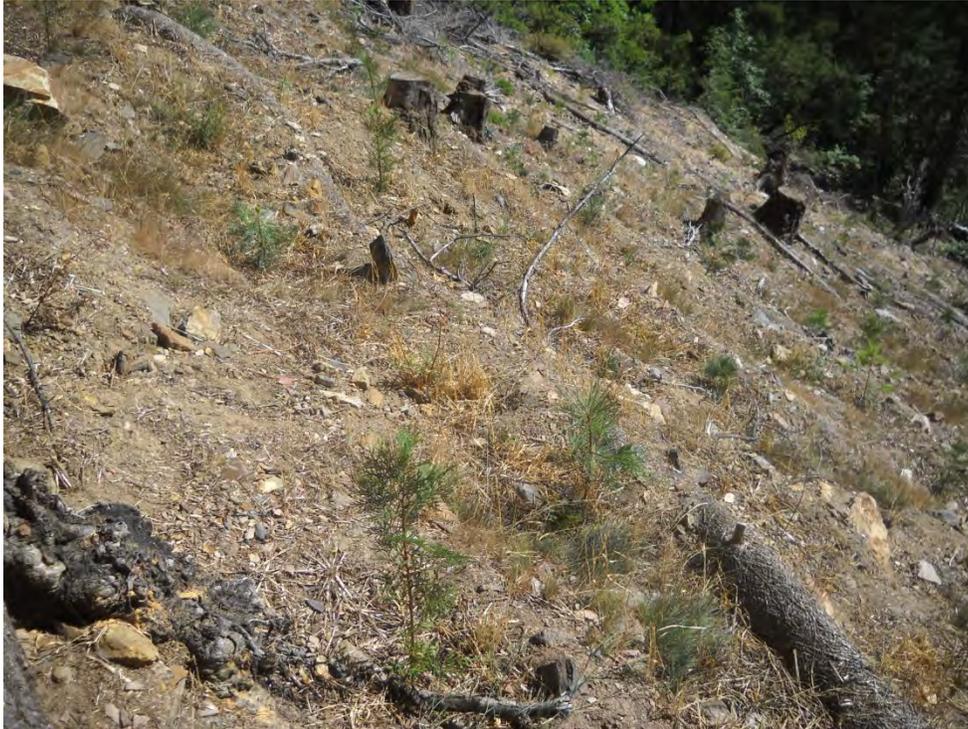
Photograph 23: WRP-4 reclamation plants and grass.
Blue Ledge Mine, Rogue River-Siskiyou National Forest, CA
Photographed by: Brian Wetzsteon (ERRG)

Log wattles and straw wattles at WRP-3 and WRP-4 were maintained by plugging any gaps or washouts under log wattles, and re-staking straw wattles that had pulled loose over the previous winter.

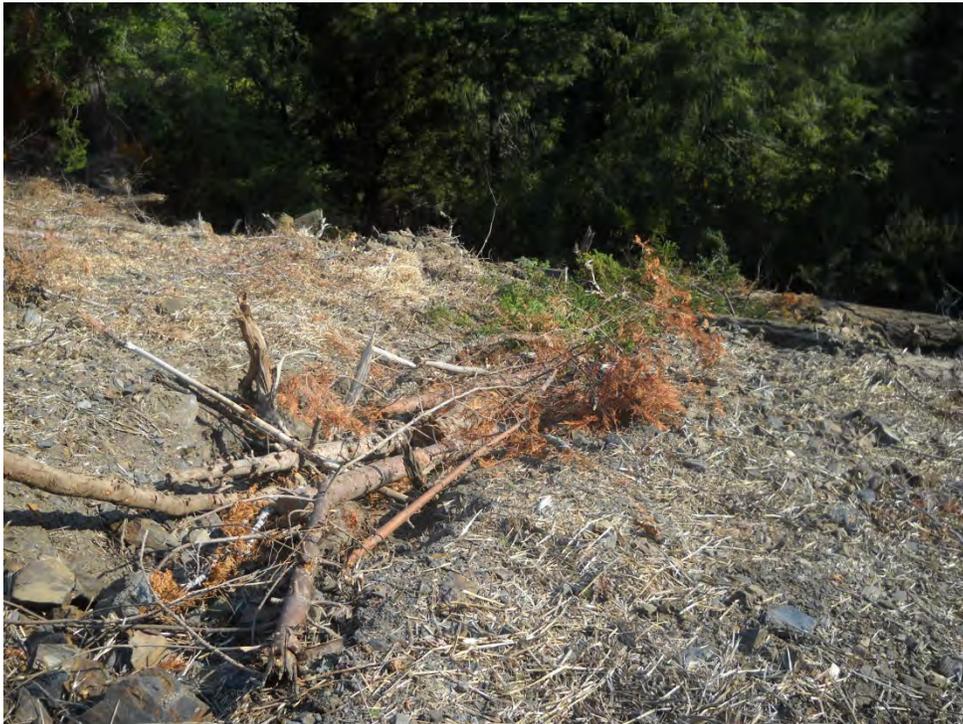
Photograph 24: Repaired erosion rill above basin 3, in Haul Road 4 fill slope.
Blue Ledge Mine, Rogue River-Siskiyou National Forest, CA
Photographed by: Brian Wetzsteon (ERRG)

- Install two new water bars at the Haul Road 1 switchback at Adit A5 to capture runoff from the hillside.
- Repair erosion rills on the fill slope of Haul Road 4 above sediment basin 2B and above sediment basin 3 by armoring with rock and slash to limit further erosion.

Comments: Two erosion rills were repaired on the side bank of Haul Road 4. Additional berms, water bars, straw, slash were installed during the August 2012 maintenance event to reduce further erosion.

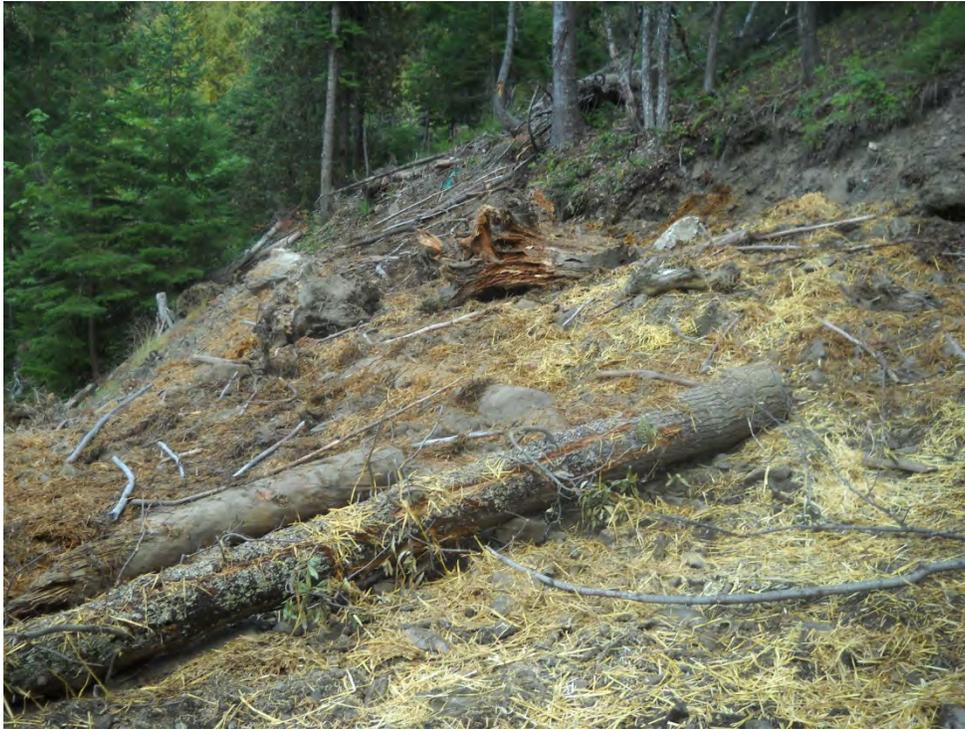
Photograph 25: Sediment from basins 1A to 1F buried under soil at Haul Road 3 upper switchback.

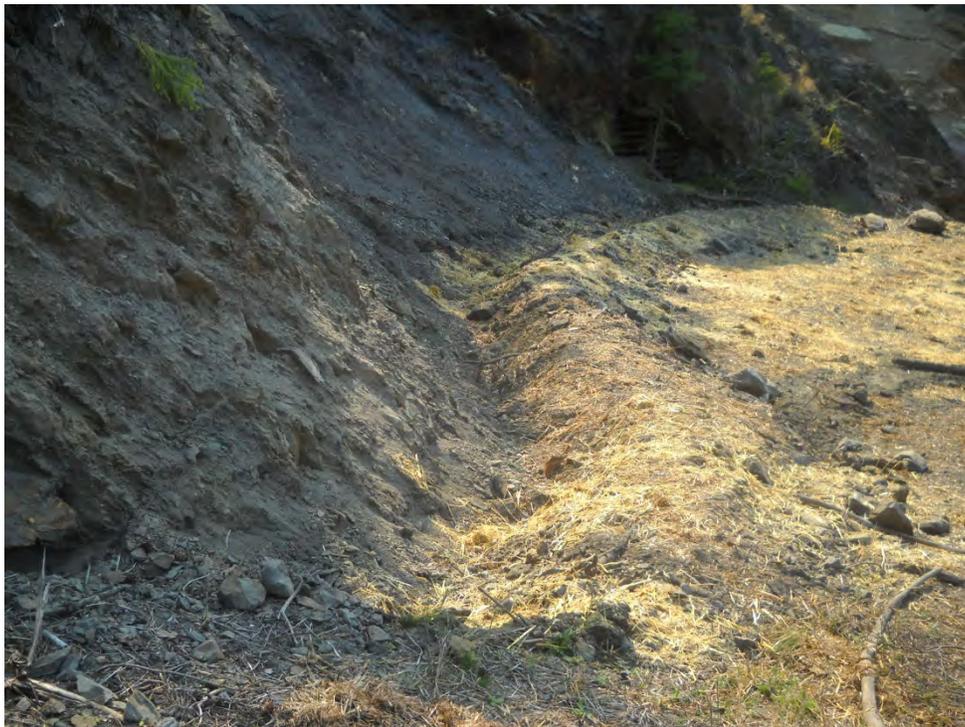
Photograph 26: Water bar at Adit 5 to direct hillside runoff away from road.

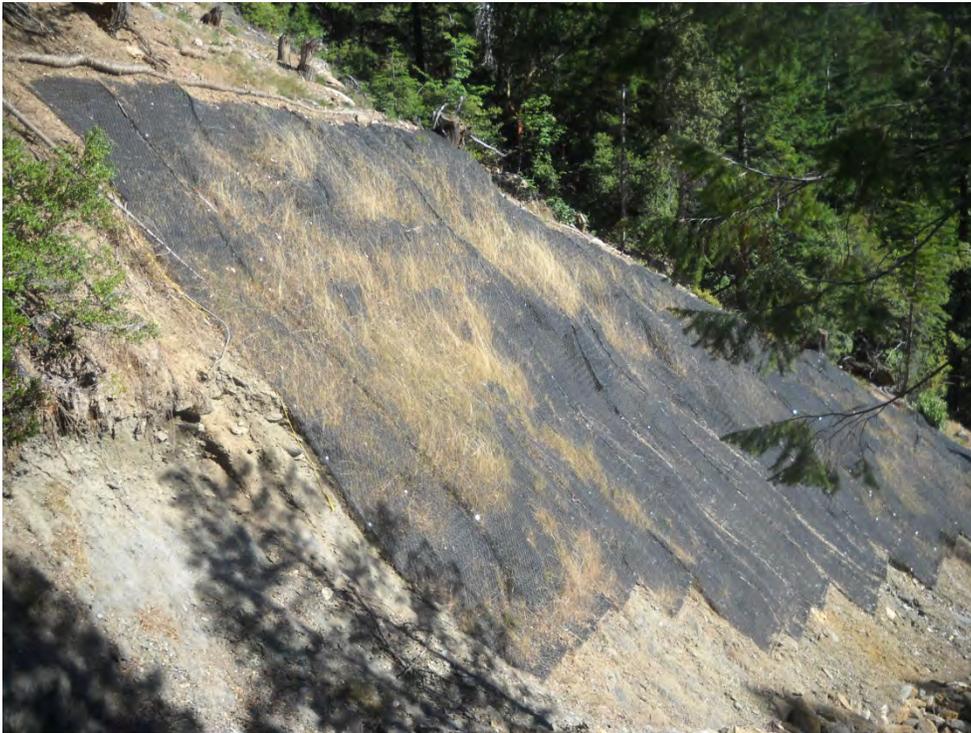
Comments: Nailed down all anchor nails. The fabric is well anchored and in good condition.

Photograph 27: Reinforced slope stability fabric at WRP-4.
Blue Ledge Mine, Rogue River-Siskiyou National Forest, CA
Photographed by: Brian Wetzsteon (ERRG)

The reinforced fabric at the toe of WRP-4 was maintained by nailing down loose anchor nails. All anchor nails were hammered to verify they are well-seated.

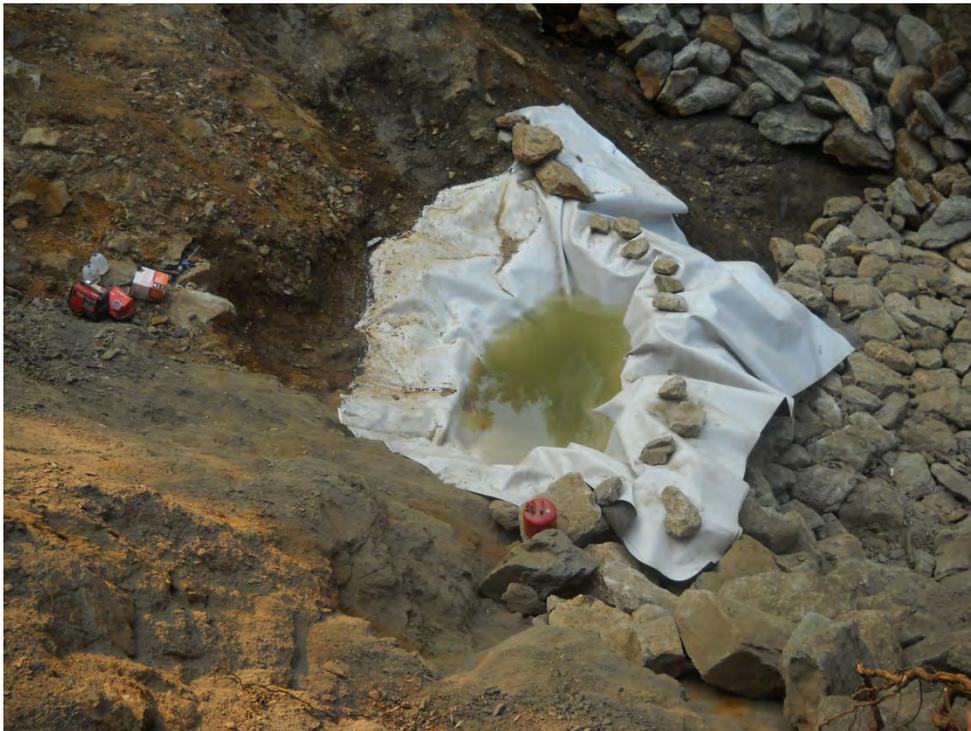
An additional basin at the southeast edge of basin 1F was constructed under separate contract with the U.S. Environmental Protection Agency (USEPA) contractor ITSI to collect acid mine seepage at this location. This acid collection basin was constructed using riprap and lined with a geotextile cushion layer and two layers of 60 mil LLDPE geomembrane. The geomembrane was anchored to bedrock using stainless steel wedge anchors, and a roofing sealant that works under water was applied to seal the liner to the bedrock. Future installation and operation of a pilot treatment system for acid mine drainage is by ITSI and is not part of ERRG's scope of work. The basin was completed August 23, 2012 and the seep flow through the spillway was measured at 500 ml in 35 seconds.

Photograph 28: EPA acid seep collection basin. Basin 1F at right edge of photo.
Blue Ledge Mine, Rogue River-Siskiyou National Forest, CA
Photographed by: Brian Wetzsteon (ERRG)
