USDA-FOREST SERVICE

FS-2500-8 (7/08)
Date of Report: 9/25/12

BAGLEY FIRE BURNED-AREA REPORT
(Reference FSH 2509.13)

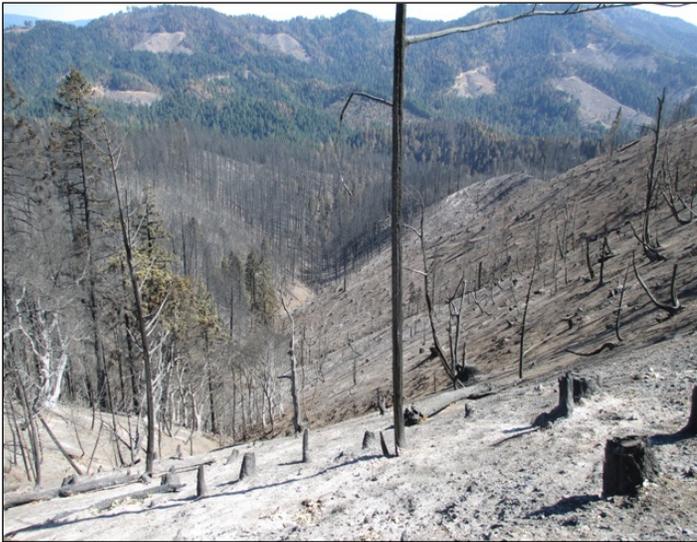
High soil burn severity in mixed pine/brush in U. Squaw Ck.

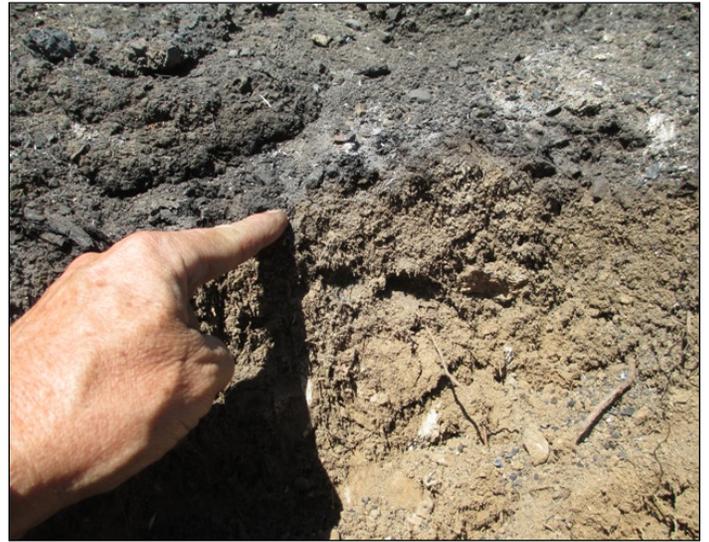
High soil burn severity with char to 2" in Upper Squaw Creek.

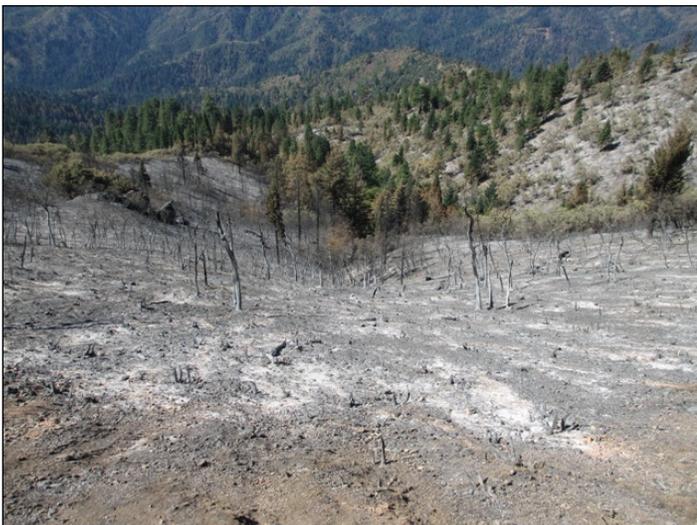
High soil burn severity in scrub oak along Bagley Mtn.

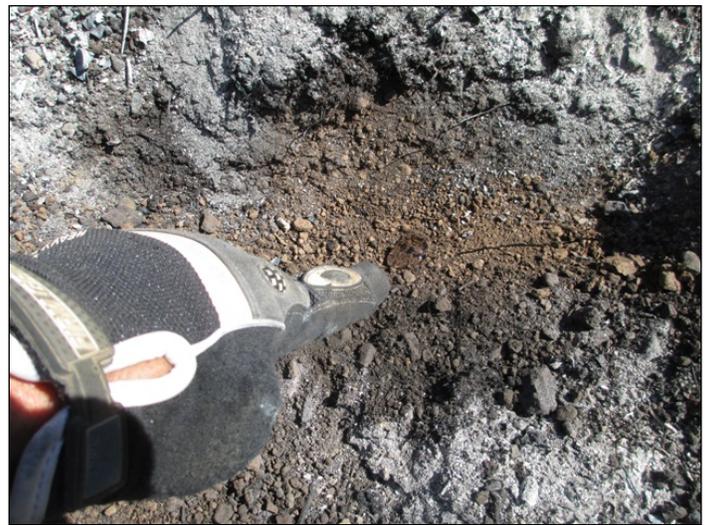
High soil burn severity with char to 4 inches with repellency

Water repellancy is running from 2 to 8 inches deep depending on soil texture and vegetation that was burned. Steep gravelly scrub oak/manazinita areas that were either south or west-facing burned hot leaving strong water repellancy down to 8 inches. Deep char and soil organic matter destruction was also present (see pics above).

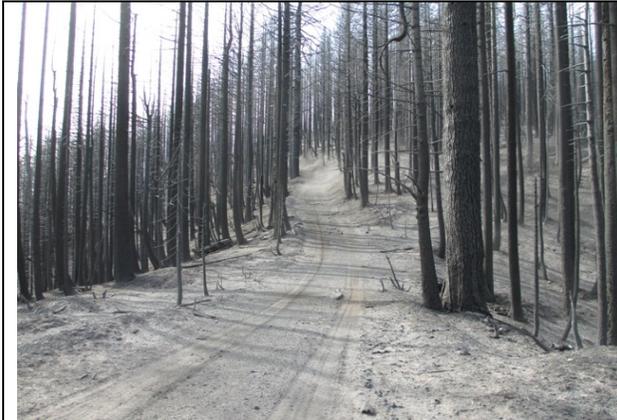
Destroyed plantations in upper Squaw Creek

1. Establish appropriate forest cover in areas burned into deforested condition (NFMA 1976).
2. Accelerate the establishment of late successional forest structure (STNF 1999).
3. Plant an appropriate mix of coniferous tree species that occur naturally (STNF LSRA).
4. Reduce the hazard to public safety by removing dead and dying trees as a result of the Bagley fire.

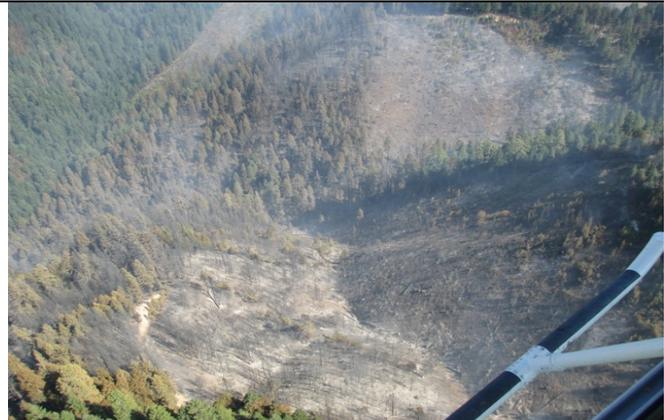
Destroyed plantations in Bone Gulch - Ladybug

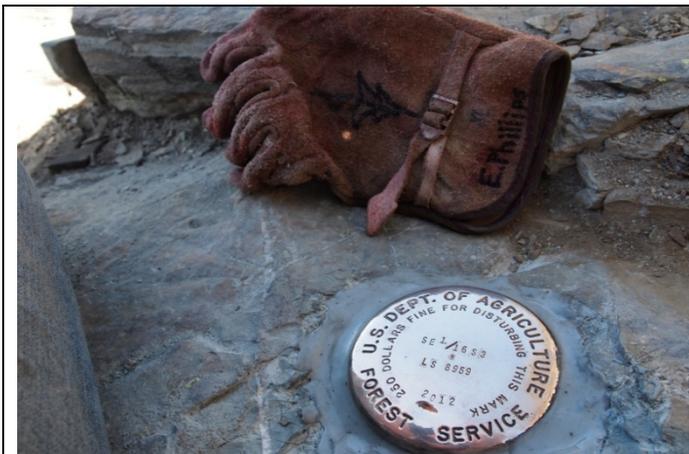
Almost 90 miles of boundary line, between Forest Service administered land and private lands, were affected by the Bagley Fire. Almost 100 survey monuments, controlling the location of these boundaries, were affected. These boundaries are critical to the Forest Service and the private entities, during any type of activity occurring near the boundaries. The most obvious of these activities, in the near future, would be timber salvage and tree planting. In the future, any tree harvests, or other administrative activities, would require the location of these lines.

National Forest survey monument burned over

It would be of benefit to the Forest Service, financially, to have cadastral survey crews replace these monuments and boundaries in a timely manner. Surveying before the brush comes back is a benefit to production rates, but a more immediate need for these boundaries would be to prevent trespass by adjoining land owners, as they do their salvage operations.

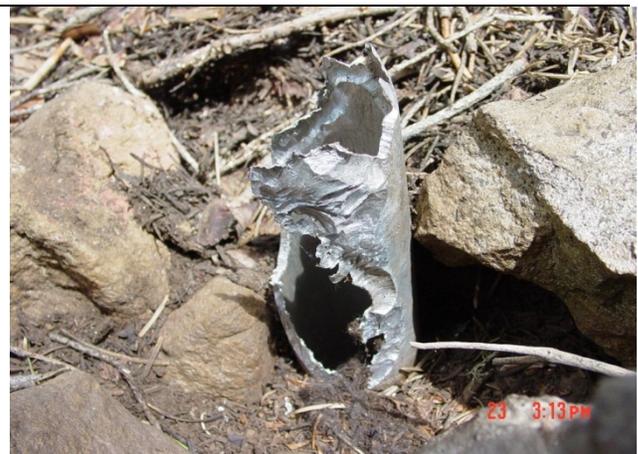
Bagley fire burned boundary line marker
