BAGLEY COMPLEX AREA EMERGENCY RESPONSE

GEOLOGY REPORT

SHASTA TRINITY NATIONAL FOREST

September 21, 2012

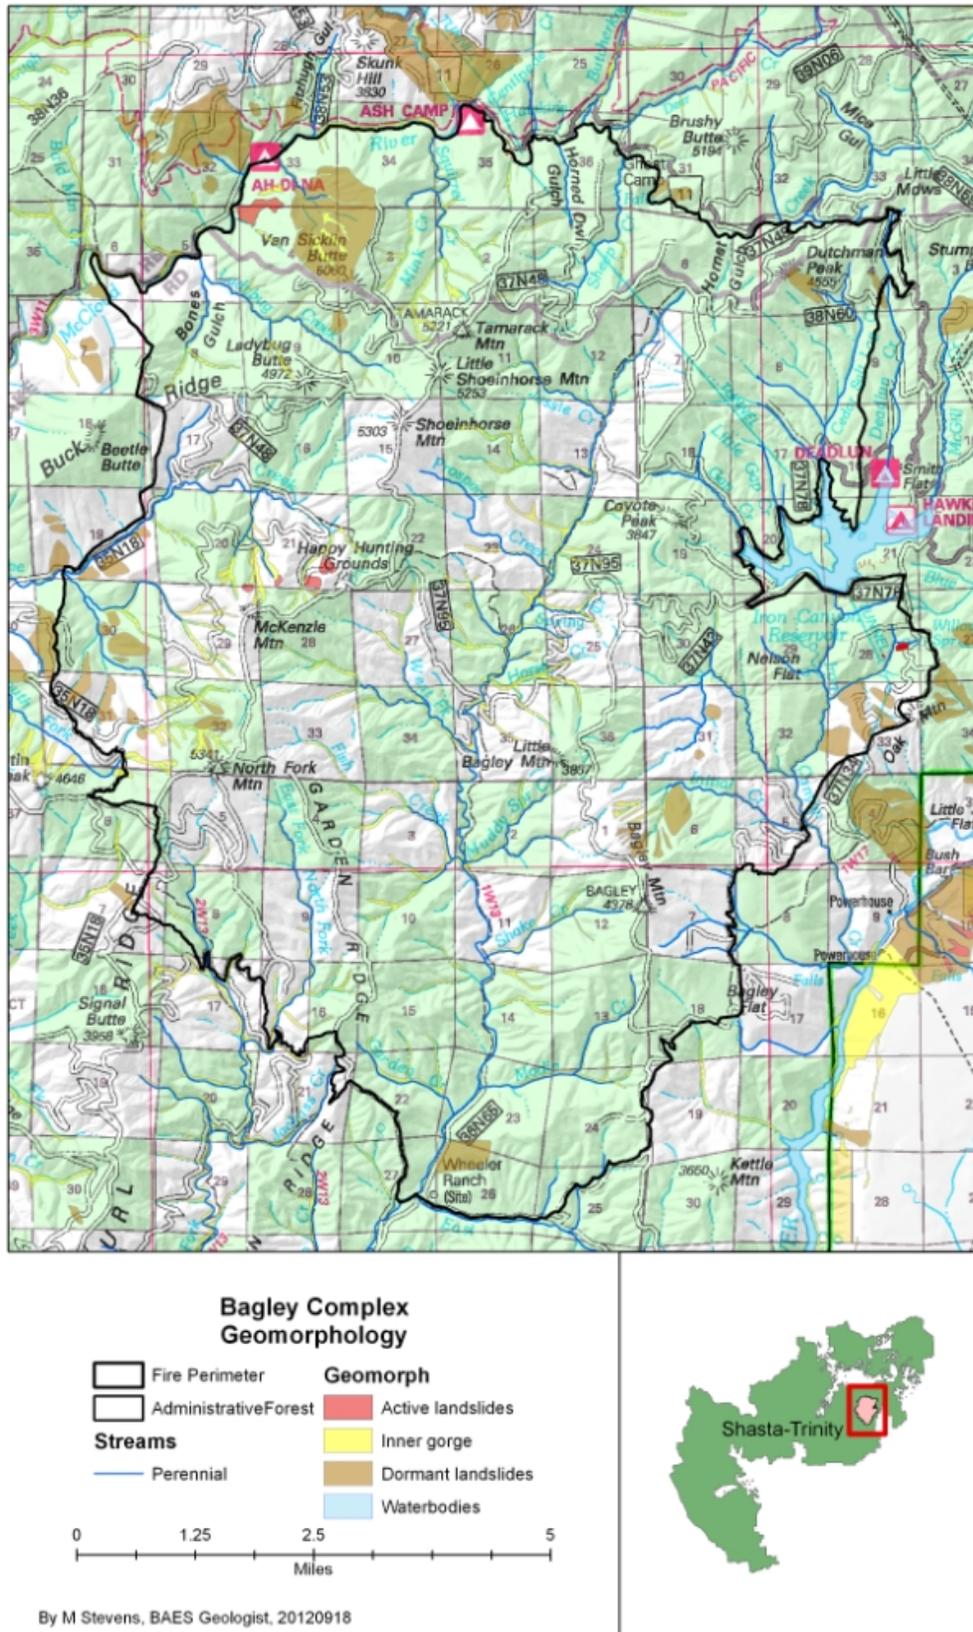
Figure 3: Geomorphology for the Bagley Complex

Geomorphic mapping from the GIS database shows several large dormant landslides located along the fire boundary, with the largest being located at the northern part of the fire across for Ah-Di-Na campground. Inner gorges are mapped within all the drainages within the fire perimeter except for, from north to south, Iron Canyon Reservoir, Pit 5 Power House and East Fork Squaw Creek – Hoffmeister Creek which are all located on the eastern part of the fire boundary (Figure 3).

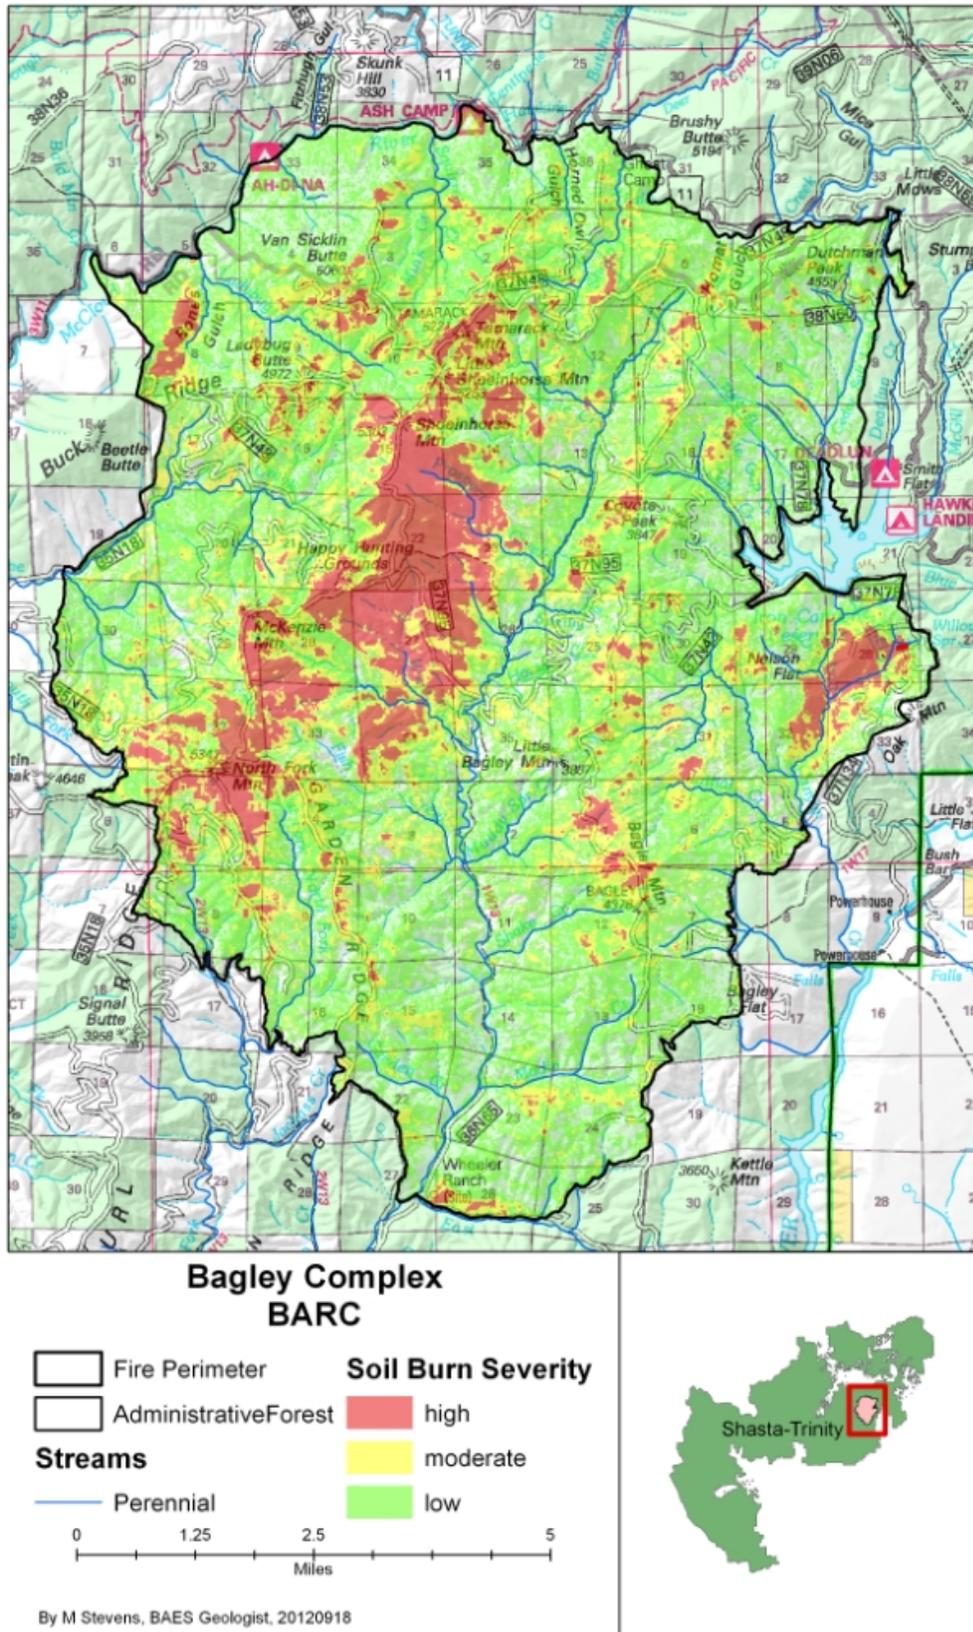
Figure 4: BARC imagery for the Bagley Complex

Debris slides are shallow, rapidly moving landslides and are *possible* where slopes are >36 degrees² (Figure 6). The Burn Severity Map (Figure 4) shows areas of moderate and high severity fire, where the Geomorphology Map (Figure 3) shows headwall basins and inner gorges where debris slides may occur. Debris slides also commonly occur on toes of dormant, deep seated landslides thus generating debris flows (Reid, Brien, LaHusen, Roering, de la Fuente, & Ellen, 2003). This elevated potential for debris slides is due to the loss of vegetation and associated evapotranspiration and root support. The large earthflow identified at road 37N33 and road 37N33C intersection is an example of this within the burned area and has the potential to generate a debris slide. Debris slide potential in areas of shallow soils will be greatest later in the winter when soils become saturated by multiple storms, or a single long duration storm. Debris slide potential on the toes of dormant landslides will remain elevated for 10 years or more, and the potential will be greatest when sustained rainfall activates the dormant, deep seated landslides. Seismic shaking also has the potential to trigger debris slides.

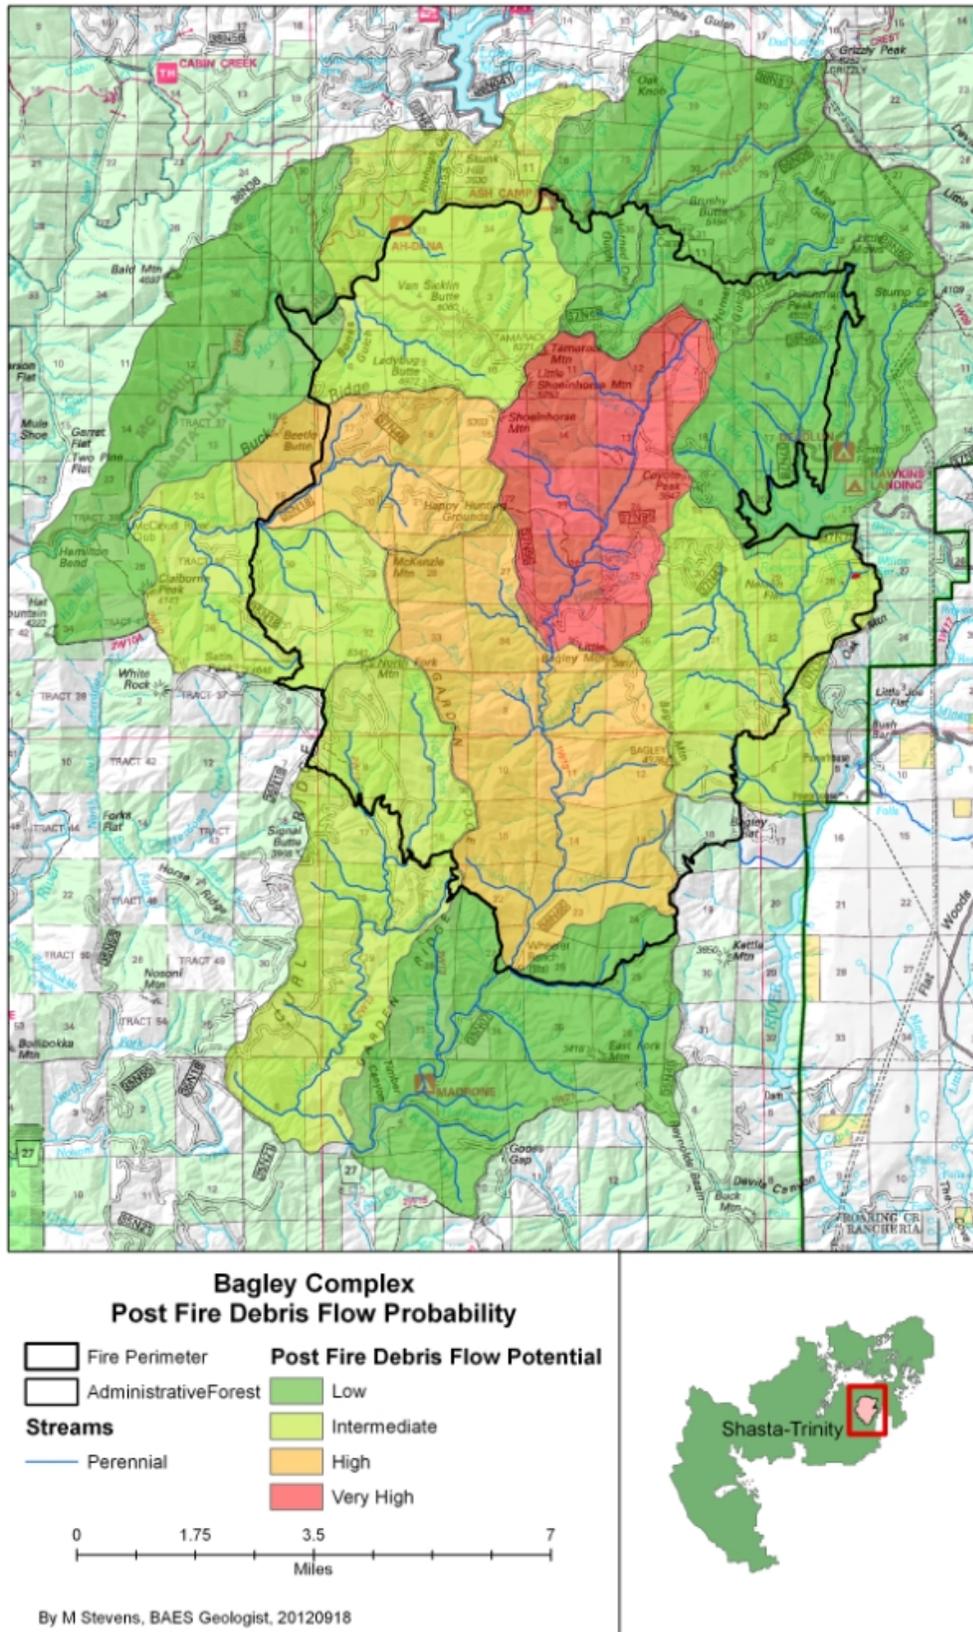
Figure 5: Post fire debris flow probability by hydrological unit code seven (HUC7)

Debris flows are thick slurries of water, soil, rock, and organic debris that travel rapidly down channels which strip vegetation from riparian areas and delivers large volumes of sediment to streams. Post fire debris flows can be triggered by rapid inputs of sediment from surface erosion processes into channels, extremely high flow volumes mobilizing channel bed material or by landslides such as debris slides as described above. A debris flow probability model, *Predicting the probability and volume of postwildfire debris flows in the intermountain western United States* (Cannon et al, 2010) was used to determine the probability of post fire debris flows. The model was run on the drainages (HUC7) that are located within the burned area of the Bagley Complex. The following drainages have been identified as having a low, intermediate, high, or very high probability of post fire debris flow: Lower Hawkins Creek, East Fork Squaw Creek – Hoffmeister Creek, Upper Hawkins Creek, Bald Mountain Creek – Hat Mountain Creek, and Iron Canyon Reservoir is modeled to have a low probability post fire debris flows; North Fork Squaw Creek – NE, Ah-Di-Na, Lower Claiborne Creek, and Iron Canyon drainages have an intermediate probability of producing post fire debris flows; Upper Claiborne Creek and West Fork Squaw Creek – Modin Creek have a high probability of producing post fire debris flows; and Jessie Creek – Horse Creek has a very high probability of producing post fire debris flows (Cannon, Gartner, Rupert, Michael, Rea, & Parrett, 2010). See Figure 5 for post fire debris flow potentials.

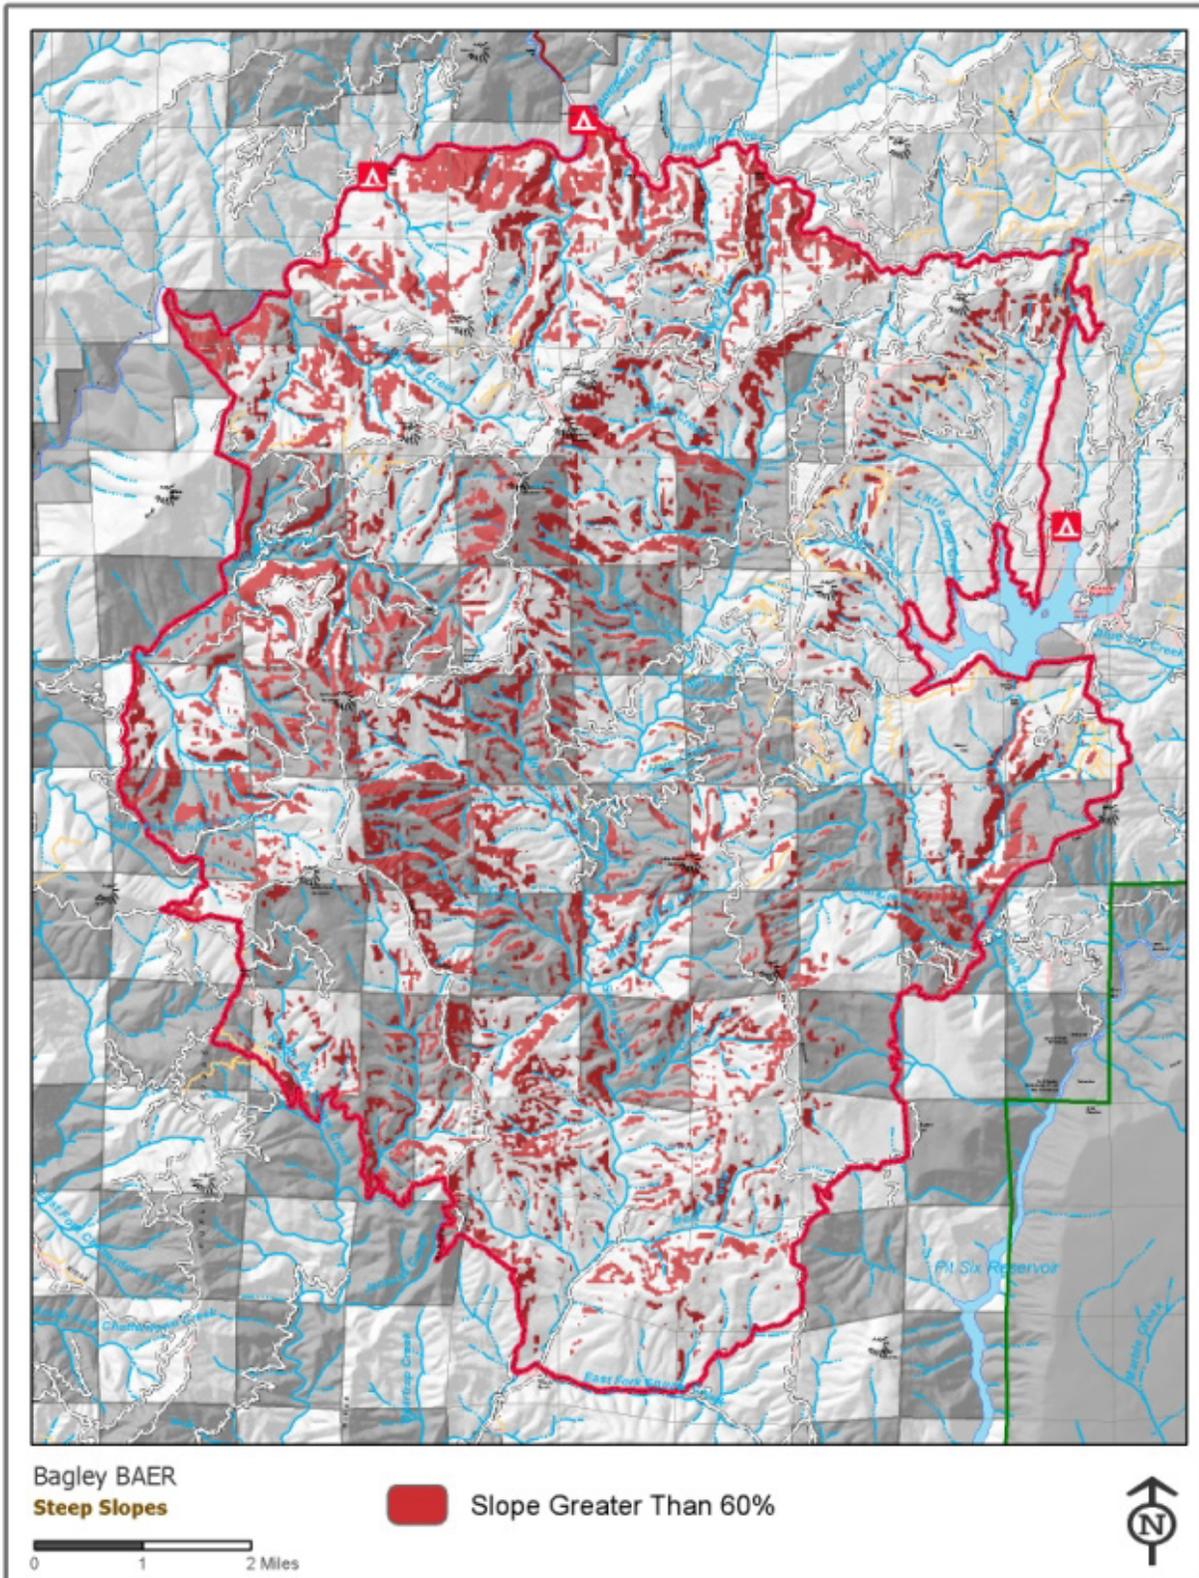
Figure 7: 60% slope and greater overlaid by roads within the burned area

potential has been elevated by the fire on all roads traversing steeper slopes, particularly where burn severity above the road is moderate to high. Figure 7 shows all roads which traverse slopes >60% and Figure 8 shows where burn severity above the road is moderate to high. The potential for rock falls will be greatest with the first heavy rains of the fall or with intense summer storms and then decrease over the next few years, as vegetation in the area recovers. Seismic shaking can also trigger deep seated slides.
