Burned Area Emergency Response (BAER) OHV Recreation Report

OHV Recreation Report

Bagley Fire

September 2012

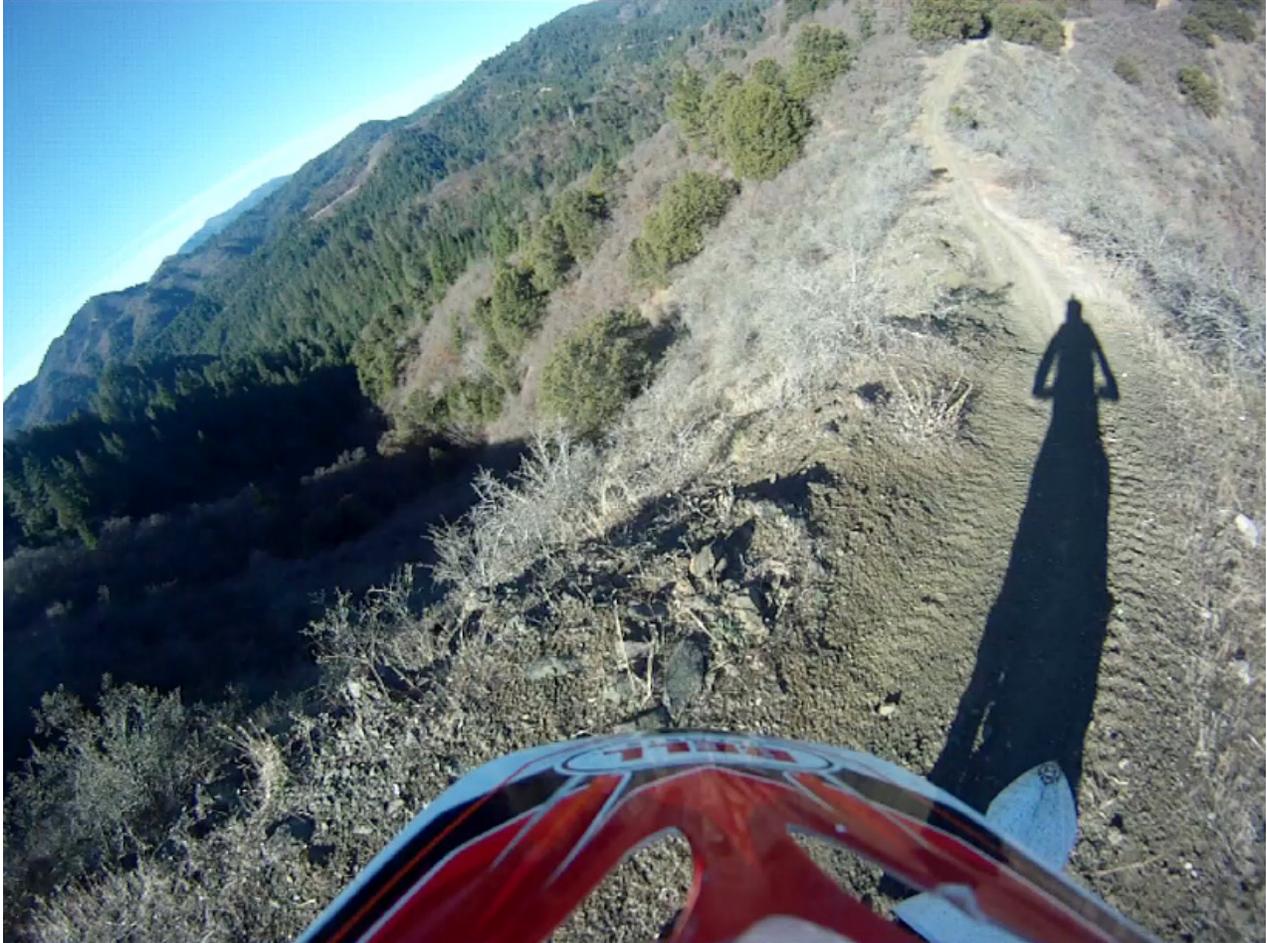
Garden Ridge (Pre-Fire)

36N40(02W32--Garden Ridge Legacy Trail) The road crosses squaw creek at a very deep and misleading spot. The North end of the creek crossing is very deep (3 ½ feet) in October. There is also a very large boulder (15ft by 7ft) in the path that vehicles try to cross. The boulder forms a deep eddy on the back side of the rock which causes ATVs and MCs to drown out their machines. If an individual can cross the creek (experts only) the road continues onto garden ridge. The ascent to the ridge top is roughly a mile hill climb. The road is 40% in spots. Not recommended for high –clearance vehicles. The private portions of garden ridge are not marked and riders continue on the trail. The trail narrows to single track in numerous spots and is very technical.
