SALT CREEK BURN AREA EMERGENCY RESPONSE

GEOLOGY REPORT

SHASTA-TRINITY NATIONAL FOREST

August 13, 2012

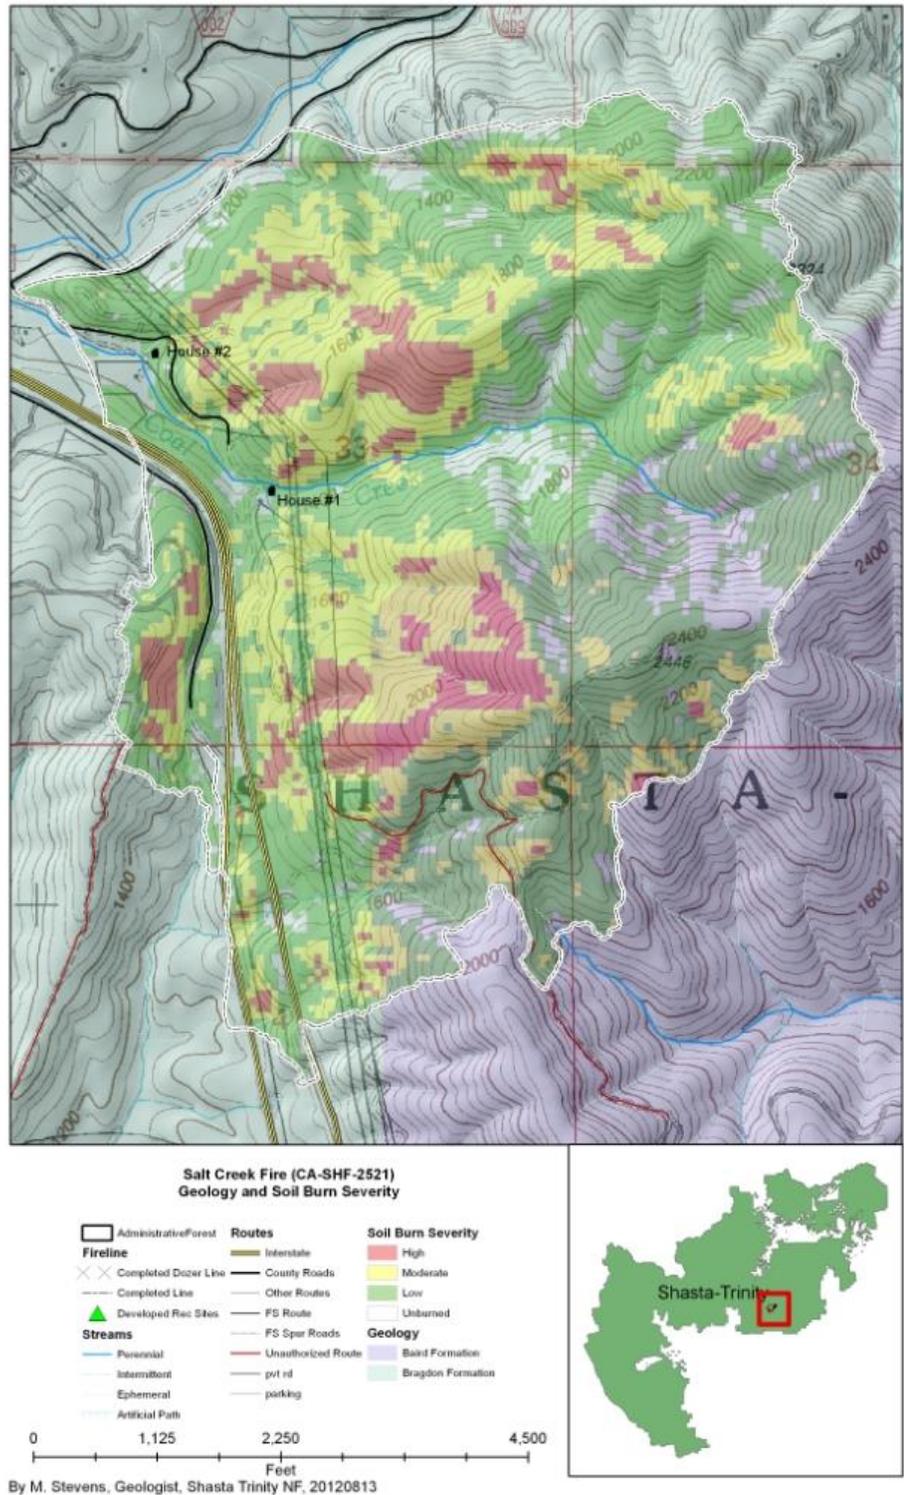
Figure 1: Geologic terrane of the Salt Creek Fire

The Salt Creek Fire is underlain by the Redding terrane which consists of the Bragdon formation (metasediments) in the western and northern areas of the fire, and Baird formation (metavolcanics) in the southeastern area of the fire (Figure 1). Geomorphology mapping from the GIS database shows two rotational-translational slumps in the northern section of the fire area and one rotational-translational slump along the south edge of the fire and headwall basins on the eastern edge of the fire. Coal Creek and an unnamed tributary to Salt Creek are mapped as being located within inner gorges. One large rotational slide was mapped during aerial photo review on the eastern edge of I-5, along with a debris flow in the headwater of Coal Creek and along Forest Service Road U34N12C. Two additional active landslide features were mapped during field reconnaissance on 8/7/2012. There are no other active features mapped within the fire perimeter (Figure 2).

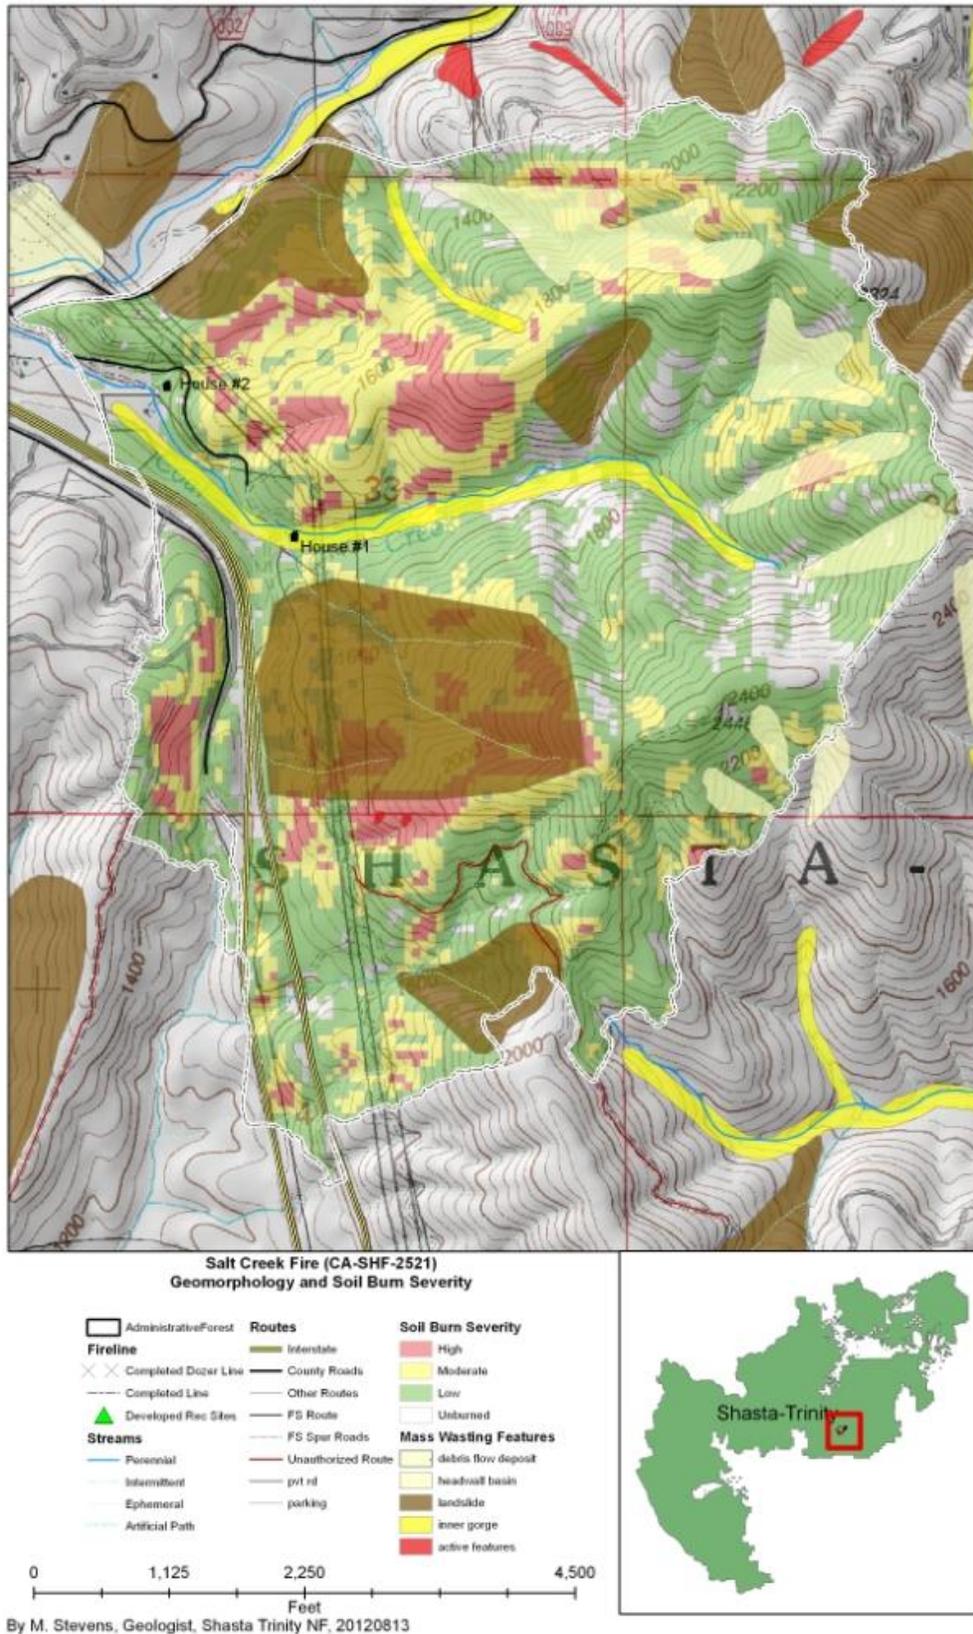
Figure 2: Geomorphology overlain by soil burn severity

On 8/7/2012, Brad Rust (BAER Team Lead), Dave Young (BAER Soil Scientist), and Melanie Stevens (BAER Geologist) conducted a field visit of the burned area to identify values at risk and potential hazards that could affect these areas. Thomas Ranch Road on the western edge of the fire was driven get an overview of the burned portion on the east side of Interstate 5. Coal Creek Road was driven to PG&E power line road and then to Lakeview Drive. The drainage behind House #1 (as indicated on Figure 2) along the perennial tributary Coal Creek up to PG&E power line was driven and hiked. The large

dormant landslide mapped during air photo reconnaissance was hiked from PG&E power line road to the southern edge of the feature. As indicated in the BARC imagery most of this landslide was burned at moderate to high soil burn severity. Two additional landslides were observed to the south of the large dormant landslide and were mapped. The first was a slump feature with observable eroded scarp, approximately 100 feet wide by 300 feet long located in a high soil severity burn area of the fire, on a southwest facing slope. A second landslide feature, headwall, was mapped in the same drainage, approximately 100 feet wide by 300 feet long, in a high soil severity burned area of the fire on a southwest facing slope, GPS point 10. Forest Service Road U34N12C was driven and hiked until it intercepted the PG&E power line road. The slopes near the road were mostly low soil burn areas with a couple of moderate and one high severity burn area observed. The hillslopes above and below the road are steep (>30%) but no obvious landslide features were observed. Gilman Road was driven to Valley Road (private road). *Mailbox* Road (fire nicknamed road) and Valley Road were drive to identify possible risks. No immediate risks were observed from potential landslides, debris flows, debris slides and rockfalls.

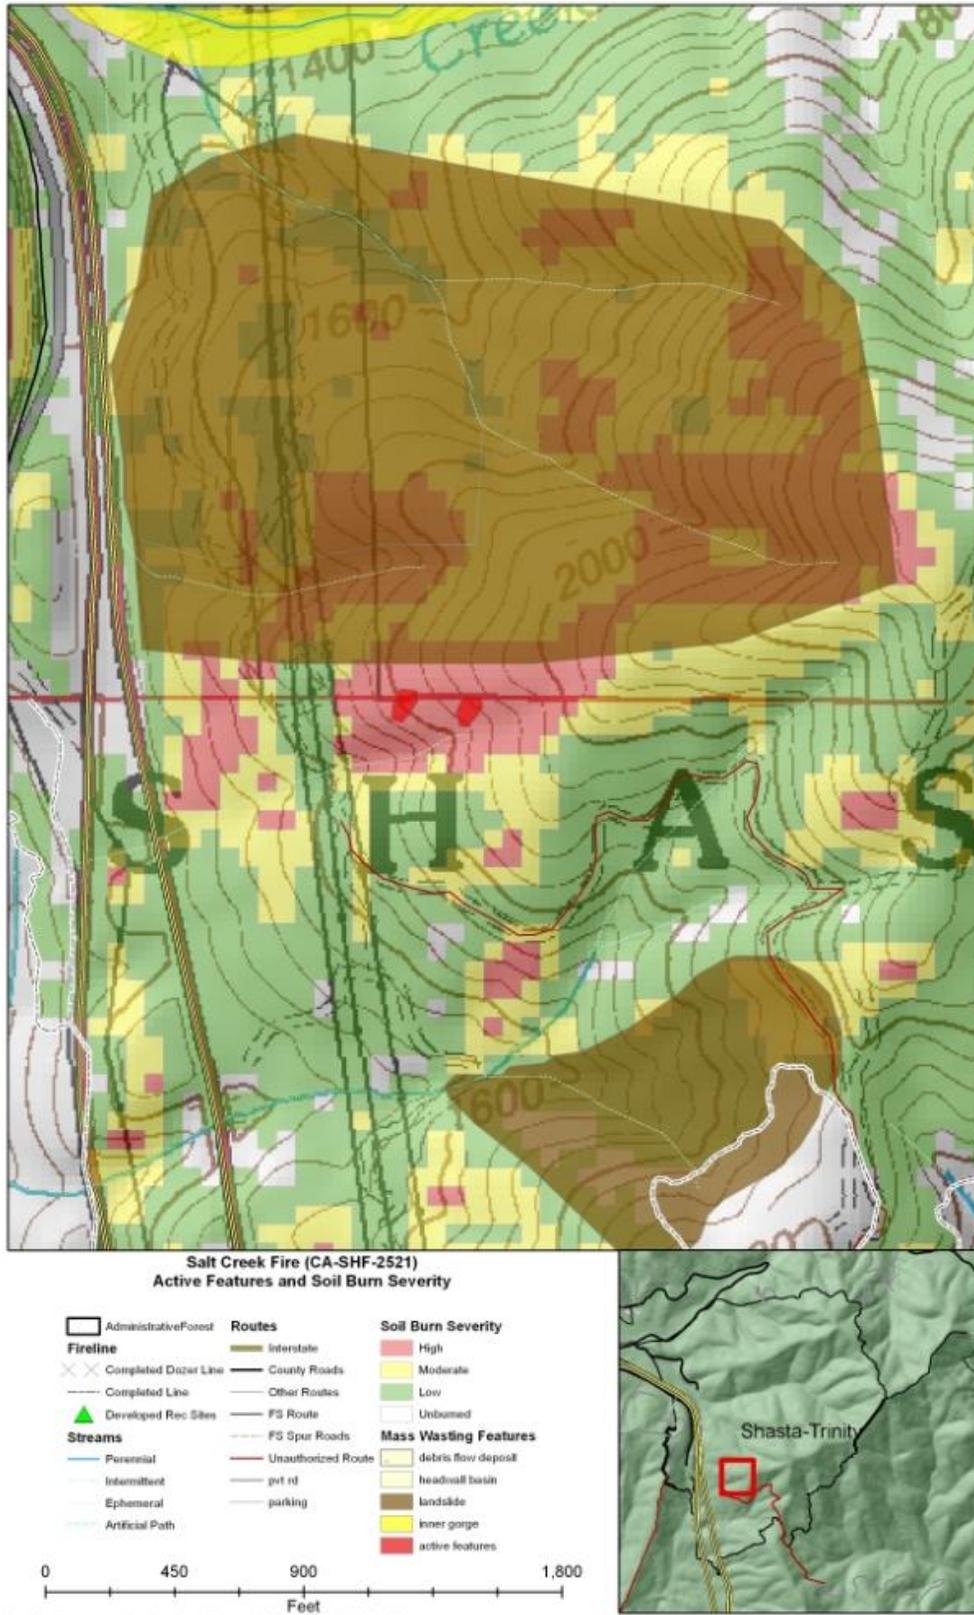
Figure 3: Zoomed in on active features in geomorphology overlain by soil burn severity

Debris slides have a *possible* of occurring were steep slopes, >36 degrees² having moderate to high burned soils according to the Burn Severity Soils Map due to the ground vegetation being removed during the fire and limiting the evapotranspiration and root strength that will occur as vegetation recovers. A *likely* occurrence of a debris slide will occur were previous landslide features have been identified and a rating of moderate to high soil burn severity has occurred (Figure 3). This area includes the large landslide, south of House #1 (indicated on the map). Debris flows can be initiated from the toes of large, deep, slow moving landslides during wet conditions such as intense summer storms and the first heavy rains of the fall (Reid, Brien, LaHusen, Roering, de la Fuente, & Ellen, 2003). The two small debris slides south of the large landslide also have a *likely* occurrence of reactivating and initiating debris flows.
