November 9, 2012

Technical Memorandum
November 2012 Planting and Site Inspection Report
Blue Ledge Mine
Rogue River-Siskiyou National Forest

**Blue Ledge Mine Removal Project
Siskiyou County, California
Operation, Maintenance, and Monitoring Period**

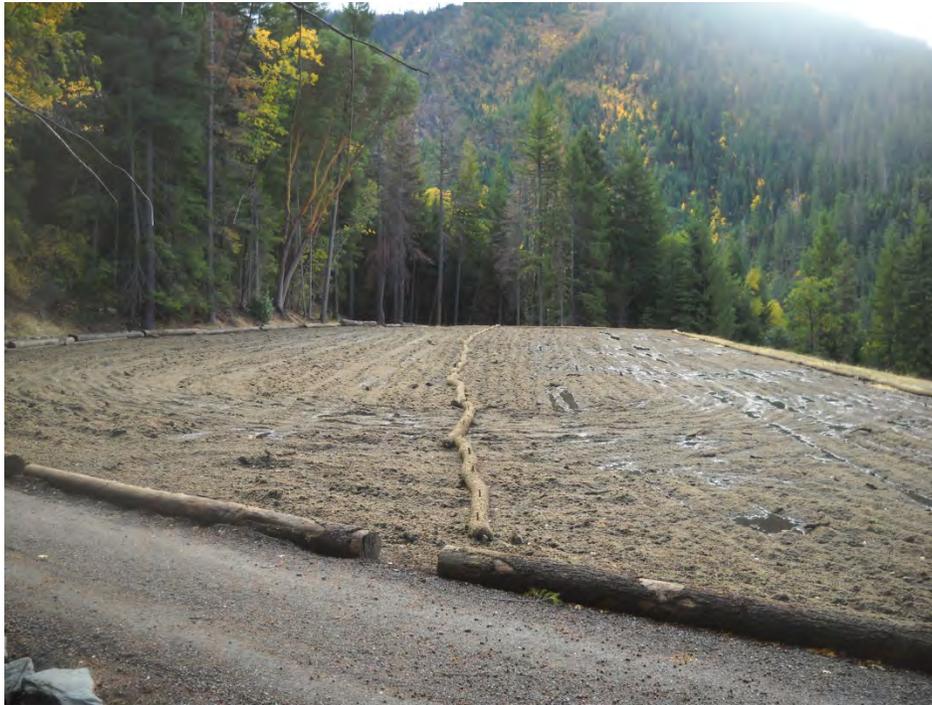
Comments: The top deck hydroseeded area is showing new grass sprouts. The existing grass on the slope is turning green with the fall rain. No erosion from recent rain.

Photograph 1: Top of Repository looking south.

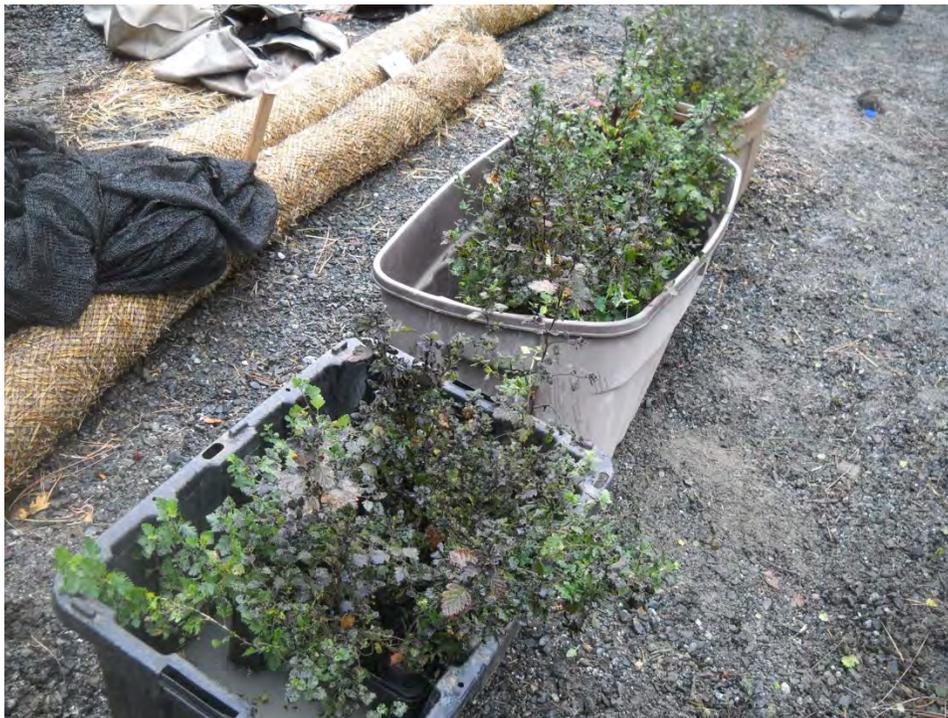
Comments: 1,640 replacement plants (oceanspray) were planted on the slope above the repository road and below the road along the south end. Douglas fir and Ponderosa pine replacement plants were planted on the repository stockpile area. Big game repellant was sprayed on the plants while stored in the delivery trailer before planting and again on November 2 after planting.

Photograph 2: Soaking plants in mycorrhizae and coated with big game repellent.

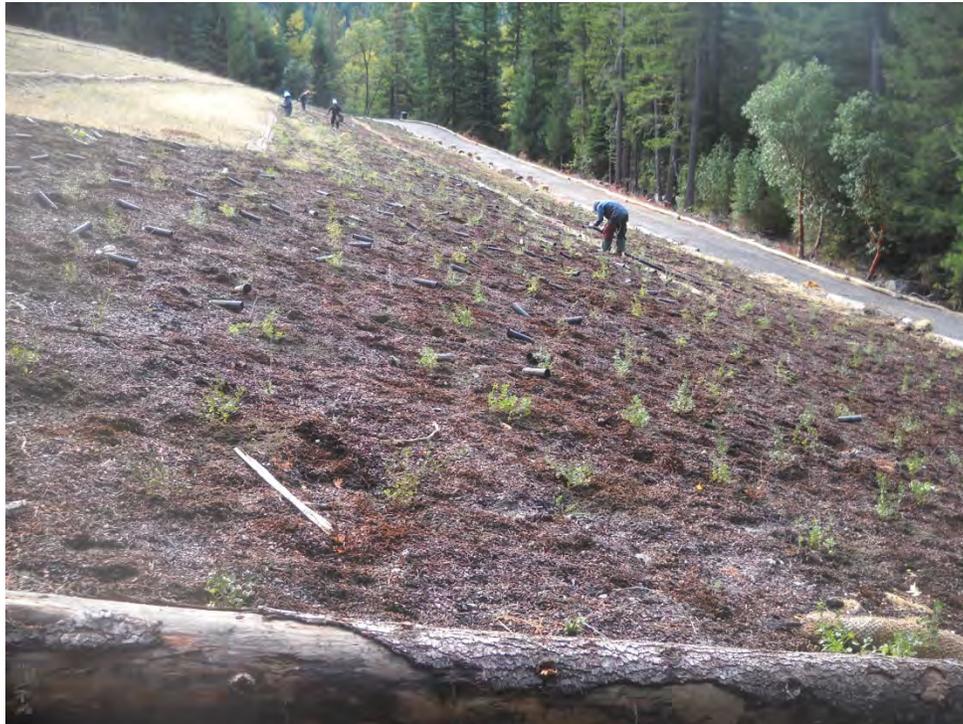
Photograph 3: Planting Oceanspray on repository slope, looking south.

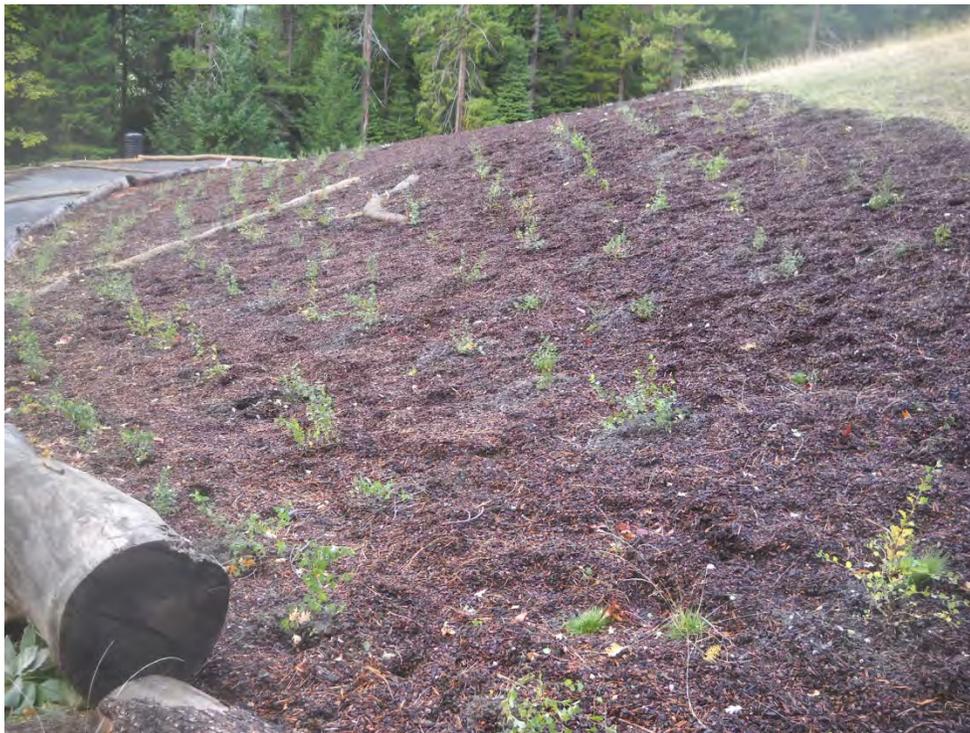
Photograph 4: Plants on repository slope above access road, south end looking west.

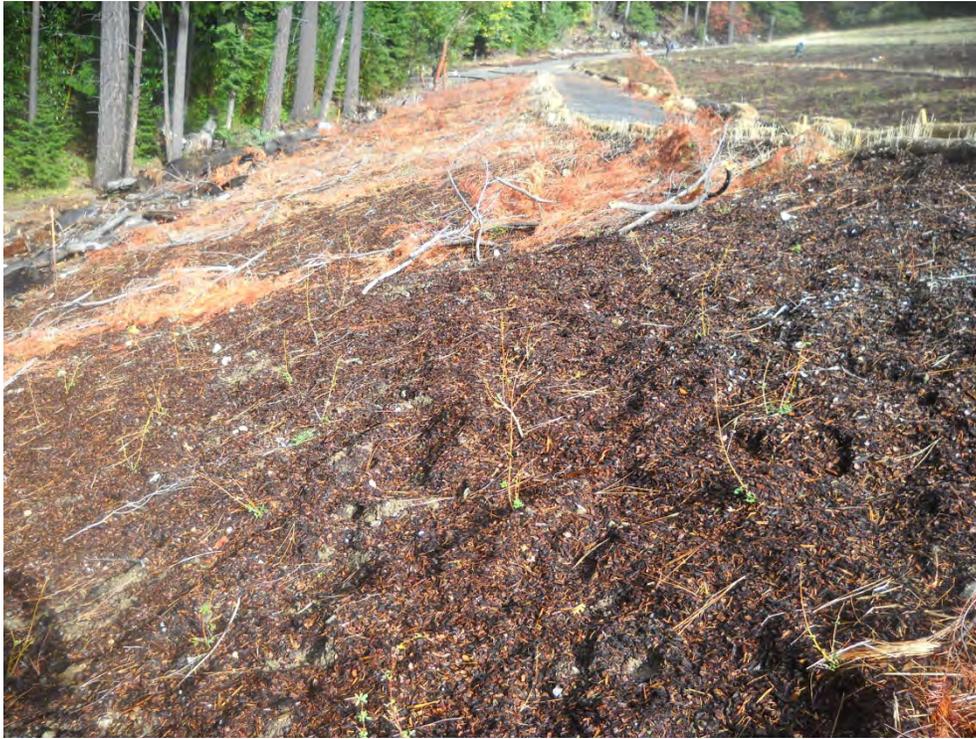
Photograph 5: Live Scoulers Willow plants below repository perimeter road, looking north.
Blue Ledge Mine, Rogue River - Siskiyou National Forest, CA
Photographed by: Brian Wetzsteon (ERRG) Date: November 1, 2012

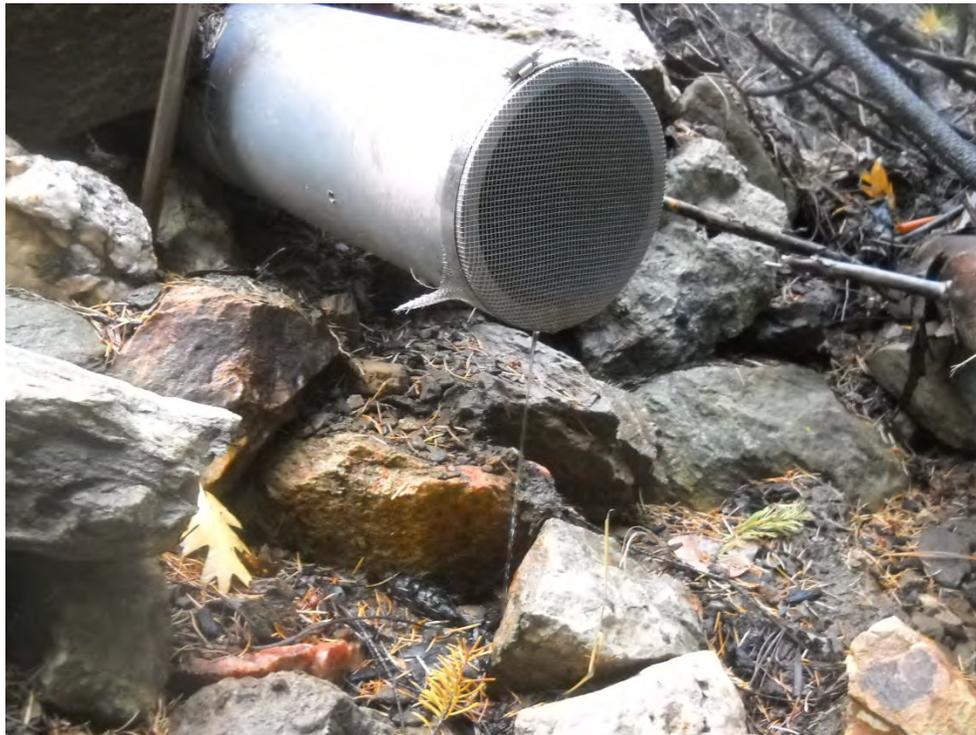
Comments: A small trickle of water is draining from the southernmost anchor trench drain pipe due to the recent rain (see photo log). All other drain pipe outlets are dry.

Photograph 6: Anchor trench drain outlet water discharge, south end of repository.
Blue Ledge Mine, Rogue River - Siskiyou National Forest, CA
Photographed by: Brian Wetzsteon (ERRG) Date: November 1, 2012

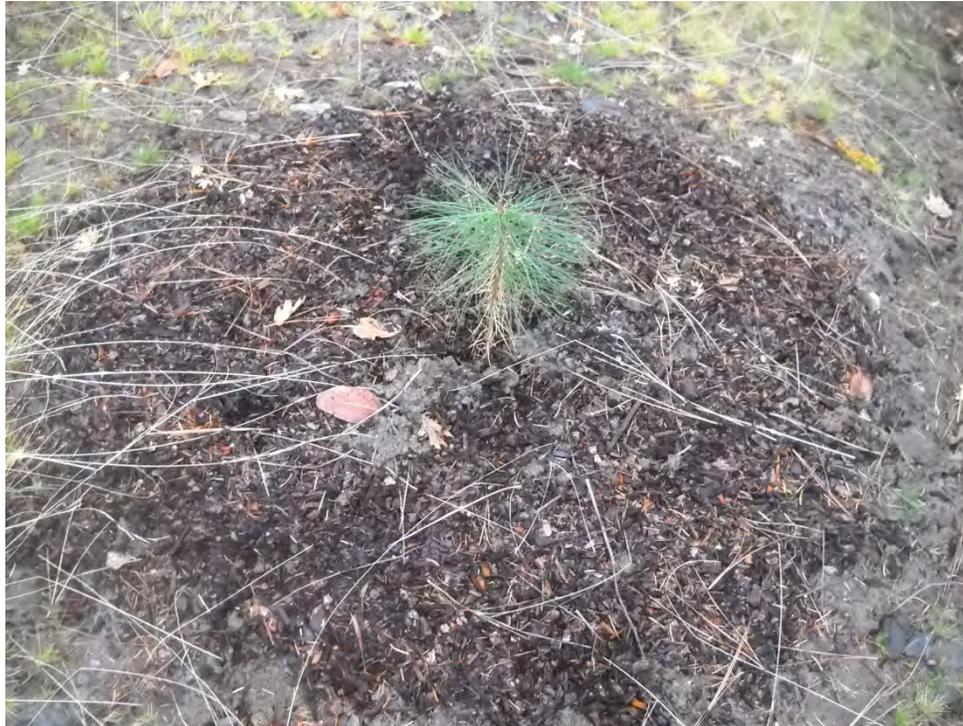
Photograph 7: Ponderosa Pine replacement plant on Repository Stockpile Area.

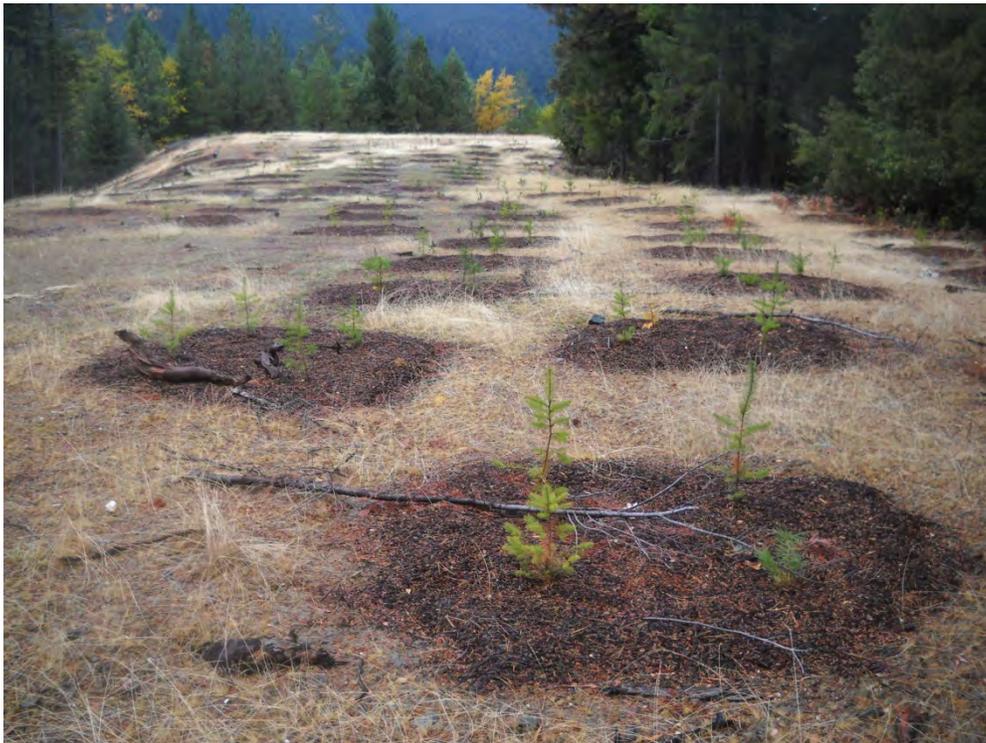
Comments: This area has sufficient live plants. Plants look healthy from the rain.

Photograph 8: North Storage Area looking west.

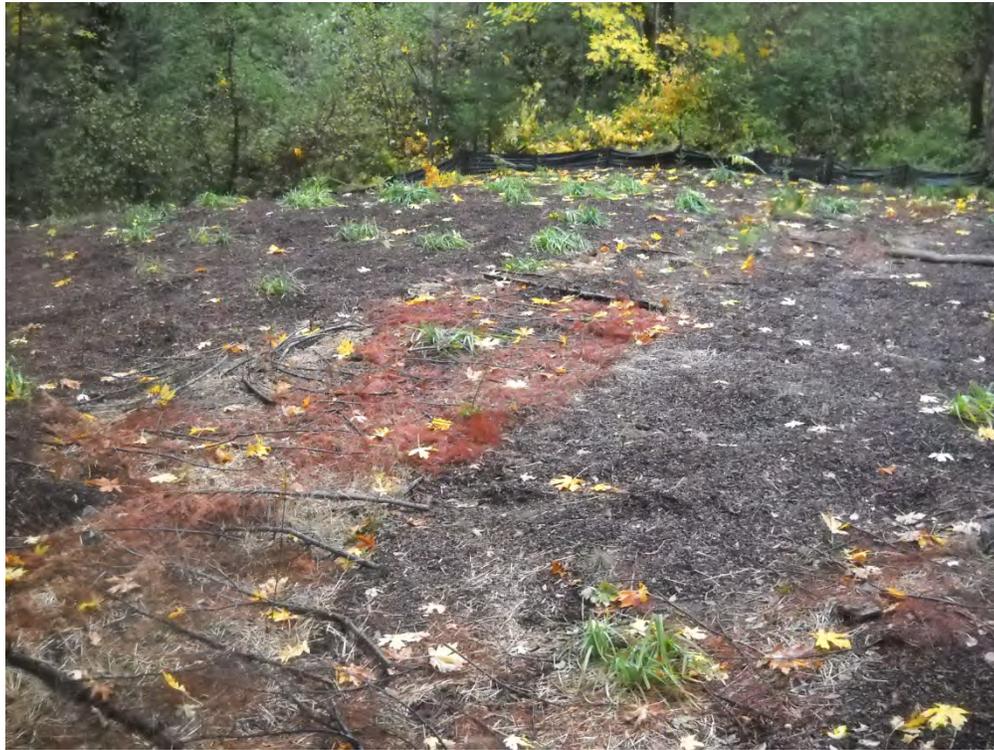
Photograph 9: South Stockpile Area looking east.
Blue Ledge Mine, Rogue River - Siskiyou National Forest, CA
Photographed by: Brian Wetzsteon (ERRG)

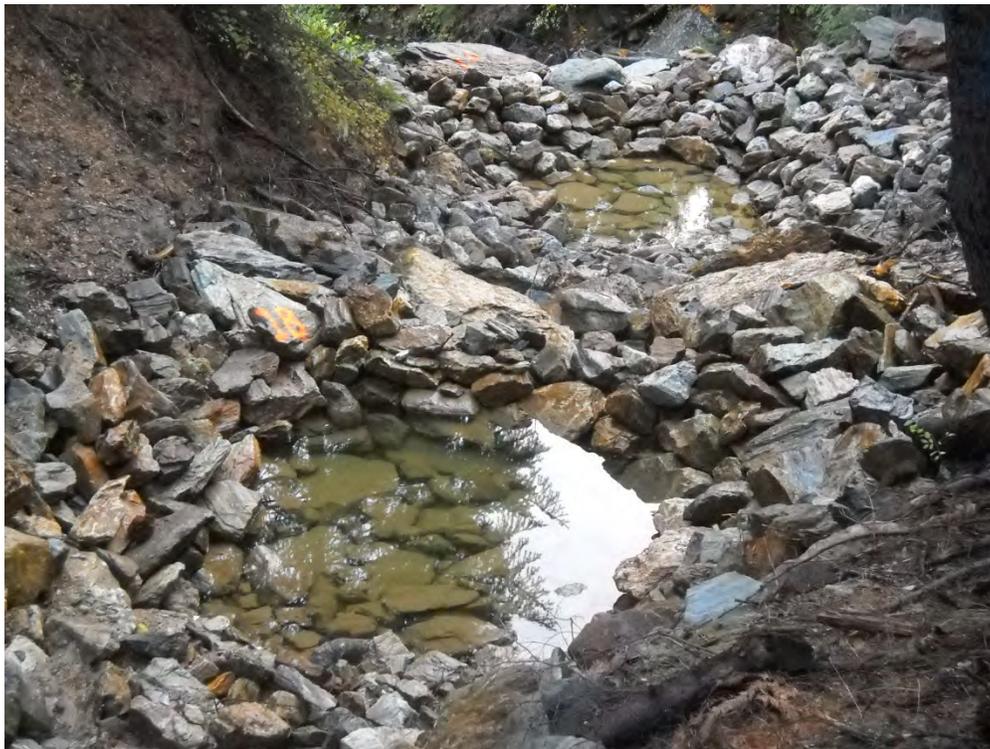
Photograph 10: Sediment/pH Treatment Basin 1A and 1B.
Blue Ledge Mine, Rogue River - Siskiyou National Forest, CA
Photographed by: Brian Wetzsteon (ERRG)

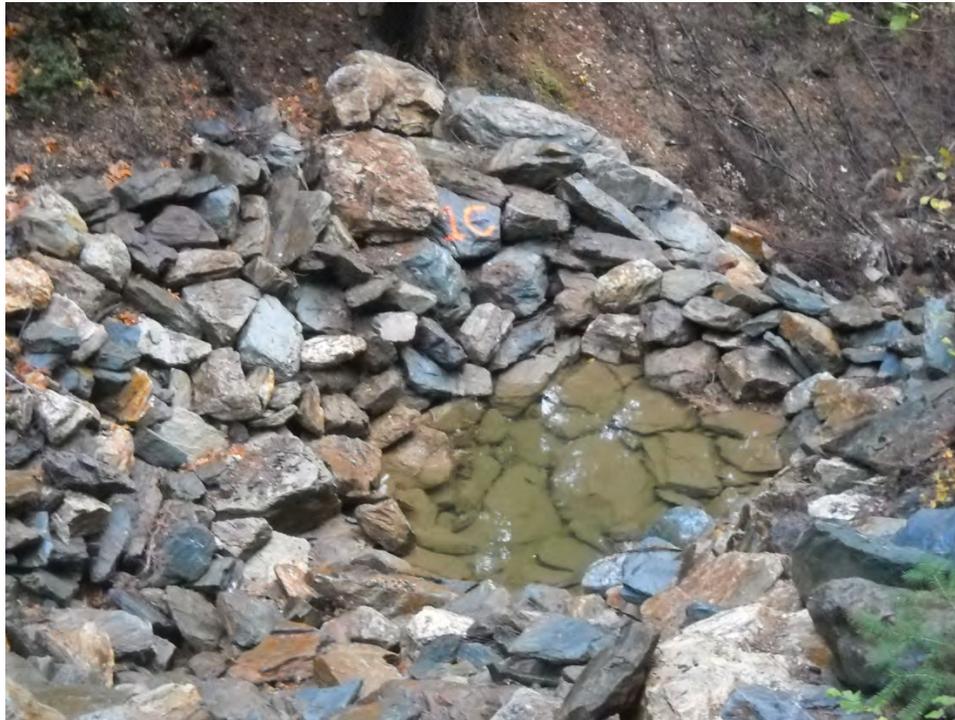
Photograph 11: Sediment/pH Treatment Basin 1C.
Blue Ledge Mine, Rogue River - Siskiyou National Forest, CA
Photographed by: Brian Wetzsteon (ERRG)

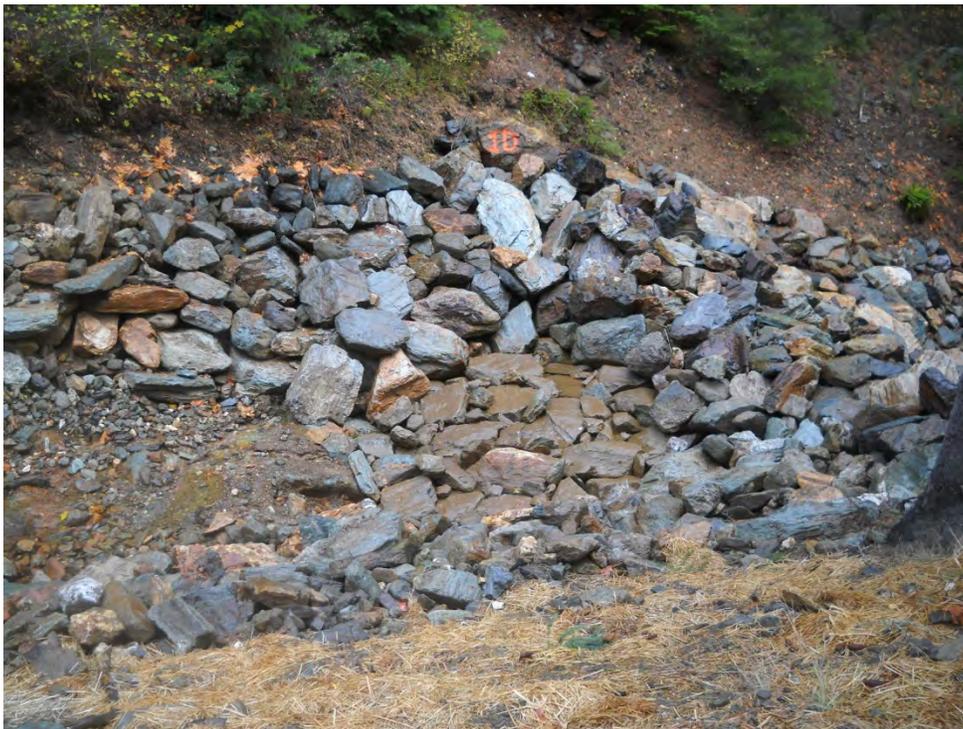
Photograph 12: Sediment/pH Treatment Basin 1D.
Blue Ledge Mine, Rogue River - Siskiyou National Forest, CA
Photographed by: Brian Wetzsteon (ERRG)

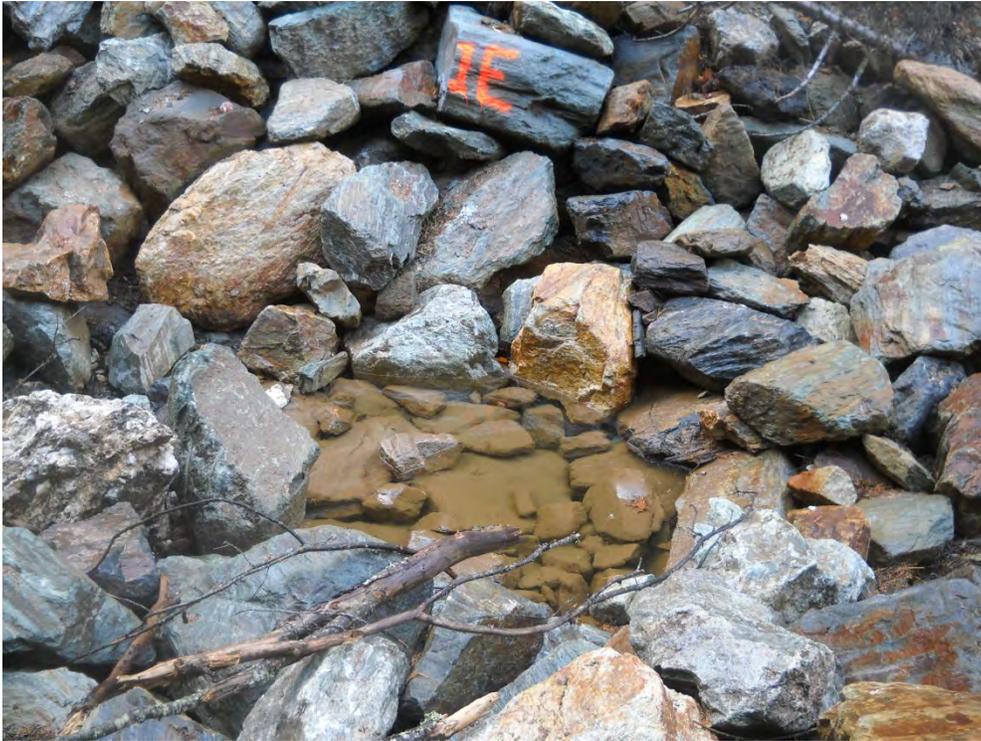
Photograph 13: Sediment/pH Treatment Basin 1E.
Blue Ledge Mine, Rogue River - Siskiyou National Forest, CA
Photographed by: Brian Wetzsteon (ERRG)

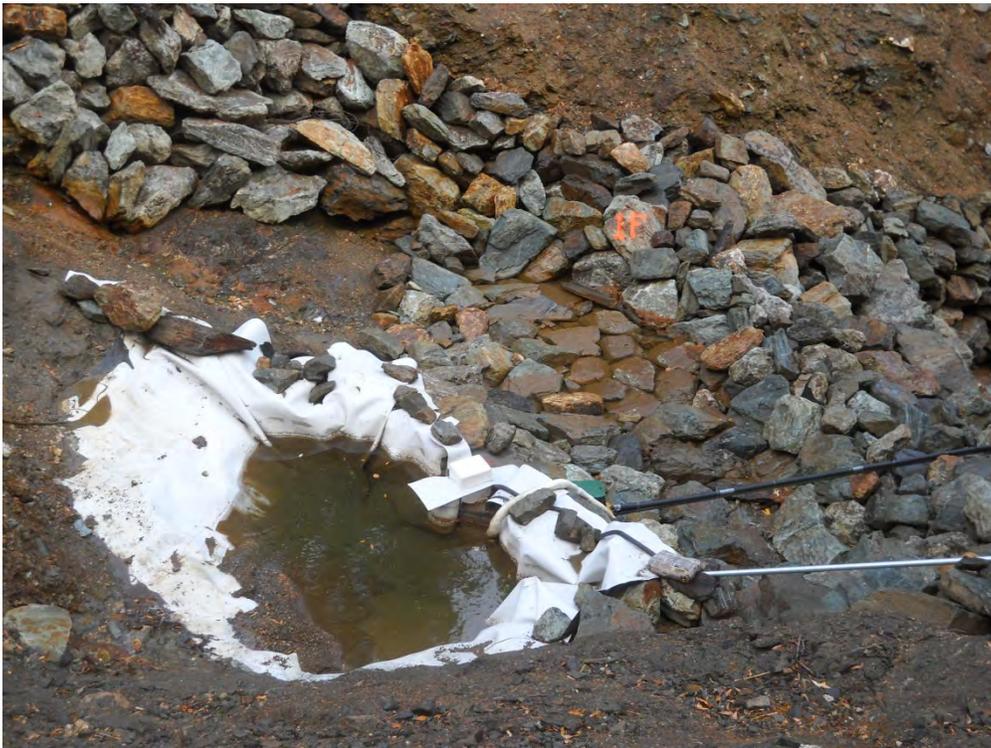
The pH of the water in the WRP-1 drainage entering basin 1F remained consistent since the October 2012 inspection. The acid seep previously entering the east side of basin 1F is being captured by the USEPA acid seep collection basin. The water seeping from adit A1N2 has been diverted by the USEPA to flow down the face of the WRP-1 bedrock to run to the acid seep collection basin. The pH in the USEPA acid seep basin was measured at 3.3, which is 0.1 pH unit less than the October measurement.

The USEPA acid seep basin overflow spillway is functioning due to the recent rainfall runoff being more than the pilot treatment system piping inlet can handle. The 3.3 pH overflow water is running through the rip rap into basin 1E and comingling with the 4.1 pH water coming down the main drainage and flowing through basin 1F. This is likely why the pH in basin 1E is lower than basin 1F. There is effectively a split flow of water between the main drainage into basin 1F and the overflow of the USEPA acid seep basin that does not fully comingle until it reaches basin 1E. Basins 1D through 1A subsequently raised the pH by one unit from 3.6 to 4.6 before entering Joe Creek. The USEPA pilot treatment system discharges at a low flow rate through multiple outlet pipes into the drainage just above basin 1D. The USEPA pilot treatment system discharges were not tested. There is no measurable pH change in the water flowing through the basins due to the USEPA pilot treatment system discharge.

Photograph 14: Sediment/pH Treatment Basin 1F and EPA acid seep collection basin.
Blue Ledge Mine, Rogue River - Siskiyou National Forest, CA
Photographed by: Brian Wetzsteon (ERRG)

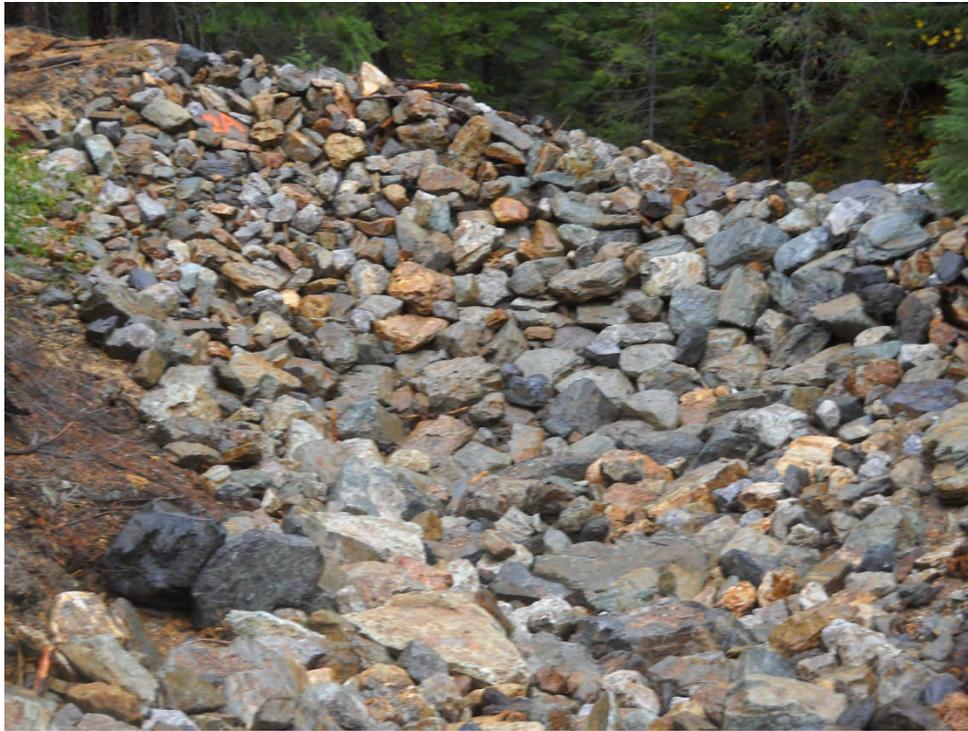
Photograph 15: Sediment/pH Treatment Basin 2A.
Blue Ledge Mine, Rogue River - Siskiyou National Forest, CA
Photographed by: Brian Wetzsteon (ERRG)

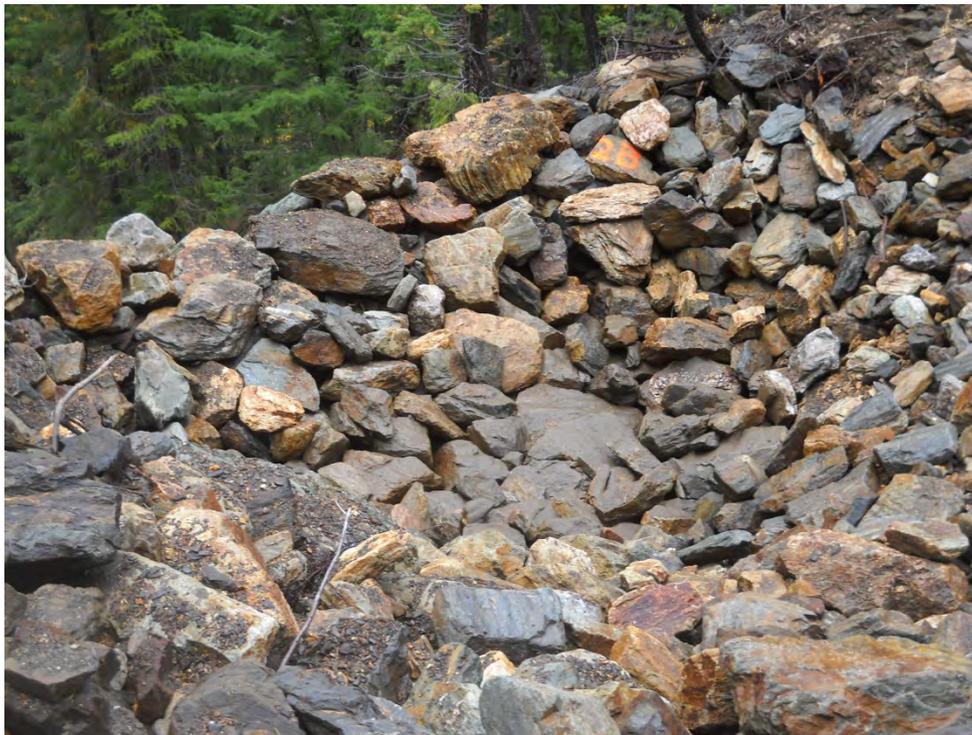
Photograph 16: Sediment/pH Treatment Basin 2B.
Blue Ledge Mine, Rogue River - Siskiyou National Forest, CA
Photographed by: Brian Wetzsteon (ERRG)

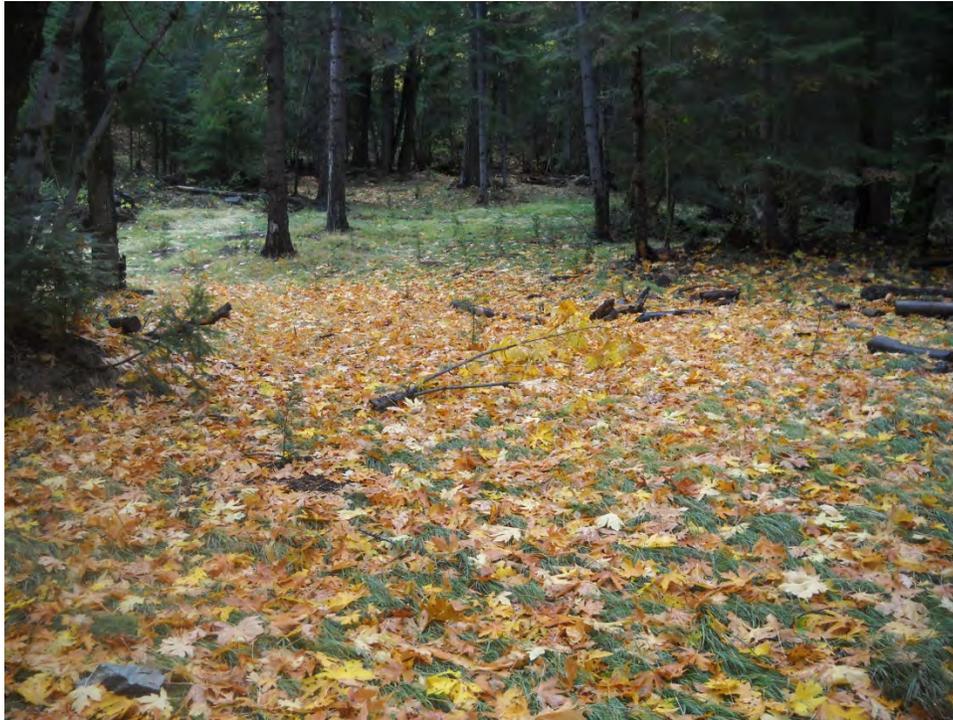
Comments: Very good grass growth in this area.

Photograph 17: Rock Stockpile reclamation plants and grass looking south.

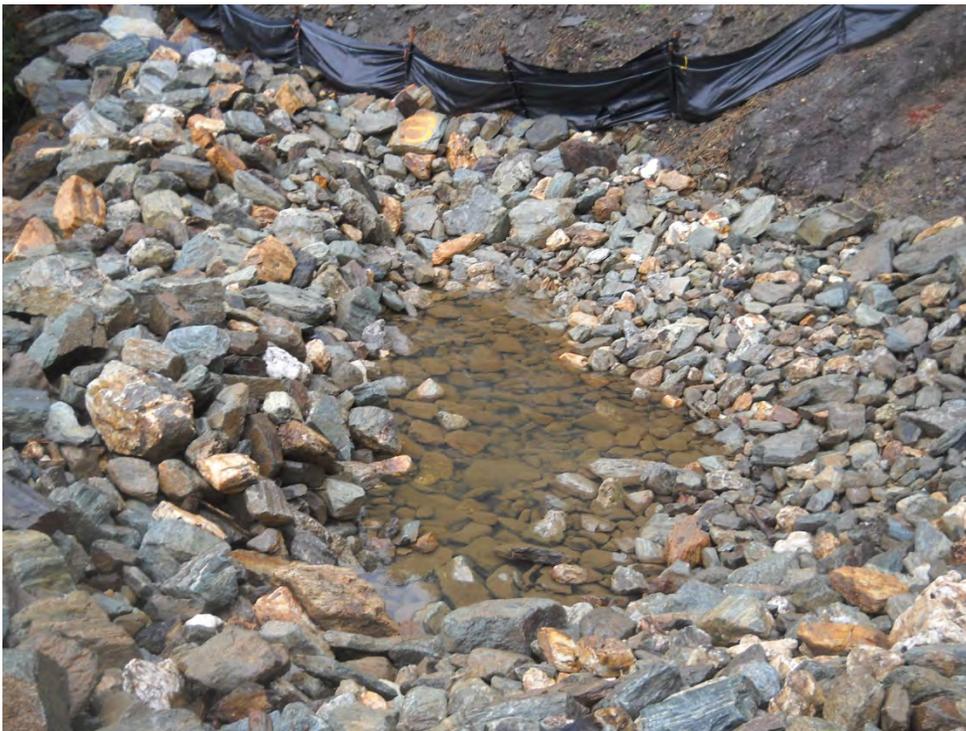
Photograph 18: Sediment/pH Treatment Basin 3.

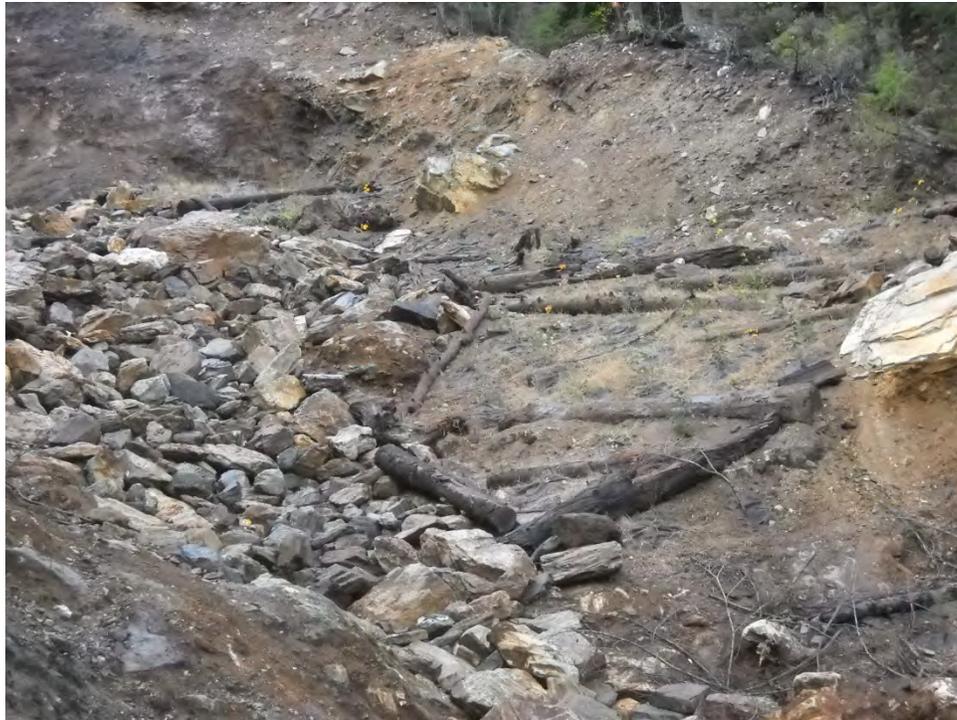
Photograph 19: WRP-1 reclamation plants and grass.
Blue Ledge Mine, Rogue River - Siskiyou National Forest, CA
Photographed by: Brian Wetzsteon (ERRG)

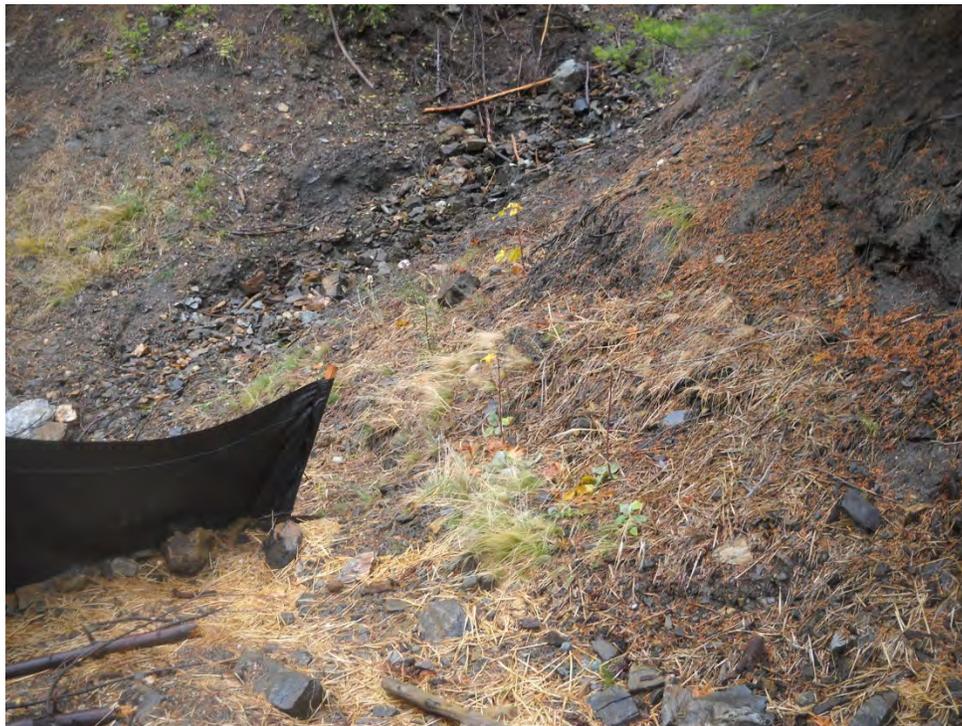
Photograph 20: WRP-2 reclamation plants and grass.
Blue Ledge Mine, Rogue River - Siskiyou National Forest, CA
Photographed by: Brian Wetzsteon (ERRG)

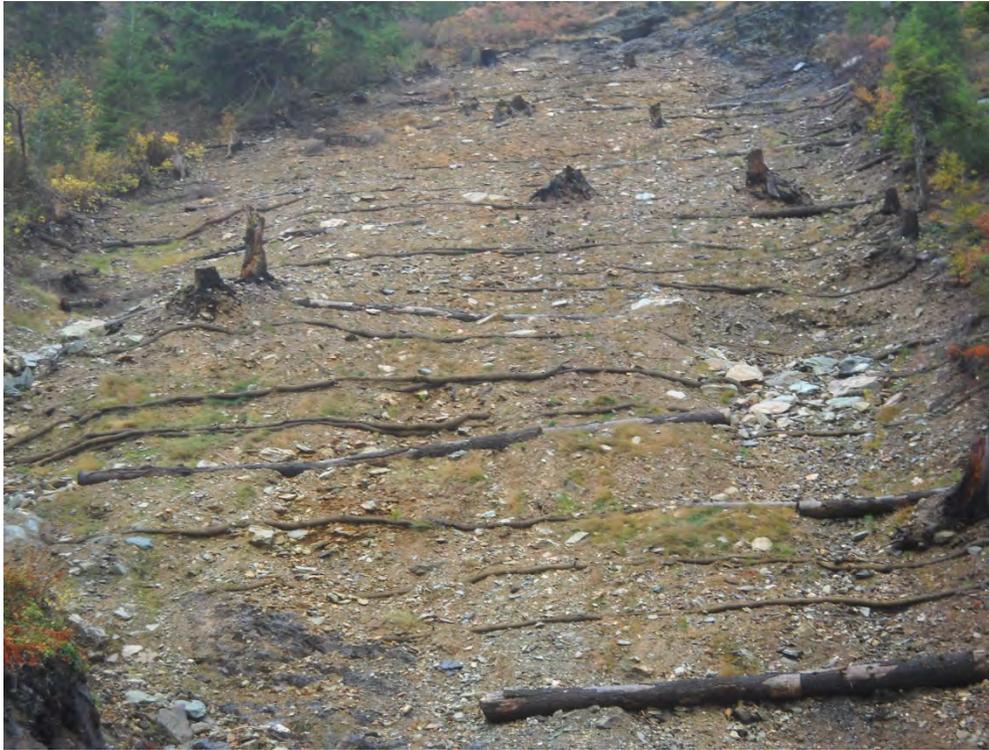
Photograph 21: WRP-3 reclamation plants and grass.
Blue Ledge Mine, Rogue River - Siskiyou National Forest, CA
Photographed by: Brian Wetzsteon (ERRG)

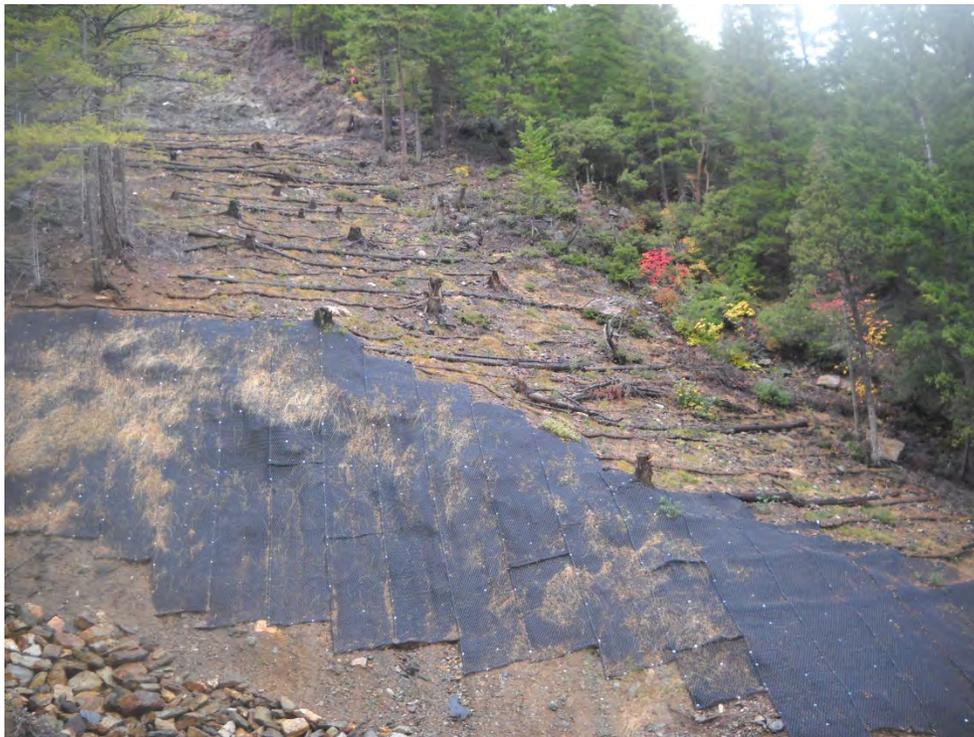
Photograph 22: WRP-4 reclamation plants and reinforced erosion fabric.
Blue Ledge Mine, Rogue River - Siskiyou National Forest, CA
Photographed by: Brian Wetzsteon (ERRG)
