TECHNICAL MEMORANDUM

SUBJECT: Existing Monte Cristo Road Evaluation Summary

Cascade Earth Sciences (CES) has prepared the following Condition Assessment of the Monte Cristo Road between the confluence of Weden Creek with the South Fork Sauk River and the Monte Cristo Townsite. The purpose of this assessment is to identify required repairs and priorities associated with needed equipment access to the Townsite. On June 20, 2009, approximately three miles of road was surveyed and assessed by Mr. Timothy Otis, P.E. and Ryan Tobias of CES. Survey categories include:

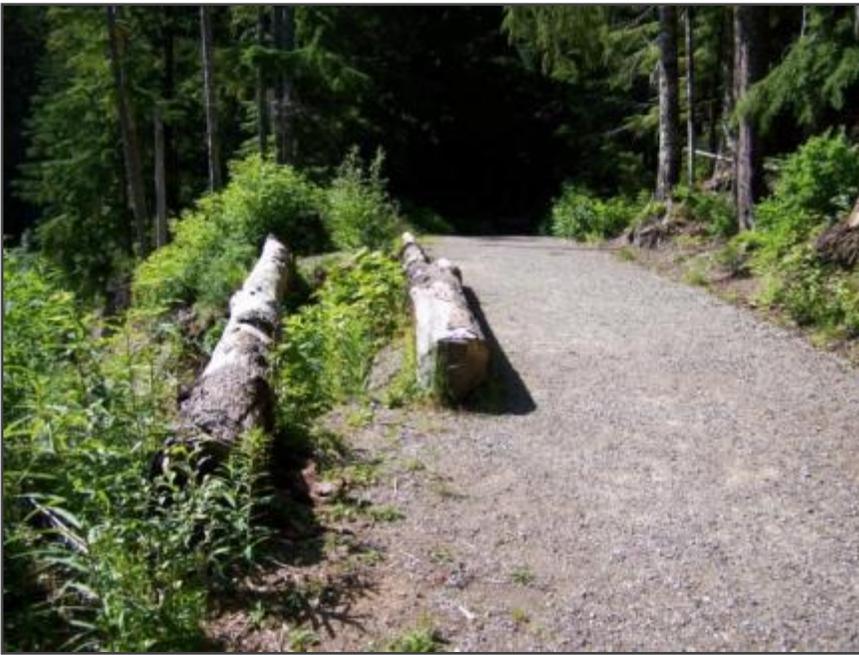
A South Fork of the Sauk River meander at this location has undercut the toe of the slope below the road, resulting in bank erosion and loss of a portion of the roadway (see Photographs 1 and 2). The recommended repair includes re-alignment of the roadway approximately 25-30 feet (ft) upslope to the north (see Figure 1). The 65 ft of eroded roadway will require approximately 100 ft of replacement road, plus 100 ft transitions at each end, for a total of 300 ft of road construction. The forested area of road relocation will require clearing and grubbing, and some cut and disposal of excavation to minimize vertical alignment change. The proposed horizontal alignment change concept is shown in Figure 3.

Photograph 1. Site 1A
Looking northwest down roadway.

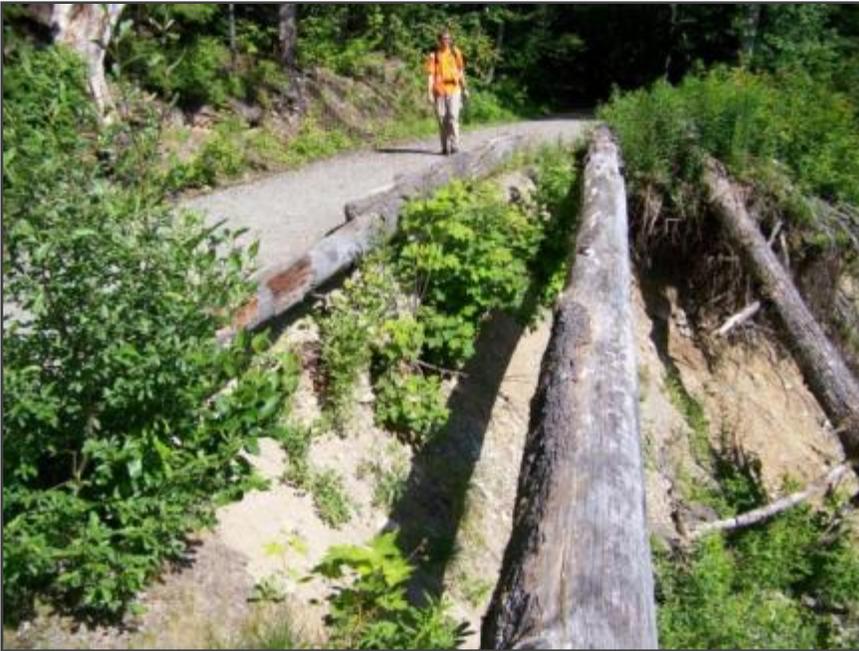
Photograph 2. Site 1B
Stream bank erosion encroaching on roadway, with log barriers, looking southeast.

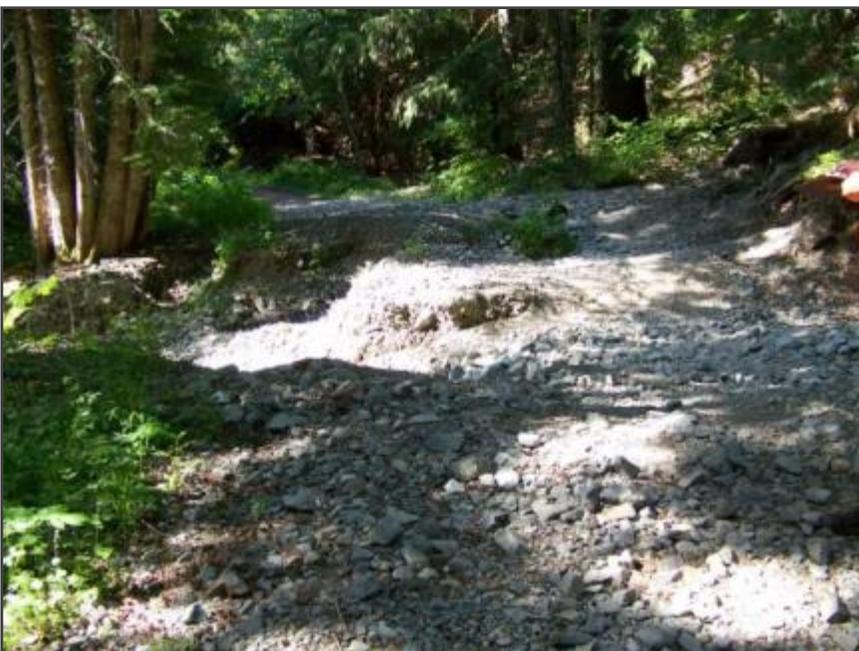
Site 2 contains a 36 inch by 50 ft long high density polyethylene (HDPE) culvert (see Photograph 4) which has filled with sediment and experienced both erosion along the culvert alignment and deposition across approximately 110 ft of roadway (see Photographs 3 and 5). The recommended repair is to remove the culvert, re-grade the roadway, side-casting the material on downslope (south) side of the road, and add and compact 6 inches of 3 inch (minus) crushed rock. This crossing is in a sediment transport and deposition zone, and will require periodic maintenance following runoff/deposition events. No culvert or other drainage structure is recommended due to the large volume of sediment located upslope from this site.

Photograph 3. Site 2A
Sediment deposition and erosion, looking northwest.

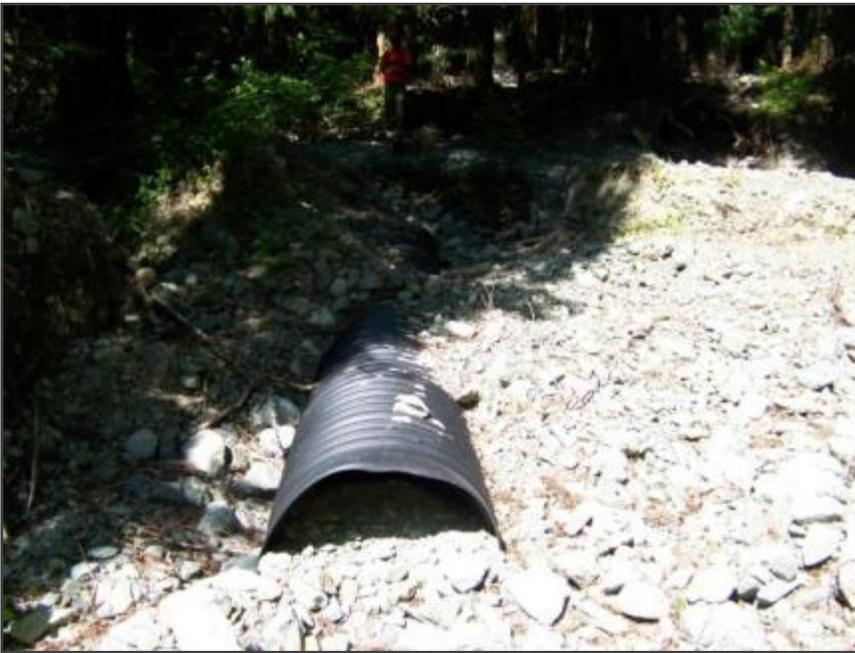
Photograph 4. Site 2B
36 inch culvert blocked with sediment.

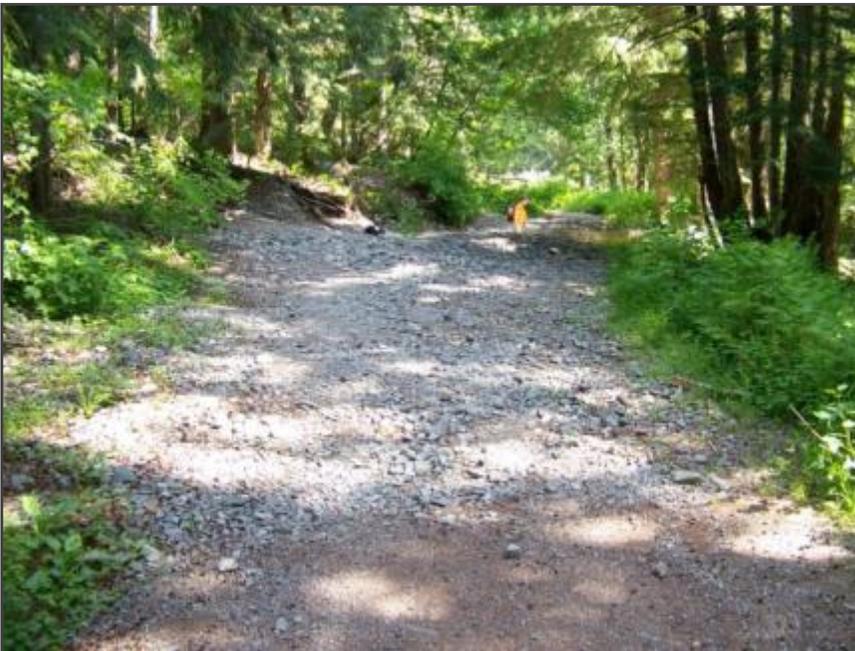
Photograph 5. Site 2C
Sediment deposition, looking southeast.

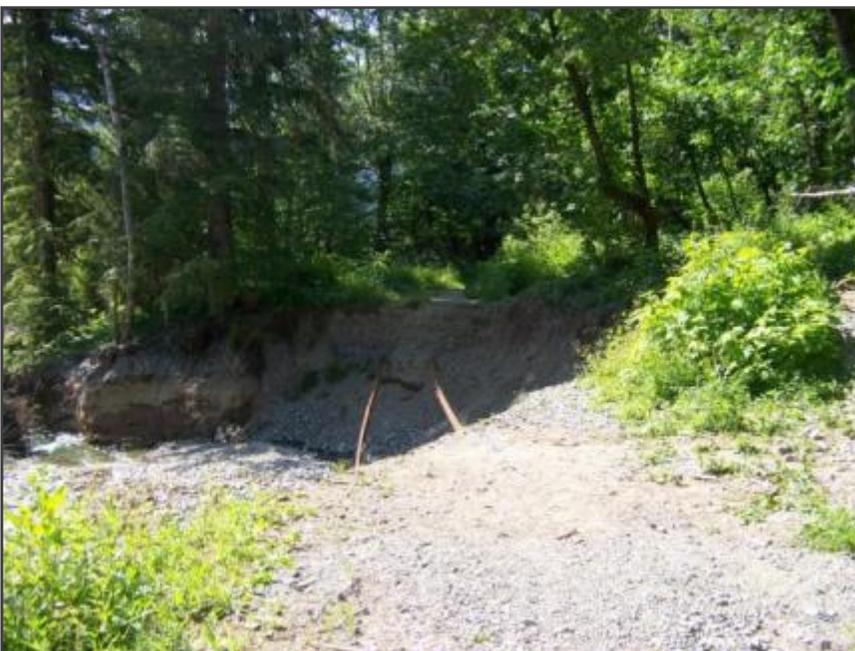
Site 3 is in a depositional outwash area of a seasonal drainage. The original rails of the Monte Cristo Railway are exposed under approximately 4 ft of sediment (see Photograph 6). The South Fork of the Sauk River meander has undercut the southern section of the roadway (see Photograph 7), causing a collapse of the entire roadway into the river. The recommended repair is similar to Site 1, moving the roadway approximately 25-30 ft north, for a total of 300 ft of road construction, including transitions (see Figure 3).

Photograph 6. Site 3A
Former railway tracks, sediment
deposition, and streambank erosion.

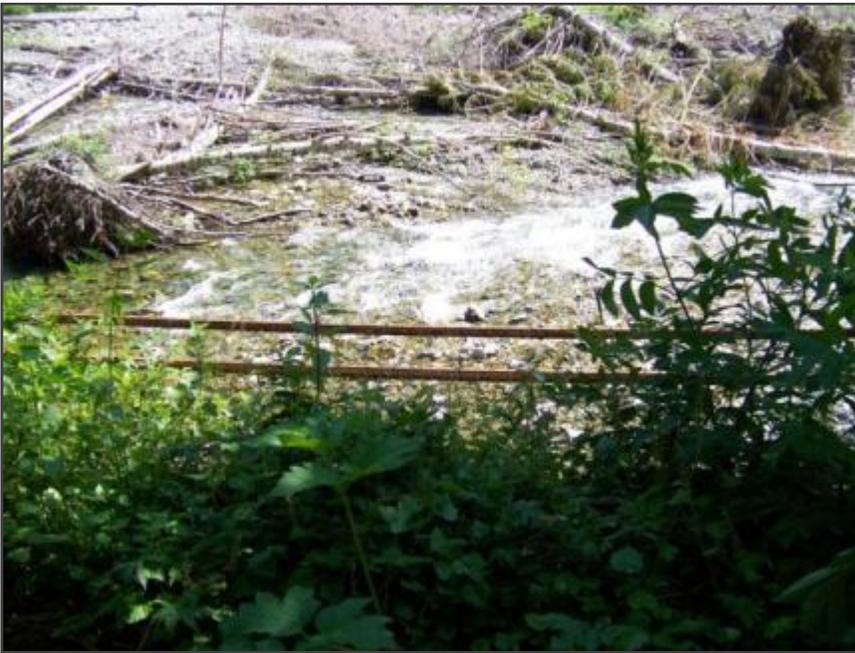
Photograph 7. Site 3B
View of tracks from bypass trail above roadway.

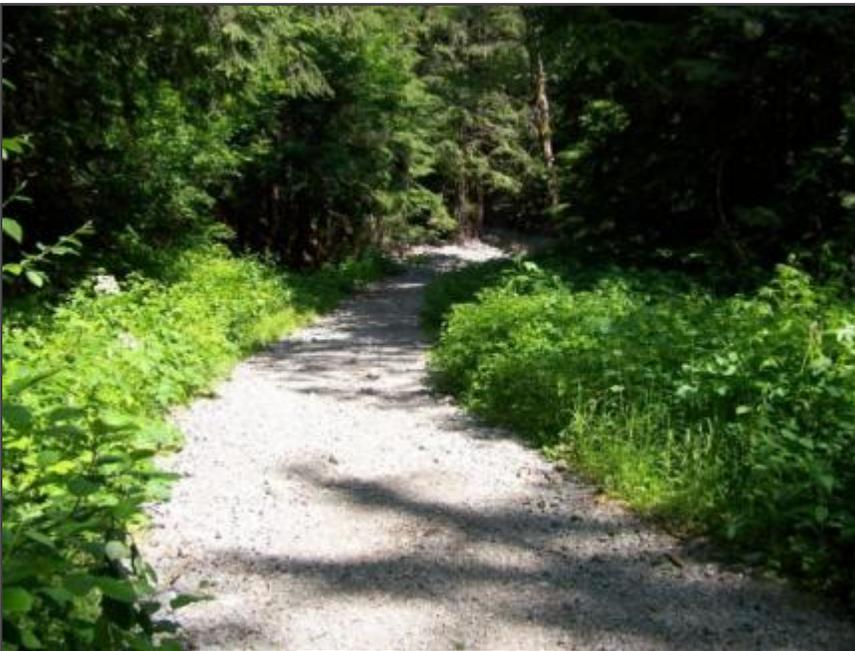
Approximately 265 linear ft of the roadway in this area has been overlain by gravel and cobble debris flows of depths up to about 4 ft (see Photographs 8, 9, and 10). The upslope drainage lacks a defined channel, making future deposition possible across any of the previous outwash areas. The recommended repair, similar to Site 2, is to re-grade the roadway, side-casting the material on downslope (south) side of the road, and add and compact 6 inches of 3-inch (minus) crushed rock. This crossing is in a sediment transport and deposition zone, and will require periodic maintenance following runoff/deposition events. No culvert or other drainage structure is recommended due to the large volume of sediment located upslope from the site.

Photograph 8. Site 4A
Looking southeast to sediment which has flowed down roadway.

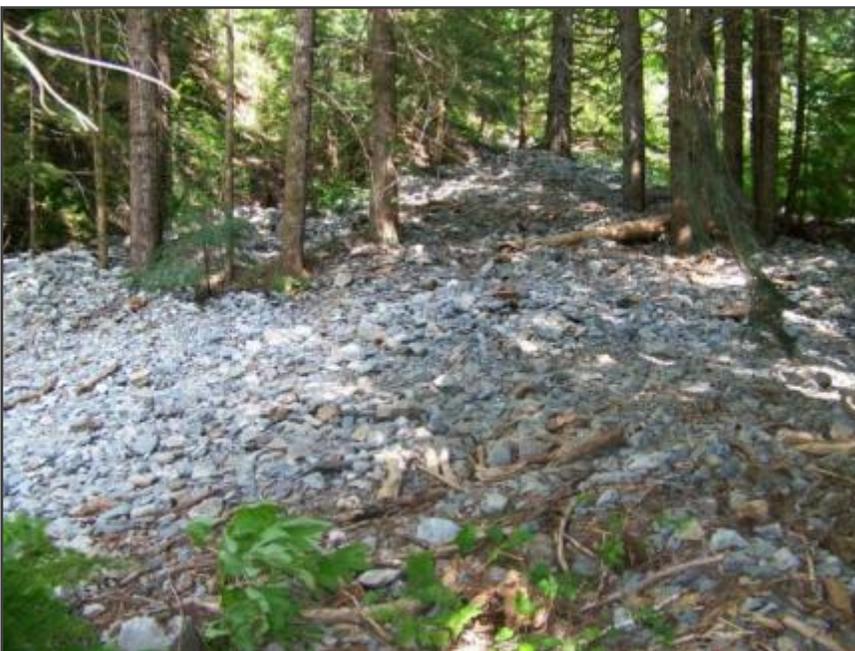
Photograph 9. Site 4B
Looking upslope across road to northeast.

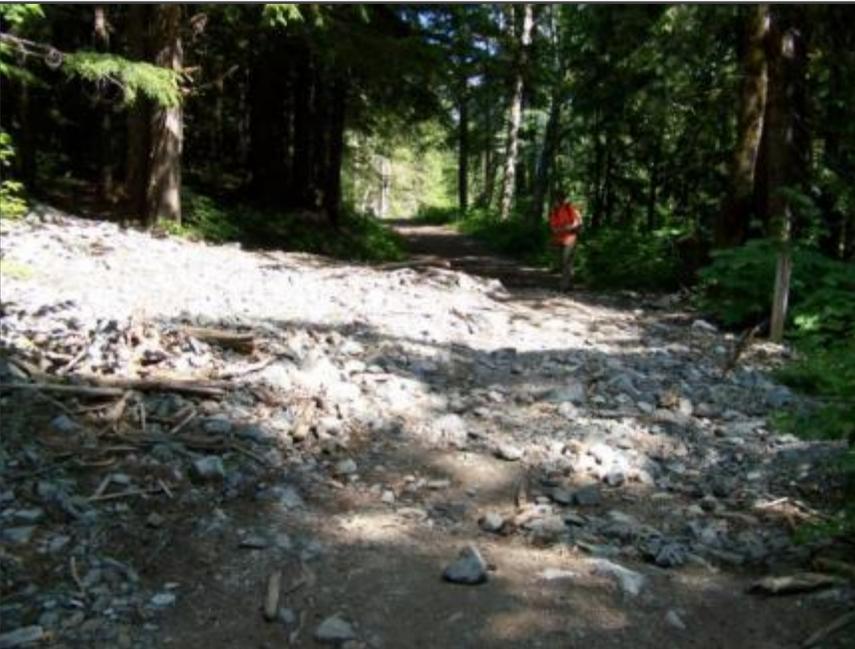
Site 5 is similar to Site 4, and appears to be a part of the same depositional delta, with approximately 65 linear ft of the roadway overlain by gravel and cobble debris flows to a depth of about 2 ft (see Photographs 11, 12, and 13). The recommended repair, similar to Site 2, is to re-grade the roadway, side-casting the material on downslope (south) side of the road, and add and compact 6 inches of 3-inch (minus) crushed rock. This crossing is in a sediment transport and deposition zone, and will require periodic maintenance following runoff/deposition events. No culvert or other drainage structure is recommended due to the large volume of sediment located upslope from the site.

Photograph 11. Site 5A
Looking southeast.

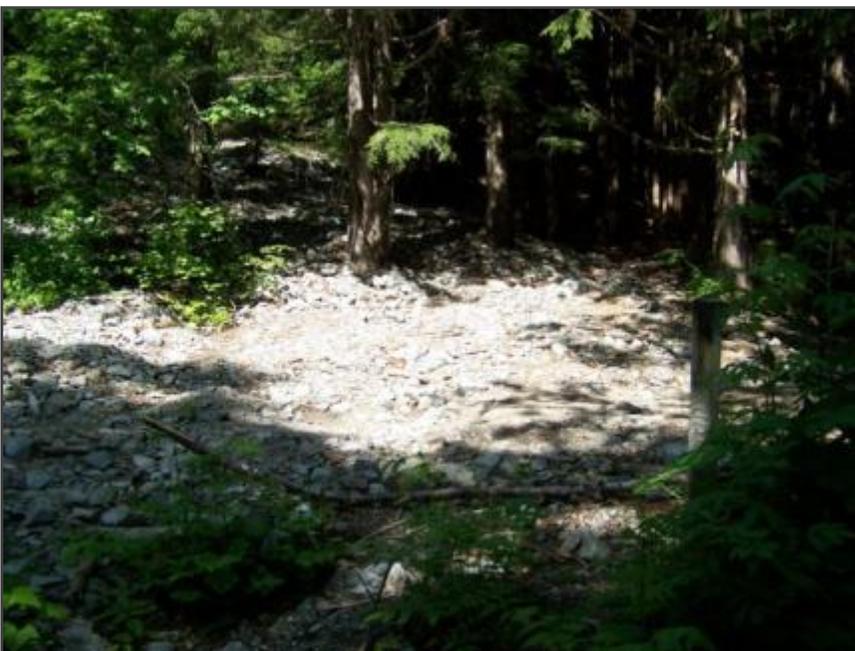
Photograph 12. Site 5B
View across roadway to
Northeast.

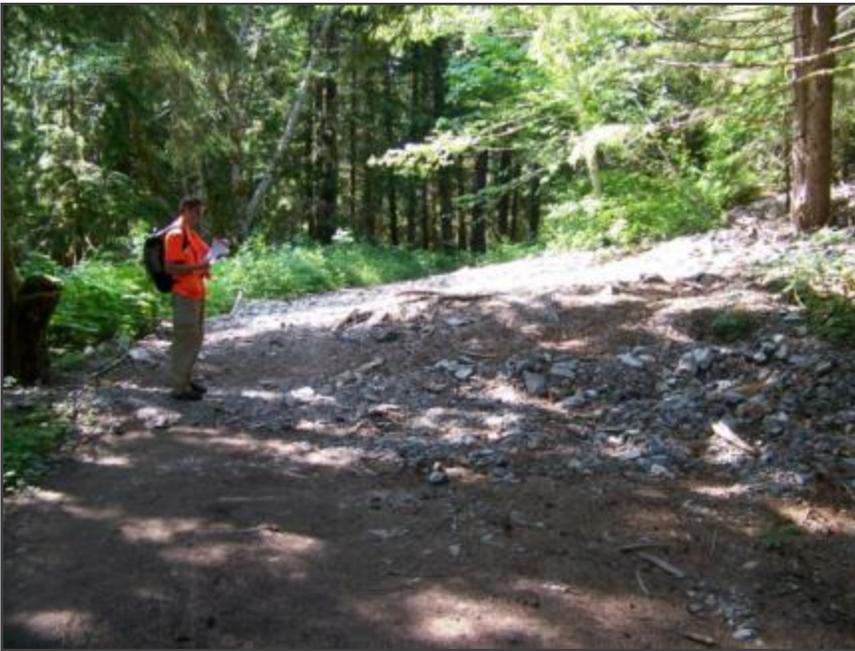
Photograph 13. Site 5C
Looking northwest.

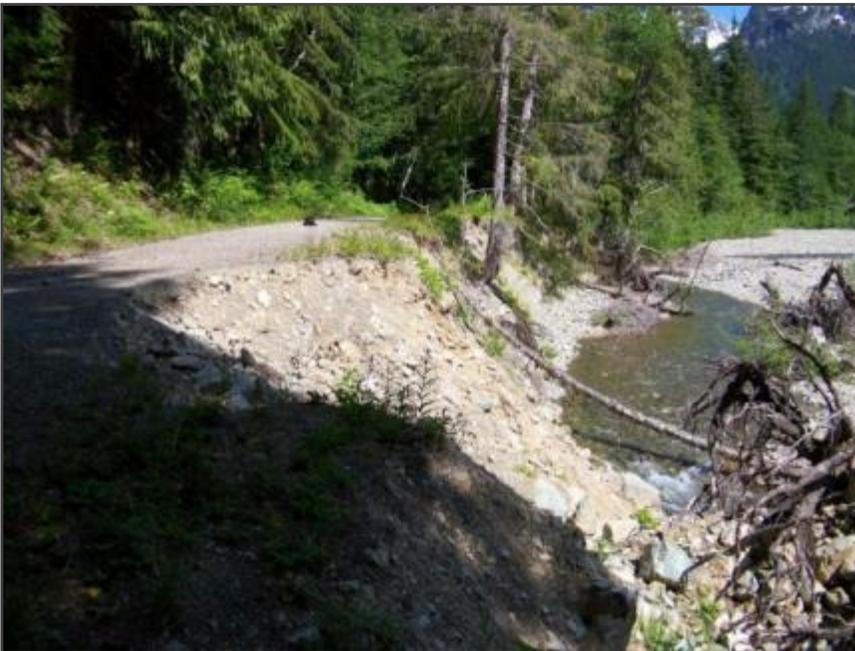
Similar to Site 1, the South Fork of the Sauk River meander at this location has undercut the toe of the slope below the road, causing bank erosion and loss of a portion of the roadway (see Photographs 14 and 15). The recommended repair includes re-alignment of the roadway approximately 25-30 ft upslope to the north. The 160 ft of eroded roadway requires approximately 200 ft of replacement road, plus 100 ft long transitions at each end, for a total of 400 ft of road construction. The forested area of road relocation will require clearing and grubbing, and some cut and disposal of excavation to minimize vertical alignment change. The proposed horizontal alignment change concept is shown in Figure 3.

Photograph 14. Site 6A
Looking southeast.

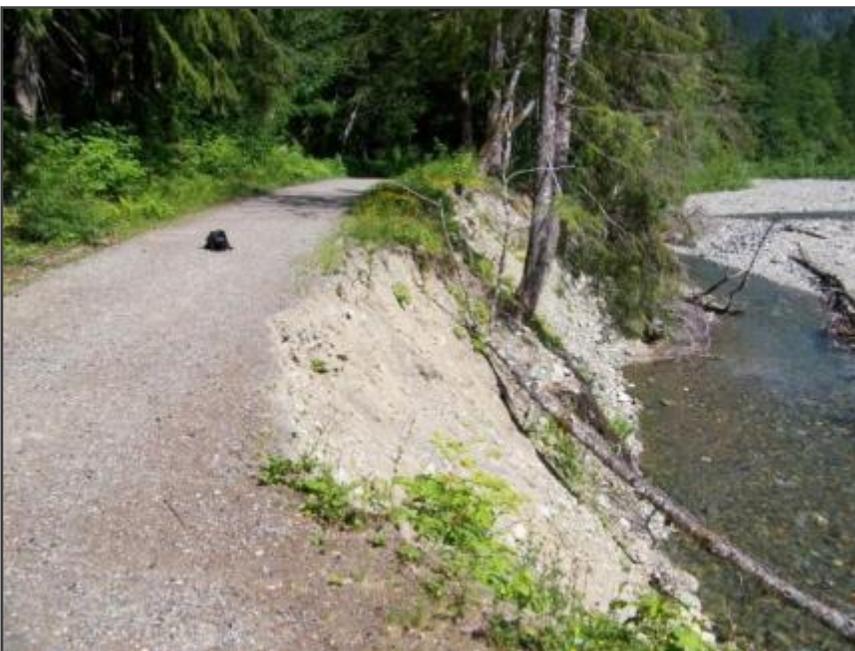
Photograph 15. Site 6B
Looking southeast, backpack in
roadway for scale.

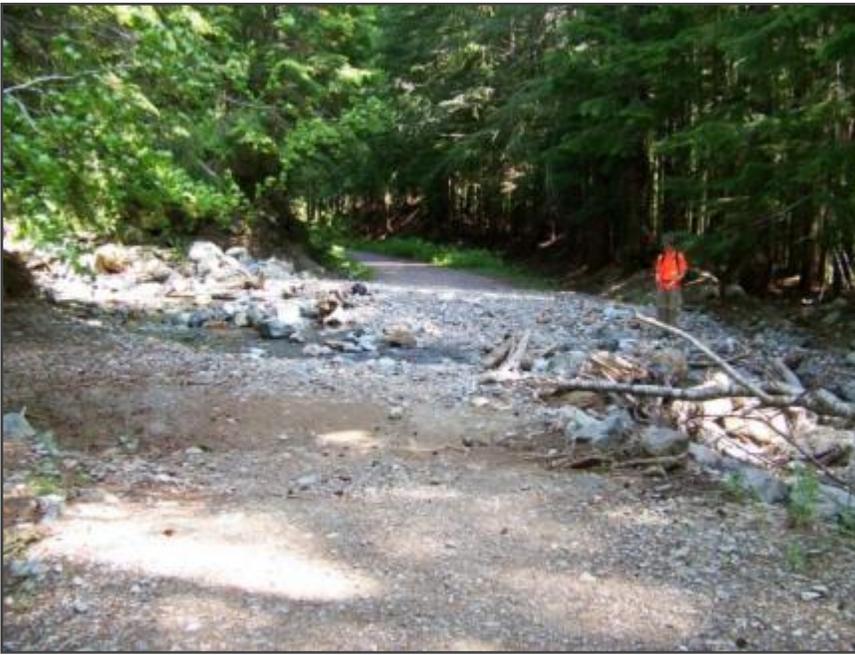
Site 7 is located at a perennial stream crossing of the roadway (see Photographs 16 and 17). The recommended repair is to construct a road dip and an armored ford for the stream crossing. The largest of the available boulders can be used to construct a 12 ft wide by 15 ft long armored ford section. This should be constructed to allow lowest flows to move among the armoring boulders. The downstream side of the road should be armored with a gabion weir to control loss of roadway materials during high flows. The remainder of the disturbed roadway (60 linear ft) should be graded smooth and finished by placing and compacting 6 inches of 3-inch (minus) crushed rock. This crossing is in a sediment transport and deposition zone, and will require periodic maintenance following runoff/deposition events.

Photograph 16. Site 7A
Roadway looking northwest.

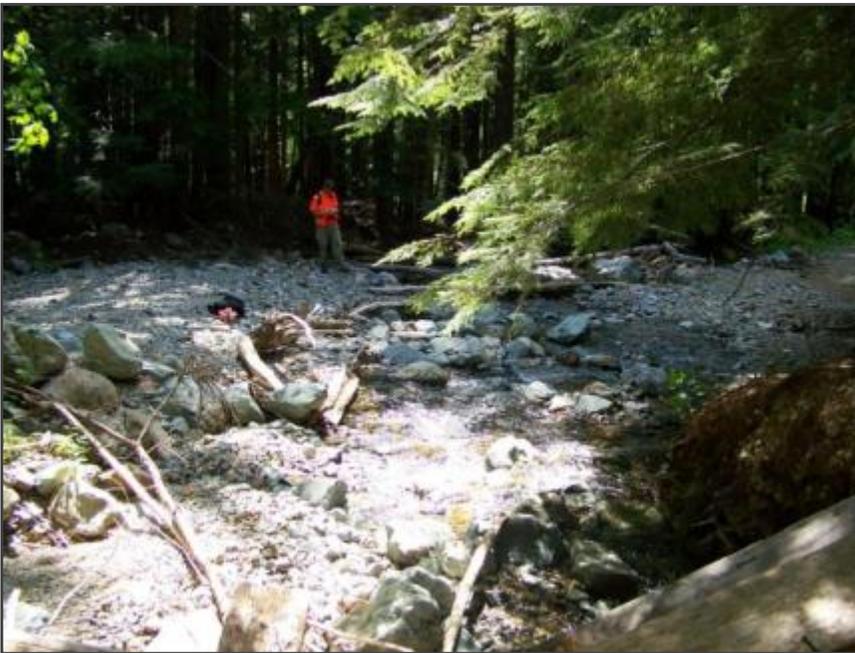
Photograph 17. Site 7B
Looking downstream across road.

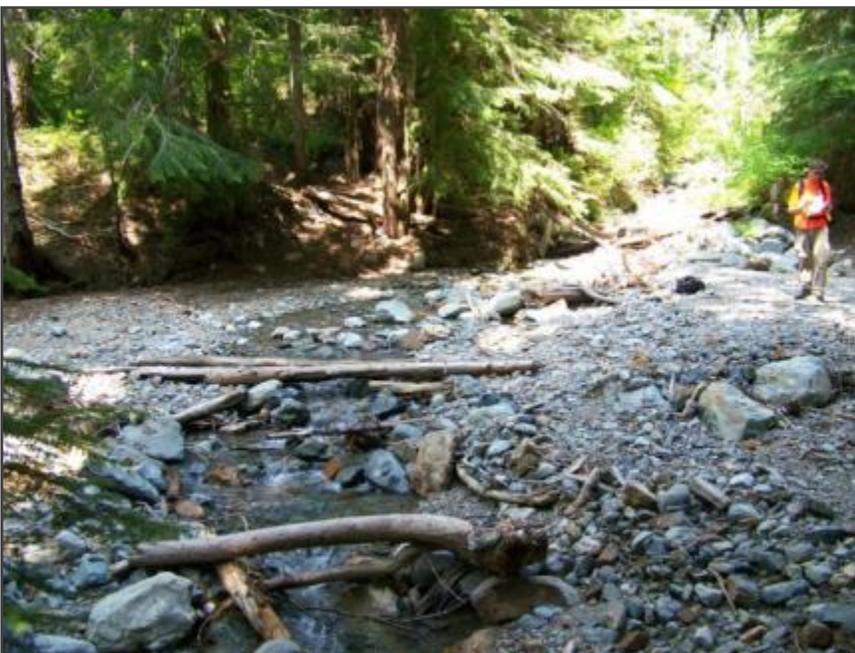
Photograph 18. Site 7C
Roadway looking upstream to the northwest.

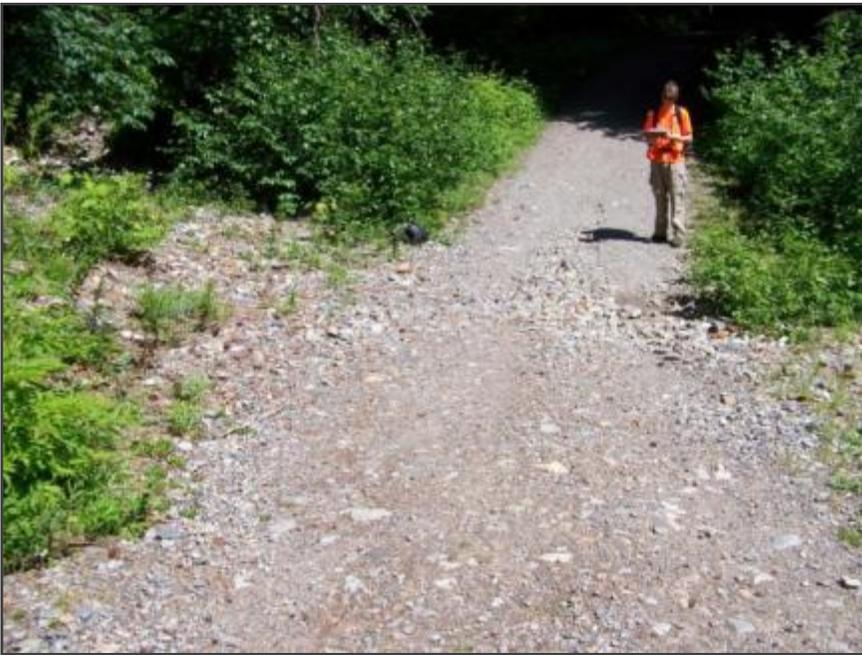
Site 8 contains an ephemeral stream crossing with a proper functioning culvert installation, constructed in a rolling dip section to remove road surface drainage and pass high stream flows (see Photograph 19). The two 48-inch corrugated metal culverts are partially blocked by sediment and woody debris at the upstream (north) end, which should be removed (see Photograph 20). The multiple pipe design tends to accumulate debris and should be periodically checked and maintained. There is evidence of high flows overtopping the roadway, but upstream armoring and road surfacing remain intact.

Photograph 19. Site 8A
Roadway looking southeast.

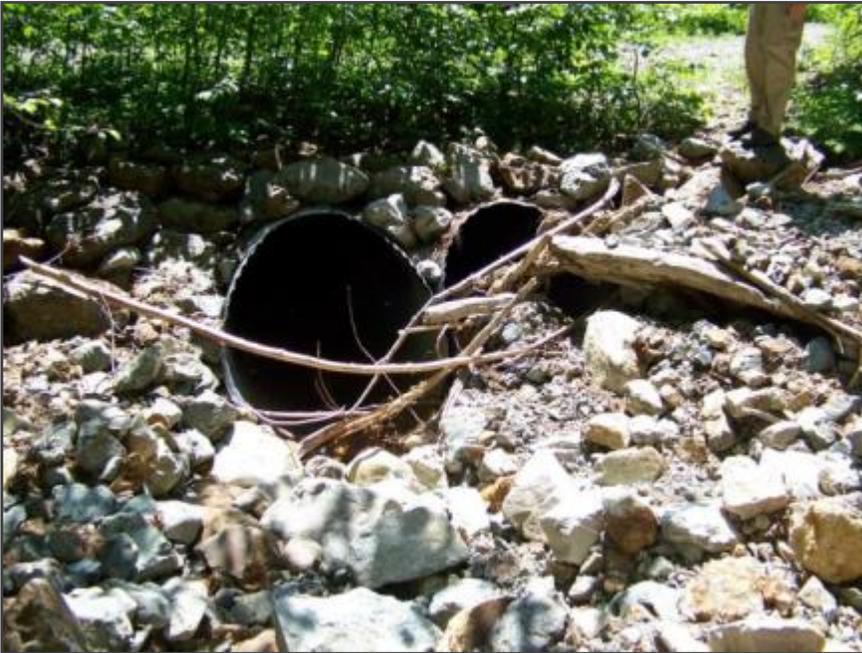
Photograph 20. Site 8B
Inlet end of culverts.

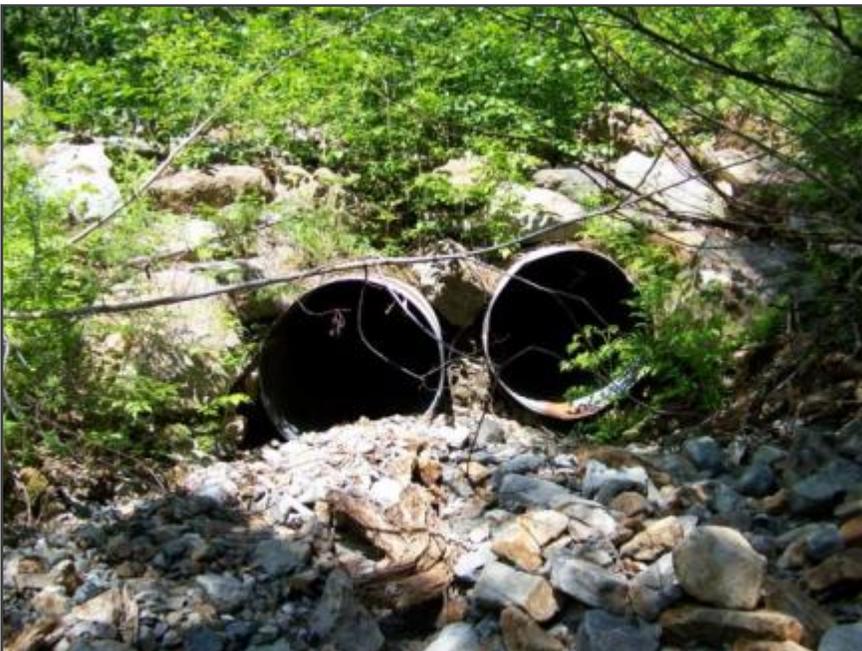
Photograph 21. Site 8C
Outlet end of culverts.

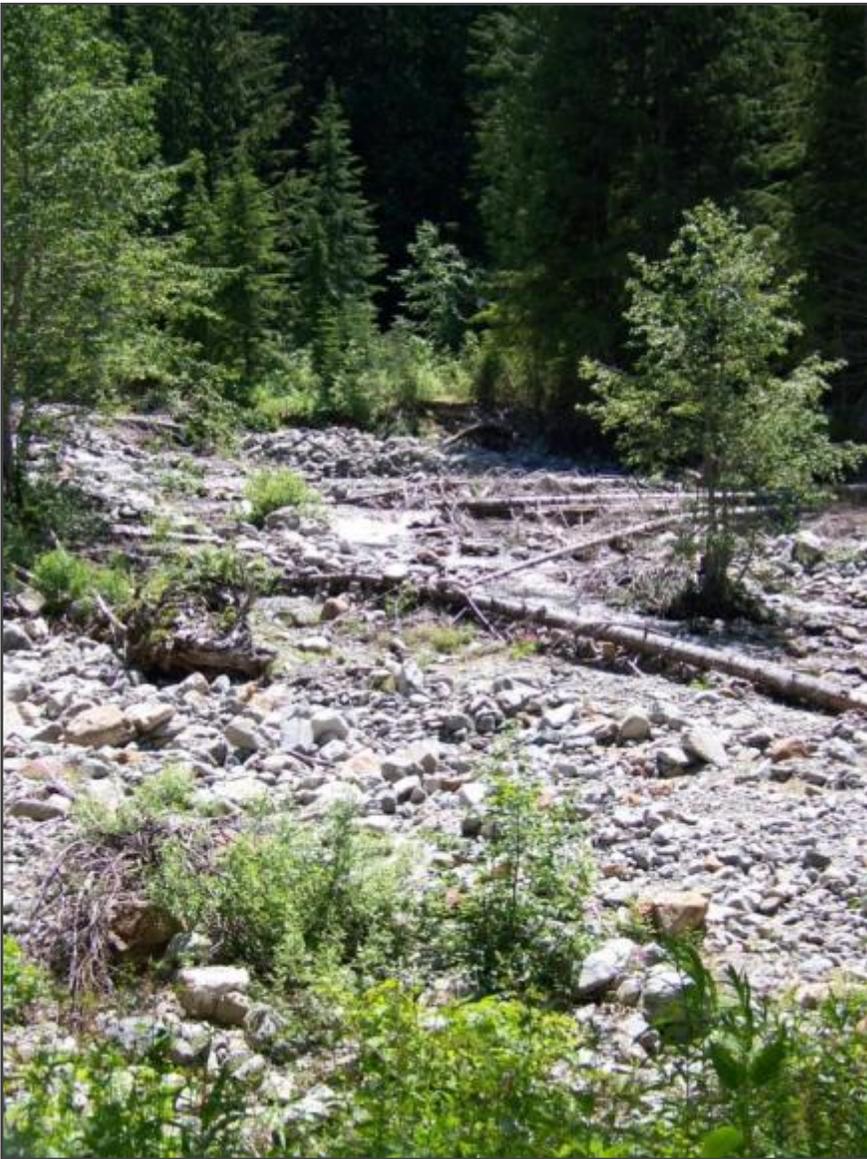
Photograph 22.
Equipment crossing site across Glacier
Creek, looking approximately north
from the Concentrator Site.

Access to the Monte Cristo Concentrator should be completed from the north stream bank of Glacier Creek, approximately 1,500 ft east of the terminus of the existing road. Equipment can follow the existing access road for approximately 1,500 ft to the proposed ford location on Glacier Creek (see Photograph 22). This ford location was utilized by CES for equipment access during sampling activities at the Concentrator in July 2006. A temporary roadway can be rented, from one of several manufacturers, for the approximate 400 ft long crossing. Design and specifications for this crossing should be developed as a part of the RA.
