Bear Creek Watershed Trails Assessment

Assessment prepared by:
Amber Shanklin, RMFI Program Director

November 14, 2012

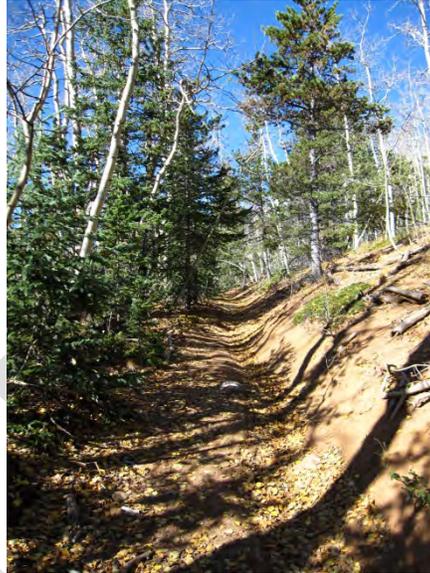
Photo 1. Erosion and downcutting along trail. Possible Solutions – construct 20 timber risers.

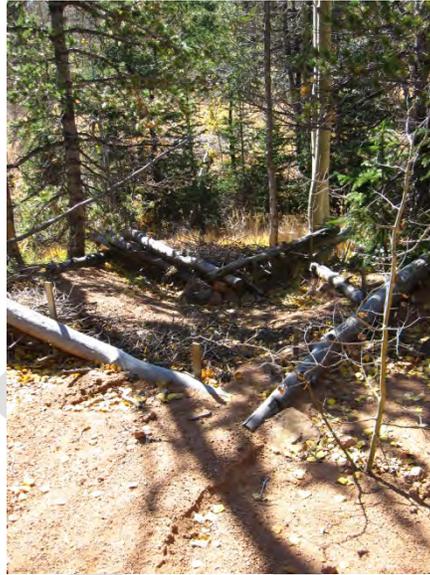
Photo 4. Sediment deposition area.
Possible Solutions – add 2 brush check dams.

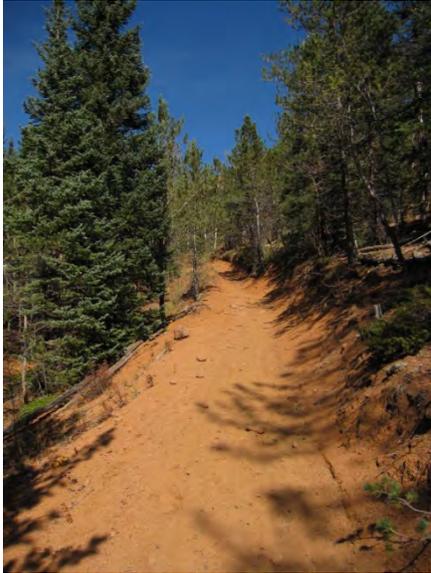
Photo 6. Erosion and downcutting along trail. Possible Solutions – construct 30 timber risers.

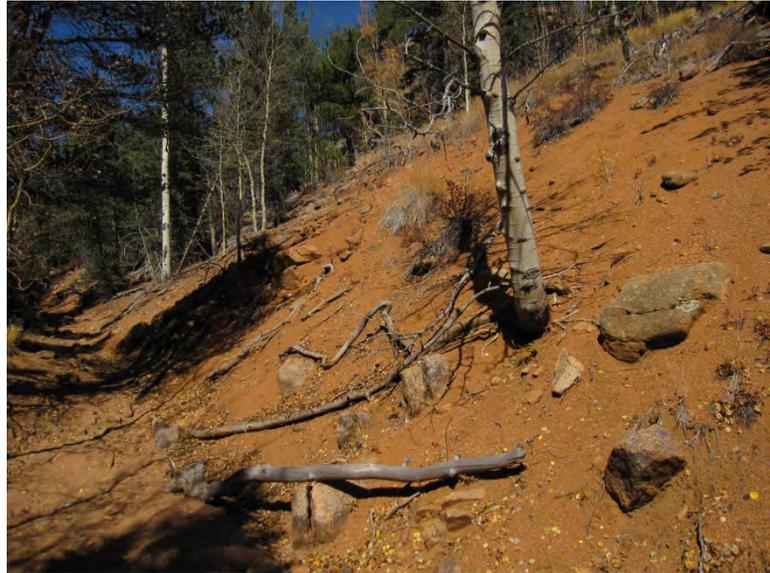
Photo 7. Erosion occurring on bare slope. Possible Solutions – stabilize slope and revegetate.

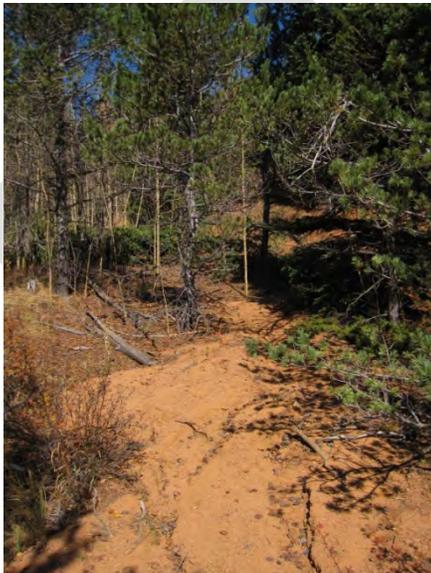
Photo 8. Sediment depositional area. Possible Solutions – install 10 horizontal log check dams.

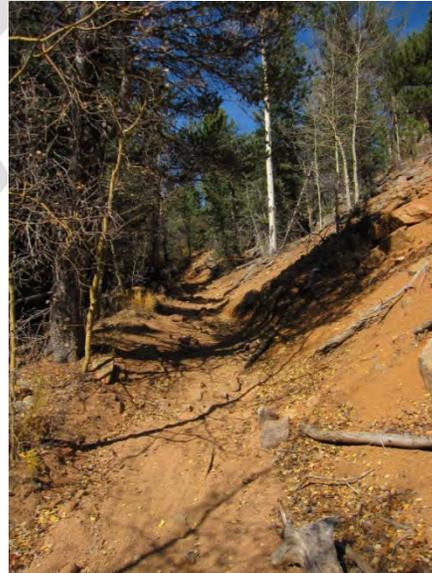
Photo 9. Erosion and downcutting along trail. Possible Solutions – construct 21 timber risers.

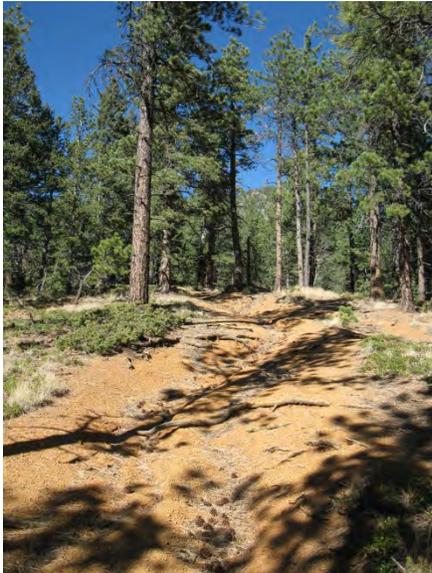
Photo 14. Gullies near Loud's Cabin social trail.

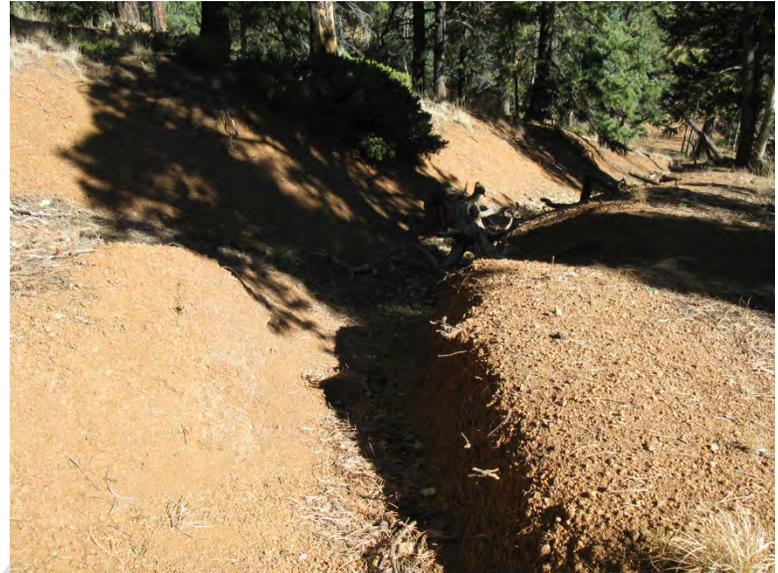
Photo 15. Gullies near Loud's Cabin social trail.

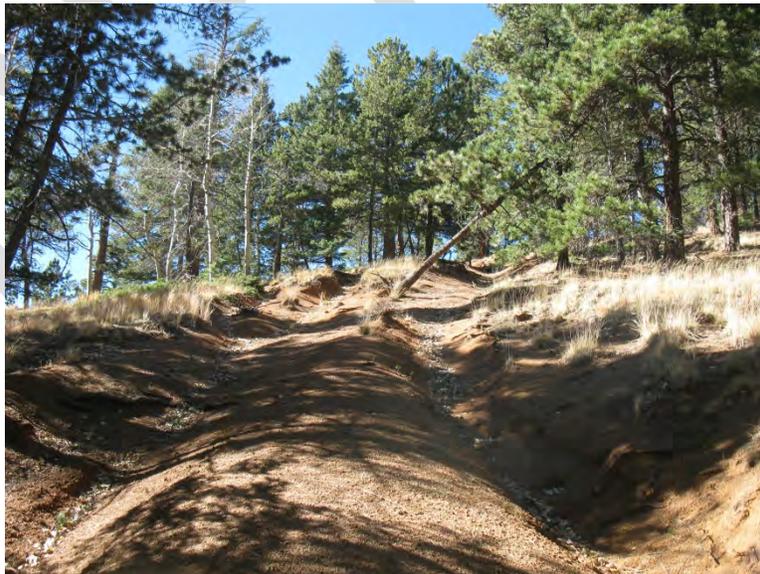
Photo 16. Gullies near Loud's Cabin social trail.

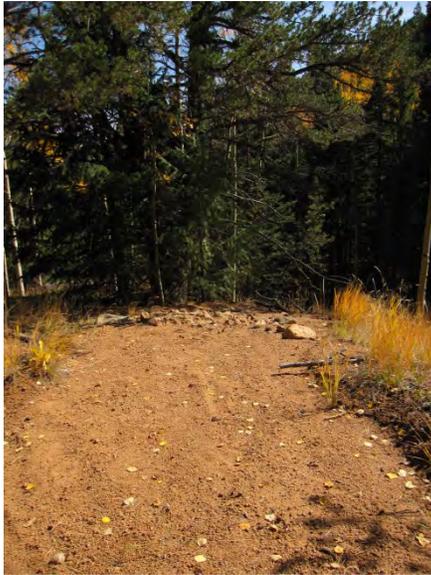
Photo 20. Sediment depositional area.
Possible Solutions – install 2 brush check
dams (Trail #667).

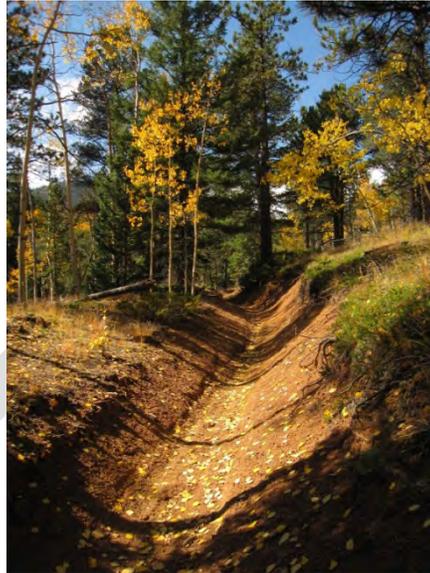
Photo 21. Erosion and downcutting along
trail. Possible Solutions – construct 9
timber risers (Trail #667).

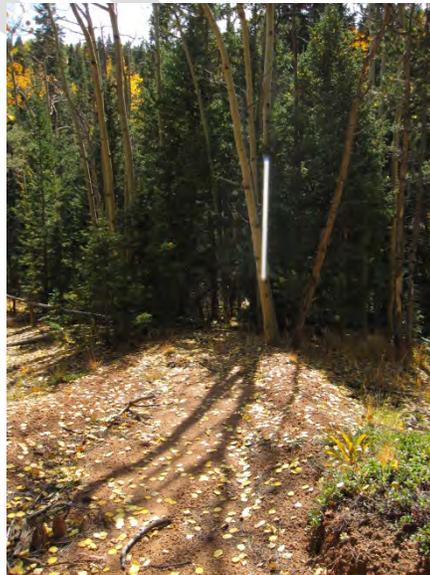
Photo 22. Sediment depositional area.
Possible Solutions – install 2 brush check
dams (Trail #667).

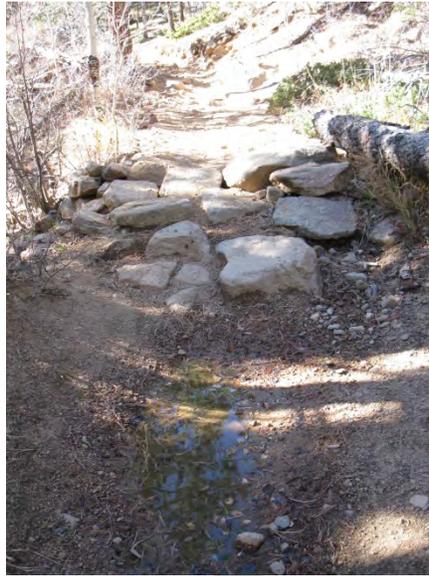
Photo 26. Existing in-trail culvert is collecting sediment and diverting water down trail. Possible Solutions – needs repair and maintenance (could add bridge to minimize annual maintenance).

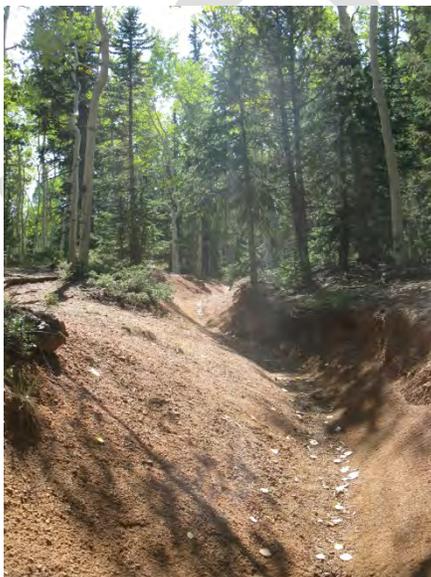
Photo 27. Erosion and downcutting occurring in trail. Possible Solutions – construct 15 timber risers

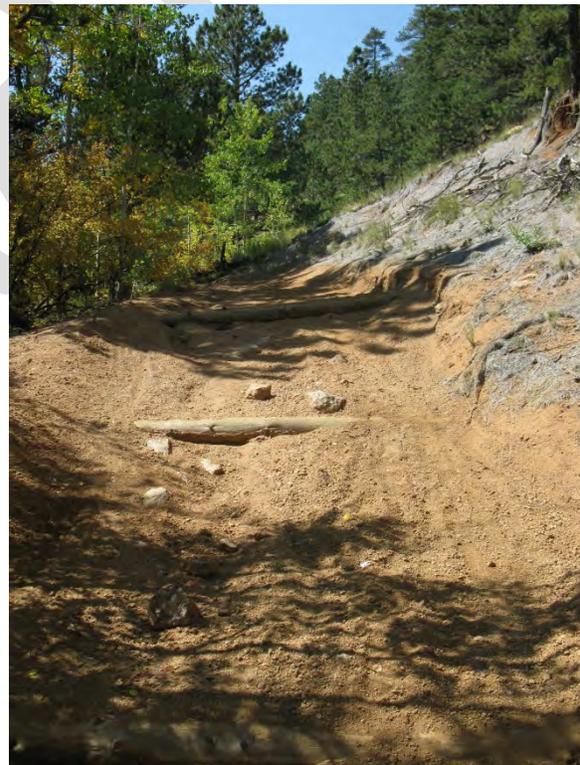
Photo 28. Erosion occurring in trail. Possible Solutions – remove logs and install timber risers.

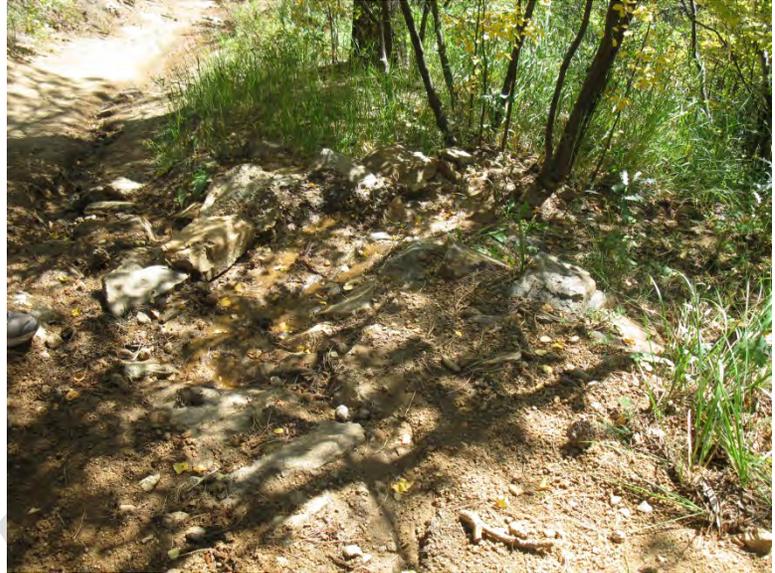
Photo 30. Drain that is clogged with sediment. Possible Solutions – maintain drain and/or replace with culvert or bridge (Trail #667).

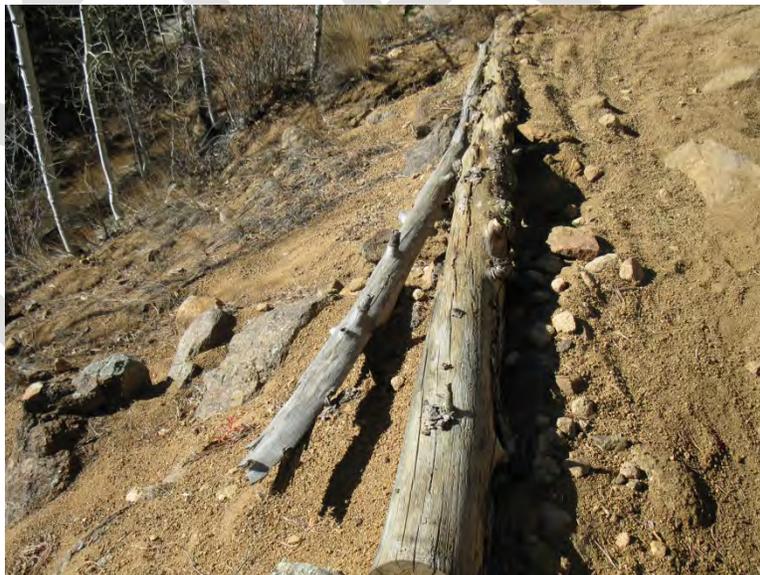
Photo 31. Erosion occurring under existing retaining wall. Possible Solutions – add new log and reconstruct retaining wall (Trail #667).

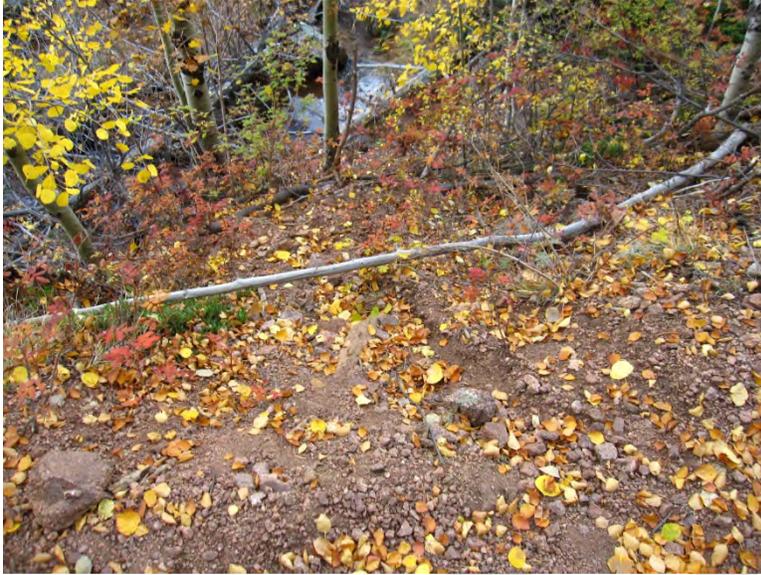
Photo 32. Deposition from trail entering stream. Possible Solutions – construct outslope retaining wall.

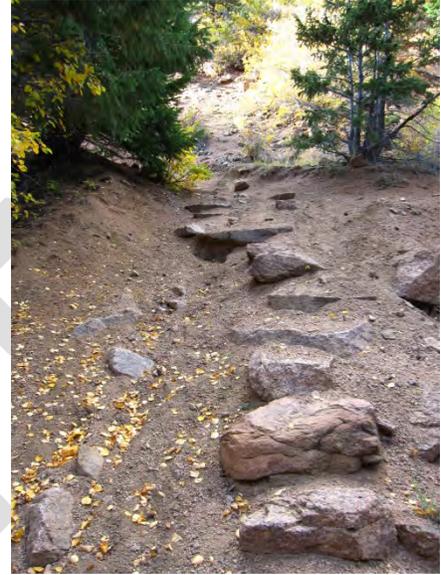
Photo 33. Erosion and downcutting in trail. Possible Solutions – construct 21 timber risers.

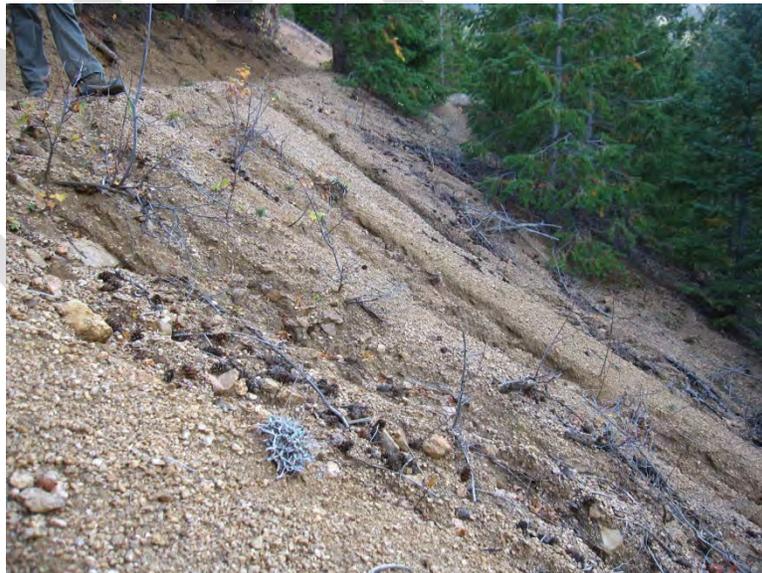
Photo 34. Steep, bare slope causing sediment to enter stream. Possible Solutions – Construct outslope retaining wall with vegetated terraced boxes.

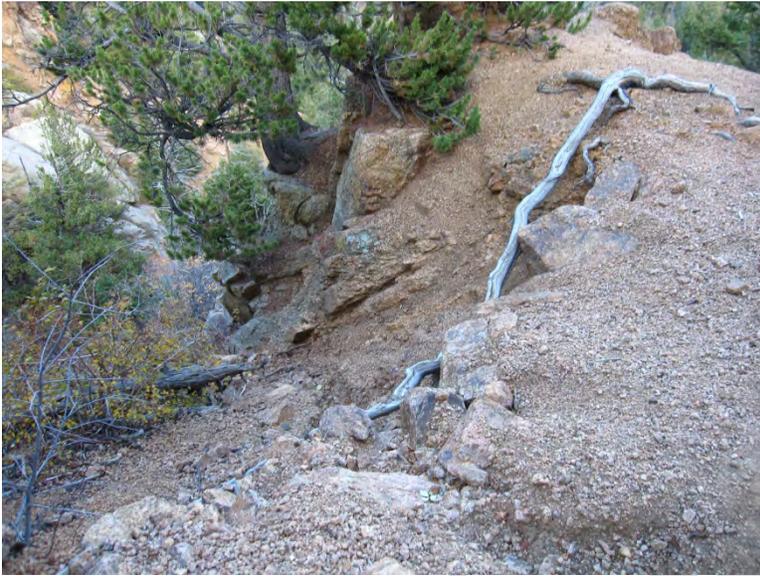
Photo 35. Deposition from trail entering stream. Possible Solutions – construct 24 foot outslope retaining wall and revegetate.

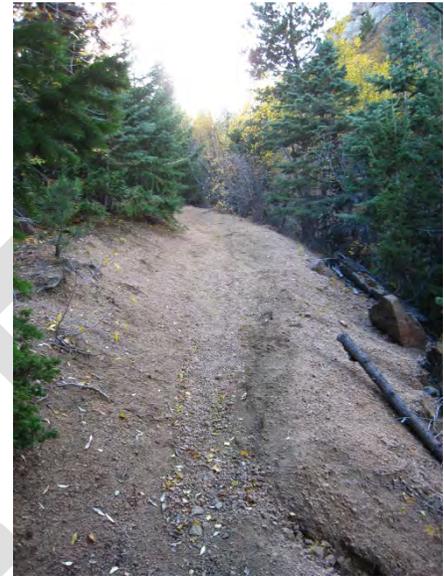
Photo 36. Erosion and downcutting in trail. Possible Solutions – construct 30 timber risers.

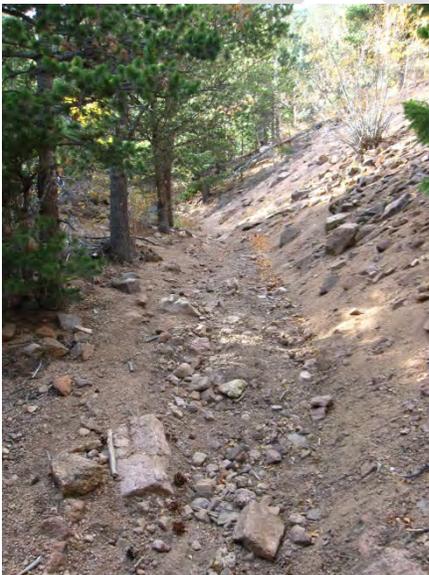
Photo 37. Erosion and downcutting in trail. Possible Solutions – construct 23 timber risers.

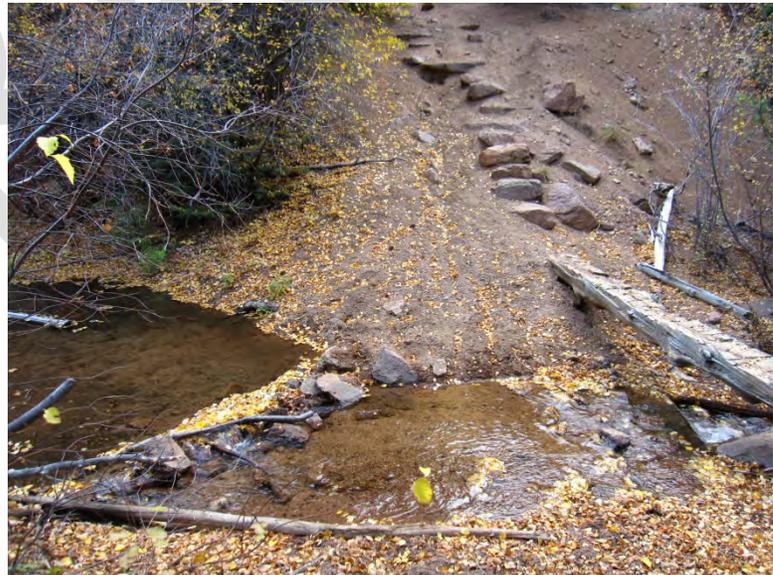
Photo 38. Sediment from trail entering stream. Possible Solutions – construct bridge over stream.

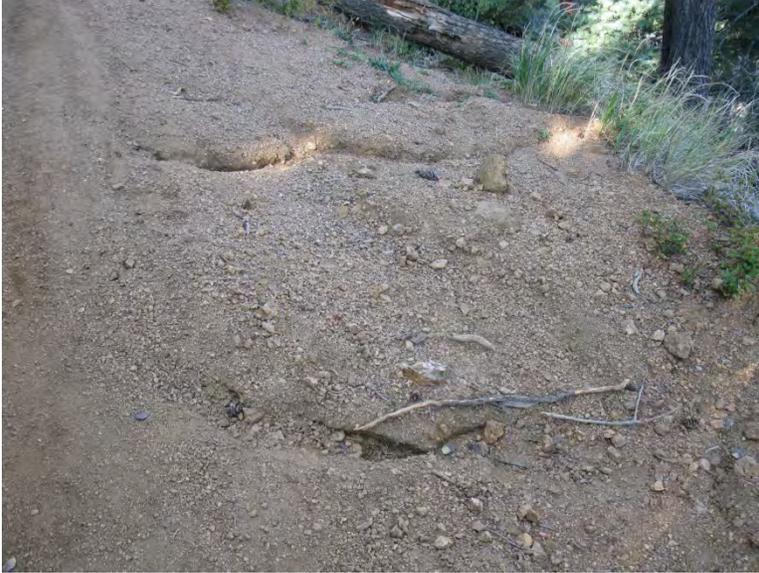
Photo 39. Bare, eroding slope. Possible Solutions – construct outslope retaining wall and revegetate.

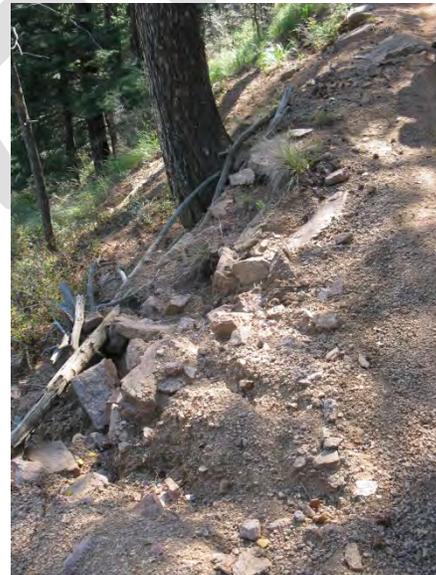
Photo 40. Bare, eroding slope. Possible Solutions – construct outslope retaining wall.

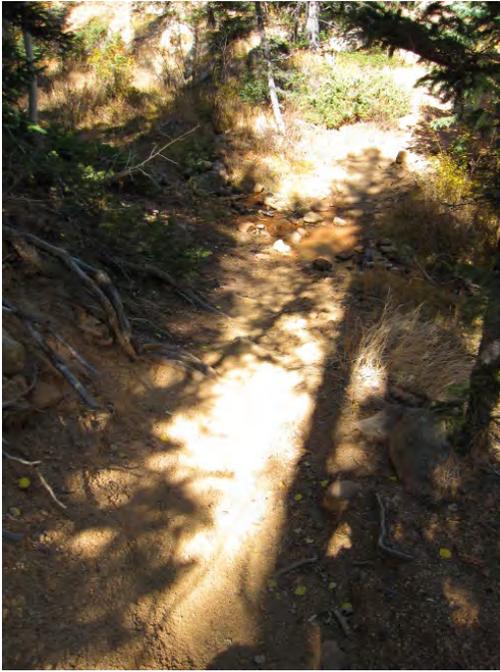
Photo 41. Trail crosses stream. Possible Solutions – install rock culvert or bridge.

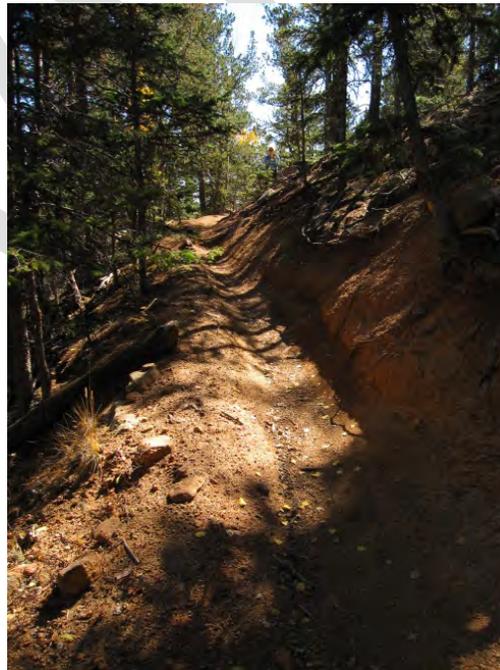
Photo 42. Erosion and downcutting in trail. Possible Solutions – construct 8 timber risers.

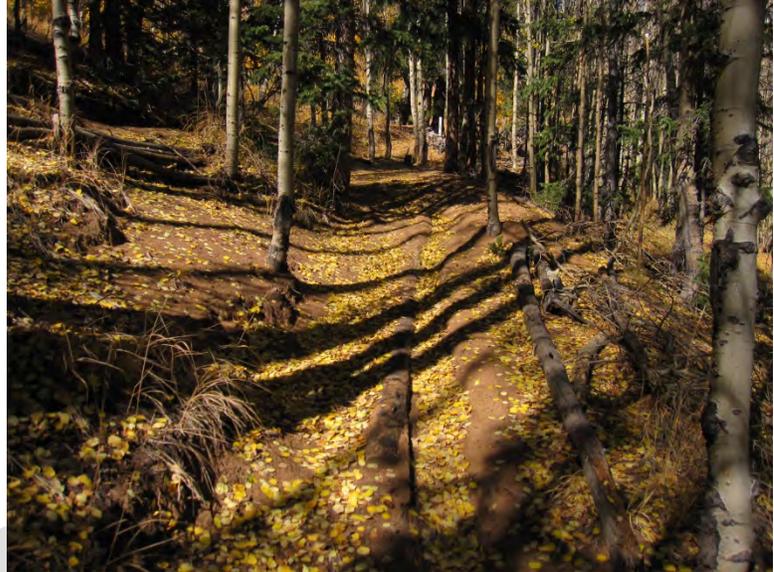
Photo 44. Erosion and downcutting occurring in trail. Possible Solutions – remove current log structure in trail and construct 12 timber risers (Trail #720).

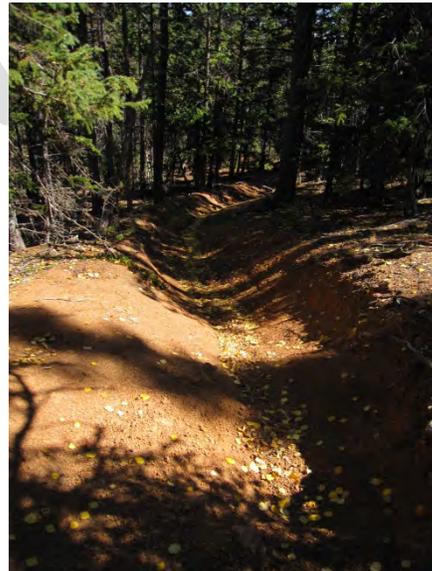
Photo 46. Erosion and downcutting occurring in-trail. Possible Solutions – construct 36 timber risers (Trail #720).

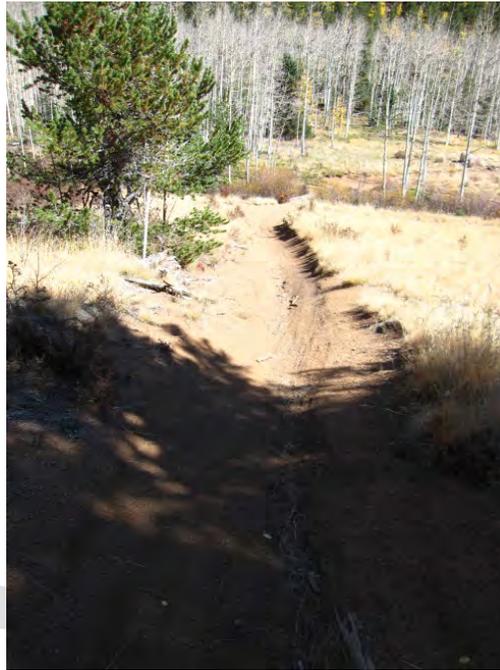
**Photo 47. Erosion and downcutting in trail.
Possible Solutions – construct 27 timber risers
(Trail #701).**

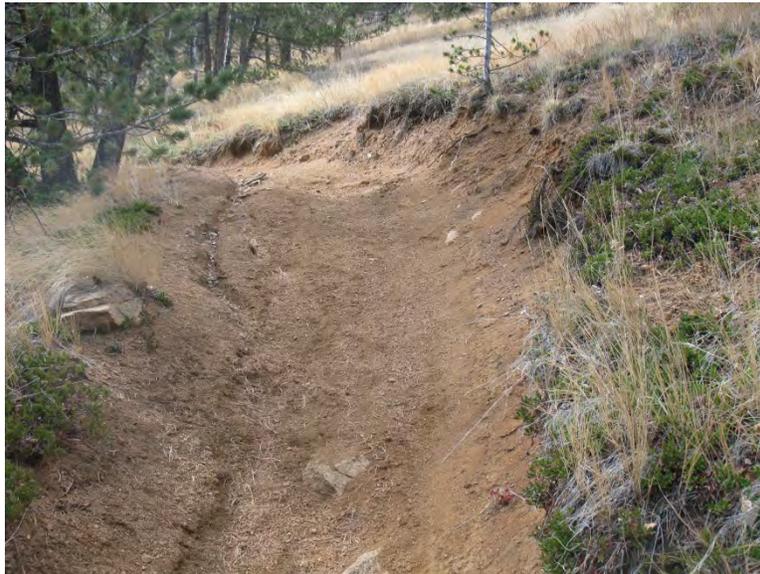
Photo 48. Erosion issues along trail and sharp turn causing slope failure. Possible Solutions – install waterbars and rock retaining wall (Trail #720).

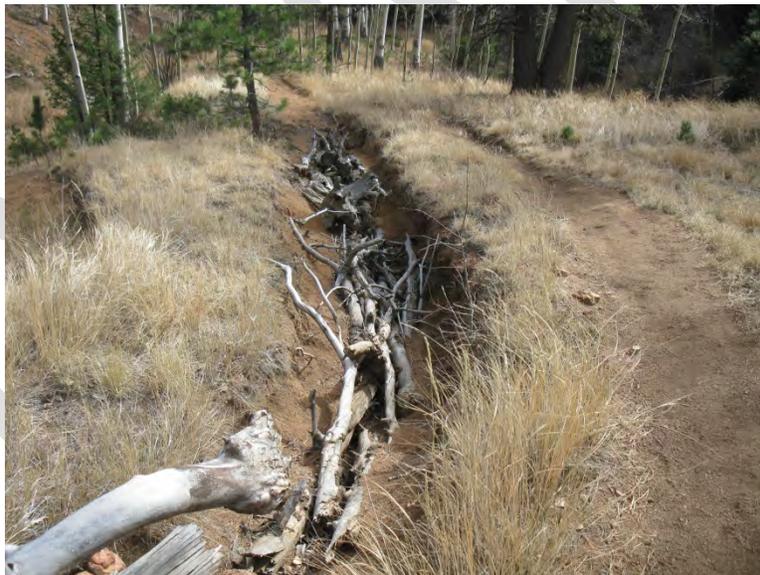
Photo 49. Trail downcutting caused users to create a new trail alongside old trail. Possible Solutions – fully restore area with check dams and vegetation (Trail #720).

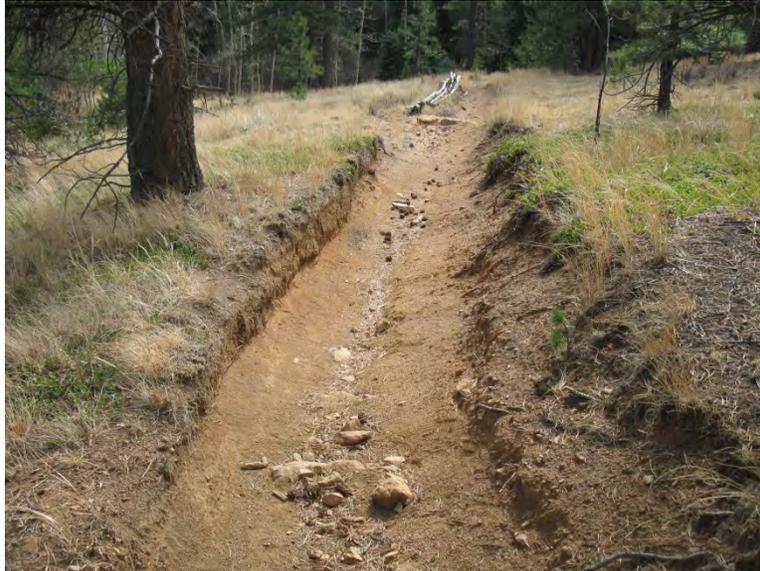
Photo 50. Incision along trail. Possible Solutions – install timber risers and waterbars to move water from trail and to stabilize trail tread (Trail #720).

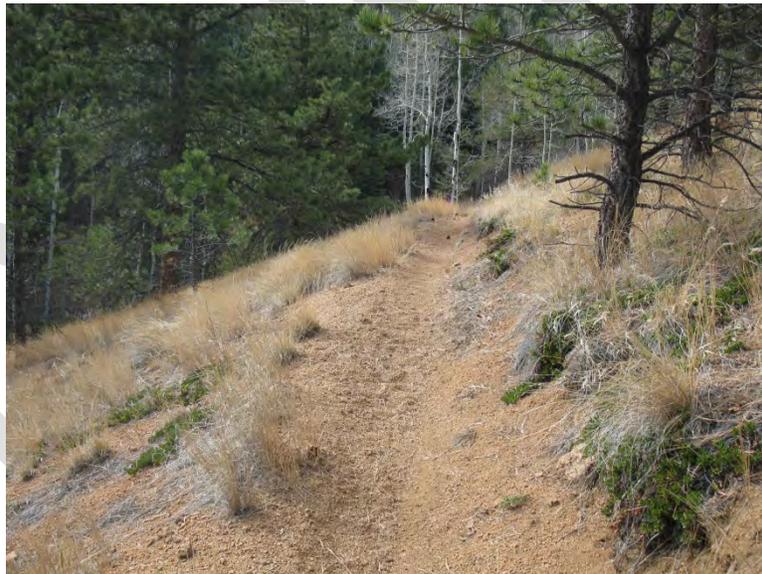
Photo 51. Incision along trail. Possible Solutions – install waterbars to move water from trail to reduce flow of water down trail (Trail #720).

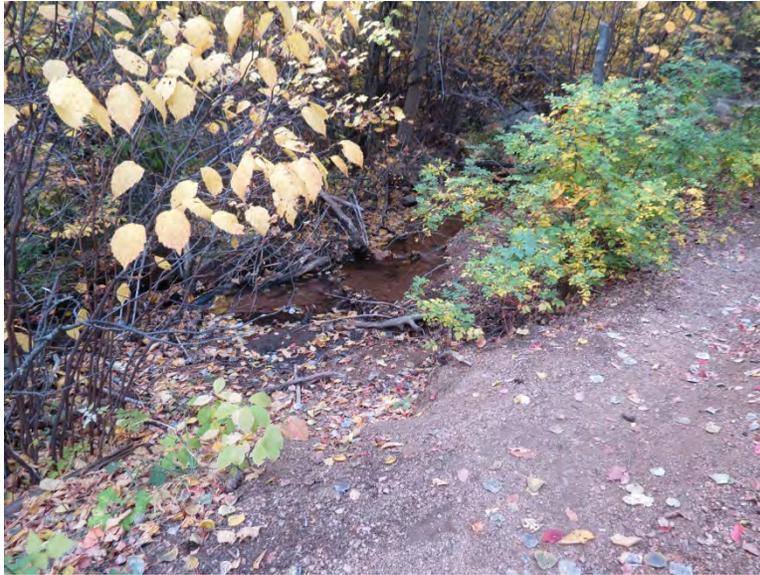
Photo 52. In-stream sediment deposition. Possible Solutions – construct retaining wall to minimize sediment movement.
