# Soil and Water Question 2a Appendix

## Best Management Practices Implementation and Effectiveness Monitoring Ketchikan-Misty Fiords Ranger District Recreation Trip Report – Winstanley Island Cabin, McDonald Lake Cabin, and Leduc Lake Dispersed Recreation Site August 23, 2012

Summarized by Suzanne Webb

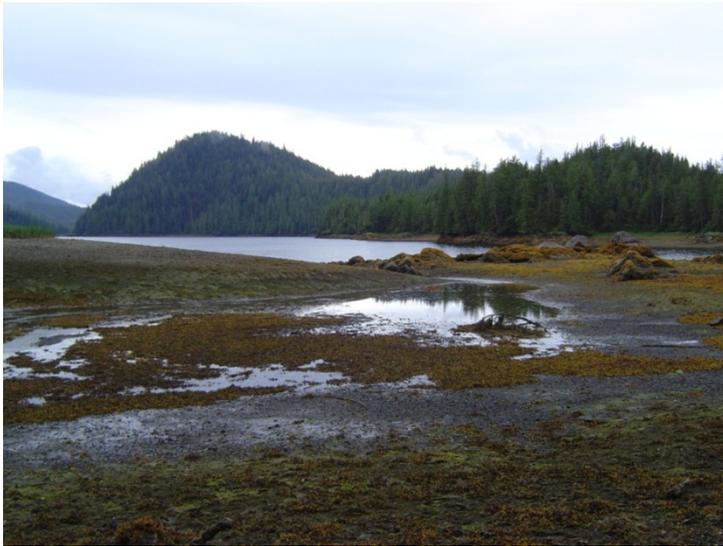
**Picture 1.** Winstanley Island cabin beach

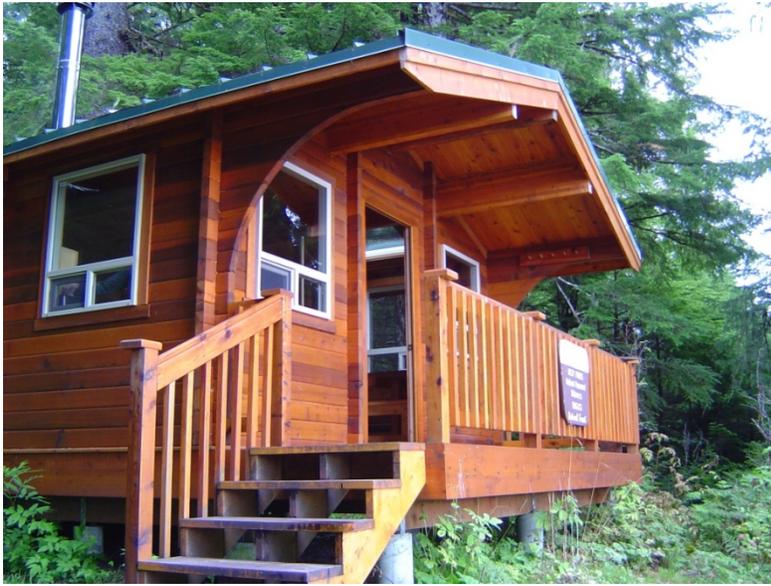
**Picture 2.** Winstanley Island cabin

The IDT determined that neither corrective actions nor adaptive management actions are needed to improve effectiveness or implementation of water quality standards and guidelines. The only impacts noted were incidental and minor. The new cabin was placed within the footprint of the old cabin. There is no impact to the site beyond the footprint of the original cabin, and there is no evidence of the old cabin. There are no new impacts to water quality from the reconstruction project.

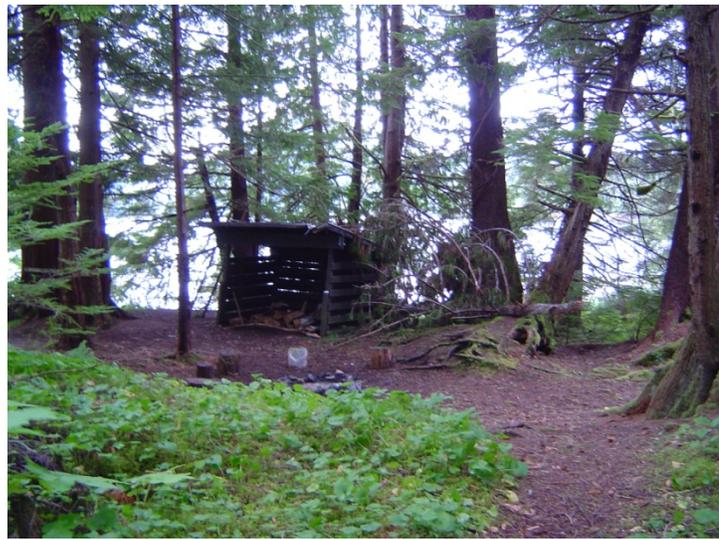
**Picture 3.** Winstanley Island cabin wood shed

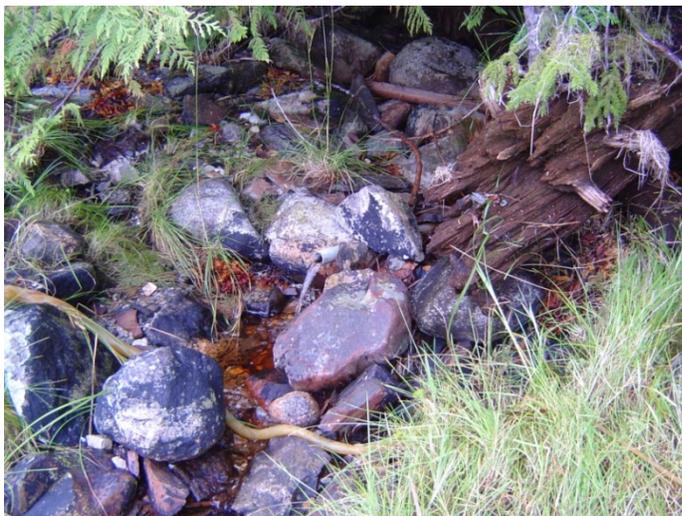
**Picture 4.** Winstanley Island cabin water source

The cabin receives moderate use by reservation, and it is likely that the area receives at least occasional day use also. At current levels of use there are no observable impacts to soil and water resources. There is a tree down on the path to the water source. The site is clean with little impact and no rutted soil.

The IDT has determined that no corrective actions or adaptive management actions are needed to improve implementation or effectiveness of standards and guidelines to protect water quality.

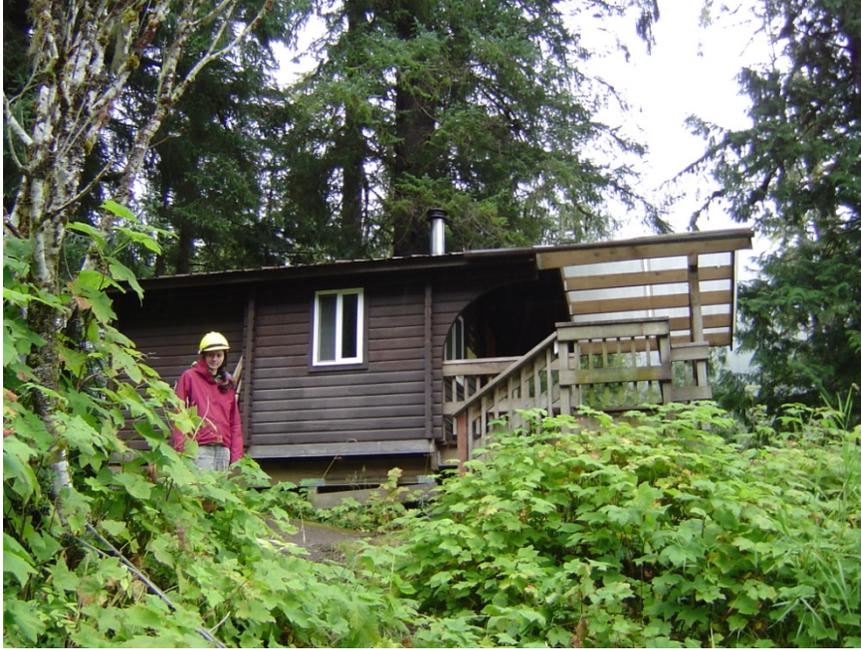
**Picture 5.** McDonald Lake cabin

Of the three trails reviewed in this evaluation, two were user created. The total length of trails evaluated is 100 feet and the total length of the user created trail is sixty feet. The total length of the water body transect is 250 feet. The IDT found minor impacts to water quality along ten percent of the length of the water body transect. Minor bank trampling and compaction from foot traffic were noted on both Forest Service and user created trails. The IDT determined that these impacts are a result of normal use. There is no evidence of impacts to water quality on the trails leading to water bodies.

The IDT determined that neither corrective actions nor adaptive management actions are needed to improve effectiveness or implementation. The only impacts noted by the IDT were incidental and minor impacts. Overall the site is in good condition with very little past erosion and no current erosion observed.

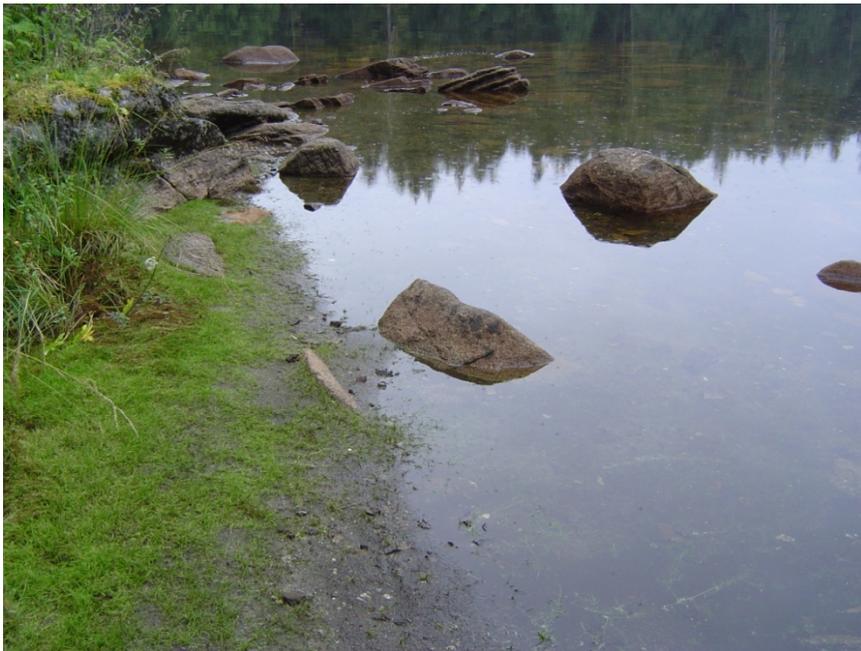
**Picture 6.** Dispersed recreation site adjacent to McDonald Lake cabin

cabin receives moderate use by reservation, and at current levels of use there are no observable impacts to soil and water resources. No soil damage or erosion was noted.

The IDT has determined that no corrective actions or adaptive management actions

are needed to improve implementation or effectiveness of soil and water standards and guidelines. The

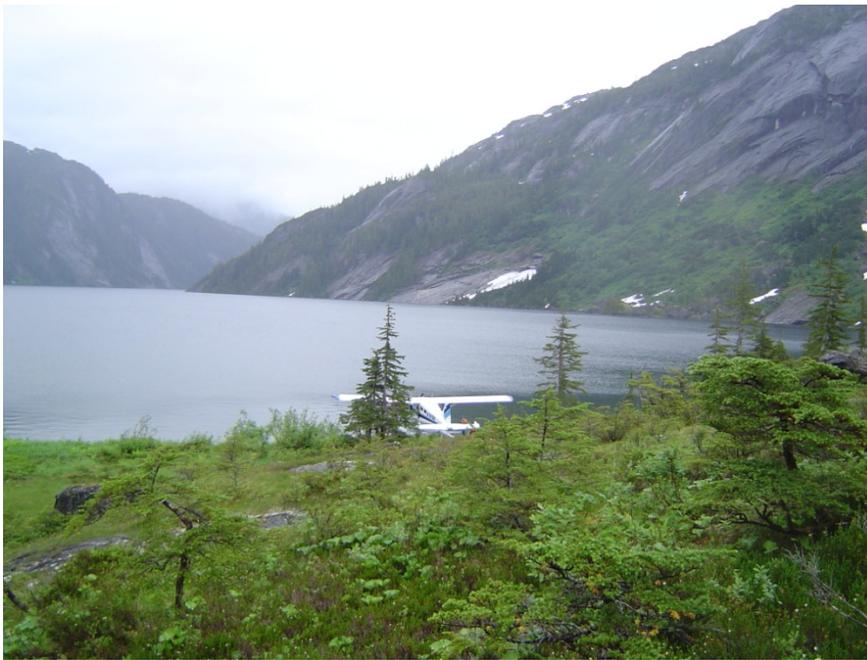
**Picture 7.** Leduc Lake dispersed recreation site

action in the last five years because no spills, leaks, or dumping have been reported in that timeframe. No evidence of potential or current impacts to water quality was observed along the water body transect.

The IDT has determined that no corrective actions or adaptive management actions are needed to improve implementation or effectiveness of soil and water standards and guidelines. There is no evidence of sediment transport, trampled vegetation, rilling, gullies, or any other sign of visible impact to water, aquatic, and riparian resources. Other observations that the IDT

made include a few small trees cut, three to five inches in diameter, and the partial wreckage of a plane from a crash that occurred in the 1980s. The wreckage is located several hundred feet to the north of the site. There is no fuel leakage. The District Ranger is investigating options for removal of the wreckage.
