Soil and Water Question 2a Appendix

Best Management Practices Implementation and Effectiveness Monitoring Ketchikan-Misty Fiords Ranger District Timber Trip Report - Boundary II Timber Sale; September 17, 2012

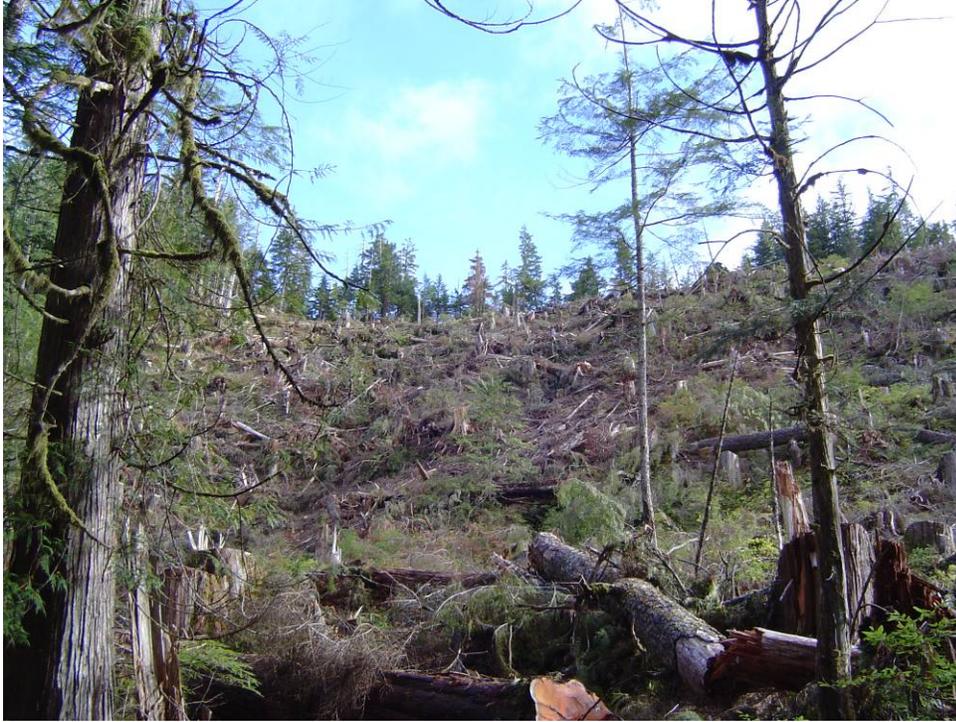
Picture 1. Unit 5 looking up from the lower part of the unit

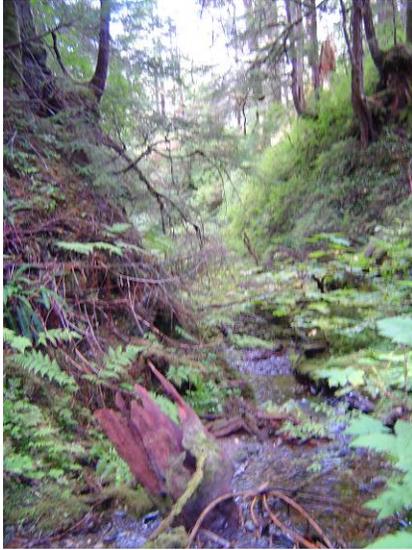
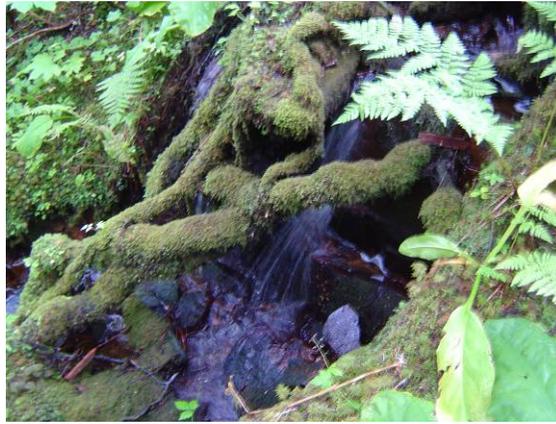
Pictures 2 and 3. Class III stream immediately below unit; no sediment transfer noted

The unit is located on a side slope of a ridge that lies above a low lying series of muskegs. The class III stream, which traverses in a HC channel west of the unit, is a tributary of a class III stream that flows approximately 1.3 miles to Talbot Lake. This class III stream is over 100 feet outside the unit. The confluence of the class III streams is roughly 1.4 miles west of the unit, measured approximately along the stream course. The class III stream adjacent to the unit is roughly 2.7 miles along the stream reaches to Talbot Lake. The IDT team reviewed the lower reach of the stream below the unit and found no sediment or evidence of impact to the stream channel or aquatic management zone (AMZ). Within the unit, there were two streams that were not mapped but noted by the IDT team. The streams were treated as intermittent side slope drainages and no treatment was implemented. These intermittent streams flow to a wetland area below the unit. The IDT reviewed the lower reaches of these streams and found no evidence of sediment in the streams. The water was still flowing in the channels and maintained in the reaches below the unit. The unit was yarded using logical setting breaks and the trees were retained adjacent to the class III stream to provide a buffer.

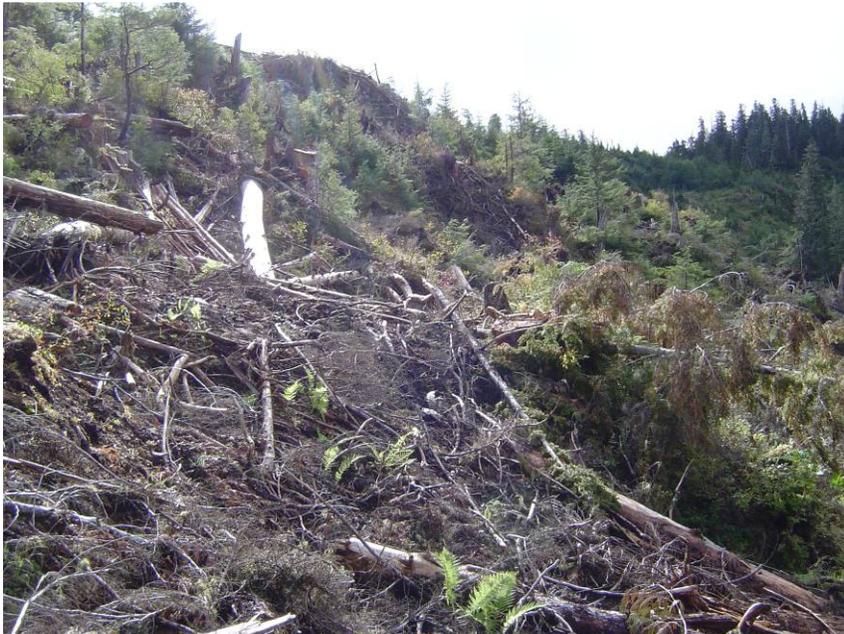
Overall the unit card had identified the slopes in the original unit were 10-85+ percent slope gradient. The average slope was noted to be 50% slope gradient although approximately 14 acres are noted to exceed 85 percent slope. The unit was not field reviewed by a soil scientist prior to layout or harvest. Partial suspension was not required in the unit; however, steep slopes up to 85 percent slope gradient were identified in the unit. Partial suspension was achieved in the unit through application of the cable yarding system. The unit card identified low to moderate risk of management induced landslides or other impacts to water quality. The IDT agreed that field review by a soil scientist should have been completed and would have resulted in a prescription of partial suspension throughout the areas that showed a slope gradient over 72 percent slope and dropped the unstable landslide terrain during planning.

Cable yarding was monitored in the unit. The group noted that the unit was harvested within the boundaries as designated on the sale area map. The cable system required yarding logs up a steep 85 percent slope face to the landing and these steep pitches showed some bared soil and soil disturbance. The ground disturbance was within 3 percent of the unit area, which is less than the 15% allowable detrimental soil conditions described in the soil quality standards. In few isolated areas, water rills and sheet erosion was noted in the one cable corridor; however, the erosion extended for less than 40 feet length. An area roughly 6 feet by 40 feet along the steep bluff in the unit showed bared and displaced soil where logs had been yarded up the steep slope in a blind lead. Reviewing the unit card, no suspension was required in the unit. Soil erosion was isolated on the steep bluff and did not extend to the stream management zone. Planning should have been made to design settings to minimize yarding up the steep slope face. There was no noted erosion in the intermittent streams and minor impact from the cable operation.

Picture 4. Some of the steep slopes in the unit

- Units with slopes over 72 percent slope gradient need to be field reviewed by a soil scientist. If field review does not occur during planning, it should be completed prior to layout and definitely prior to harvest. This review is necessary to limit potential slope stability concerns and detrimental soil disturbance.
- Units showing evidence of old landslides and slope stability issues should be field reviewed by soil scientists during planning. Deletion high mass movement index terrain should be considered during planning.
- The landings and temporary road constructed on non-FS land needs to be considered and the best management practices employed on private or state land defined.

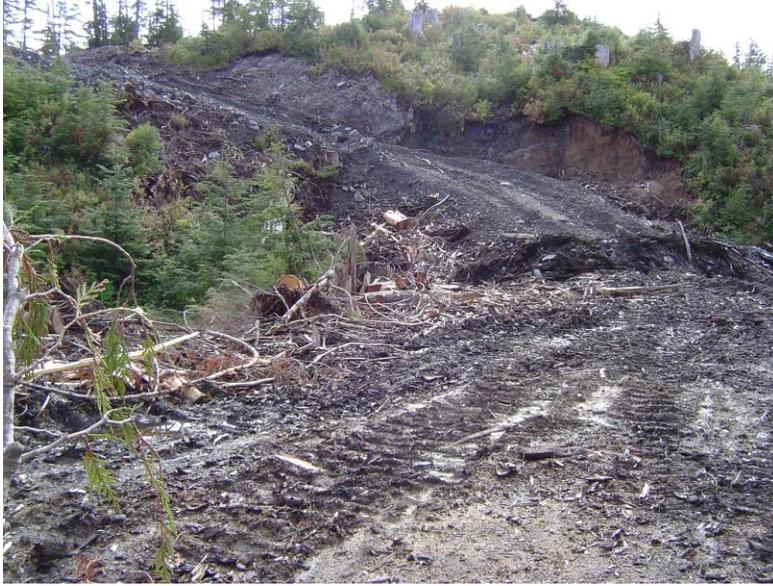
The landing had been graded during operation; however, a few ruts, rills and water ponding were noted on the landing. The four to eight ruts and rills noted on the landing were 4 to 6 inches deep, 10 to 15 feet long. The disturbed soil was limited to the landing deck and the sediment was retained by slash on the edge of the landing. The group noted the landing location provided the operator the opportunity to achieve deflection in most of the unit although there was a short blind lead below the landing.

The temporary road that accessed this unit was closed. There were ruts and erosion noted on the running surface of the road. This road was not on Forest land as the operator had accessed the unit through Cape Fox Corporation land. A water bar was excavated to provide cross drainage across the road surface and limited water from running down the road to the landing. The water bars did not provide effective water transport; although did serve to limit water flowing on the road surface. Grading of the road surface as well as shaping the water bars should have been required prior to removing equipment from the site to limit surface erosion if the road was a Forest temporary road.

Overall, the unit harvest was completed to implement the best management practices. There was only minimal disturbance shown in the unit and not impact was noted relative to the class III stream that is shown outside the unit boundary. The construction of the landing and temporary road on non-Forest land limited the ability of the Forest to require grading and limited the requirements for cross drains and water bars.

Picture 5. Landing in foreground with temporary road in background

Corrective actions noted in this unit are focused on the landing and temporary road and suspension prescriptions. The IDT recommends the following:
