Soil and Water Question 2a Appendix

Best Management Practices Implementation and Effectiveness Monitoring Petersburg Ranger District Road Storage Trip Report – Mitkof and Kuiu September 2012

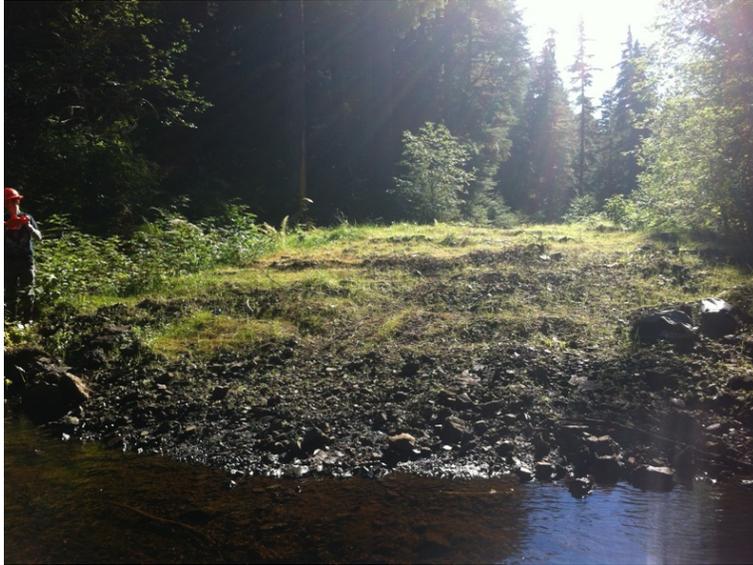
Although there was no contract inspection of Kuiu Road 6409 when it was stored in 2011, applicable practices for erosion control, equipment-stream crossings, drainage, and revegetation appeared to be fully implemented (picture 1).

Picture 1. Road 6409 MP 0.271 view of downstream left bank after log stringer bridge removal. Despite failure to fully restore channel width, note bank slopes and success of erosion control seeding.

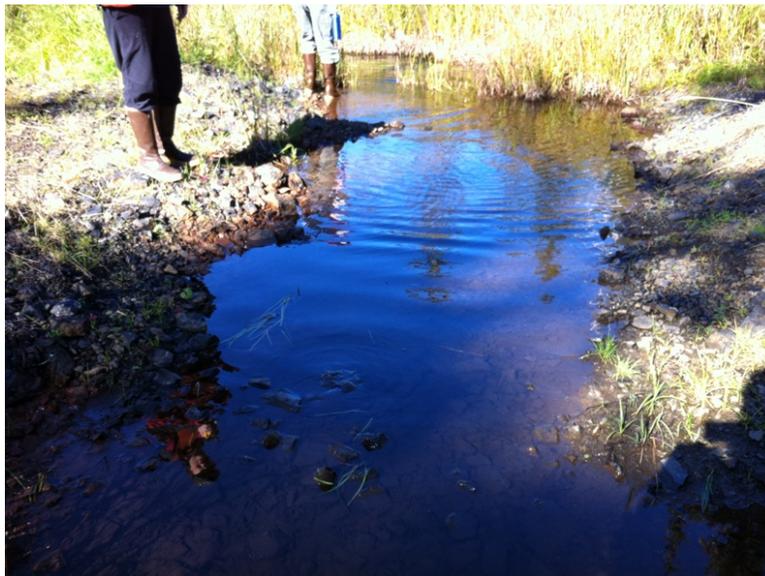
Excavated material at streambanks was stable and additional water bars (more than the contract specified) were appropriately located. Practices for stream channel stabilization and fish timing windows were not fully implemented and unauthorized OHV use is evident. We noted a previously un-identified fish stream (not identified as a work item in the contract) that was partially treated by removing some fill over a culvert to allow water to cross the road (picture 2).

Picture 2. Road 6409 vicinity of MP 0.3. Unmapped anadromous fish stream with 24" CMP left in place.

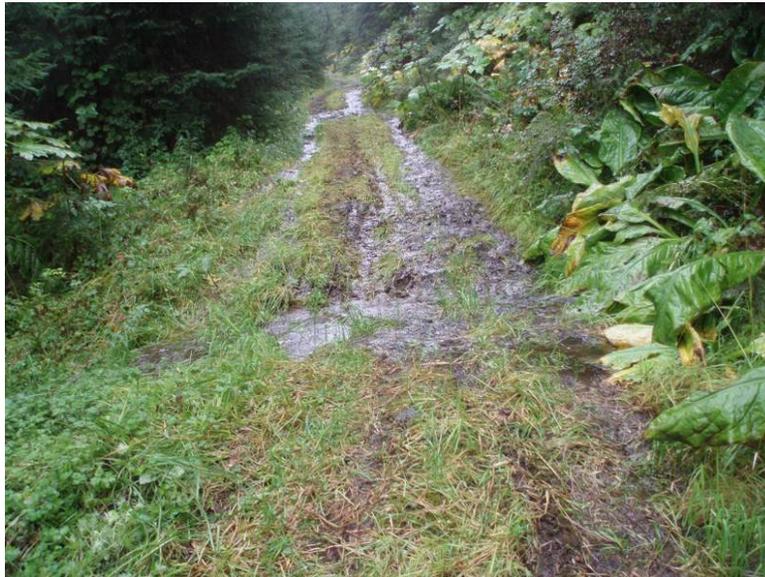
Mitkof Road 6226 was stored as an OHV trail at least five years ago, so we did not evaluate contract specifications for applicable BMPs. We think the plan was to remove all structures, but this was changed in consultation with aquatic personnel and log culverts were retained (other structures had previously been removed) in order to avoid steep/deep OHV crossings. The road surface is well-vegetated and water bars are appropriately located (picture 3). We did not identify corrective actions for this road, but agreed that we would have added additional waterbars to prevent stream diversions if we were storing the road now.

Picture 3. Road 6226 road surface is well-vegetated with water bars. Additional water bars needed, though the ones present were appropriately located.

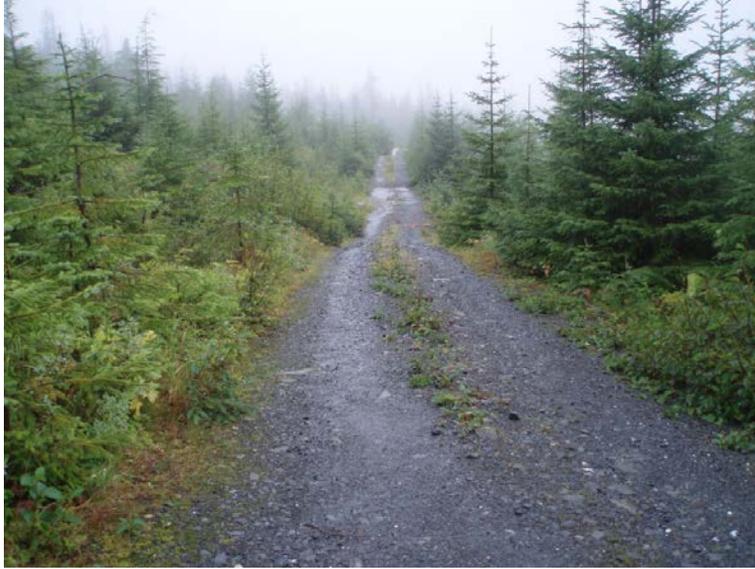
Picture 4. Road 40007, open and drivable, with Class IV stream diversions. Storm proofing is needed.

- Mitkof Road 40007: Culverts are plugged and small streams are diverted down the road during high flows (picture 4). We recommend cleaning catch basins, ditches, and adding drivable waterbars.

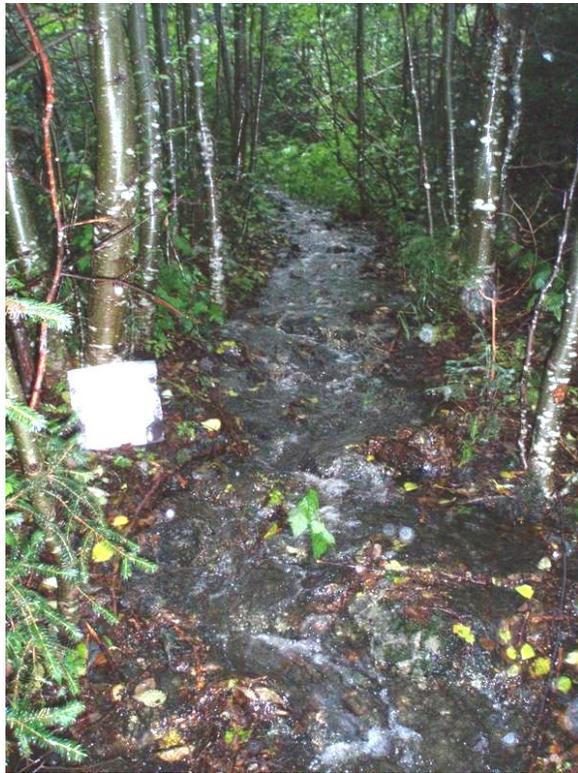
Picture 5. Road 6280 near MP 2.2. Stream is diverted onto road for about 400 feet. Storm proofing, water bars and structure removal needed.

- Mitkof Road 6280: Culverts are plugged and streams are diverted down road during high flows (pictures 5 and 9). We recommend removal of culverts and installation of water bars. Brush may limit equipment access, will need to be evaluated for blasting.

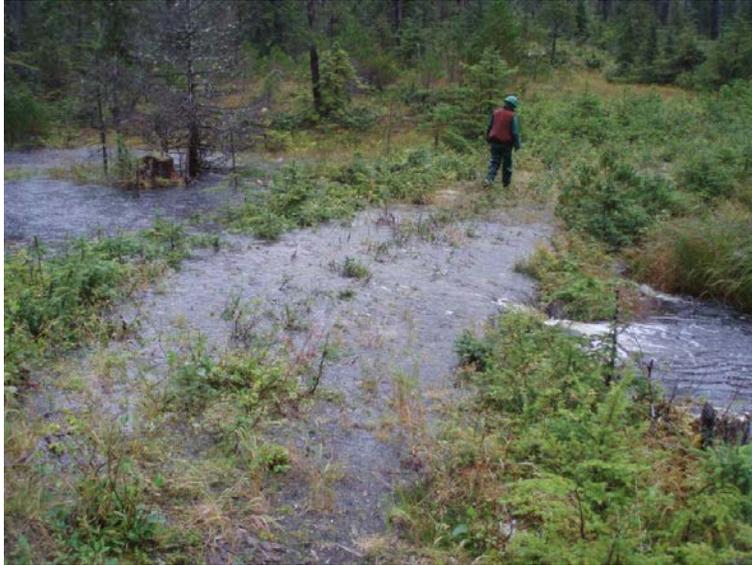
Picture 6. Road 6200 MP 0.273, resident fish stream. 36" CMP appears plugged, with water running across road. Structure needs maintenance, storm proofing and evaluation for fish passage.

- Mitkof Road 6200: Water was concentrating on road in a couple places. A fish stream culvert at MP 0.273 is plugged, with water flowing across road (picture 6). We recommend storm proofing culverts and adding drivable waterbars. The fish stream culvert was rated green for fish passage in 2004; we recommend maintenance, reassessment, and possible remediation.

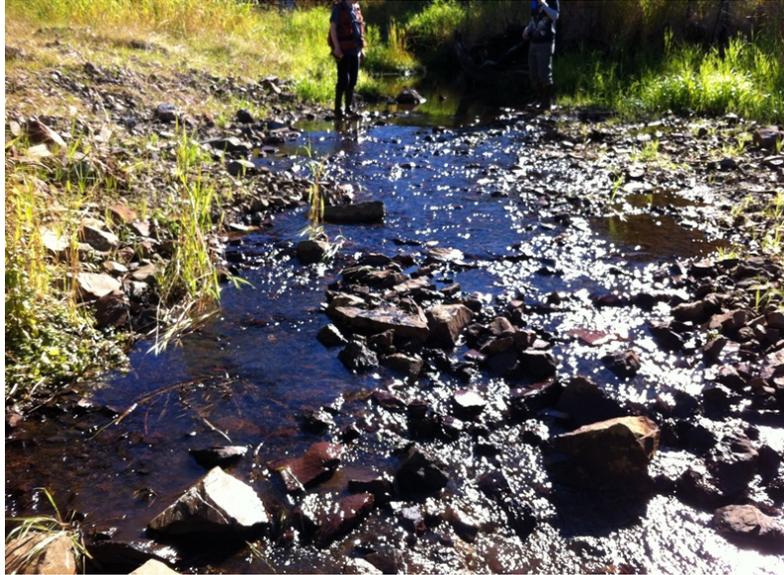
Picture 7. Road 6409 MP 2.016 after 48" CMP removed from anadromous fish stream. Excessive fill left in channel.

- Kuiu Road 6409: Removal of culverts from fish streams did not meet contract specifications for excavating to the streambed's original elevations. Excessive road fill left in channels resulted in channel widening through the road prism and potential barriers to fish passage at low flows (picture 7). Bridge removal from a fish stream did not restore streambanks to natural channel bed width (pictures 1 and 7). Since no equipment is mobilized on Kuiu Island, the cost is not justified to return equipment to this road to correct. We recommend monitoring (including un-mapped fish stream near MP 0.3) to determine if fish passage is impaired during dry seasons. Hand work or blasting may be necessary in the future.

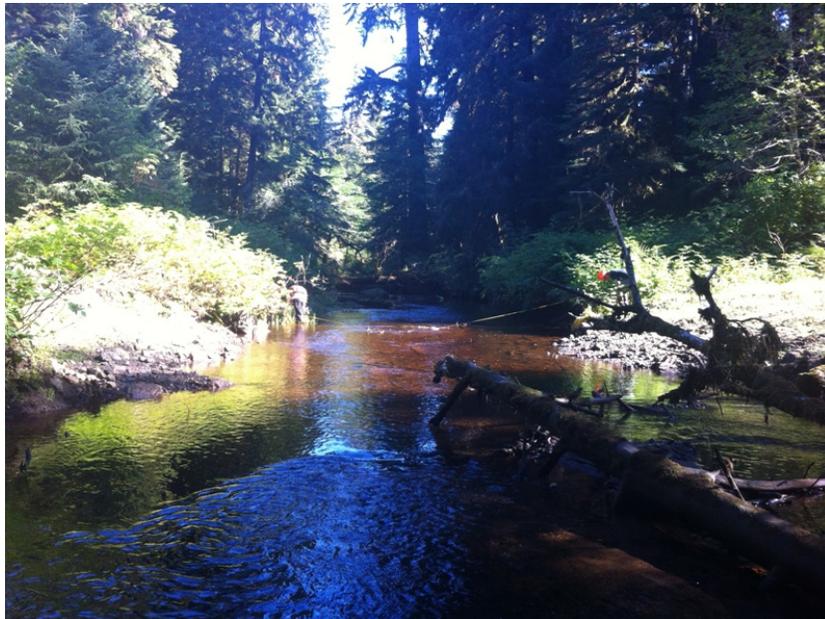
Picture 8. Road 6409 MP 0.271. Log stringer bridge removed from anadromous fish stream. Note road fill constricting channel.

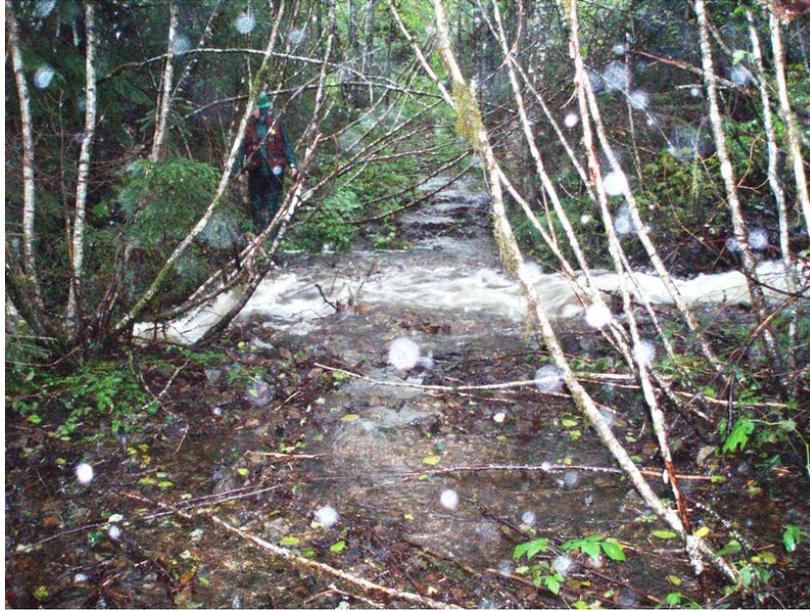
Picture 9. Road 6280 MP 1.846. Alluvial fan crossing where a 24" CMP has plugged. Water is flowing over road and diverted down road.

- Kuiu Road 6409: No traffic barrier was installed. OHVs (and possibly high clearance vehicles) can still access fish stream crossings. We recommend installing a more effective traffic barrier to prohibit motor vehicle access.
- Mitkof Road 6280: The alluvial fan crossing at MP 1.85 had plugged culverts recorded in 1999. We recommend evaluating the fan and its stream channels up and downstream of the road to determine the most effective treatments to re-connect downslope fish streams and avoid cascading failures caused by stream diversions. Culvert and fill removal may require installation of bed control structures to minimize headcutting.
