Soil and Water Question 2a Appendix

Best Management Practices Implementation and Effectiveness Monitoring Thorne Bay Ranger District Road Storage Trip Report – Wolf Pup / Stoney Creek, Logjam; September 20-21, 2012

Summarized by Carol Seitz Warmuth

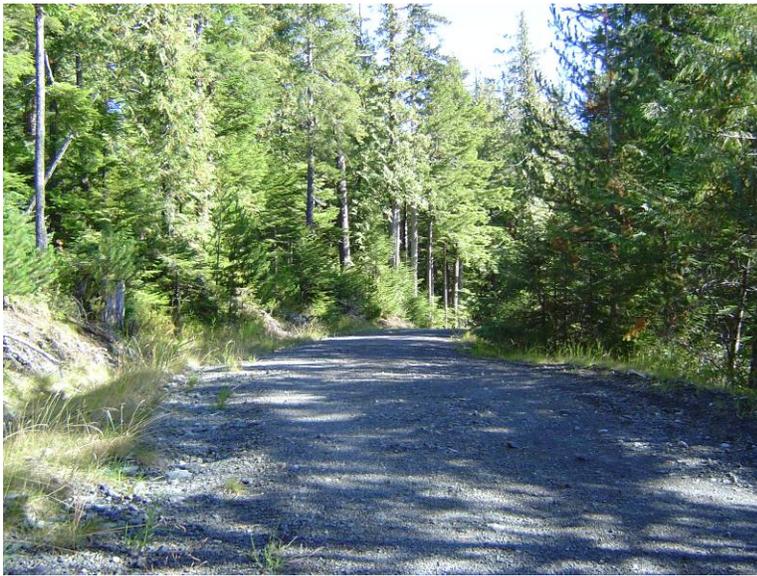
Picture 1. Road 3000360 looking back at MP 0.90

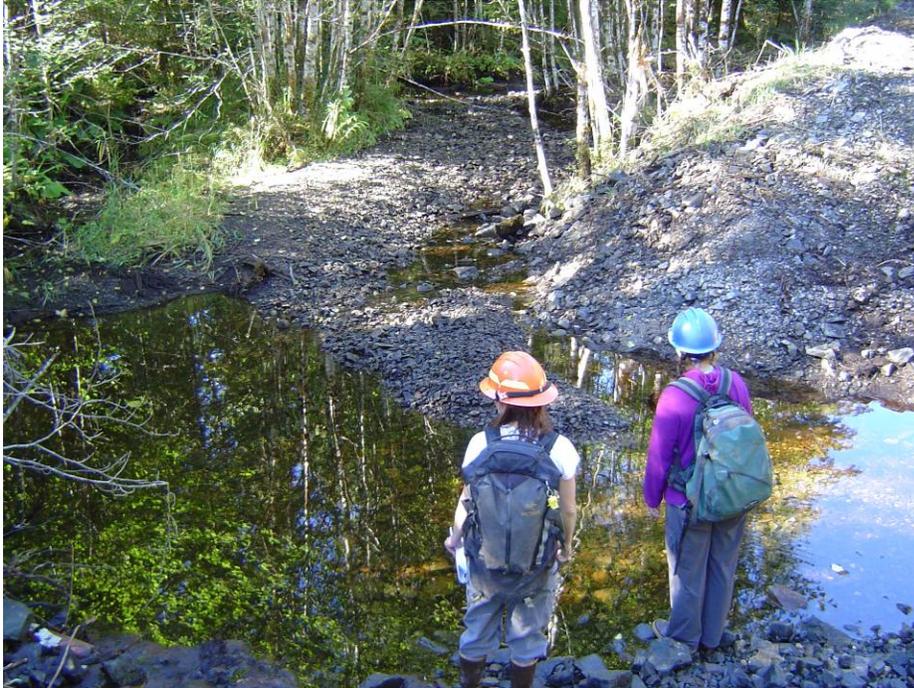
The crossing structures at MP 0.43 and MP 0.44 were designated to be “dual culvert sites” since the road crossed the same stream with adjacent culverts. Concurrence for the in-stream work was documented in an August 17, 2012 letter from ADF&G. At MP 0.43, the excavated stream crossing showed relatively low gradient side slopes and the fill material was relatively stable and not raveling into the stream. The road was excavated to the natural stream channel dimensions and the channel did not exhibit any channel adjustment. There was a side channel shown upstream of the crossing and confluence immediately upstream of the crossing. There is water running in the road ditch and on the road on the far side of the crossing that flows to the stream. At MP 0.44, the side slopes on the excavated channel banks were relatively low gradient and stable, although there was evidence of some raveling. There were some fines deposited along the base of the slope adjacent to channel that indicated channel cutting and channel realignment.

Picture 2. Road 3000360 inlet at MP 0.43

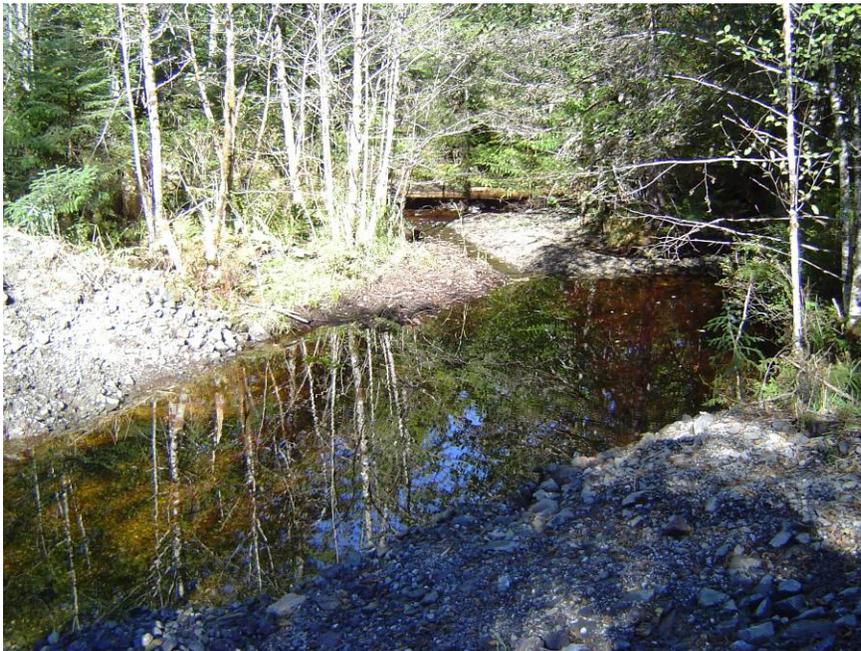
Picture 3. Road 3000360 crossing outlet at MP 0.43

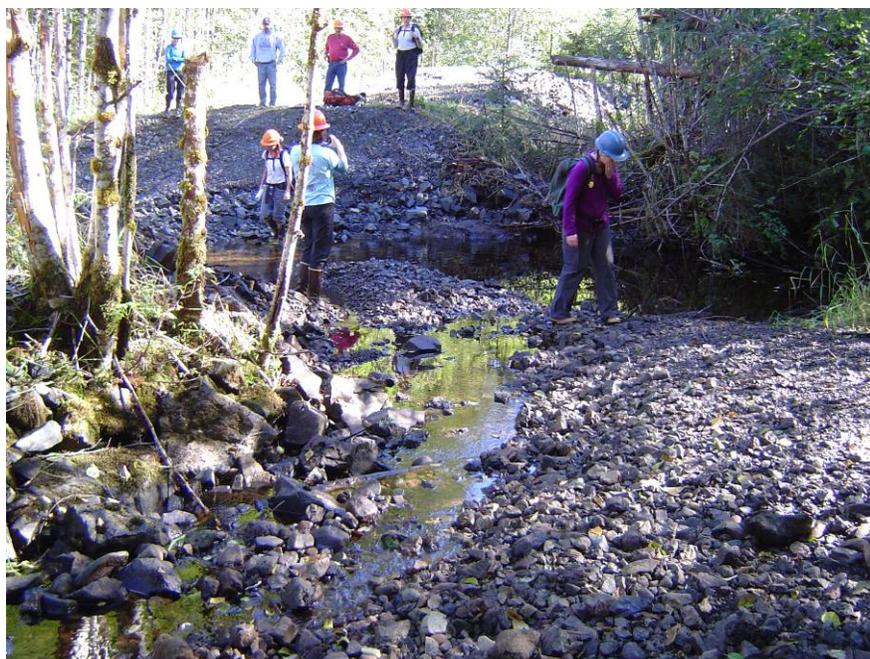
Picture 4. Road 30000360 at MP 0.43; water from ditch line flowing to fish stream at crossing

road prism was in good condition and showed only minimal sheet wash and water rills on the road near the stream crossing at MP 0.43. Ponded water was noted along the road between MP 0.43 and 0.44. The ponded water was shown along both sides of the road just past MP 0.44 for roughly 40 feet. Road maintenance should have been completed during the closure to mitigate the ponding by excavating a cross drain through the road prism at this site. Besides the noted problems near MP 0.44, there was no other evidence of sediment transport or water diversion on the running surface of the road.

No specific corrective actions were identified, although a few notes on problems to follow up on to completion of the contract. Monitoring will be required to check the status of the water ponded near MP 0.44 and culvert at the end of the road. Adaptive management actions that are recommended by the IDT to improve implementation include:

Overall the road was stored in good condition with minimal signs of erosion. The ditch blocks constructed on the water bars will serve to limit diversion potential. The road bed was seeded when the road was closed. The seed germinated to stabilize the road bed. The stream crossings were functioning well to transport water across the road, although an additional cross drain adjacent to MP 0.44 was needed.

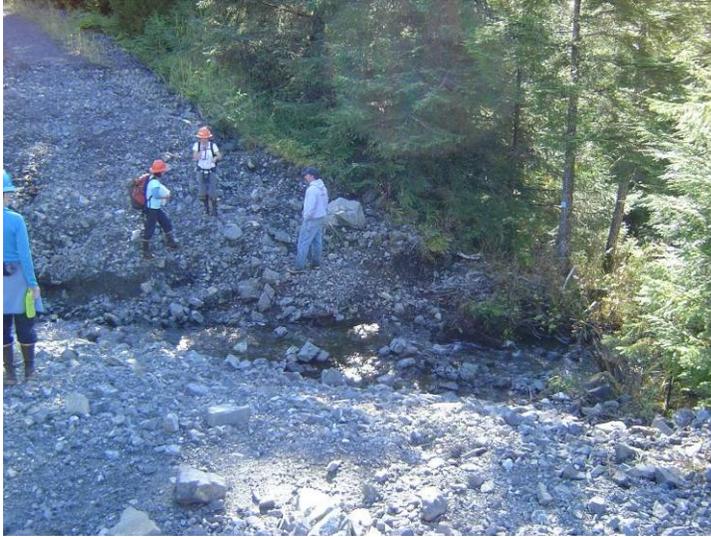
Picture 5. Road 3000382; cross drain at MP 0.1

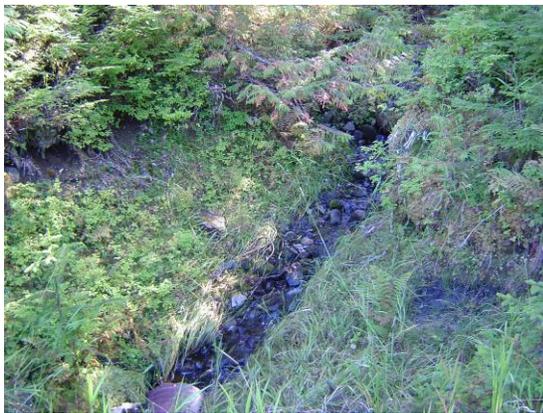
Picture 6. Culvert inlet at MP 0.154

ADF&G Title 16 Concurrence for the in-stream work was documented in an August 17, 2012 letter. This culvert was scheduled to be removed; however, was not pulled at the time of the monitoring review. The stream was delineated as a red fish pipe on the road condition survey. The red fish pipe designation identified the site where fish could not pass through the culvert at all flows. The Contracting Officer Representative (COR) and Engineer on the project required the Operator to return to the site to remove this culvert.

No specific corrective actions were identified, although a few notes on problems to follow up on to completion of the contract. Monitoring will be required to check the status of the removal of the red fish pipe at MP 0.154. Adaptive management actions that are recommended by the IDT to improve implementation include:

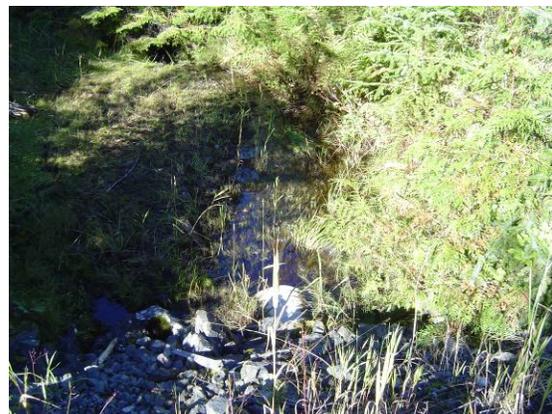
Picture 7. Culvert outlet at MP 0.154

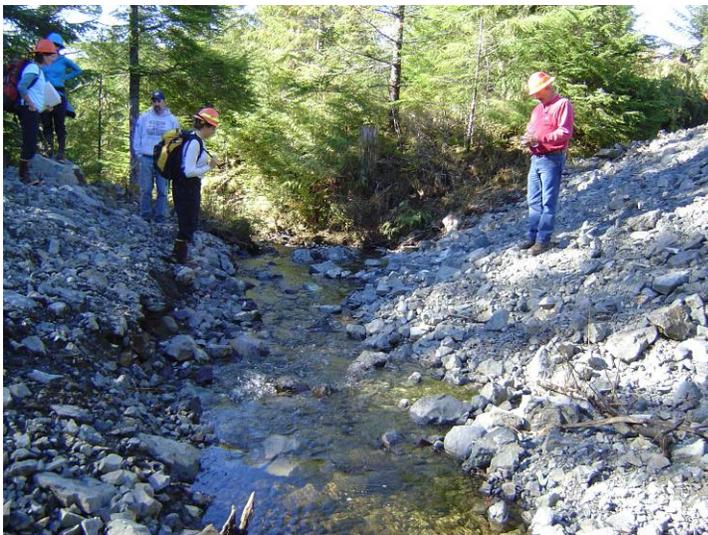
Picture 8. Cross drain at MP 0.1; looking downstream

At the stream crossings where the culverts had been removed, the channels showed some minor channel adjustments. The slopes on the crossing at MP 0.1 showed some raveling with cobbles and 8- 10 inch rocks in the stream channel. These rocks did not obstruct flow and the crossing was functioning to transport water. The contract included laying the slopes back to a 2:1 slope gradient on the stored crossings. The excavated rock was spread on the road surface to minimize ravel into the stream crossings. The culvert removed from the site at MP 0.14 was at a small non-fish bearing wetland stream. The excavation was relatively shallow and the height deviation between the stream channel and road was only about three to four feet. The contractor had excavated a ditch block to direct water to flow through the crossing; however, the operator had constructed the ditch block on the upslope side of the inlet. The COR was going to direct the Contractor to reconstruct or remove the ditch block so the water in the ditch would flow to the cross drain. The cross drain at MP 0.4 was functioning well to transport water across the road prism. The slopes at this site were relatively low in height of roughly four feet and laid back to a shallow slope gradient. This stream was a minor Class IV stream that was roughly one foot wide and transported water across a wet area. The culvert at MP 0.41 was left in place even though the contract specified removal and was functioning to transport water across the road prism. The inlet of this culvert had been cleaned by the contractor and a pool excavated to facilitate drainage and minimize the potential from plugging.

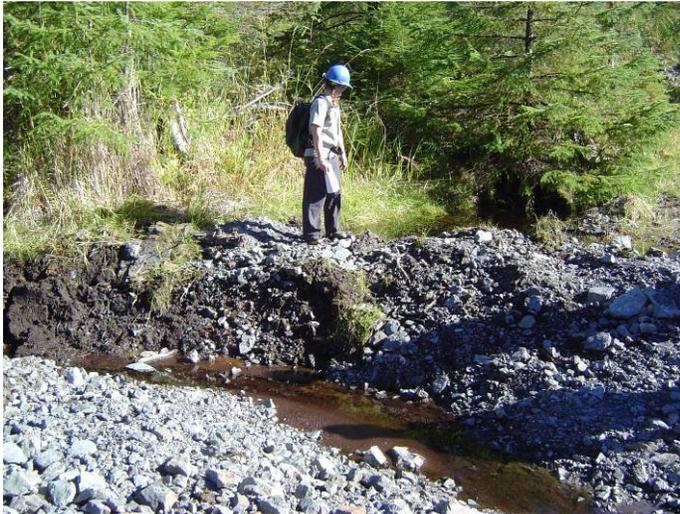
Picture 9. Crossing at MP 0.14 ditch block

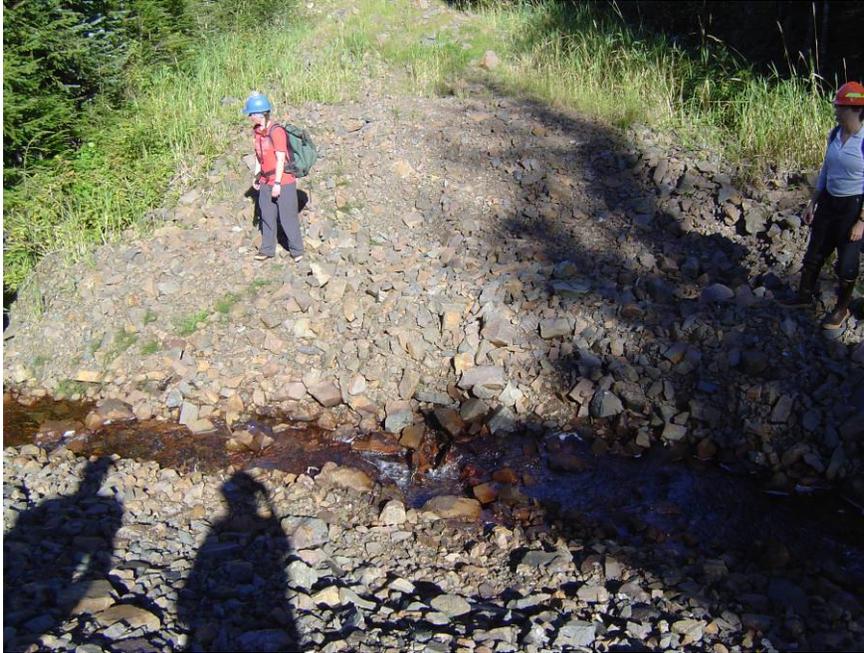
The 48 inch culvert removed at MP 0.050 was the focal point of the monitoring. The side slopes on the crossing at MP 0.050 were laid back to the 2:1 to 3:1 slopes as shown on the contract drawings on the near side of the road. The slopes were roughly 6 feet high. The stream is a small meandering AF/ HC channel that was designated as a resident cutthroat fish stream. The culvert had been evaluated prior to storage and was documented in the road condition survey (RCS) to not pass fish at all water flows. The stream was roughly two to three feet wide and six inches deep at the time of the monitoring. The outlet of the stream, beyond the cross drain, showed terraced pools. The inlet showed ponded water in a low gradient wet area that was roughly one foot deep. The channel upstream of the culvert adjacent to the

Picture 10. Lateral view of cross drain at MP 0.05

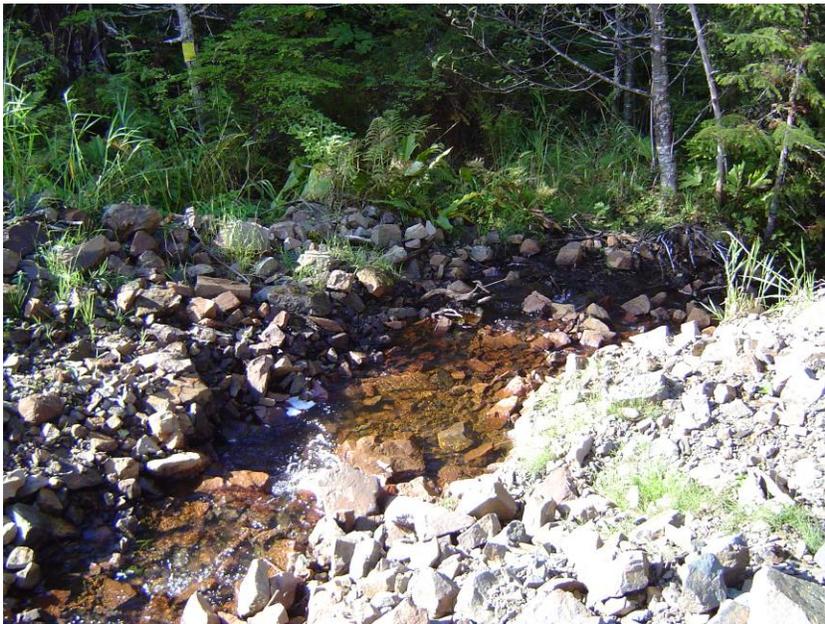
Picture 11. Outlet of cross drain at MP 0.05

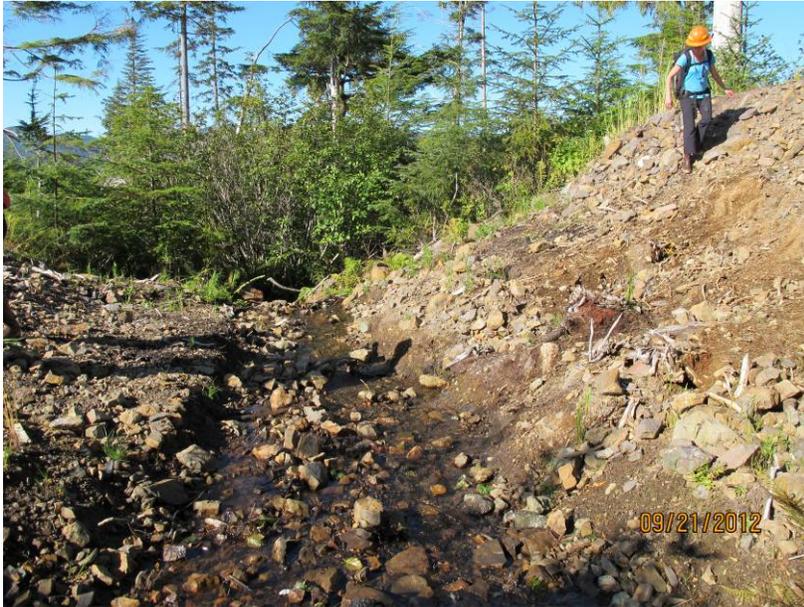
Picture 12. Over steep slope at MP 0.44

Continuing up the road, the next culvert removed at MP 0.44 was a 36" culvert. The stream at this crossing was a shallow channel. The water quality stream was roughly one to two feet wide and three to four inches deep with a gradient of two to four percent slope. This stream was located at a slightly increased elevation and the height road cut fill in the cross drain was roughly ten feet high. The slopes of the excavation were steeper and showed a slope gradient of 1 horizontal: 1 vertical. Some erosion was noted on the cut slopes in over-steep sections near the stream as some of the fill material was slumping into the stream. There were some fines shown in the raveling and slumping slopes of the excavation. The channel substratum was primarily road fill of cobbles and gravel with a few boulders.

No specific corrective actions were identified as necessary on this road, although notes indicated that the contractor inspectors should focus the contractor to remove the culverts shown in the contract and lay the slopes back to the gradients shown on the drawings.

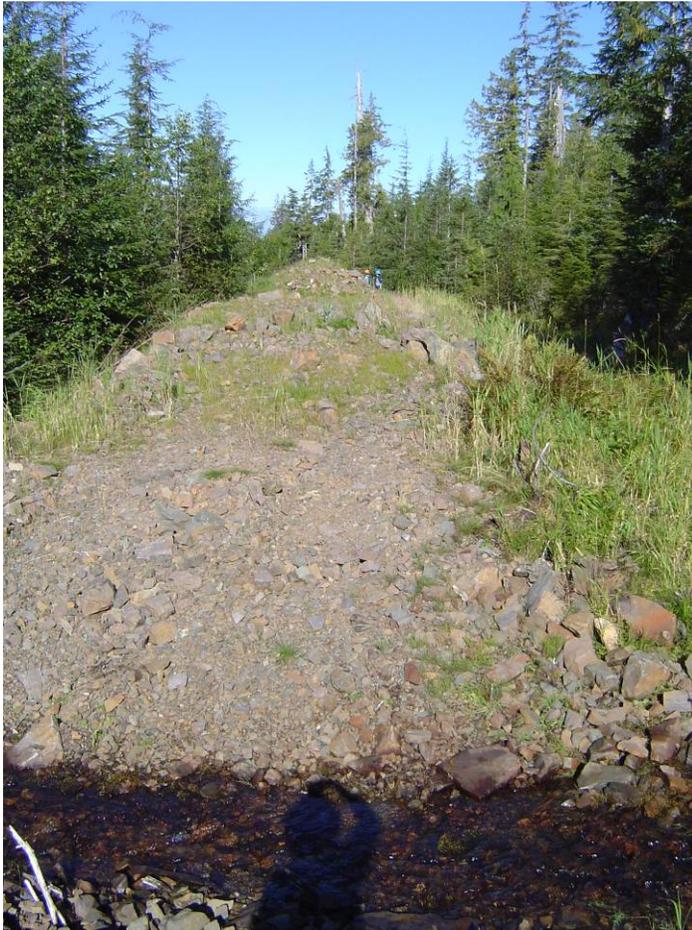
At MP 0.090, an 18" culvert had been removed. The water quality stream crossing at MP 0.090 was roughly three feet wide and two to four inches deep. The slopes were laid back at 1.5: 1 to 2:1 slopes. The slopes were roughly four feet high at the cross drain and the material excavated from the culvert site was spread on the running surface of the road. The excavated material was more than five feet from the top of the excavated slope of the cut for the cross drain. The stream flowed in a shallow, low gradient

Picture 13. Cross drain at MP 0.09 and road corridor ahead

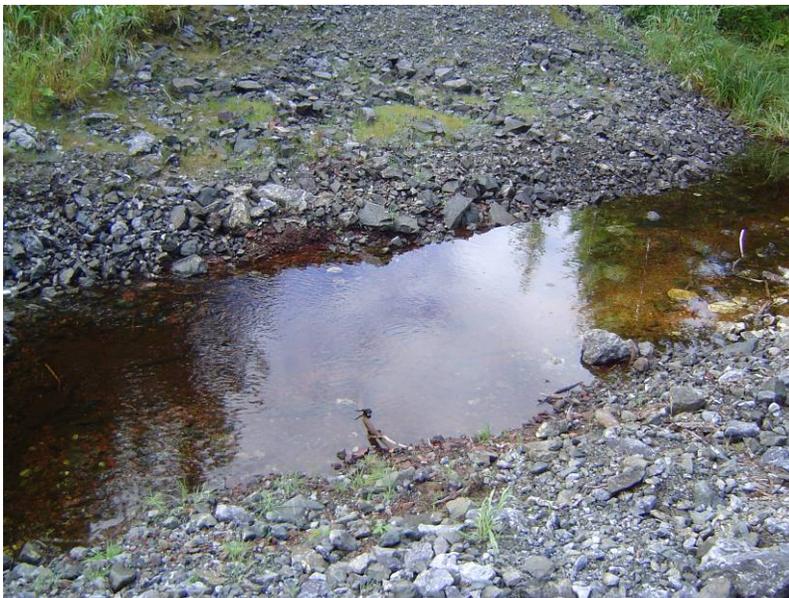
Picture 14. Cross drain at MP 0.26

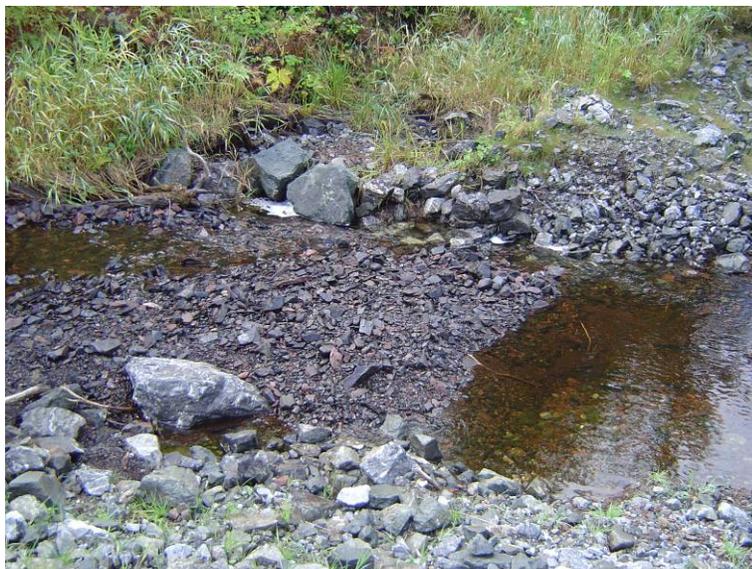
Picture 15. Removed Class II stream crossing at MP 0.26; inlet

The 48 inch culvert removed at MP 0.260 was the focal point of the monitoring. The side slopes on the crossing at MP 0.260 were laid back to the 2:1 slopes as shown on the contract drawings. The fill was spread in stepped terraces along the road. The slopes were roughly two to three feet high. The stream is a small meandering channel that was designated as a Class II stream with Dolly Varden presence. The culvert had been evaluated prior to storage and was documented in the road condition survey (RCS) to not pass fish at all water flows. The stream was roughly four to five feet wide and six to ten inches deep at the time of the monitoring. The outlet of the stream, beyond the cross drain, showed pooled water in a low gradient channel in a wet area. The inlet showed a gravel bar and low gradient channel that was one to three inches deep. The channel upstream of the culvert adjacent to the road showed a one foot wide meandering channel that was incised roughly four to six inches. Organic soils were shown in the in the banks and wetland vegetation was noted along with a mixed cedar second growth stand. The gradient of the cross drain was roughly 0.5- one percent slope gradient and water was flowing through the cross drain. The substrate showed gravels to cobbles. There was some rock from the road fill that raveled into the stream; however, no erosion was noted on the banks. The gravel bar consisted of road fill material from the excavation. Grass was noted growing on the road surface and cut slopes of the excavation.

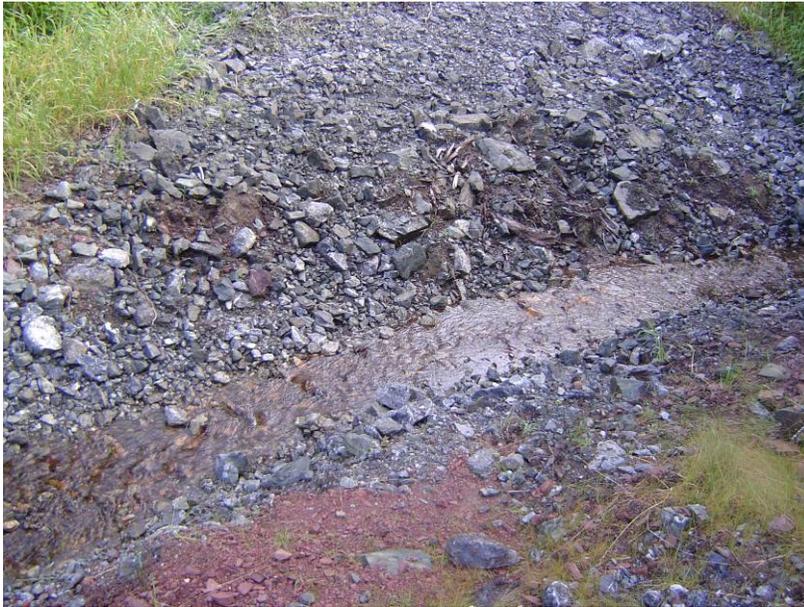
Picture 16. Cross drain at MP 0.15

Continuing up the road, the next culvert removed at MP 0.150 was a 36" culvert. The stream at this crossing was a shallow, side slope channel on the inlet that flowed to a wetland at the outlet. The Class II stream was roughly one to two feet wide and two to three inches deep with a gradient of two to four percent slope. This stream was located at a slightly increased elevation and the height road cut fill in the cross drain was roughly five feet high. The slopes of the excavation were steeper and showed a slope gradient of 1 horizontal: 1 vertical to 1.5 horizontal: 1 vertical. Some erosion was noted on the cut slopes in over-steep sections near the stream as some of the fill material eroded into the stream. There was a minor amount of fines shown in the raveling slopes of the excavation. The channel substratum was primarily road fill of gravel and cobbles.

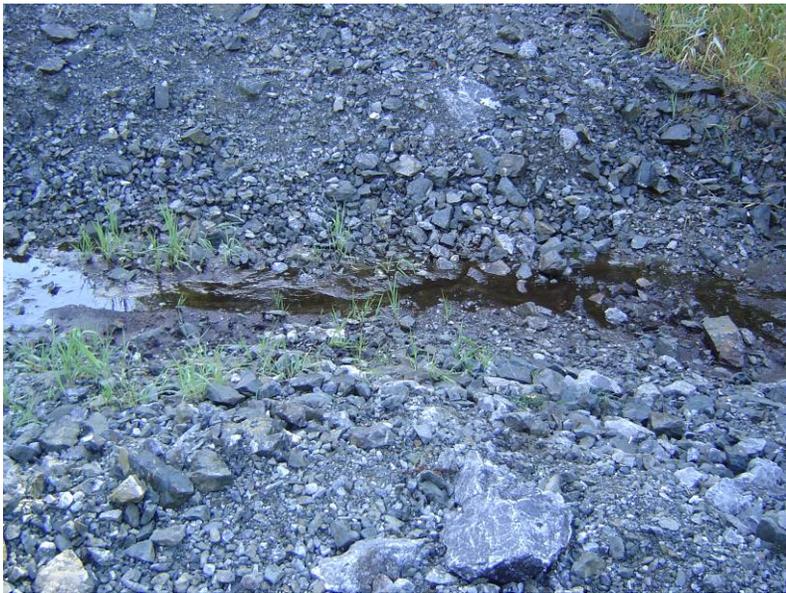
Picture 17. Cross drain/ water bar past MP 0.23
