Soil and Water Question 2a Appendix

Best Management Practices Implementation and Effectiveness Monitoring Thorne Bay Ranger District Timber Trip Report – Slake Timber Sale August 28 and 29, 2012

Summarized by Carol Seitz Warmuth

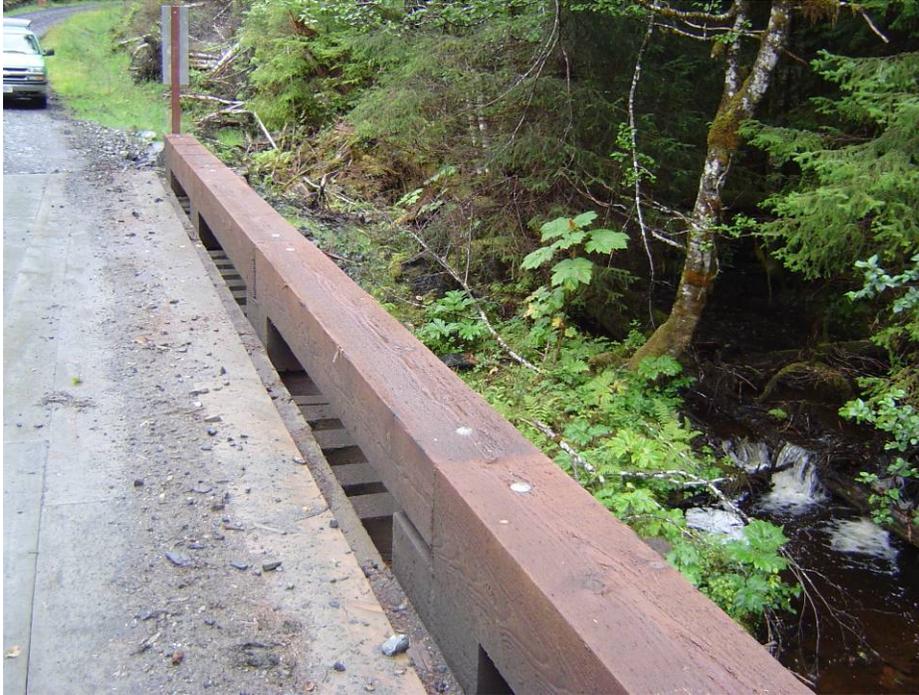
Picture 3. Road 3030720 bridge crossing

The segment monitored through the national bmp protocol was focused on a bridge that crossed a class II stream at MP 1.18. The length of connected road surface approaches are 2,640 feet in both directions and the length of road in the aquatic management zone is roughly 270 feet. The connected road ditches were measured at 170 feet on the left and 235 feet on the right.

the crossing. There is some diversion potential from the tree debris in the class III and IV channels along the road. The crossing monitored is a bridge that provides access across a class II stream. The re-vegetation standard was met on the banks of the stream crossing; the bank was grass seeded and grass and natural vegetation is growing on the stream banks. There was evidence of down cutting in the ditch along the road that flowed to the bridge. No sediment or deposition was noted in the stream; the stream has turbulent fast moving water in a bedrock controlled channel.

Corrective actions recommended for this road construction implementation included removal of the tree debris that is blocking the channels and grading of the road. The ditch along the approach to the bridge at MP 1.18 showed some erosion evidenced by down cutting. This ditch should have been lined with rock to minimize erosion. There was some unstable silt- sand soil shown in the road cuts that were excavated to over steep slope gradients. Slope stability, in these isolated areas, is a concern since the soil slopes are raveling. There was a rock buttress wall constructed to minimize erosion and limit slope stability along the road. The water ponded at the base of the wall needs to be drained to limit slope stability problems from water. There is a potential that water could pipe up behind the rock buttress wall and saturate the underlying soils and decrease the stability of the road cut. During post haul maintenance, the sale administrator should re-excavate the ditches in the sections where ponding is apparent and grade the road to contour and crown the surface to limit the potential for water ponding. This road should be monitored for slumps in the cut slopes and culverts that are plugged from eroded soils.

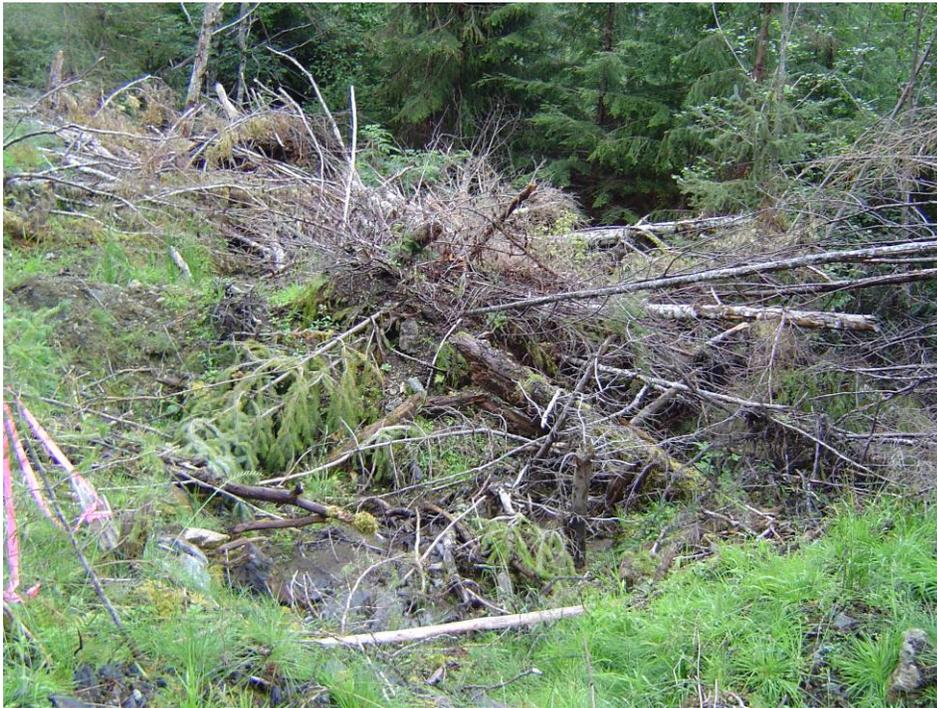
This road had been reconstructed by excavating the trees that had re-established on the road surface over the past 20 years. These trees were side cast along the road corridor and some of the class III and IV stream channels were blocked with tree debris. The streams appear to be flowing under the tree debris and contained in the channels. The road running surface was in overall moderate to good condition; however, there was evidence of rilling and sediment transport from the road to the streams. Some water was noted ponded on the road and along the base of a rock buttress wall. The road was in active use for the timber sale and will be graded as part of the timber sale operation. Road grading will contour the running surface and eliminate the berms on the edge of the roads.

Picture 5. Tree debris blocking class IV stream

The engineers and sale administrator were going to follow up immediately after the review and develop a plan to remove the tree debris that was blocking the stream channels along the road.

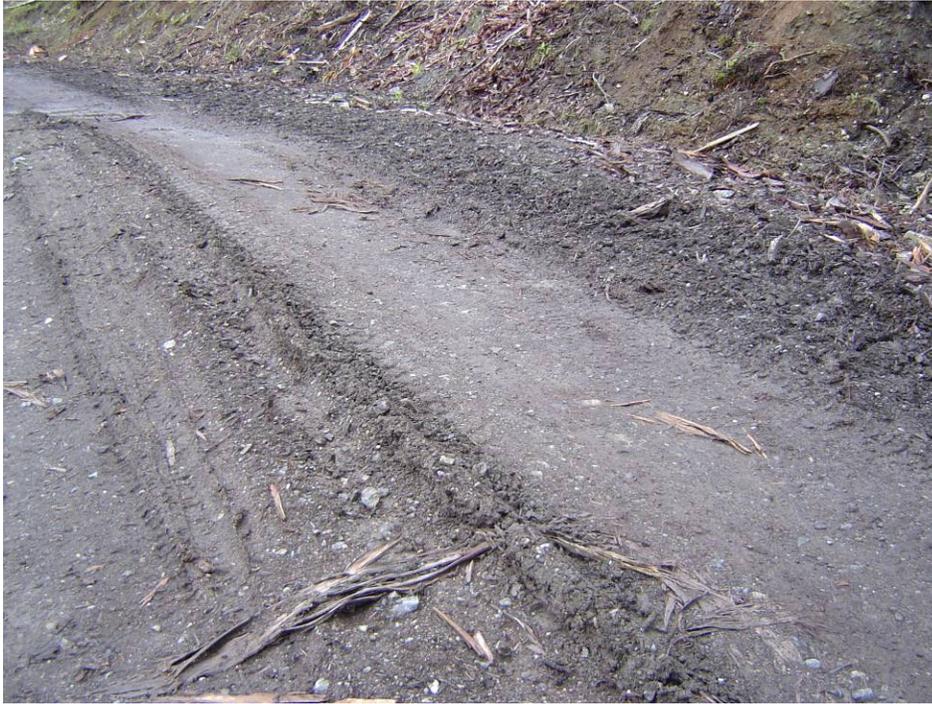
Effectiveness monitoring completed by the IDT noted that road is providing access to the units. There is minor erosion evidenced on the road surface, slumps in the cut slopes in the ditches, and head cutting at

Picture 6. Road running surface that needs to be shaped and graded.

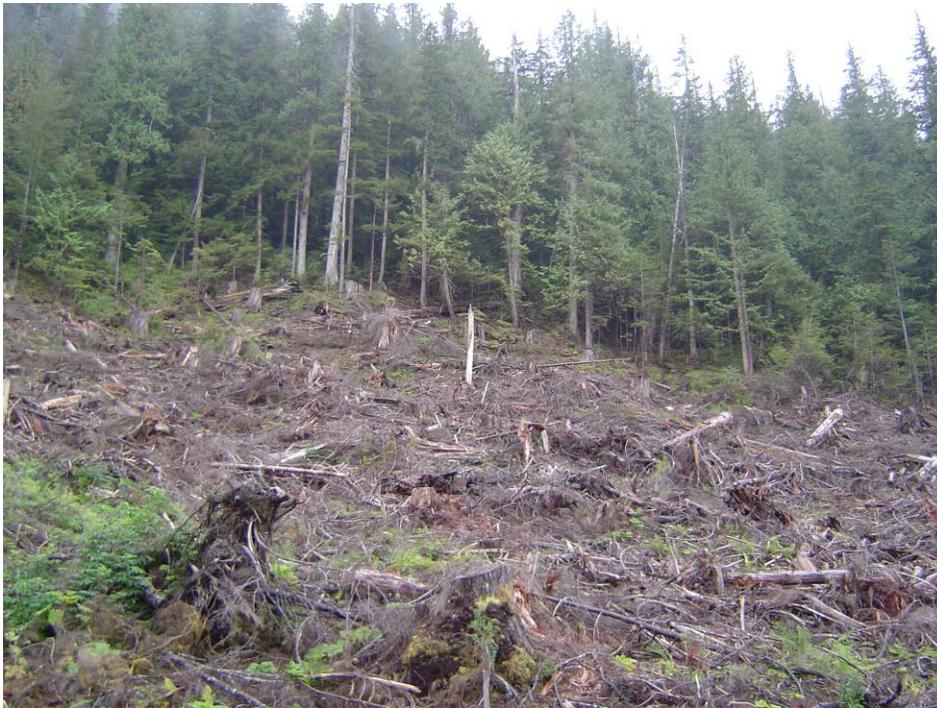
Picture 7. Unit 69 shows steeper slopes shovel yarded in first segment

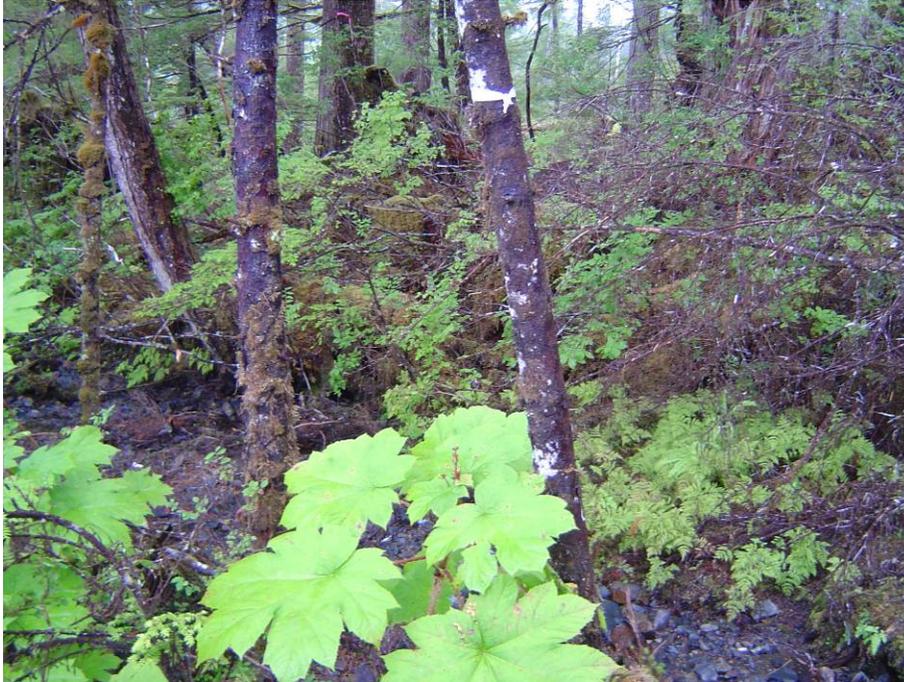
Picture 8. Class III stream monitored in second segment

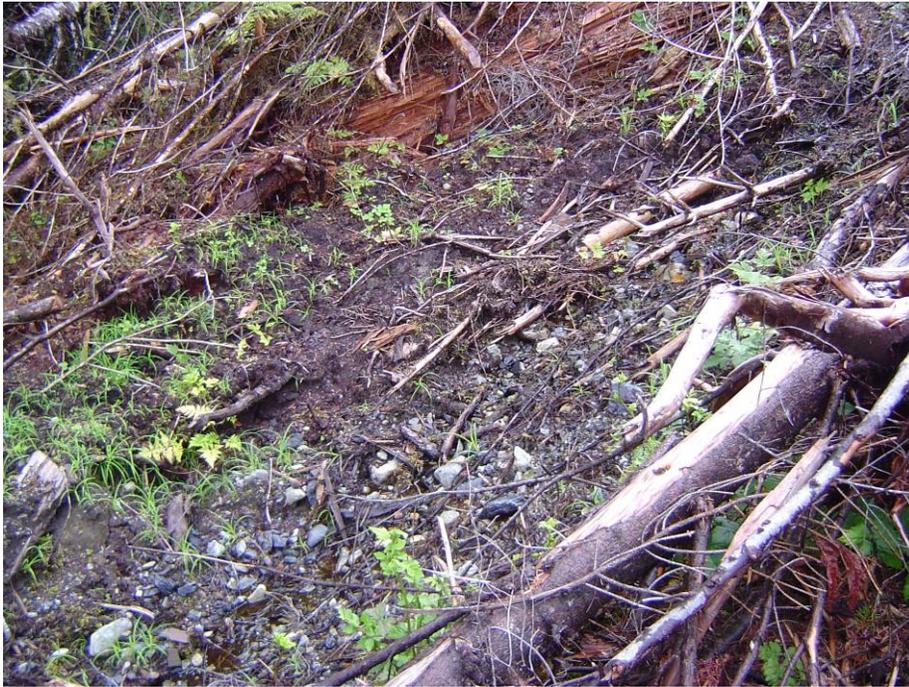
Picture 9. Class IV stream monitored in third section

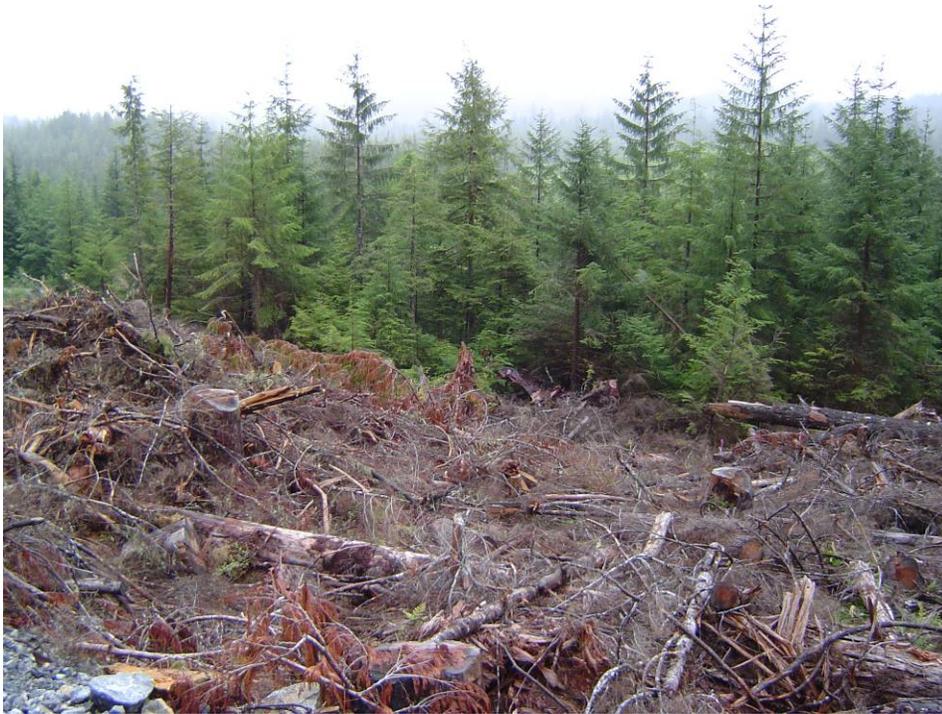
Picture 10. Shovel yarded area in section 1

The change analysis described the rationale for modification to the unit boundary to reflect soil deletion areas and updated stream locations as well as to adjust the boundary for logical settings and to minimize isolation of timber. The change of the upper portion of segment 1 to shovel yarding from cable yarding was completed to assure logging feasibility, improve timber sale economics and complete logical settings. Additional acreage was removed from harvest to provide for RAW buffers. The shovel and cable yarding met the soil and wetland protection measures as described in BMP 13.5 and 13.9. Puncture and slash were used to minimize rutting although additional slash would have further minimized the compaction and rutting of the soils.

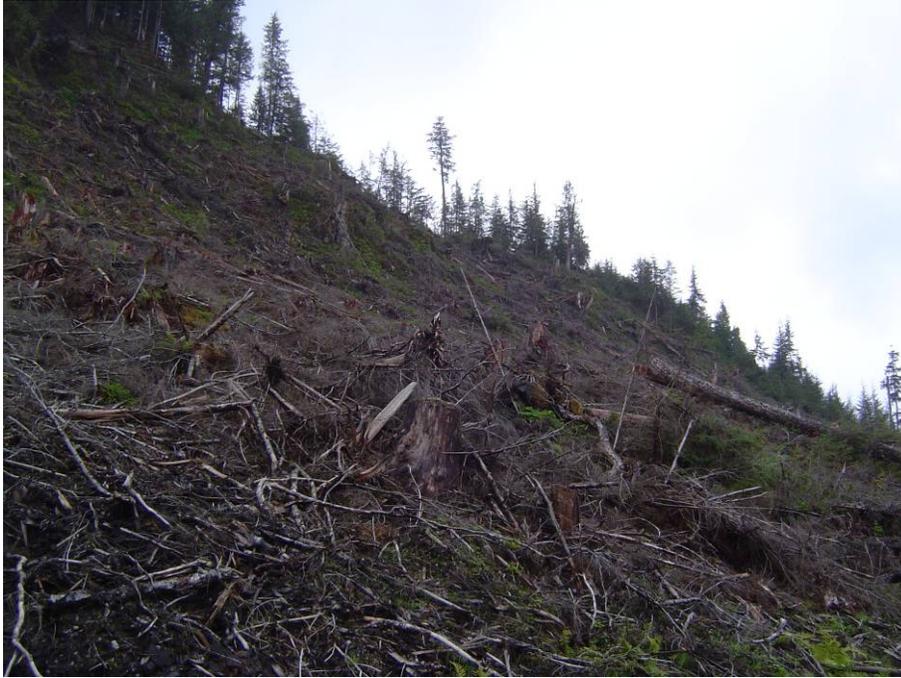
Picture 11. Steeper cable yarded area in the upper part of section 3

Cable yarding was monitored in two of the segments designated on the sale area map. The aerial extent of the disturbance is within the three percent estimated in the NEPA document and partial suspension was achieved in 95 percent of the unit. The unit was shifted downslope and part of the planned unit in the higher gradients was dropped due to soil slope stability issues. The backline of the unit was designed with the soil scientist. Supplemental erosion control included application of seed and slash. The harvest areas were designated on the sale area map as well as marked on the ground. There was an area in the southwest corner where the logs were not lifted off the ground; the backline could have been adjusted to improve the lift and minimize soil disturbance. There were minor soil ruts and disturbance noted at the landing where the suspension was not achieved in an area roughly forty by three feet. There were a few yarding corridors where partial suspension was not achieved. In the short ruts, minor water rilling and sheet erosion was noted; however, the rills were isolated and do not transport water or sediment to the streams. Otherwise within the unit, partial suspension was achieved in the cable yarding. Two class IV streams were shown within the second segment. There was no noted bank damage or erosion in the class IV streams that were managed with C protection. Class IV and III streams were buffered from the unit between segment 1 and 2 as well as between segments 2 and 3. No impact was noted relative to the buffered class IV and Class III streams managed with B protection. Trees were standing in the buffer as designated; although, some trees had blown down in the buffers prior to planning and layout. There was a thick layer of moss and duff shown on the ground that minimizes erosion potential.

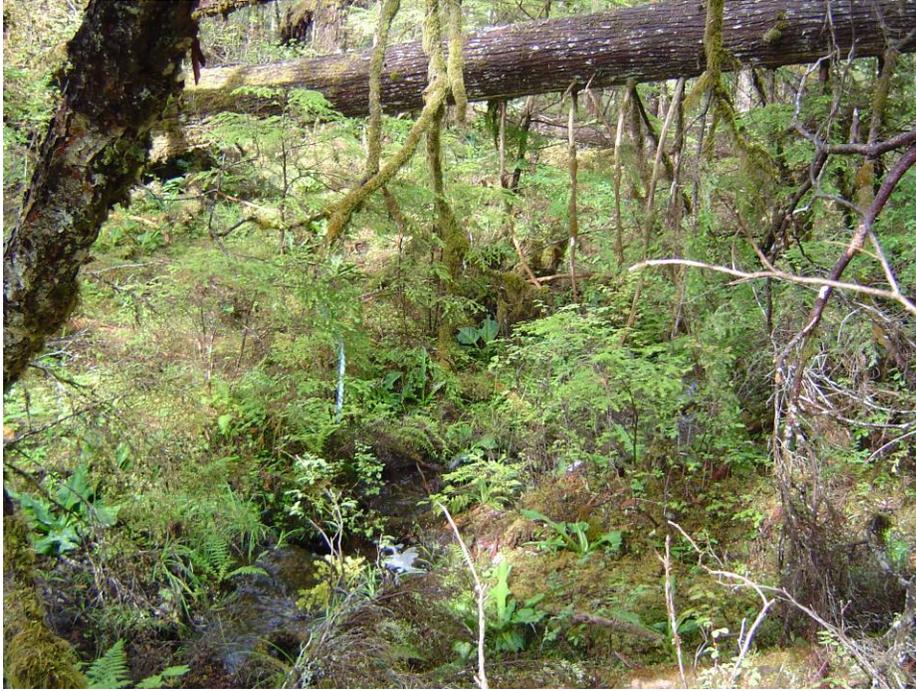
Picture 13. Class II stream; buffered with A protection (upper part of unit)

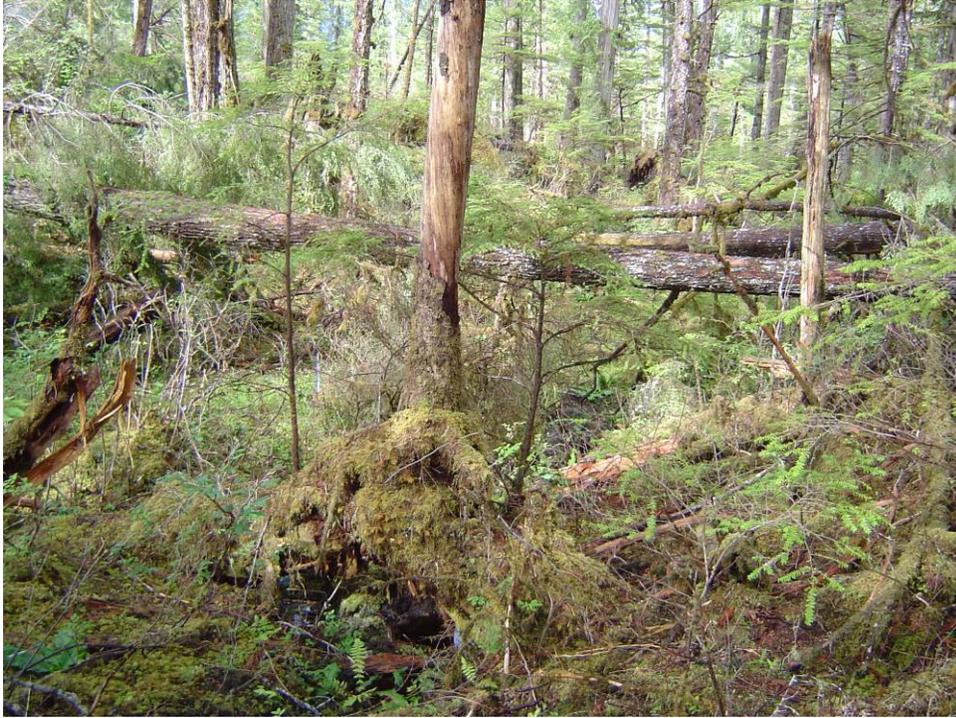
Picture 14. Class II buffered stream

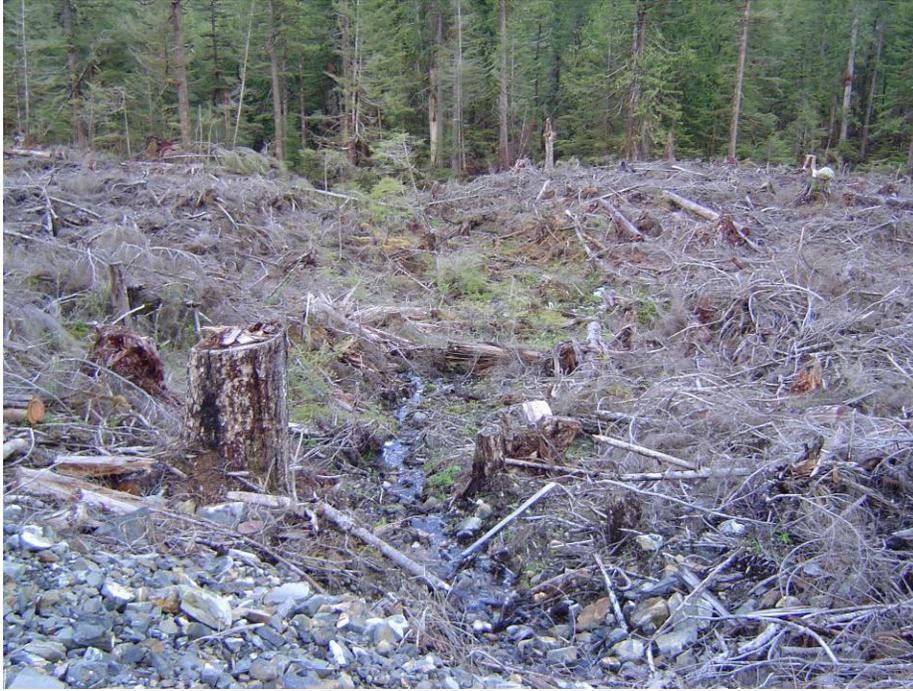
Picture 15. Class IV Stream in lower section of Unit 67B

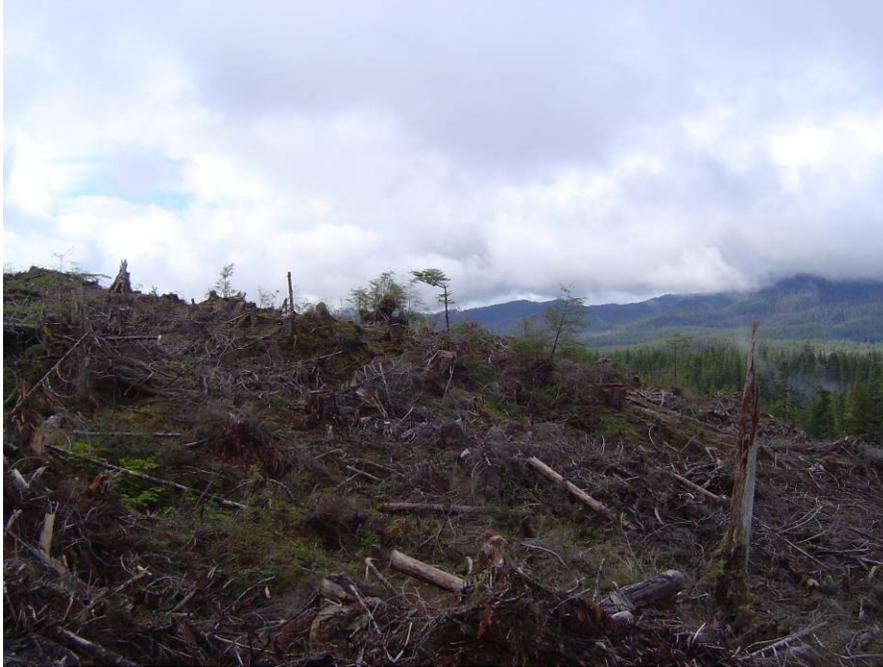
Picture 16. Cable yarded portion of unit 67B; upper unit

Reviewing the cable yarded portion of unit 67B, this portion of the unit was accessed by temporary road 3030710-2. This road had been modified as documented in the change analysis to improve the landing locations and drop a stream crossing. The sale administrator had required the operator to lay puncheon across the class IV streams to cross the channels. The tree debris was effective in protecting the channels and was removed after yarding. Corrective action recommended by the group was focused on location of the landing. The landing was recommended to be located on the ridge to achieve better suspension, although suspension was achieved in roughly 98 percent of the unit. Monitoring showed the minor disturbed areas in the unit, where soil was bared, were seeded. Slash was placed on the disturbed areas to minimize erosion potential. The temporary road was used as a landing for the helicopter yarding and was still in use at the time of the review. The temporary road will be seeded, drainage structures pulled and closed upon completion of the timber sale.

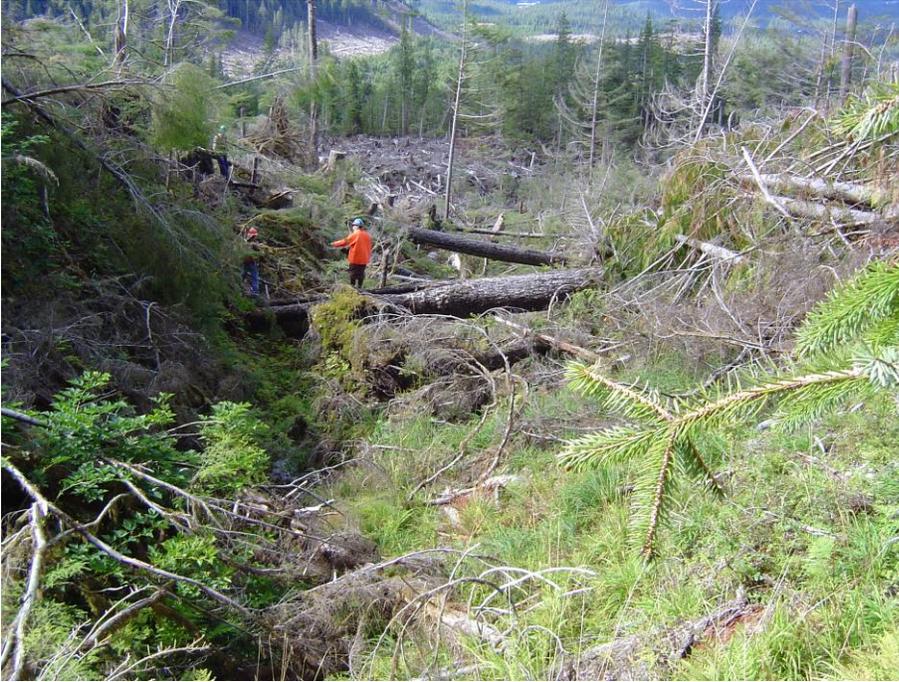
Picture 19. Class III stream

Reviewing the unit, the IDT found the stream protection BMPs and Riparian area designation and protection was implemented. The IDT noted that some of the mapped class IV streams were not identified in layout of the unit. One 300 foot long section of the class III stream buffer of Stream 4.4L had blown down. The stream protection measures were implemented on the class III streams. Trees were left with leave tree mark (LTM) designations along the channels and split yarding was implemented so there was no yarding across the channels. The slope break buffers were shown to be 25-60 feet in width.

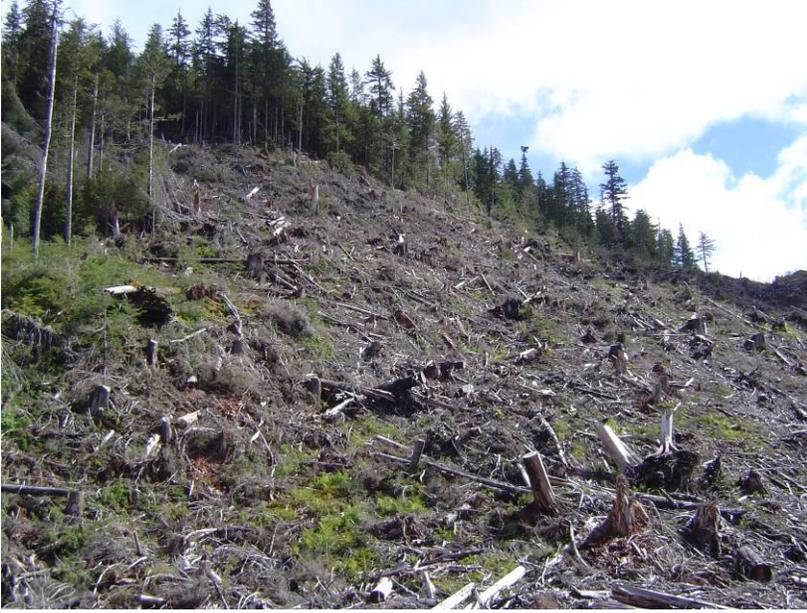
Picture 20. Upper part of unit 73D; cable yarded area

The IDT found minor disturbance in the cable yarded portion of the unit. The unit boundaries were designated on the sale area map and on the ground. The class III streams were well marked on the ground. There was no bank damage or impact noted along the stream channels from logging. The IDT noted that roughly eighty percent of the slope break buffer on the class III stream had blown down. Inspection the aquatic management zones showed no evidence of sediment transport or erosion in the streams, channels and buffers. The temporary road is not closed out yet since the road is in use for landings for the helicopter operation. Upon completion of the unit and timber sale, the temporary road will be closed, culverts removed and the cut slopes seeded. Adaptive management recommendations follow to conduct more analysis and prediction of wind to develop improved site specific buffer designs.

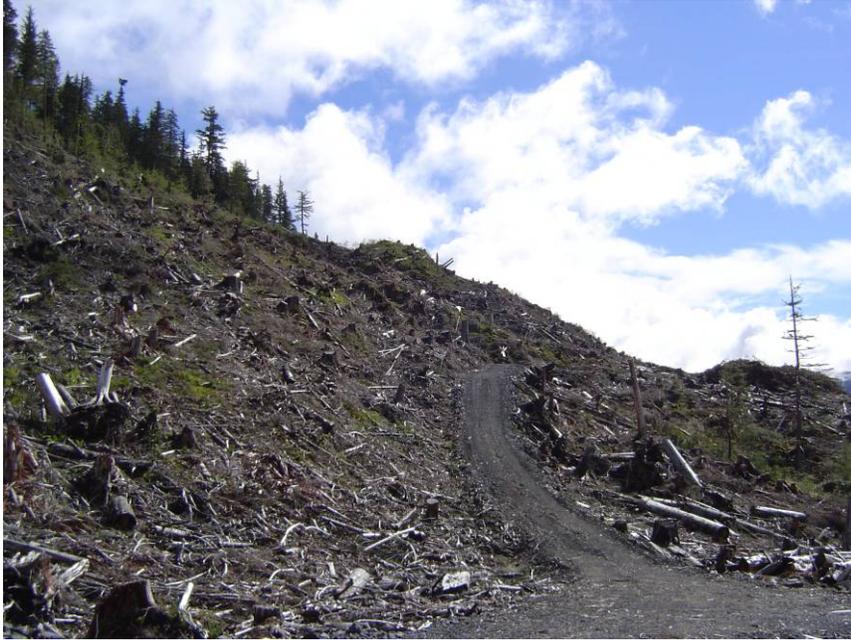
Picture 21. Unit 73D showing temporary roads from 3030720; 3030720-1

Monitoring the downslope shovel yarded portion of the unit was conducted by the IDT. The IDT found that this unit was effectively yarded and there was no noted impact to the streams from the timber harvest. The streams were designated on the sale area map; however, a couple of the class IV streams were not marked on the ground. The erosion control measures were fully implemented on the ground. Slash was used to minimize impact to soils from the yarder and minimize erosion as directed in the contract and erosion control plan. There was no noted incidence of equipment leaks or petroleum spills in the unit. Good housekeeping measures were implemented. The units selected for monitoring were in some of the most difficult terrain with the combination of steep slopes, unstable soils, blown down timber and high density of streams. The layout and sale administration people have demonstrated that it is possible to effectively implement the BMPs on complex landscapes and irregular terrains.
