Ref.: 2010-084

Technical Memorandum
May 2013 Site Inspection Report
Blue Ledge Mine
Rogue River-Siskiyou National Forest

**Blue Ledge Mine Removal Project
Siskiyou County, California
Operation, Maintenance, and Monitoring Period**

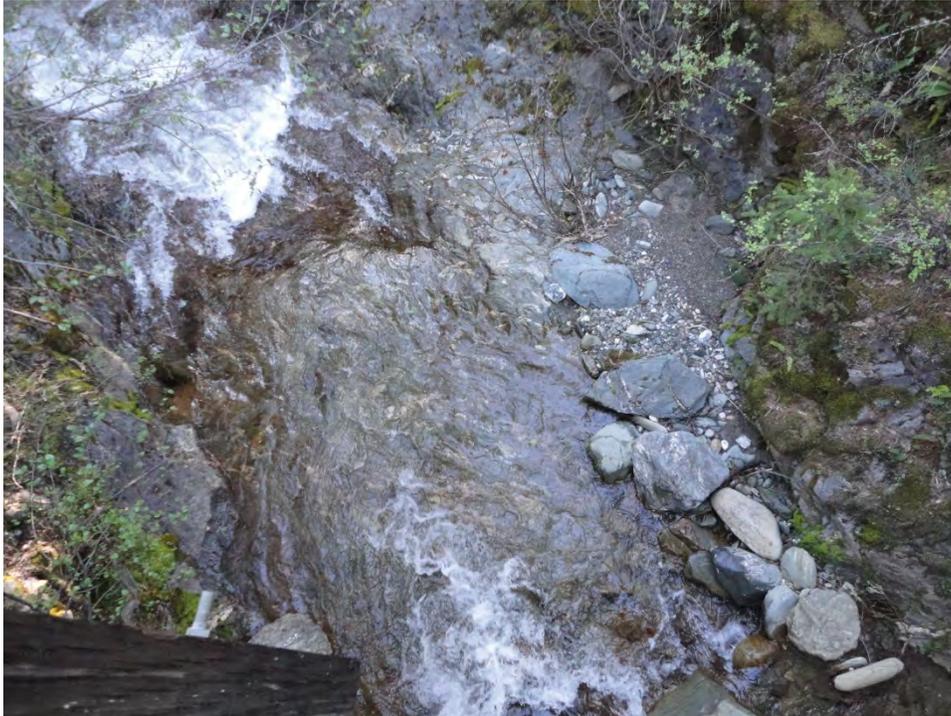
Photograph 1: Joe Creek at Joe Creek Bridge.
Blue Ledge Mine, Rogue River - Siskiyou National Forest, CA
Photographed by: Annica Nord (ERRG)

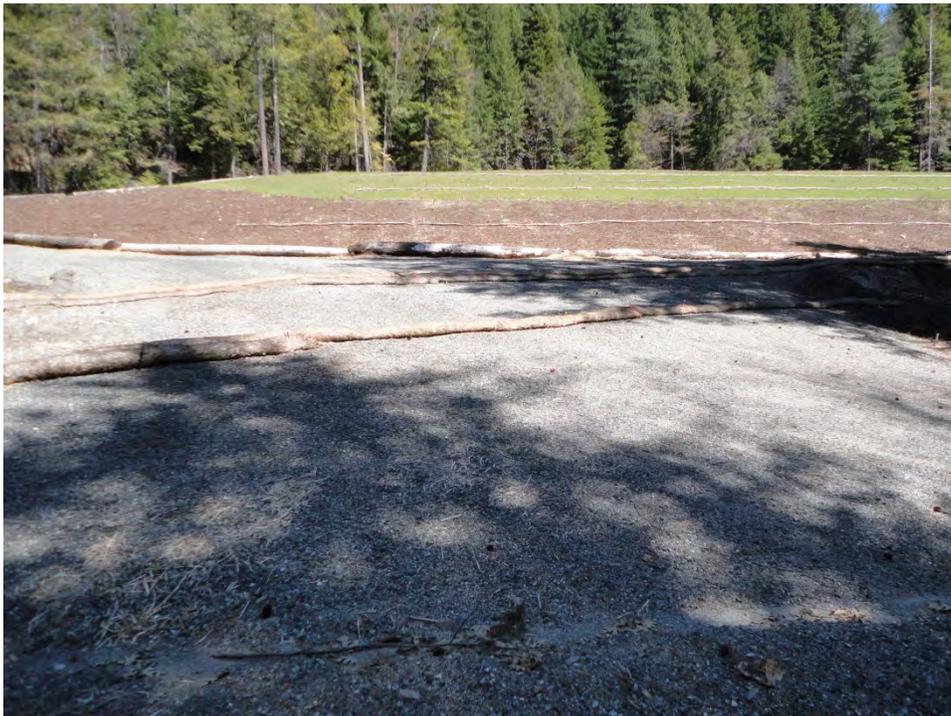
Comments: Water bars on the access road are functioning in the recent rain.

Photograph 2: View of repository access road, facing east. Waterbar is in the foreground.
Blue Ledge Mine, Rogue River - Siskiyou National Forest, CA
Photographed by: Annica Nord (ERRG)

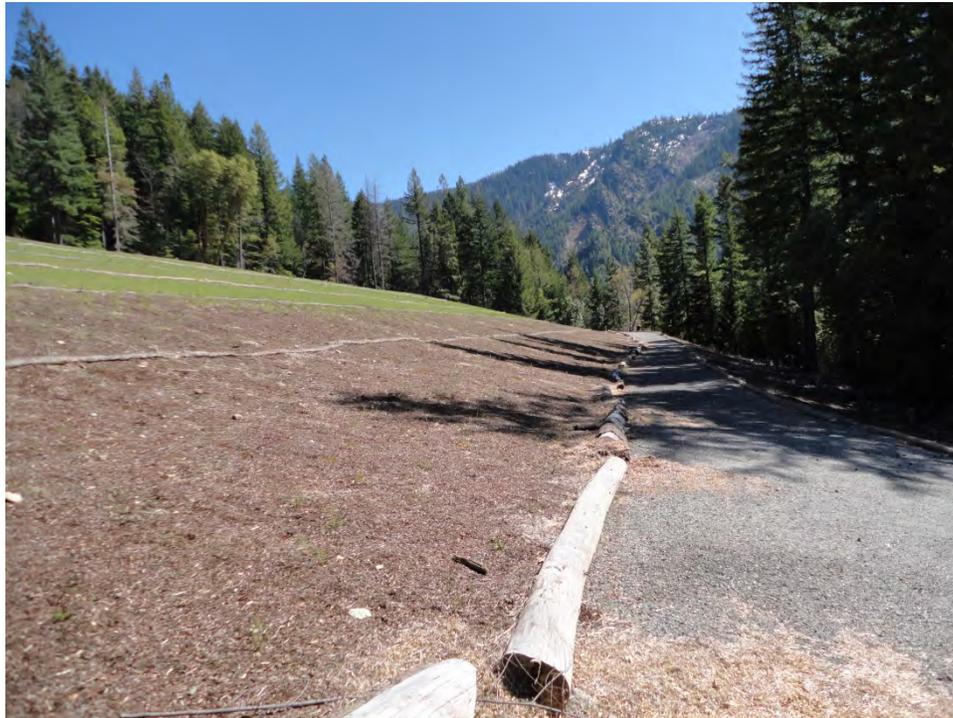
Photograph 3: View of access road, facing south. Note there is no evidence of erosion.
Blue Ledge Mine, Rogue River - Siskiyou National Forest, CA
Photographed by: Annica Nord (ERRG)

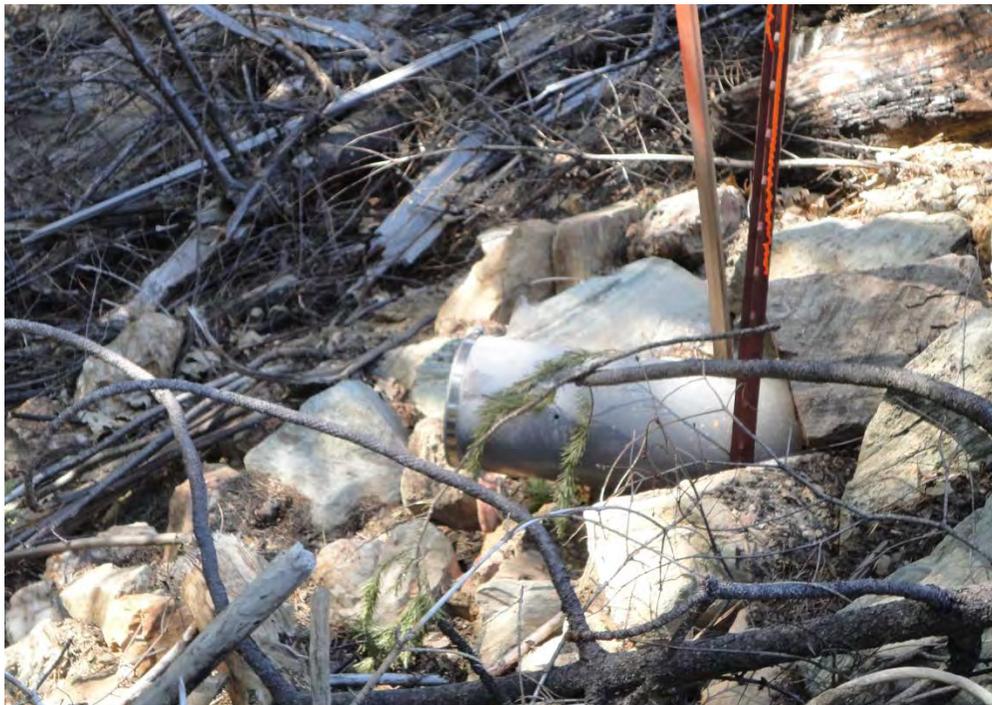
Comments: The southernmost anchor trench drain pipe is not blocked but no water is flowing from the drain as observed in April 2013.

Photograph 4: Anchor trench drain outlet, south end of repository. No water.
Blue Ledge Mine, Rogue River - Siskiyou National Forest, CA
Photographed by: Annica Nord (ERRG)

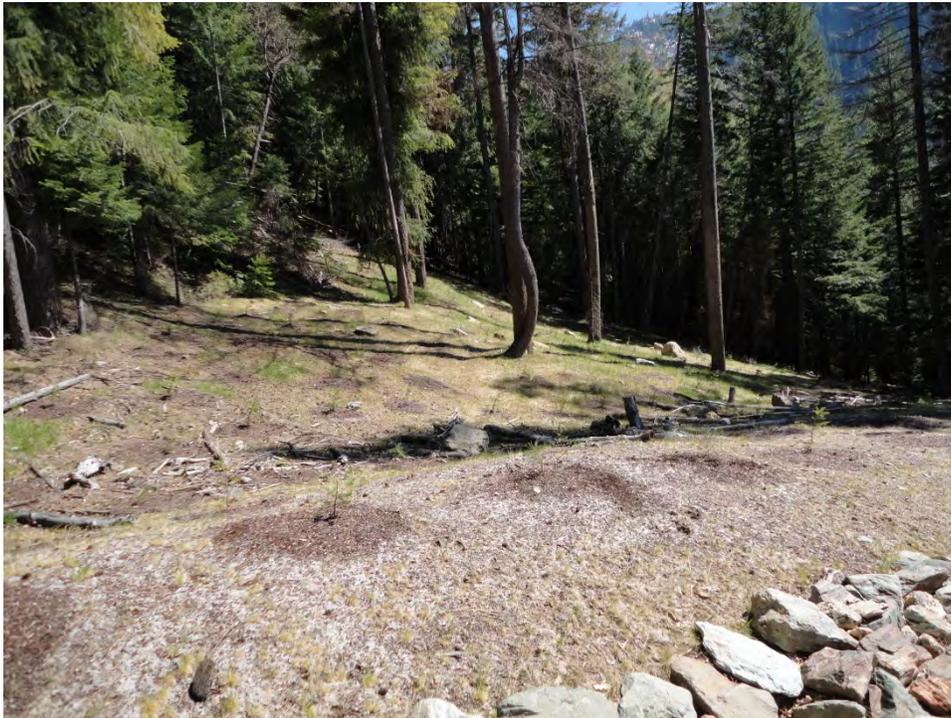
Photograph 5: Repository Stockpile Area with hydroseeded and reclamation planting.
Blue Ledge Mine, Rogue River - Siskiyou National Forest, CA
Photographed by: Annica Nord (ERRG) Date: May 1, 2013

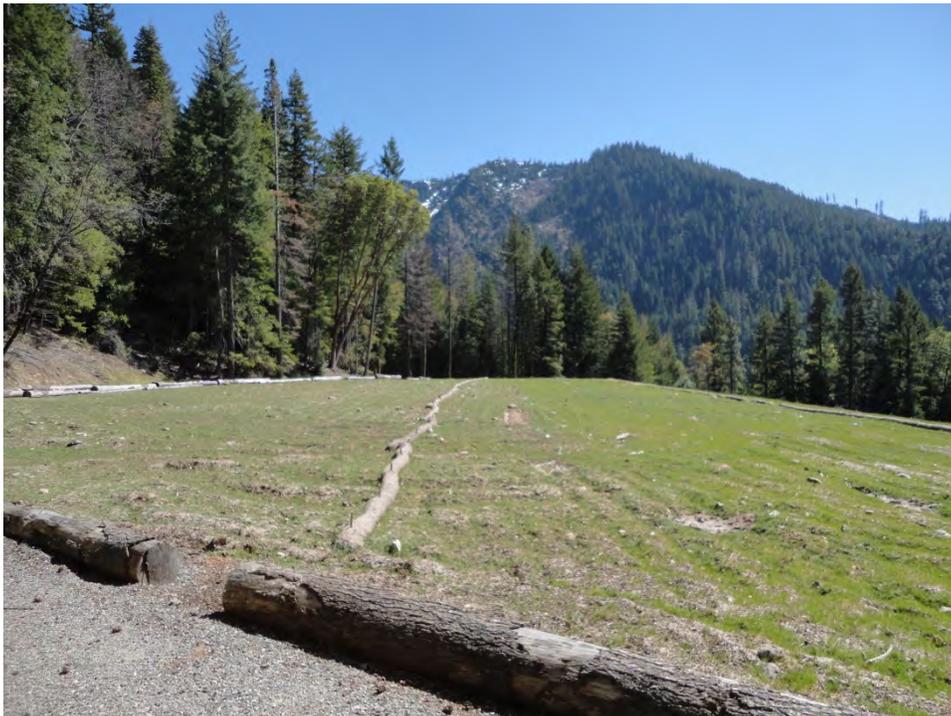
Comments: The top deck hydroseeded area is growing and appears healthy. The existing grass on the slope appears healthy.

Photograph 6: Newly hydroseeded top of repository looking southwest.
Blue Ledge Mine, Rogue River - Siskiyou National Forest, CA
Photographed by: Annica Nord (ERRG) Date: May 1, 2013

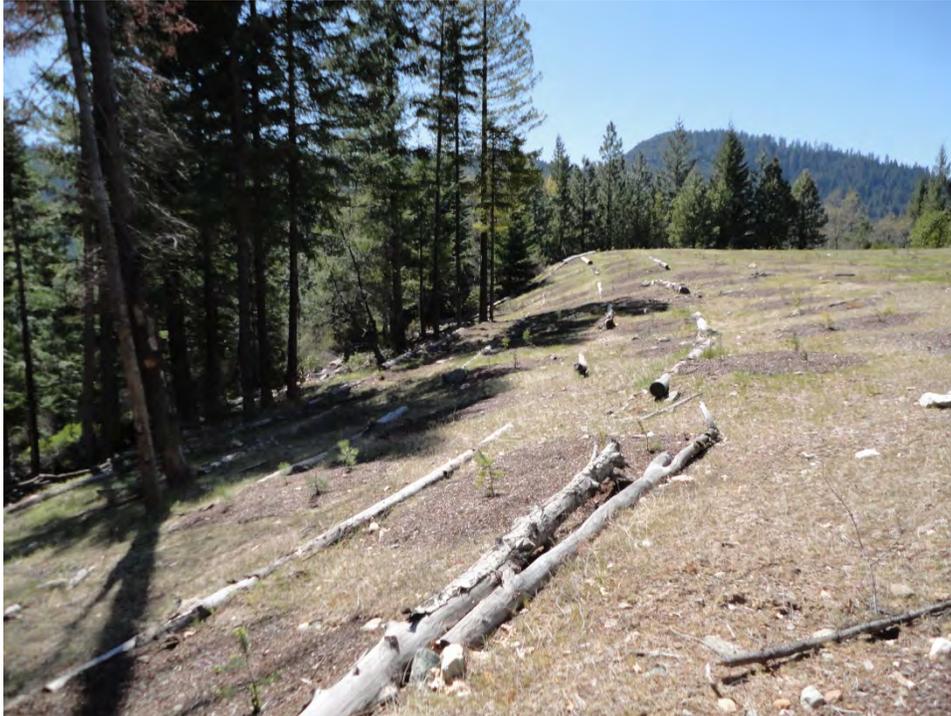
Photograph 7: North Storage area looking west.
Blue Ledge Mine, Rogue River - Siskiyou National Forest, CA
Photographed by: Annica Nord (ERRG)

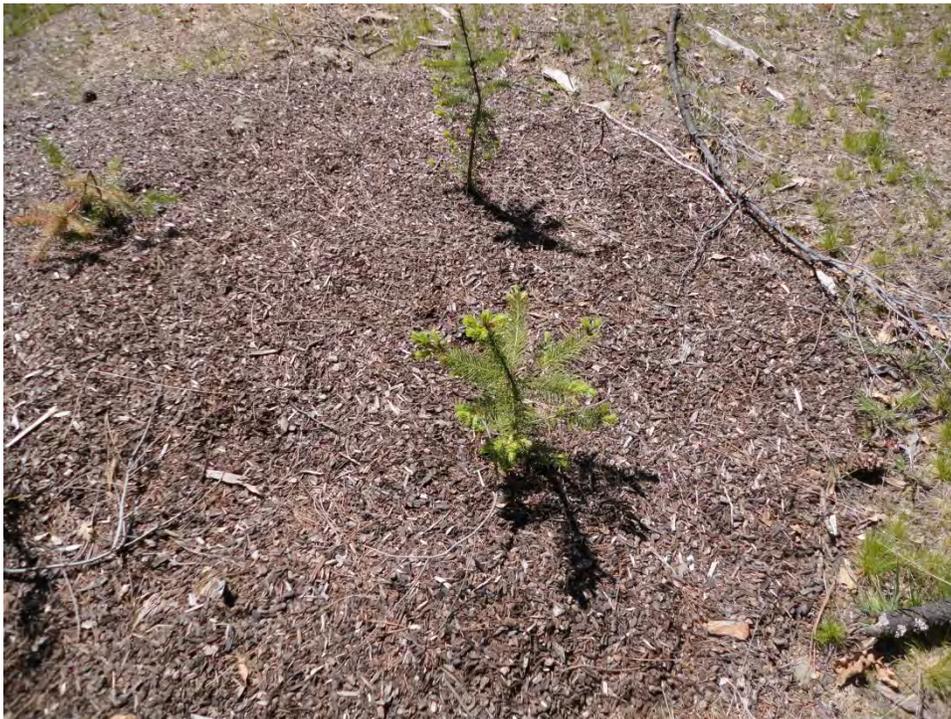
Comments: This area has sufficient live plants. Plants look healthy. Some pines have new spring growth and a few appear to be dying. 80% of the plants are alive.

Photograph 8: New growth on pines and dying pines observed in North Storage area.
Blue Ledge Mine, Rogue River - Siskiyou National Forest, CA
Photographed by: Annica Nord (ERRG)

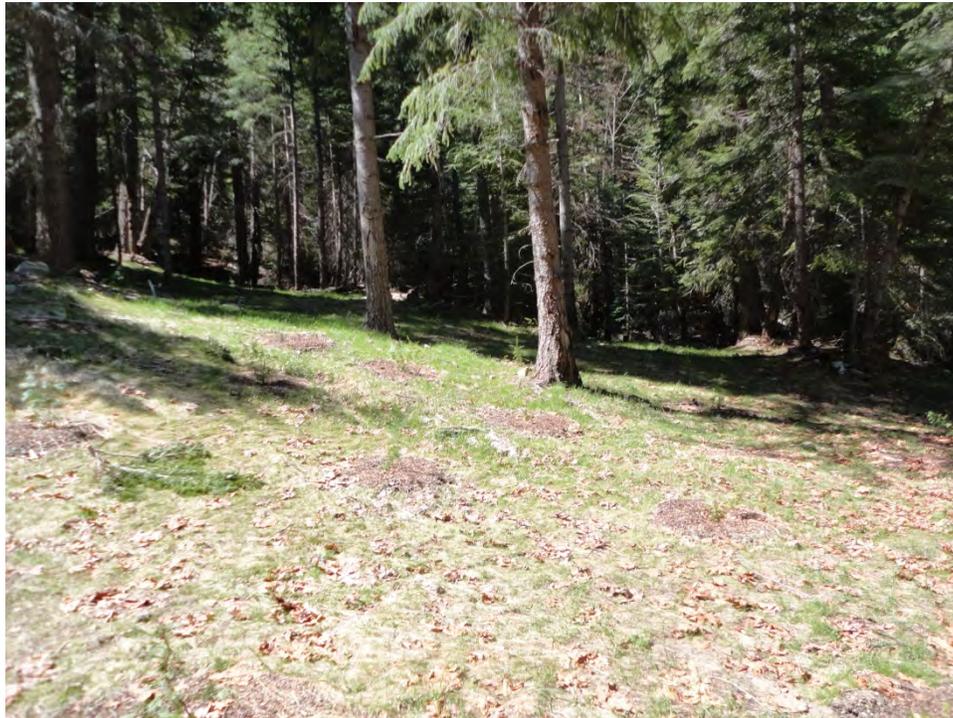
Comments: There is no existing silt fence. The ground is vegetated and appears to be stable.

Photograph 9: Rock Stockpile Area facing west.
Blue Ledge Mine, Rogue River - Siskiyou National Forest, CA
Photographed by: Annica Nord (ERRG)

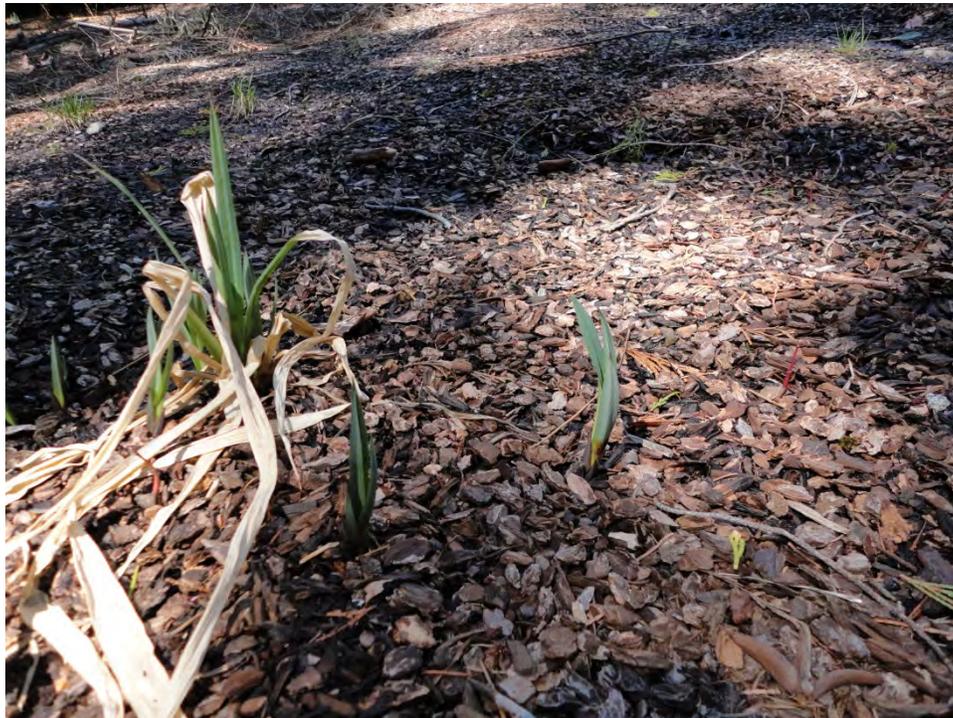
Comments: Plants appear to have new spring growth. The cedars do not appear to have been eaten by deer.

Photograph 10: New spring growth on plants in the South Storage area looking northeast.
Blue Ledge Mine, Rogue River - Siskiyou National Forest, CA
Photographed by: Annica Nord (ERRG)

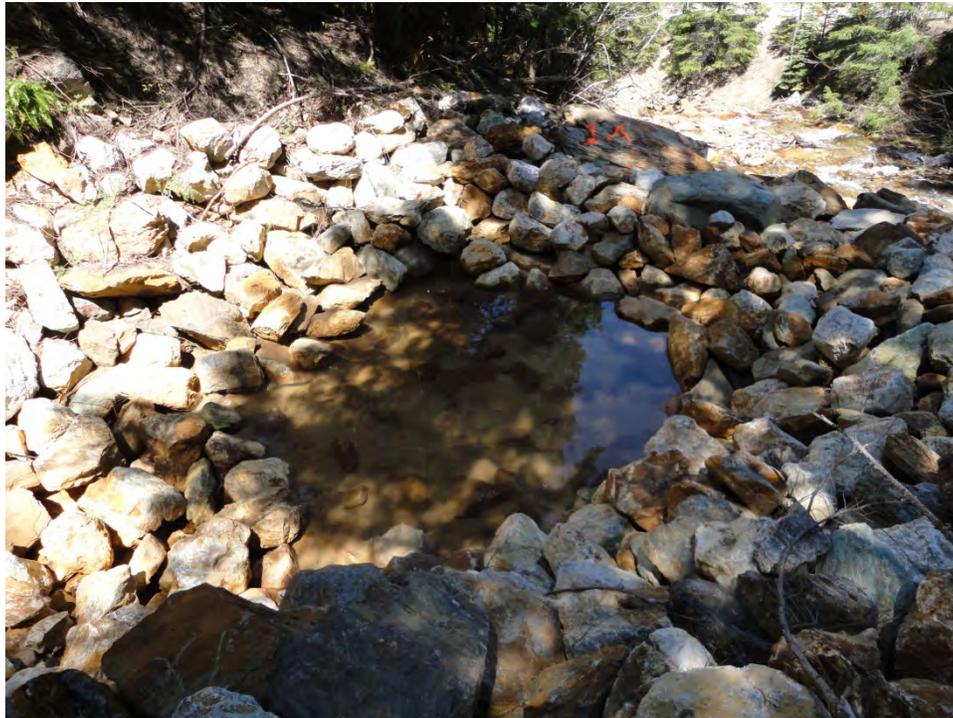
Photograph 11: Sediment/pH Treatment Basin 1A.
Blue Ledge Mine, Rogue River - Siskiyou National Forest, CA
Photographed by: Annica Nord (ERRG)

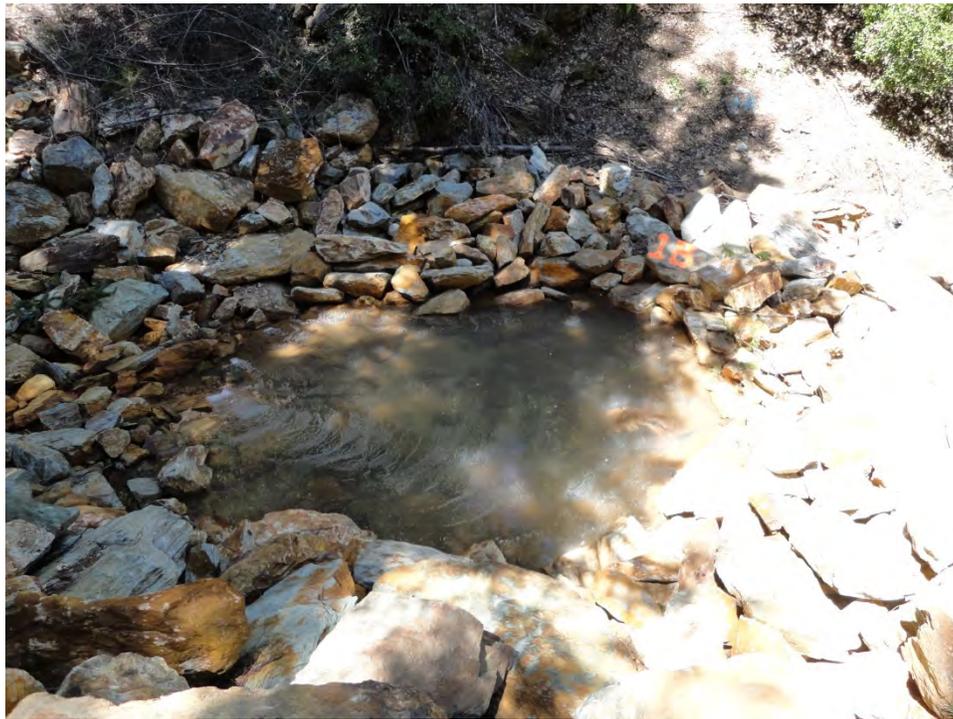
Photograph 12: Sediment/pH Treatment Basin 1B.
Blue Ledge Mine, Rogue River - Siskiyou National Forest, CA
Photographed by: Annica Nord (ERRG)

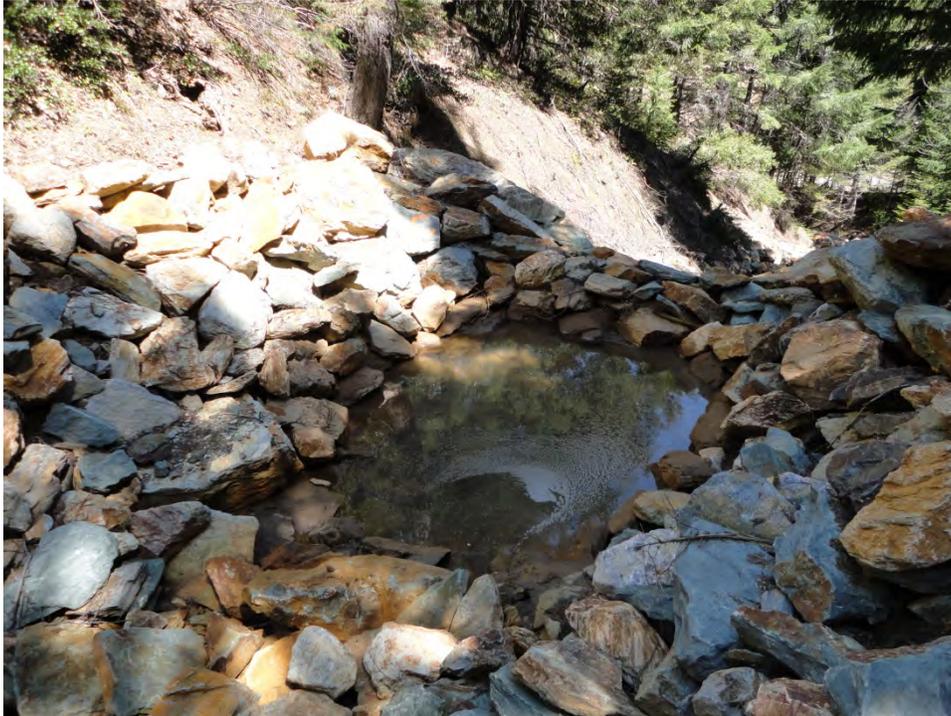
Photograph 13: Sediment/pH Treatment Basin 1C.
Blue Ledge Mine, Rogue River - Siskiyou National Forest, CA
Photographed by: Annica Nord (ERRG)

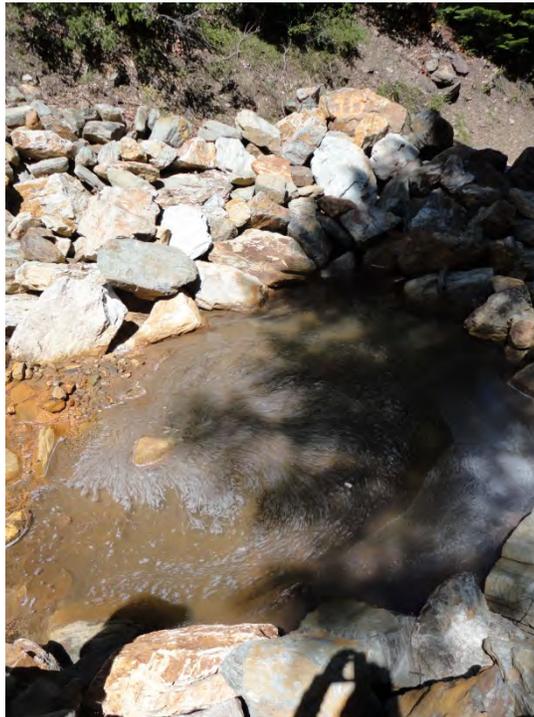
Photograph 14: Sediment/pH Treatment Basin 1D.
Blue Ledge Mine, Rogue River - Siskiyou National Forest, CA
Photographed by: Annica Nord (ERRG)

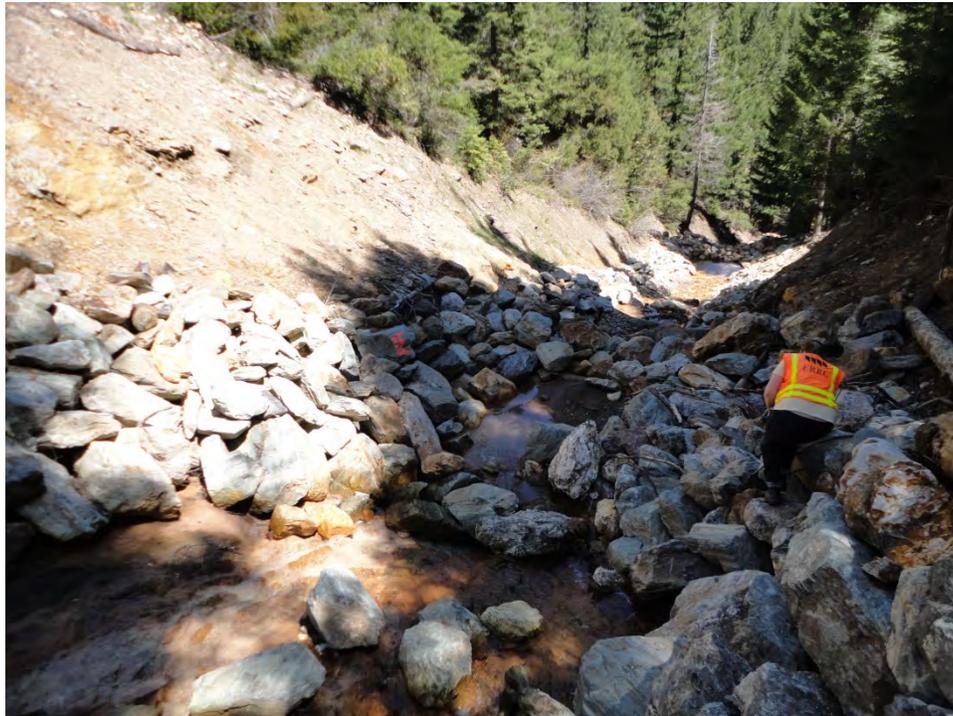
The repository had no new erosion. No additional erosion was observed on the incoming Forest Road 1060 and haul roads. The stockpile areas did not appear to have any new erosion. WRP 1 had sediment filling basins 1E and 1F. However basins 1A through 1D did not have significant sediment accumulation. WRP 2, 3, and 4 had little to no new erosion and the sediment basins in these areas contained very little sediment.

Photograph 15: Sediment/pH Treatment Basin 1E. Mostly filled with sediment.
Blue Ledge Mine, Rogue River - Siskiyou National Forest, CA
Photographed by: Annica Nord (ERRG)

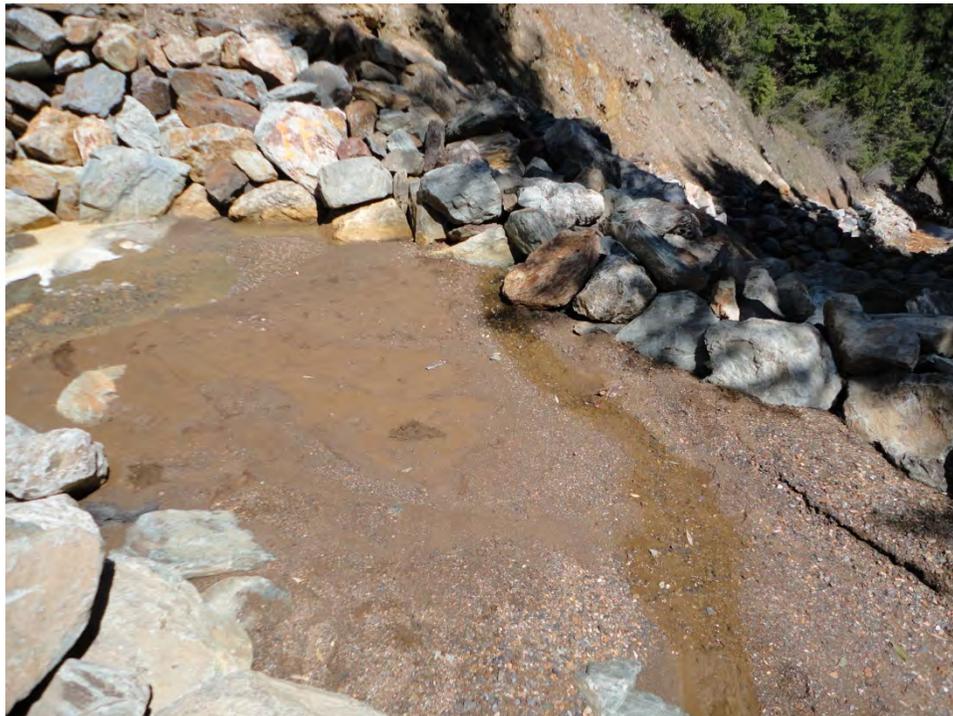
The pH of the water in the WRP-1 drainage entering basin 1F was more acidic than in April 2013 likely due to the lack of snow and decreased runoff. Typically pH has been measured using a pH meter. However, batteries in the pH meter were empty, therefore pH strips were used. pH results may not be as precise as previous tests and may also account for the lower pH readings in sediment basins 1A, 1B, 1C, 1D, 1E, 1F, and 3 as compared with May 2013.

Photograph 16: Sediment/pH Treatment Basin 1F. Full of sediment.
Blue Ledge Mine, Rogue River - Siskiyou National Forest, CA
Photographed by: Annica Nord (ERRG)

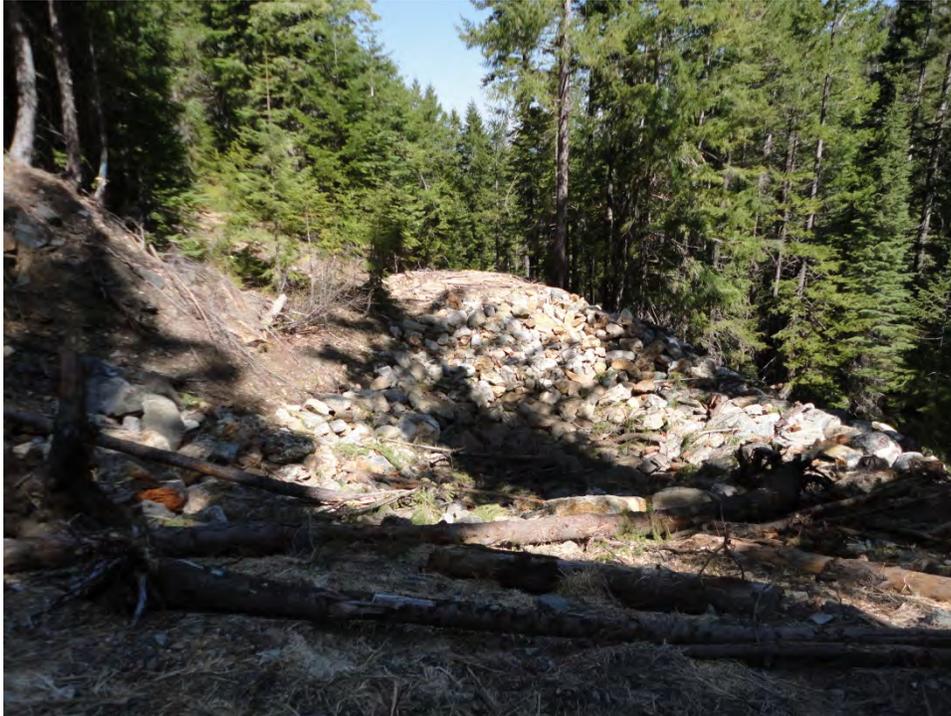
Photograph 17: Sediment/pH Treatment Basin 2A.
Blue Ledge Mine, Rogue River - Siskiyou National Forest, CA
Photographed by: Annica Nord (ERRG)

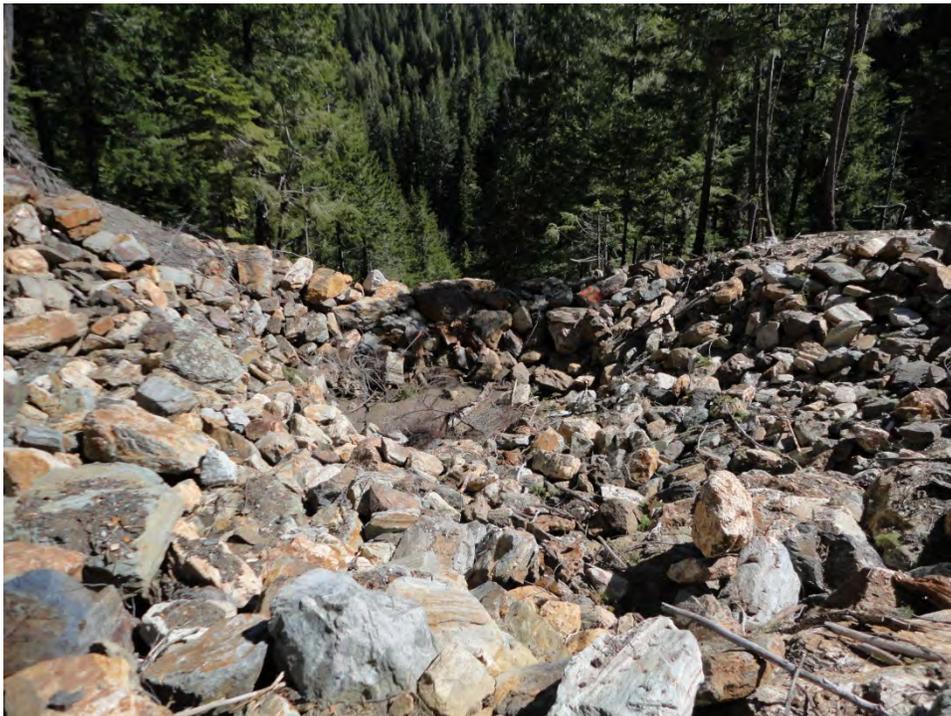
Photograph 18: Sediment/pH Treatment Basin 2B.
Blue Ledge Mine, Rogue River - Siskiyou National Forest, CA
Photographed by: Annica Nord (ERRG)

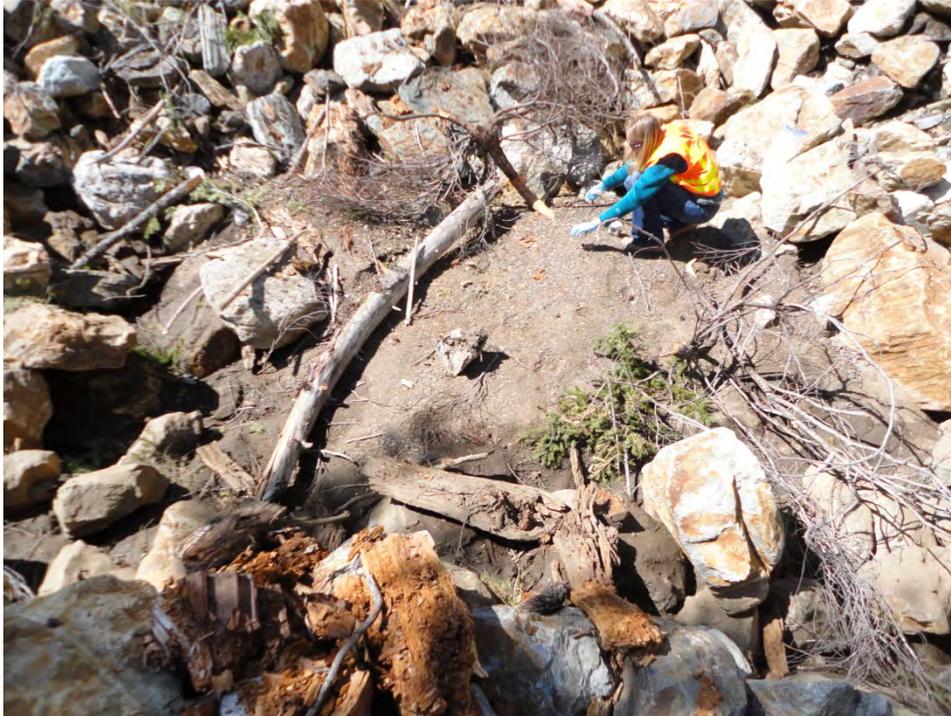
Photograph 19: Closeup of Sediment/pH Treatment Basin 2B. No water was observed to be flowing through Basin 2B.

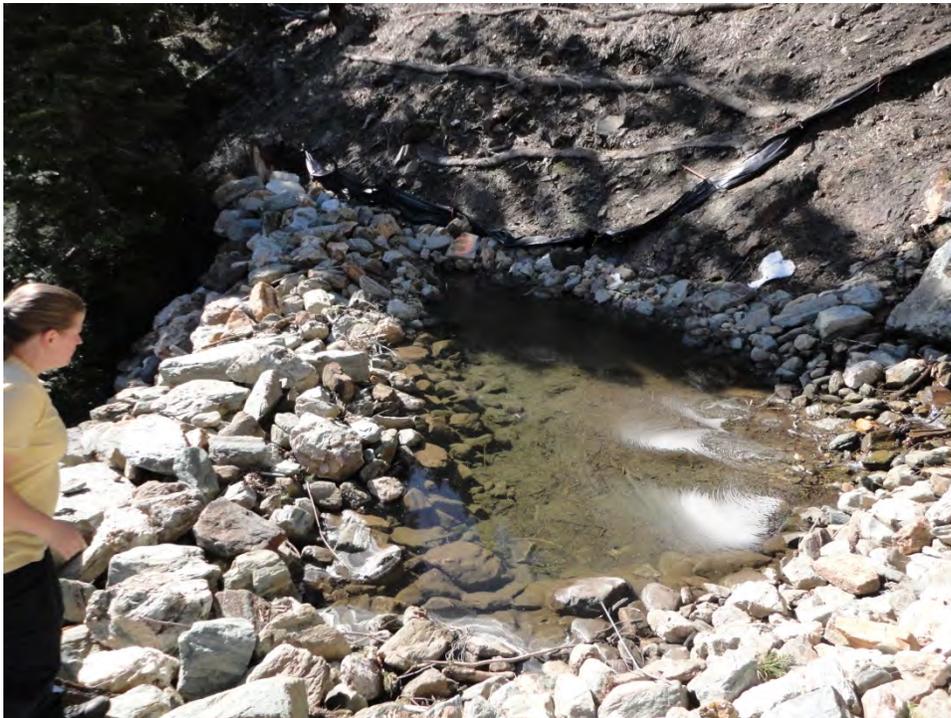
Photograph 20: Sediment/pH Treatment Basin 3.

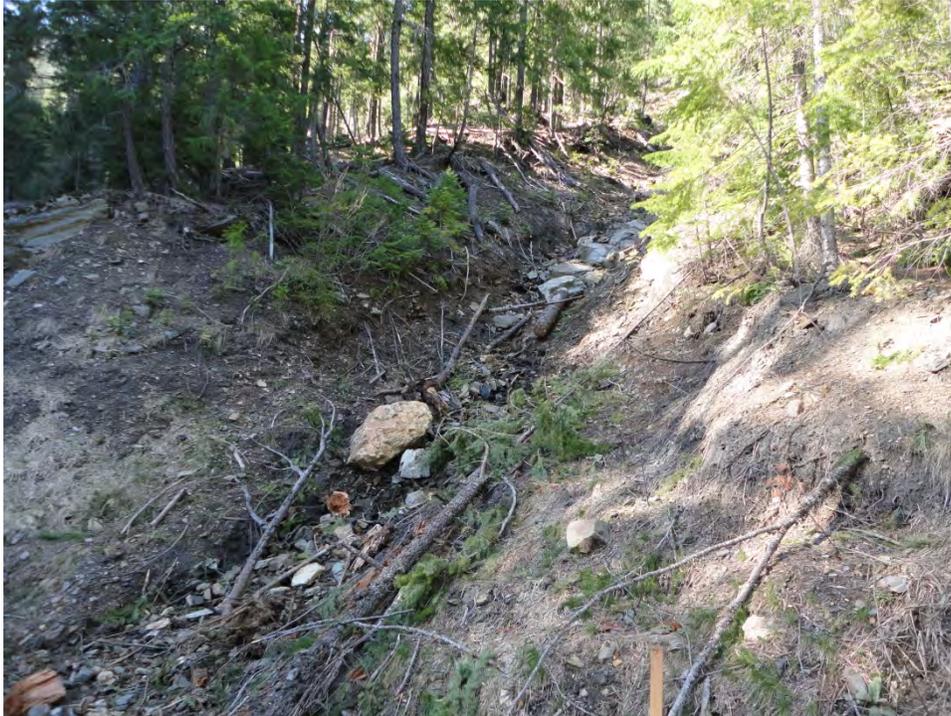
Photograph 21: WRP-2 reclamation plants and grass.
Blue Ledge Mine, Rogue River - Siskiyou National Forest, CA
Photographed by: Annica Nord (ERRG)

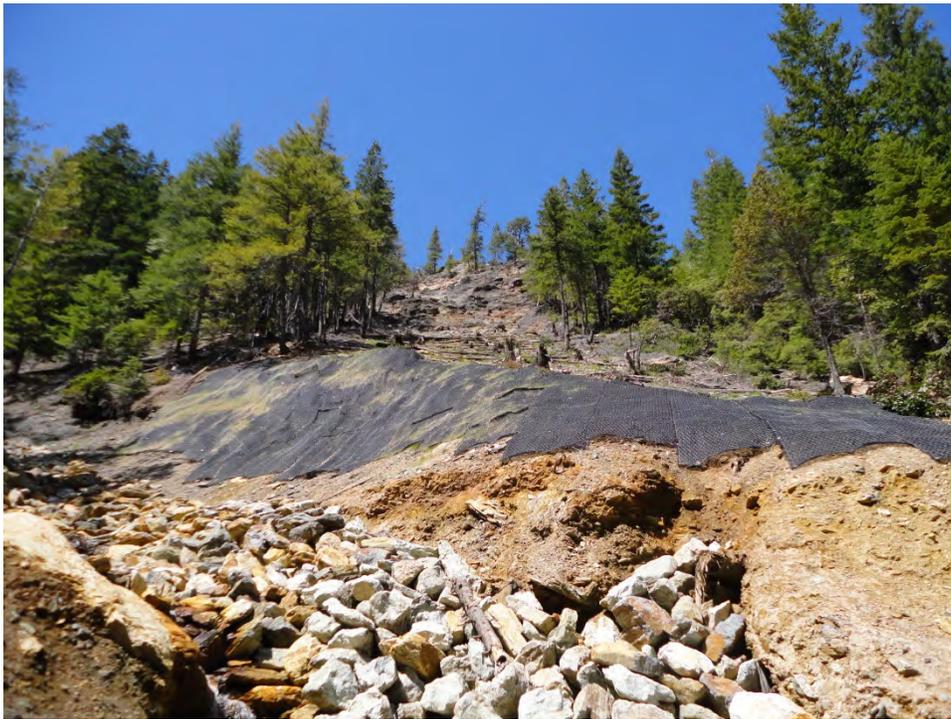
Photograph 22: WRP-4 reclamation plants and reinforced erosion fabric.
Blue Ledge Mine, Rogue River - Siskiyou National Forest, CA
Photographed by: Annica Nord (ERRG)

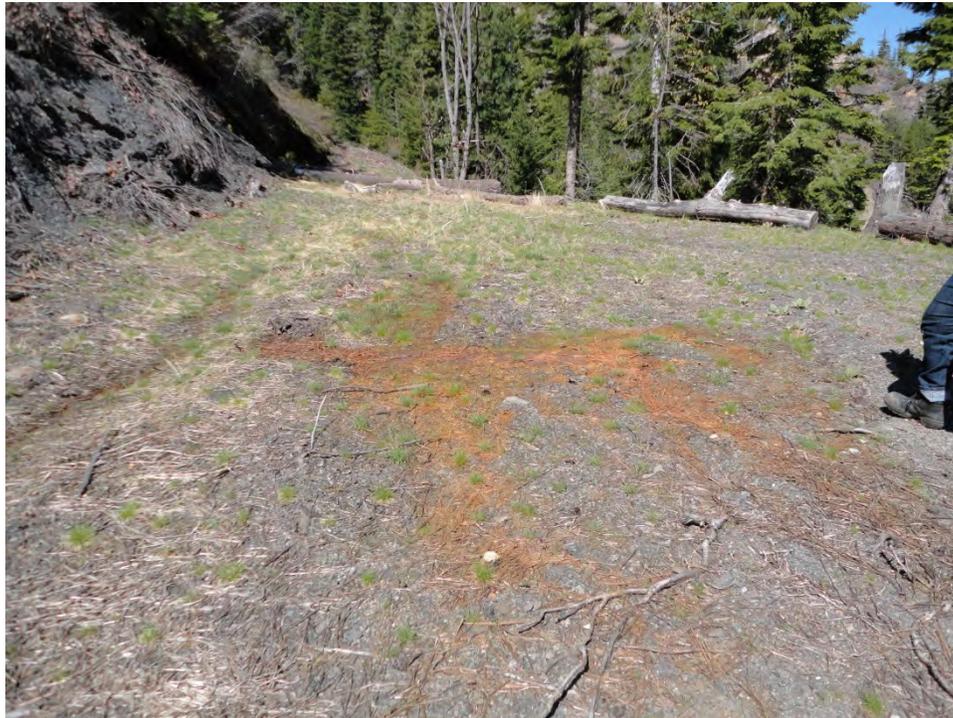
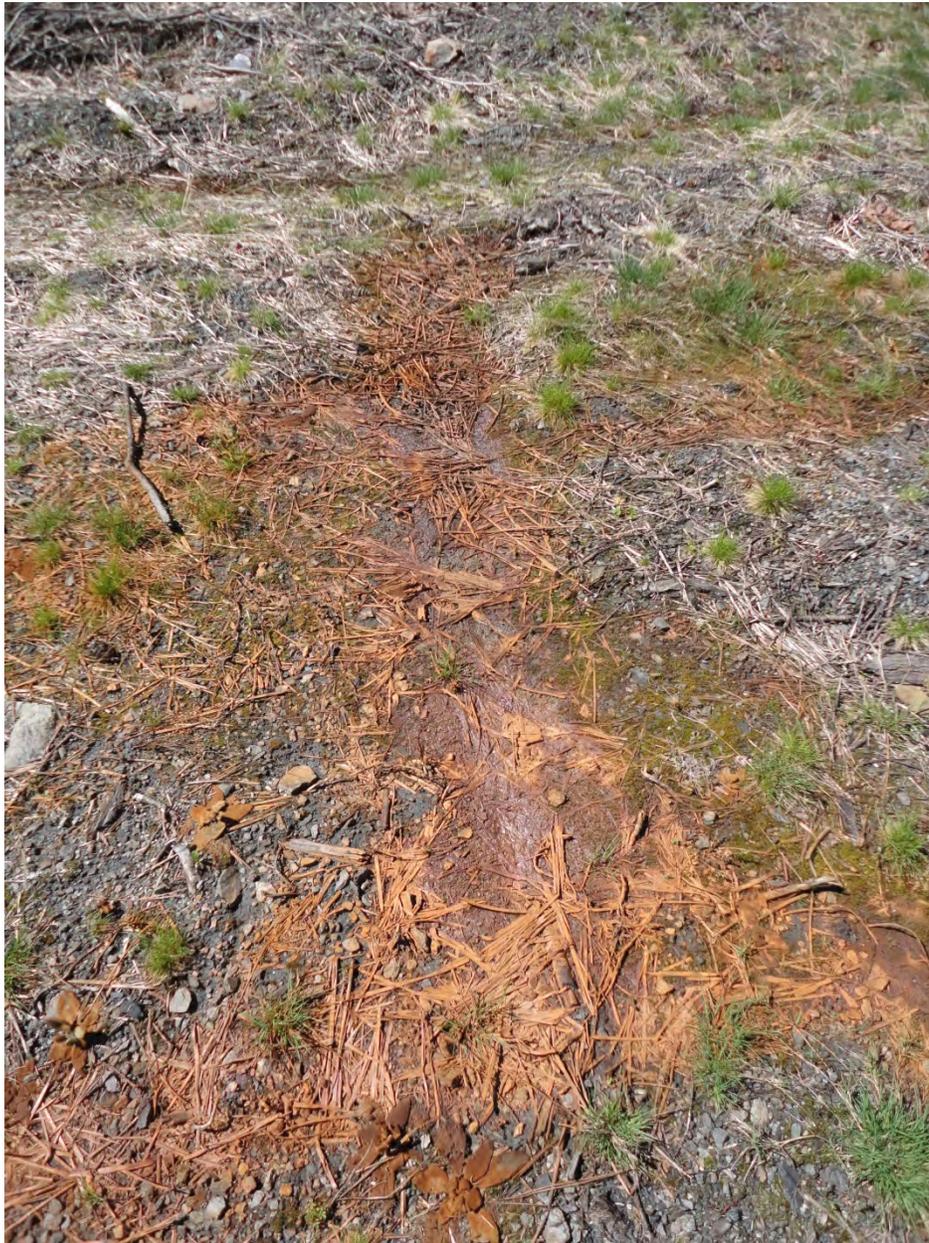
Rust colored staining was observed on the miners trail parking area. The rust staining appeared to originate from a seasonal spring releasing iron mineralized water onto the parking area. Photographs of the area are provided in the attached photographs. ERRG will inspect the conditions during the upcoming inspection event in June 2013.

Comments: Grass is growing on the roads. Plants on the miners trail parking area appears to be slowly growing. A red rust stain in two separate patches of wet soil were observed. The surrounding soil appeared dry. This is apparently a springtime seep with iron mineralized water. (see photo log).

Photograph 23: Rust-colored staining on ground at the miners trail parking area.

Photograph 24: Closeup of rust-colored staining on ground at the miners trail parking area. Note the center is moist from a water seep.
