1772-F

ASBESTOS INSPECTION REPORT

July 13, 2013

SITE: USFS Vermillion Castle Guard Station, UT 84761

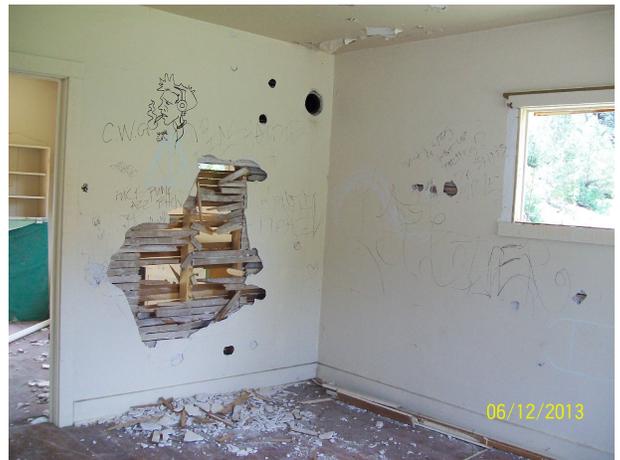
(below) wall damage
