Ref.: 2010-084

Technical Memorandum
June 2013 Site Inspection Report
Blue Ledge Mine
Rogue River-Siskiyou National Forest

**Blue Ledge Mine Removal Project
Siskiyou County, California
Operation, Maintenance, and Monitoring Period**

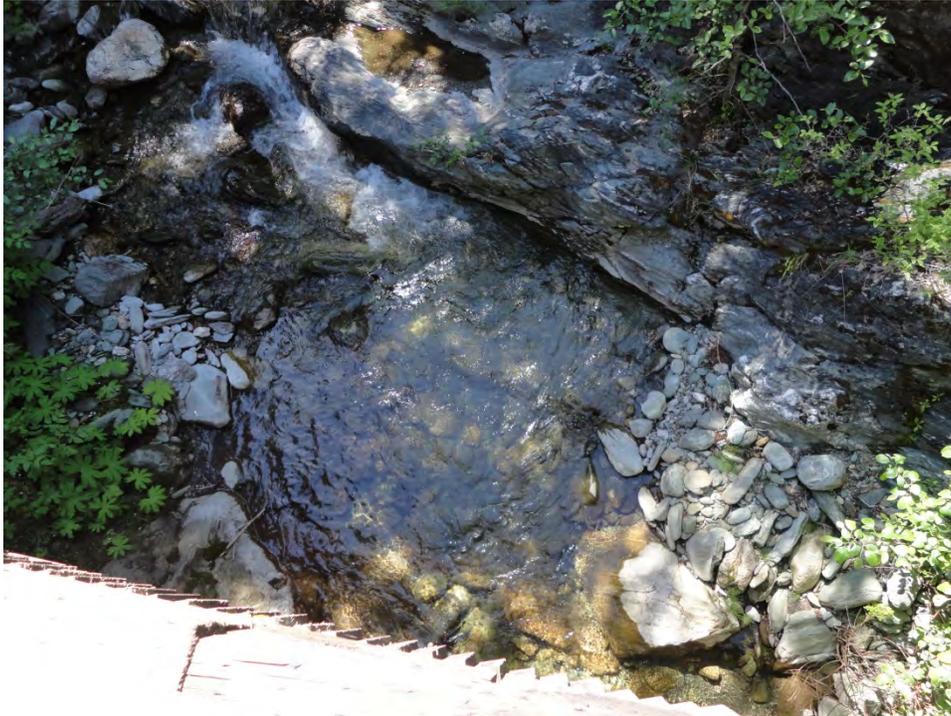
Photograph 1: Joe Creek at Joe Creek Bridge.
Blue Ledge Mine, Rogue River - Siskiyou National Forest, CA
Photographed by: Annica Nord (ERRG)

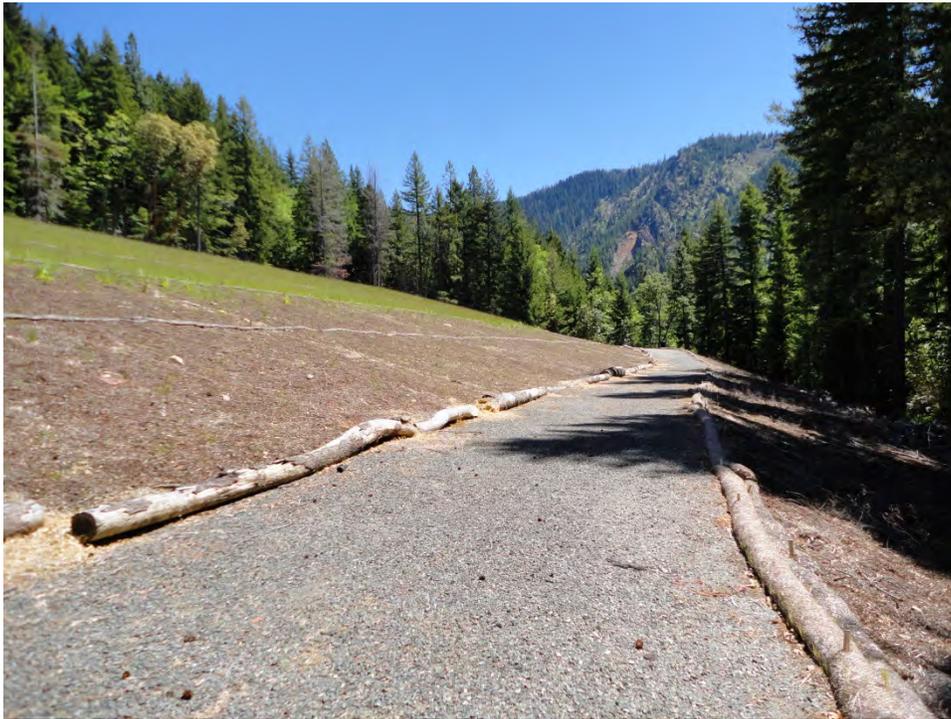
Photograph 2: View of access road, facing south. Note there is no evidence of erosion.
Blue Ledge Mine, Rogue River - Siskiyou National Forest, CA
Photographed by: Annica Nord (ERRG)

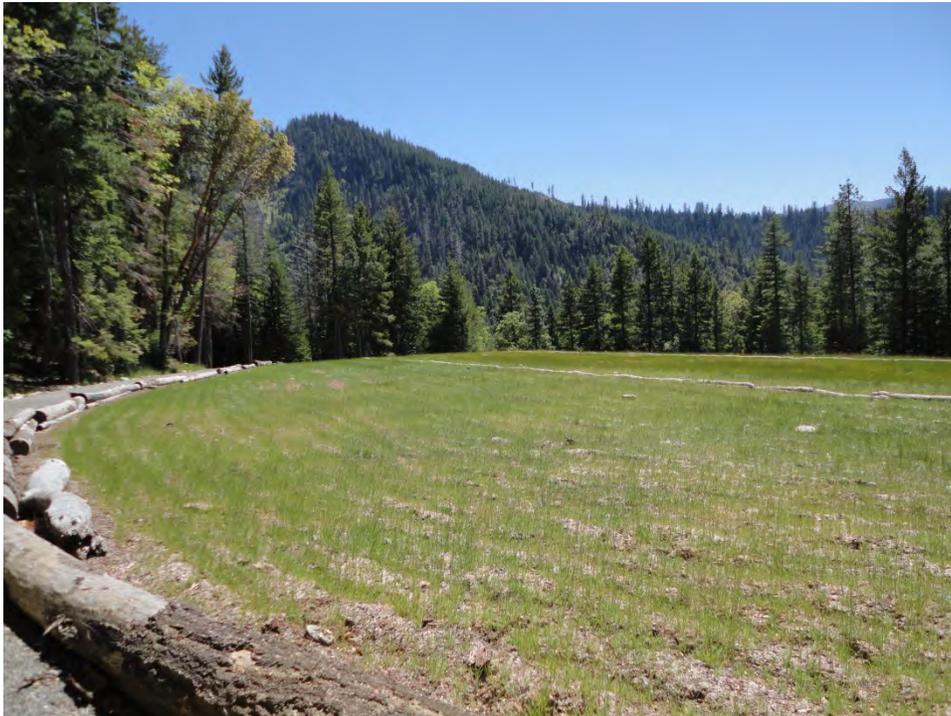
Comments: The top deck hydroseeded area is growing and appears healthy. The existing grass on the slope appears healthy.

Photograph 3: View of the top of the repository, facing south. Grass is becoming established.

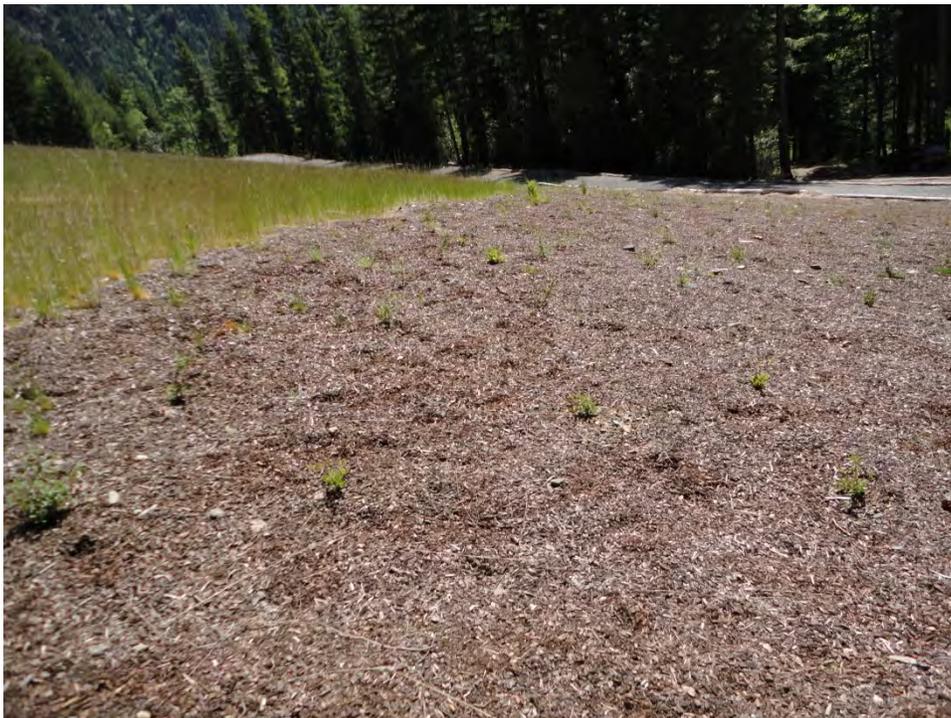
Comments: Plants still appear small and show signs of animals nibbling. They are the same size as observed in May.

Comments: The grass is growing well but the plants remain small.

Photograph 4: Plant on the repository are alive but remain small.

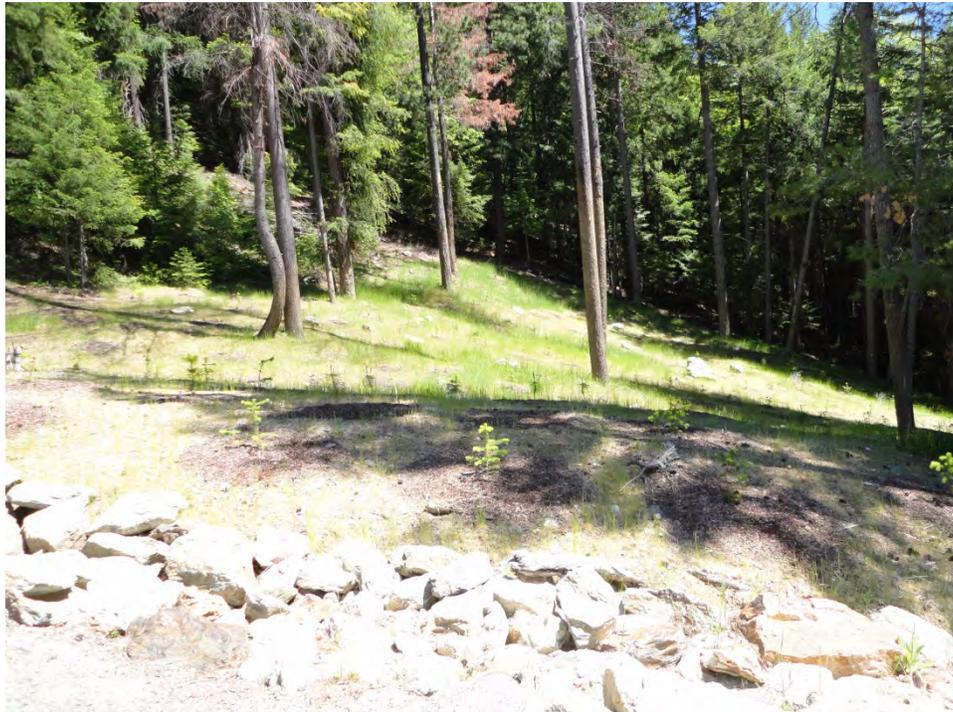
Photograph 5: Repository Stockpile Area with hydroseed and reclamation planting.
Blue Ledge Mine, Rogue River - Siskiyou National Forest, CA
Photographed by: Annica Nord (ERRG) Date: June 4, 2013

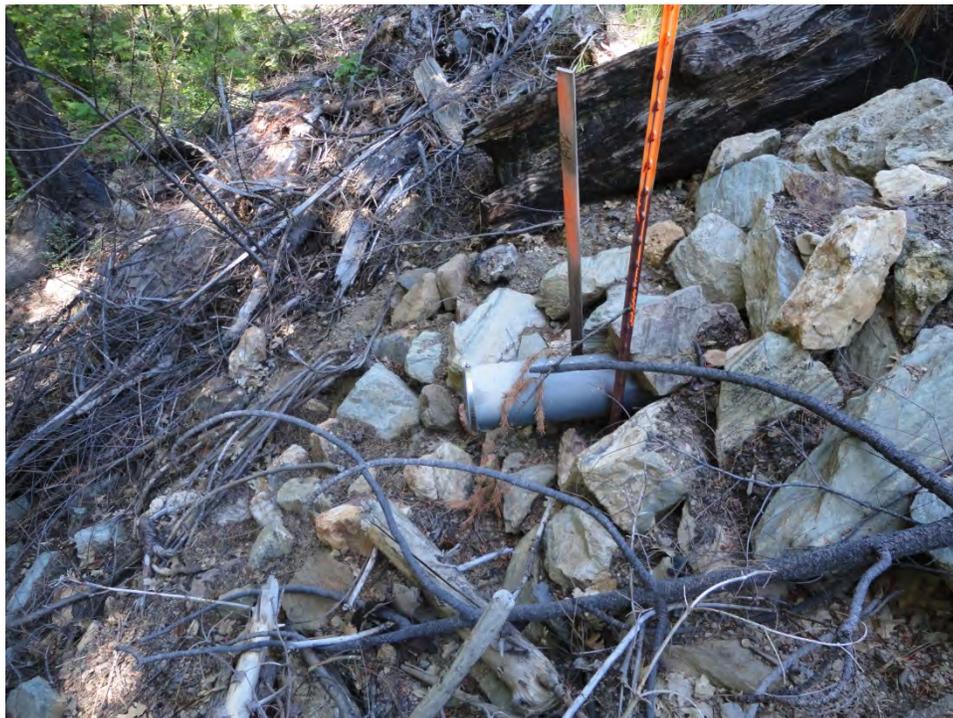
Comments: The southernmost anchor trench drain pipe is not blocked but no water is flowing from the drain.

Photograph 6: Anchor trench drain outlet, south end of repository. No water.
Blue Ledge Mine, Rogue River - Siskiyou National Forest, CA
Photographed by: Annica Nord (ERRG) Date: June 4, 2013

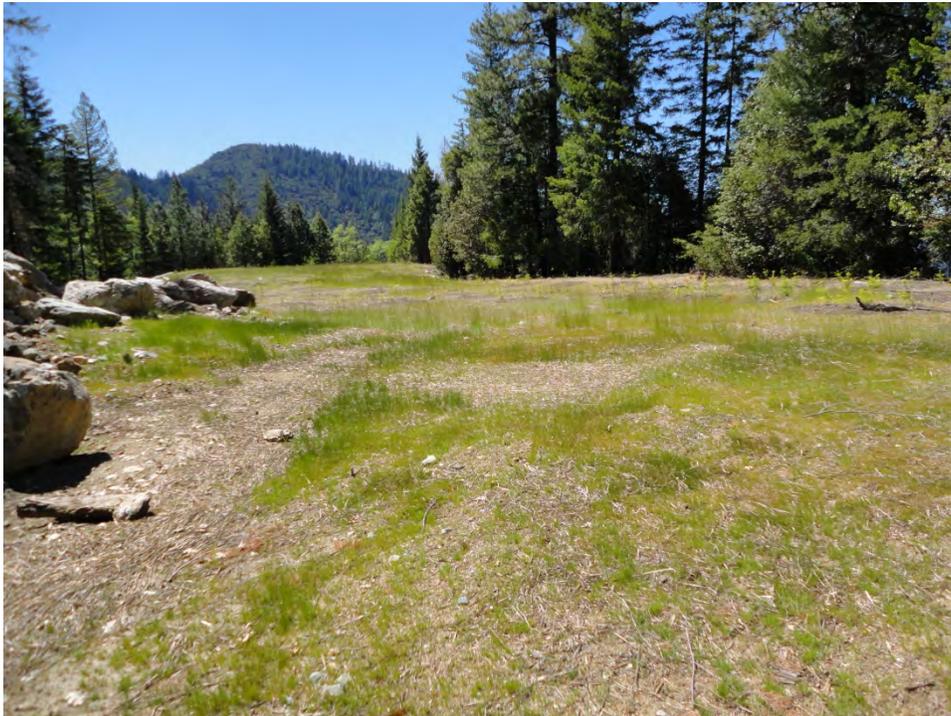
Comments: Plants show new growth and appear healthy.

Photograph 7: North storage area with hydroseed and reclamation planting.
Blue Ledge Mine, Rogue River - Siskiyou National Forest, CA
Photographed by: Annica Nord (ERRG)

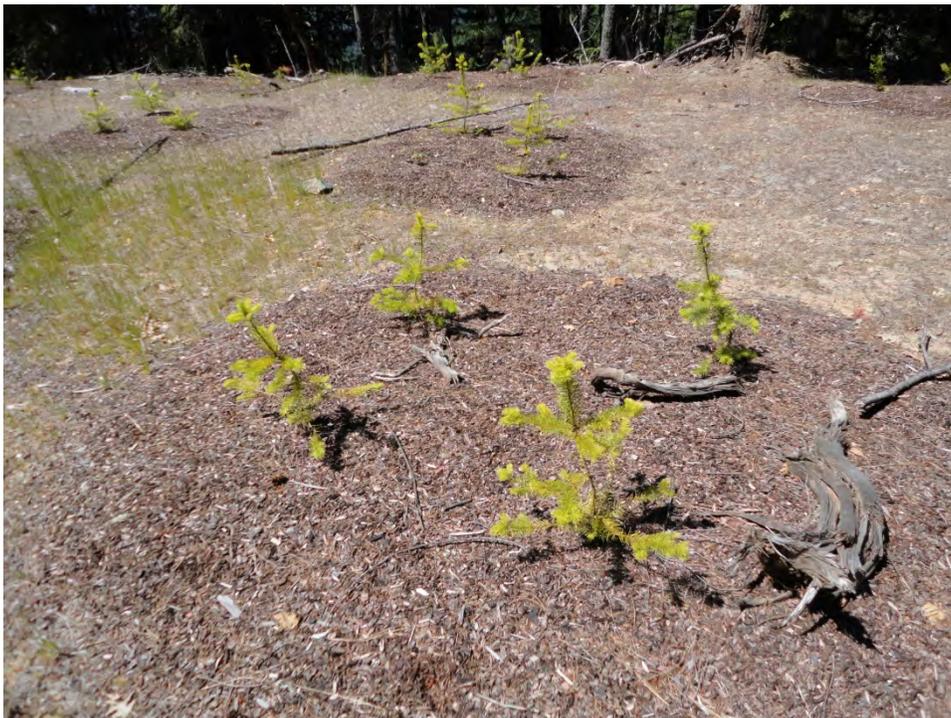
Comments: The tops of the cedars have been eaten by deer but the plants remain healthy. The pines have new spring growth.

Comments: This area has sufficient live plants. Plants look healthy. Most pines have new spring growth and a few appear to be dying. 80% of the plants are alive.

Photograph 8: New growth on pines at North Storage area.
Blue Ledge Mine, Rogue River - Siskiyou National Forest, CA
Photographed by: Annica Nord (ERRG)

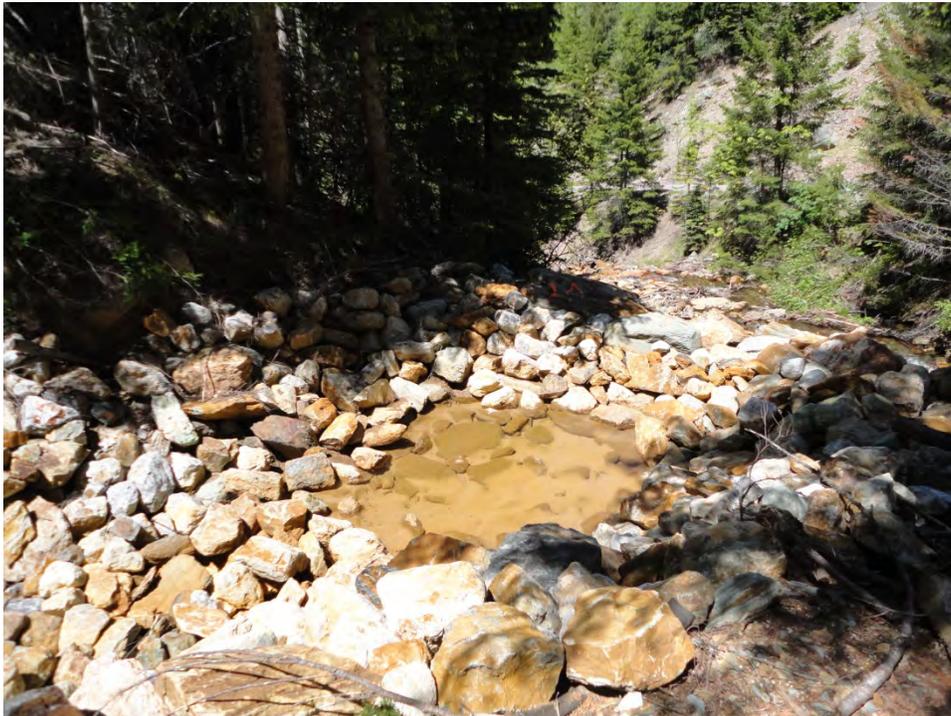
Photograph 9: Sediment/pH Treatment Basin 1A.
Blue Ledge Mine, Rogue River - Siskiyou National Forest, CA
Photographed by: Annica Nord (ERRG)

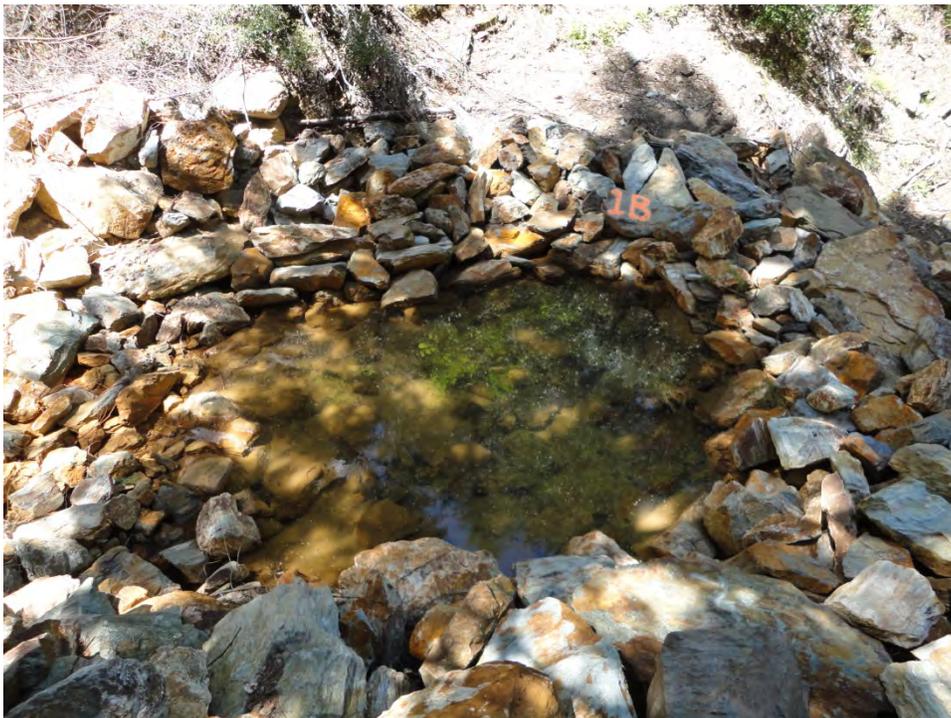
Photograph 10: Sediment/pH Treatment Basin 1B.
Blue Ledge Mine, Rogue River - Siskiyou National Forest, CA
Photographed by: Annica Nord (ERRG)

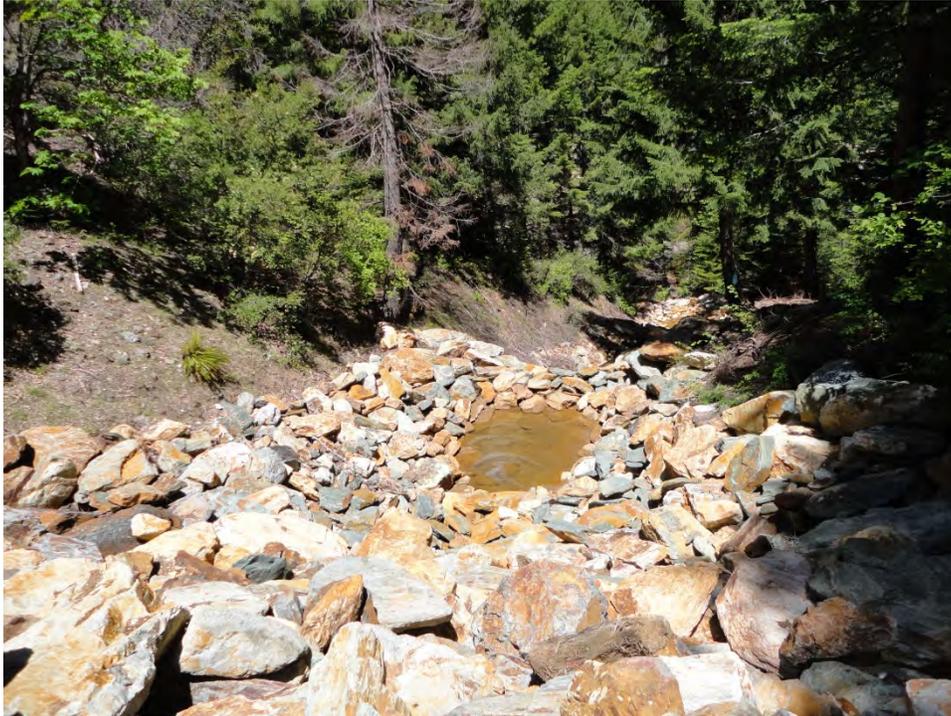
Photograph 11: Sediment/pH Treatment Basin 1C.
Blue Ledge Mine, Rogue River - Siskiyou National Forest, CA
Photographed by: Annica Nord (ERRG)

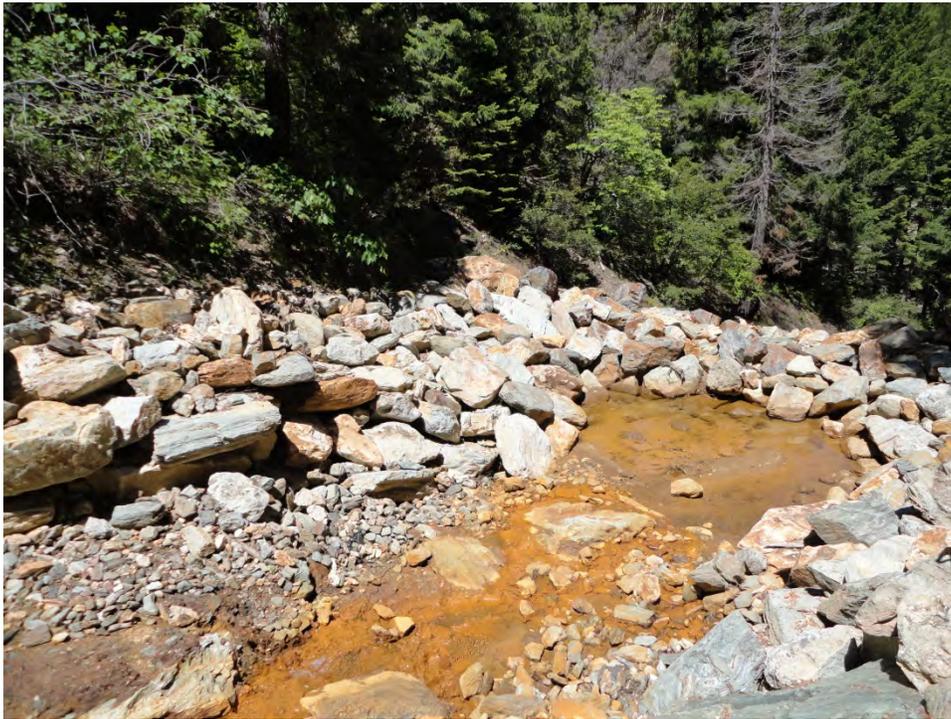
Photograph 12: Sediment/pH Treatment Basin 1D.
Blue Ledge Mine, Rogue River - Siskiyou National Forest, CA
Photographed by: Annica Nord (ERRG)

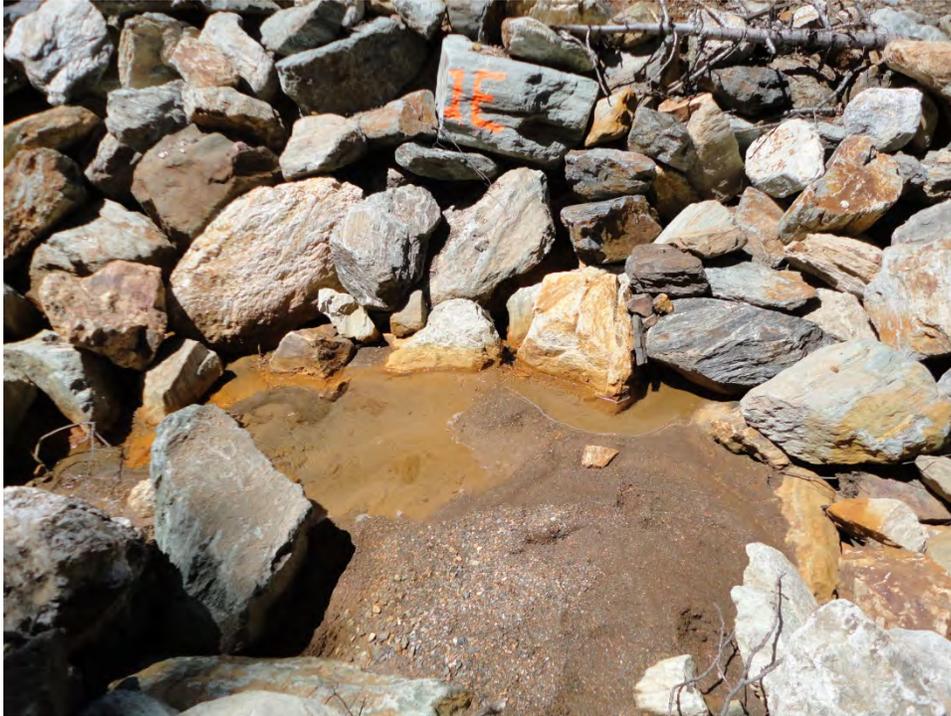
The repository had no new erosion. No additional erosion was observed on the incoming Forest Road 1060 and haul roads. The stockpile areas did not appear to have any new erosion. WRP 1 had sediment filling basins 1E and 1F. However basins 1A through 1D did not have significant sediment accumulation. WRP 2, 3, and 4 had little to no new erosion and the sediment basins in these areas contained very little sediment.

Photograph 13: Sediment/pH Treatment Basin 1E. Mostly filled with sediment.
Blue Ledge Mine, Rogue River - Siskiyou National Forest, CA
Photographed by: Annica Nord (ERRG)

Based on the sample results, the pH of the water in basins 1A through 1F appears to be reacting with the limestone. Limestone fouling will be evaluated during clean out of the accumulated sediment during the summer maintenance activities. If the limestone has fouled, it will be blended to improve the permeability and to expose limestone that is not reacted, or replaced.

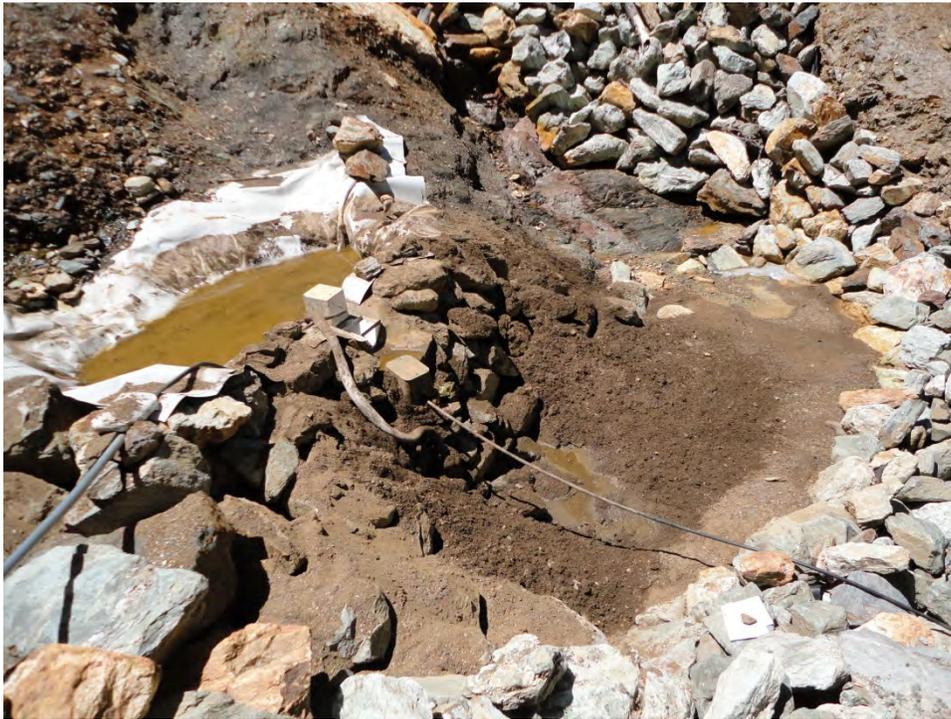
The acid seep previously entering the east side of basin 1F is being captured by the USEPA acid seep collection basin. The water seeping from adit A1N2 has been diverted by the USEPA to flow down the face of the WRP-1 bedrock to run to the acid seep collection basin. The pH in the USEPA acid seep basin was measured at 3.59, which is 0.31 pH unit lower than the May 2013 measurement. It is expected that the pH will continue to decrease as the flow of water decreases.

The USEPA acid seep basin overflow spillway is functioning due to the recent rainfall runoff and spring snowmelt. The 3.59 pH overflow water is running through the rip rap into basin 1E and comingling with the water coming down the main drainage and flowing through basin 1F. There is effectively a split flow of water between the main drainage into basin 1F and the overflow of the USEPA acid seep basin that does not fully comeingle until it reaches basin 1E. The USEPA pilot treatment system was not visibly functioning at the time of this inspection. During the site walk, USEPA was on site setting up their treatment system.

Photograph 14: Sediment/pH Treatment Basin 1F(right) and EPA treatment basin (left). Sediment from the EPA treatment basin was cleaned out and placed into 1F on 6/3/2013.

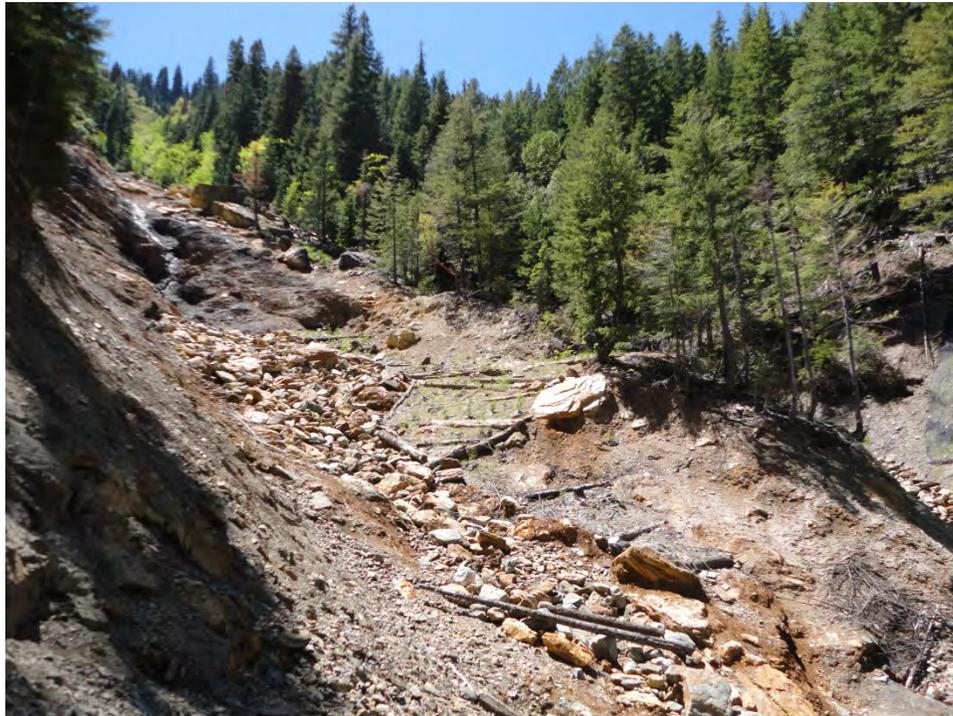
Comments: Straw wattles are in good condition and in place.

Photograph 15: WRP-1 reclamation area and plants.
Blue Ledge Mine, Rogue River - Siskiyou National Forest, CA
Photographed by: Annica Nord (ERRG)

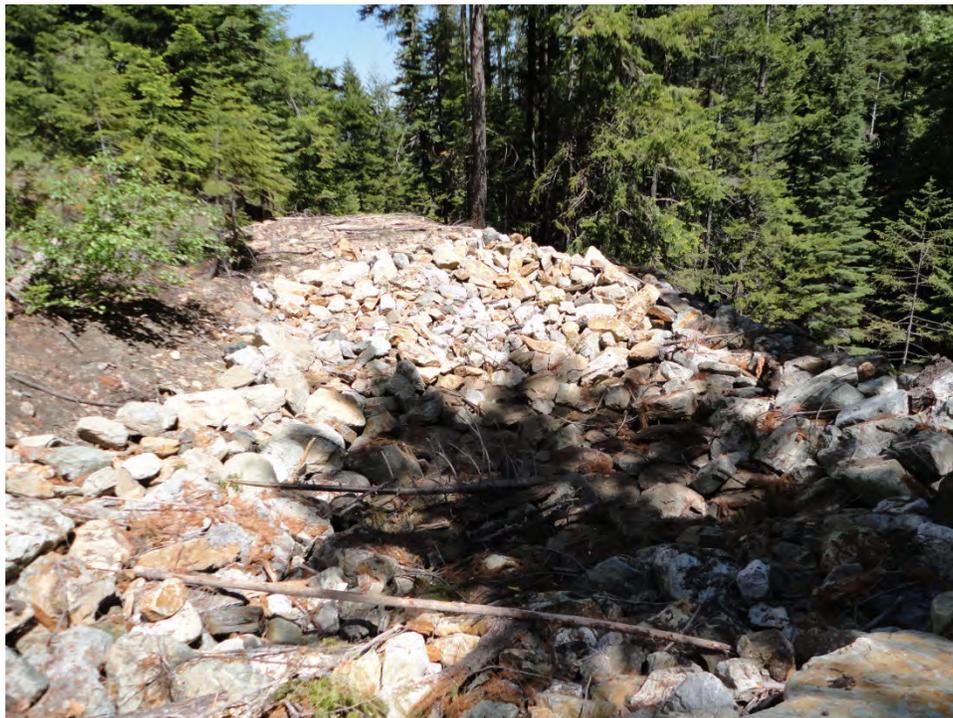
Photograph 16: Sediment/pH Treatment Basin 2A.
Blue Ledge Mine, Rogue River - Siskiyou National Forest, CA
Photographed by: Annica Nord (ERRG)

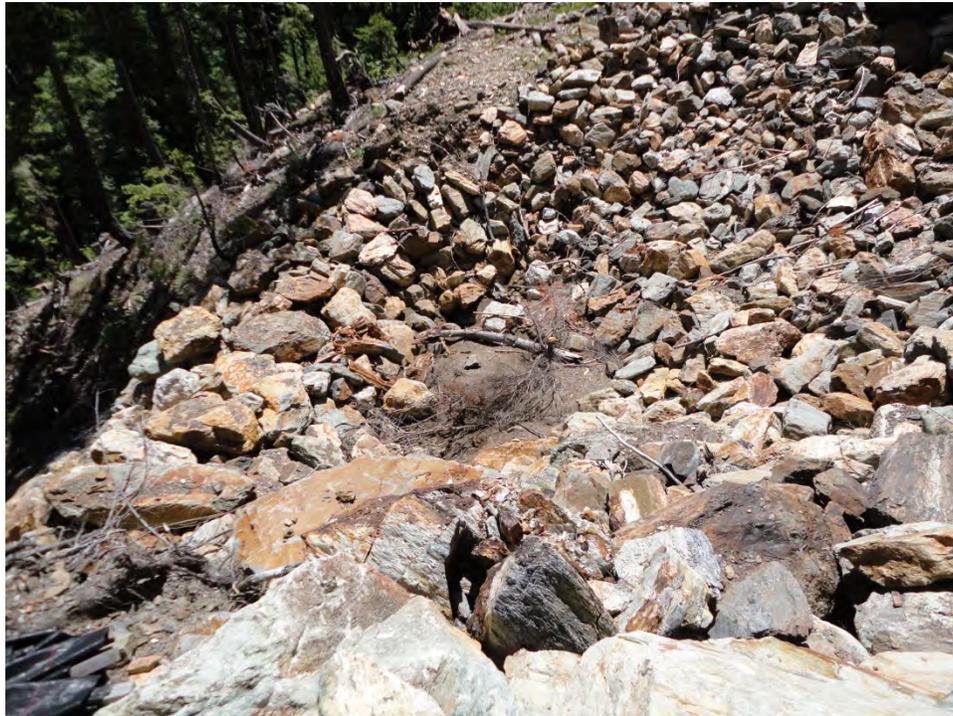
Photograph 17: Sediment/pH Treatment Basin 2B.
Blue Ledge Mine, Rogue River - Siskiyou National Forest, CA
Photographed by: Annica Nord (ERRG)

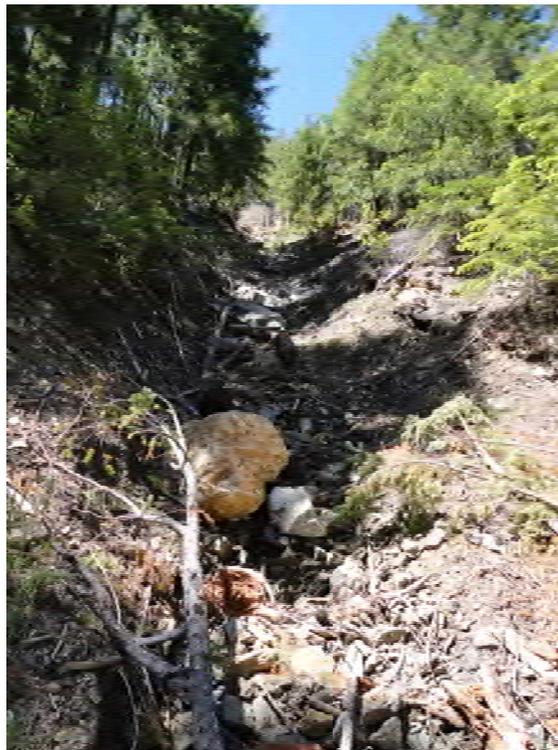
Photograph 18: WRP-2 reclamation area plants.
Blue Ledge Mine, Rogue River - Siskiyou National Forest, CA
Photographed by: Annica Nord (ERRG) Date: June 4, 2013

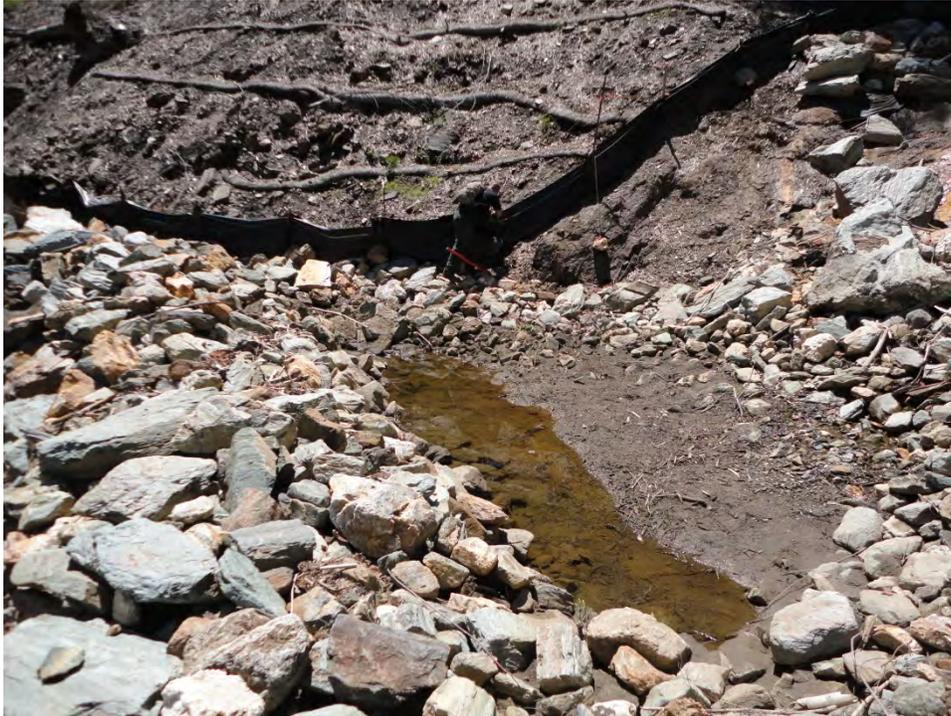
Photograph 19: Sediment/pH Treatment Basin 3.
Blue Ledge Mine, Rogue River - Siskiyou National Forest, CA
Photographed by: Annica Nord (ERRG)

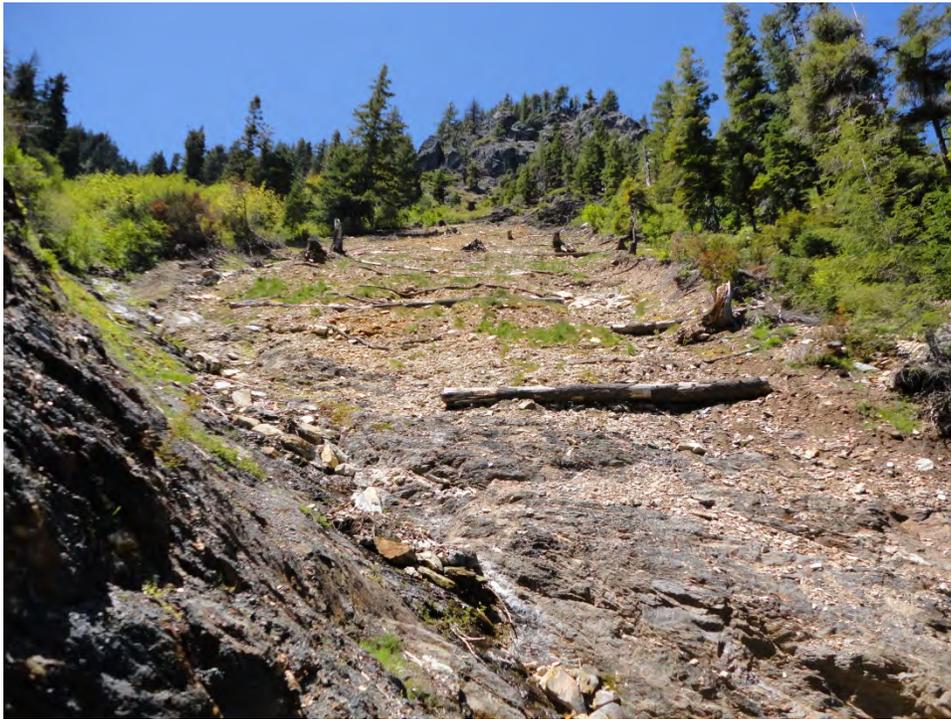
Comments: Straw wattles are in place. Silt fence on the south side was repaired.

Photograph 20: WRP-3 reclamation plants and grass.
Blue Ledge Mine, Rogue River - Siskiyou National Forest, CA
Photographed by: Annica Nord (ERRG)

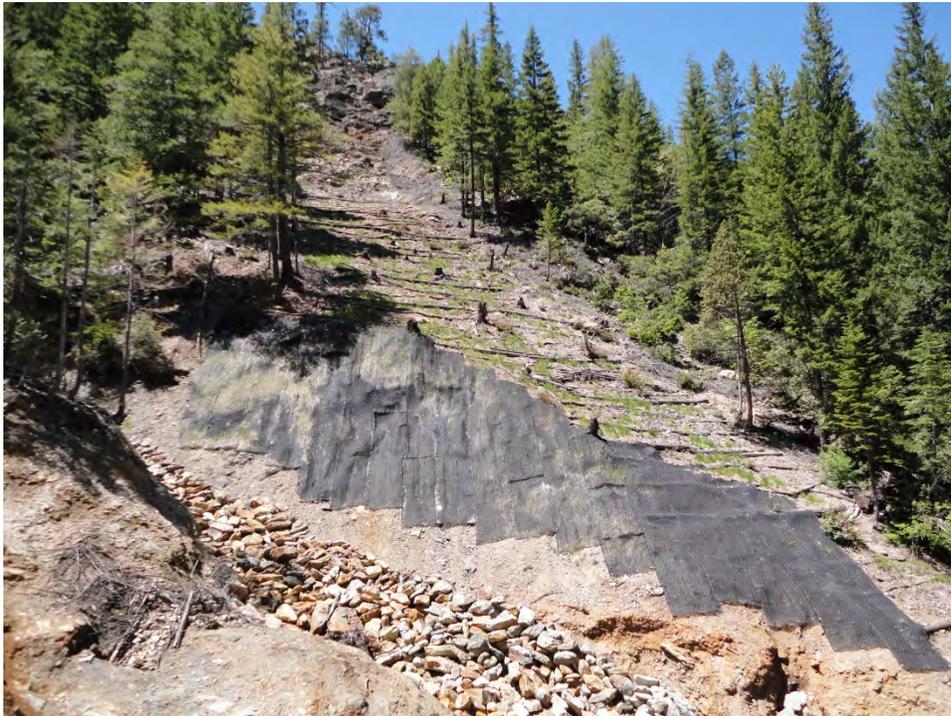
Photograph 21: WRP-4 reclamation plants and reinforced erosion fabric.
Blue Ledge Mine, Rogue River - Siskiyou National Forest, CA
Photographed by: Annica Nord (ERRG)

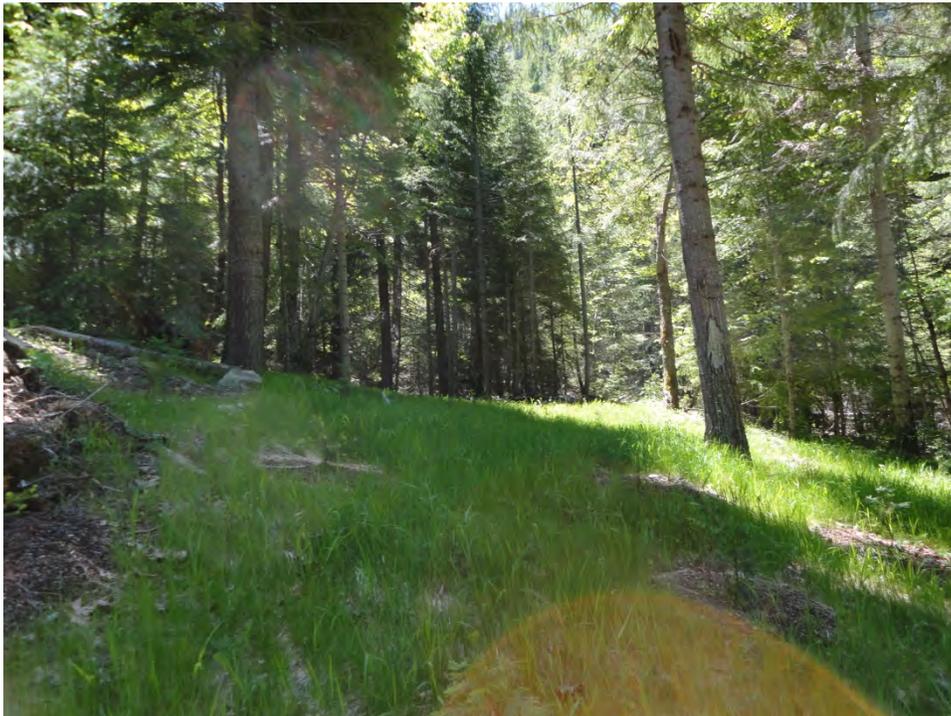
Comments: There is no existing silt fence. The ground is vegetated and appears to be stable.

Photograph 22: Rock Stockpile Area with hydroseed and reclamation planting.
Blue Ledge Mine, Rogue River - Siskiyou National Forest, CA
Photographed by: Annica Nord (ERRG)

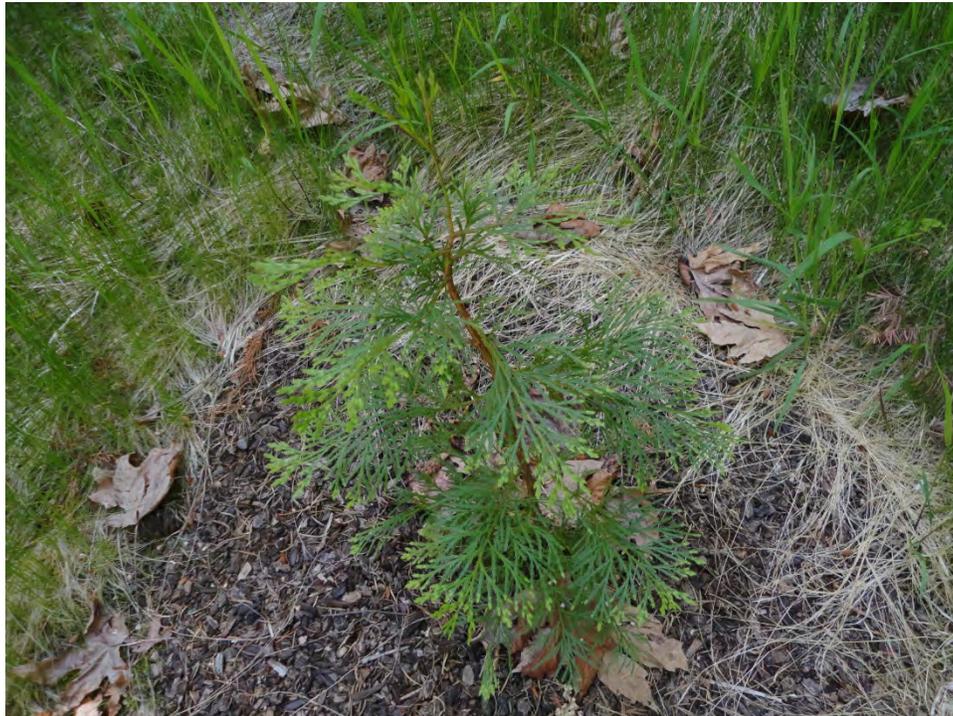
Photograph 23: Close-up of cedar tree on Rock Stockpile Area.
Blue Ledge Mine, Rogue River - Siskiyou National Forest, CA
Photographed by: Annica Nord (ERRG)

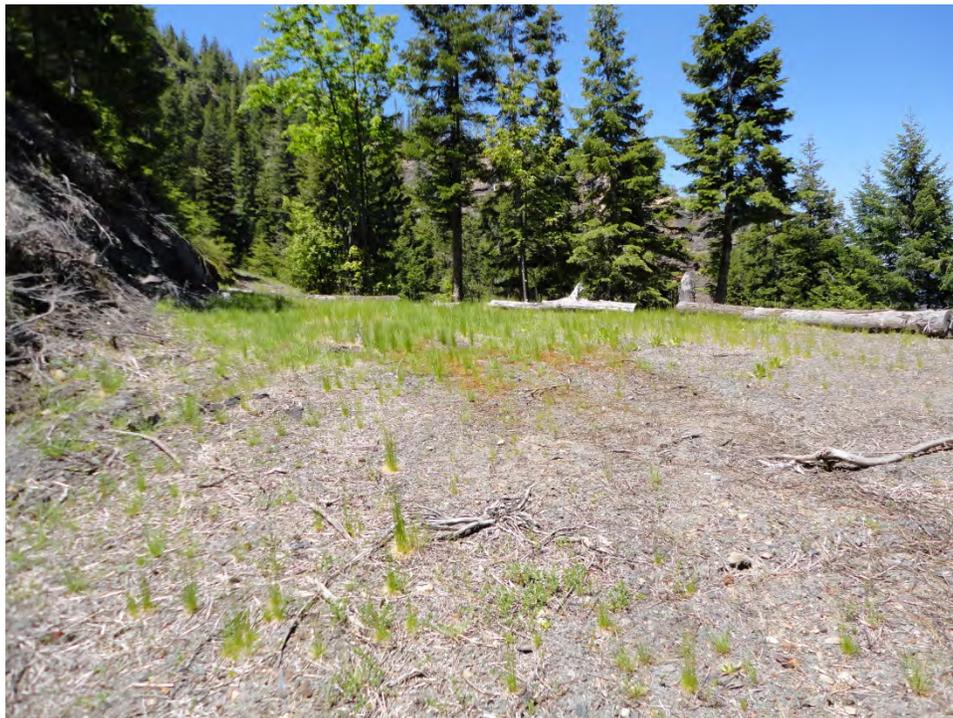
Rust colored staining as observed in April 2013 on the miners trail parking area was still evident. However, the stain appeared to not have an effect on the grass which appeared healthy and growing on the miners trail parking area. The rust staining appeared to originate from a seasonal spring releasing iron mineralized water onto the parking area in April 2013. The area was dry during the June 2013 investigation. Photographs of the area are provided in the attached photographs.

Comments: Grass is growing on the roads. Plants on the miners trail parking area appear to be growing. A red rust stain in two separate patches of soil were observed similar to April 2013. The soil is no longer wet and plants are growing both in and around the red stain and appear to be unaffected. The red stain appears to be a stain from a springtime seep with iron mineralized water. (see photo log).

Photograph 24: Rust-colored staining on ground at the miners trail parking area.
Blue Ledge Mine, Rogue River - Siskiyou National Forest, CA
Photographed by: Annica Nord (ERRG)

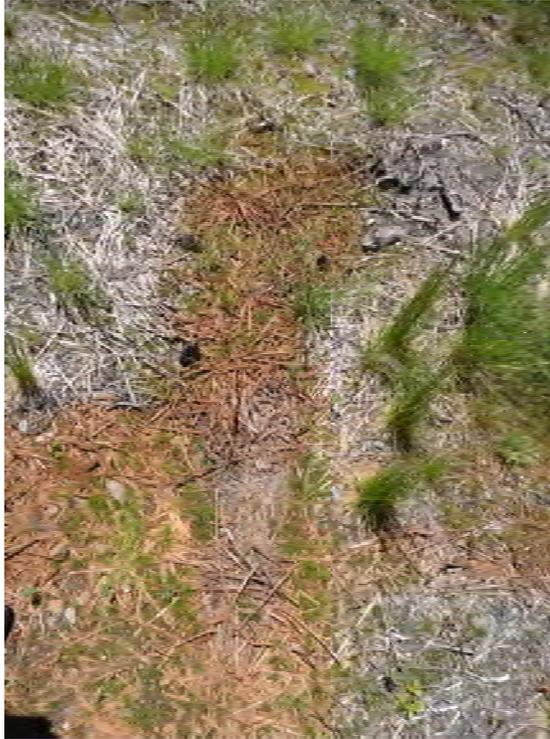
Silt fences along creek crossings were re-hammered in place and straightened. The rust area at the miners trail parking lot is still evident but appears to not be affecting the plant growth. This area was observed to be dry during the site investigation. EPA (Bonnie, Nick, and one other employee) was on site working on their remediation system above basin 1F. No one else was on site. No unauthorized access was observed.

Photograph 25: Closeup of rust-colored staining on ground at the miners trail parking area. Note plants do not appear to be affected by the stained area.

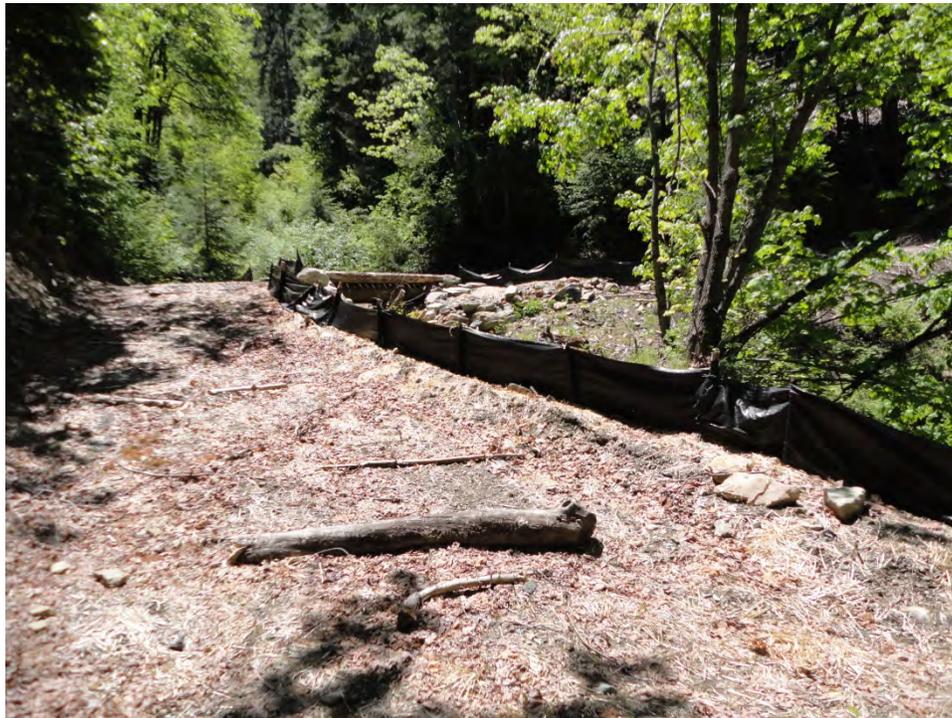
Photograph 26: Silt fences along creek crossings were straightened.
