Ref.: 2010-084

Technical Memorandum
July 2013 Site Inspection Report
Blue Ledge Mine
Rogue River-Siskiyou National Forest

**Blue Ledge Mine Removal Project
Siskiyou County, California
Operation, Maintenance, and Monitoring Period**

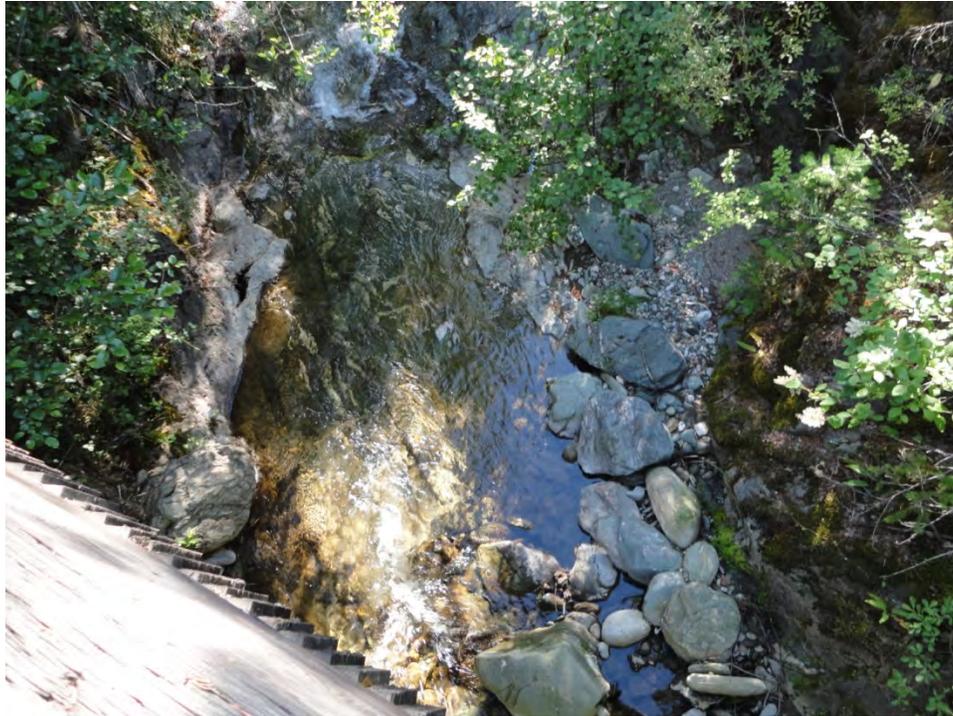
Photograph 1: Joe Creek at Joe Creek Bridge.
Blue Ledge Mine, Rogue River - Siskiyou National Forest, CA
Photographed by: Annica Nord (ERRG)

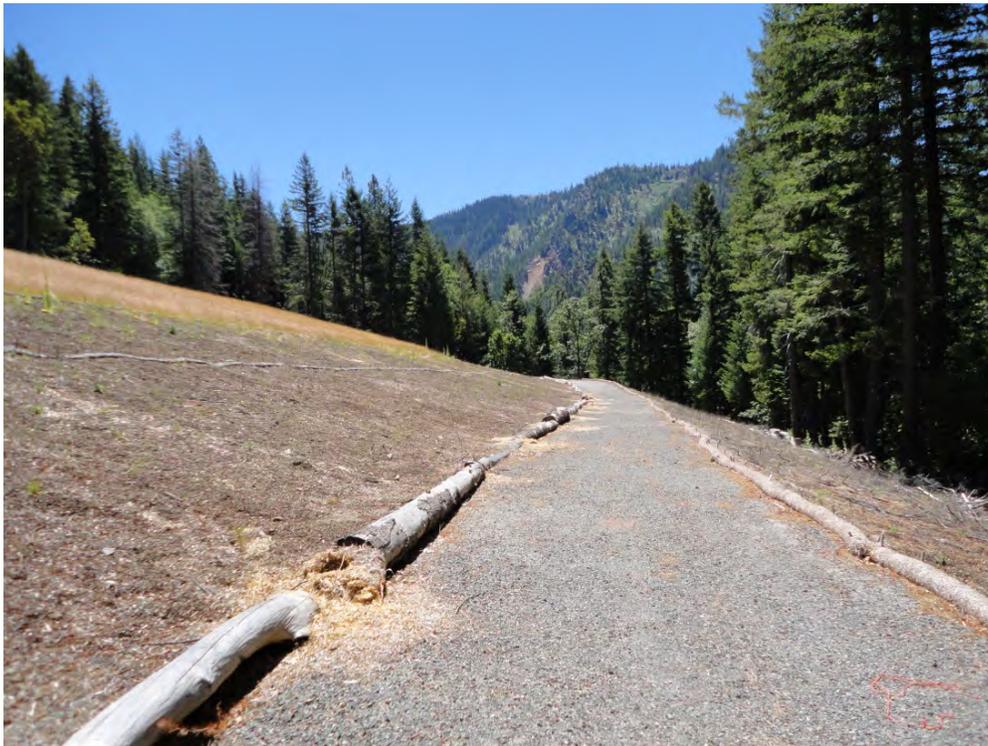
Photograph 2: View of access road, facing south. Note there is no evidence of erosion.
Blue Ledge Mine, Rogue River - Siskiyou National Forest, CA
Photographed by: Annica Nord (ERRG)

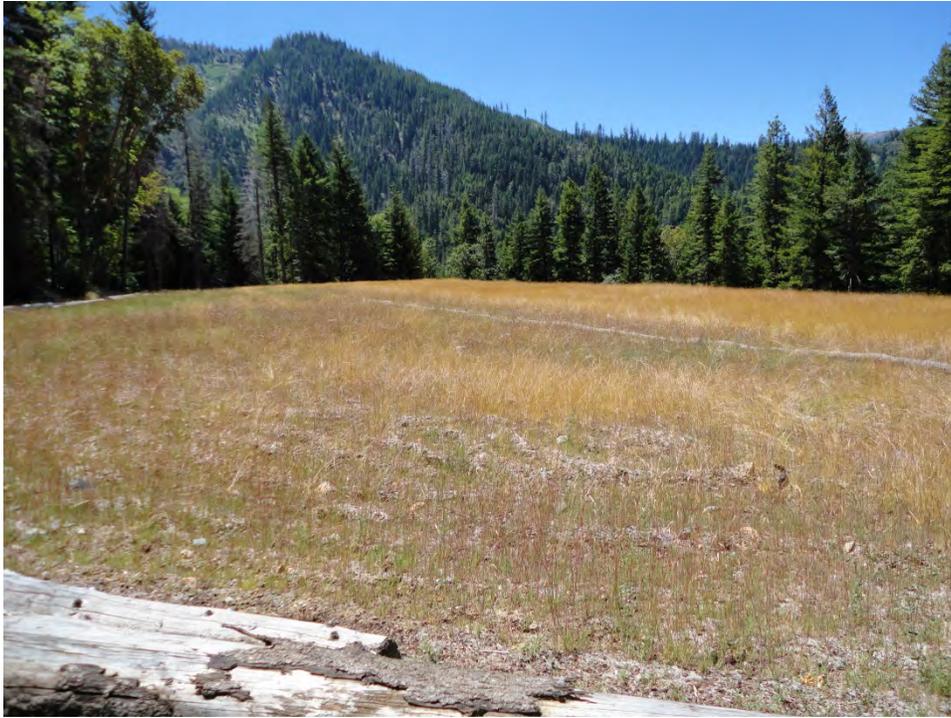
Comments: Plants appear healthy and green. Plants show signs of previous animal browsing. Grass is mostly brown on top of the repository but remains green in the repository stockpile area.

Photograph 3: View of the top of the repository, facing south. Grass is turning seasonally brown.

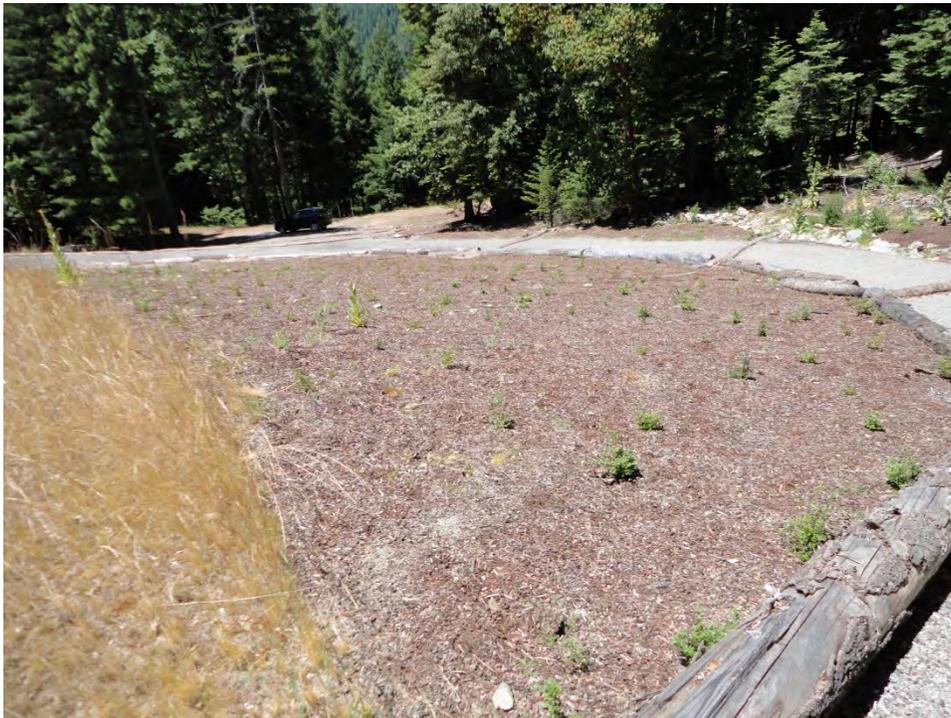
Photograph 4: Plants on the repository are alive and healthy.

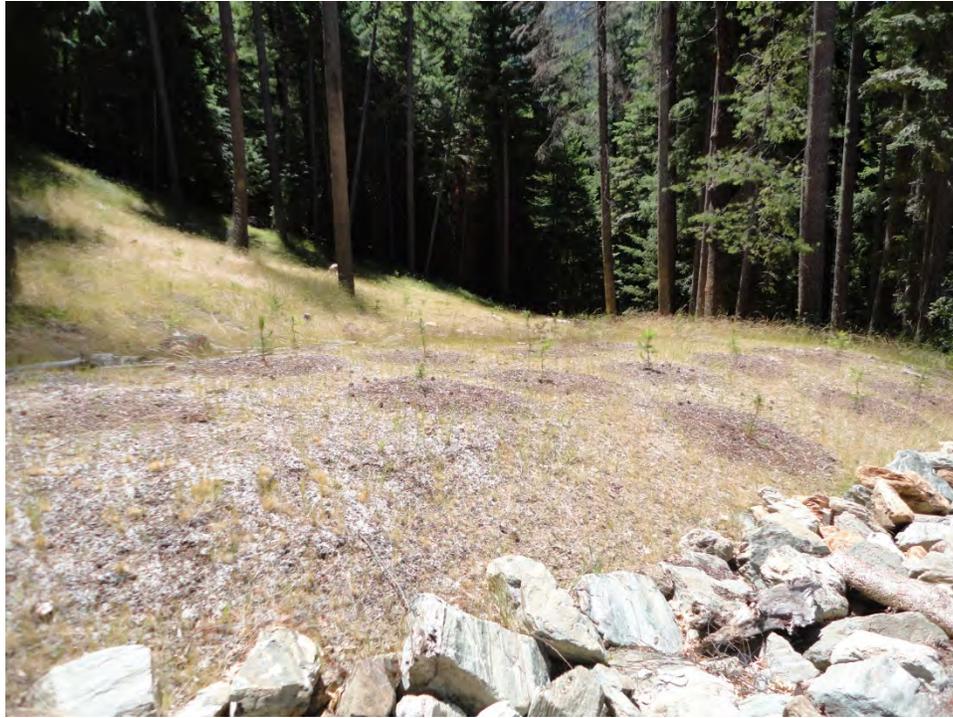
Photograph 5: Repository Stockpile Area with hydroseed and reclamation planting.
Blue Ledge Mine, Rogue River - Siskiyou National Forest, CA
Photographed by: Annica Nord (ERRG)

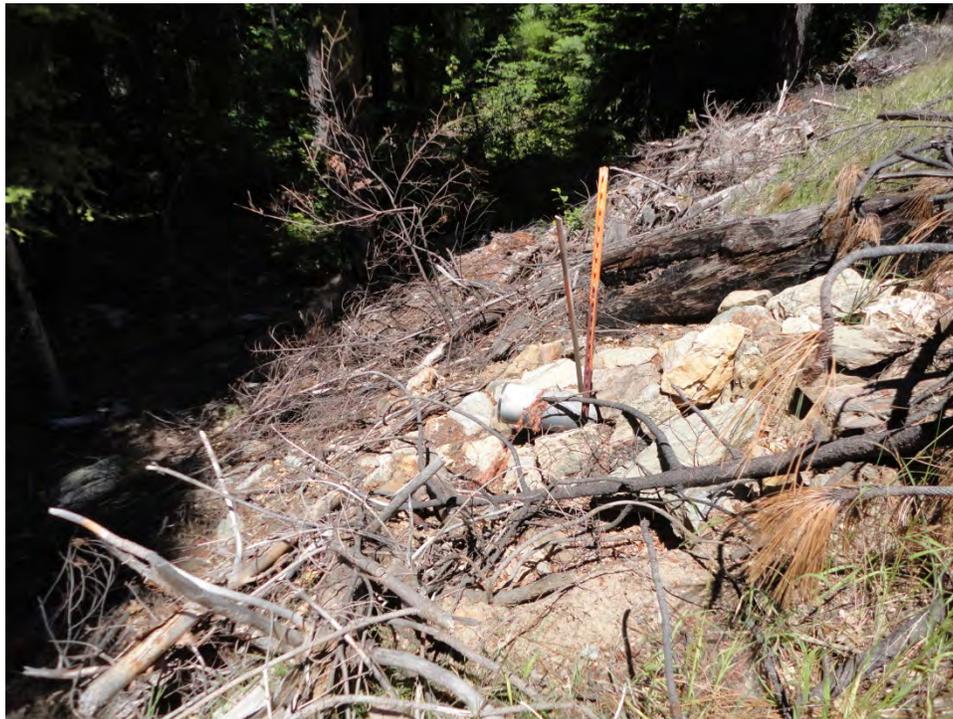
Comments: The southernmost anchor trench drain pipe is not blocked but no water is flowing from the drain. The underdrain is not blocked and a small trickle of water is flowing out.

Photograph 6: Anchor trench drain outlet, south end of repository. No water.
Blue Ledge Mine, Rogue River - Siskiyou National Forest, CA
Photographed by: Annica Nord (ERRG)

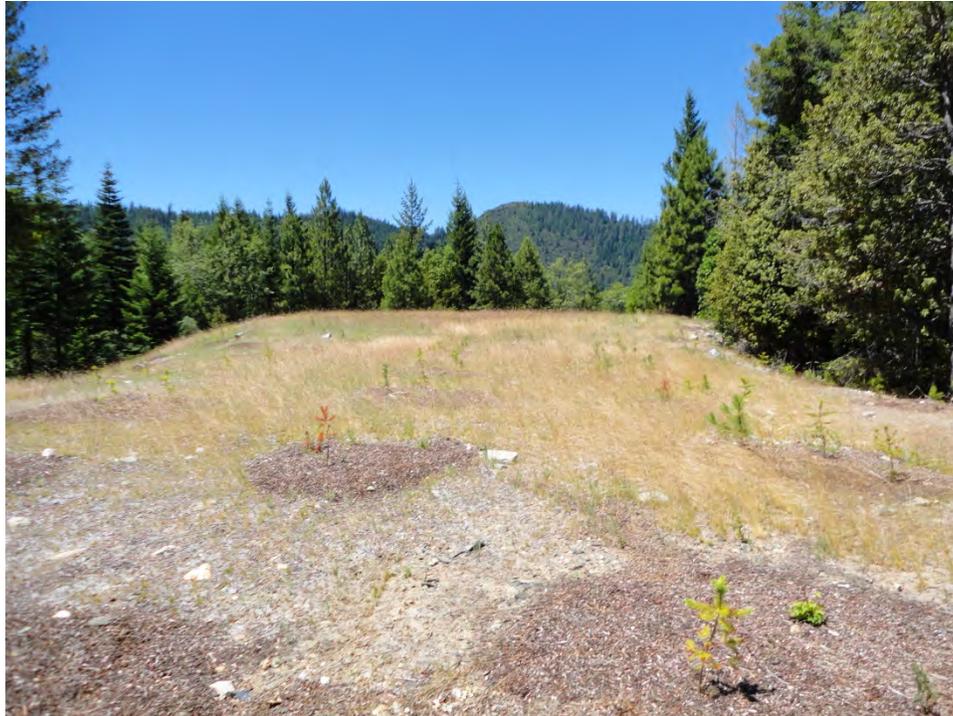
Comments: Plants show new growth and appear healthy. Grass is turning brown from the lack of rain but appears to be established.

Photograph 7: North storage area with hydroseed and reclamation planting.

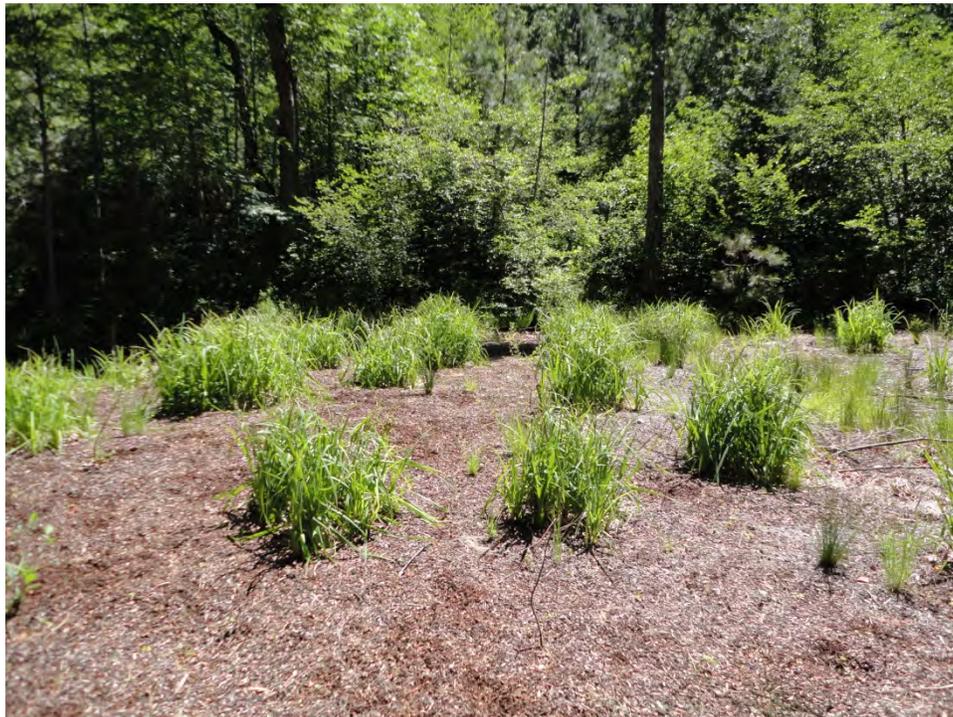
Comments: The uphill silt fence which was knocked down by snow was removed. Grass seed and fertilizer was placed in the location of the removed silt fence. The downhill fence is standing and functional.

Photograph 8: South Storage area, facing east. Uphill silt fence was removed and replaced with hydroseed and fertilizer.

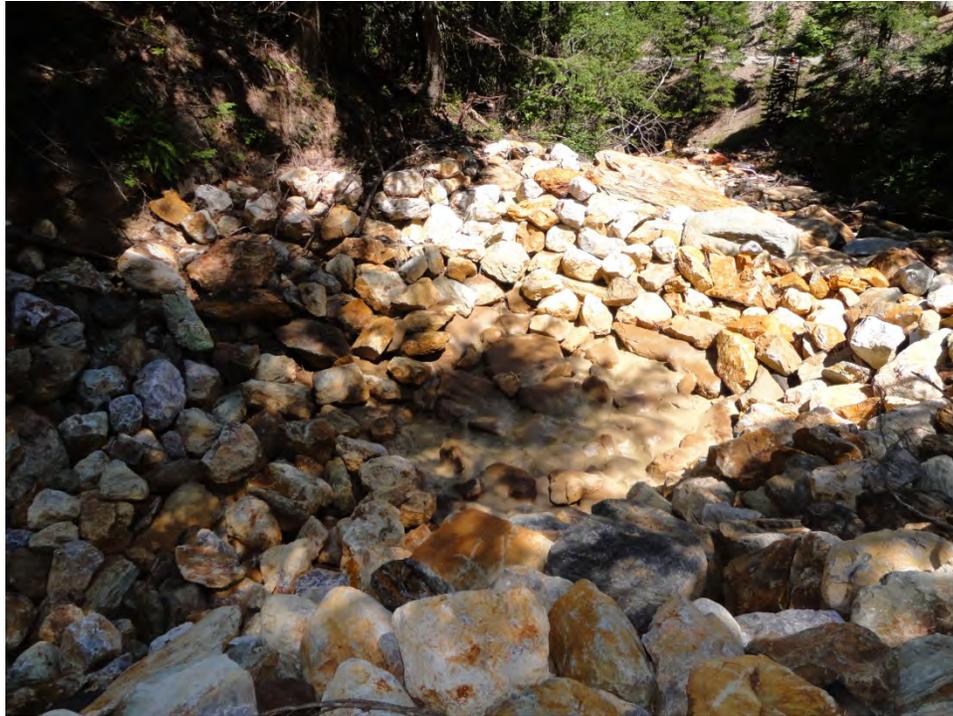
treatment process. No pH reading was collected in basin 1A because there was no water in the basin. pH readings collected from above sediment basin 3 in July 2013 is 0.6 higher than July 2012. Both readings are within a neutral measurement range.

Photograph 9: Sediment/pH Treatment Basin 1A. Note no water is in the basin.
Blue Ledge Mine, Rogue River - Siskiyou National Forest, CA
Photographed by: Annica Nord (ERRG)

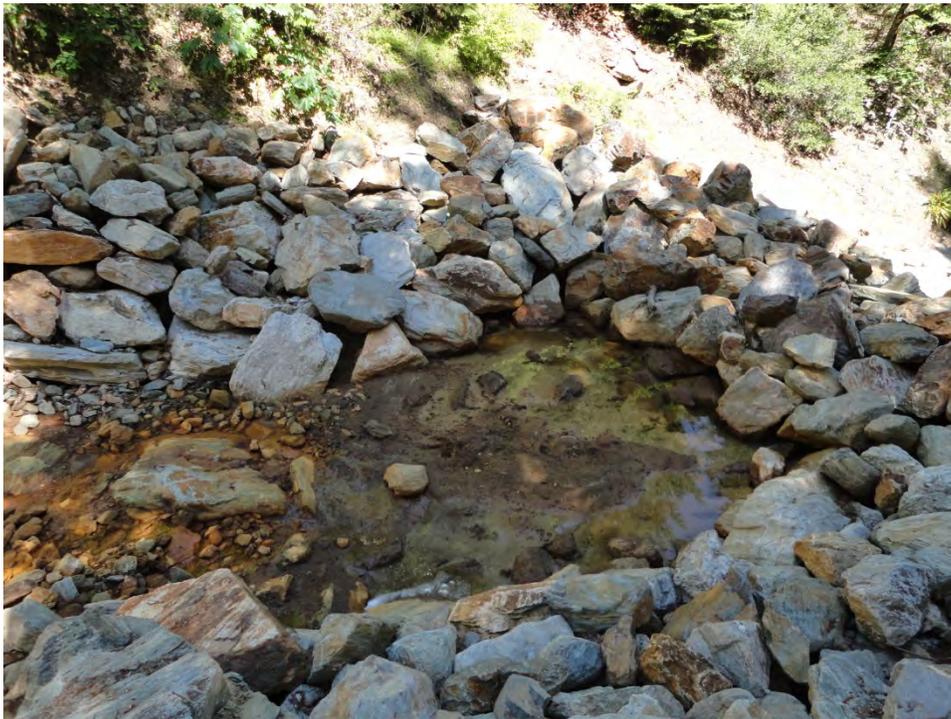
Photograph 12: Sediment/pH Treatment Basin 1D.
Blue Ledge Mine, Rogue River - Siskiyou National Forest, CA
Photographed by: Annica Nord (ERRG)

The acid seep previously entering the east side of basin 1F is being captured by the USEPA acid seep collection basin. The water seeping from adit A1N2 has been diverted by the USEPA to flow down the face of the WRP-1 bedrock to run to the acid seep collection basin. The pH in the USEPA acid seep basin was measured at 3.55, which is 0.04 pH unit lower than the June 2013 measurement. It is expected that the pH will continue to decrease as the flow of water decreases. The water in the acid seep collection basin is diverted into piping which runs into the treatment building before discharging above basin 1D. The overflow spillway is currently not functioning.

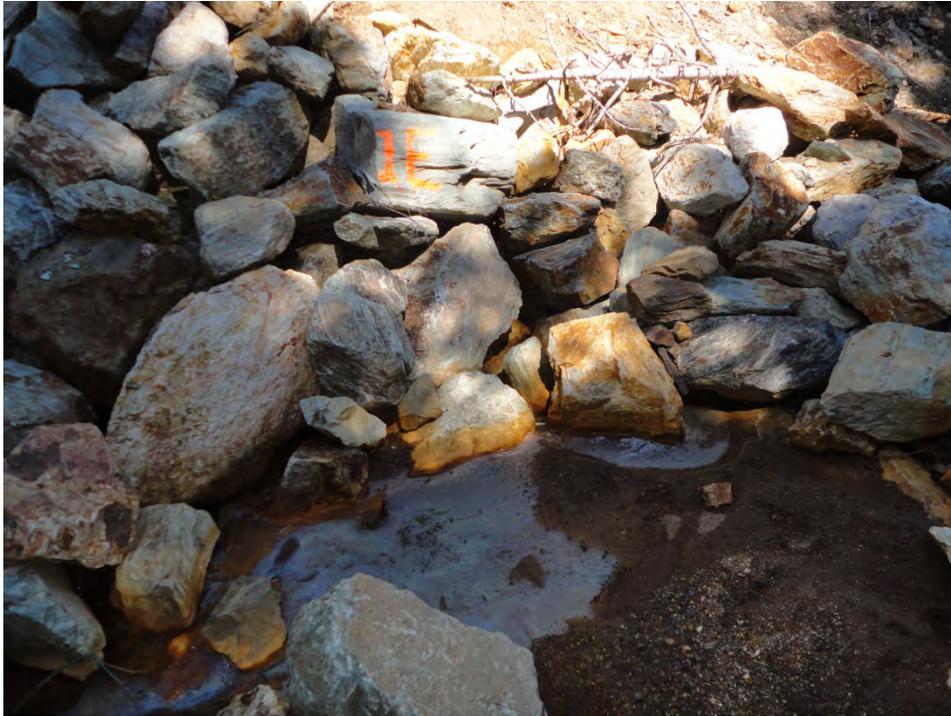
The repository had no new erosion. No additional erosion was observed on the incoming Forest Road 1060 and haul roads. The stockpile areas did not appear to have any new erosion. WRP 1 had sediment filling basins 1E and 1F. However basins 1A through 1D did not have significant sediment accumulation. WRP 2, 3, and 4 had little to no new erosion and the sediment basins in these areas contained very little sediment. Uphill silt fences on the north side of basins 2A and 2B, on the south side of 3, and the east side of the south storage area which were knocked down this past winter from the snow were removed taking care to minimize disturbance of the soil. Grass seed and fertilizer was spread over the area where the silt fence was removed.

Photograph 13: Sediment/pH Treatment Basin 1E. Mostly filled with sediment.
Blue Ledge Mine, Rogue River - Siskiyou National Forest, CA
Photographed by: Annica Nord (ERRG)

Based on the sample results, the pH of the water in basins 1A through 1F appears to be reacting with the limestone. Limestone fouling will be evaluated during clean out of the accumulated sediment during the summer maintenance activities. If the limestone has fouled, it will be blended to improve the permeability and to expose limestone that is not reacted, or replaced.

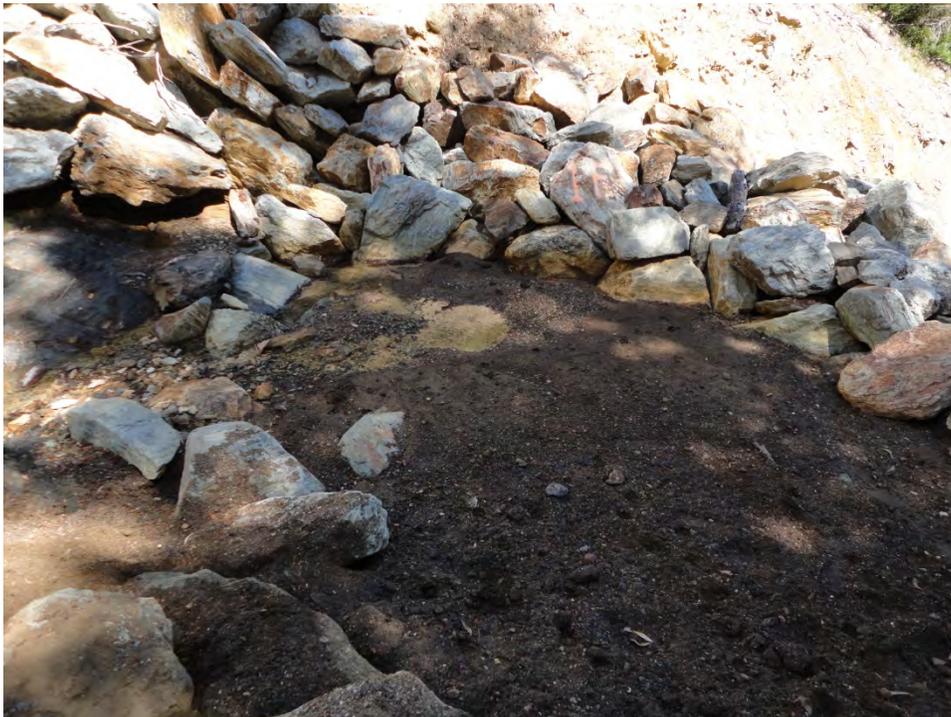
The pH of the water in the WRP-1 drainage entering basin 1F was comparable to concentrations measured in July 2012. pH readings in sediment basins 1C, 1D, and 1F are comparable to those collected in July 2012. pH readings in sediment basins 1B and 1E are approximately 1.3 higher than those collected in July 2012 and 0.7 and 0.8, respectively, higher than June 2013. This may be a result of functioning limestone and the EPA pilot treatment system diverting the most acidic water through a

Photograph 14: Sediment/pH Treatment Basin 1F. Sediment from the EPA treatment basin was cleaned out and placed into 1F on 6/3/2013.
Blue Ledge Mine, Rogue River - Siskiyou National Forest, CA
Photographed by: Annica Nord (ERRG)

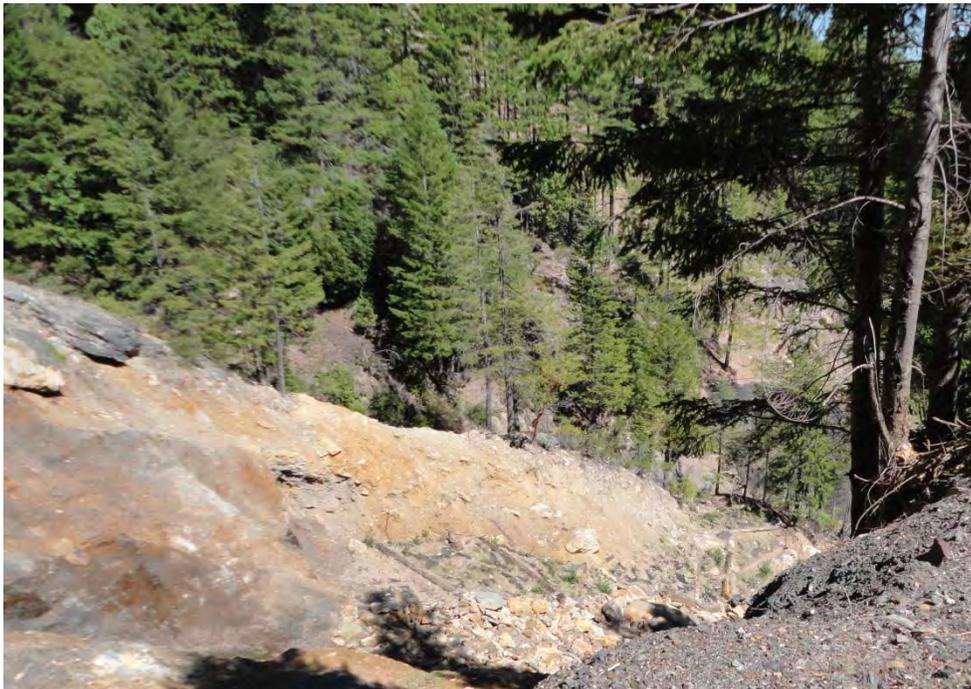
Photograph 16: WRP-1 reclamation area and plants.
Blue Ledge Mine, Rogue River - Siskiyou National Forest, CA
Photographed by: Annica Nord (ERRG)

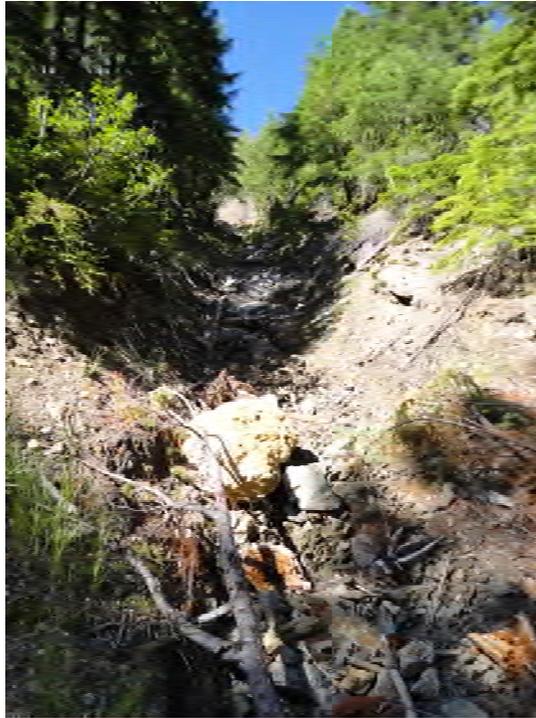
Photograph 19: WRP-2 reclamation area plants.
Blue Ledge Mine, Rogue River - Siskiyou National Forest, CA
Photographed by: Annica Nord (ERRG) Date: July 5, 2013

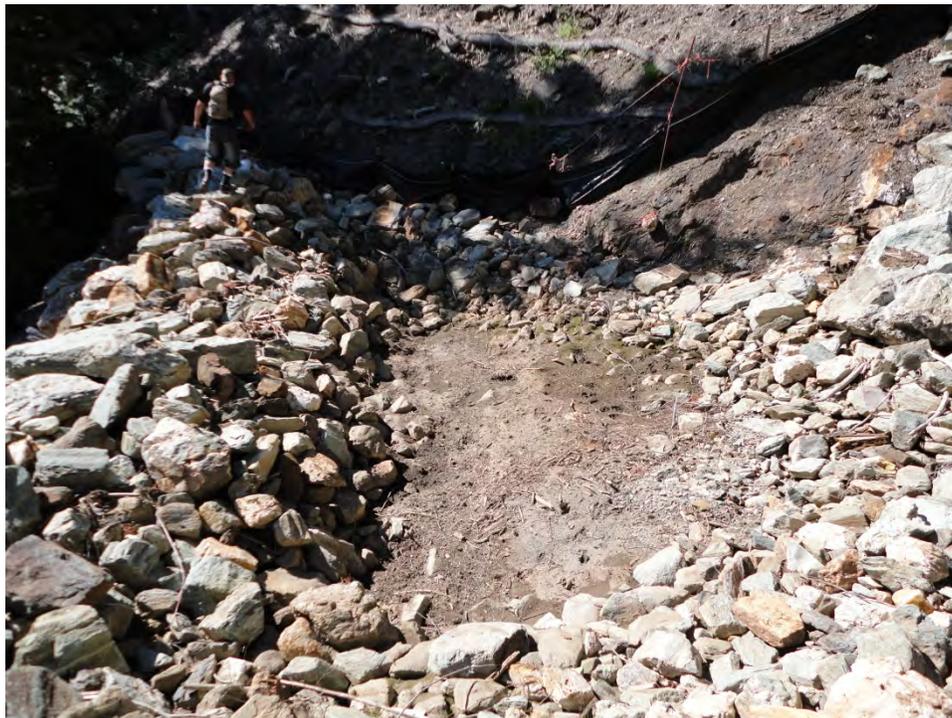
Photograph 20: Sediment/pH Treatment Basin 3 before the silt fence was removed.
Note no water is in the basin.
Blue Ledge Mine, Rogue River - Siskiyou National Forest, CA
Photographed by: Annica Nord (ERRG) Date: July 5, 2013

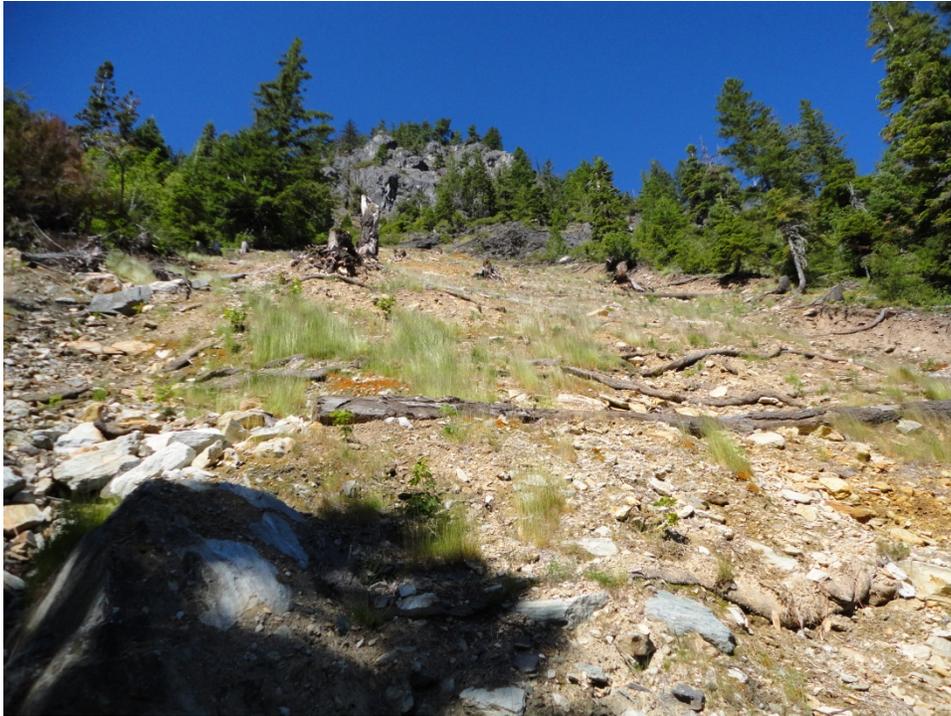
Photograph 21: WRP-3 reclamation plants and grass.
Blue Ledge Mine, Rogue River - Siskiyou National Forest, CA
Photographed by: Annica Nord (ERRG)

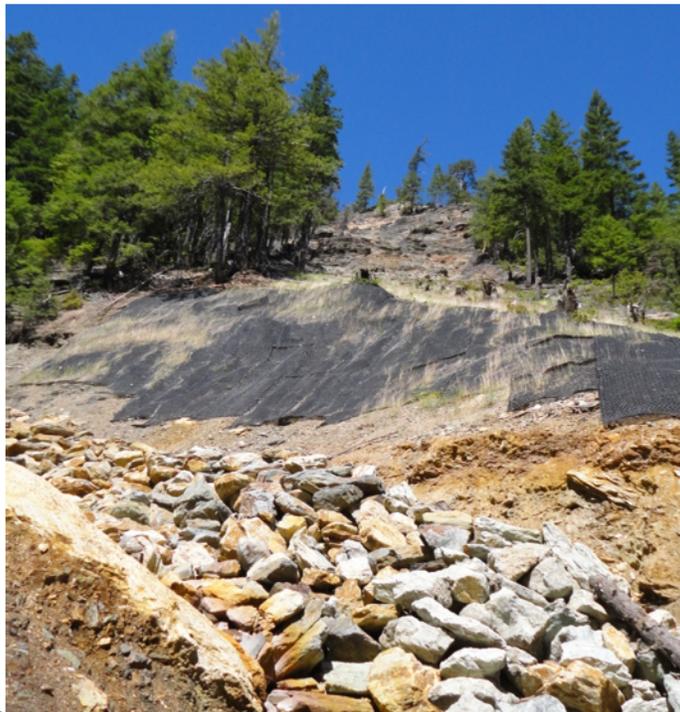
Photograph 22: WRP-4 reclamation plants and reinforced erosion fabric.
Blue Ledge Mine, Rogue River - Siskiyou National Forest, CA
Photographed by: Annica Nord (ERRG)

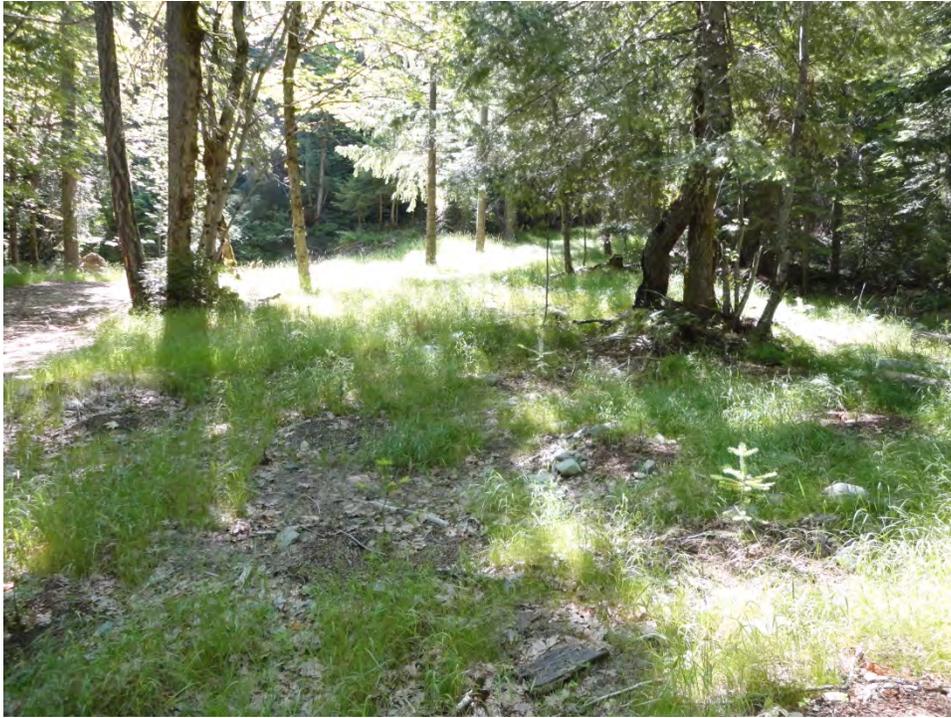
Photograph 23: Rock Stockpile Area with hydroseed and reclamation planting.

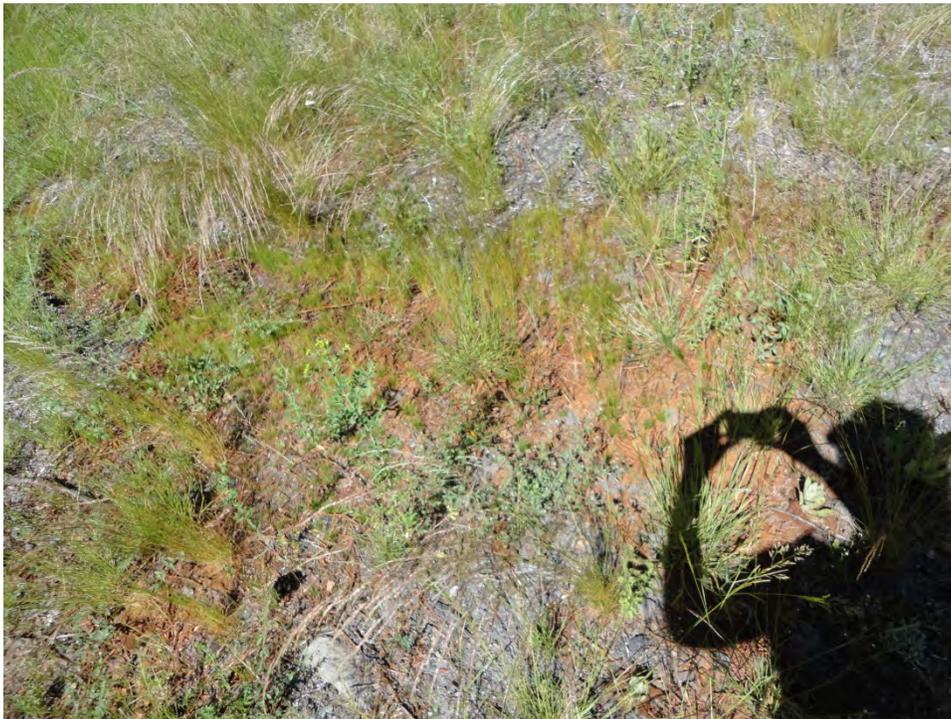
Rust colored staining as observed in April 2013 on the miners trail parking area was still evident. However, the stain appeared to not have an effect on the grass which appeared healthy and growing on the miners trail parking area. The rust staining appeared to originate from a seasonal spring releasing iron mineralized water onto the parking area in April 2013. The area was dry during the June and July 2013 investigation. Photographs of the area are provided in the attached photographs.

Comments: Grass is growing on the roads. Plants on the miners trail parking area appear to be growing. A red rust stain in two separate patches of soil were observed similar to April 2013. The soil is no longer wet and plants are growing both in and around the red stain and appear to be unaffected. The red stain appears to be a stain from a springtime seep with iron mineralized water. (see photo log).

The rust area at the miners trail parking lot is still evident but appears to not be affecting the plant growth. This area was observed to be dry during the site investigation. EPA treatment system above basin 1F appears to be functioning. No one on site. No unauthorized access was observed.

Photograph 24: Rust-colored staining on ground at the miners trail parking area.

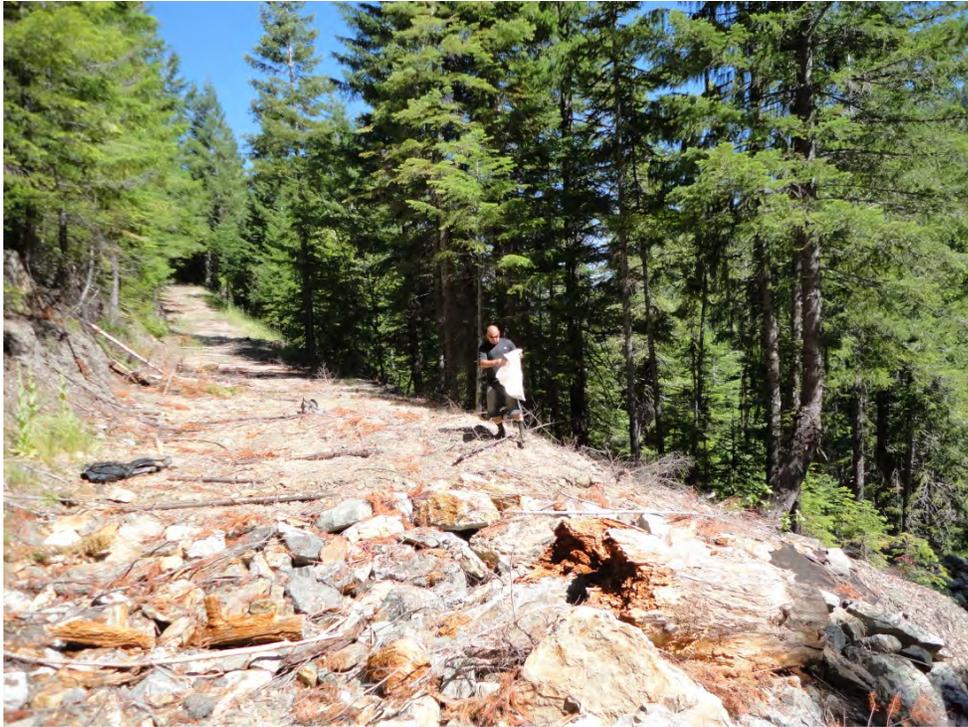
Photograph 25: Spreading grass seed and fertilizer on areas where the silt fence was removed along the north (upper) side of sediment basin 2A. Silt fences were also removed adjacent to basins 2B and 3.
