Engineering/Remediation
Resources Group, Inc.
616 First Ave, Suite 300
Seattle, WA 98104

Technical Memorandum
September 2013 Site Inspection Report
Blue Ledge Mine
Rogue River-Siskiyou National Forest

**Blue Ledge Mine Removal Project
Siskiyou County, California
Operation, Maintenance, and Monitoring Period**

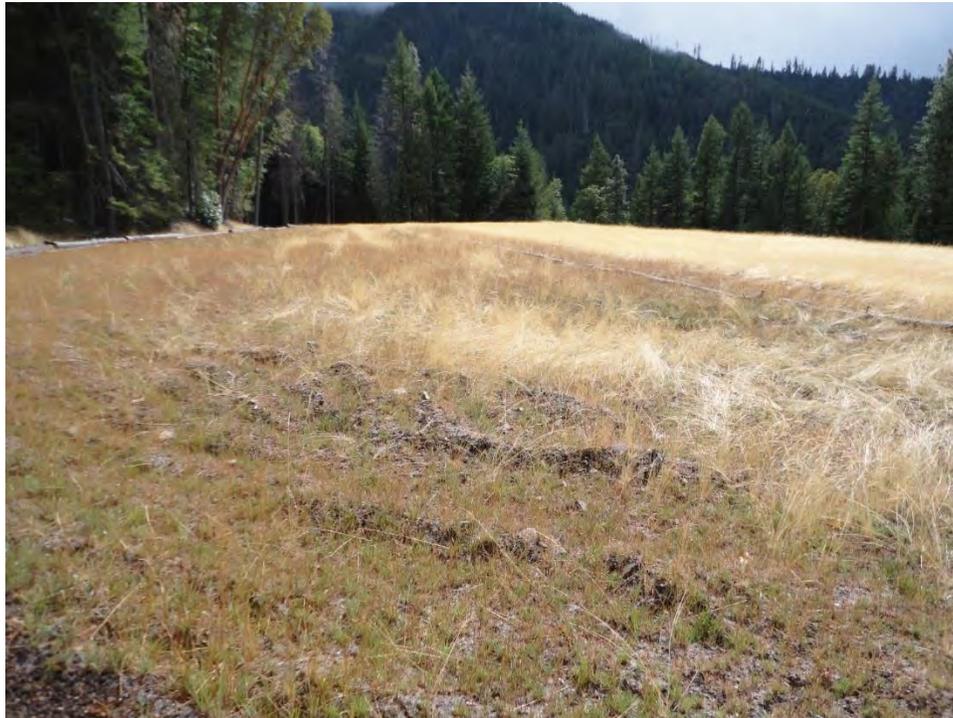
Comments: Wattles, Flexterra, and bark are functioning on the repository.

Photograph 1: Top of Repository looking south.
Blue Ledge Mine, Rogue River-Siskiyou National Forest, CA
Photographed by: Annica Nord (ERRG) Date: September 25, 2013

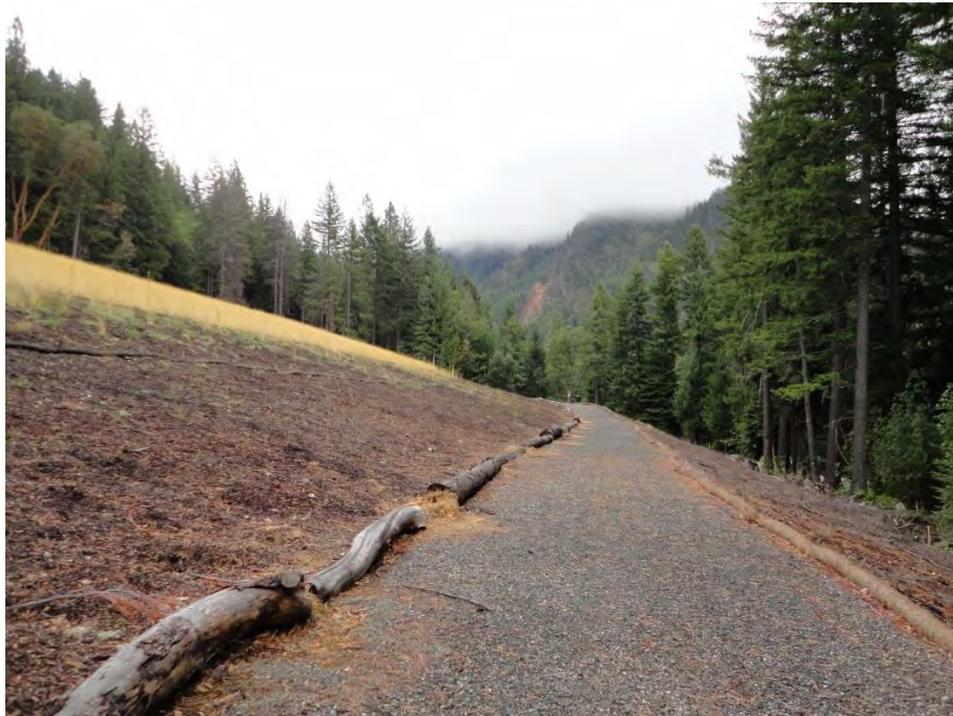
Photograph 2: Repository slope and access road, facing south.
Blue Ledge Mine, Rogue River-Siskiyou National Forest, CA
Photographed by: Annica Nord (ERRG) Date: September 25, 2013

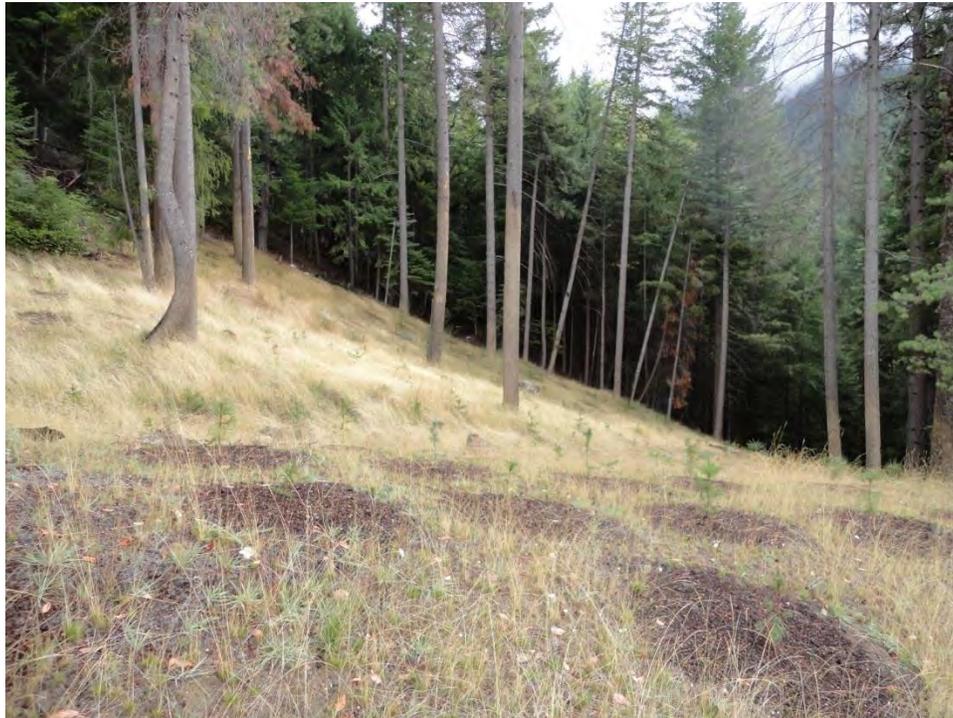
Comments: Plants appear healthy and green. Grass is brown as a result of the lack of rain over the summer.

Photograph 3: Repository stockpile looking south. Good plant and grass growth.
Blue Ledge Mine, Rogue River-Siskiyou National Forest, CA
Photographed by: Annica Nord (ERRG)

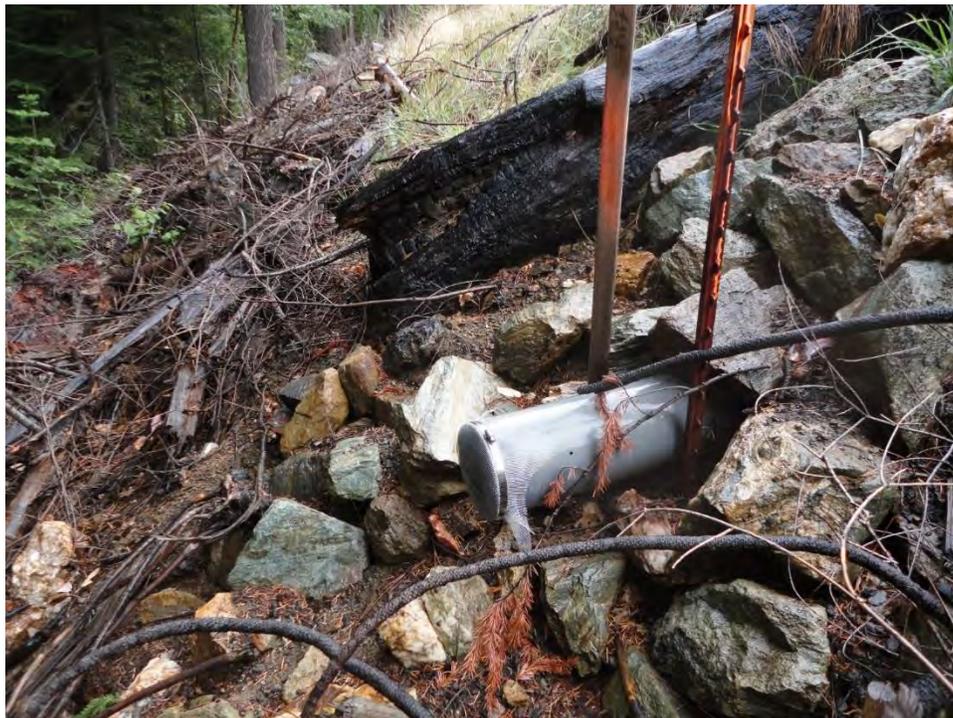
Comments: The southernmost anchor trench drain pipe is not blocked but no water is flowing from the drain. The screen has been repaired with a second layer of screen over the pipe. The underdrain is not blocked and a small trickle of water is flowing out.

Photograph 4: Anchor trench drain outlet, south end of repository. No water.
Damaged screen has been repaired.
Blue Ledge Mine, Rogue River-Siskiyou National Forest, CA
Photographed by: Annica Nord (ERRG)

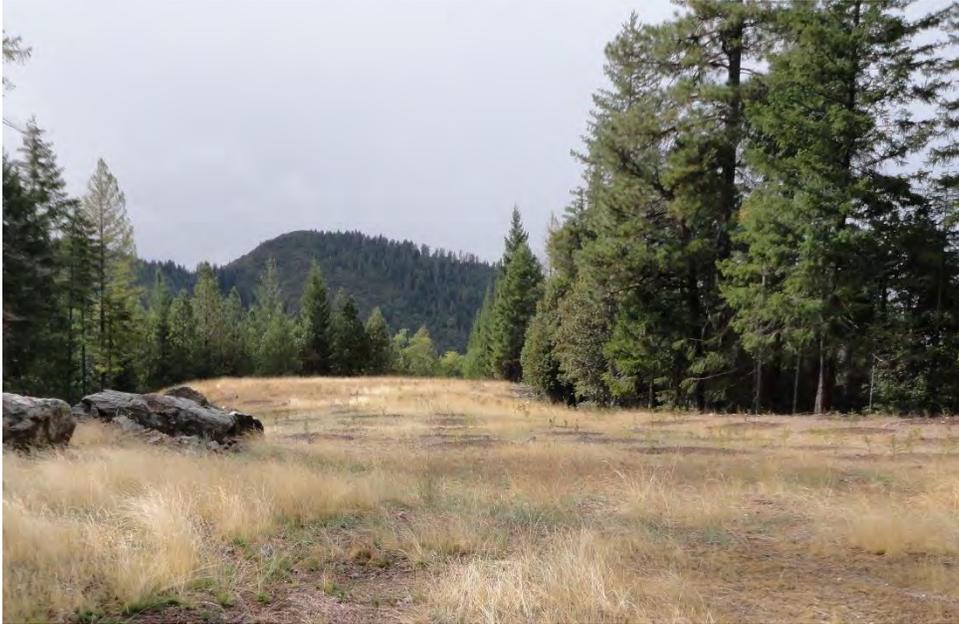
Comments: Grass is brown from the lack of rain over the summer but appears to be established.

Comments: This area has sufficient live plants. Plants look healthy. Only a few plants appear to be dying. 90% of the plants are alive.

Photograph 5: North Storage Area looking west.

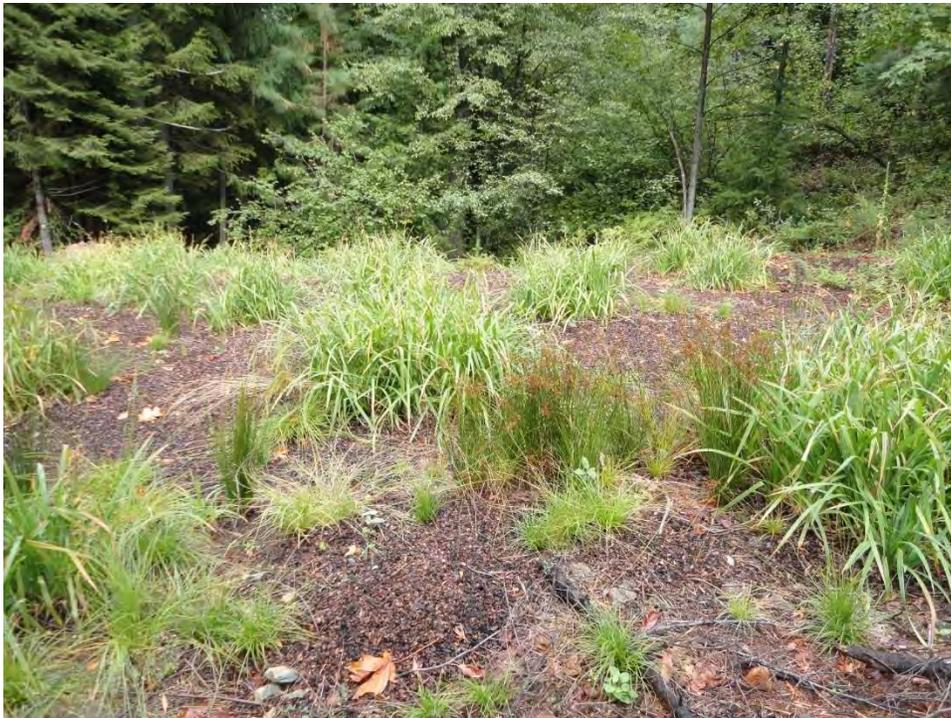
Comments: Plants are growing and becoming established.

Comments: The plants are green and appear healthy.

Photograph 6: South Stockpile Area looking east.

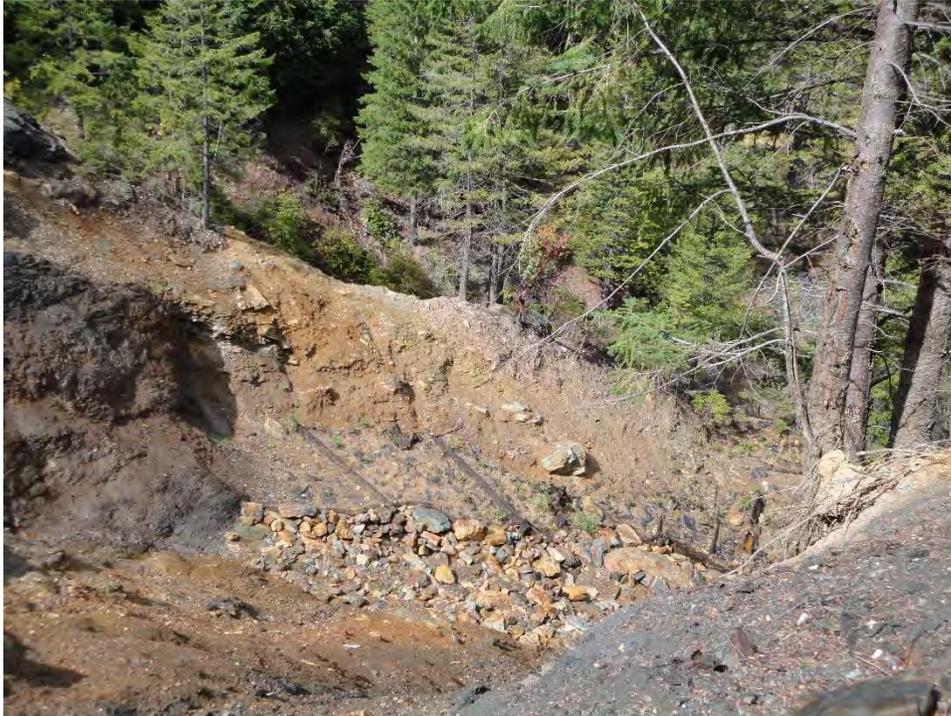
Comments: Straw wattles are in good condition and in place.

Comments: Plants appear healthy.

Photograph 7: WRP 1.

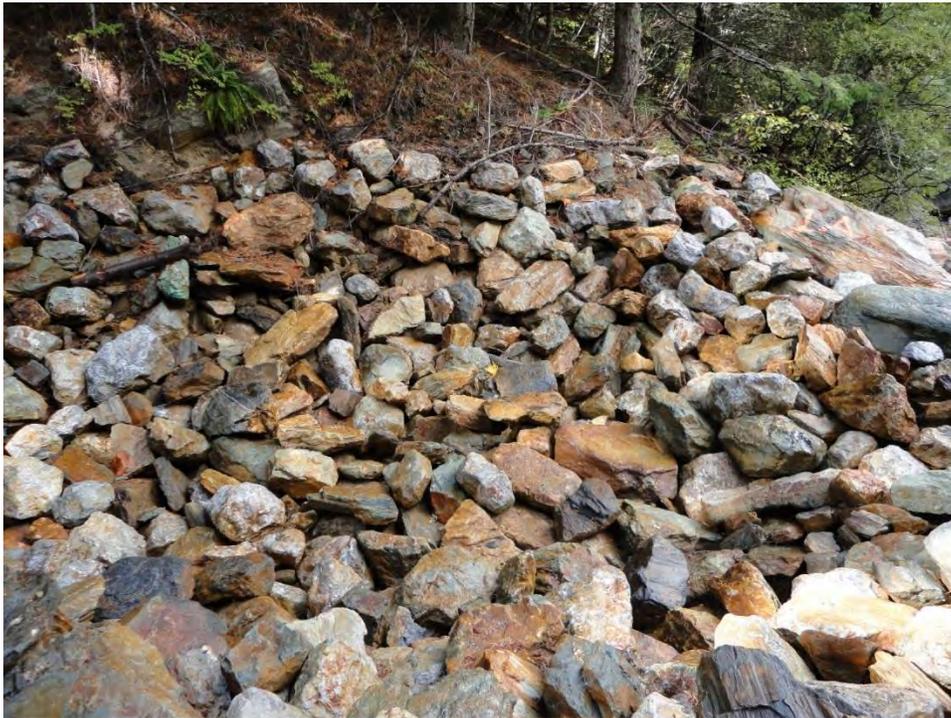
Accumulated sediment: 0%

pH in basin 1A: N/A. There was no water in basin 1A.

pH below basin 1A: 7.19 (measured in Joe Creek. There was no access to water after basin 1A and before Joe Creek)

Water depth: No water in the basin

Photograph 8: Sediment/pH Treatment Basin 1A.

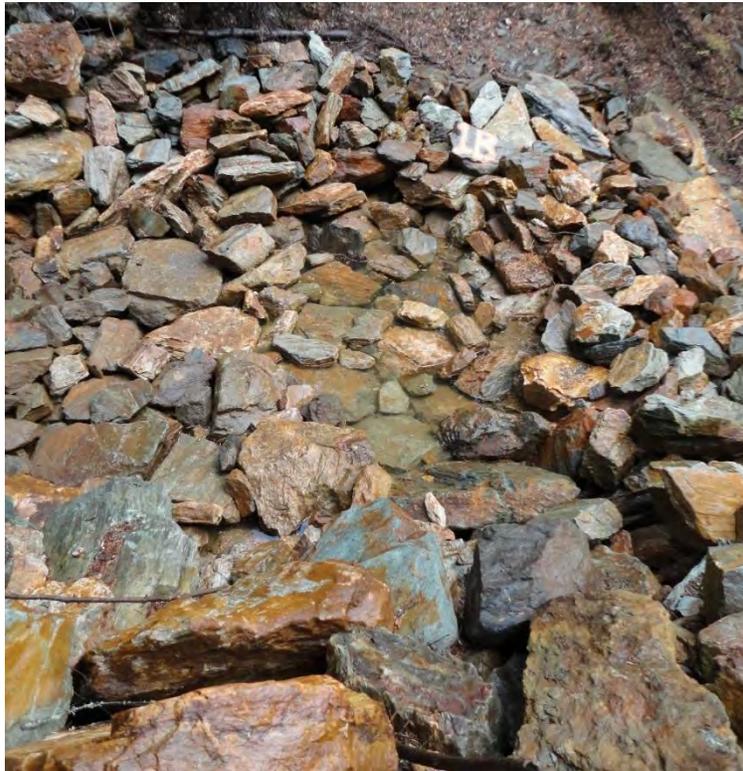
Accumulated sediment: 0%

pH in basin 1B: 5.34

Water depth: 7 inches

Photograph 9: Sediment/pH Treatment Basin 1B.
Blue Ledge Mine, Rogue River-Siskiyou National Forest, CA
Photographed by: Annica Nord (ERRG)

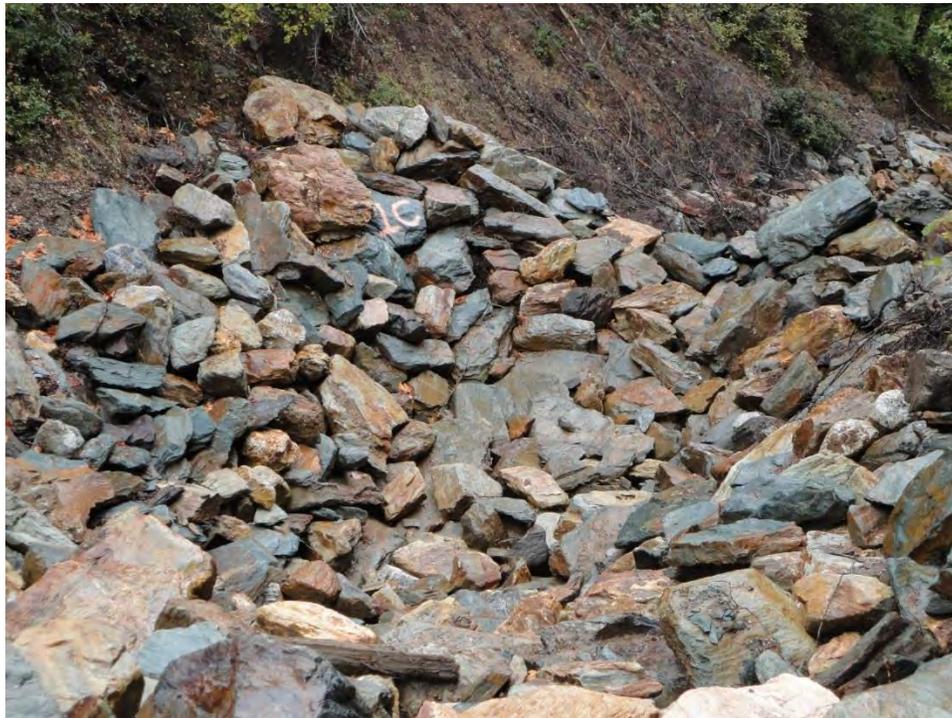
Photograph 10: Sediment/pH Treatment Basin 1C.
Blue Ledge Mine, Rogue River-Siskiyou National Forest, CA
Photographed by: Annica Nord (ERRG)

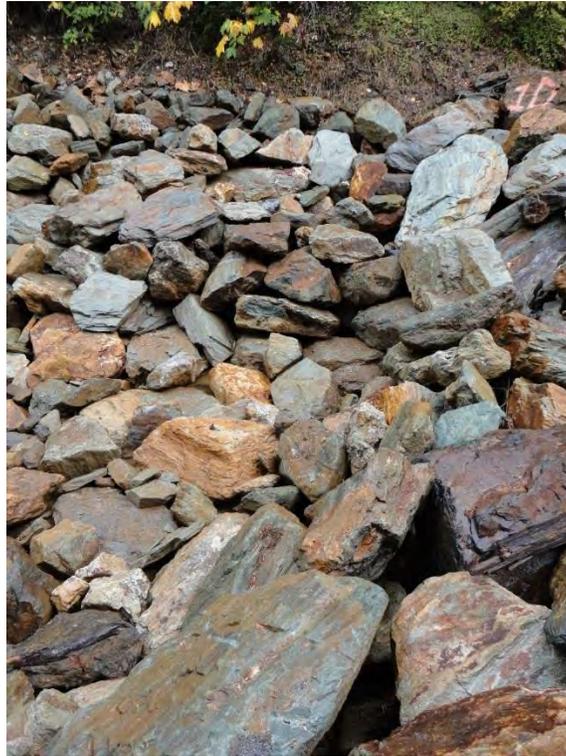
Photograph 11: Sediment/pH Treatment Basin 1D.
Blue Ledge Mine, Rogue River-Siskiyou National Forest, CA
Photographed by: Annica Nord (ERRG)

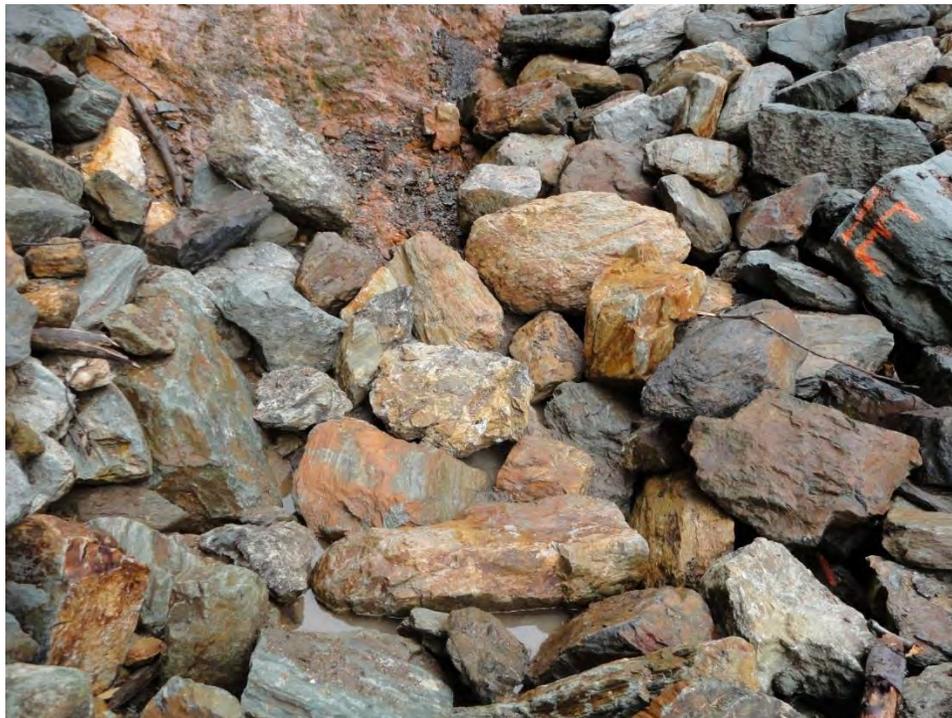
Photograph 12: Sediment/pH Treatment Basin 1E.
Blue Ledge Mine, Rogue River-Siskiyou National Forest, CA
Photographed by: Annica Nord (ERRG)

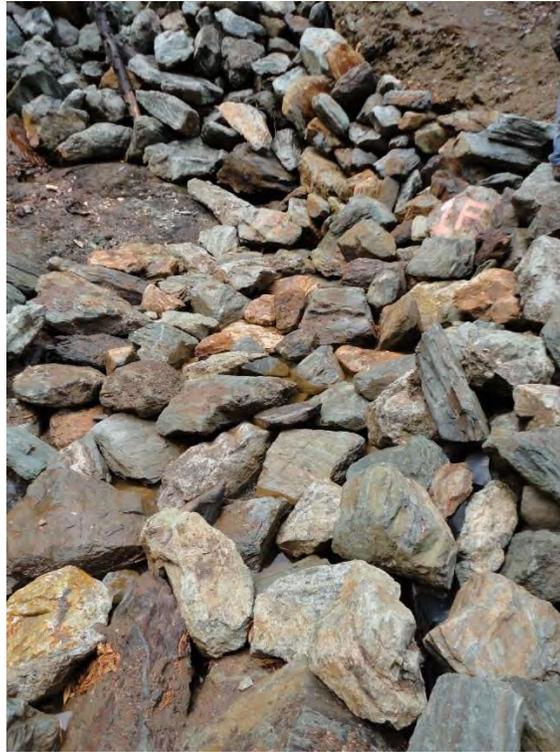
The pH of the water in the WRP-1 drainage entering basin 1F was higher than concentrations measured in September 2012. The limestone in the basins appears to be successful in raising the pH prior to entry into Joe Creek.

Photograph 13: Sediment/pH Treatment Basin 1F.
Blue Ledge Mine, Rogue River-Siskiyou National Forest, CA
Photographed by: Annica Nord (ERRG)

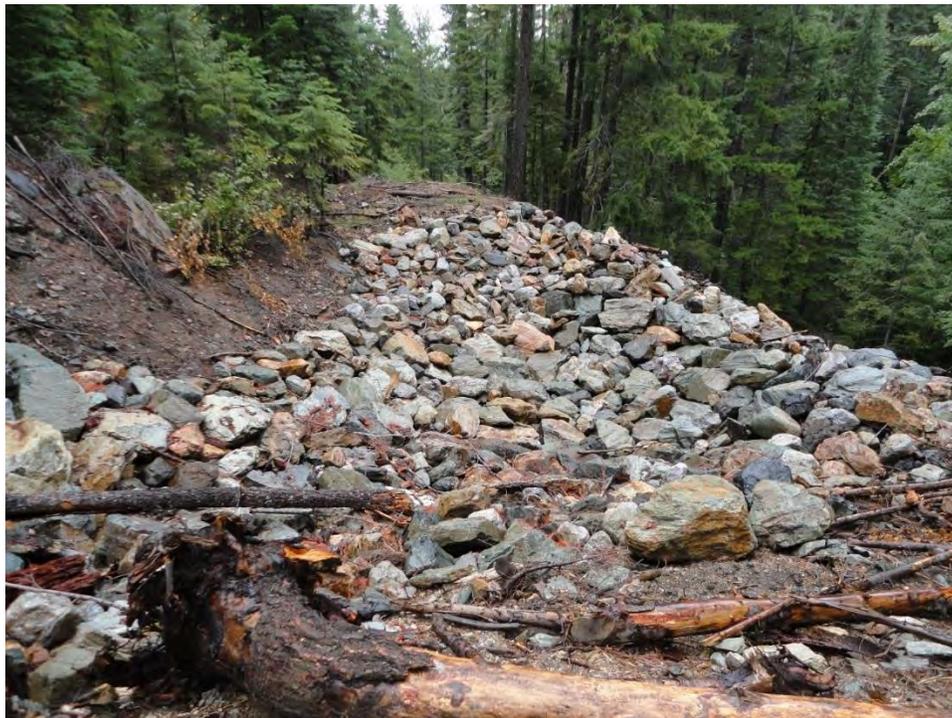
Photograph 14: Sediment/pH Treatment Basin 2A.
Blue Ledge Mine, Rogue River-Siskiyou National Forest, CA
Photographed by: Annica Nord (ERRG)

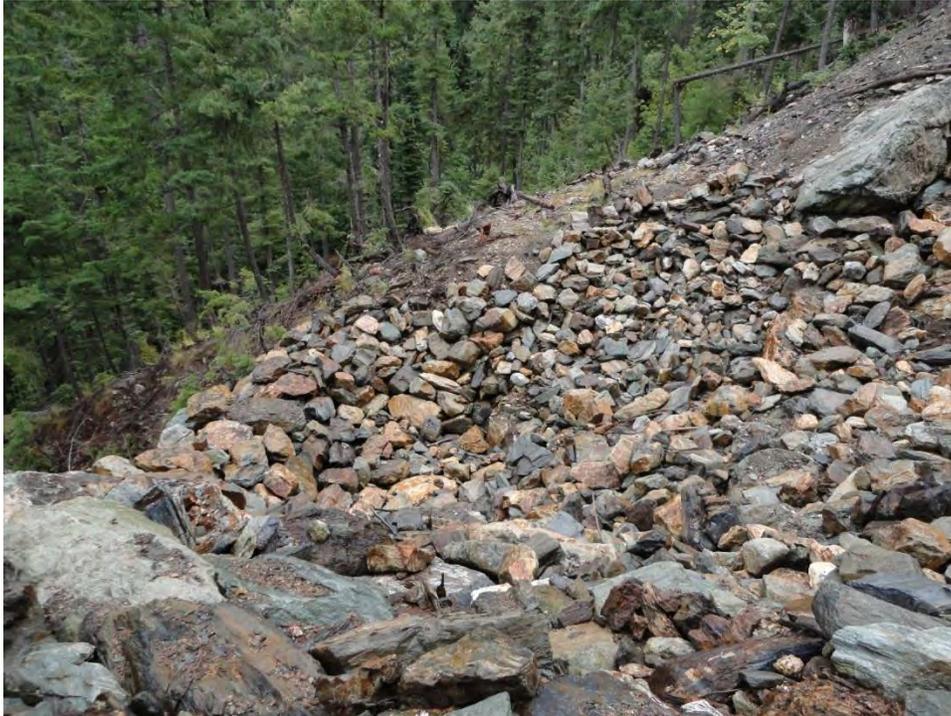
Photograph 15: Sediment/pH Treatment Basin 2B.
Blue Ledge Mine, Rogue River-Siskiyou National Forest, CA
Photographed by: Annica Nord (ERRG)

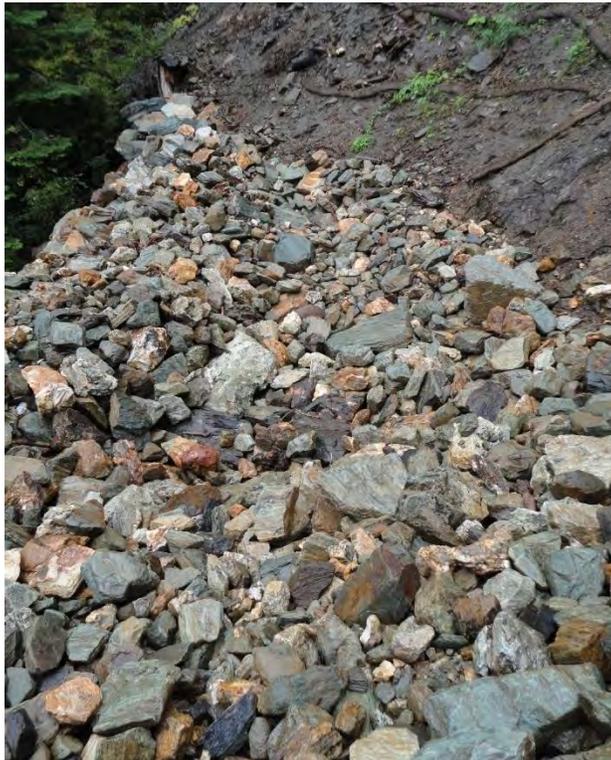
Photograph 16: Sediment/pH Treatment Basin 3.
Blue Ledge Mine, Rogue River-Siskiyou National Forest, CA
Photographed by: Annica Nord (ERRG)

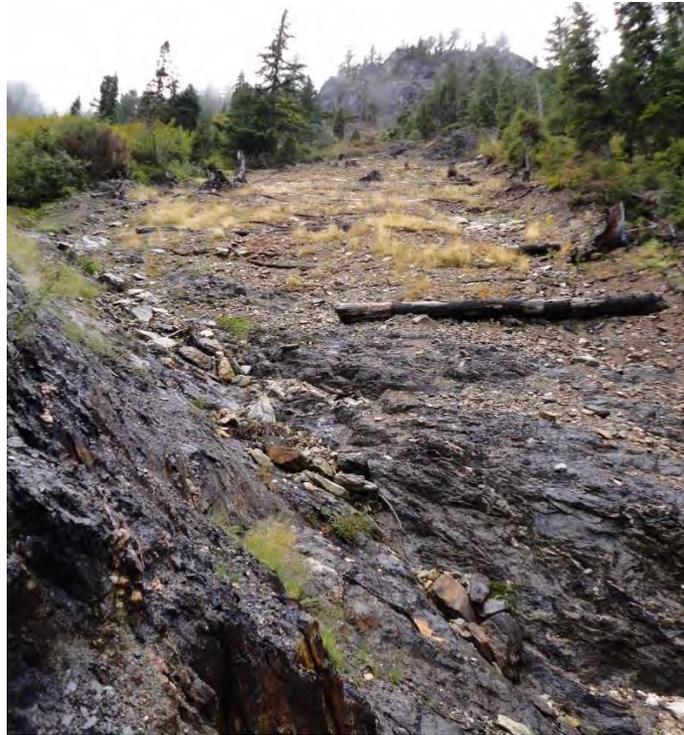
Photograph 17: WRP-3.

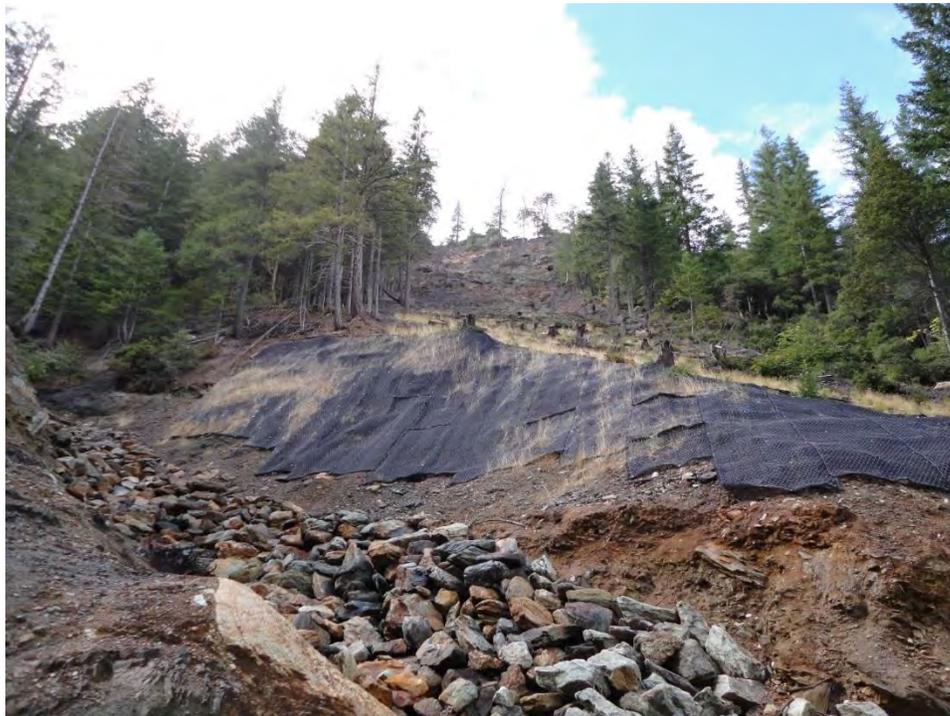
Photograph 18: WRP-4 reclamation plants and grass.

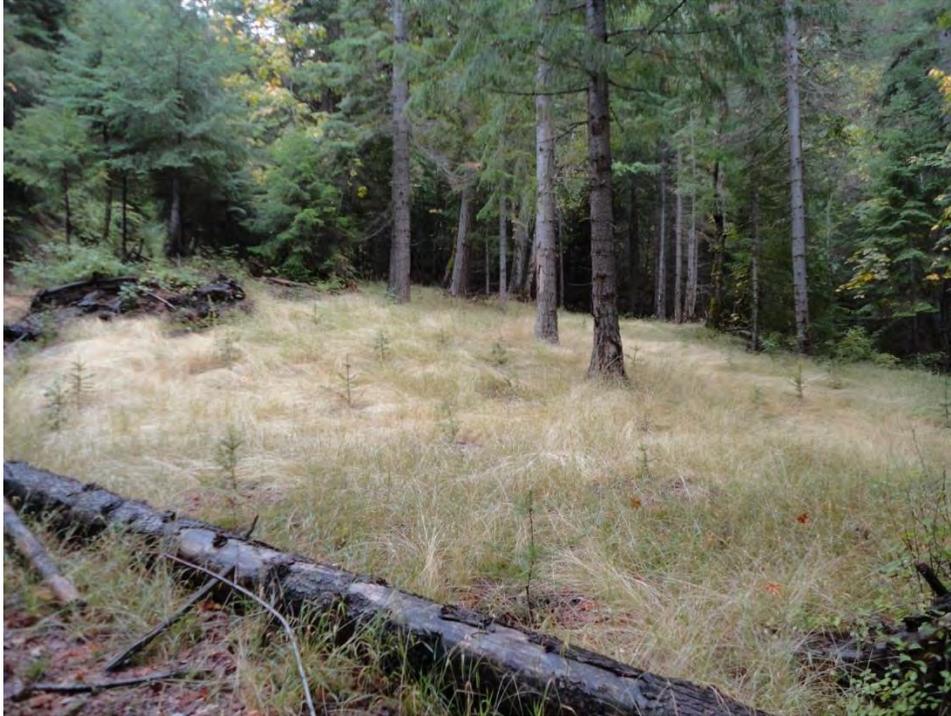
Comments: There is no existing silt fence. The ground is vegetated and appears to be stable.

Comments: Plants appear healthy.

Comments: The grass is tall. The grass is brown as a result of the lack of rain over the summer.

Photograph 19: Rock stockpile area, looking west. Good plant and grass growth.
