October 29, 2013

Ref.: 2010-084

Technical Memorandum  
October 2013 Site Inspection Report  
Blue Ledge Mine  
Rogue River-Siskiyou National Forest

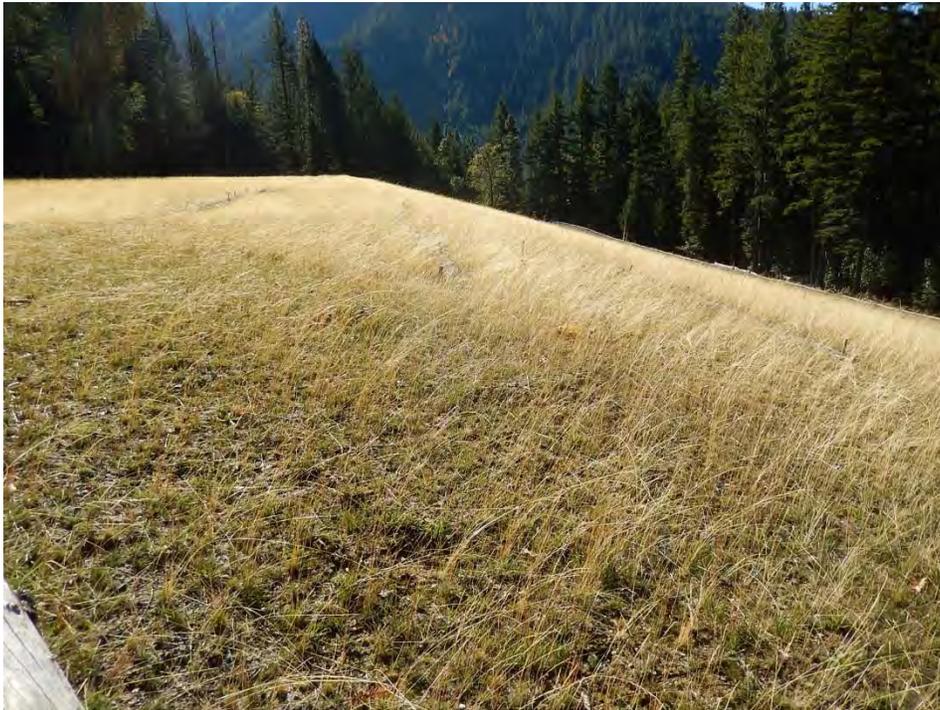
**Photograph 1: Top of Repository looking south.**  
Blue Ledge Mine, Rogue River-Siskiyou National Forest, CA  
Photographed by: Brian Wetzsteon (ERRG)

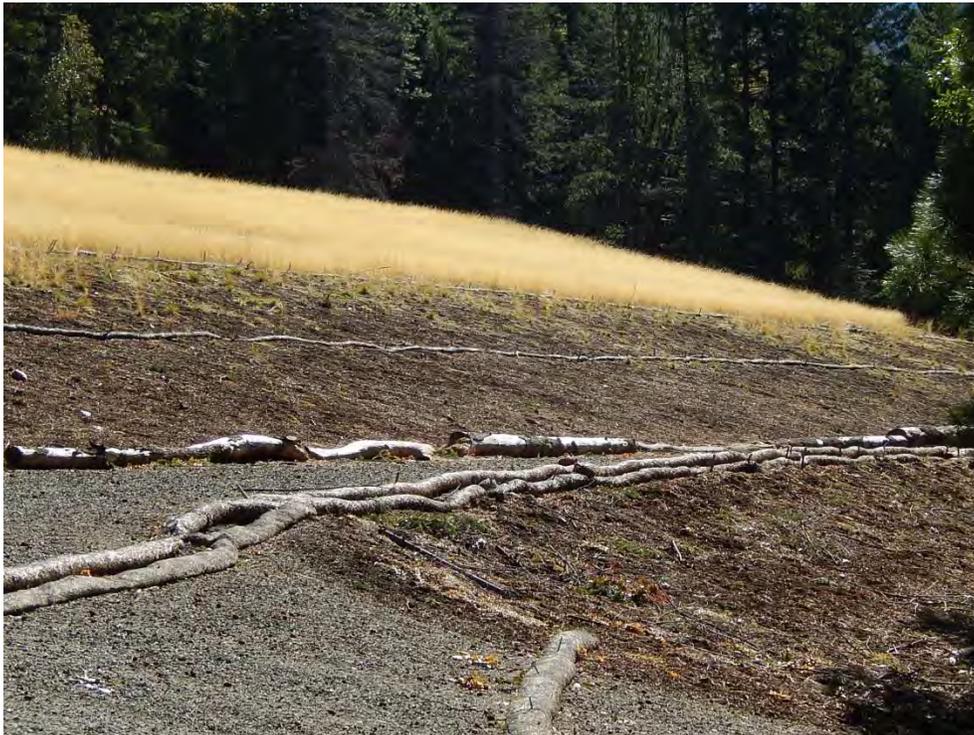
**Photograph 2: Repository slope and access road, facing southeast.**  
Blue Ledge Mine, Rogue River-Siskiyou National Forest, CA  
Photographed by: Brian Wetzsteon (ERRG)

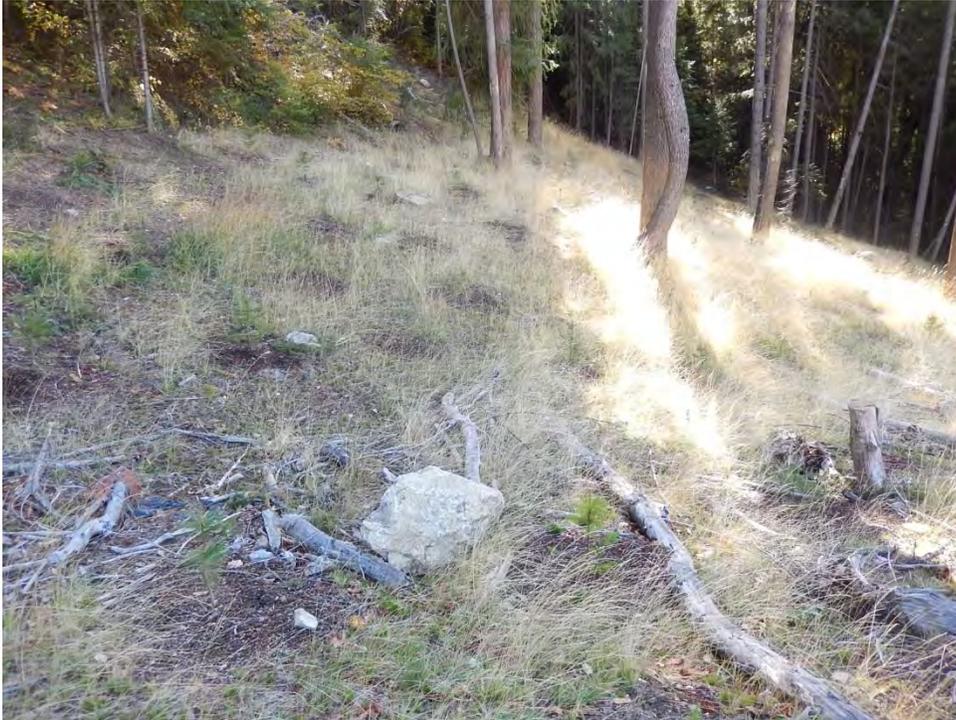
**Photograph 3: Repository stockpile looking south.**  
Blue Ledge Mine, Rogue River-Siskiyou National Forest, CA  
Photographed by: Brian Wetzsteon (ERRG)

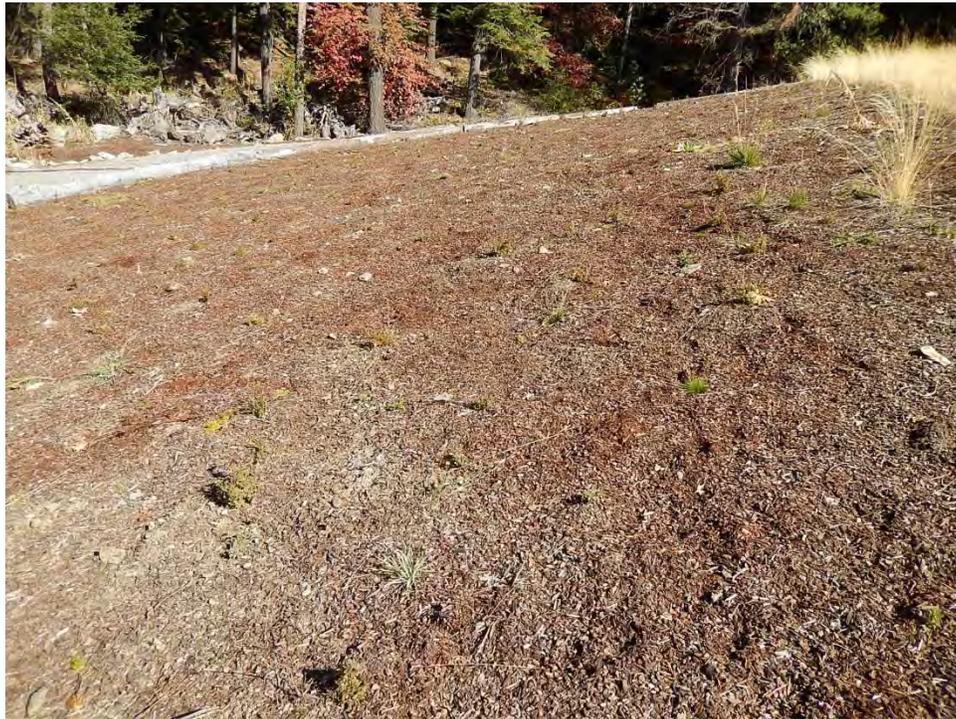
In October 2012 1,640 new shrubs were planted on the repository slope and along the south end and southwest corner to replace shrubs that had died. An additional 50 plants were installed at the repository stockpile. The majority of repository replacement plants have survived, but have been heavily browsed by deer. Repository shrubs appear stunted due to the heavy browsing. The shrubs were treated with big game repellent after planting in October 2012 and again in the spring of 2013, but the deer are continuing to browse the plants.

Comments: The grass appears to be well established. Currently the grass is brown as a result of the lack of rain during the summer. The majority of repository replacement plants (planted in October 2012) have survived, but have been heavily browsed by deer. Repository shrubs appear stunted due to the heavy browsing.

**Photograph 4: Shrubs browsed by deer on north end of repository.**  
Blue Ledge Mine, Rogue River-Siskiyou National Forest, CA  
Photographed by: Brian Wetzsteon (ERRG)

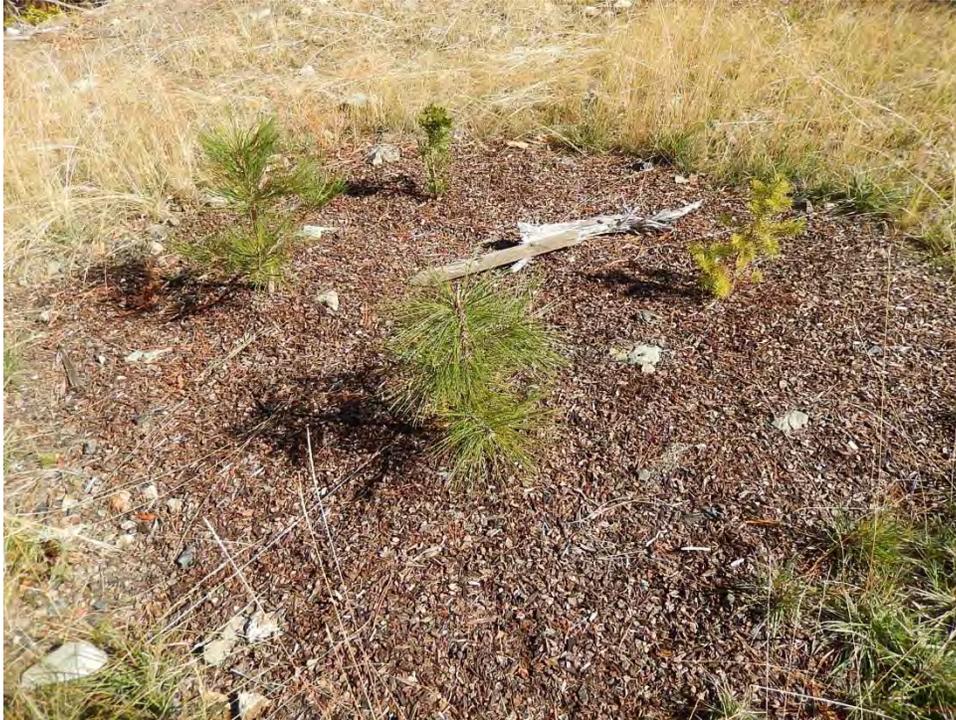
Evidence of animal browsing was observed in the incense cedars planted on the north stockpile area. The cedars appear similar in size to the pine and fir planted in the area. Browsing was not noted on plants in any other areas.

Comments: Evidence of animal browsing was observed in the incense cedars planted on the north storage area. The cedars appear similar in size to the pine and fir planted in the area.

**Photograph 5: North Storage Area pine, fir and cedar. Cedar browsed by deer.**

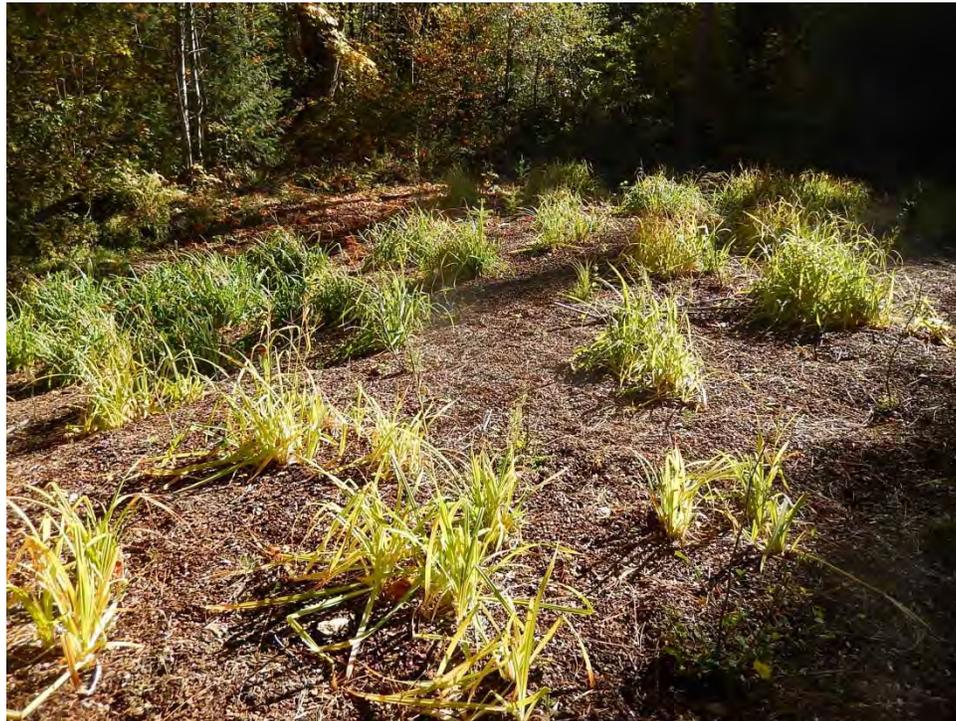
**Photograph 6: South Stockpile Area looking east.**

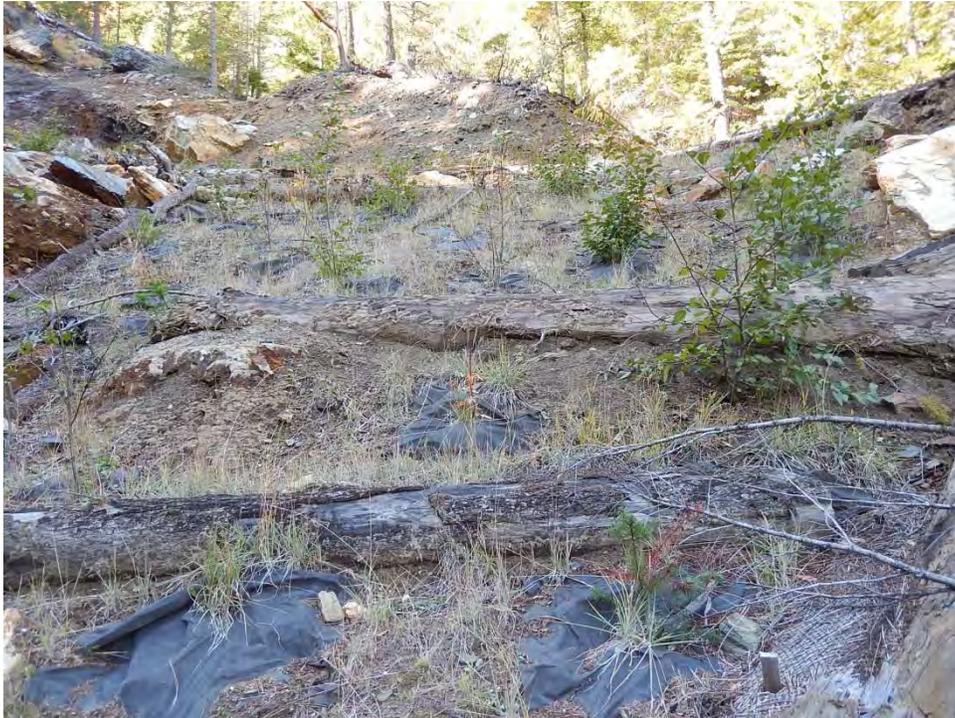
**Photograph 7: WRP 1 reclamation plants and grass.**  
Blue Ledge Mine, Rogue River-Siskiyou National Forest, CA  
Photographed by: Brian Wetzsteon (ERRG)

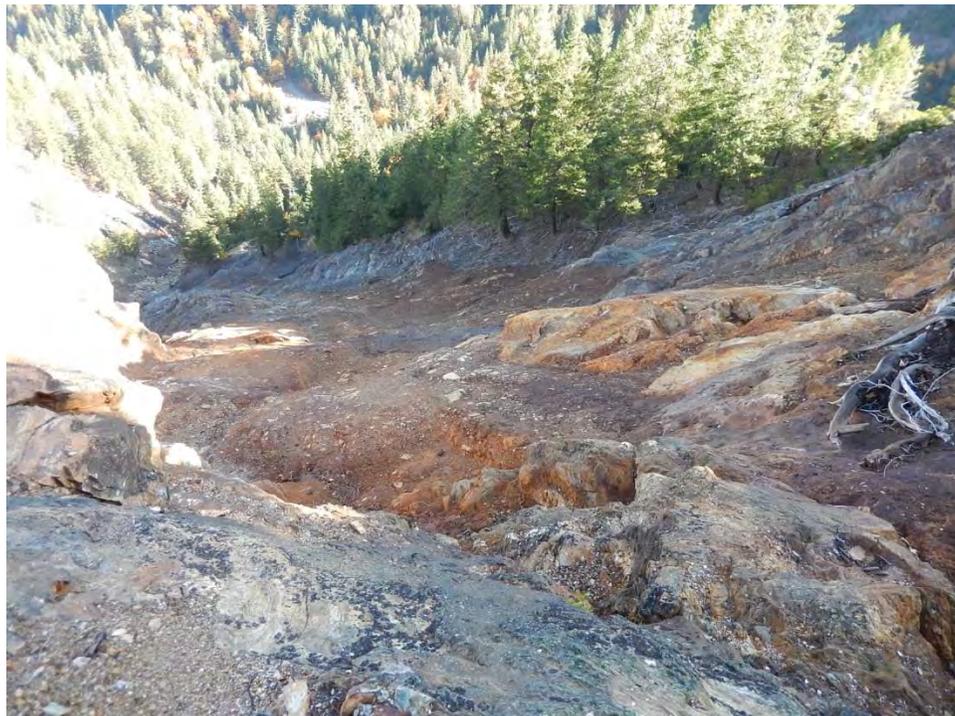
**Photograph 8: WRP-1 area looking northeast from Adit A1S.**  
Blue Ledge Mine, Rogue River-Siskiyou National Forest, CA  
Photographed by: Brian Wetzsteon (ERRG)

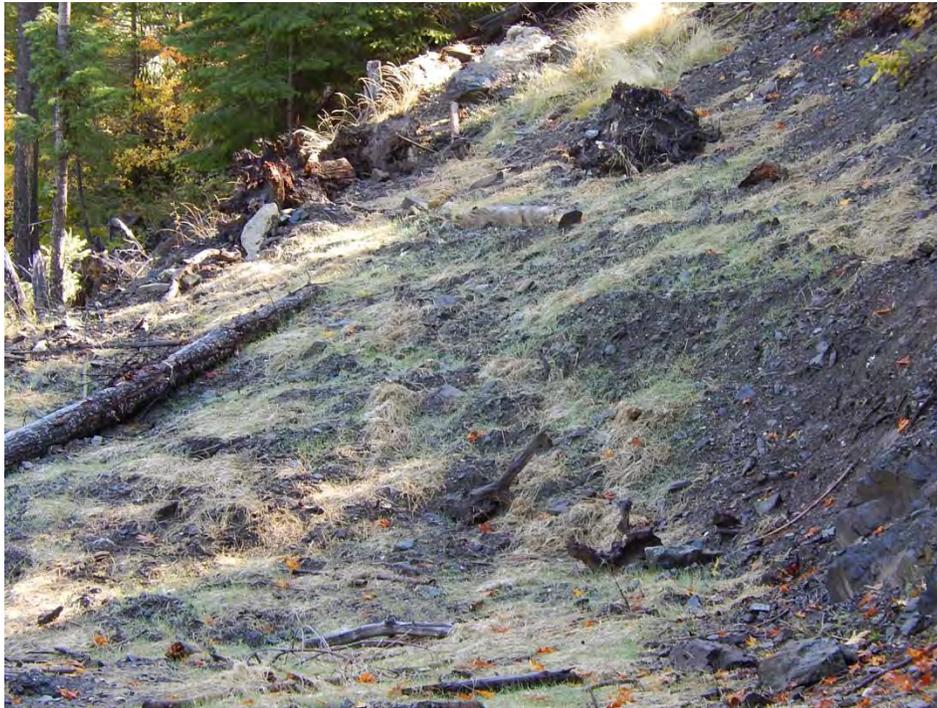
**Photograph 9: Reclaimed sediment disposal area near WRP-1.**

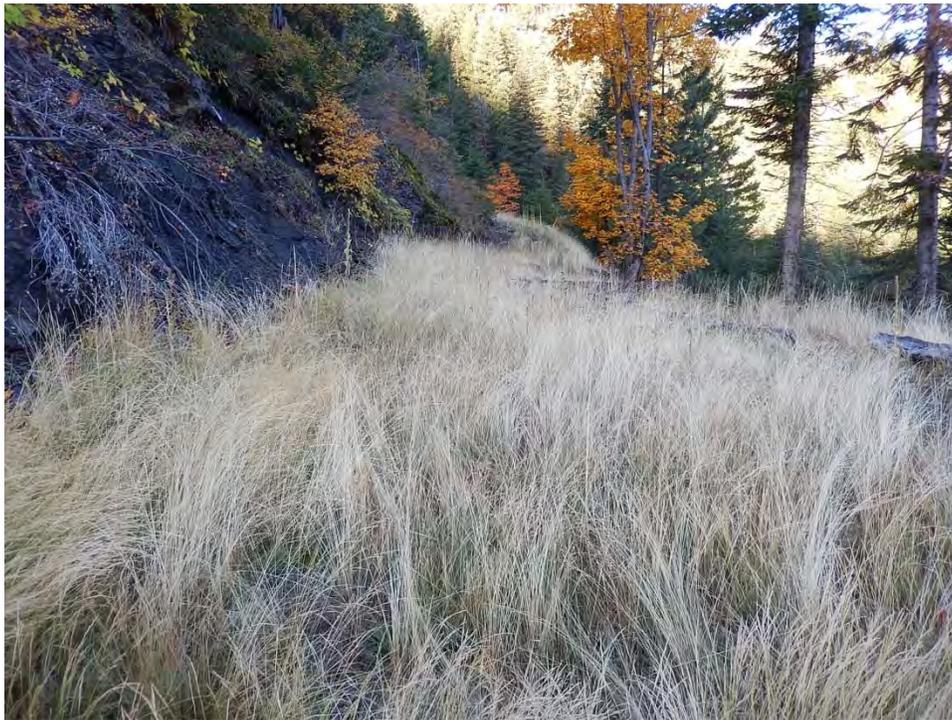
Comments: Grass is growing on the roads. Numerous maple and fir volunteer natural plants were observed on the haul roads.

**Photograph 10: Vegetation on abandoned haul road and miners trail parking area.**

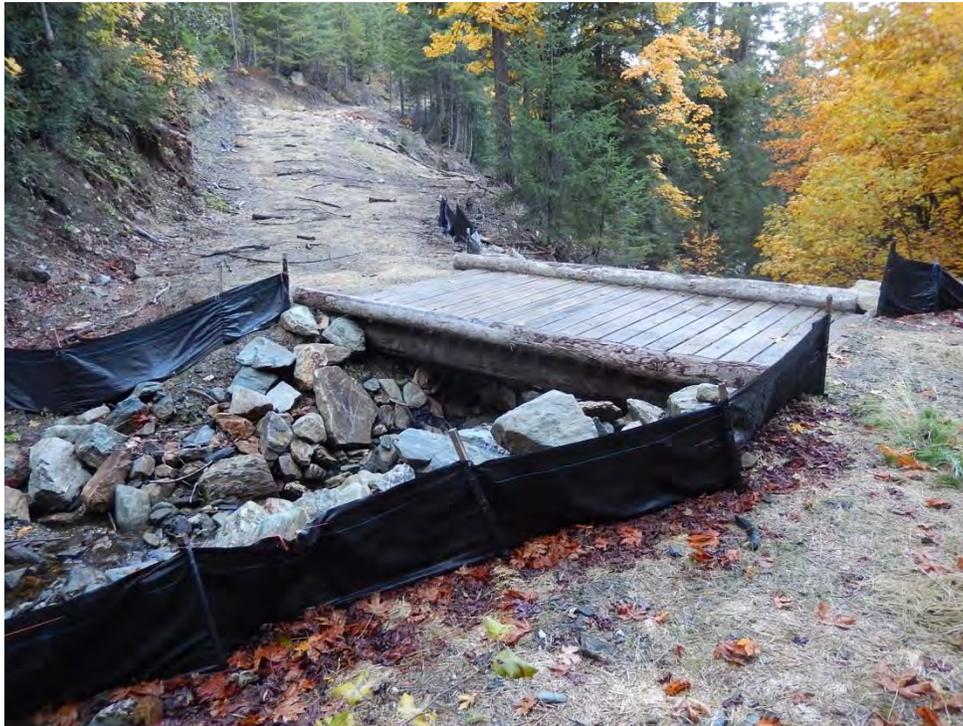
**Photograph 11: Bridge, silt fence, and haul road condition near Basin 2A.**

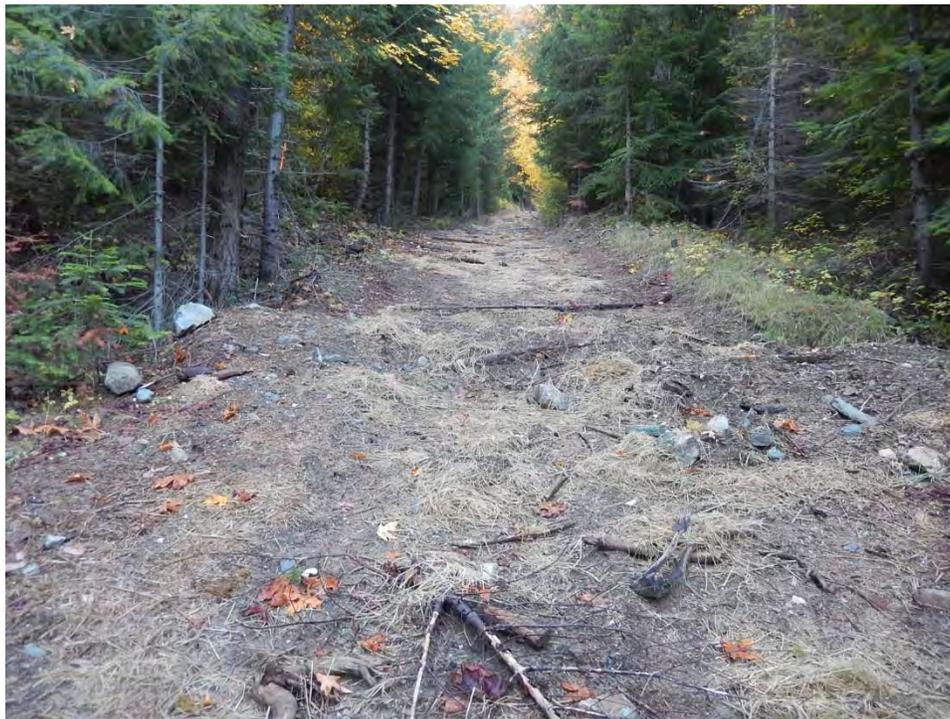
**Photograph 12: Haul road winterized looking south from Rock Stockpile Area.**

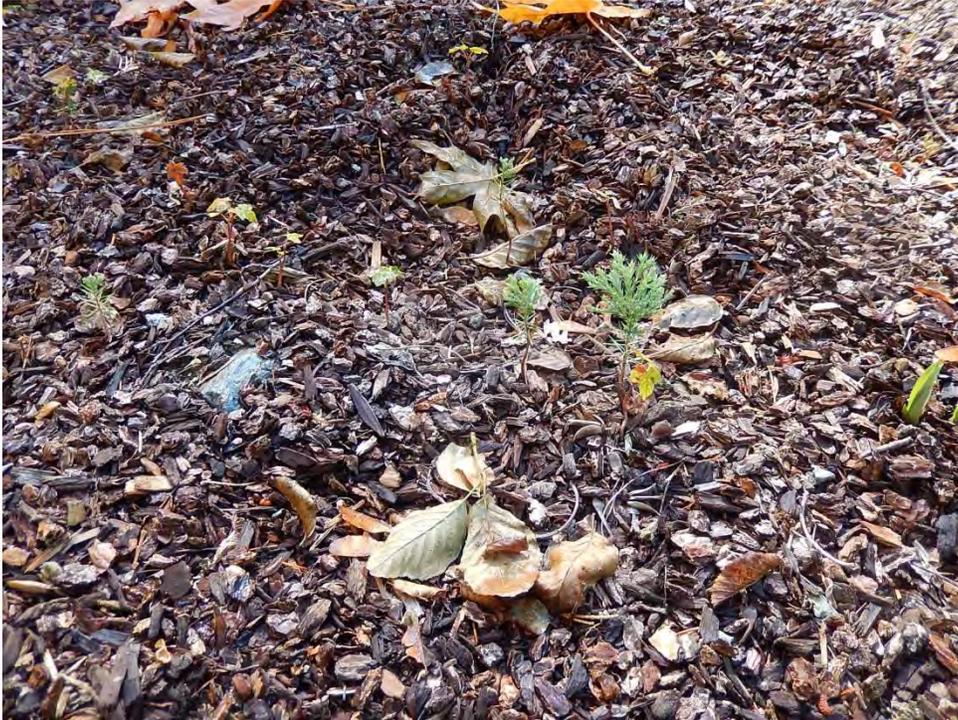
Numerous maple and fir volunteer natural seedlings were observed on many of the reclamation areas and haul roads.

**Photograph 13: Natural regrowth seedlings (L-R) Fir, Maple, Cedar**

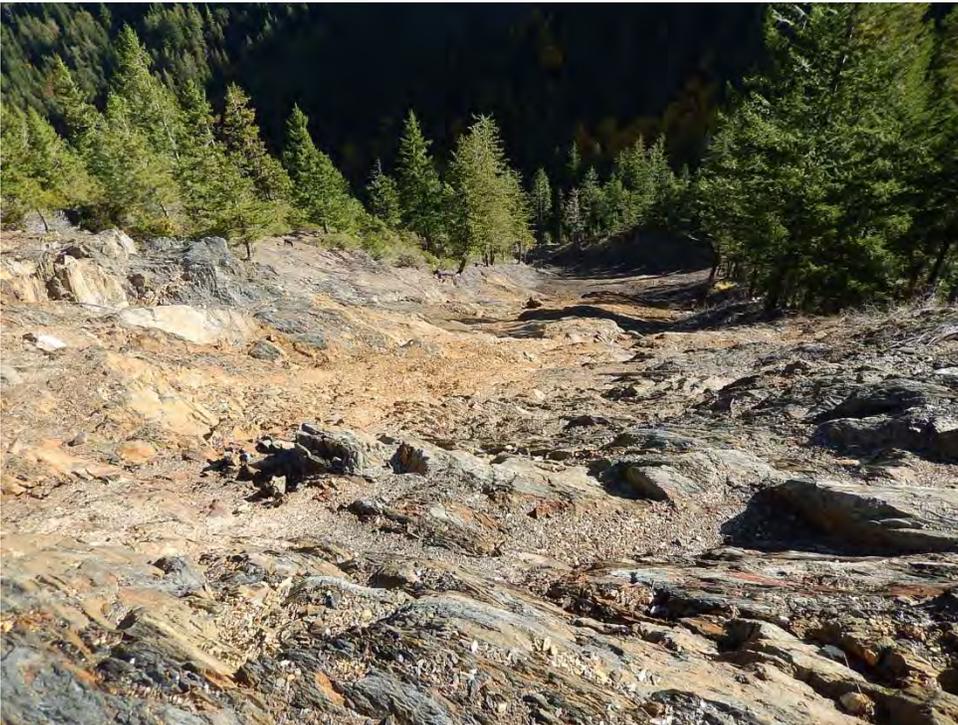
**Photograph 14: WRP-2 looking east.**

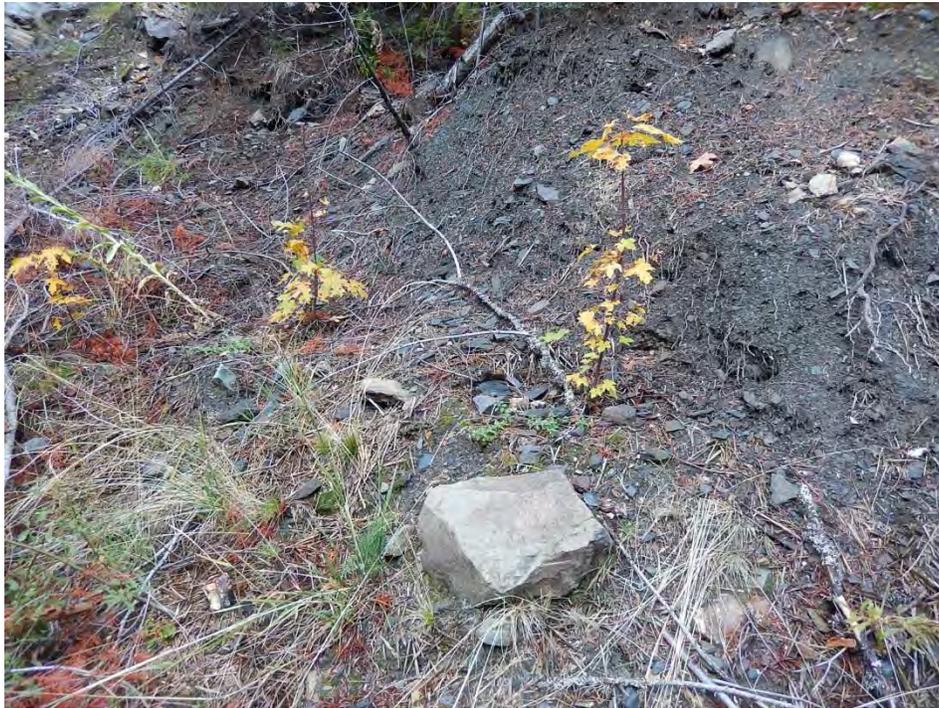
**Photograph 15: Typical plants on WRP-2.**  
Blue Ledge Mine, Rogue River-Siskiyou National Forest, CA  
Photographed by: Brian Wetzsteon (ERRG)

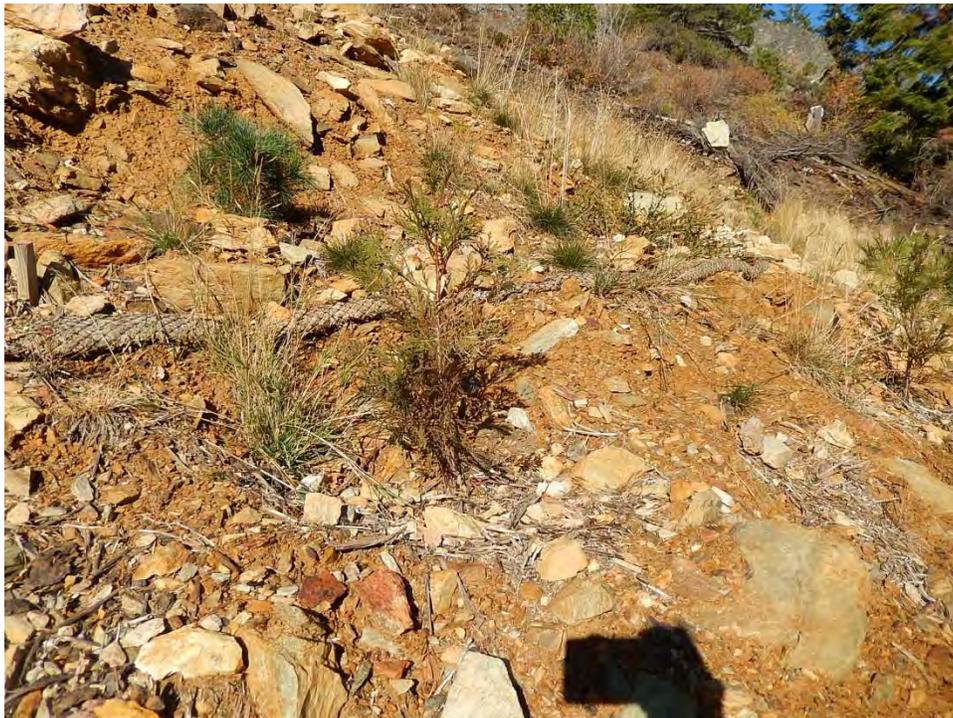
**Photograph 16: Typical plants and patches of grass on WRP-3.**  
Blue Ledge Mine, Rogue River-Siskiyou National Forest, CA  
Photographed by: Brian Wetzsteon (ERRG)

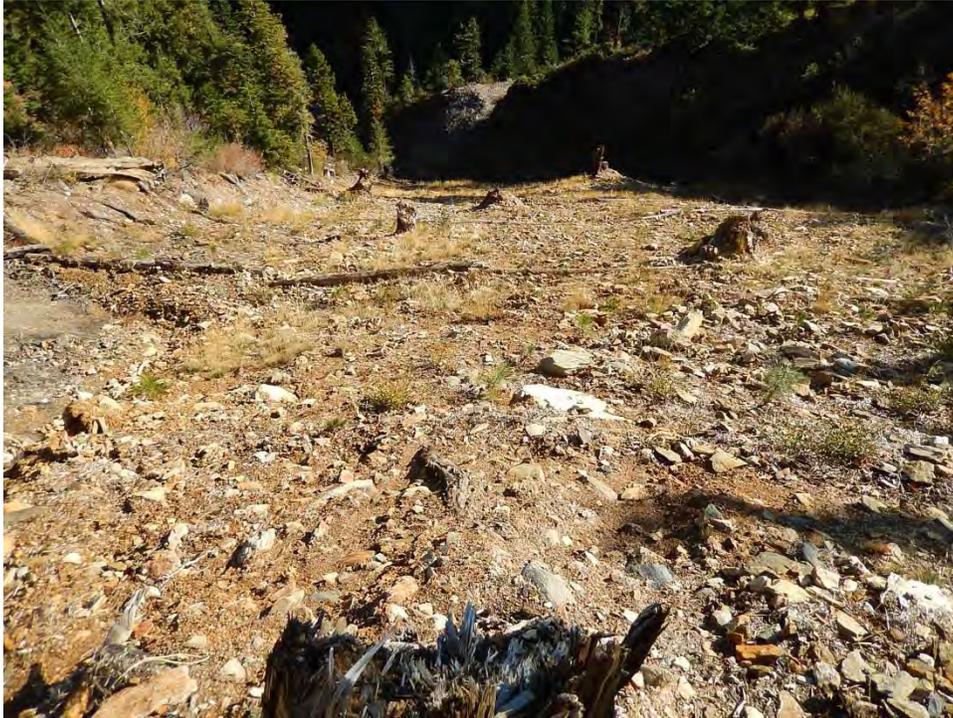
**Photograph 17: WRP-3 looking east showing plants and grass growth.**  
Blue Ledge Mine, Rogue River-Siskiyou National Forest, CA  
Photographed by: Brian Wetzsteon (ERRG)

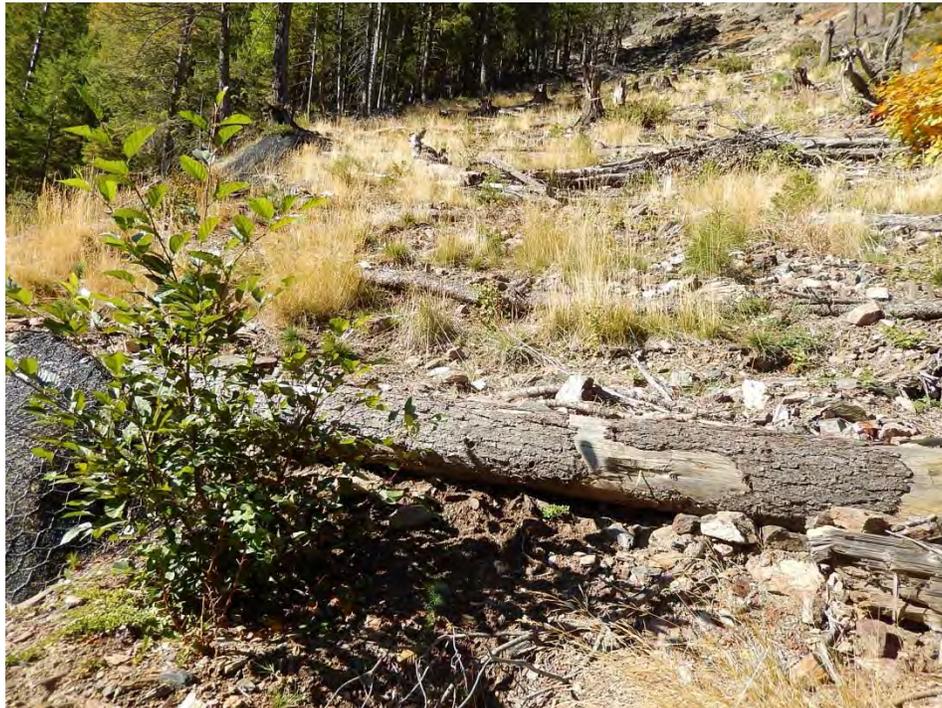
**Photograph 18: WRP-4 reclamation plants and grass.**  
Blue Ledge Mine, Rogue River-Siskiyou National Forest, CA  
Photographed by: Brian Wetzsteon (ERRG)

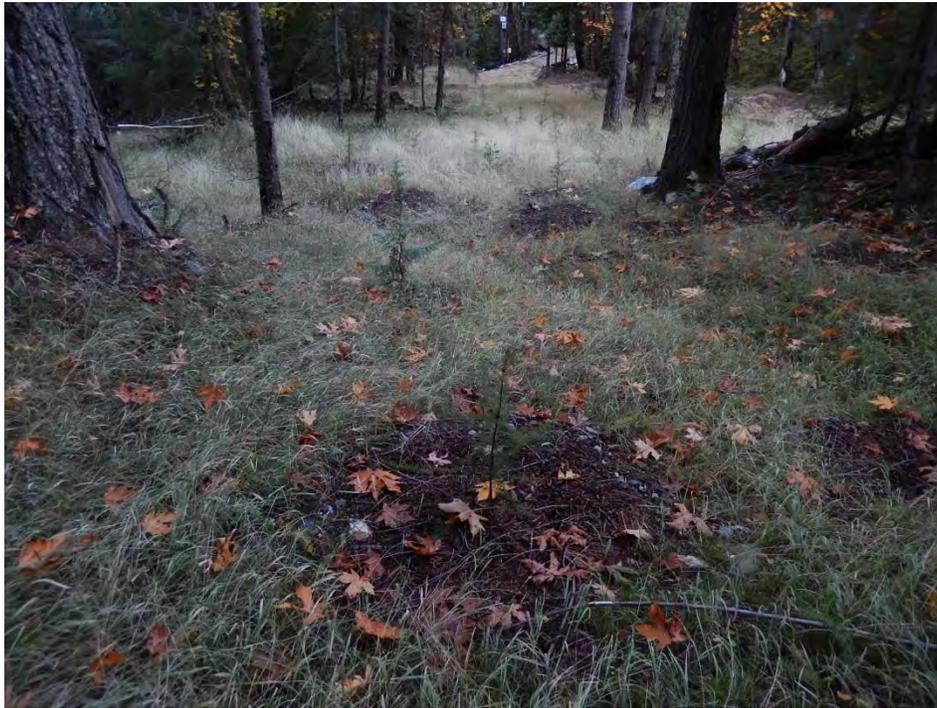
**Photograph 19: Rock stockpile area, looking north.**  
Blue Ledge Mine, Rogue River-Siskiyou National Forest, CA  
Photographed by: Brian Wetzsteon (ERRG)

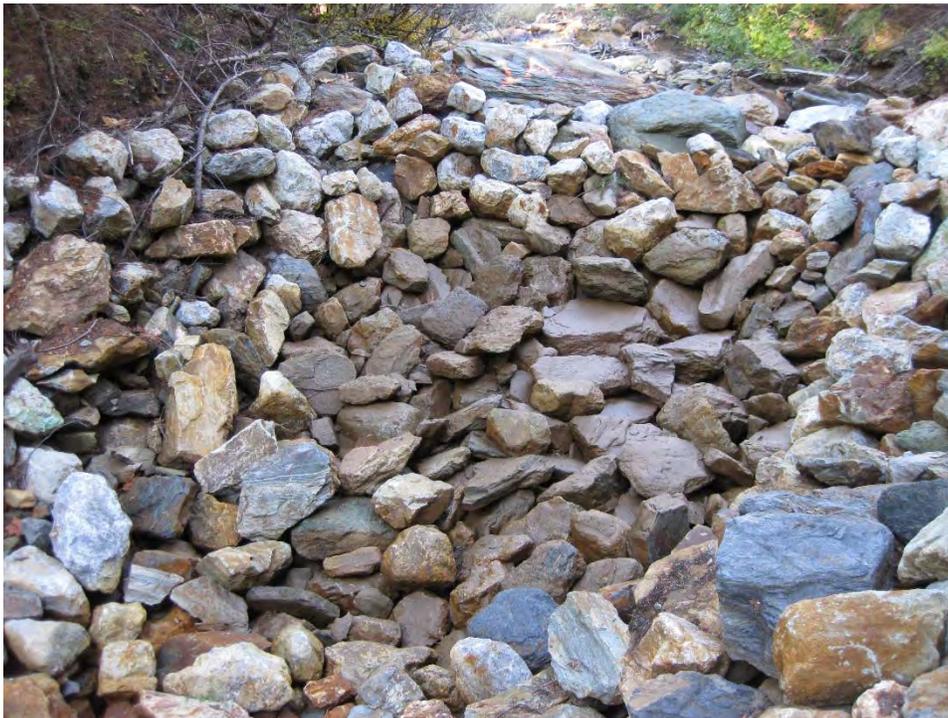
**Photograph 20: Sediment/pH Treatment Basin 1A.**  
Blue Ledge Mine, Rogue River - Siskiyou National Forest, CA  
Photographed by: Annica Nord (ERRG)

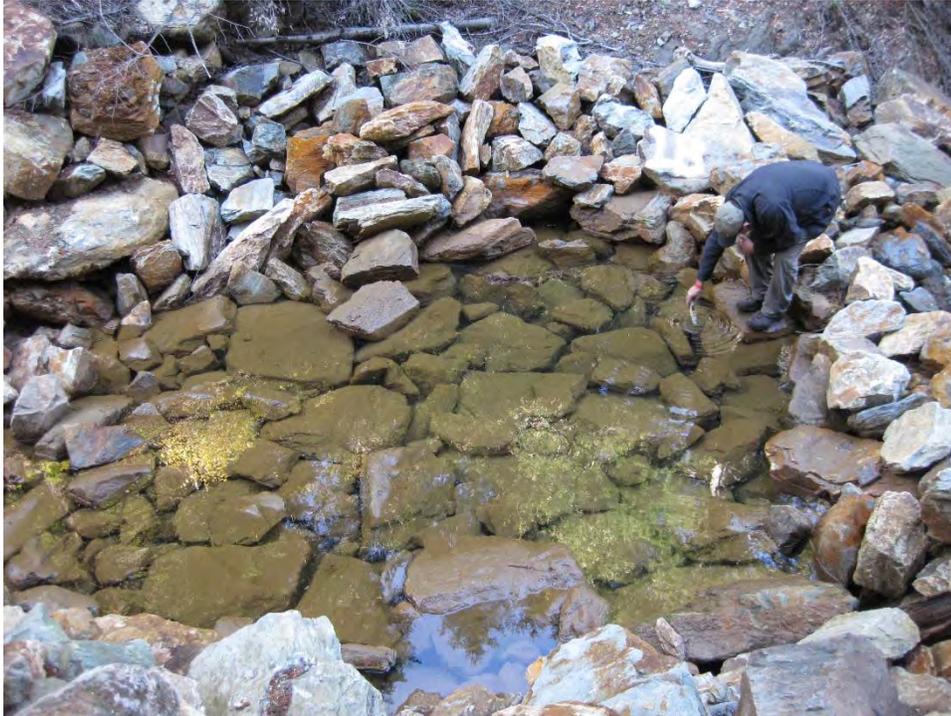
**Photograph 21: Sediment/pH Treatment Basin 1B.**  
Blue Ledge Mine, Rogue River - Siskiyou National Forest, CA  
Photographed by: Annica Nord (ERRG)

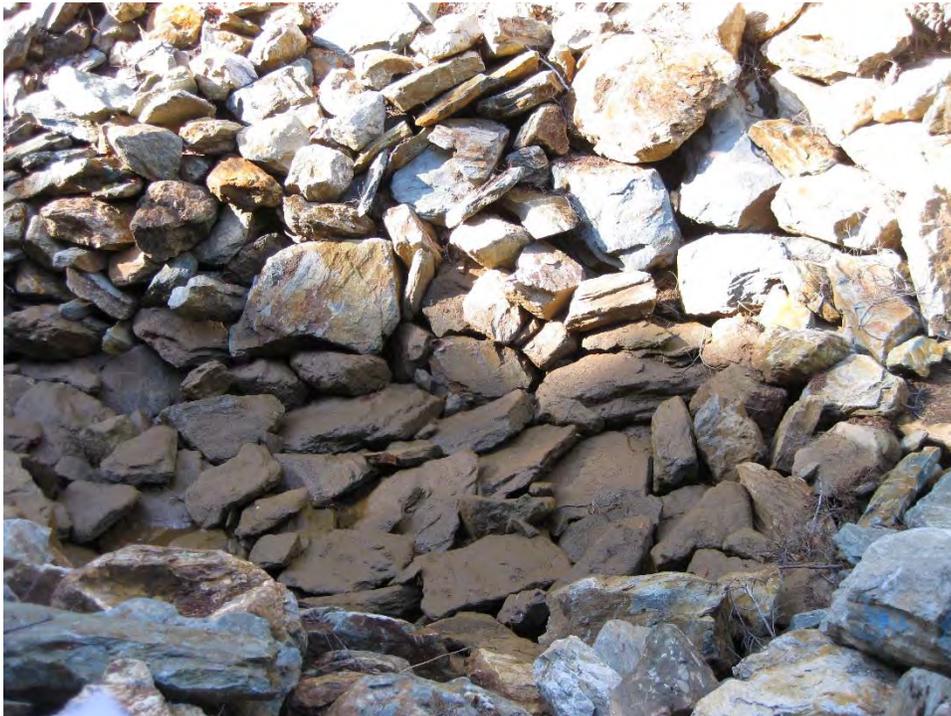
**Photograph 22: Sediment/pH Treatment Basin 1C.**  
Blue Ledge Mine, Rogue River - Siskiyou National Forest, CA  
Photographed by: Annica Nord (ERRG)

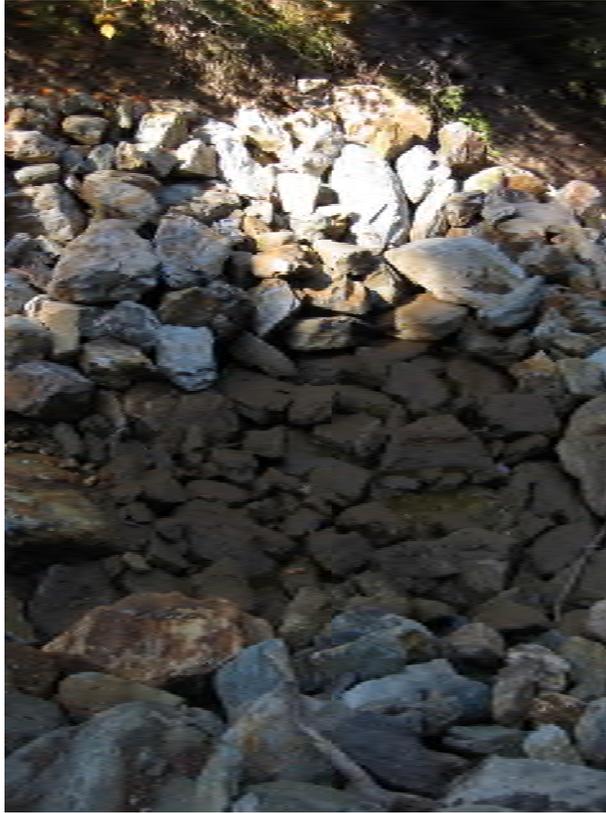
**Photograph 23: Sediment/pH Treatment Basin 1D.**  
Blue Ledge Mine, Rogue River - Siskiyou National Forest, CA  
Photographed by: Annica Nord (ERRG)

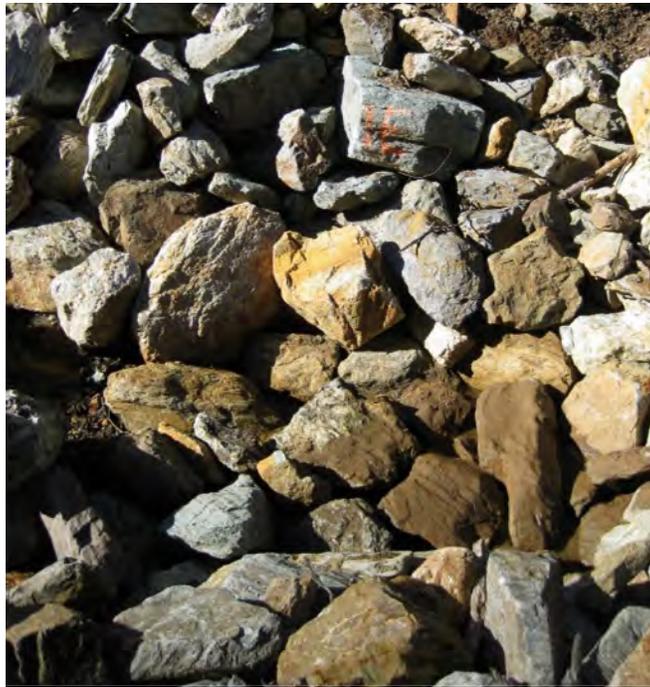
**Photograph 24: Sediment/pH Treatment Basin 1E.**  
Blue Ledge Mine, Rogue River - Siskiyou National Forest, CA  
Photographed by: Annica Nord (ERRG)

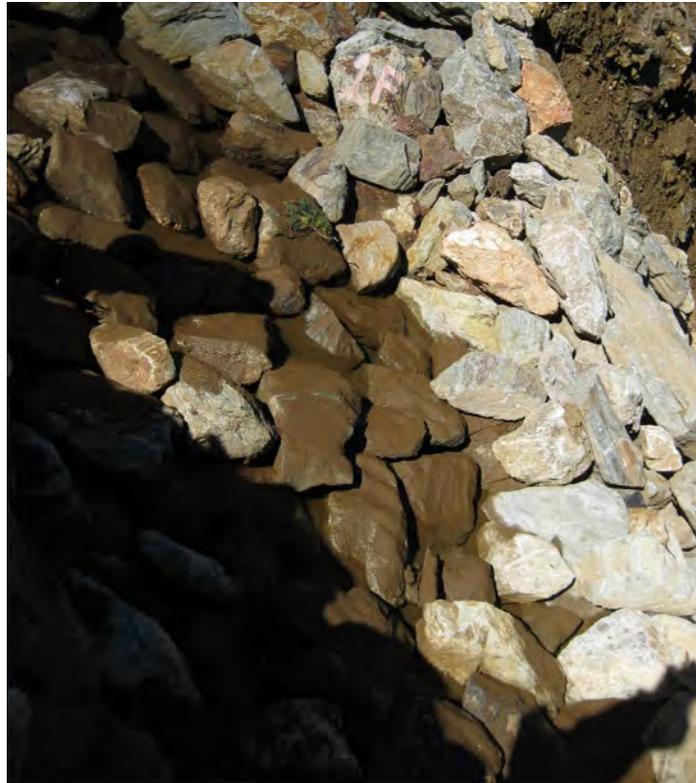
The pH of the water in the WRP-1 drainage entering basin 1F was slightly higher than the pH 4.53 concentration measured in September 2013. The limestone in the basins appears to be successful in raising the pH prior to entry into Joe Creek.

**Photograph 25: Sediment/pH Treatment Basin 1F.**  
Blue Ledge Mine, Rogue River - Siskiyou National Forest, CA  
Photographed by: Annica Nord (ERRG)

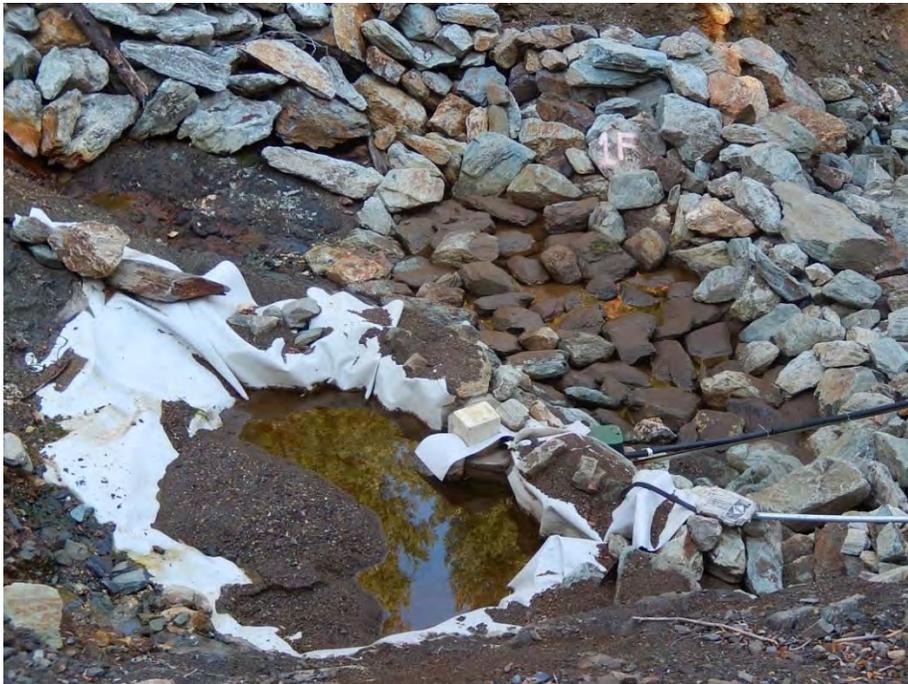
The acid seep previously entering the east side of basin 1F is being captured by the USEPA acid seep collection basin. The water seeping from adit A1N2 has been diverted by the USEPA to flow down the face of the WRP-1 bedrock to run to the acid seep collection basin. The pH in the USEPA acid seep basin was measured at 3.65, which is 0.16 higher than the September 2013 measurement. The water in the acid seep collection basin is diverted into piping which runs into the treatment building before discharging

**Photograph 26: Sediment/pH Basin 1F and EPA acid seep collection basin.**  
Blue Ledge Mine, Rogue River-Siskiyou National Forest, CA  
Photographed by: Brian Wetzsteon (ERRG)
