2013 BEST MANAGEMENT PRACTICES EVALUATION PROGRAM

ANNUAL REPORT
JANUARY, 2014

USDA FOREST SERVICE
LAKE TAHOE BASIN MANAGEMENT UNIT
ECOSYSTEM CONSERVATION DEPARTMENT

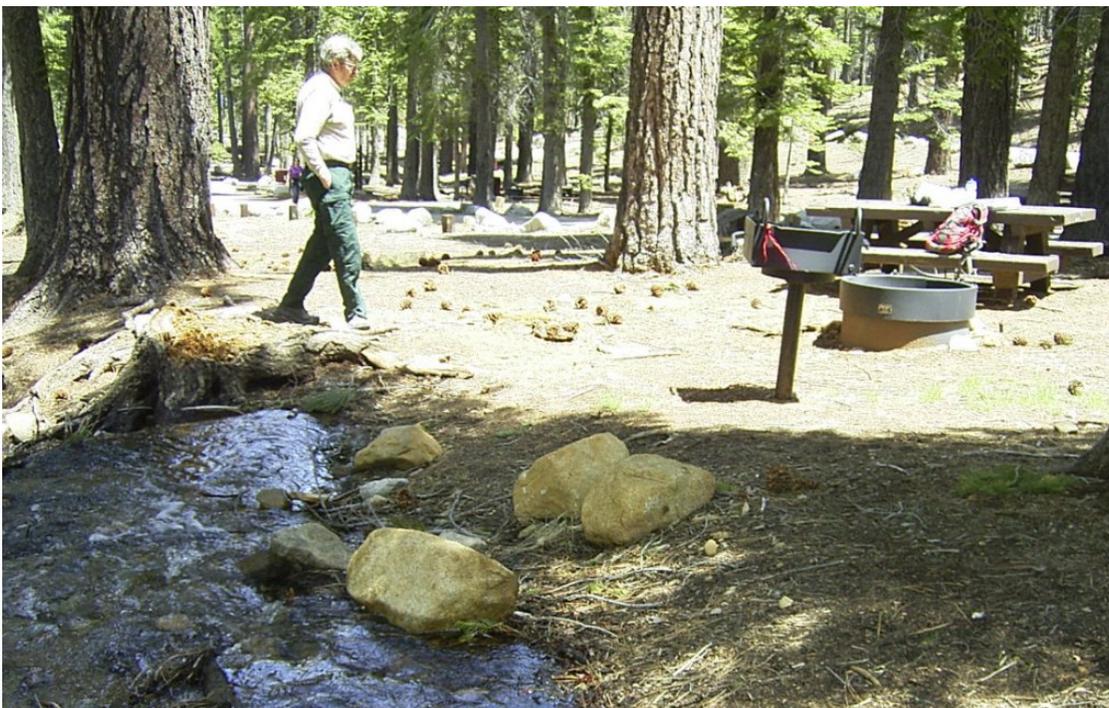
The evaluation determined, there is one campsite (#7) in which the pedestal grill lies within 10 feet of an intermittent stream (see photo below).

The proximity of this grill to the stream channel encourages some degree of soil compaction from trampling, which can result in less infiltration and increased surface runoff and erosion. However because the ground is flat, and pine needle cover is provided from adjacent conifers, the risk of significant soil erosion is low.

(67) A pedestal grill located in one campsite (#7) lies within the SEZ buffer as described in the state Lahontan Regional Water Quality Control Board Basin Plan; i.e. for confined intermittent streams with the adjacent slope in good condition the buffer should be 15 feet. The pedestal grill is located within 5 to 10 feet of the edge of stream currently.

Confined Ephemeral or Intermittent Stream: When a confined ephemeral or intermittent stream is present, the following setbacks are established based on the corresponding slope conditions:

- (a) Good Slope Condition: When the slope condition is identified as good, the setback is 15 feet from the edge of the SEZ or 10 feet from the edge of a terrace if present, whichever is less.

This work should be scheduled for 2014. Conduct an informal follow-up evaluation to determine status of implementing this recommendation, to report on in the 2014 annual report.
