RE: **Rocky Gulch Salmonid Access and Habitat Restoration Project**  
**(Contract No. AWIP-N-1)**

## **ROCKY GULCH TIDEGATE COMPLETION: FINAL REPORT**

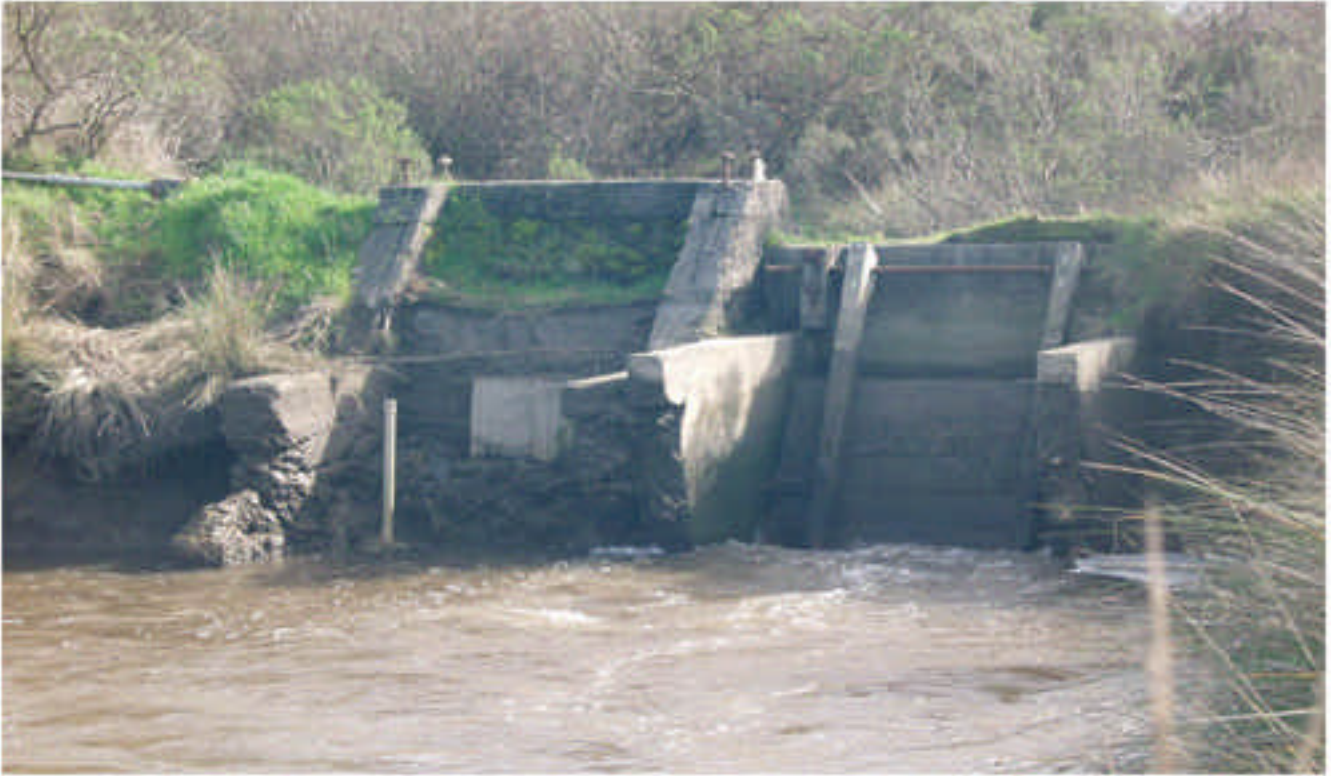
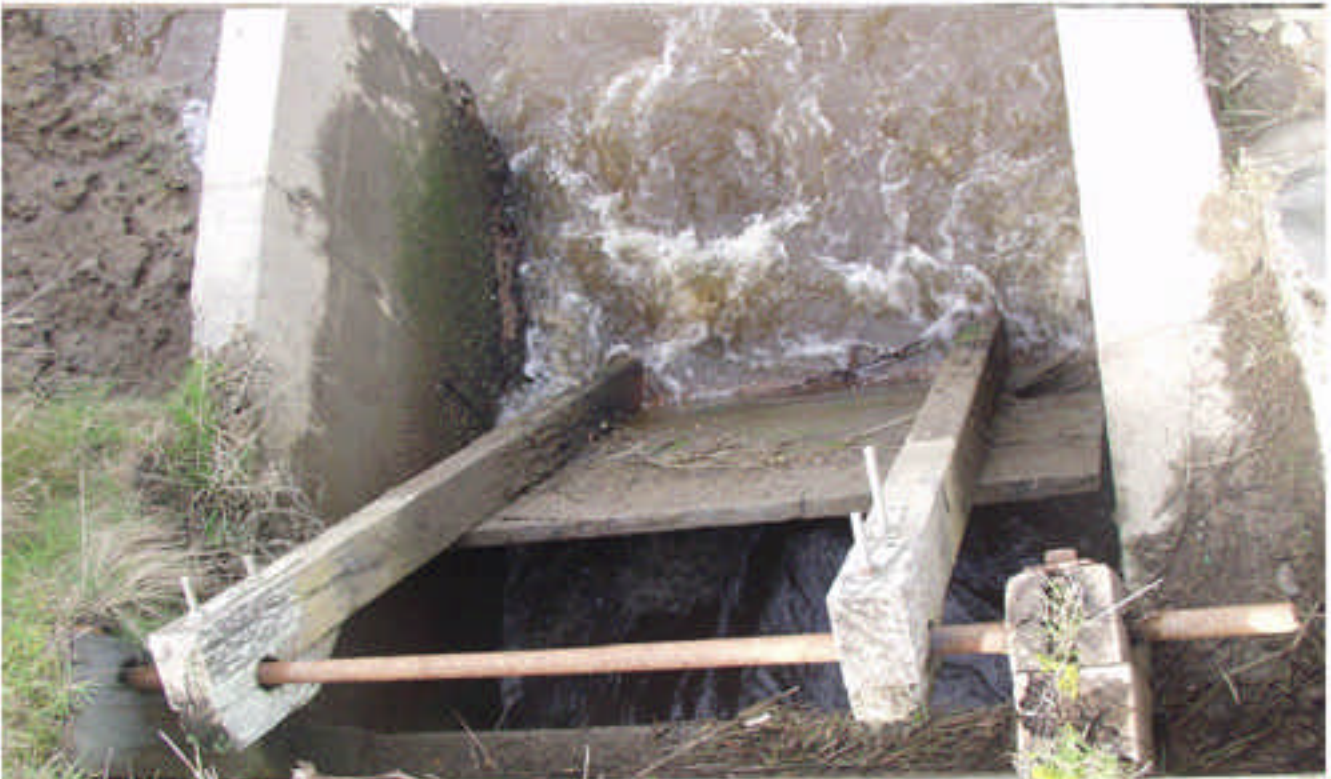
Figure 2. The old wooden tidegate on Rocky Gulch, at ebb tide. The top photo shows the abandoned tidegate to the left of the functioning tidegate.

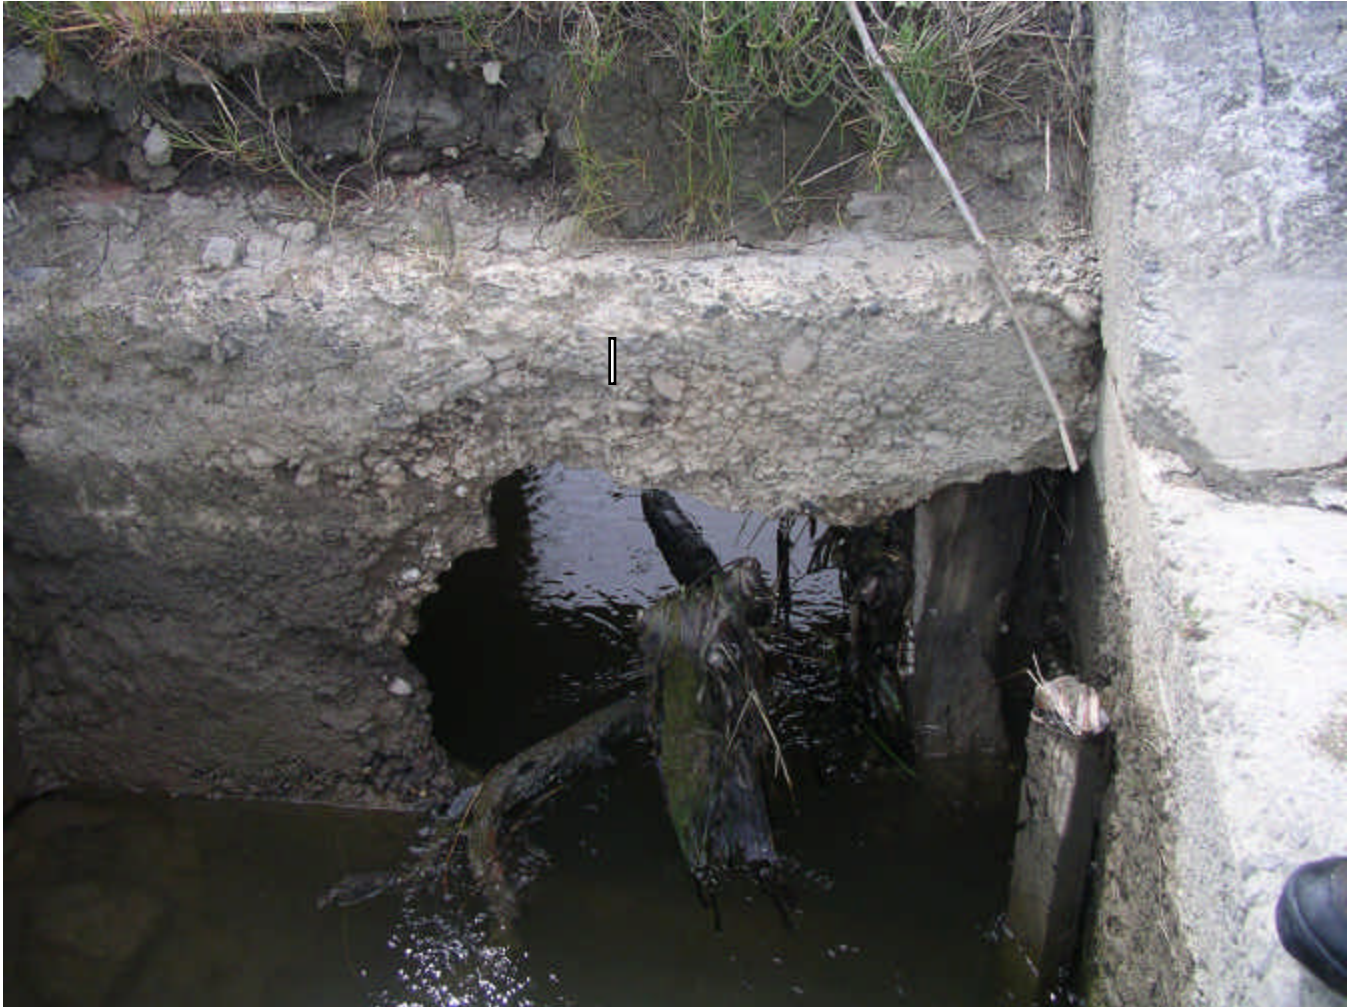
that can be adjusted up and down by rotating a stainless nut and threaded rod. The 1 ft wide auxiliary opening can be reduced to 0.5 ft wide by mounting a choke plate over the opening on the back side of the gate. The auxiliary door can be closed completely by screwing down the stainless nut and threaded rod. Installation of the new tidegate required repairs to the existing concrete wing-walls and construction of a concrete “ceiling” spanning the wing-walls between the new tidegate headwall and the existing headwall to prevent water from pouring over the concrete wing-walls. After installation of the new tidegate, the concrete headwall of the adjacent non-functioning tidegate was repaired to plug a hole (Figure 4). The total tidegate installation cost was \$15,000.00

Figure 4. Photo showing the hole in the old tidegate headwall, with mud and debris cleared out.

- Once the new tide gate installation was complete, the fill material plugging the hole in the adjacent tidegate’s headwall was removed to allow the hole to be permanently plugged. The area surrounding the hole was cleared, and forms were installed to plug the hole with approximately a cubic yard of concrete. This task also used a rapid drying concrete and was done on the upstream side of the tidegate to prevent tidewater from inundating the concrete patch until after the concrete had set-up. Once the concrete was set, the forms were removed.

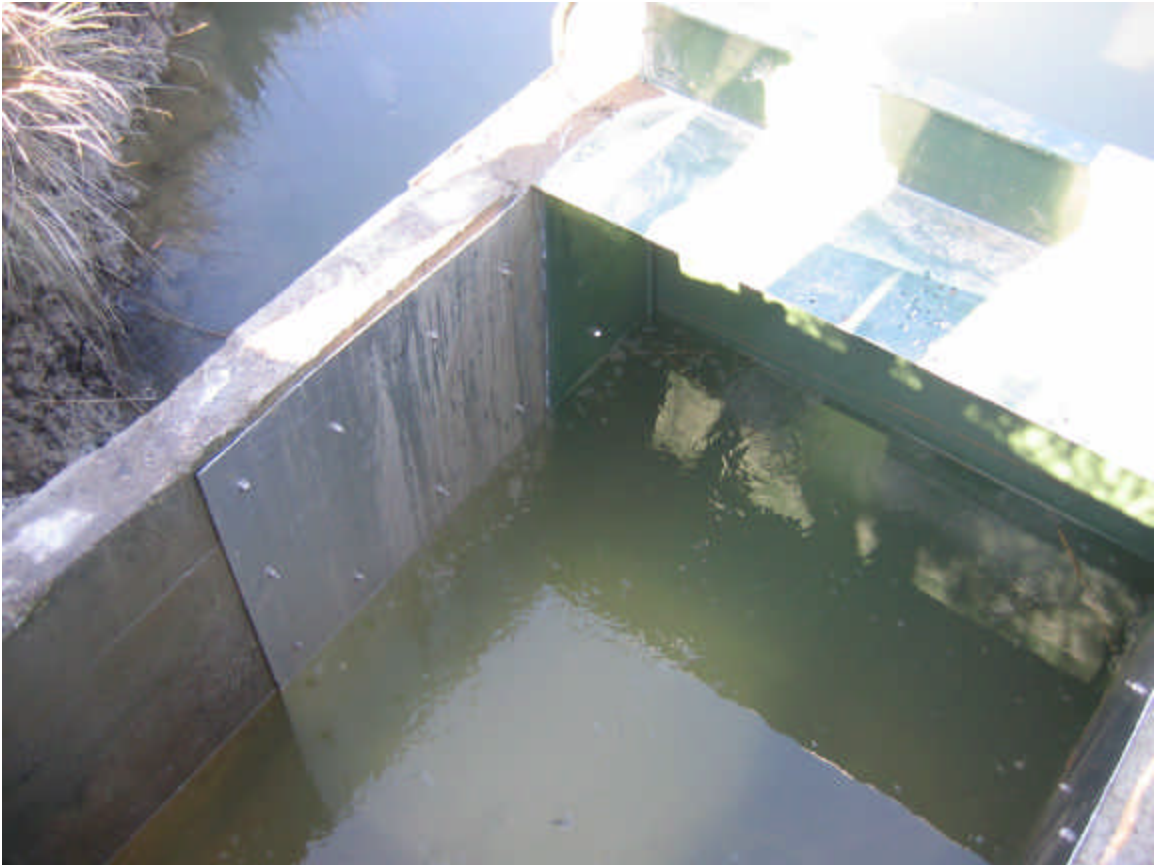
Figure 5. Top view of the new tidegate structure during assembly, before the aluminum ceiling was installed. The aluminum sleeves are shown bolted to the concrete wing-walls.

- The new tidegate headwall included a 4 ft aluminum sleeve that was bolted onto the inside of the concrete wing-walls. The sleeves enclosed the ends of the eroded wing-walls (Figure 5) and created small void spaces that were dry-packed with concrete to reinforce the walls. A “high-early” type of concrete was used that hardened rapidly and allowed full loading by approximately 12 hours. Metal rebar was installed to reinforce the concrete. Approximately 4 cubic ft of concrete were required for the aluminum sleeve installation. Before being inundated with tidewater, the concrete wing-walls and aluminum sleeve were scrubbed down, and the wash-water and debris were collected on the floor of the tidegate in temporary tarpaulin ponds where it was removed for disposal in the upland area. This activity prevented discharge of concrete or other debris into the adjacent waters.

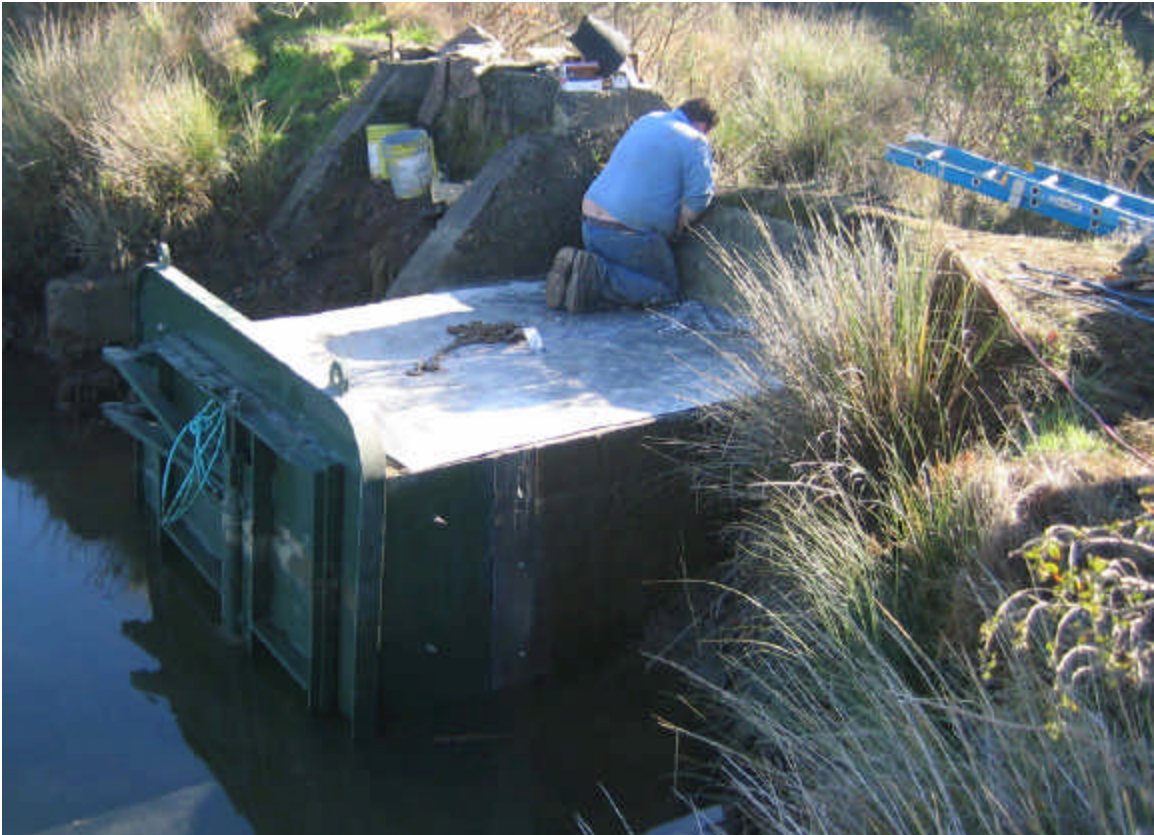
Figure 6. Installation of the aluminum ceiling to fully enclose the wing-walls to form a box culvert type structure.

- After the tidegate was installed onto the wing-walls and secured adequately, an aluminum ceiling was installed over the wing-walls to create an enclosed box culvert (Figure 6). The project originally proposed using concrete for the ceiling, but during implementation the existing concrete was judged to be not structurally sound enough to support the weight of concrete, so the aluminum ceiling was installed. This reduced the amount of concrete used in the project by approximately 12-15 cubic ft. All bolting was done with stainless steel expansion bolts.

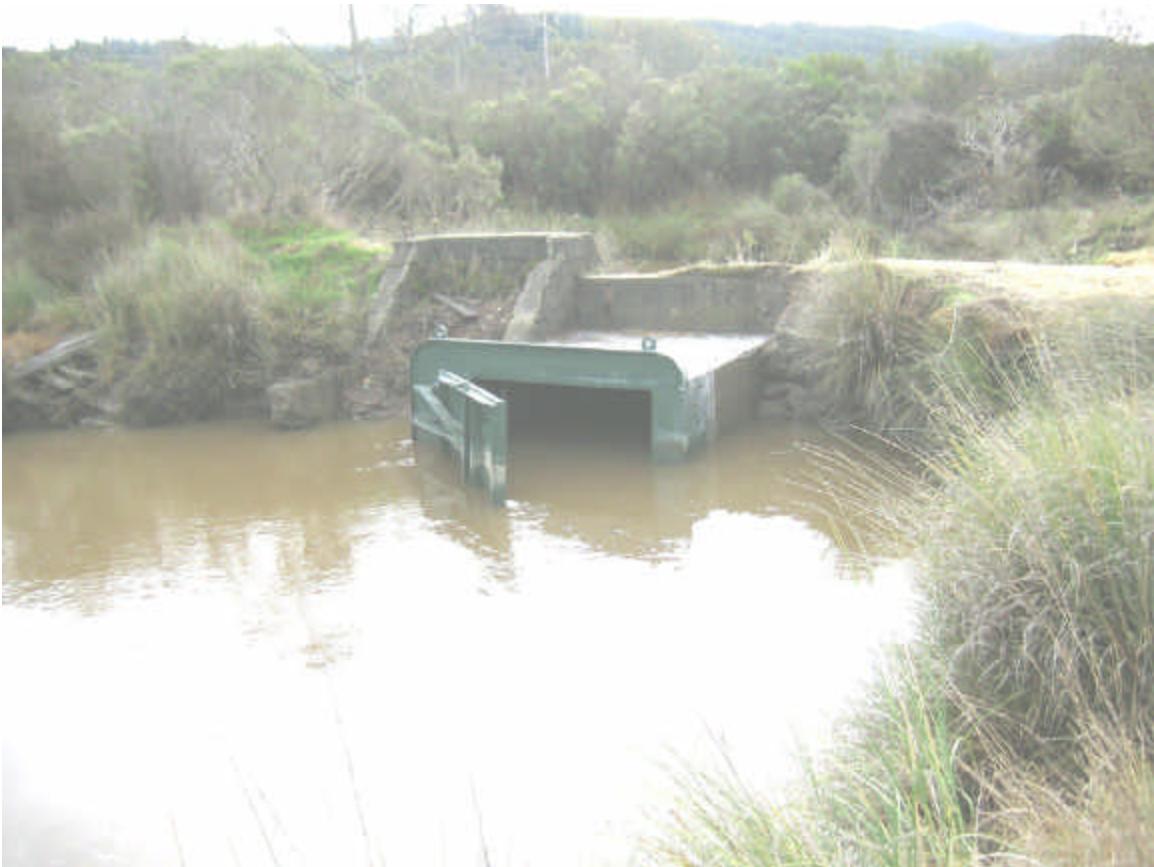
After completion of the tidegate installation (Figure 7), the area surrounding the construction site was seeded with grass to reduce erosion of exposed soil. The tidegate auxiliary door was initially kept closed until the tidegate was observed during a one-month period of tide cycles, including high tides that exceeded 9 ft MLW. The hydraulic model developed for the project was used to determine the size of the auxiliary door opening, which has been set at 1.0 ft<sup>2</sup>. Daily tidal inundation of the tidegate now allows a muted tide prism to flow through the auxiliary door to fill the slough channels upstream of the tidegate. There are numerous benefits to daily seawater intrusion upstream of the tidegate. Regular tidal flux will help maintain slough channel capacity by flushing fine sediments delivered from the upper watershed into the bay, suppresses vegetation from growing in the channel, and provides highly valuable brackish aquatic habitat used by migratory marine, anadromous, and resident fish species. At the peak tide, the auxiliary door allows tidewater to rapidly fill behind the tidegate and achieve equilibrium in water surface elevations on the inside and outside of the tidegate. As the tide ebbs, the tidegate is pushed fully open to nearly 90 degrees (Figure 7). This wide opening will allow anadromous salmonids to pass through the tidegate and migrate upstream to their spawning grounds.

Figure 7. The completed tidegate project showing the tidegate open approximately one hour after the peak tide.
