Deadwood Creek Tributary South

Culvert Scour Assessment

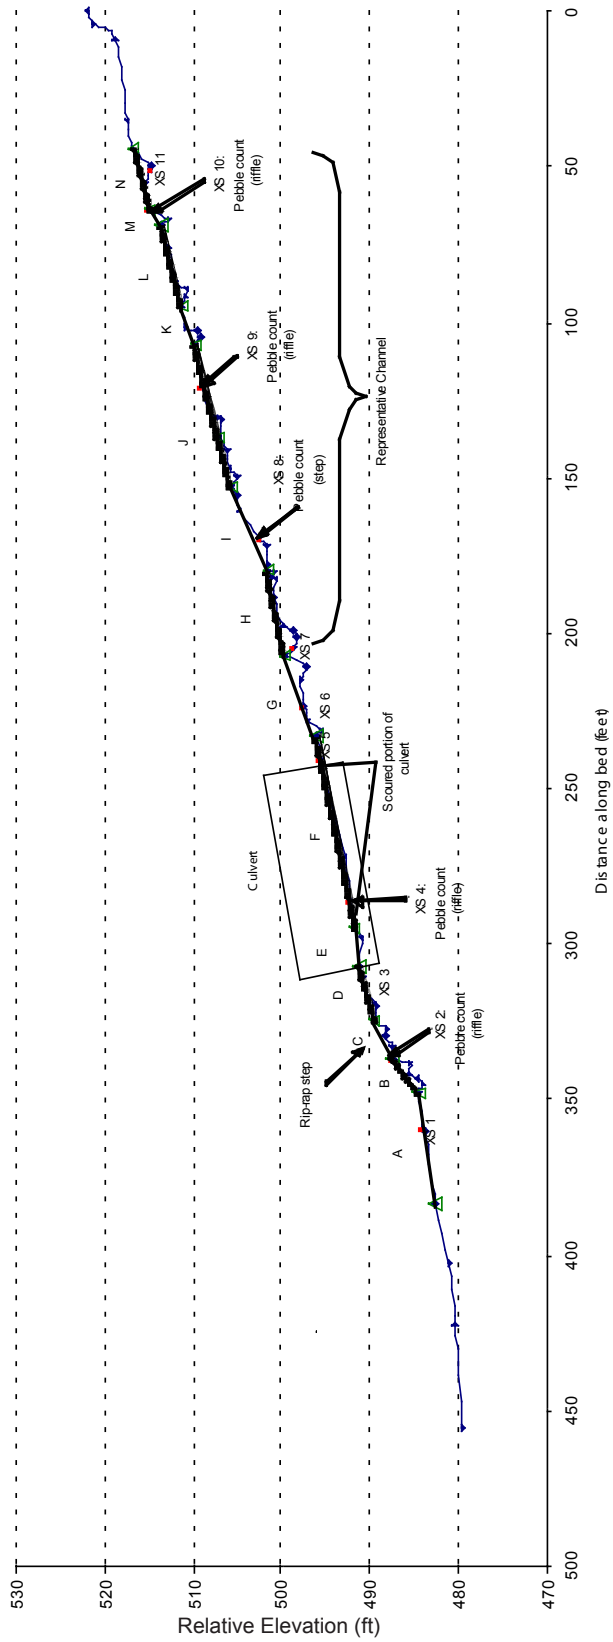
Figure 2—Deadwood Creek Tributary South longitudinal profile.

Profile characteristics – The profile is concave at the crossing but convex downstream of the outlet (figure 2). The profile was described as a “dual grade break” by the designer (see History section). The site is located at the transition from the small, confined valley of the tributary to the broader valley of mainstem Deadwood Creek. The profile shape is very likely an artifact of the previous culvert at this site, which had a large scour pool at the outlet and then dropped off steeply to Deadwood Creek. The steep downstream segment is now a steep riprap step.

This is a steep stream and an even steeper culvert, and a very challenging installation to keep from scouring. Regrading the profile to eliminate the dual grade break may avoid the steeper sections that currently pose a passage issue for migrating fish. Using an open-bottom pipe and constructing stable steps through the crossing may provide more stability and scour resistance. Constructing channel banks within the pipe would allow for terrestrial organism passage. A series of wood and rock steps between the outlet and Deadwood Creek similar to those above the culvert would also improve passage conditions.

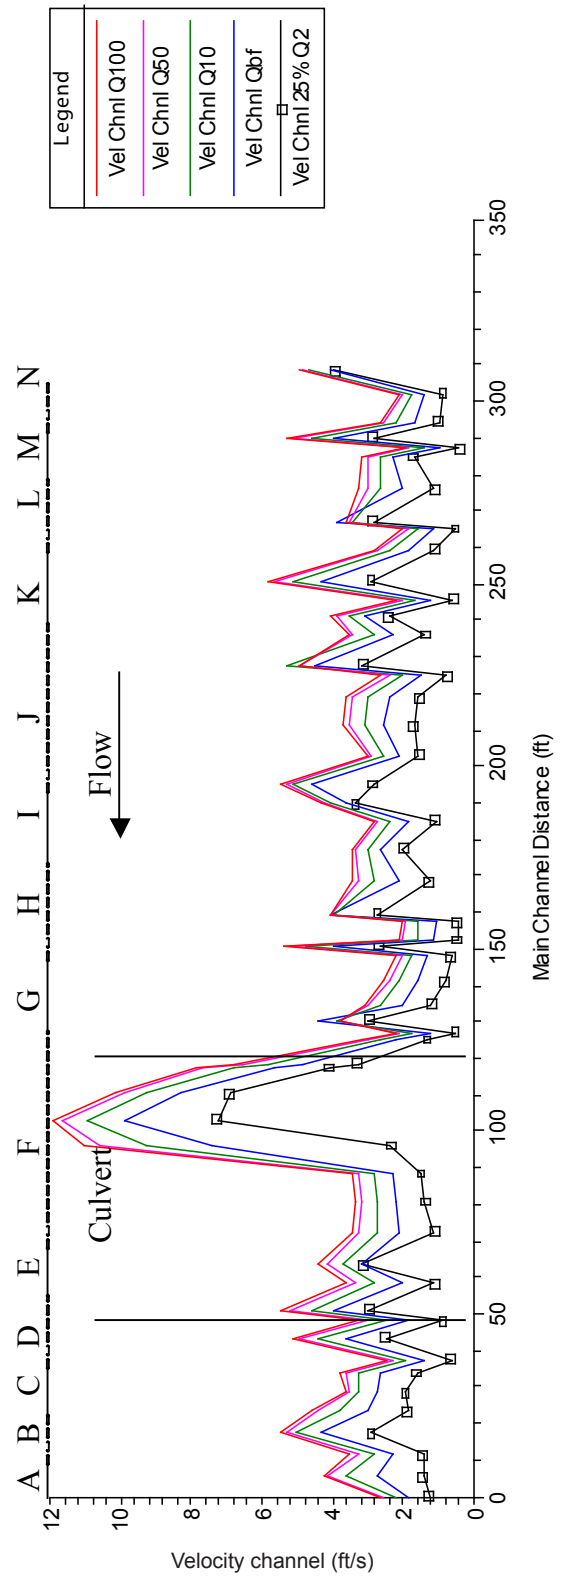
Figure 11—Velocity (channel) profile plot.

Velocity – Velocity in the upper portion of the culvert is extremely high in relation to the natural channel (figure 11). The downstream portion of the culvert and the transition segments have velocities that are more in line with the channel outside the crossing.

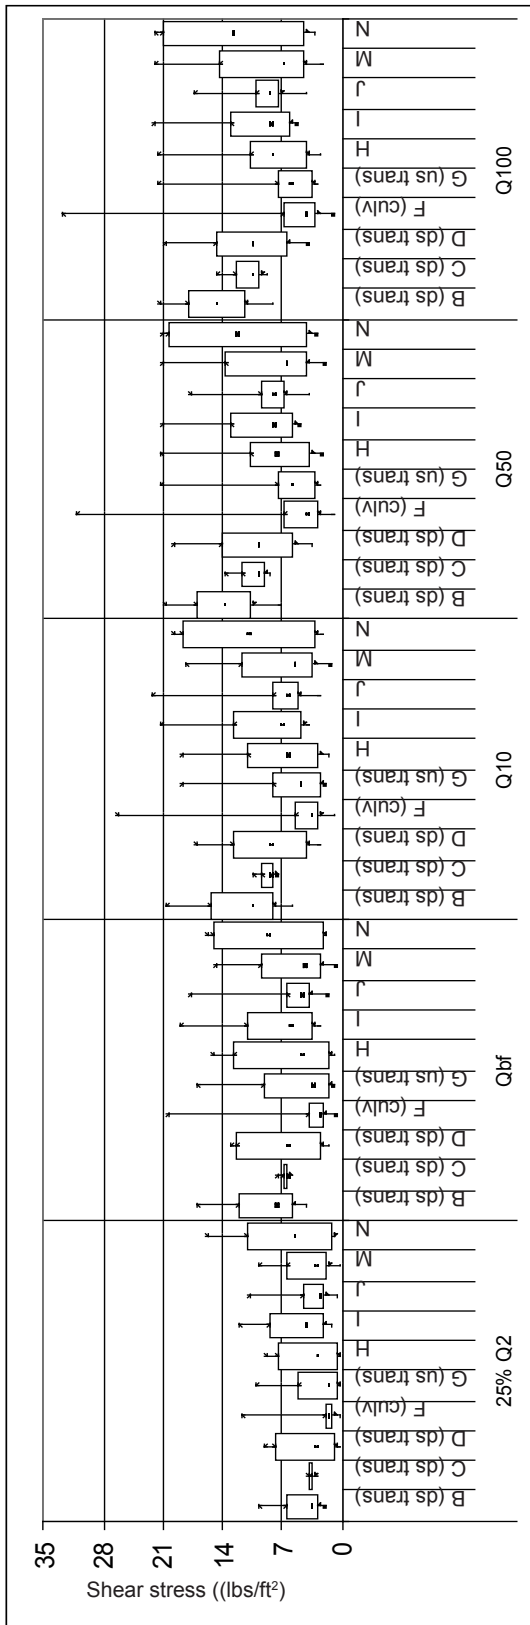
Figure 19—Shear stress (channel).

Shear stress – Modeled shear stress in the culvert has a greater range than the natural channel at the Q_{10} and above, with more extreme (lower as well as higher) values (figure 19). Transition segments do not differ significantly from the natural channel.

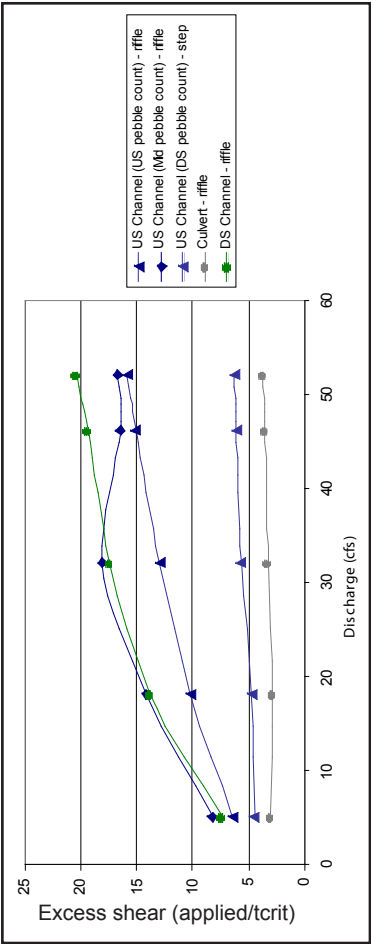
Figure 20—Excess shear stress.

Excess shear – The excess shear analysis suggests that bed material in the culvert is mobilized less frequently than material in the natural channel (figure 20). Past scour of culvert material may have served to stabilize the bed by scouring out smaller material and leaving larger material that is capable of withstanding high flows.

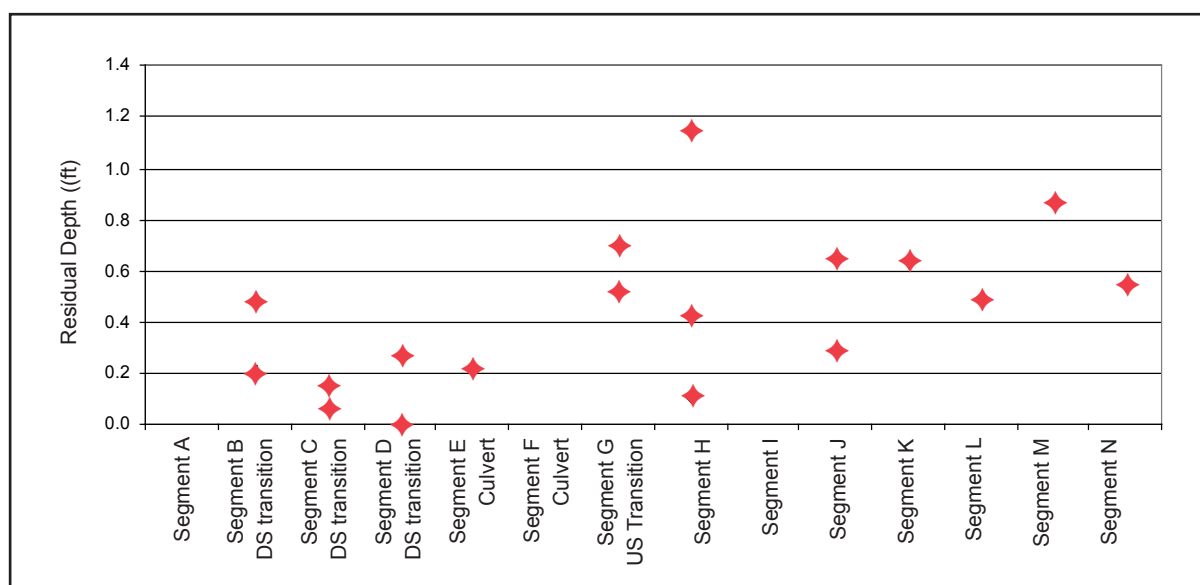
Figure 21—Residual depths.

Residual depths – The one residual depth in the culvert is located in a profile segment that has no comparable profile segment in the natural channel; however, this depth is at the lower end of the range of residual depths found within all the profile segments in the channel outside the

crossing (figure 21). Transition segments have residual depths that do not vary substantially from corresponding profile segments.

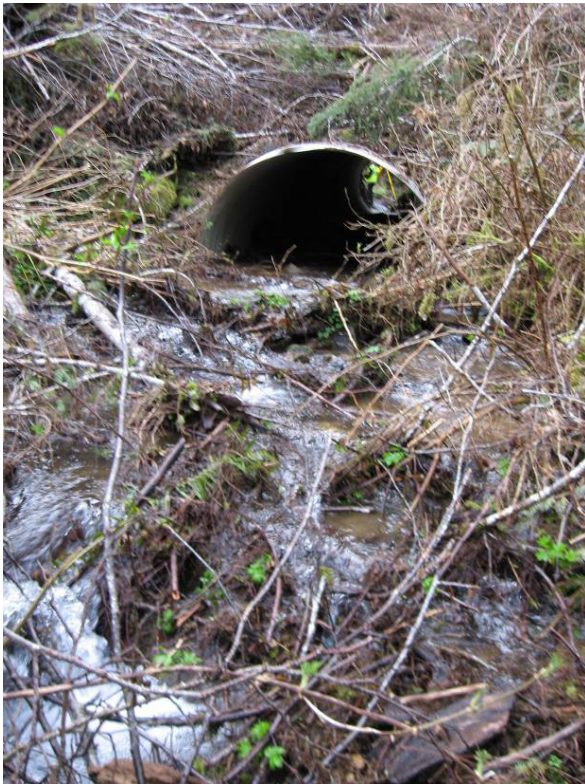
Structure scour – The upstream half of the pipe was scoured to the culvert base. Supercritical flow was present along the exposed culvert base at the time of the survey.

Culvert bed adjustment – The culvert bed has scoured placed material out of the upstream half of the pipe. This has resulted in a slope adjustment of the culvert bed, which is now about half of the slope of the structure itself. Material still remains in the downstream portion of the pipe, some of the material appears to have aggraded in the downstream portion and may have been sourced from the scour in the upstream portion.

View upstream through culvert.

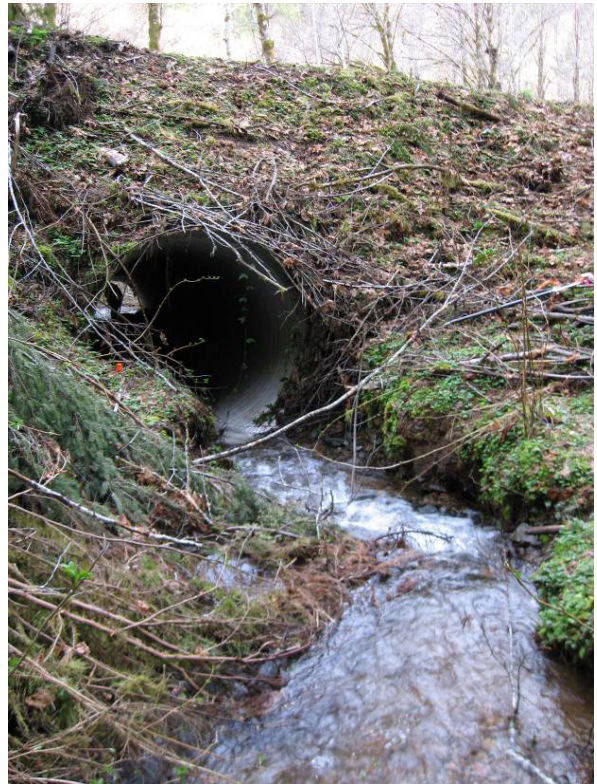
View downstream through culvert.

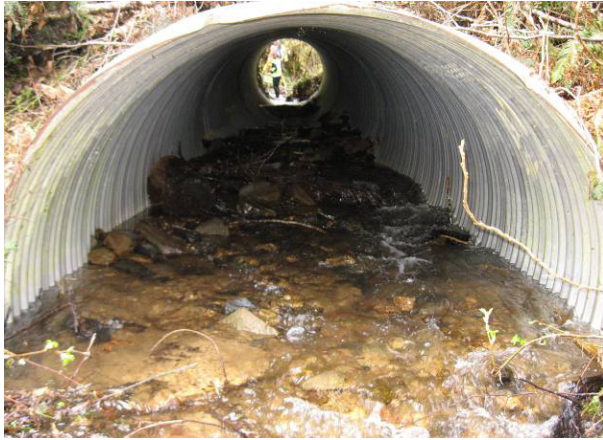
View upstream in culvert.

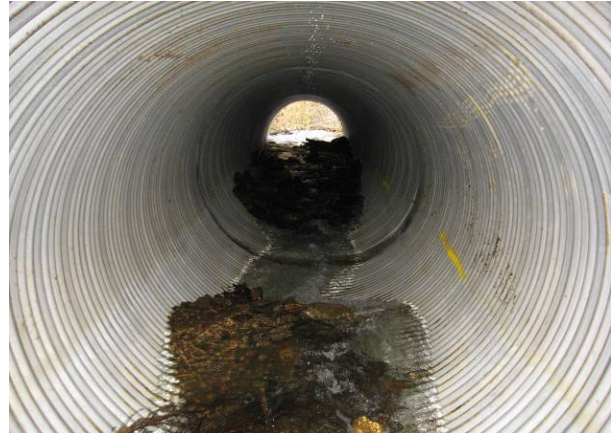
View downstream in culvert.
