## Lower Eightmile Creek

### Site Information

## Culvert Scour Assessment

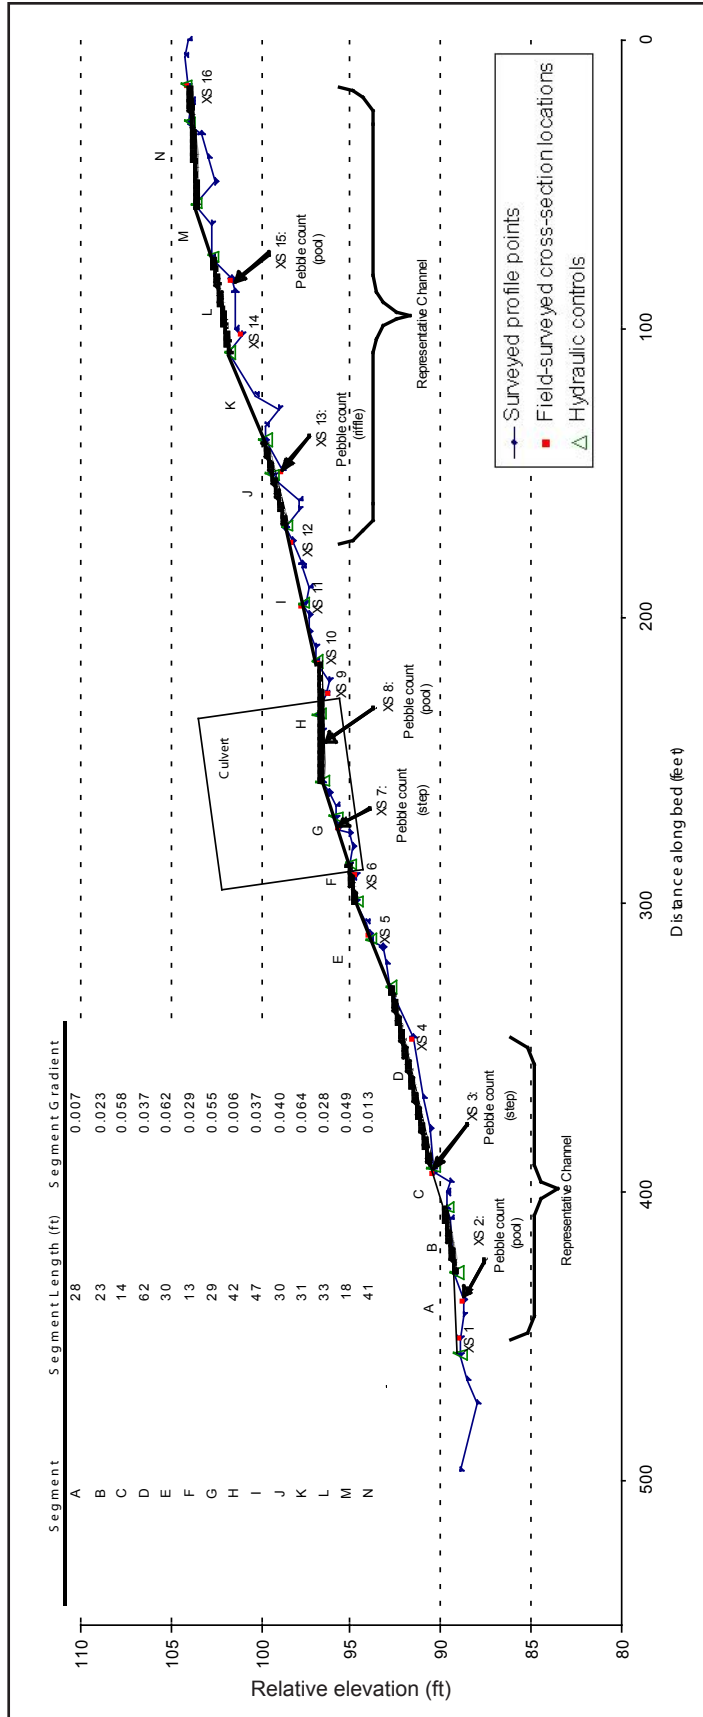
Figure 2—Lower Eightmile Creek longitudinal profile.

*Profile characteristics* – The profile has a convex shape through the crossing with a rise in bed elevation within the culvert (figure 2).

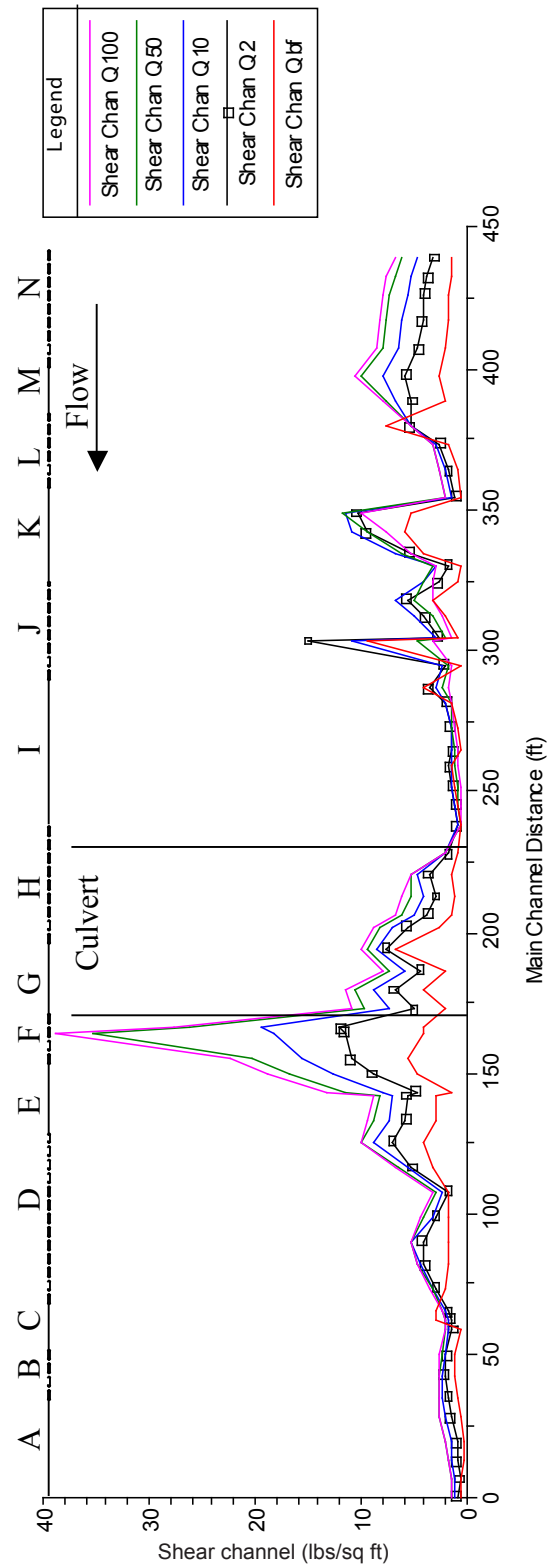
Figure 10—Shear stress (channel) profile.

*Shear stress* – Shear stress is low at the inlet because of backwater effects but increases towards the downstream end of the culvert and is very high at the outlet area (figure 10). The downstream transition area (F) exhibits the greatest shear stress (figures 10 and 19). The upstream transition (I) has low shear stress because of the effect of culvert backwater on the energy grade slope.

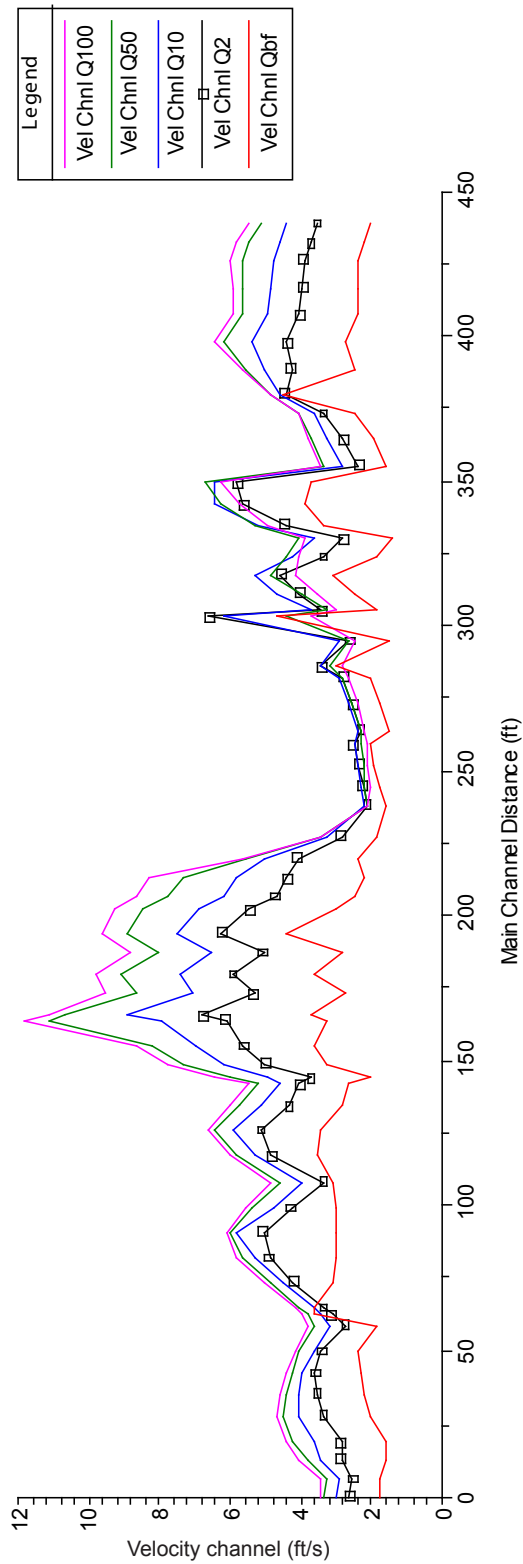
Figure 11—Velocity (channel) profile plot.

*Velocity* – Velocity is low at the inlet because of backwater effects but increases towards the downstream end of the culvert and is very high at the outlet area (figure 11). The downstream transition area (F) exhibits the greatest velocity (figures 11 and 18). The upstream transition (I) has low velocity because of the effect of culvert backwater on the energy grade slope.

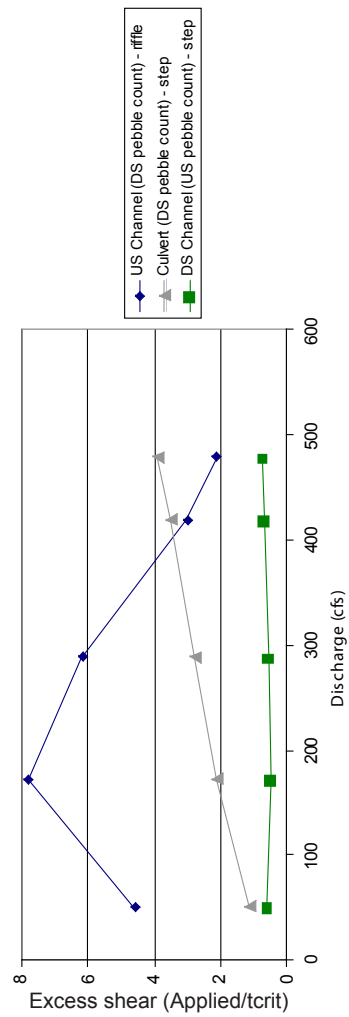
Figure 20—Excess shear stress.

*Excess shear* – Model results show that the culvert excess shear stress is within the range of channel conditions (figure 20) except at high flows ( $Q_{50}$  and above) where culvert bed mobility may exceed that of the natural channel.

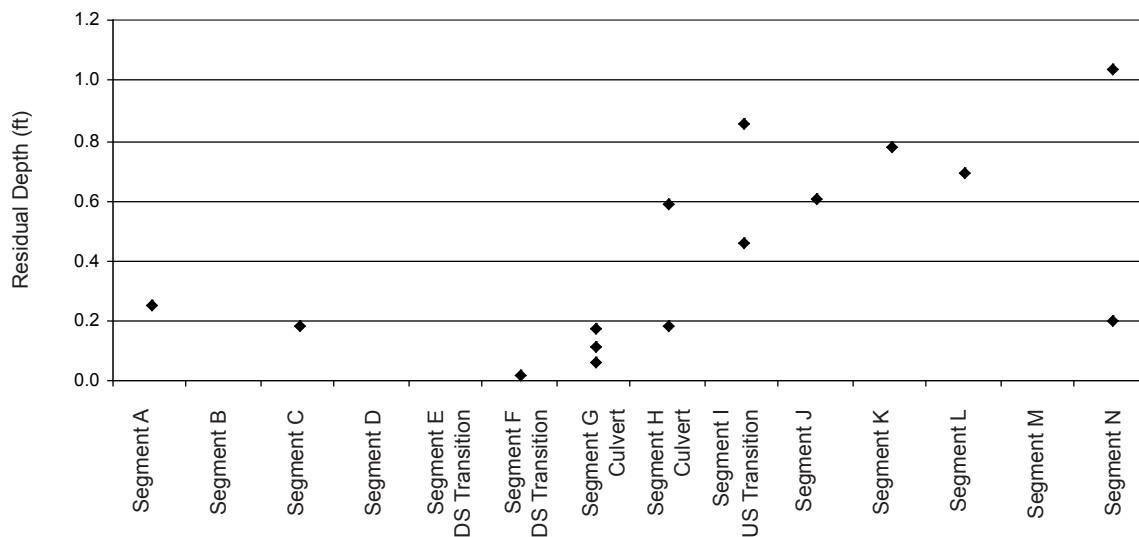
Figure 21—Residual depths.

*Residual depths* – Culvert residual depths are lower than residual depths in corresponding channel segments (C, J, and A) (figure 21). The upstream transition segment (I) has residual depths that are both greater and less than the range of residual depths in corresponding profile segments (D, J, and L). The single residual depth in downstream transition segment F is lower than the single depth in corresponding profile segment L.

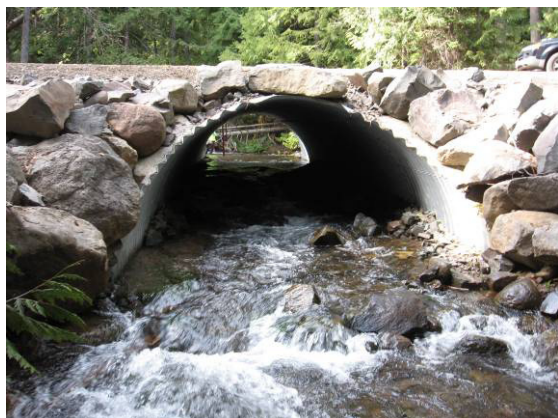
*Culvert-bed adjustment* – There are no obvious signs of bed adjustment except for some recently aggraded sediment in the upstream half of the culvert. There is angular rock forming a step in the downstream portion of the culvert; it is unknown whether this was placed during construction or if it washed in from the riprap banks at the inlet.

Currently there are no significant signs of scour in the pipe. The rise in bed elevation in the culvert appears to be related to the step that makes up the downstream half of the pipe. This step is composed of angular large cobbles and small boulders and may be riprap material washed into the culvert from the banks at the inlet. There is streambed material (rounded alluvium) that has aggraded upstream of this step. The grade control provided by the step, and the associated aggradation in the upstream half of the pipe, may be limiting culvert capacity and creating scour risk during high flows.

View upstream through culvert.

Hydraulic analysis and observations at other sample sites suggest that this site may experience bed adjustment during future high flows. The culvert appears to have insufficient capacity to adequately convey high flows. Contributing factors may include an inadequate culvert size and the presence of aggraded material within the pipe. Design improvements would include a larger culvert (current culvert is less than 75 percent of the bankfull width) and a properly constructed bed that creates a more uniform profile through the crossing. Constructed bed elements could include banks that provide flow concentration and roughness (velocity refuge) for fish passage and that also would provide exposed banks to facilitate passage of terrestrial organisms.

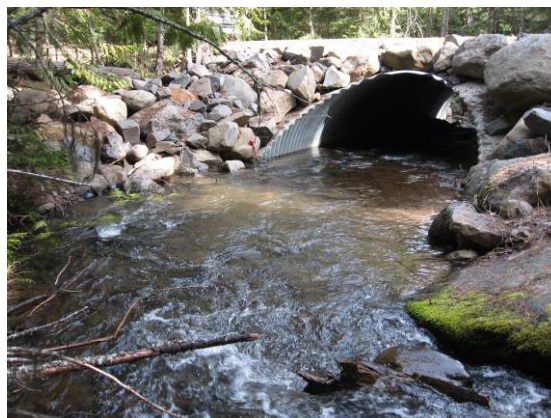
Flow in the culvert was wall-to-wall throughout much of its length at the time of the survey. At low summer flows, wide shallow flow may create fish passage issues. At higher flows, the high velocity in the downstream portion of the pipe may also impede passage, especially considering the lack of bank roughness that can provide velocity refuge.

View downstream through culvert.
