## Case Study 10. Black Canyon Concrete Plank Ford

### Crossing Description

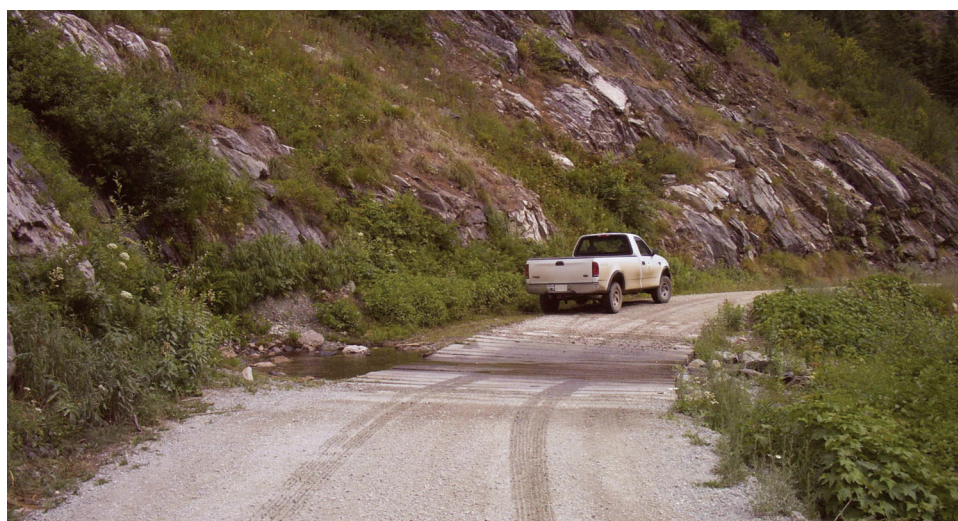
Figure A60. Ford is located on a valley bottom road at the base of an avalanche chute.

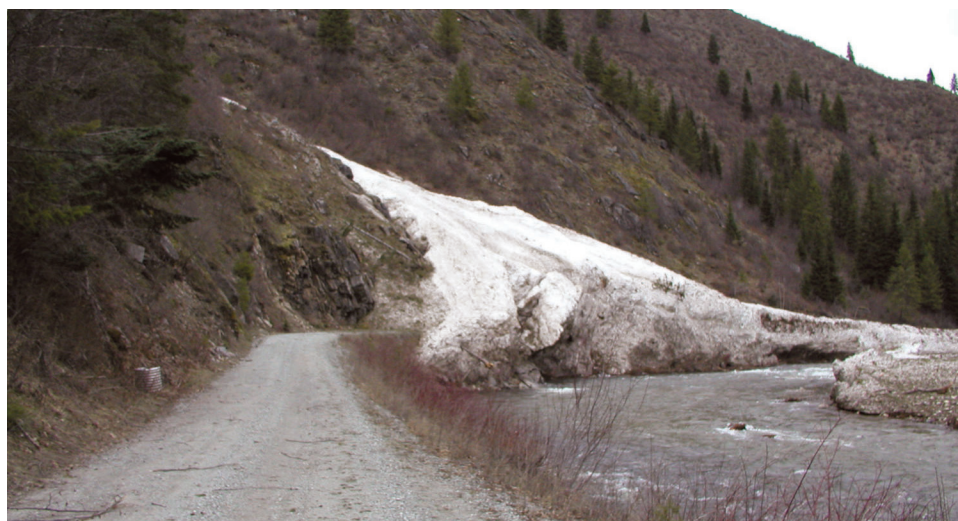
**Hydrology:** The North Fork Clearwater River is a steep perennial river. The side drainages experience massive snow slides most years (figure A61). Summer low flows on the side drainages are generally about 1 to 2 feet wide and a few inches deep.

Figure A61. Spring snow slide on top of ford, April 2003.

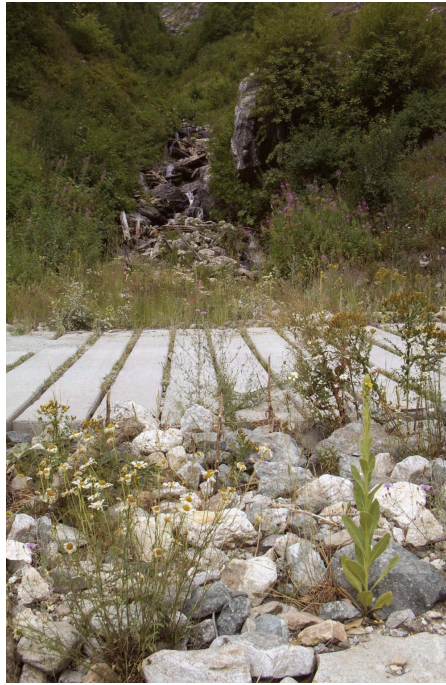
**Channel Description:** The ford is located on a steep tributary channel, a Rosgen A1a+ in a bedrock avalanche chute (figure A62). Drainage area is approximately 320 acres, and near the bottom of the slope the channel is approximately 6 feet wide. Banks are not well vegetated or particularly stable.

Figure A62. Looking upstream across the ford to the channel. The culvert is to the right out of the frame.

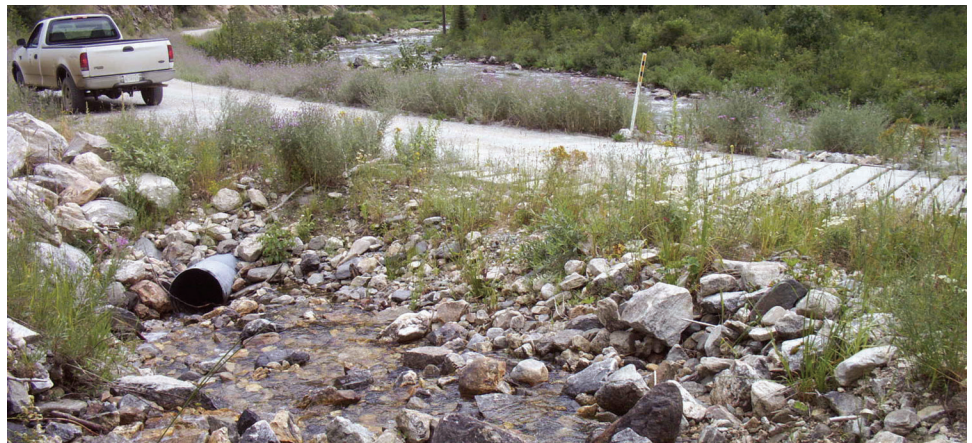
Figure A63. Looking downstream toward the North Fork Clearwater River. Note the sediment catch basin in foreground.
