## Case Study 13. North Fork Consumnes River Tributaries Box Culvert Vented Fords

Central California. Eldorado National Forest, Placerville Ranger District. About 18 miles ESE of Placerville. North Fork Consumnes River basin. Meiss Cabin Road, Forest Road 52 upstream of Capps Crossing.

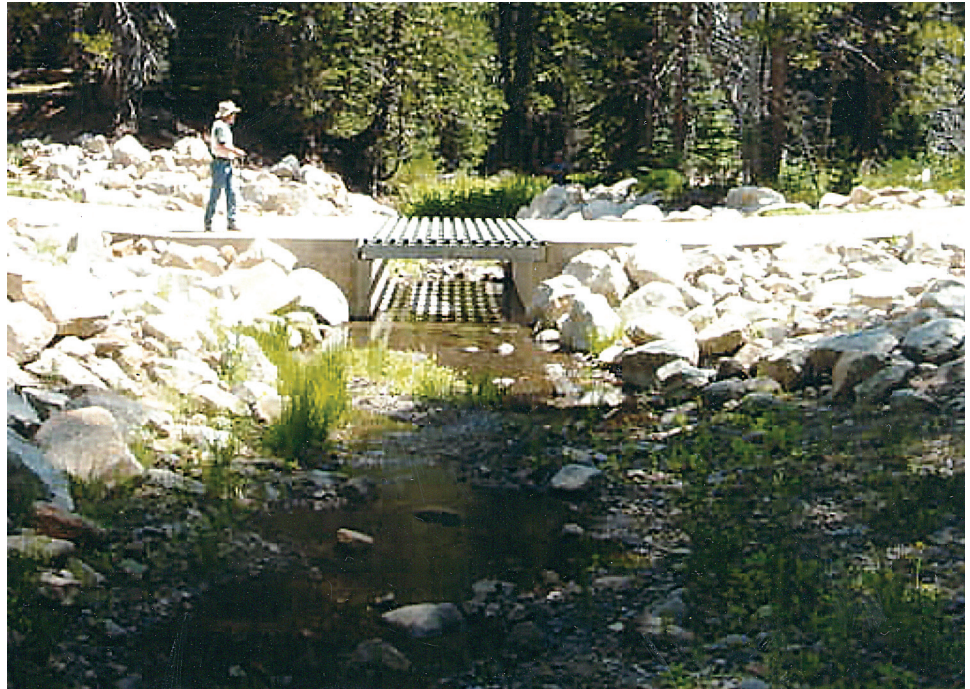
Figure A80. One of several grating-top box culvert fords on tributaries of the North Fork Consumnes River.

All the vented fords functioned well during the large flood in January 2006, an estimated 85-year flow. They were overtopped, but not blocked or damaged, and flow was not diverted away from the stream channels. For durability and ease of maintenance, these structures appear to be very appropriate in these difficult depositional settings.

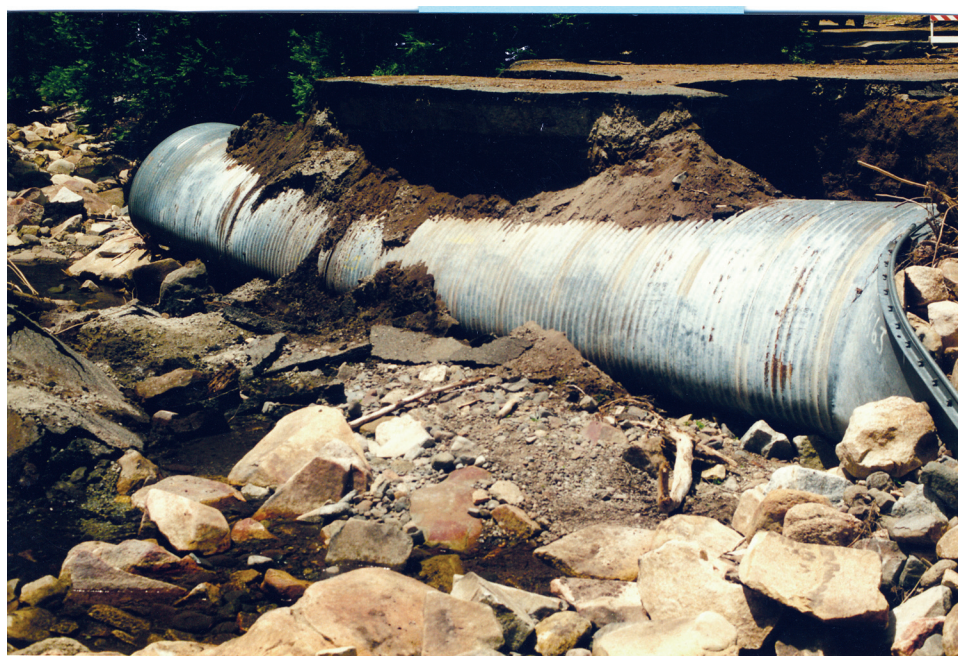
Previous structures at these sites were culverts, which had plugged and been replaced by progressively larger culverts over a period of years. All of the tributary crossings failed in the January 1997 storm event (figure A81). At one crossing, a Hilfiker welded wire headwall was so battered by boulders that it had to be removed. Refer to case study 21 for a review of watershed history and condition that explains why these tributaries are transporting so much rock and sediment.

Figure A81. Typical flood damage at edge of North Fork Consumnes River valley after 1997 rain-on-snow flood.

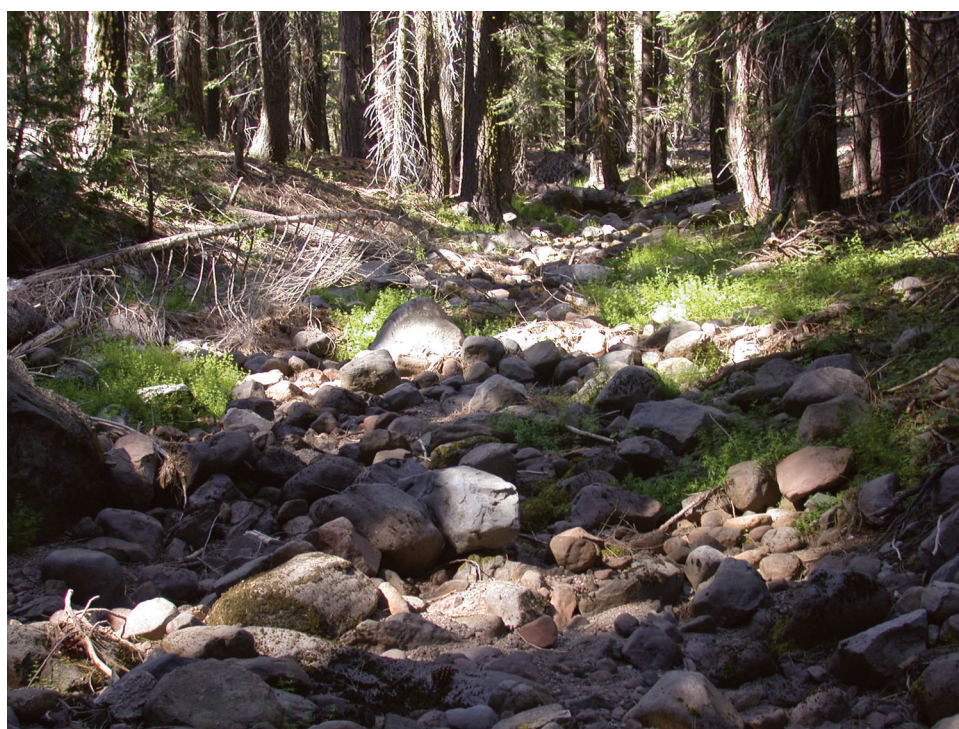
**Channel Description:** In gold rush days, roads ran right up the channels to get to mining or timber harvest areas. Coarse sediment is in ample supply in the streambeds (figure A82). These tributaries may naturally be B3 channels, but they are so disturbed in the vicinity of the crossings that they are difficult to classify. Channel slopes are at least 3 percent. Valleys are narrow and the streams are moderately entrenched.

Figure A82. Aggraded boulder-bed intermittent tributary of the North Fork Consumnes River, July 2002.

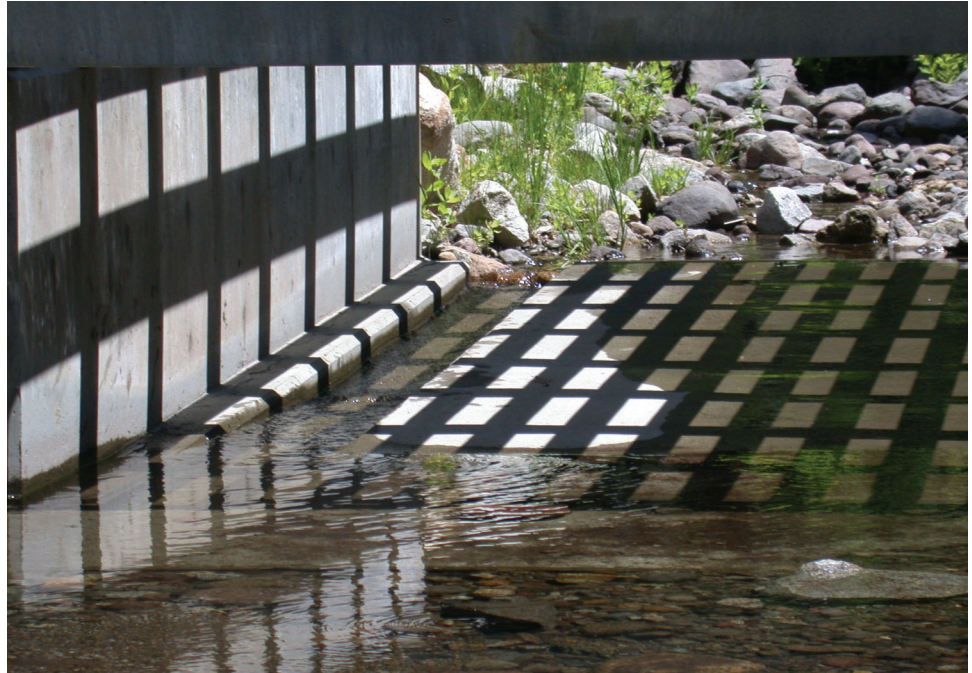
flow. Three-inch fish downstream of one culvert in July 2002 were unable to swim past the backwatered section (figure A83). There may be flows where some fish can move upstream. The structures are no more than 12 feet long, so larger fish may be able to negotiate them at higher flows.

Fish were attempting to move upstream in July 2002, but flow in the trench was too shallow and too fast.

Where fish passage is required, a similar grate-top box with an open bottom and natural streambed would better fit the need.
