## Case Study 17. Stony River Treated Timber Box Culverts

Northern Minnesota. Superior National Forest, Isabella Ranger District. Stony River, south of Boundary Waters Wilderness Area. 8 miles west of Isabella, adjacent to State Highway 1, approximately ½ mile from McDougal Lakes. Forest Road 933.

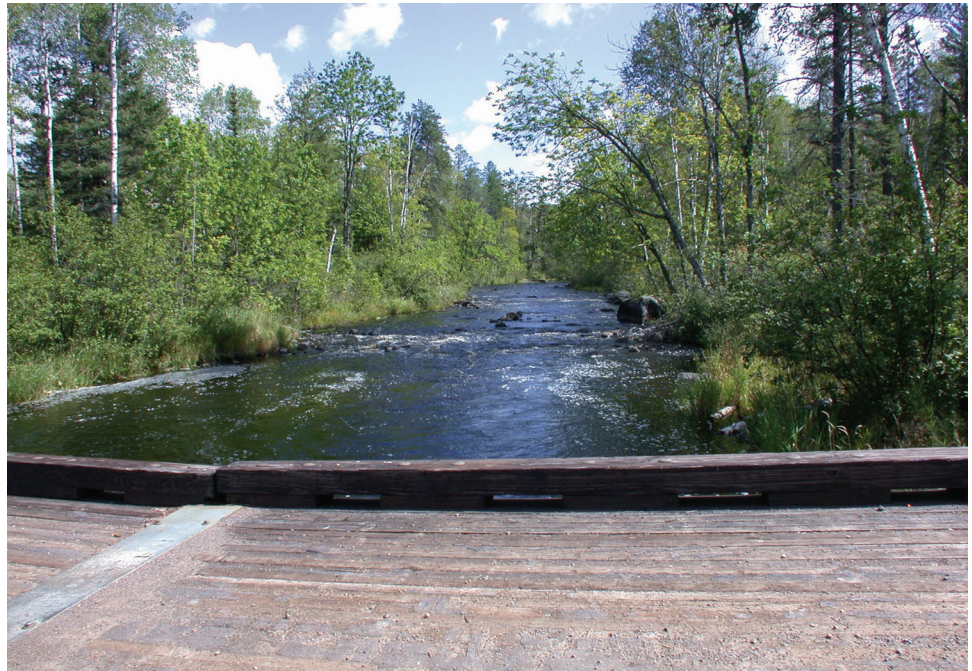
**Channel Description:** Stony River is a low sinuosity pool-riffle channel (a B2c or C2 stream type) about 50 feet wide. Boulder riffles provide streambed structure, and pools are quite shallow. Slope near the site is approximately 1.25 percent. Boulders vary from large to small, with a predominance of small to medium sizes. The adjacent riparian area has some tree cover, with dense shrub and sedge vegetation, and the potential for large woody debris recruitment to the channel is low to moderate. Boulders, wood, and vegetation provide good bank stability. The channel is moderately entrenched to unentrenched at the site, with a 5-foot terrace on one bank, and a narrow flood plain on the other (figure A113).

Figure A113. Stony River looking upstream from the ford.
