## Case Study 19. Mill Creek Embedded Box Culvert Vented Ford

Southeast Missouri. Mark Twain National Forest; Houston-Rolla Ranger District. Southeast of Rolla, south of Interstate 44, off of State Road P: Forest Road 1576. Mill Creek, tributary of Little Piney Cr, Gasconade River basin.

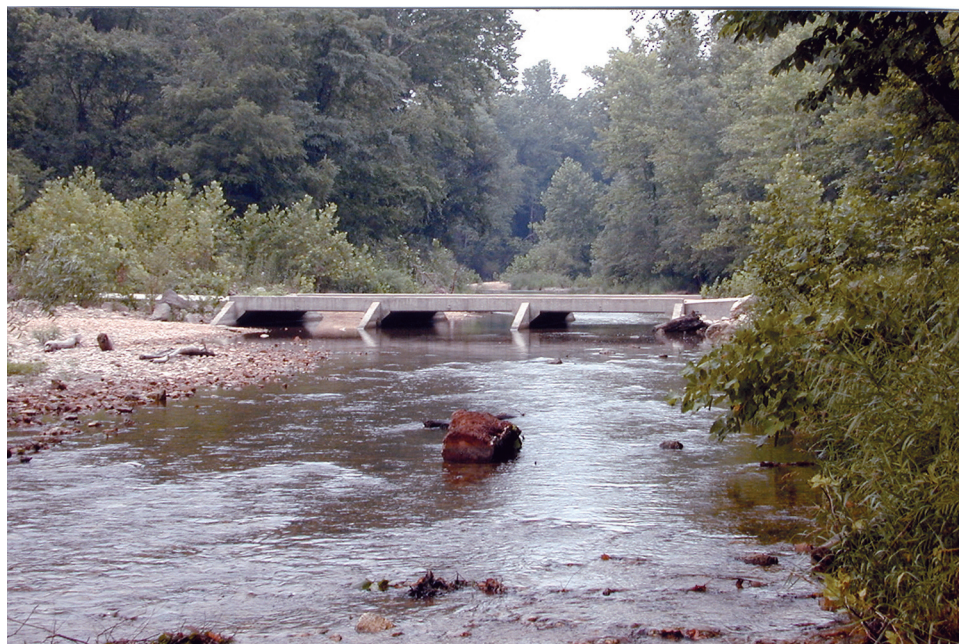
Figure A121. Looking upstream at Mill Creek box culvert vented ford, 2002.

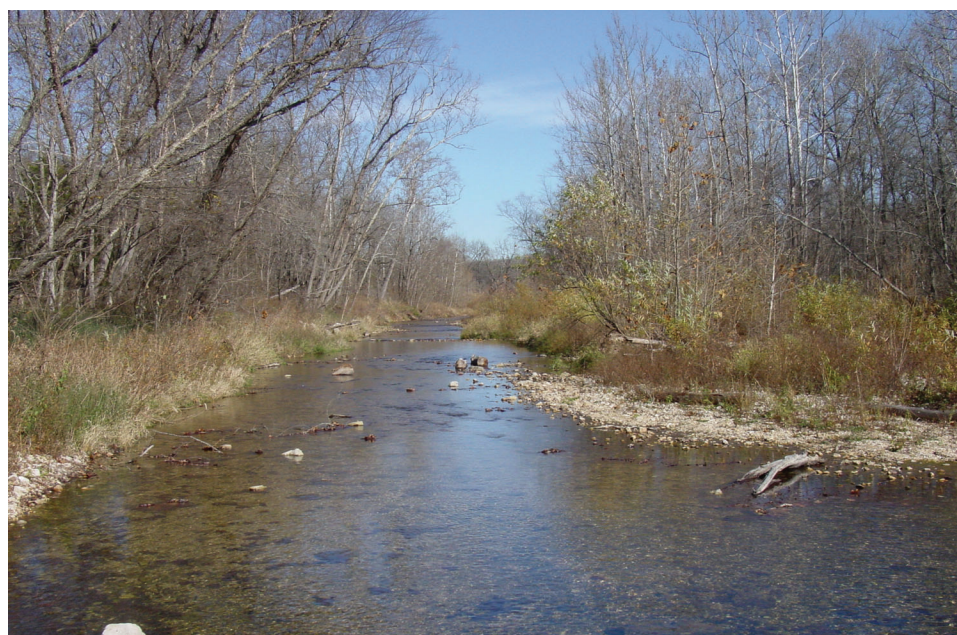
Figure A123. Looking downstream on Mill Creek from the box culvert ford.

**Channel Description:** This reach of Mill Creek is a pool/riffle, gravel bed stream with an estimated gradient of 2 percent. It is about 40 feet wide away from the widened section at the crossing, and banks are 2 to 3 feet high (figure A123). The well-vegetated flood plain is about 3 feet below the wooded terrace that forms the broader valley floor. The channel appears to be vertically stable, but has at least moderate potential to migrate laterally. The crossing is on a slight bend, and crosses a gravel bar on the right bank (bar is on left side of figure A121). Historical land use in this area of the Ozarks, especially riparian grazing and stream channelization, affected streams by removing riparian vegetation and inducing bank erosion. This mobilized large volumes of gravel, and streams responded by widening and shallowing (Jacobson and Primm, 1997). Bank erosion is prevalent on some reaches of Mill Creek.

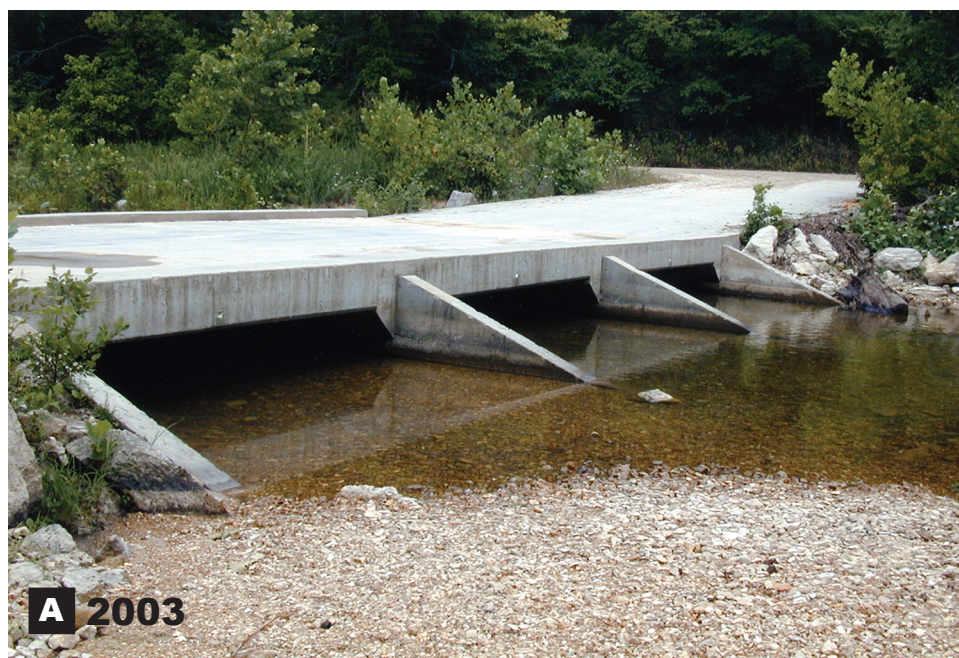
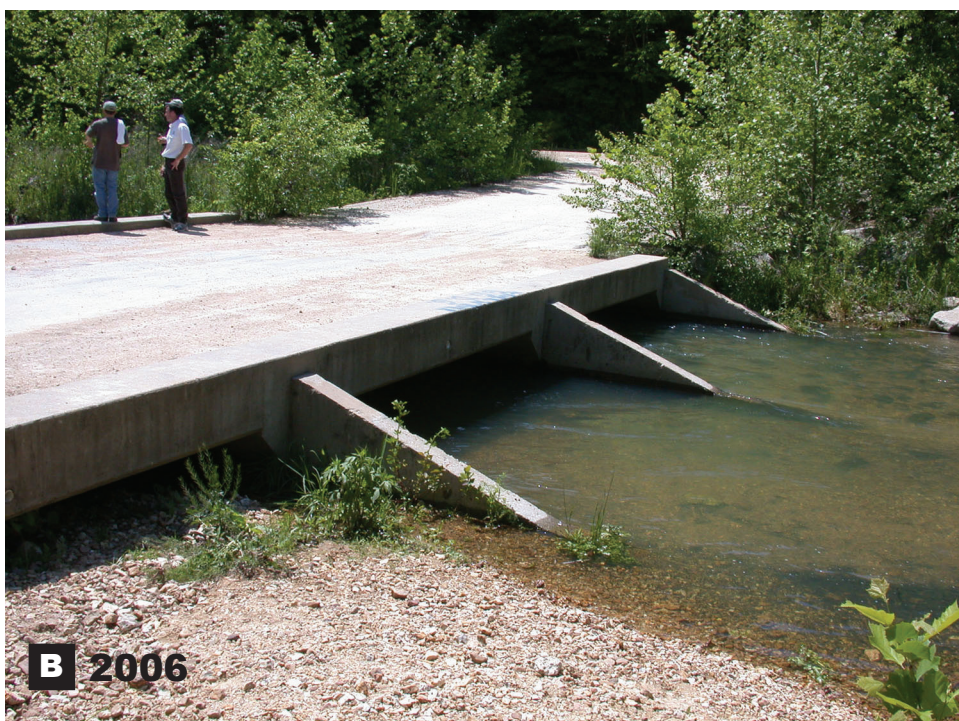
**Structure:** This current structure has three boxes, with sloping wings designed to sweep debris up and over the deck. Open area under the deck approaches bankfull cross section area, but is being reduced by gravel accumulation on the right bank (foreground, figure A124). The interior openings of the boxes are 14 feet wide and 5 feet high, and they are embedded 1 foot into the streambed so that the natural streambed is continuous throughout. The design is a standard Missouri Department of Transportation design that is available on the Internet. See Concrete Triple Box Structure drawing 703.81F for sample plans ([http://www.modot.org/business/standards\\_and\\_specs/currentsec700.htm](http://www.modot.org/business/standards_and_specs/currentsec700.htm)).

because gravel loading is so high in the stream. Some riprap is used to stabilize the banks immediately adjacent to the structure (figure A124a).

Figures A124a and A124b. Downstream side of the box culvert crossing. Between 2003 and 2006, gravel bar enlarged to block one box.

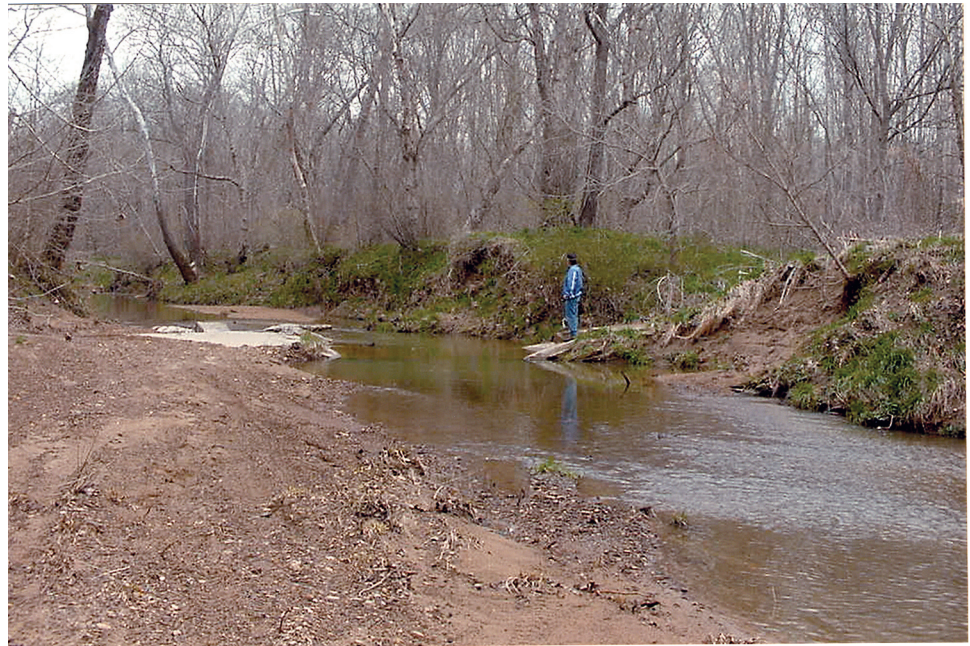
The previous crossing structure was a concrete slab ford (figure A125). Silty sediment and woody debris routinely accumulated on it during high water, frequently making it impassable. The slab collapsed when the stream undercut it on one side. The soil at the site has difficult engineering properties. It is a poorly-drained silt loam characterized by a seasonally high water table, frequent winter flooding, and stream bank erosion. Severe erosion of the 4-foot to 5-foot high banks around the ford is apparent in figure A125.

Figure A125. Looking upstream at failed Kinkaid Creek crossing, 2000. Stream slope is 0.3 percent.

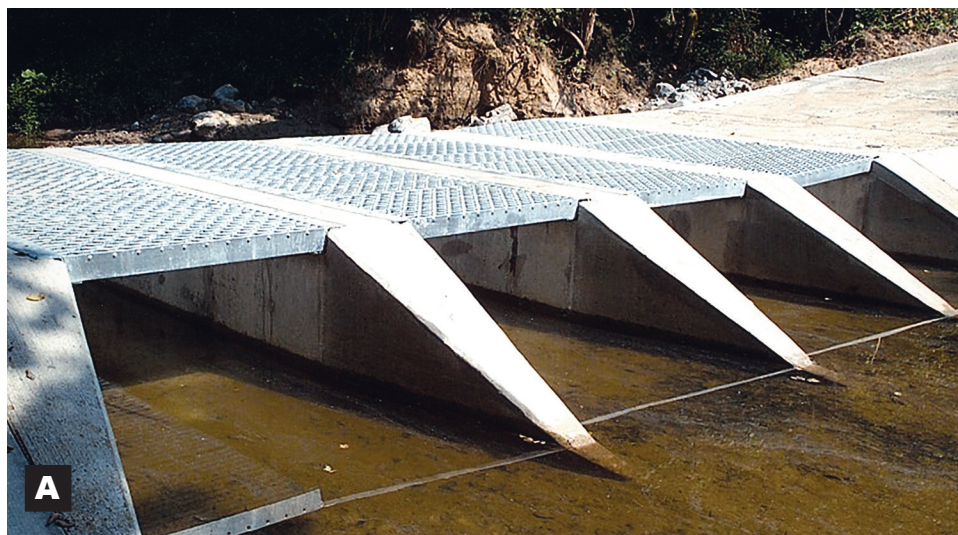
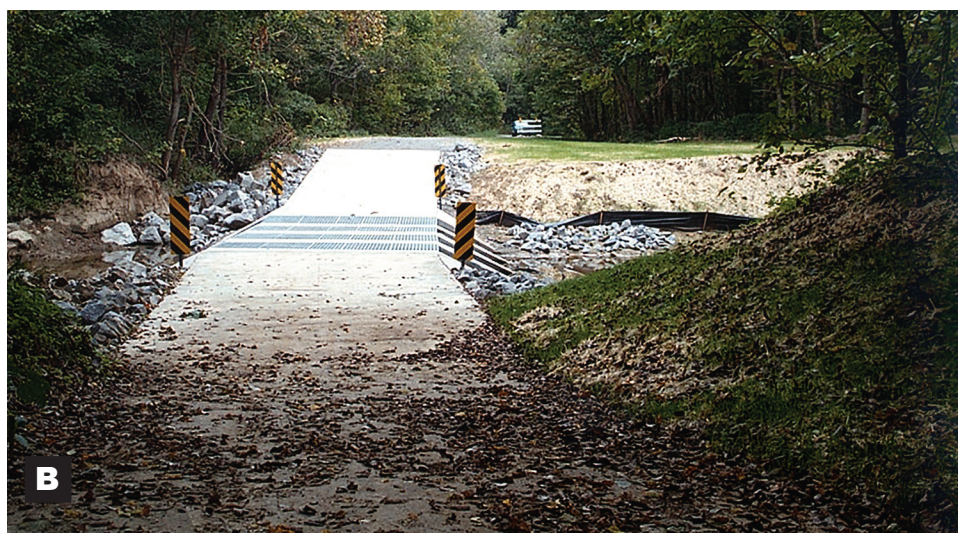
Figures A126a and A126b. Kinkaid crossing just after construction in 2001. A126a. Close up of embedded boxes; A126b. View along vented ford showing riprap.

The 3-foot-high boxes are embedded about 1 foot into the streambed for fish passage (figure A126a). The boxes were allowed to fill naturally with streambed material, and in this case the streambed was mobile enough (medium to coarse gravel) and the sediment supply high enough that no headcut resulted. The streambed in the boxes has maintained itself successfully through two approximately normal rainfall years.

The new structure was designed to pass the mean annual flow underneath the deck at a depth of 6 to 8 inches, and it is submerged at frequent high flows (3 to 4 times per year). Approach slopes are steep at 10 to 12 percent but at a site where the natural banks are nearly vertical, the structure had to be somewhat wider than the channel. Riprap provides erosion protection upstream and downstream of the cutoff walls (figure A126b). The structure cost \$23,000 to install in 2003.
