## Case Study 20. Deep Creek Low-Water Bridge

North Central Florida. Osceola National Forest. Road 237-1 at Deep Creek, 1/4 mile north of Forest Road 262-2 and about 11 miles NE of Lake City, Florida.

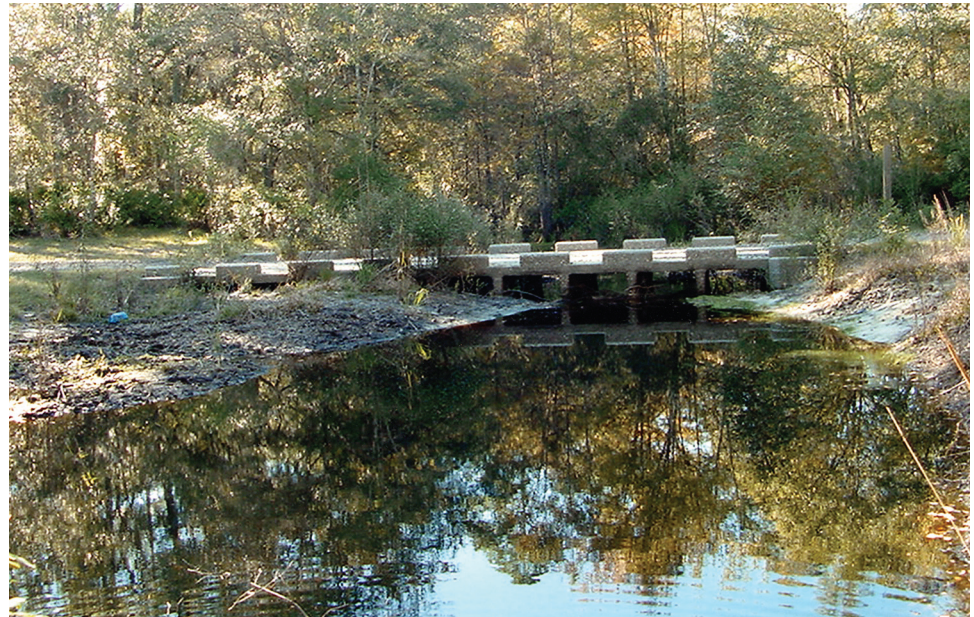
Figure A128. Looking downstream at the low-water bridge, November 2003.

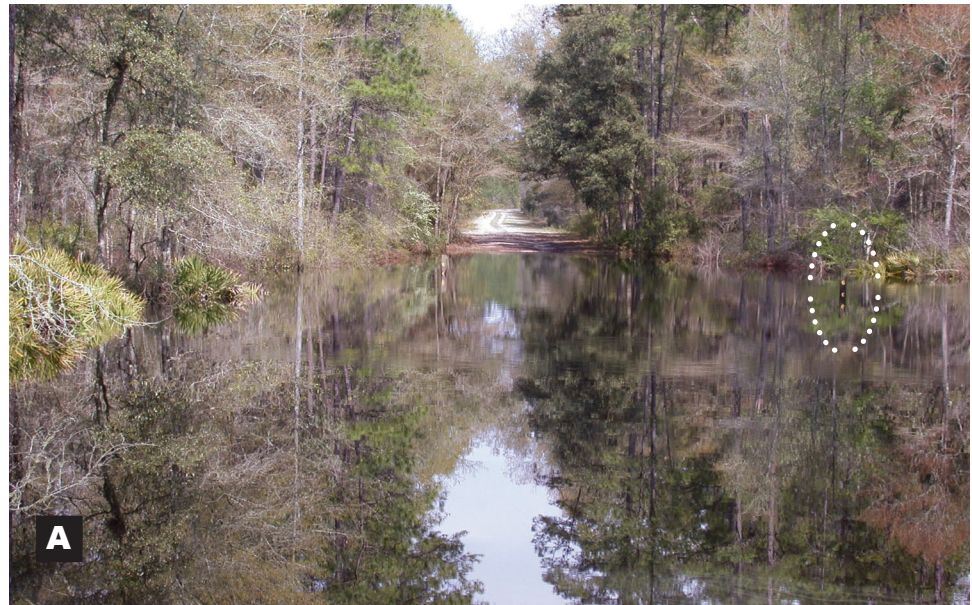
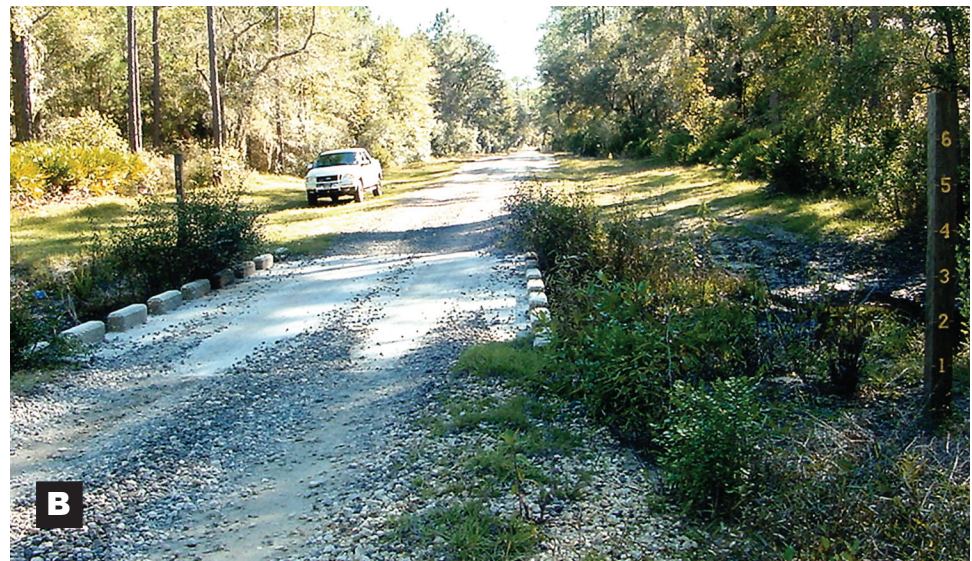
to utilize the entire width of the flood plain and to flow freely down the valley. The stream is about 10 feet wide where it flows through undisturbed forest, with nearly vertical 2-foot-high banks stabilized by an intertwined mass of roots. At the crossing site, the stream is about 40 feet wide, and the bridge matches this width. Soils in the area, including the streambed and banks, are mixed sand and clay. Because of long periods of very low surface flows, vegetation overgrows much of the streambed and tends to stabilize sediment deposits. During overbank flow in March 2003, water velocity in the thread of fastest flow was estimated at between 1 and 2 feet per second (figure A129).

Figures A129a and A129b. A129a. March 13, 2003. Bridge is under approximately 6 feet of water. Note depth marker on right. A129b. Looking opposite direction along bridge, November 2003.

**Safety:** On each edge of the bridge large, bright-yellow numbers painted on 7-foot-high wood posts indicate water depth over the structure (figure A129). Flooding and fords are both common in the very low relief Flatwoods area, and residents are used to submerged roads, so no other warning signs are considered necessary here. Discontinuous curbs also provide security.

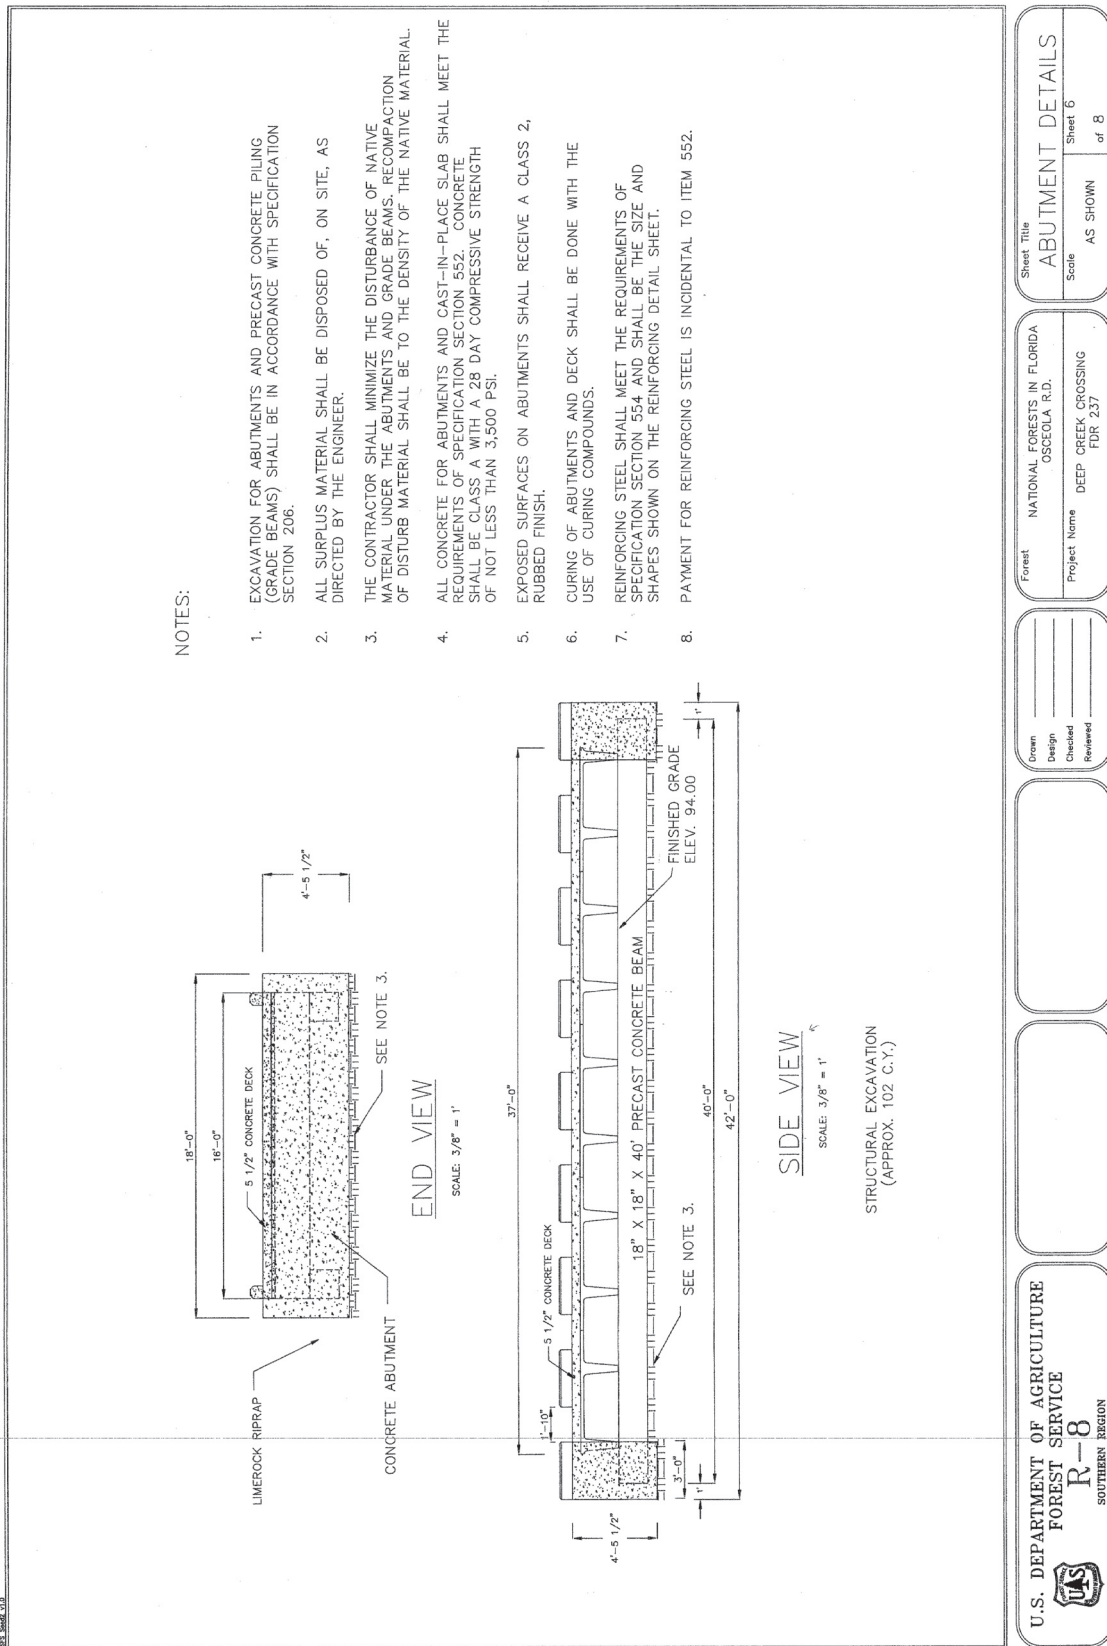
**Structure:** Two 18- by 18- by 40-inch prestressed concrete beams were set across the channel with the top of the beam at channel bed elevation (figure A130a). Eight-foot wide by 2-foot high by 18-foot long double-T sections, precast to HS 20-44 bridge specifications, were placed parallel to streamflow on the concrete beams. Normally in this kind of construction, the foundations are placed on the streambanks supporting the T-sections which span the channel. Here, the supports cross the channel and the T-sections are parallel to the direction of flow. Three-foot deep by 4½-foot high abutments on each end hold the structure in place. A concrete deck 5½-inches thick, and curbs create a safe running surface on the T-sections.

Figure A130a—1990 contract drawing, side view. A full size drawing may be found on the CD included in the back of this publication.

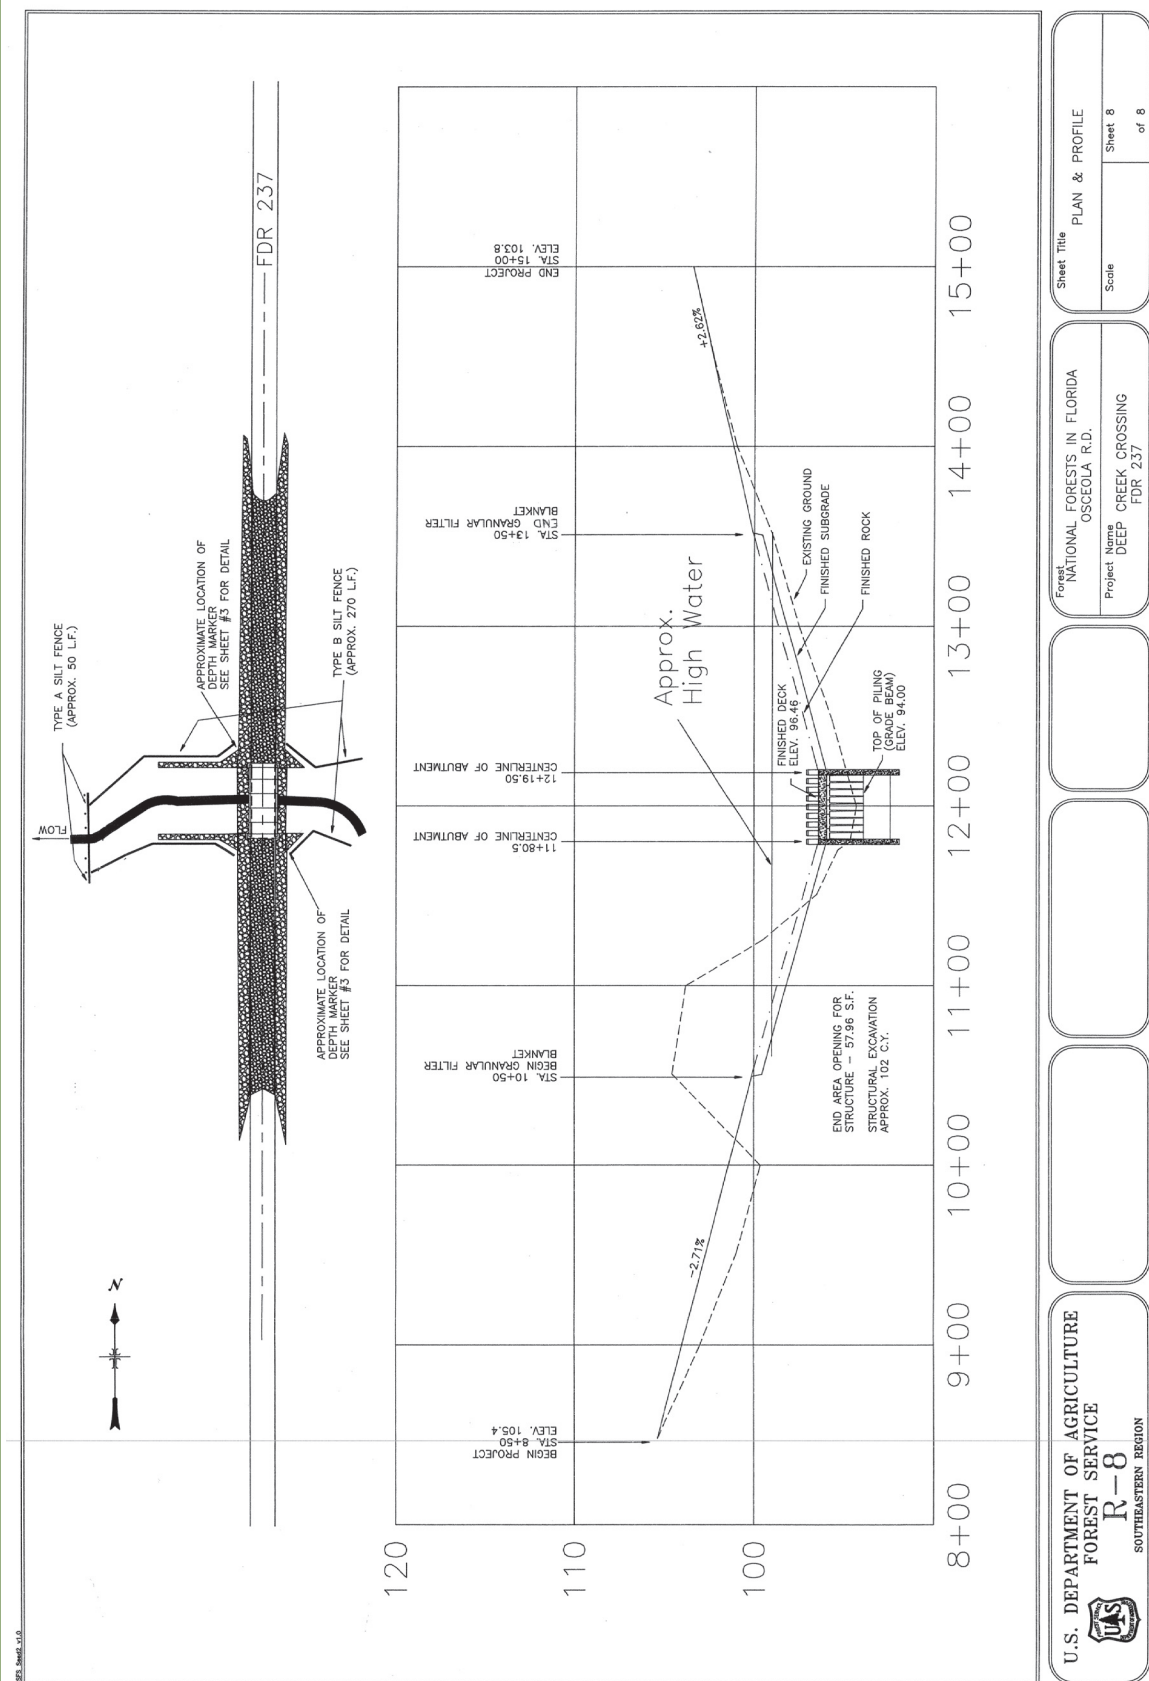
**Bank stabilization and approaches:** The approach road is crowned and slopes at about 2.6 percent into the crossing (figure A130b). A 1-foot thick layer of class II riprap over geotextile fabric extends 130 feet on each side, armoring the excavated slopes, road shoulders, and downstream banks from erosion. A riprap blanket 1½-foot thick was also placed between the bearing beams, as well as 4 feet upstream and 6 feet downstream from the foundations (figure A130c).

Figure A130b—1990 contract drawing, plan and profile. A full size drawing may be found on the CD included in the back of this publication.

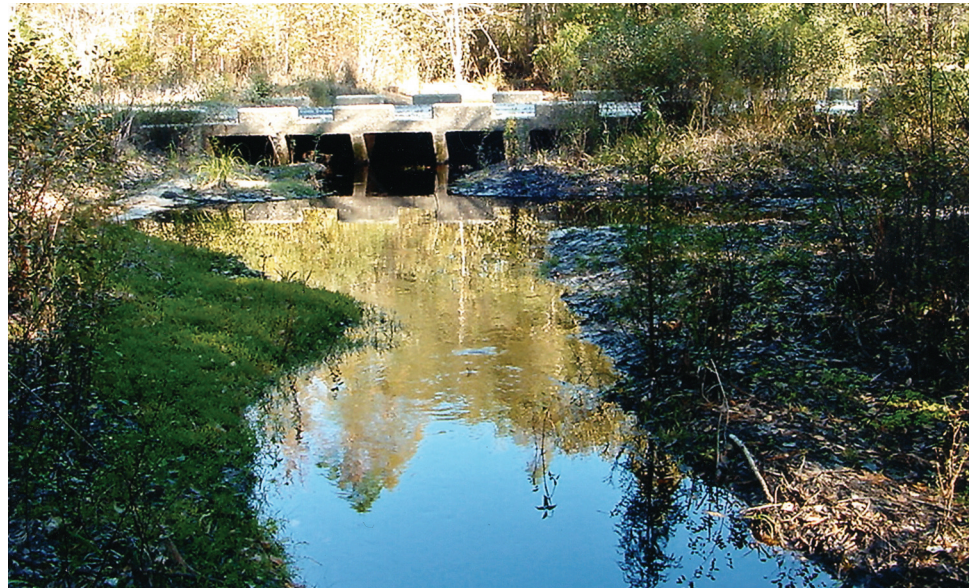
Figure A131. Sand and silt deposit downstream of the bridge (2003).

The current low-water bridge was constructed to match existing site channel dimensions. Site width was significantly wider than the natural channel due to the impacts of the previous bridge and subsequent all-terrain vehicle crossing. Sediment deposition is occurring both upstream and downstream as the stream adjusts to regain its normal width (figures A128 and A131). Given the availability of alternative access, it may be acceptable to allow this process to progress until sediment transport

capacities are equalized with those in the adjacent channel. Channel narrowing can be expected to cause a few more days of traffic interruption per year.
