Case Study 3. Nurse Creek Rock Fill Ford**Location**

Southwest Oregon. Umpqua National Forest, Diamond Lake Ranger District, north of Toketee Ranger Station. Nurse Creek, tributary to the North Umpqua River.

Appendix A—Case Study 3

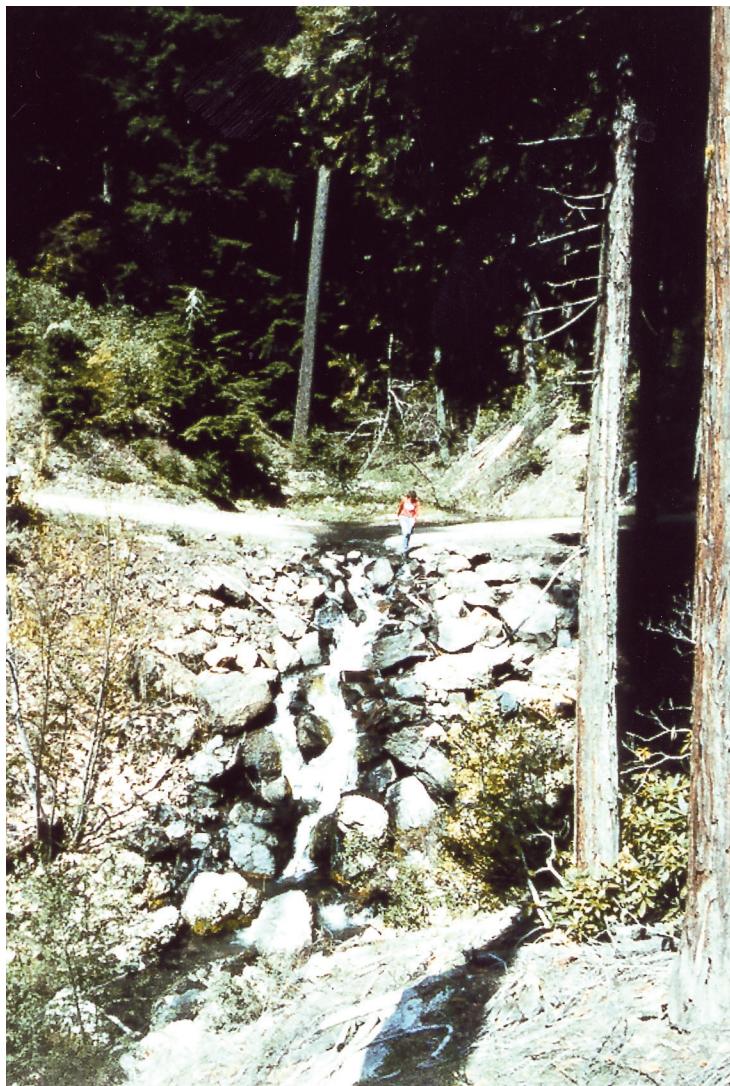
Figure A11. Nurse Creek rock fill ford in 1988

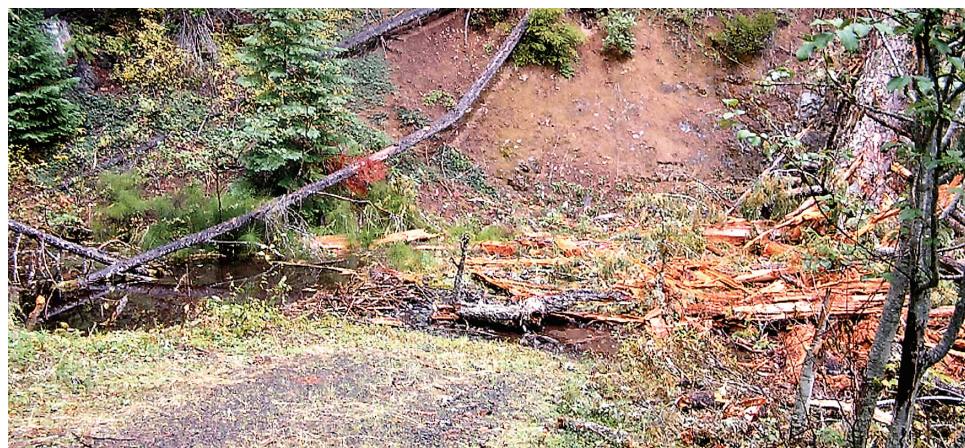
This structure went through large floods in 1996-97 with little or no damage. After more than 20 years and almost no maintenance, water still flows where it was designed to flow and vegetation has grown up all around the ford. Recently, a snag fell over the ford without damaging its function in any way (figure A12). A beaver has taken up residence in the pool at the inlet.

Figure A12. Snag fallen across the ford August 2004. Note beaver dam at upstream end of roadway.

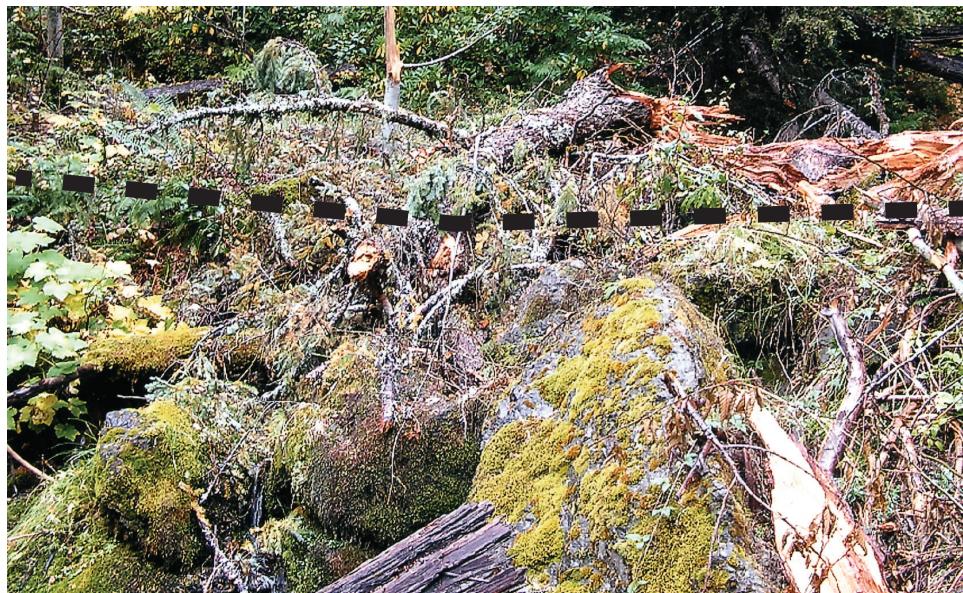
Figure A13. Stable, moss-covered rocks on the splash apron with pieces of fallen snag. Dashed line indicates approximate road surface.

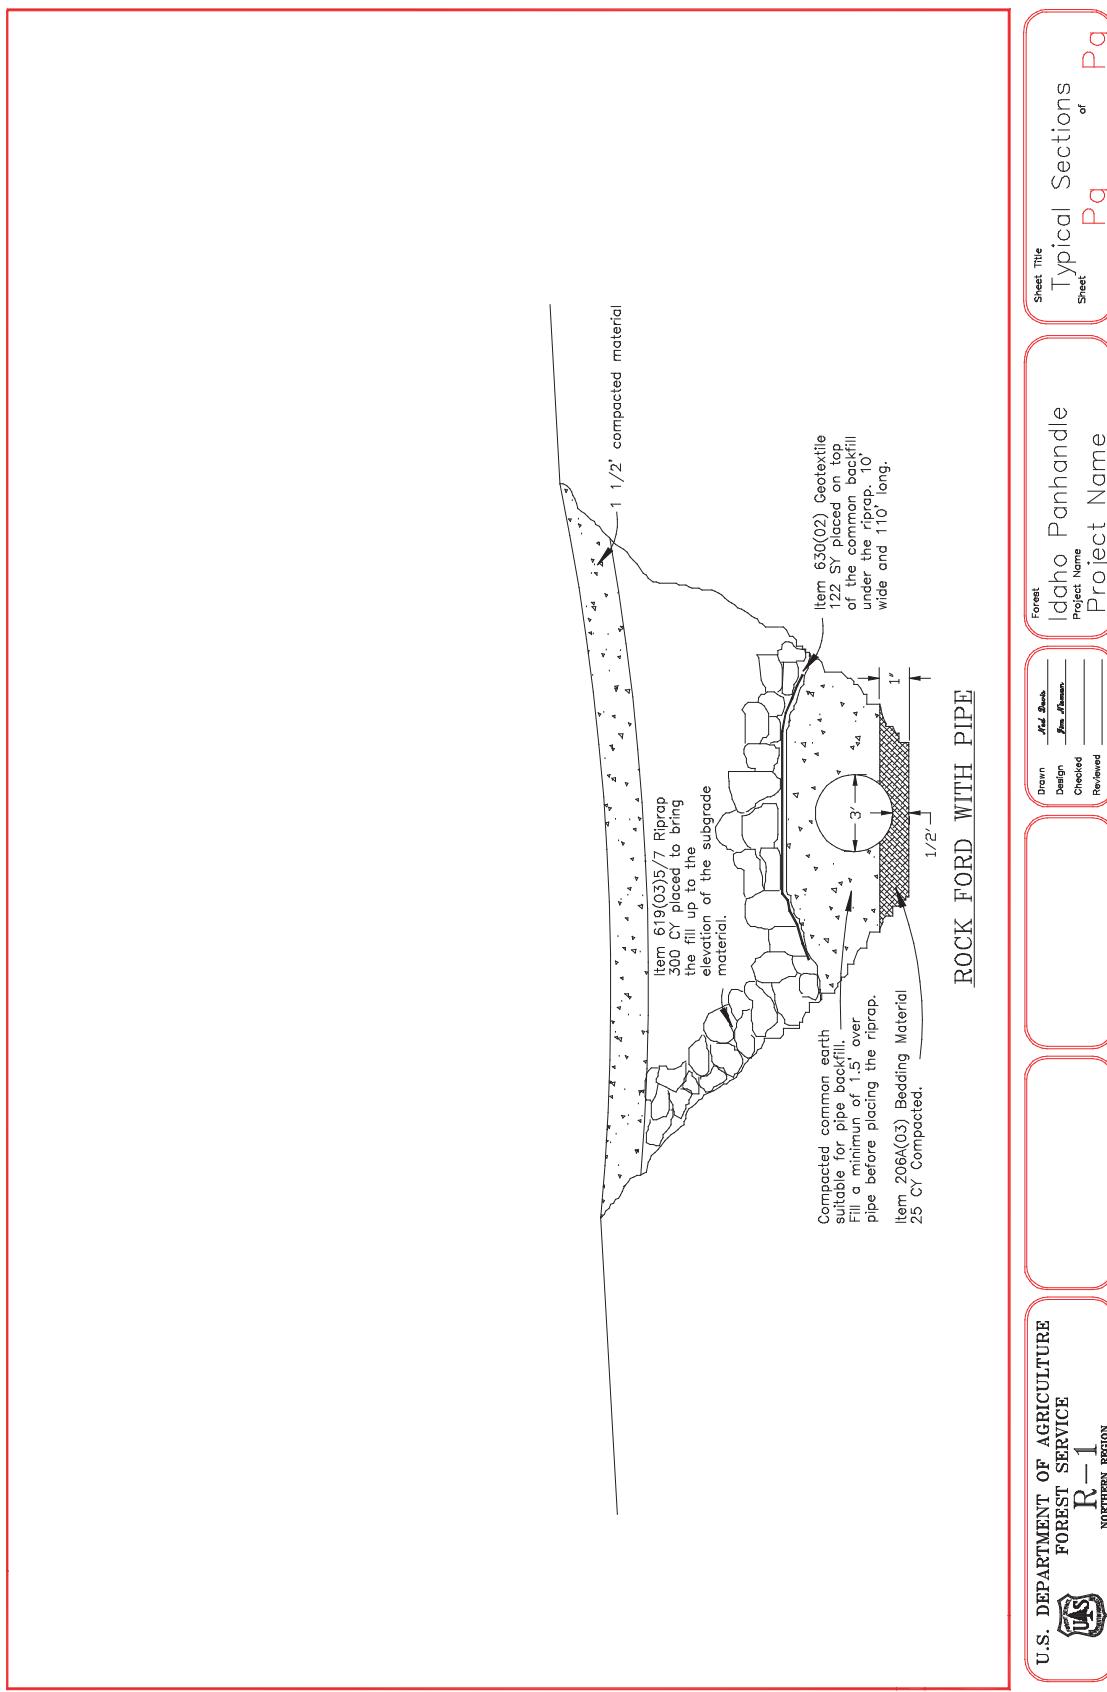
Figure A14 shows a similar rock structure built by the Idaho Panhandle National Forest in about 1996 to replace a culvert that washed out during a flood. The objective was to fortify the crossing to withstand culvert plugging and subsequent overflows. The fill is high and the structure is designed to withstand overflow (Jim Neiman, personal communication).

Figure A14. Rock ford with culvert, Idaho Panhandle National Forest.

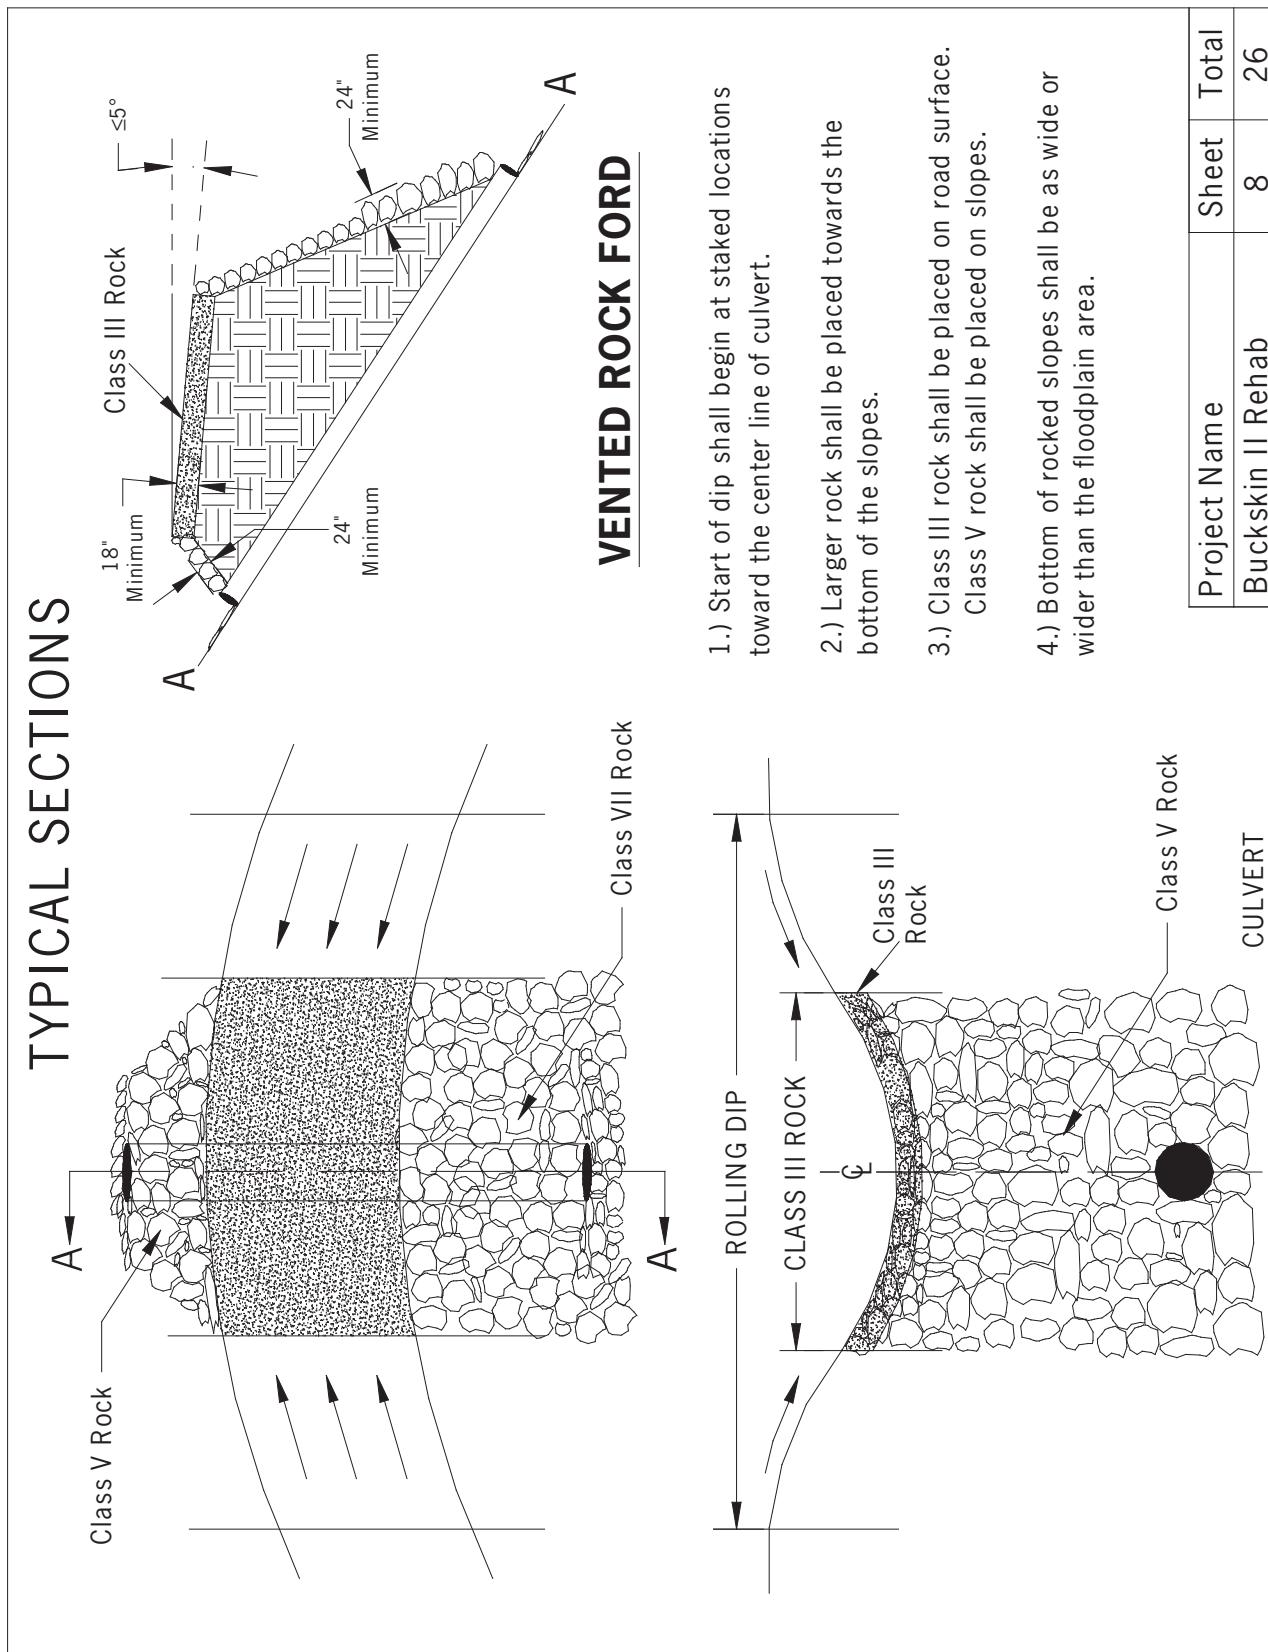
The Idaho Panhandle National Forest used a similar design to retrofit an undersized culvert that could not be replaced immediately (figure A15). Again, the goal was to prevent a catastrophic culvert failure during large floods that characteristically plug culverts with woody debris (Gary Harris, personal communication 2001). Plans called for removing fill to create a driveable dip over the culvert, and sizing the dip to contain the 100-year flow (assuming the culvert plugs). The roadway is outsloped over the dip, and up- and downstream fillslopes are riprapped with class V rock (maximum size 26 to 28 inches).

Figure A15. Vented rock ford, Idaho Pandhandle National Forest.
