Case Study 5. Willow Creek Concrete Plank Ford**Location**

Northeastern California. Plumas National Forest. Willow Creek. 5 miles northwest of Portola, CA, on Spur Road 23N97Y off Forest Road 24N12, (Smith Peak Lookout Road).

Crossing Description

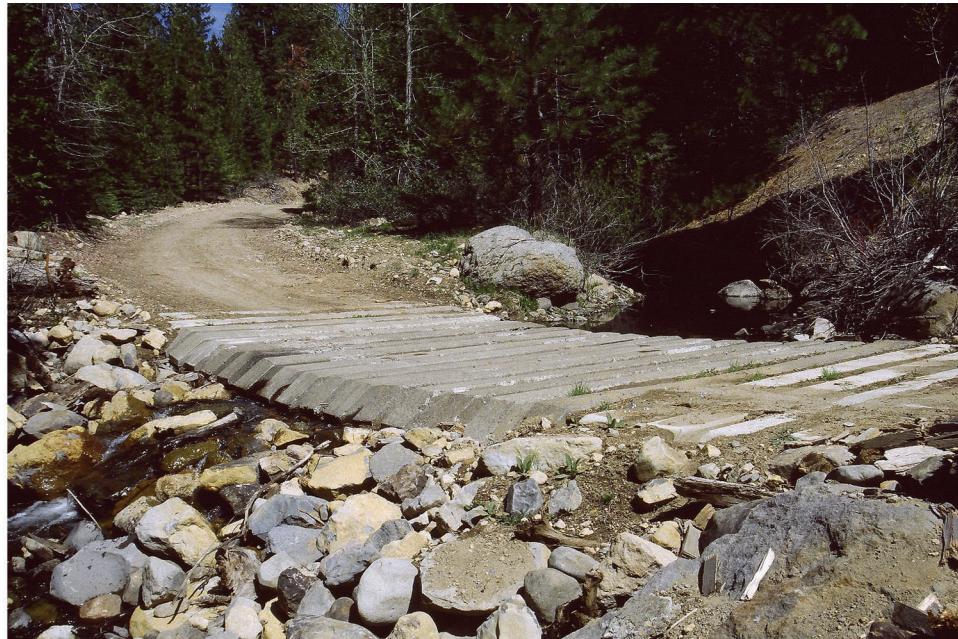
Figure A22. Willow Creek concrete plank ford.

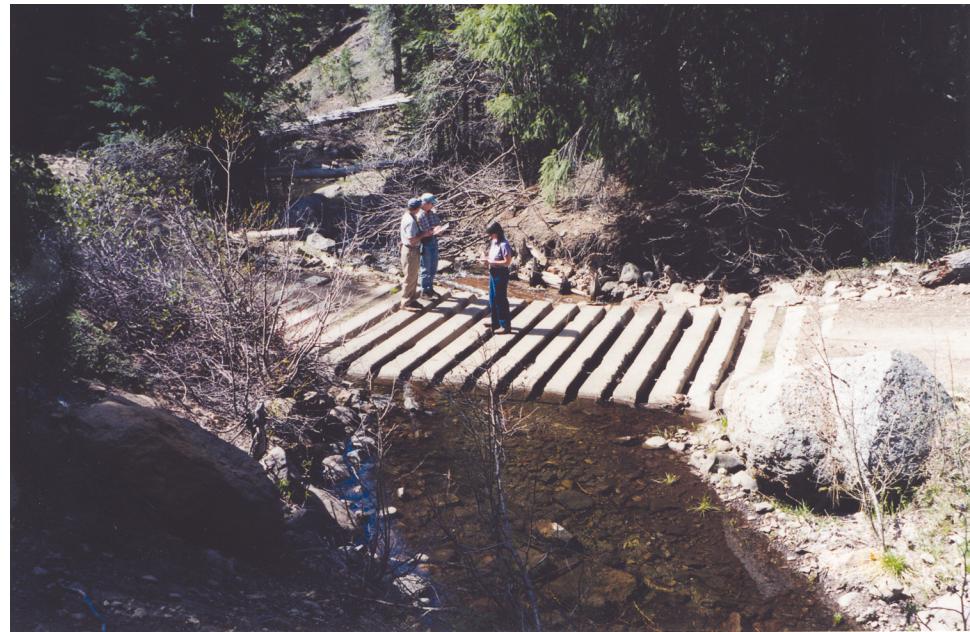
Channel Description: Channel slope is about 3 to 5 percent at the crossing. There is a drop in the channel bottom elevation of 3.5 feet just downstream of the crossing. This is partially due to scour, but also to an old wooden diversion structure that failed and caused channel cutting. A tributary also enters the stream immediately downstream of the road-crossing (figure A23—upper right). Sloping streambanks are 1 to 2 feet high and quite stable with boulders and riparian vegetation including willow and fir trees. Bankfull width is approximately 15 feet, with a bankfull depth of 2.5 feet. The substrate is a mixture of cobbles, some gravels, and large boulders.

Figure A23. Looking downstream: ford is just above a tributary junction where an old diversion structure blew out and caused streambed to degrade.

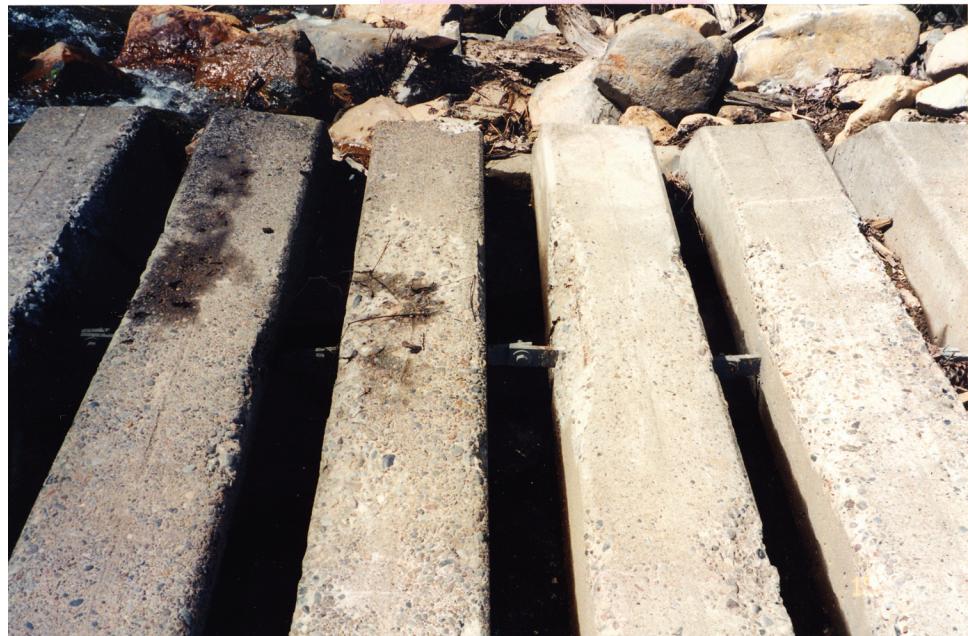
Structure: The driving surface of the ford is made of steel reinforced concrete planks 12 inches wide by 12 inches high and 15 feet long. They are spaced 6 inches apart and held in place with metal brackets between the planks (figure A24). Each plank is tapered at each end. Twenty-one planks form the 31-foot-long reinforced driving surface. The planks are set onto a smooth bed of small riprap. Additional large riprap was placed along the downstream edge of the structure for scour protection.

Figure A24. Detail of planks and metal brackets.

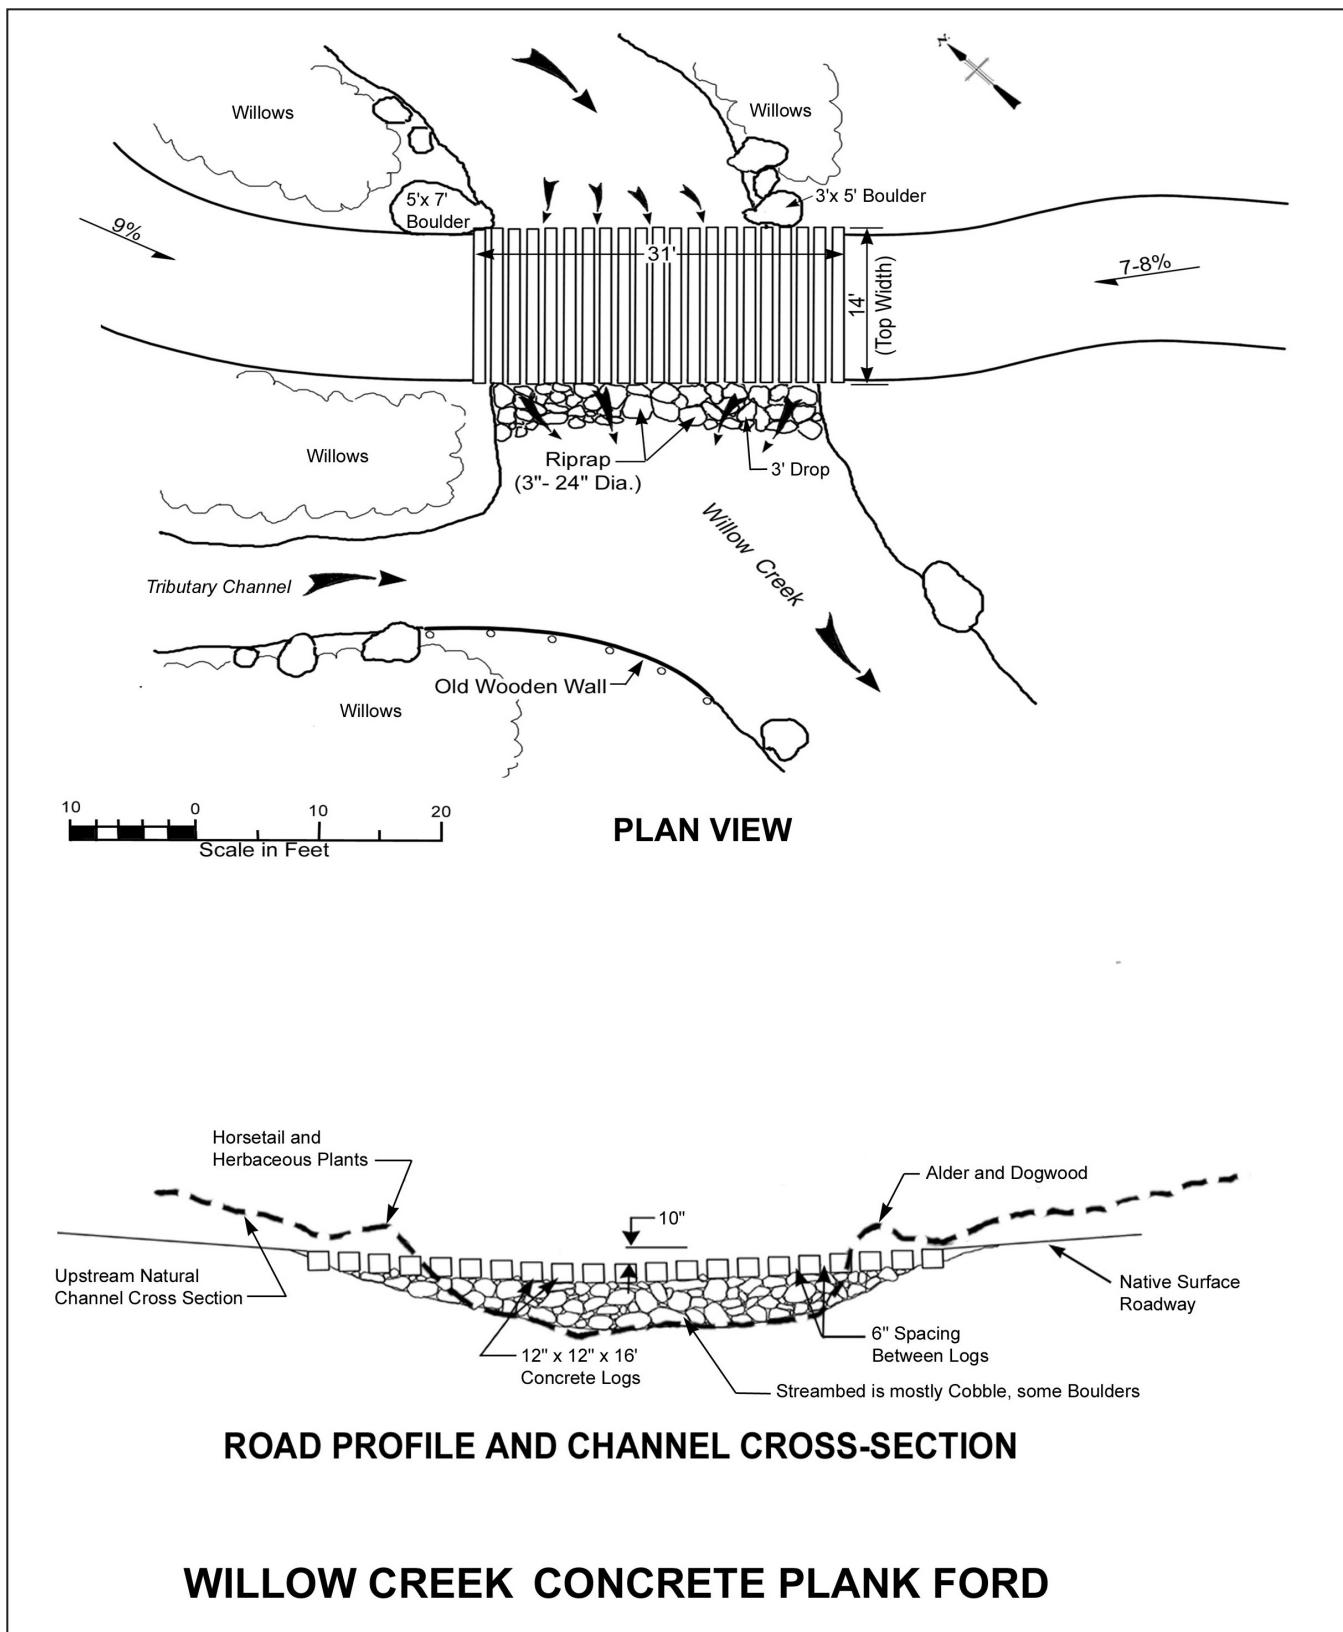
Figure A25. Site plan view and cross-section sketch.

Bank stabilization and approaches: Large riprap was added to stabilize the downstream area from the effects of the drop downstream (figure A22). Road approaches dip down into the crossing at 7- to 9-percent slope (see site sketch, figure A25).

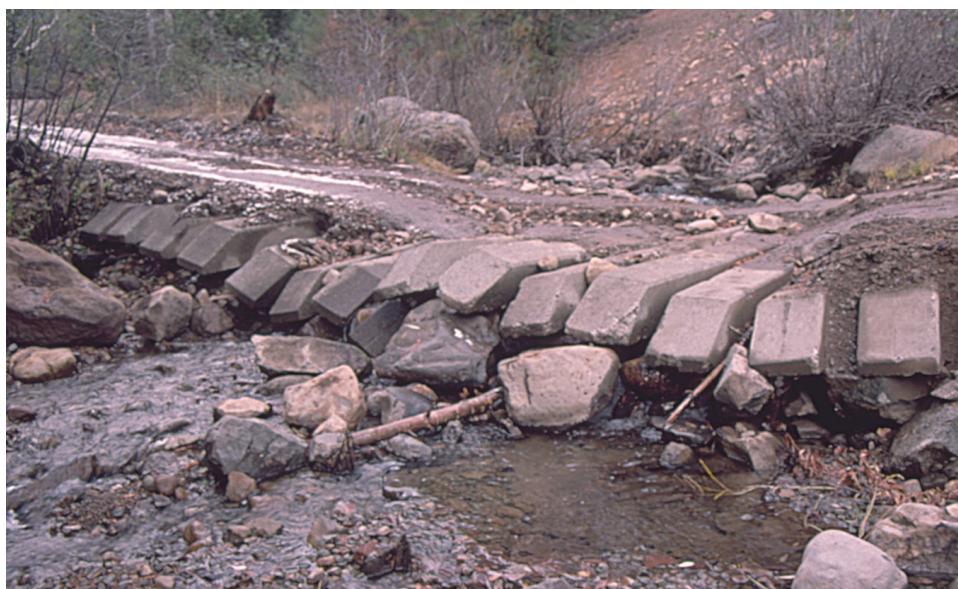
The structure received only minor damage in the large storms of 1986 and 1995. However, during the major 1997 flood (local storm of record), some of the concrete planks were undermined, cracked, and steel was exposed (figure A26). Repairs included replacing some concrete planks, rebedding most of those in the middle of the channel, and adding riprap scour protection at the downstream outlet of the structure.

Figure A26. The crossing was damaged in the 1997 flood by scour of fine bedding materials under the planks. The planks had to be reset into coarser materials and the downstream edge protected with riprap.

Two disadvantages of this design are that, during large floods, it is susceptible to scouring underneath the structure, and it allows only partial aquatic organism passage. If the structure were slightly backwatered at lower flows, fish passage would be improved.

Possible changes to improve fish passage include: lower the structure or build step pools downstream; increase the outslope of the structure to no more than 5 percent; extend structure approaches; reconstruct the approaches to create a more defined dip, and armor the steeper approaches with gravel or pavement to minimize sediment movement.
