## Case Study 8. Agua Fria River Concrete Slab Ford

North Central Arizona. U.S. Department of the Interior Bureau of Land Management Agua Fria National Monument, near Horseshoe Ranch. Approximately 15 miles North of Black Canyon City, AZ, and 3.1 miles south of Cordes Junction, Bloody Basin Road, east of I-17. Forest Road 269.

This ford was constructed in 1994 on a perennial to intermittent fish-bearing stream. It is a reinforced-concrete slab with concrete approaches. The surface is slightly raised above the streambed surface, but it allows fish passage when the structure is submerged.

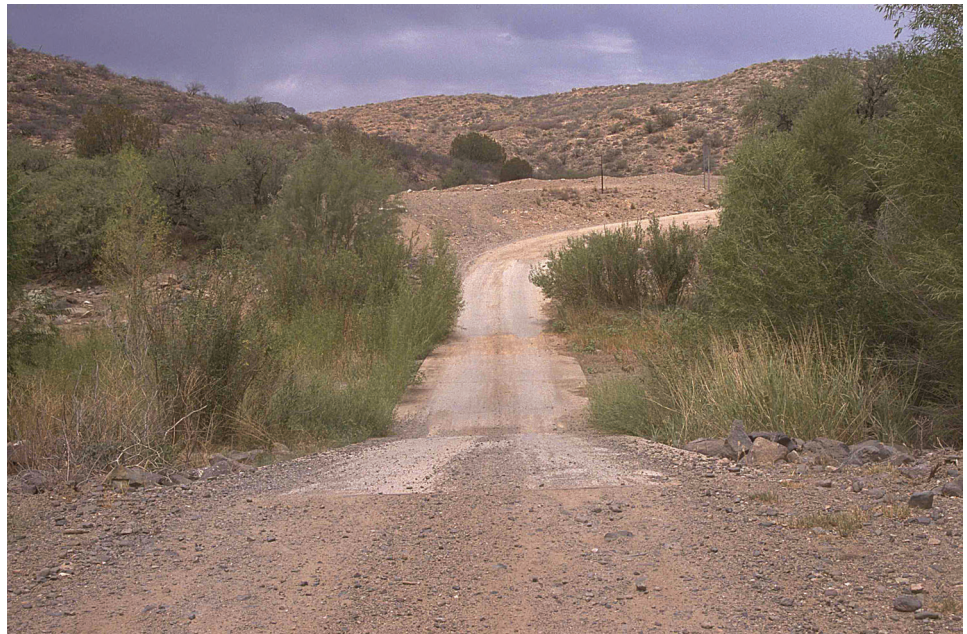
Figure A42. Agua Fria River ford.

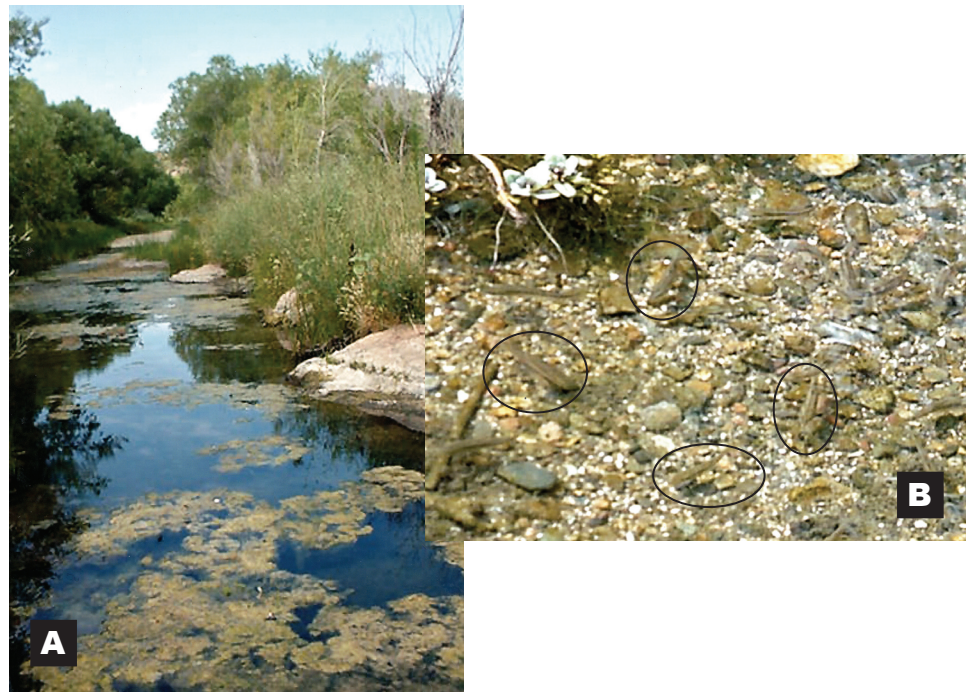
**Aquatic Organisms:** Fish biologists have recently identified fish passage as an issue of concern at this type of site (Calamusso, personal communication). As flow decreases, fish need to be able to follow the water to springs, deep pools, or other refuges. At this site, fish were observed moving downstream over the ford in less than an inch of water after a thunderstorm runoff event in May 2003. Later, in August, they were isolated in pools both upstream and downstream from the ford (figure A43). Needs for passage for other aquatic species in this area are unknown.

Figure A43a and A43b. Agua Fria River A43a. Pool several hundred feet upstream of ford in August 2003. A43b. Fish are in isolated pools both upstream and downstream of the dry ford.

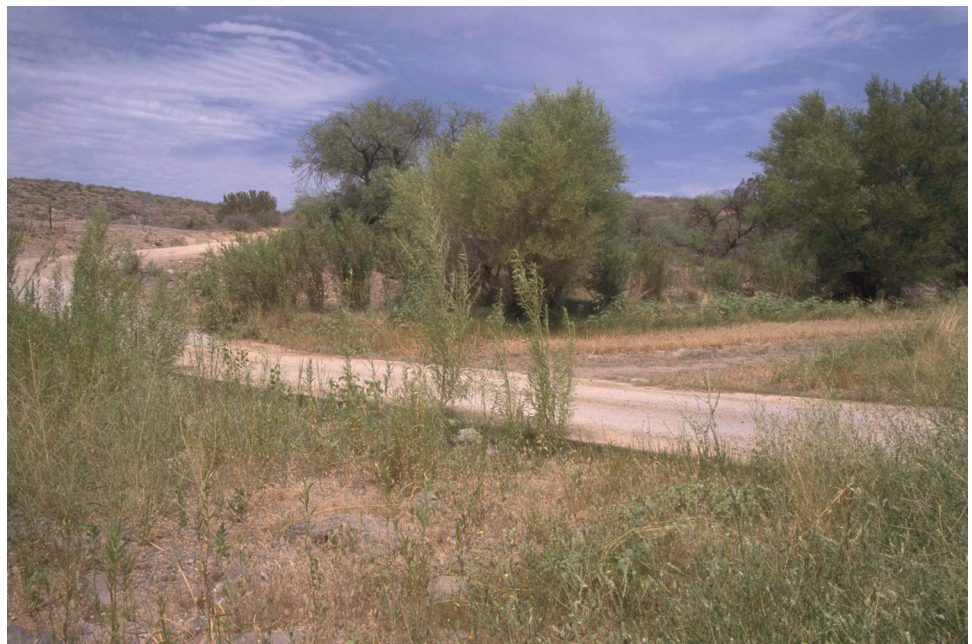
**Channel Description:** The crossing reach is moderately confined between valley and terrace walls and is controlled by bedrock outcrops in the channel and along one bank a few hundred yards above the ford. Banks are stable and vegetated with trees, shrubs, and grasses. Channel width is about 30 feet, depth about 1 to 2 feet, and slope was estimated at 1 percent (figure A45). Just upstream of the ford, three terraces are distinguishable adjacent to the channel, each one rising about 2 to 4 feet above the previous one, and each bordered by 1- to 2-foot-high vegetated levees. Bed material in transport is primarily sand and gravel, and woody debris trapped on trees shows that debris loads during floods are high. The slightly elevated ford surface has caused the active channel to aggrade somewhat upstream of the crossing.

Figure A44. Oblique view of ford and aggraded upstream channel.

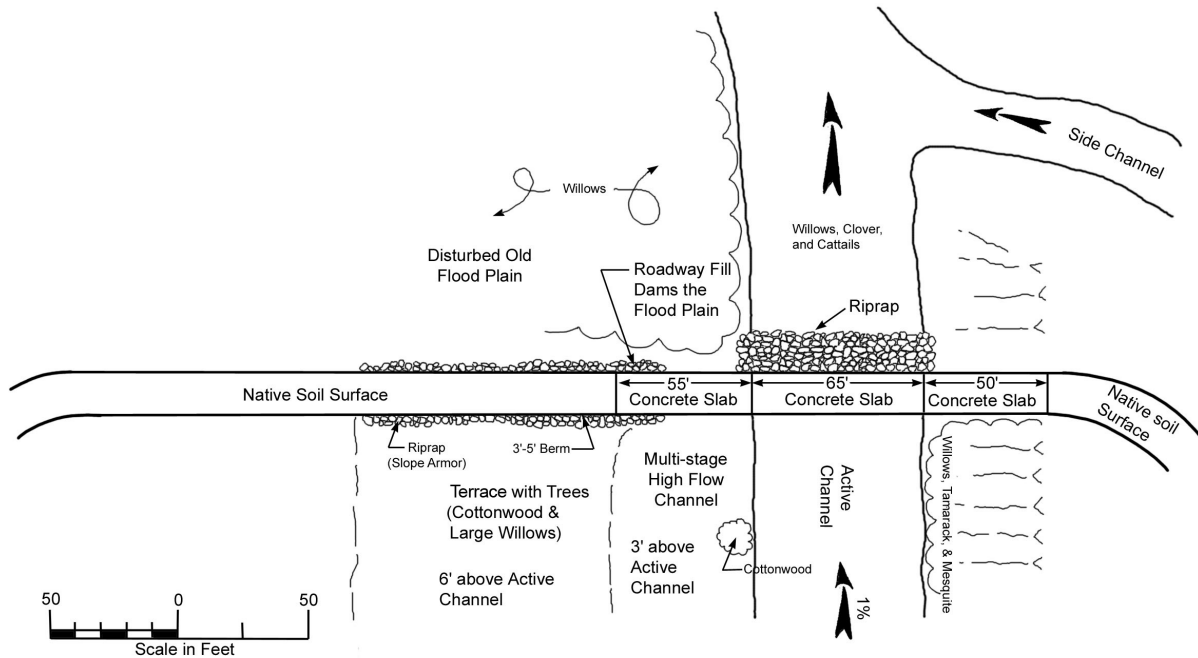
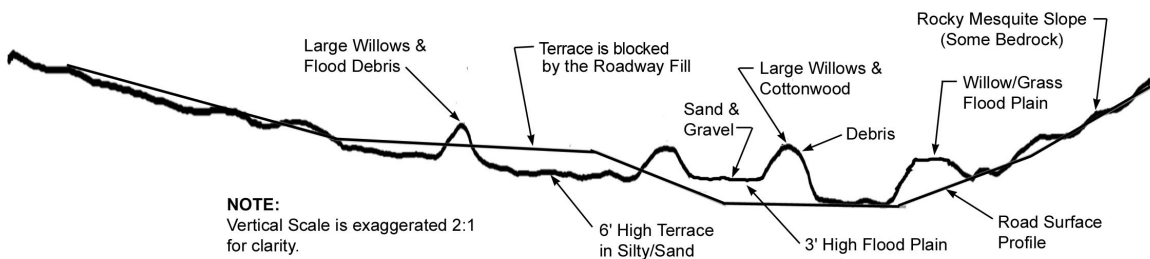
Figure A45. Site plan view and road and valley cross section sketches.

**Structure:** The ford is an 8-inch thick reinforced concrete slab raised slightly above the bed of the active channel. The driving surface is 15 feet wide and has no curbs. The slab is 65 feet long and flat across the active channel and the lowest flood terrace (figures A44 and A45). Including approaches, the structure extends a total of 170 feet across the channel and flood terraces.

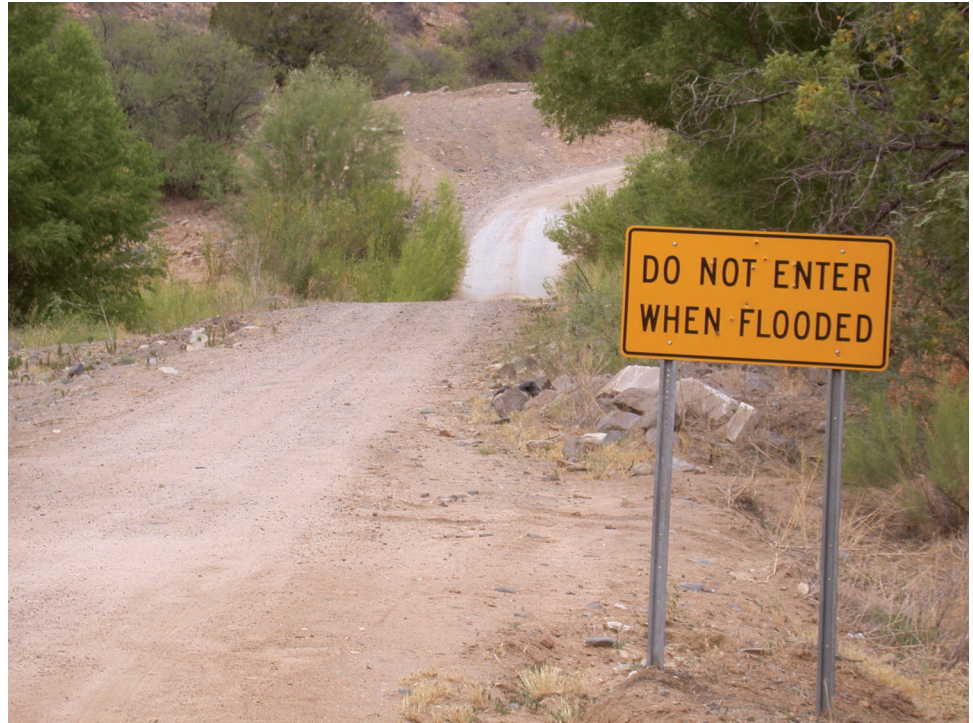
**Safety:** The crossing is signed before both approaches with “Dip - 5 MPH” and “DO NOT ENTER WHEN FLOODED” signs (figure A46). The road itself is signed as being maintained for high-clearance vehicles only at the junction with the freeway. When water flows over the ford for long times, slippery algae can sometimes be a road hazard.

Figure A46. Warning sign at Agua Fria River ford.

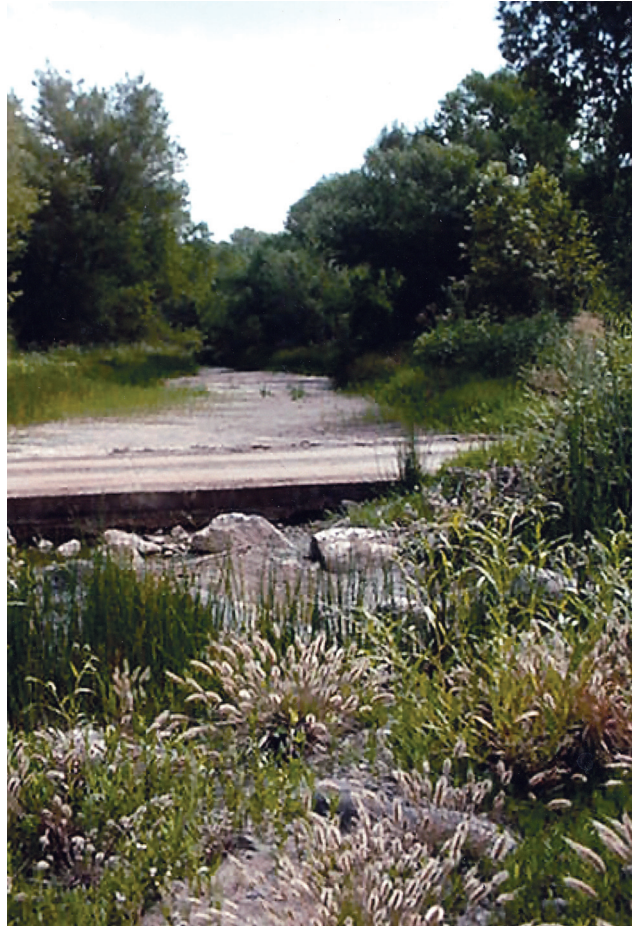
The structure fits the site, with its infrequent floods and moderate road use. It also fits the stream fairly well, except for the fact that it obstructs aquatic organism movement as flow decreases to zero after a runoff event. Since the approach roadfill slightly constricts the flood channel, some gullying and scour are expected along the edge of the road fill.

The downstream edge of the flat slab is about 1-foot above the streambed. Riprap has been placed there to control scour but minor undermining has already occurred in the fine, easily erodible streambed materials. A several-foot-deep downstream cutoff wall would be recommended here.

Figure A47. Looking upstream at ford and Agua Fria channel. Fish can move across the ford only when it is submerged.

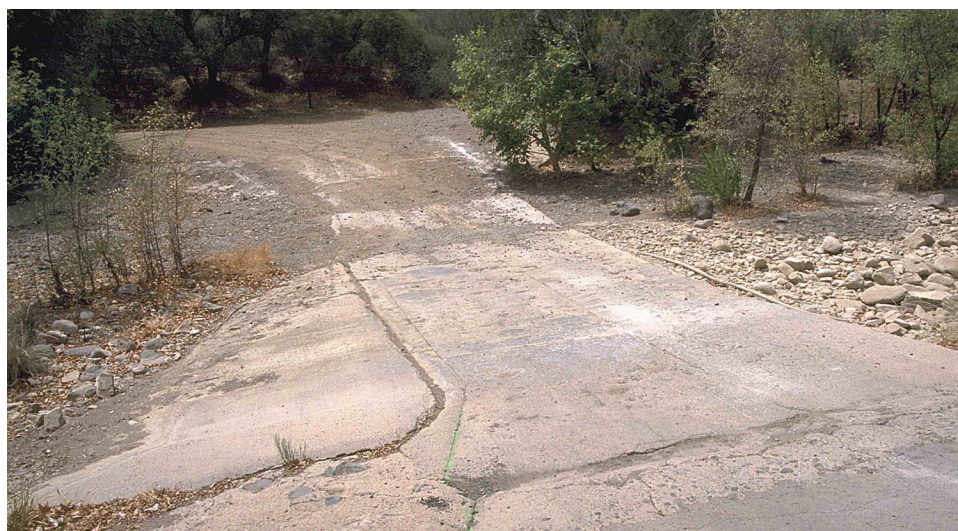
Figure A48. Ashdale concrete slab ford (downstream is to left).

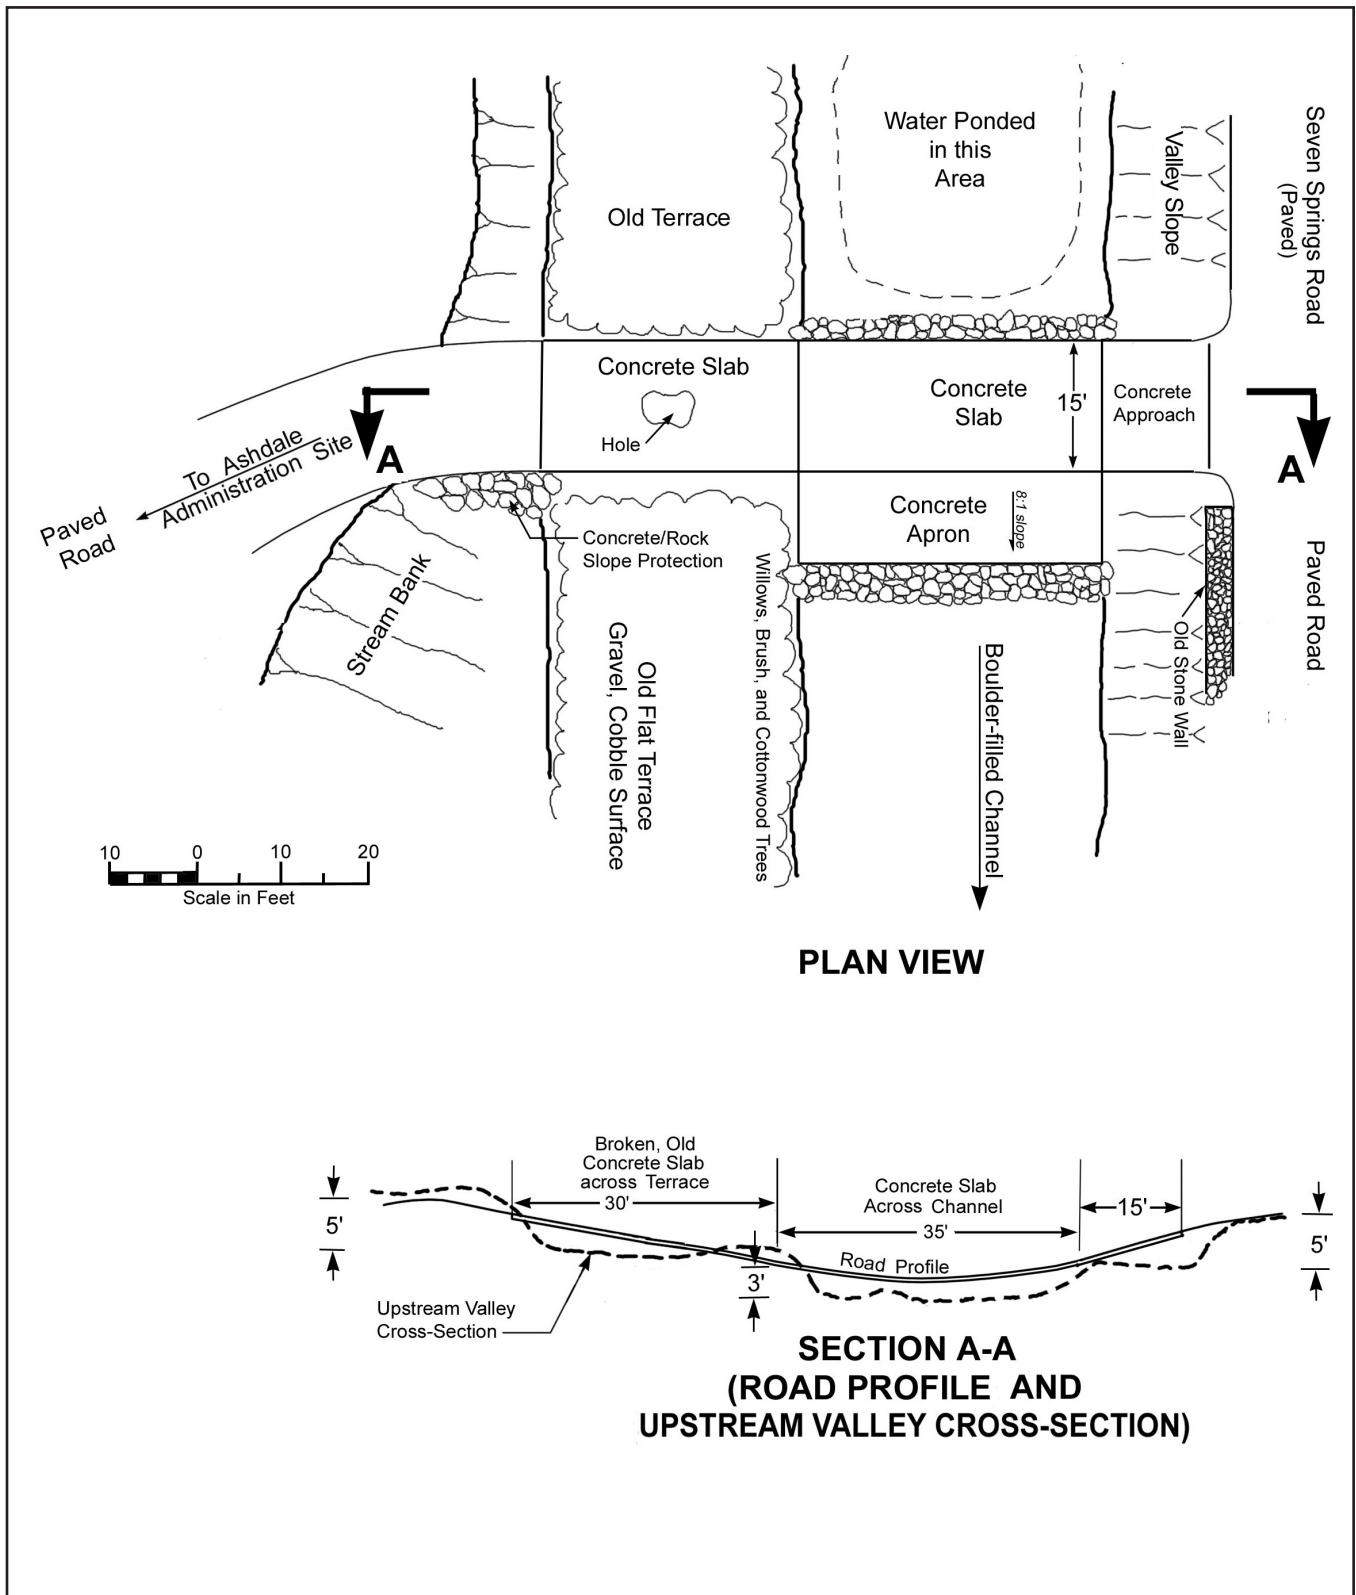
Figure A50. Ashdale ford plan view sketch and valley cross section with road profile.

The ford is 15 feet wide and 35 feet long across the active channel (figure A50), and a total of 80 feet is armored. An 8 to 1 sloping concrete apron transitions to a riprap and boulder cascade reach downstream of the crossing. The structure has a moderate vertical curve with steep, short approaches.

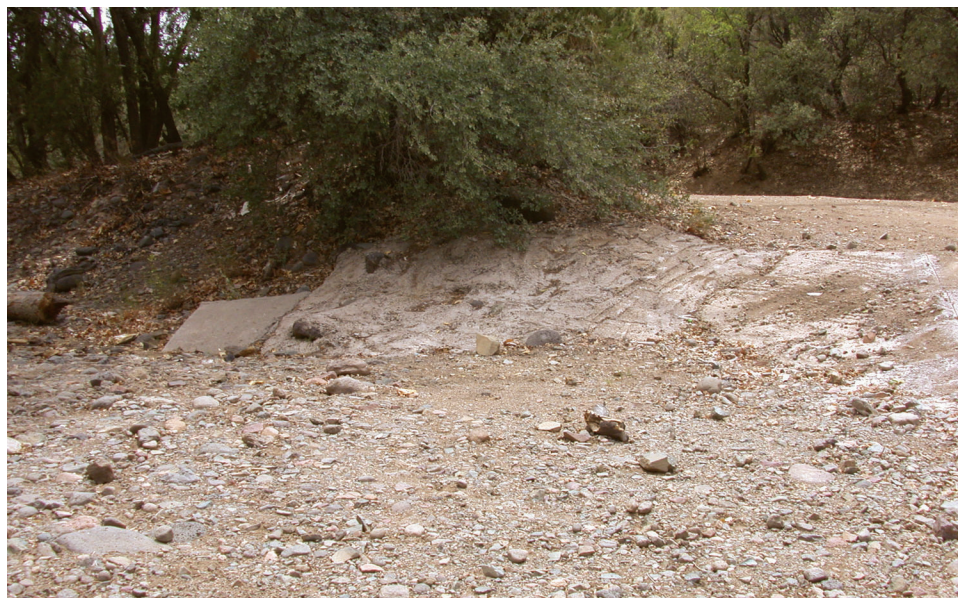
The ford is 50-years old. It has been through many desert floods, including the major 100-year-flood event of 1993. Its concrete surface is battered and has been repaired or extended on both ends. Flows have partially outflanked it at some times in the past, so grouted riprap and pieces of concrete and rock have been placed along the approaches to control scour (figure A51). Downstream scour occurred at some point in its history, leading to the construction of the concrete apron, which currently provides adequate protection against scour. The ford has not received any maintenance since the late 1980s. The structure is appropriate to this high-energy site since it provides for free passage of debris and rock during high flows and there are no aquatic animal issues.

Figure A51. Concrete apron and grouted riprap prevent downstream scour and scour around edges of the ford.
