Case Study 17. Stony River Treated Timber Box Culverts**Location**

Northern Minnesota. Superior National Forest, Isabella Ranger District. Stony River, south of Boundary Waters Wilderness Area. 8 miles west of Isabella, adjacent to State Highway 1, approximately ½ mile from McDougal Lakes. Forest Road 933.

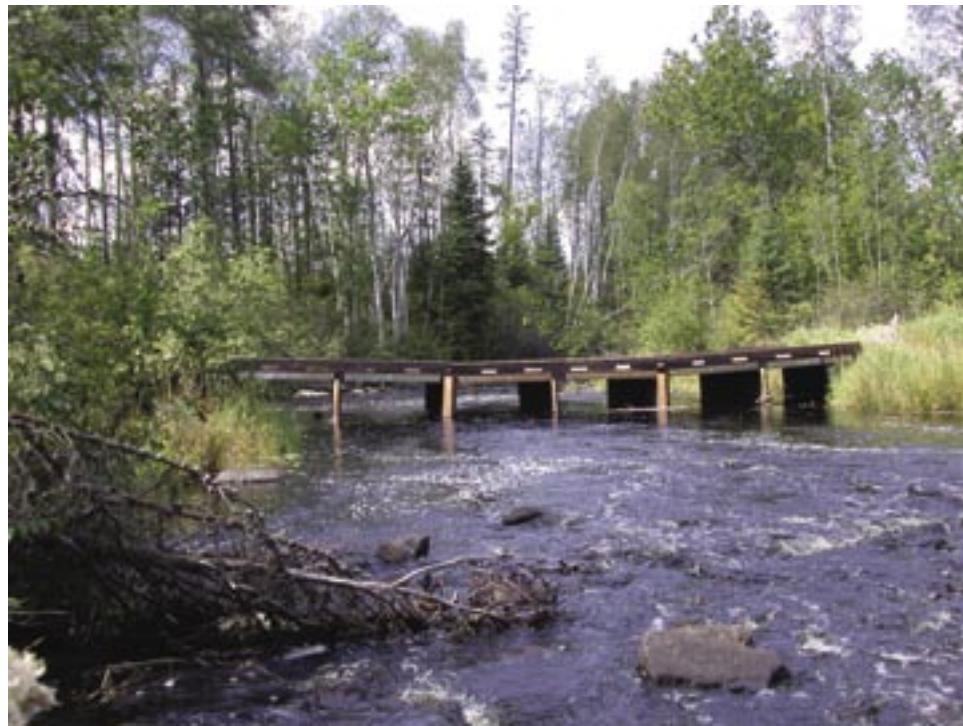
This structure was constructed in 1984 on a perennial fish-bearing stream (figure A112). It is a series of treated timber box culverts embedded into a cobble-boulder streambed. The opening is about 85 to 90 percent of bankfull width on a relatively straight pool-riffle channel. Low flows pass through the structure at similar velocities and depths as in the channel itself, and the structure appears to be passable to fish most or all of the year. The ford was designed to pass the 25-year flow under the bridge deck, and to resist common ice jams. Water has barely overtopped the deck twice, and the structure has required only occasional debris removal and some reinforcement of the joints and connectors.

Figure A112. Stony River box culvert ford.

The flood history of this site is unknown, but there have been very heavy storms in the general vicinity within the structure's lifetime. Since construction, flow has twice been observed to just overtop the structure. Some shifting has occurred and the box connectors have required reinforcement. Debris removal from the upstream face of the structure has been the only other maintenance need.

Water Quality: Water quality at this site is good, and management objectives are to maintain it. Because the graveled approaches slope directly to the crossing and some gravel washes into the river, forest personnel recommend paving the approaches.

This high-VAR ford continues to function well after 20+ years. Boulder streambed material covers 100 percent of the structure bottom, so that streambed continuity and flow velocities similar to the natural channel are maintained through structure. The designer would opt for using concrete if he were building a similar box structure today, because of structural strength and durability. Other recommendations from forest personnel are to pave approaches to protect water quality, and to provide an upstream take-out and portage for kayaks.

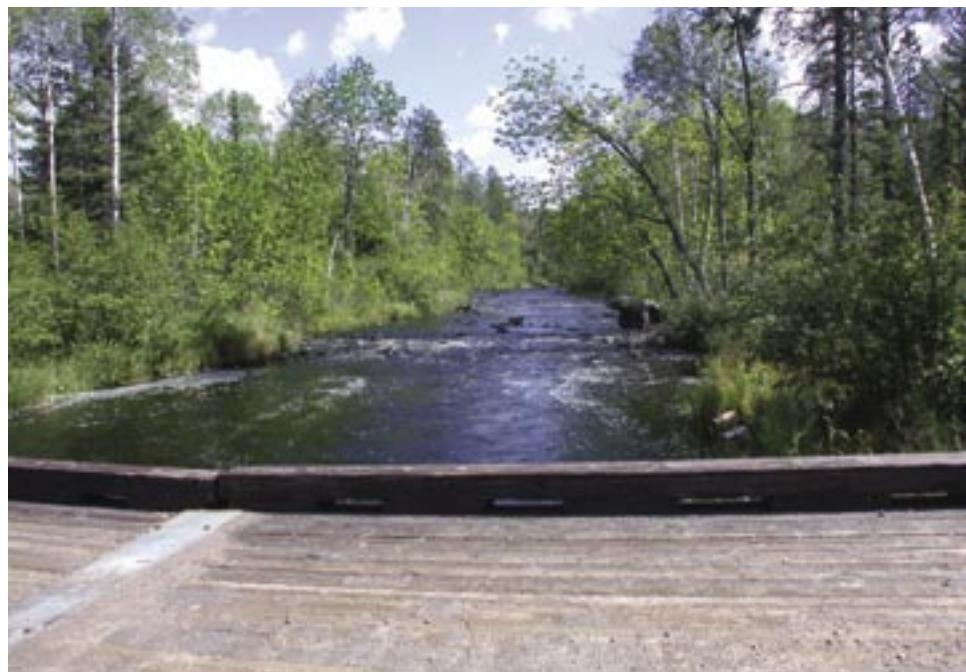
Channel Description: Stony River is a low sinuosity pool-riffle channel (a B2c or C2 stream type) about 50 feet wide. Boulder riffles provide streambed structure, and pools are quite shallow. Slope near the site is approximately 1.25 percent. Boulders vary from large to small, with a predominance of small to medium sizes. The adjacent riparian area has some tree cover, with dense shrub and sedge vegetation, and the potential for large woody debris recruitment to the channel is low to moderate. Boulders, wood, and vegetation provide good bank stability. The channel is moderately entrenched to unentrenched at the site, with a 5-foot terrace on one bank, and a narrow flood plain on the other (figure A113).

Figure A113. Stony River looking upstream from the ford.
