Case Study 2: Twenty-mile Creek Rock Fords**Location**

Washington. Okanagan National Forest. Methow Valley Ranger District. Chewuch river basin, East Chewuch Road.

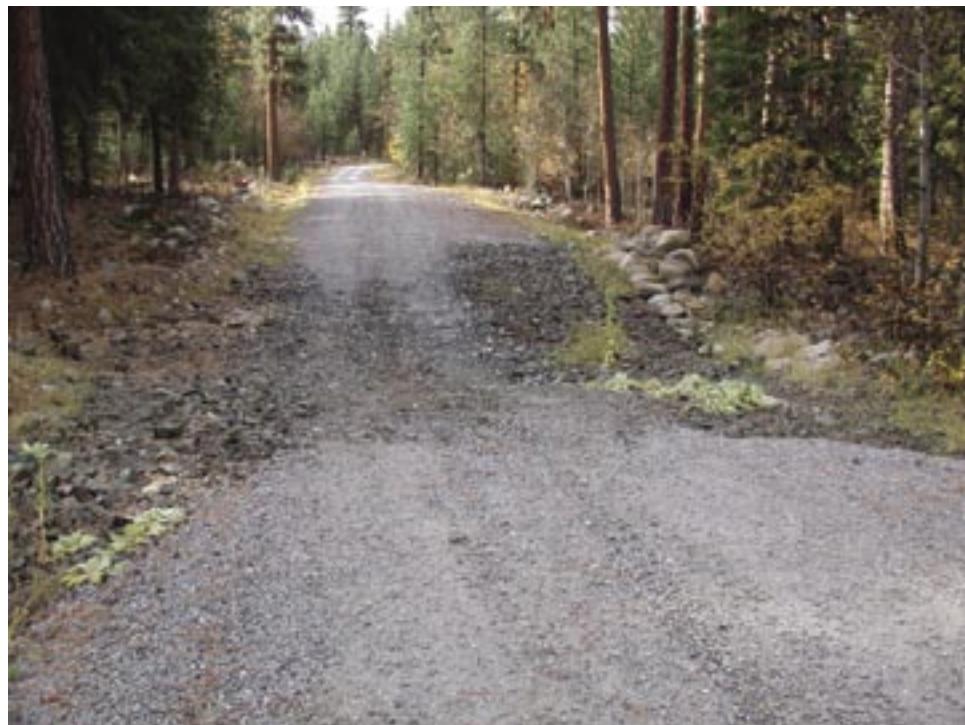
Figure A4. Hardened rock ford on East Chewuch Road.

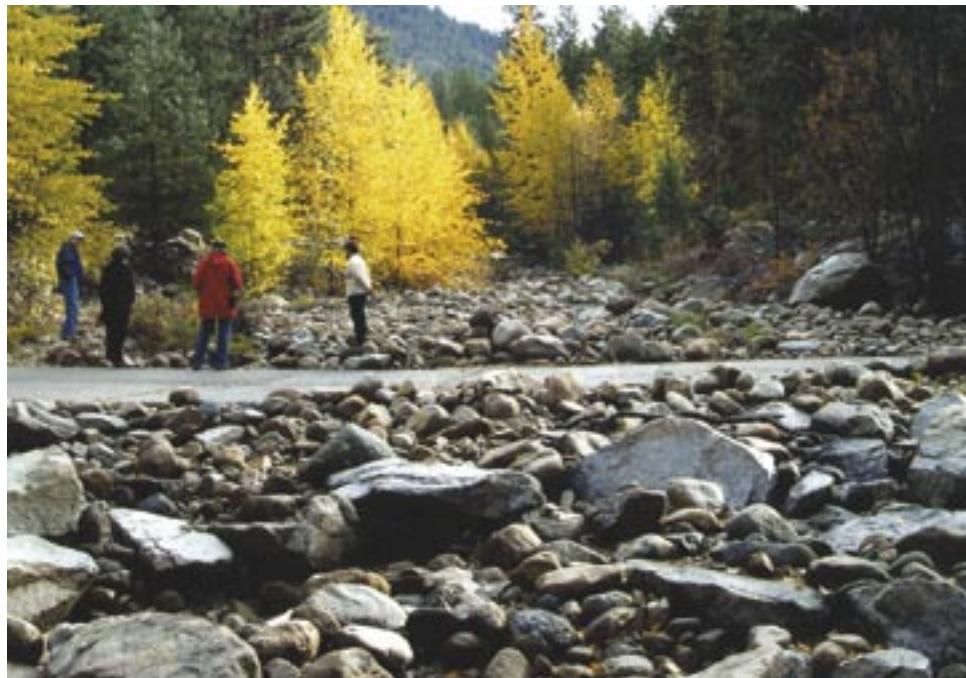
Figure A6—Vented ford plugged with boulders.

This example shows the importance of looking at offsite watershed conditions when designing road crossings. Previous channel straightening and confinement with levees had caused significant channel erosion that plugged the vented-ford crossing. Some of the alluvial fan functions that support high water quality and maintain fish habitat were also lost. Restoration required breaching the levees and allowing flow down distributary channels. The rock dips on the distributary channels are a simple, inexpensive way to provide vehicle access in summer without creating a barrier to fish passage. Fish passage is maintained by mimicking natural channel width and slope and by using rock surfacing that is rough enough to keep flow velocities within the range fish can negotiate. Rock dips are also appropriate here because they can be rebuilt easily should channel location change due to depositional patterns at the fan head.

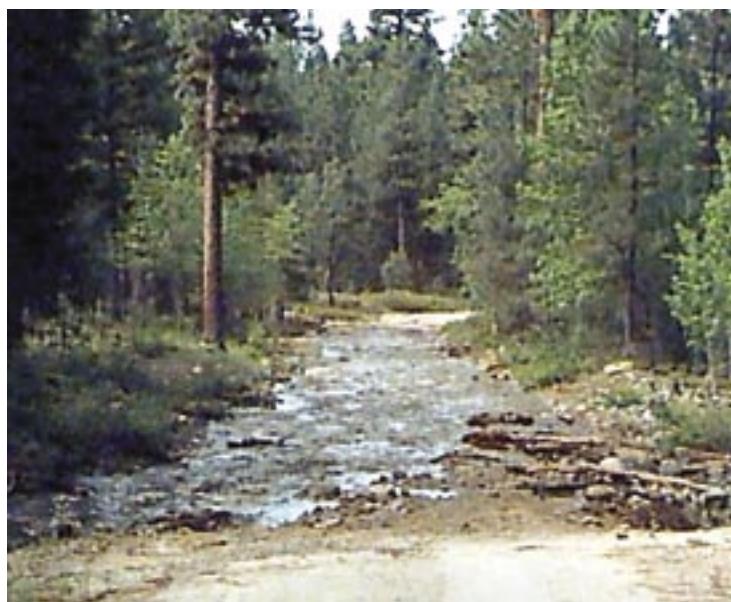
Figure A7—Plugged culvert causes water diversion down road before construction of rock fords.

To reduce sediment input to the Chewuch, and to increase water storage on the fan, the district in cooperation with the Pacific Watershed Institute undertook a channel restoration project in 1999. The levees were breached, and flow was allowed to disperse into several distributary channels down the fan, more closely simulating natural flow patterns. To permit fish passage up the secondary channels, culverts were replaced with the hardened fords described here.

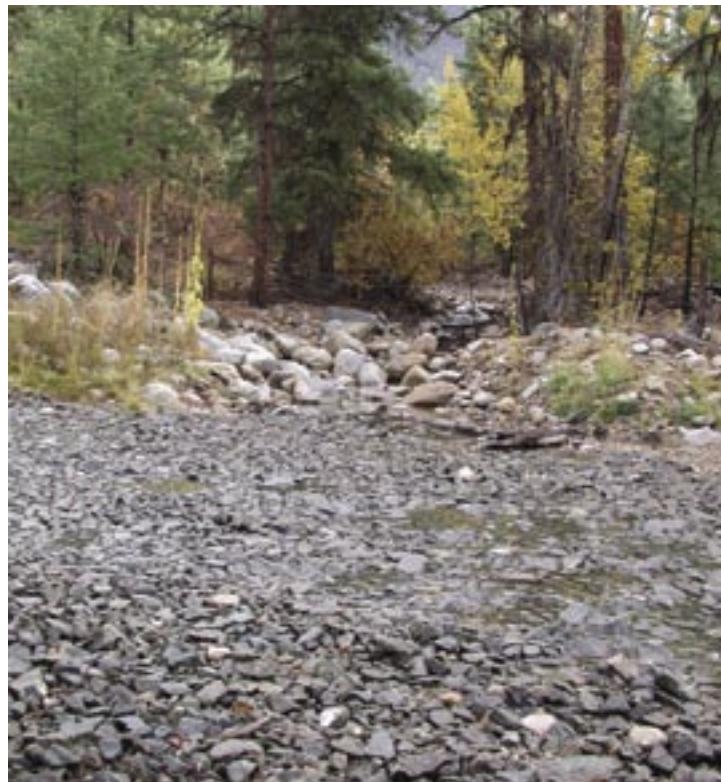
Figure A8—Looking upstream along a distributary channel (hardened dip in foreground).

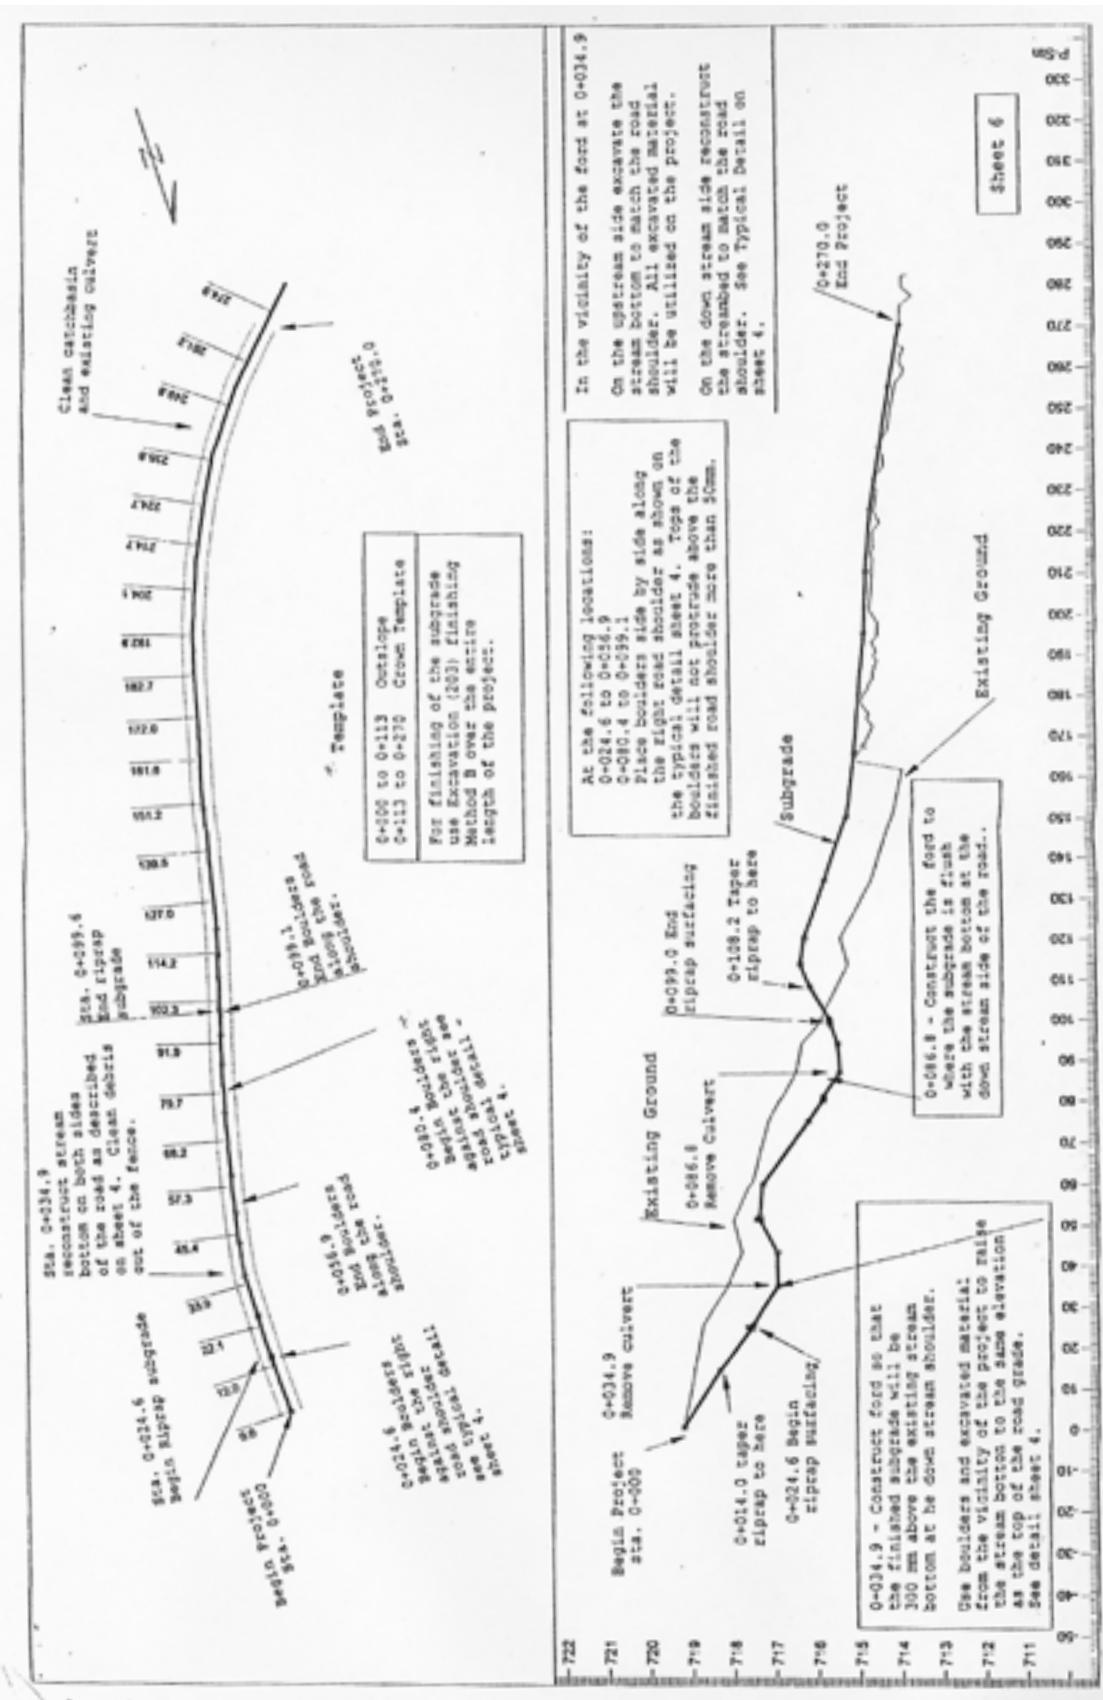
Figure A9a—Ford profile. A full size drawing may be found on the CD included in the back of this publication.

Structure: These rock dips are designed to mimic channel dimensions and slope so that water and sediment are transported through the crossing and so that fish can move up through them. The vertical curve is also designed to prevent stream diversion down the road during the 100-year flood (figure A9a). The dips are outsloped at 3 to 5 percent, similar to the slope of the channels. Riprap on the ford surface (a dense mix of Class III and V riprap) is sized to stay in place during the 100-year flood. Although the U.S. Army Corps of Engineers Hydrologic Engineering Center – River Analysis System (HEC-RAS) was not used for this design, it has been used for subsequent ones to make sure the riprap, boulders, and ford width and depth are sized appropriately for the velocity in the stream.

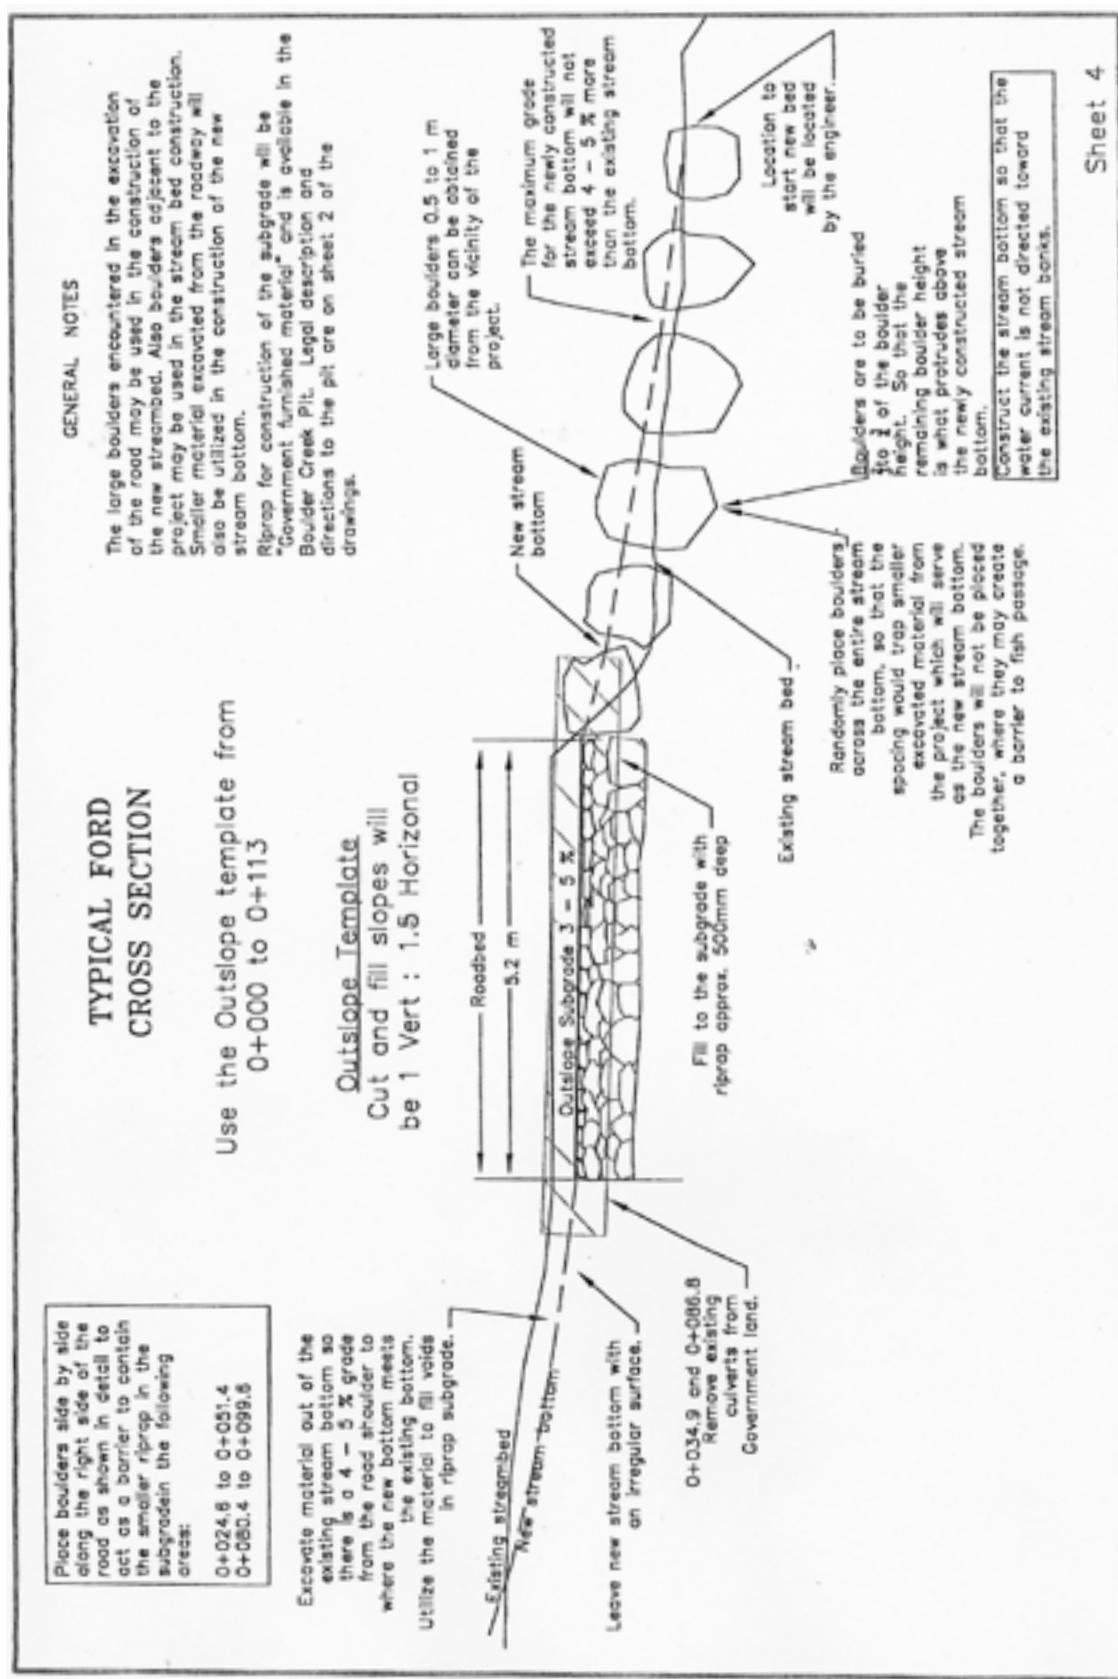
Figure A9b—Cross-section drawings. A full size drawing may be found on the CD included in the back of this publication.

Because the culvert that had been at this site had caused some downcutting downstream, boulders were placed there to trap sediment and raise the channel bed to its original elevation (figure A9b). Again, the rock was sized to mimic the larger rocks in the natural stream channel. The approach appears to be working well.

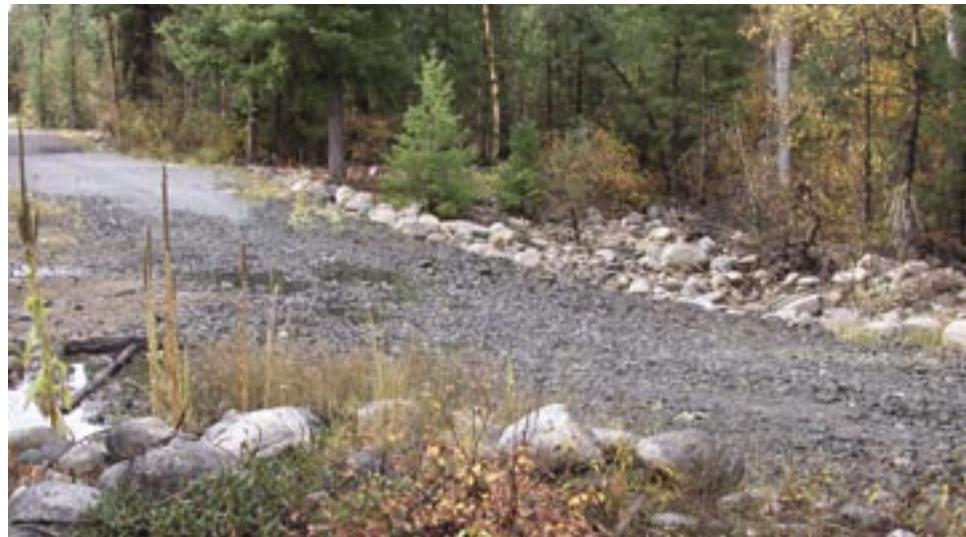
The structures were built in 1999. They have not experienced a major event and maintenance has been limited to minor reshaping of the approaches. No sediment has required clearing from the roadway. Fish are spawning in the ford, which means the road must remain closed for longer periods in the spring (2 to 3 months).

Figure A10. Hardened dip on East Chewuch Road.
