### Case Study 3. Nurse Creek Rock Fill Ford

## Appendix A—Case Study **3**

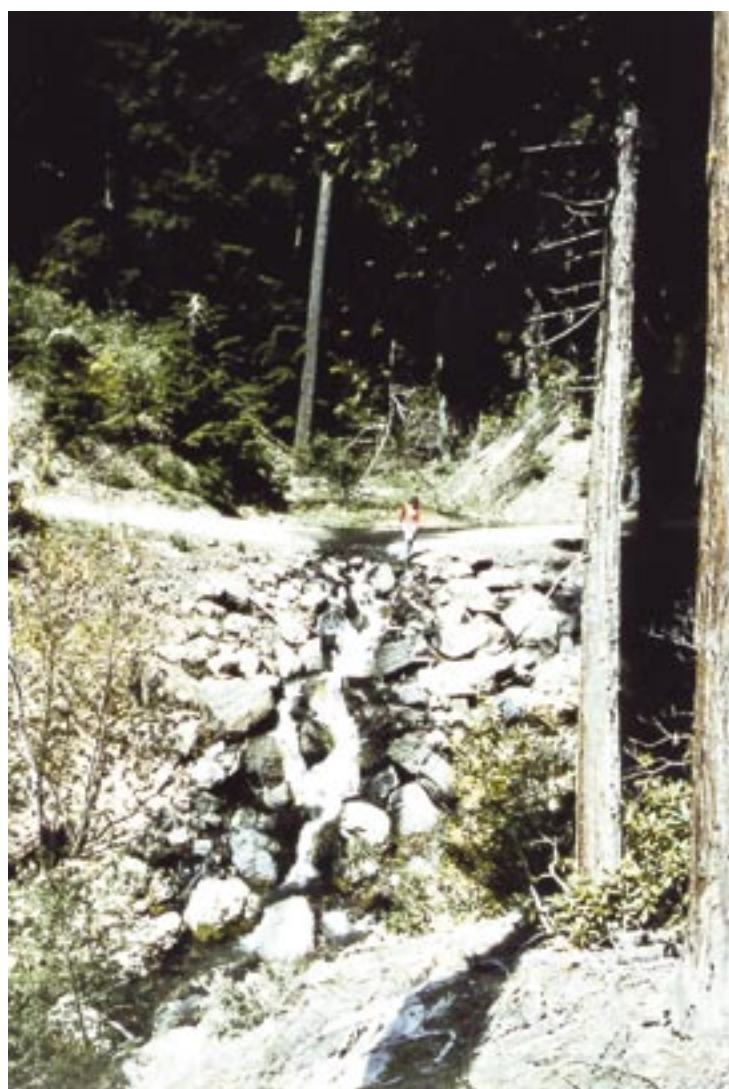
Figure A11. Nurse Creek rock fill ford in 1988

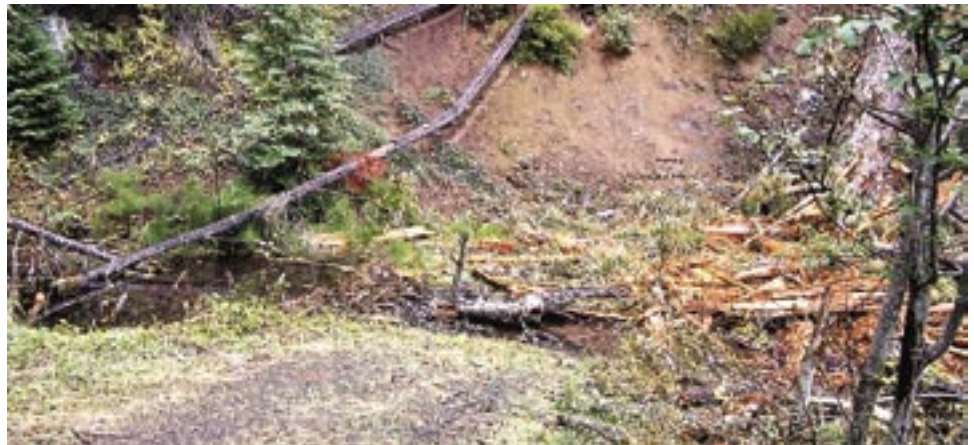
This structure went through large floods in 1996-97 with little or no damage. After more than 20 years and almost no maintenance, water still flows where it was designed to flow and vegetation has grown up all around the ford. Recently, a snag fell over the ford without damaging its function in any way (figure A12). A beaver has taken up residence in the pool at the inlet.

Figure A12. Snag fallen across the ford August 2004. Note beaver dam at upstream end of roadway.

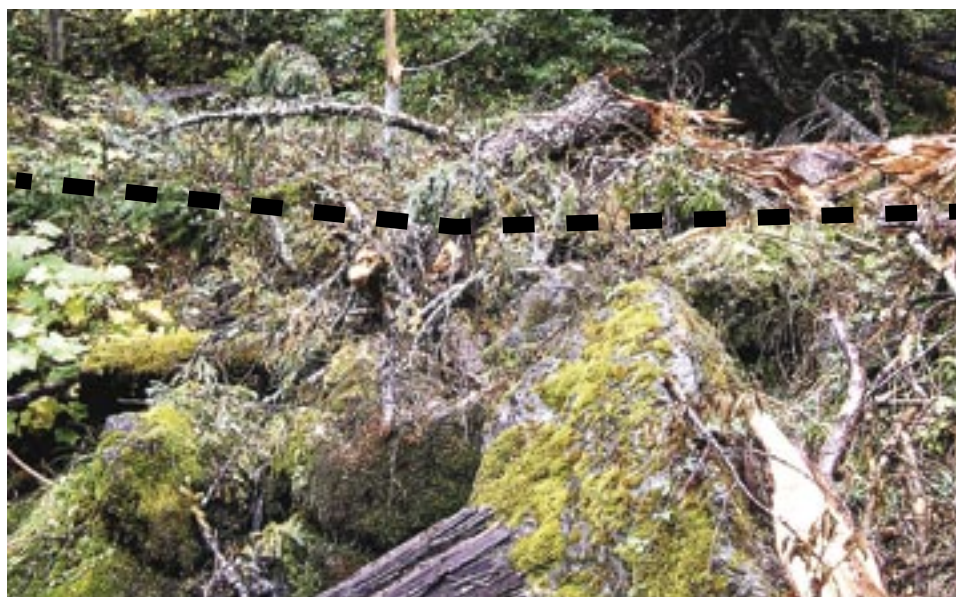
Figure A13. Stable, moss-covered rocks on the splash apron with pieces of fallen snag. Dashed line indicates approximate road surface.

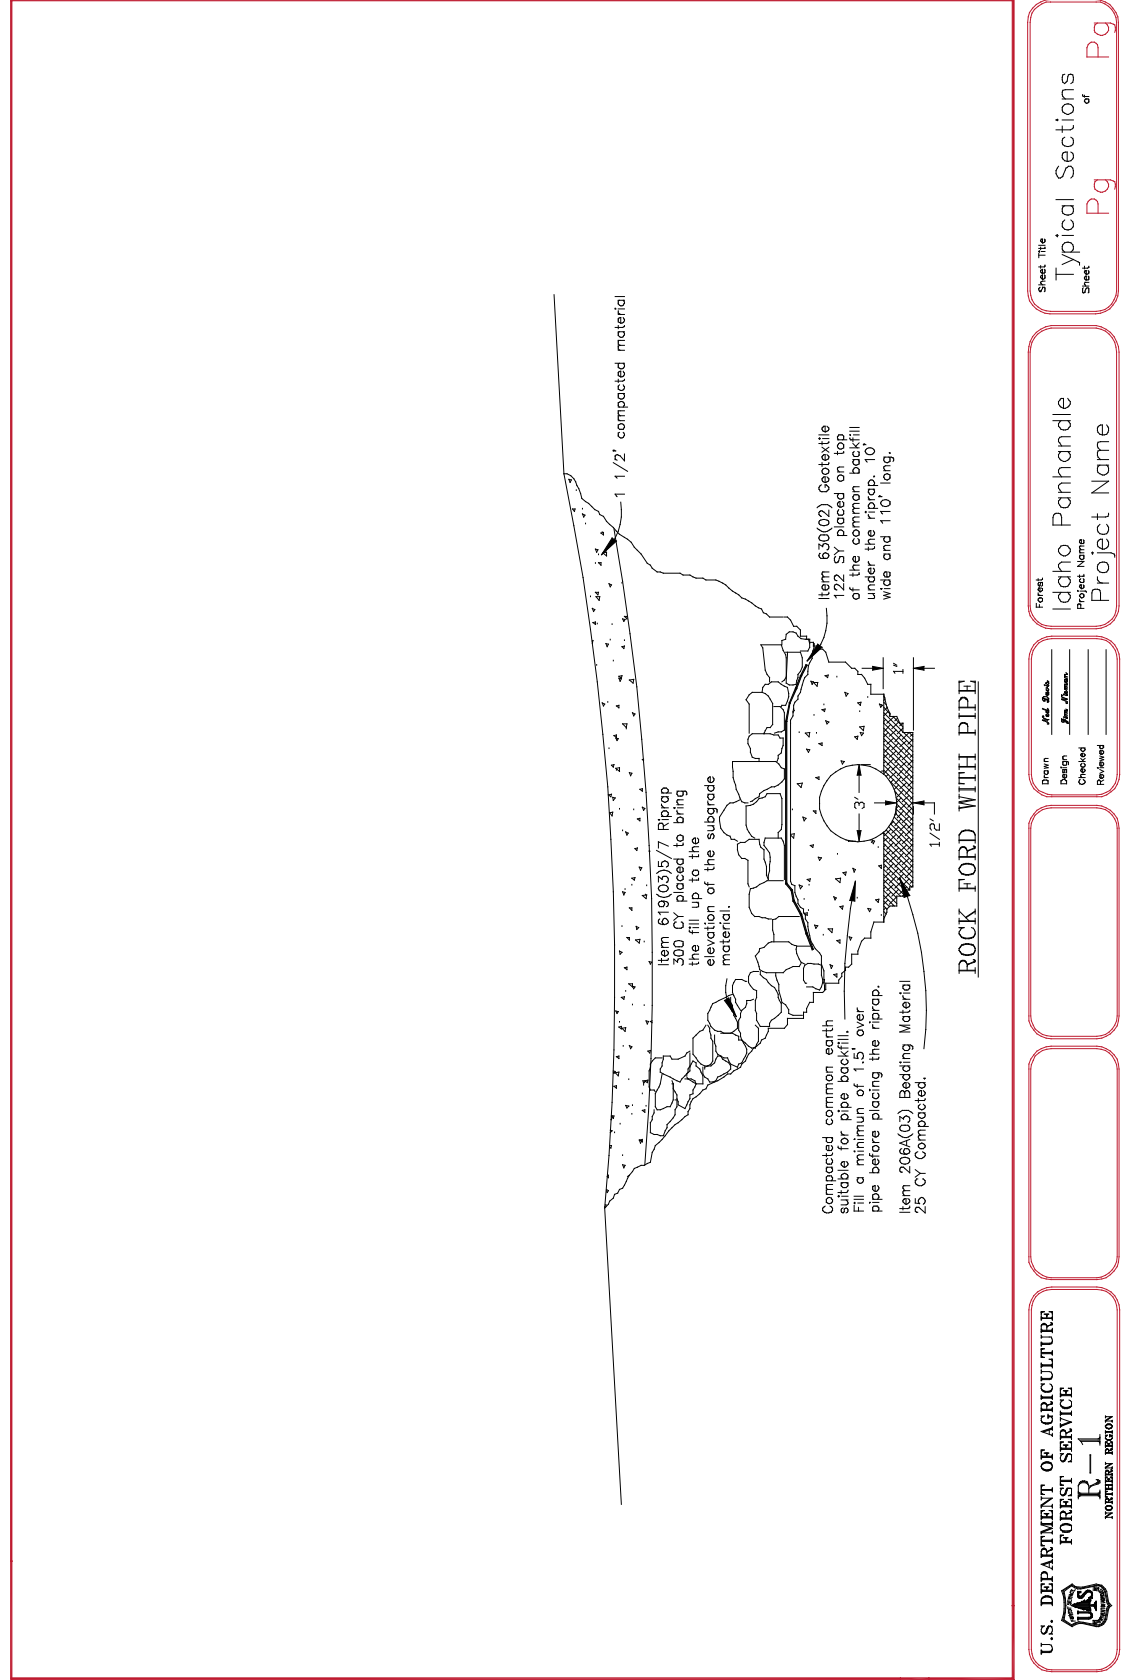
Figure A14 shows a similar rock structure built by the Idaho Panhandle National Forest in about 1996 to replace a culvert that washed out during a flood. The objective was to fortify the crossing to withstand culvert plugging and subsequent overflows. The fill is high and the structure is designed to withstand overflow (Jim Neiman, personal communication).

Figure A14. Rock ford with culvert, Idaho Panhandle National Forest.

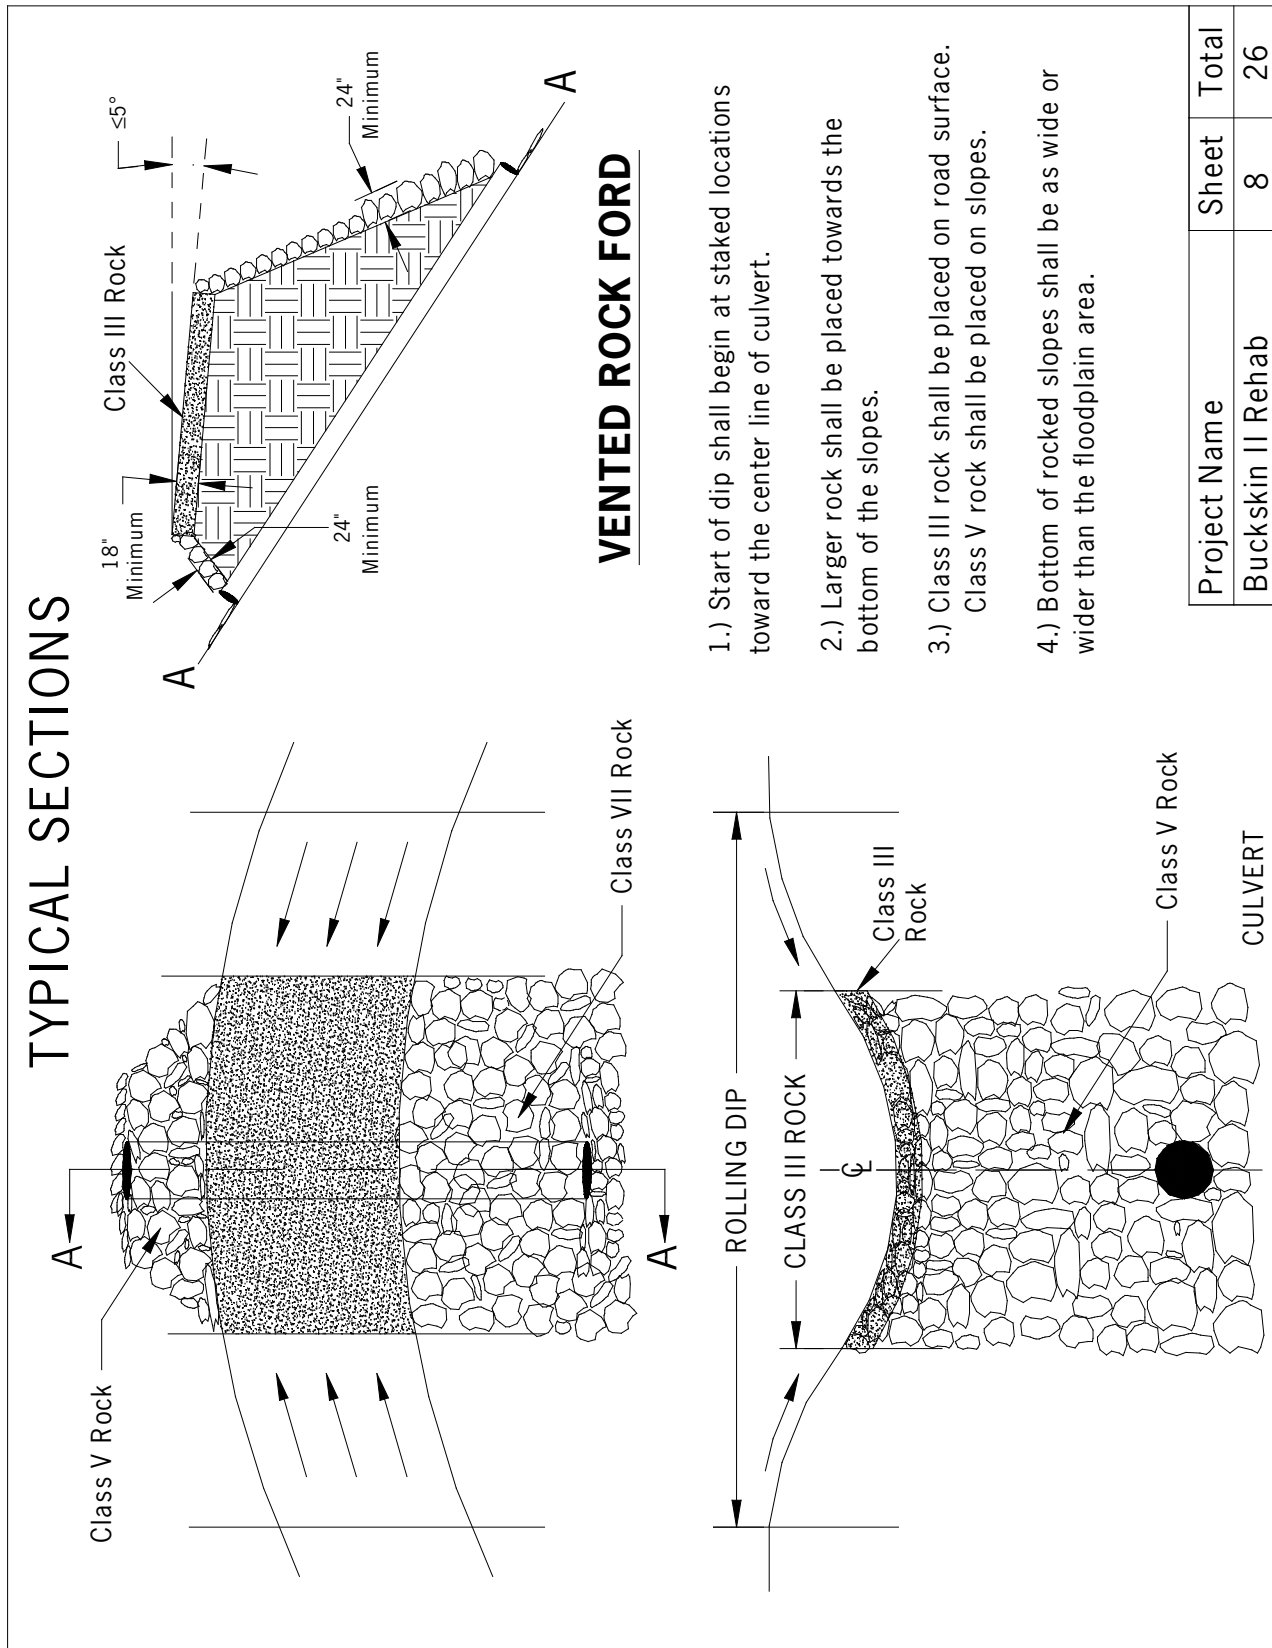
The Idaho Panhandle National Forest used a similar design to retrofit an undersized culvert that could not be replaced immediately (figure A15). Again, the goal was to prevent a catastrophic culvert failure during large floods that characteristically plug culverts with woody debris (Gary Harris, personal communication 2001). Plans called for removing fill to create a driveable dip over the culvert, and sizing the dip to contain the 100-year flow (assuming the culvert plugs). The roadway is outsloped over the dip, and up- and downstream fillslopes are riprapped with class V rock (maximum size 26 to 28 inches).

Figure A15. Vented rock ford, Idaho Pandhandle National Forest.
