FHWA-FPL-93-004

July 1994

Project Report for Launched Soil Nails— 1992 Demonstration Project

Volume 2

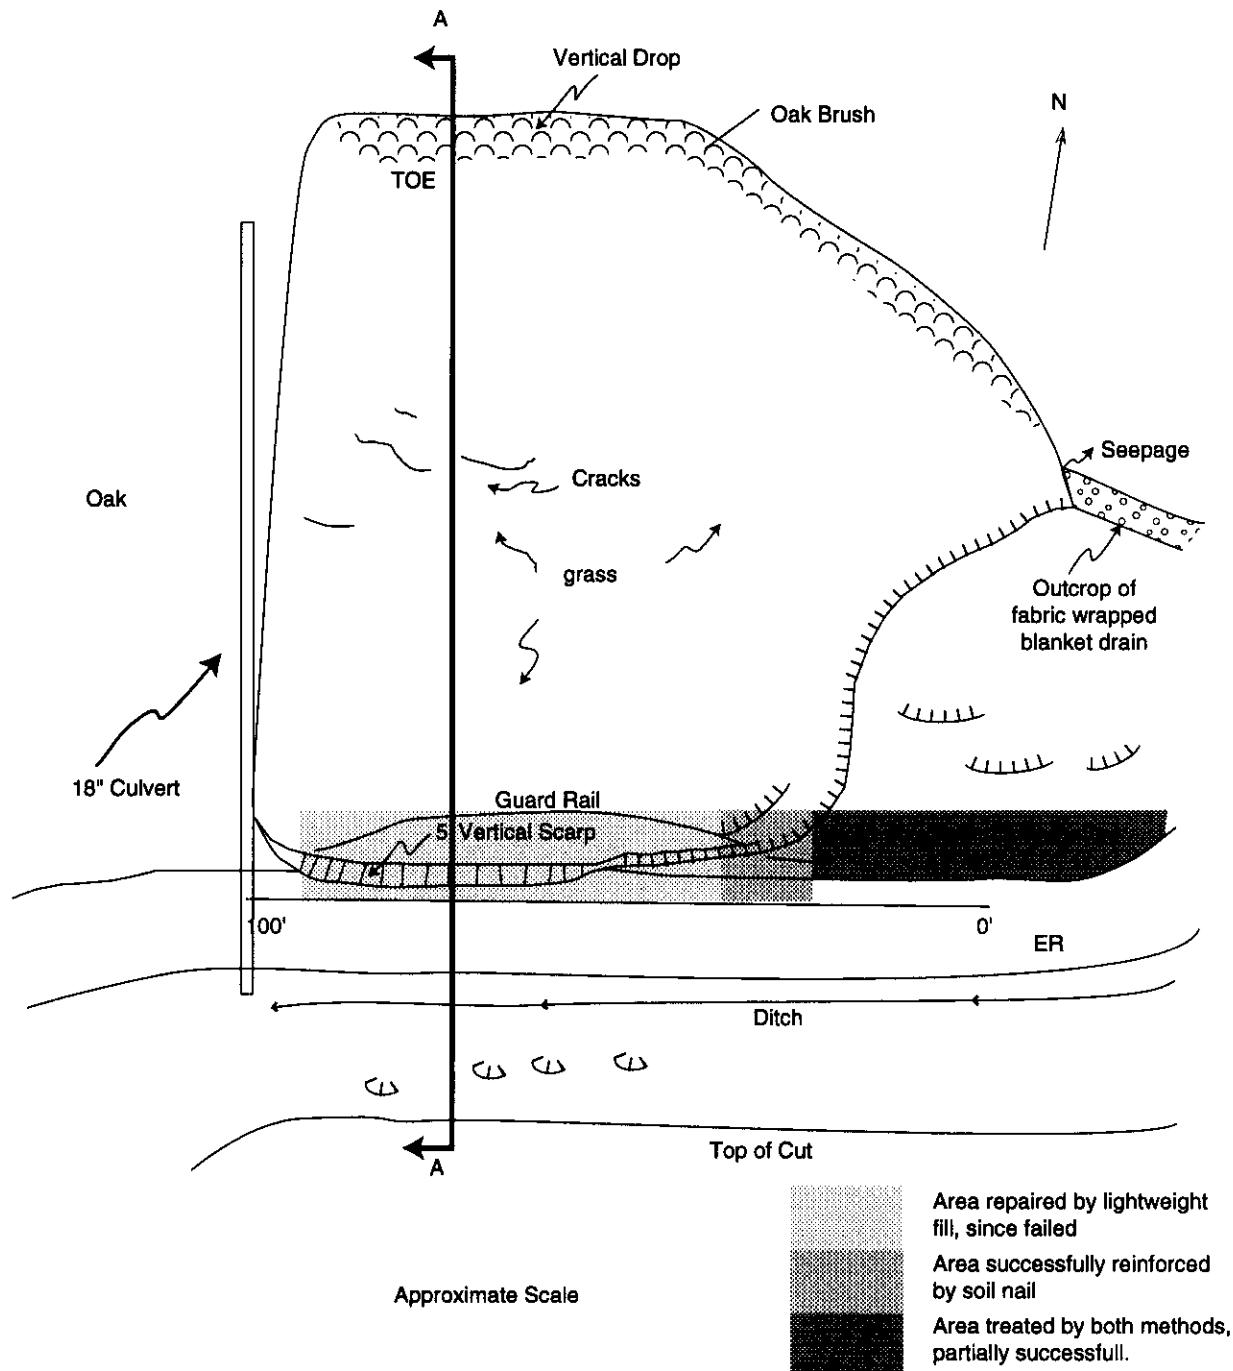
Site 6, Sketch 1

The slide is approximately 120 feet long and 150 feet wide (see the attached cross-section, site 6, sketch 1, and photo 19). Movement is rotational with a very steep 5-foot headscarp near the top and probably translational towards the bottom. The soils exposed on the headscarp and most of the slide's surface is stiff, moist medium-plasticity clays with some silt near the toe. There has been seepage from the headscarp and from the base of the blanket drain.

The nailed areas where there has been small movement (about 0.5 to 1 foot (0.15 to 0.3 m) downslope) before nailing have had no apparent movement afterwards. It appears the smaller slide areas are suitable for stabilization with launched soil nails.

Proposed repairs for the site included intercepting the failure surface with about 50 soil nails in two or three rows over approximately 90 feet (27.5 m). The concept was to stabilize the top of the slump block as a base for a lightweight sawdust fill.

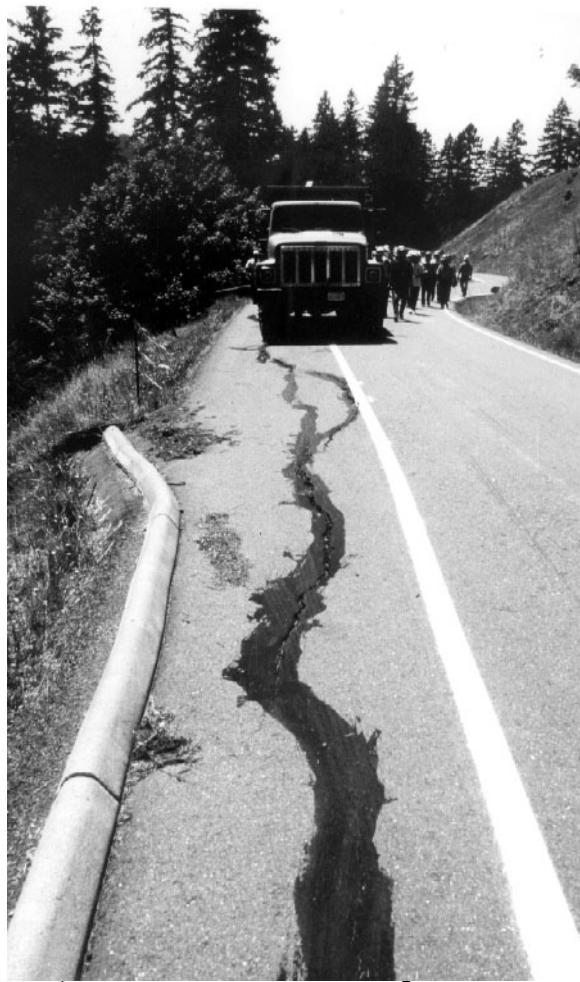
Photo 11. Showing a forest road in steep terrain with a crack adjacent to the fill side of the road. Note the attempt to patch the crack.

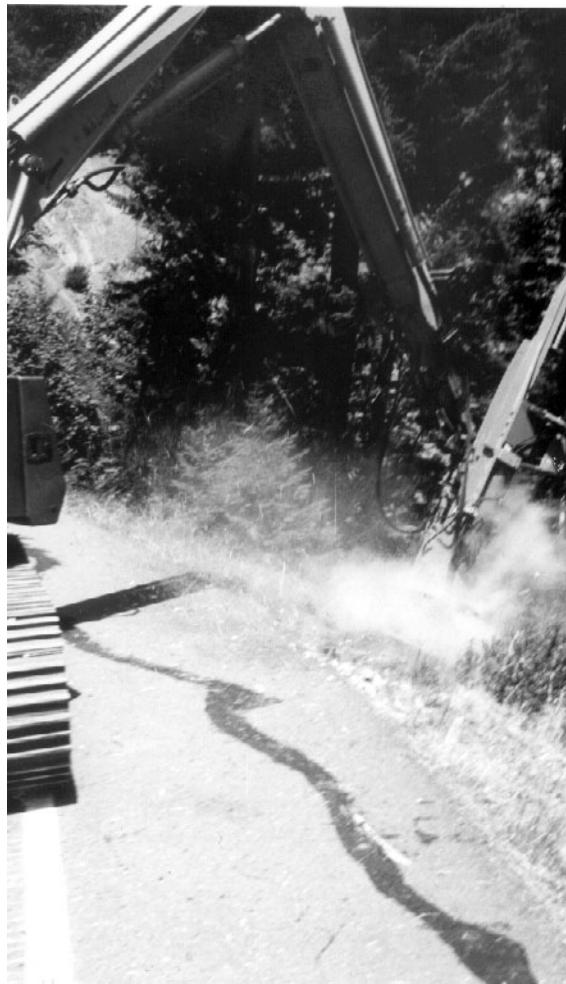
Photo 12. Showing the launch of a soil nail to retain the road shoulder and halt further crack development. Note the retention of vegetation on the site.

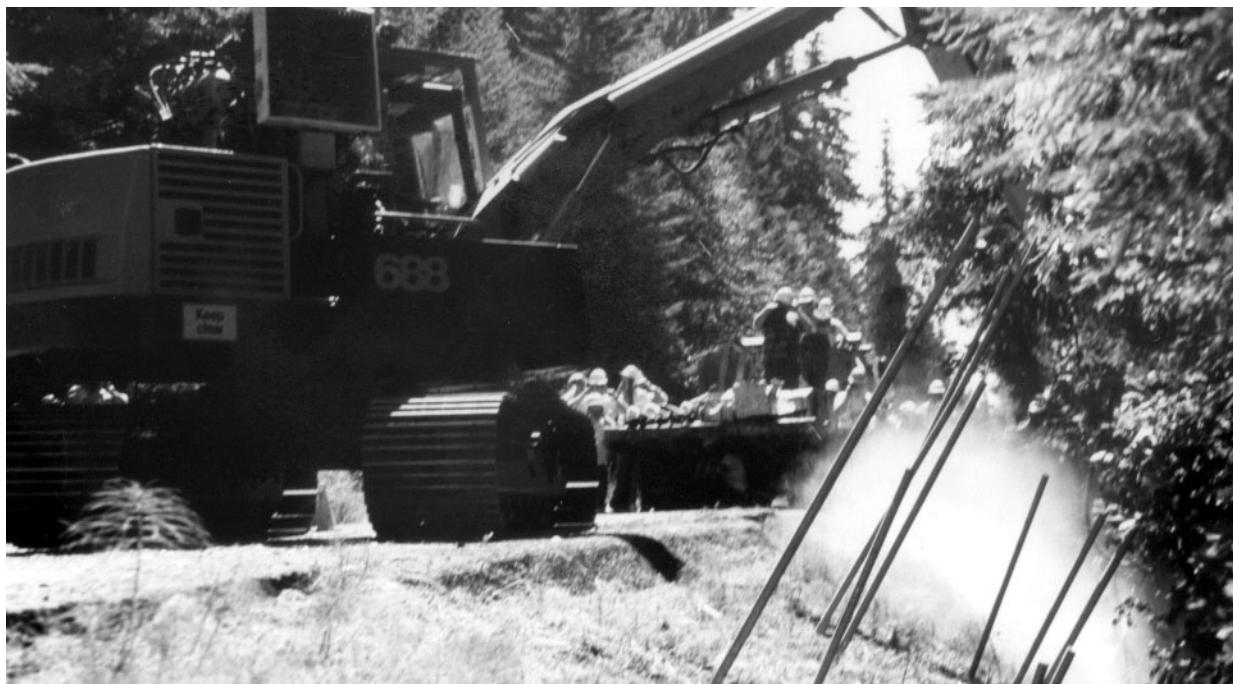
Photo 16. Launching a nail in the site in photo 15. Note the thickness of asphalt concrete pavement, indicating repeated patching of the pavement surface due to slope movement. Nails were cut off at the ground surface after the photo was taken.

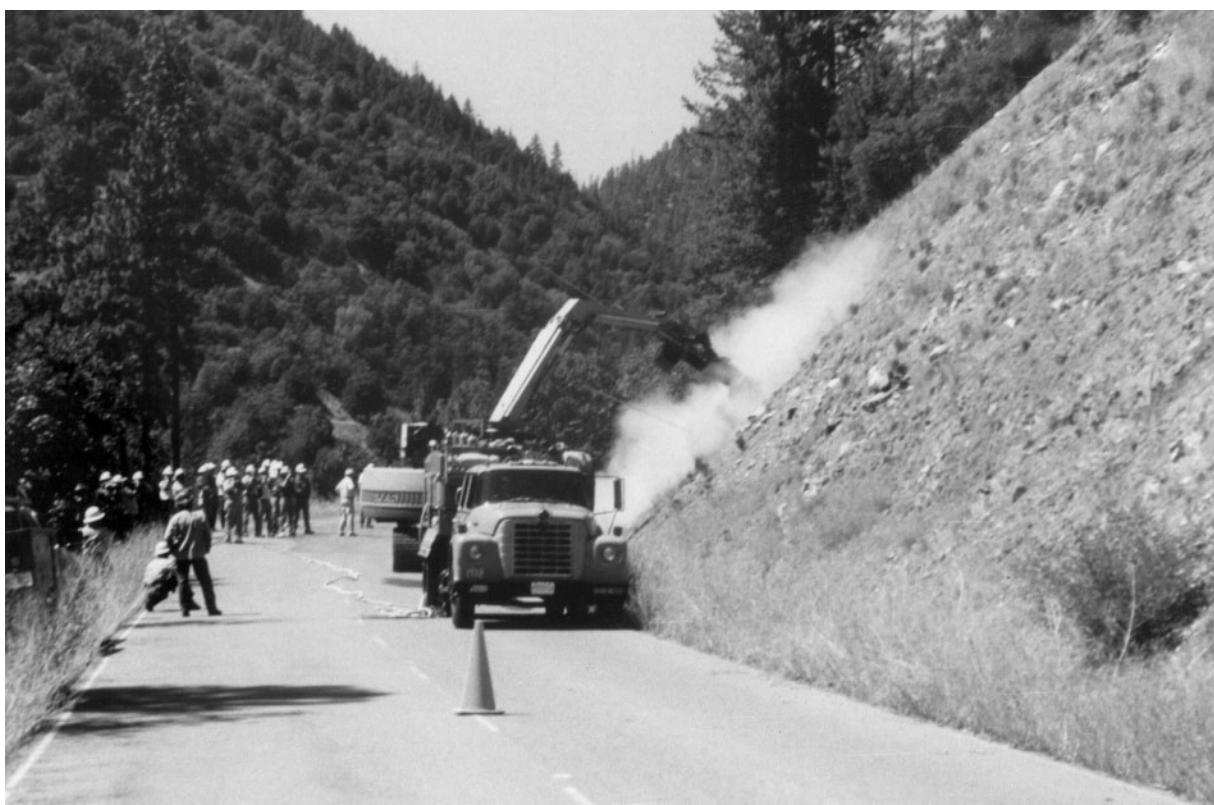
Site 3	Klamath National Forest Yreka, California
Site Type	Cut Slope Stabilization
Site Description	The Klamath demonstration site (photo 18) was a shallow rotational-translational cut slope failure. This site was picked because there were no small fill slope failures close enough to the supervisor's office morning meeting site to make it a 1-day, morning meeting—afternoon field trip. It appeared suitable since most of the other demonstration sites were fill slope stabilization projects. This showed the machine's use for various situations.
Demonstration Description	The material in the cut slope failure was a heterogeneous mixture of sandy-silt (SM) and weathered fractured rock with boulders up to 2 feet (0.6 m) in diameter. The depth to the slide plane appeared to be less than 10 feet (3 m). After driving a few nails to refusal at around 10 to 12 feet (3 to 3.6 m), it was postulated that competent bedrock was just below the slide plane in many places. Approximately 10 nails were installed in the lower one-third of the failed slope.

Photo 18. Launching a soil nail into a cutslope on the Klamath NF in Northern California.

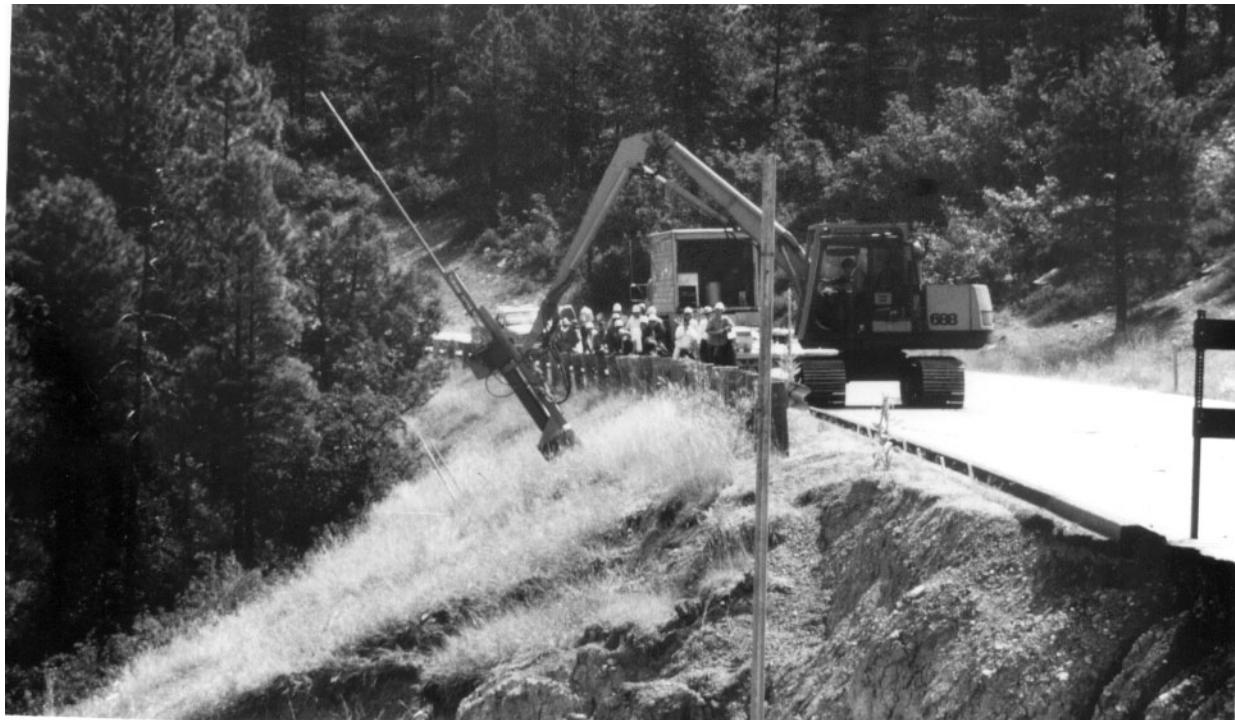
The slide at this site appears to be too deep, too high, and contains too much ground water for launched soil nails to be effective. No horizontal drain nails were installed.
Site 6	San Juan National Forest House Creek Slide (Dolores County Road 728) Dolores, Colorado
Site Type	Fill Slope Stabilization
Site Description	This slide is located on Dolores County Road 728 in the Dolores District of the San Juan National Forest in Colorado. The paved road is 26 feet (7.9 m) wide and accesses a developed recreation area. A maximum of 2 feet (0.6 m) of pavement (mainly shoulder) has been lost, with some damage to the pavement extending about 45 feet (13.7 m) along the shoulder.
	The slide, which has record of movement over 50 years, moved most recently in the spring of '92. The road was constructed about 8 years ago. A blanket drain was installed during construction in anticipation of possible trouble but it was probably installed in the wrong location. The area where there has been the most movement did not get any drainage.

Photo 19. Ready to launch a soil nail into a failing slope in Colorado. The soil nails will prevent extensive downslope movement seen in the foreground.

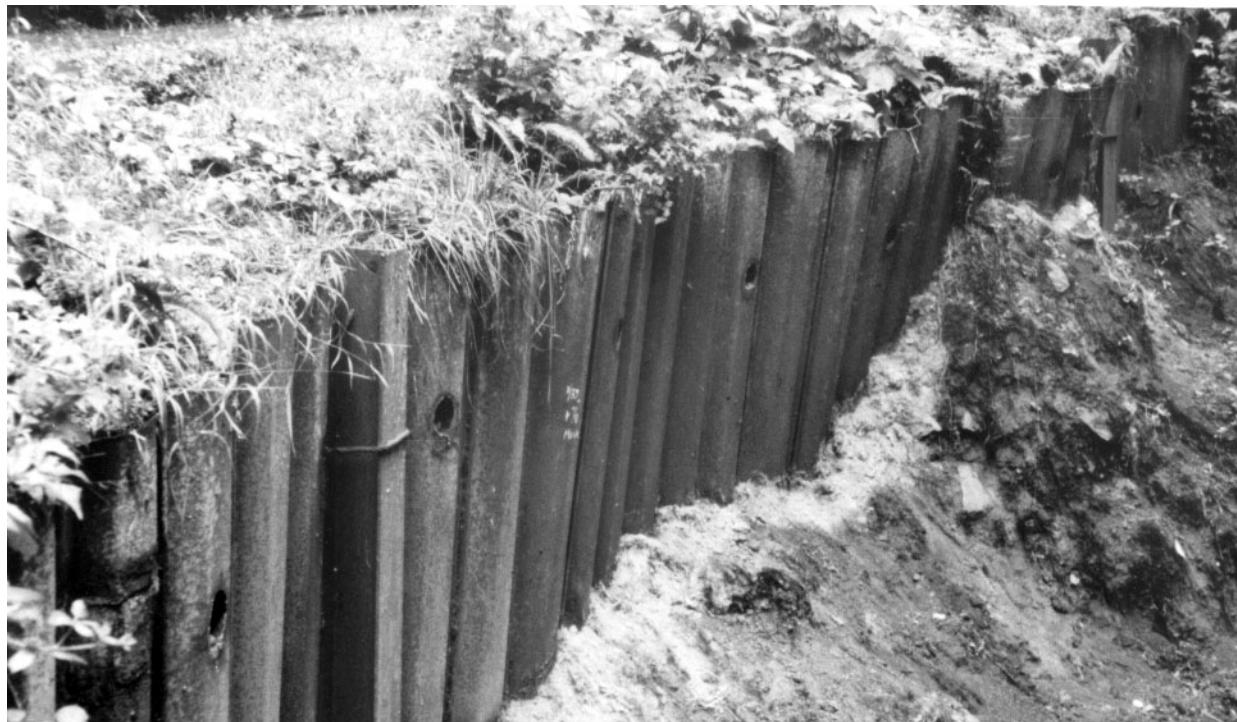
Photo 20. A driven sheet pile 1H-pile retaining wall in Oregon. Note the holes burned into the sheet pile for the launched soil nails.

Site 1	Siuslaw National Forest Tidewater Road (Road No. 52) Waldport, Oregon
Site Type	Retaining Wall
Site Description	The site was a driven sheet pile retaining wall on the outside shoulder of a single-lane, paved forest access road. The wall was about 15 feet high (exposed height) with driven H-piles on about 8-foot centers. Cable tiebacks, which were installed on the H-piles when the wall was constructed about 20 years ago, have failed due to corrosion. The road haul weight capacity has been reduced as a result of the corroded cable tiebacks.
Demonstration Description	Nails were installed in the ditchline, fill slope, and through the retaining wall face. The nails in the ditchline and fill slope demonstrated the machine's versatility and ability to install nails at various angles from the horizontal. The nails in the retaining wall showed the ability to precisely locate and install the nails (photos 20-23).

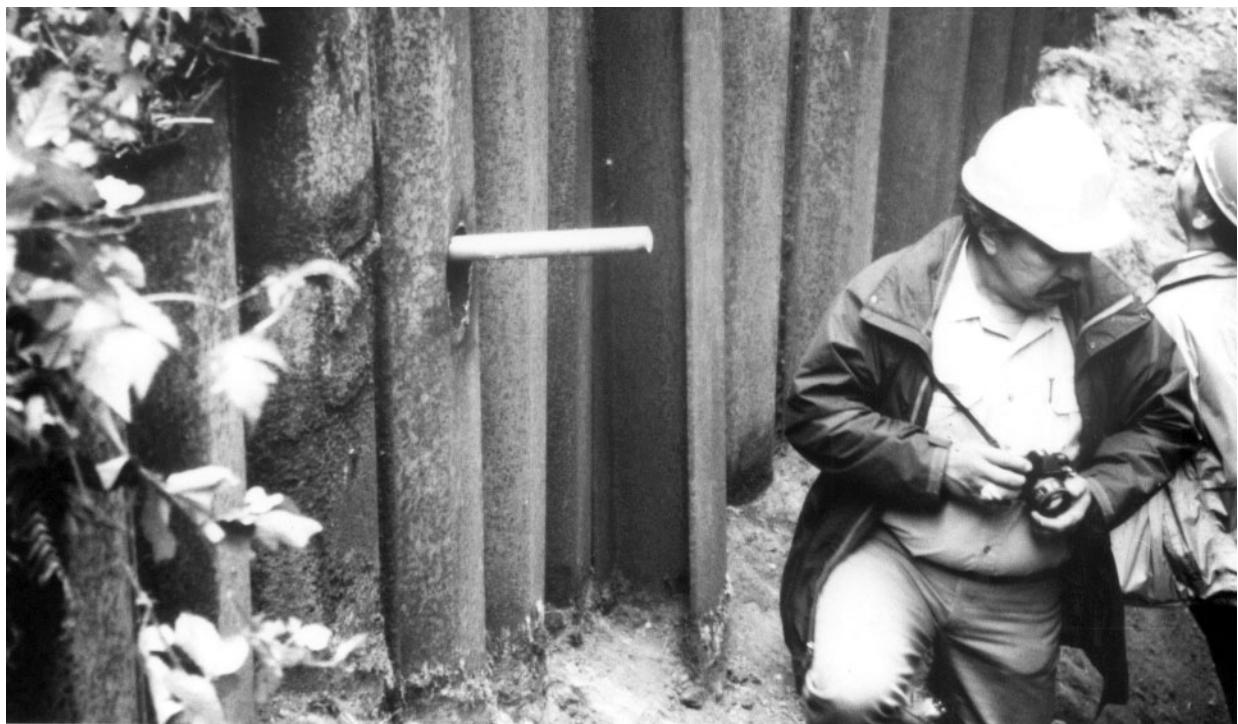
Results	The first nail was launched through the retaining wall at about 2000 psi (13.8 Pa) launch pressure, penetrating about 16 feet (4.9 m) and leaving about 2 feet (0.6 m) exposed outside the wall. The second nail launched at the same pressure penetrated over 18 feet (5.5 m), completely disappearing inside the wall. Several more nails launched at successively lower pressures completely disappeared inside the wall. Finally, a nail launched at about 600 psi (4.1 MPa) resulted in a 16-foot (4.9 m) penetration. The retaining wall backfill appeared to be of low density. This demonstration illustrated: <ul style="list-style-type: none"> • The ability to precisely install nails through holes in a retaining wall. A pipe extension (nail guide) attached to the bottom of the launcher helped guide the nail into the hole in the wall:

Photo 23. About 1.5 feet (0.5M) of the 18-foot (4.5 M) soil nail launched into the retaining wall backfill.
